Inspection Photos

Operator: TEP ROCKY MOUNTAIN LLC #96850

Location ID: 323868

Inspection Doc: 718100399

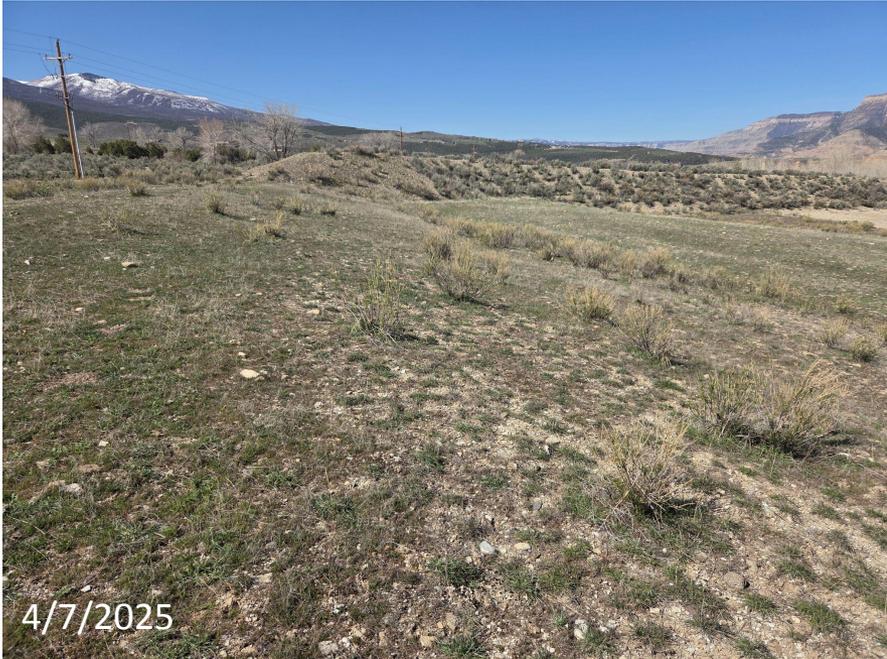
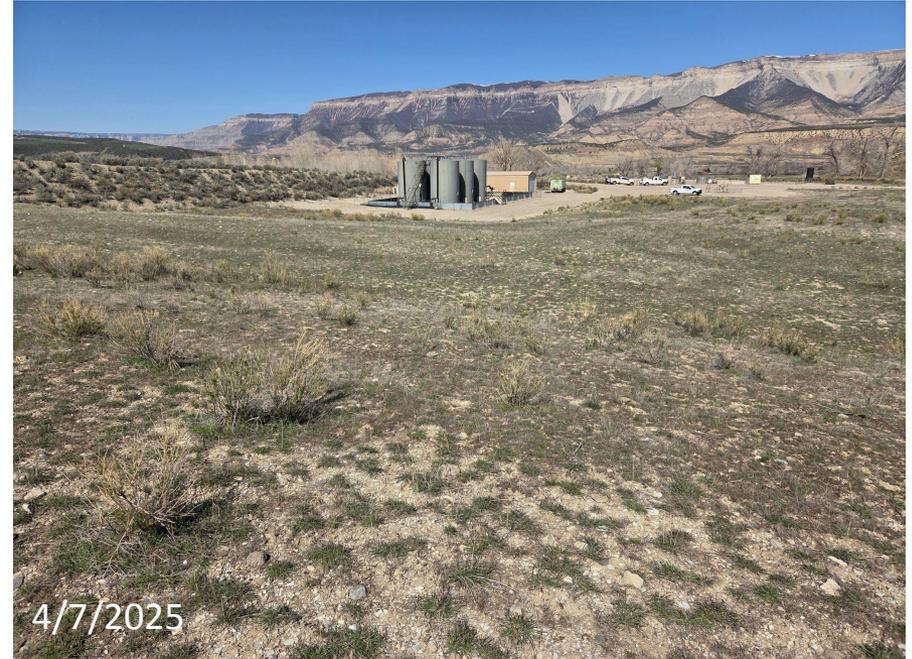
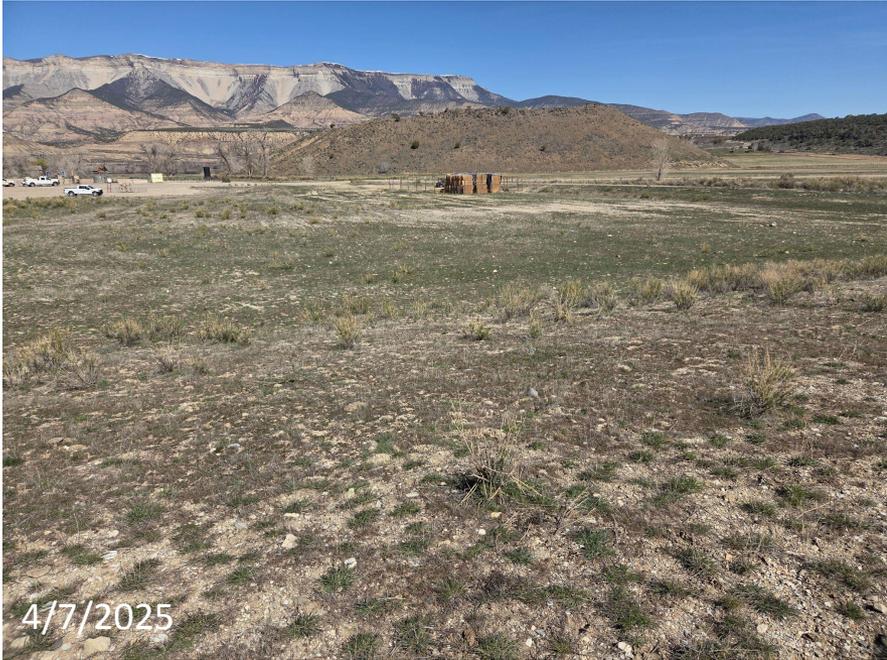
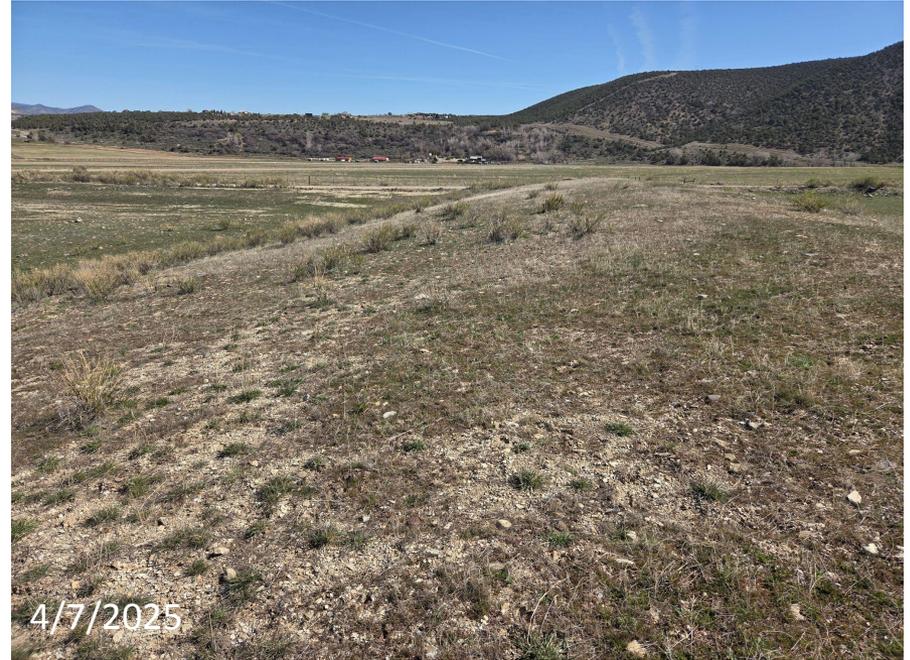
Photo 1: Photos 1-2 taken from the south end of the Location. Photos provide an overview from west, northwest, northeast to east.

Photo 2: See comments under photo 1.

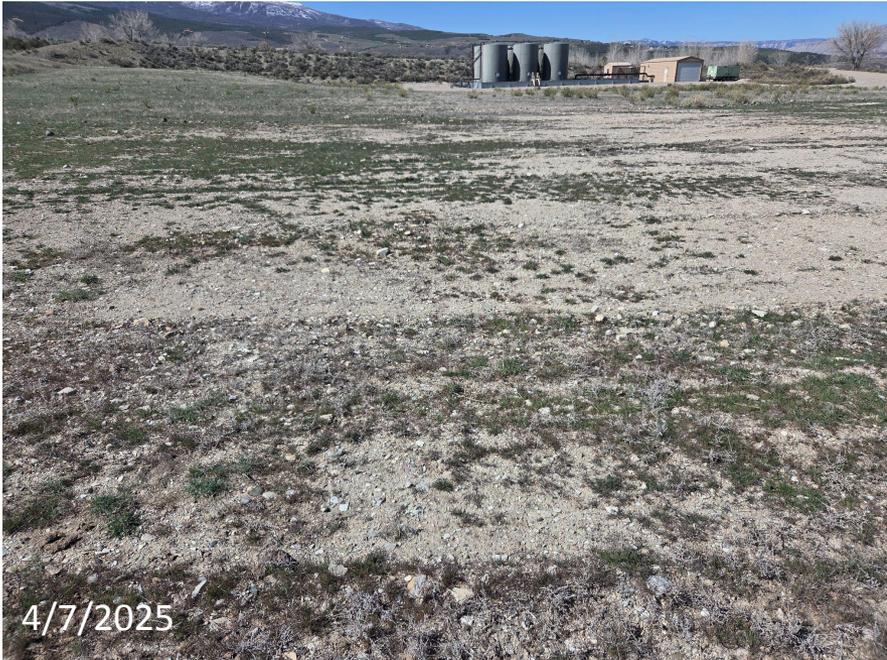
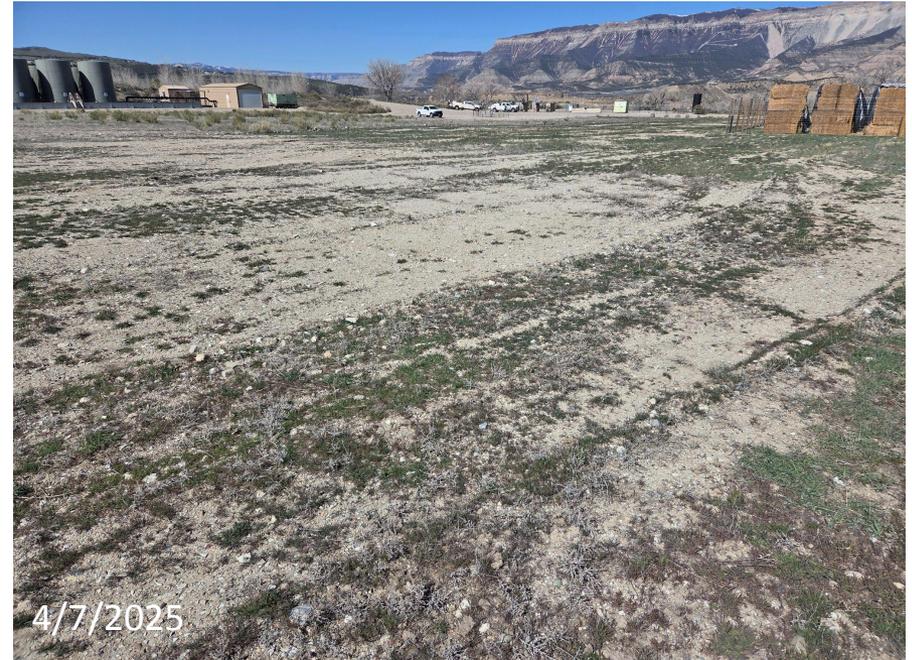
Photo 3: Photos taken from the southeast interim areas of the Location, facing west and northeast. Photos examples showing interim areas that remain predominantly bare soils, and are not progressing towards ECMC 1003 standards.

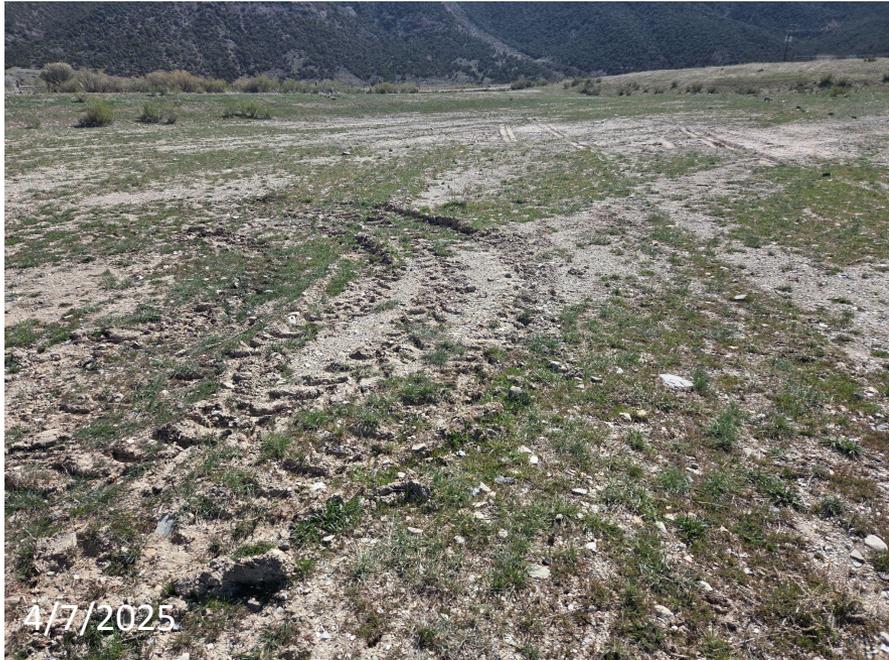
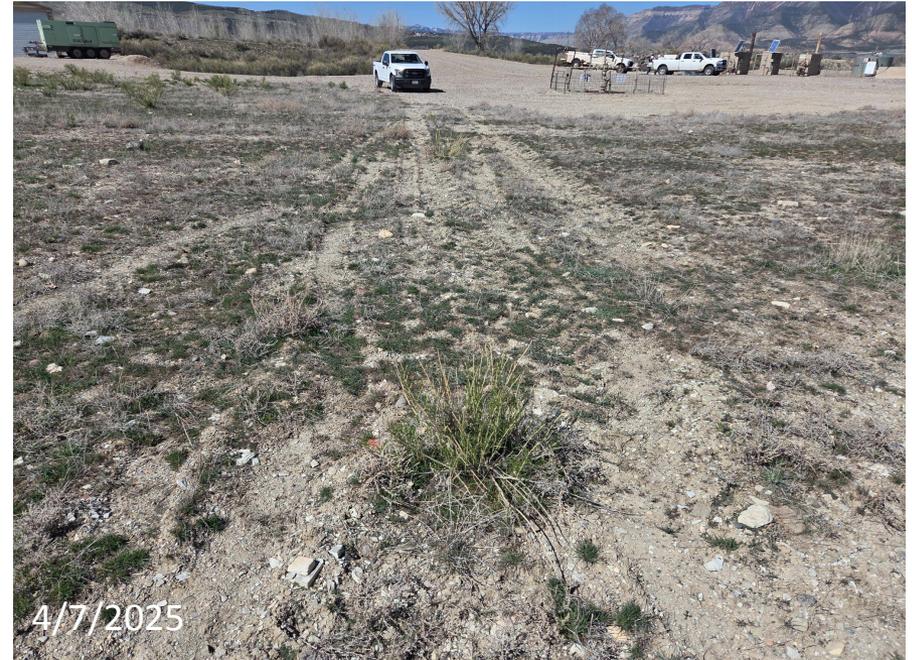
Photo 4: Photos examples showing vehicle/equipment tracking evident within the interim areas. Vehicle/equipment travel is required to be restricted to the designated working pad surface and access roads.

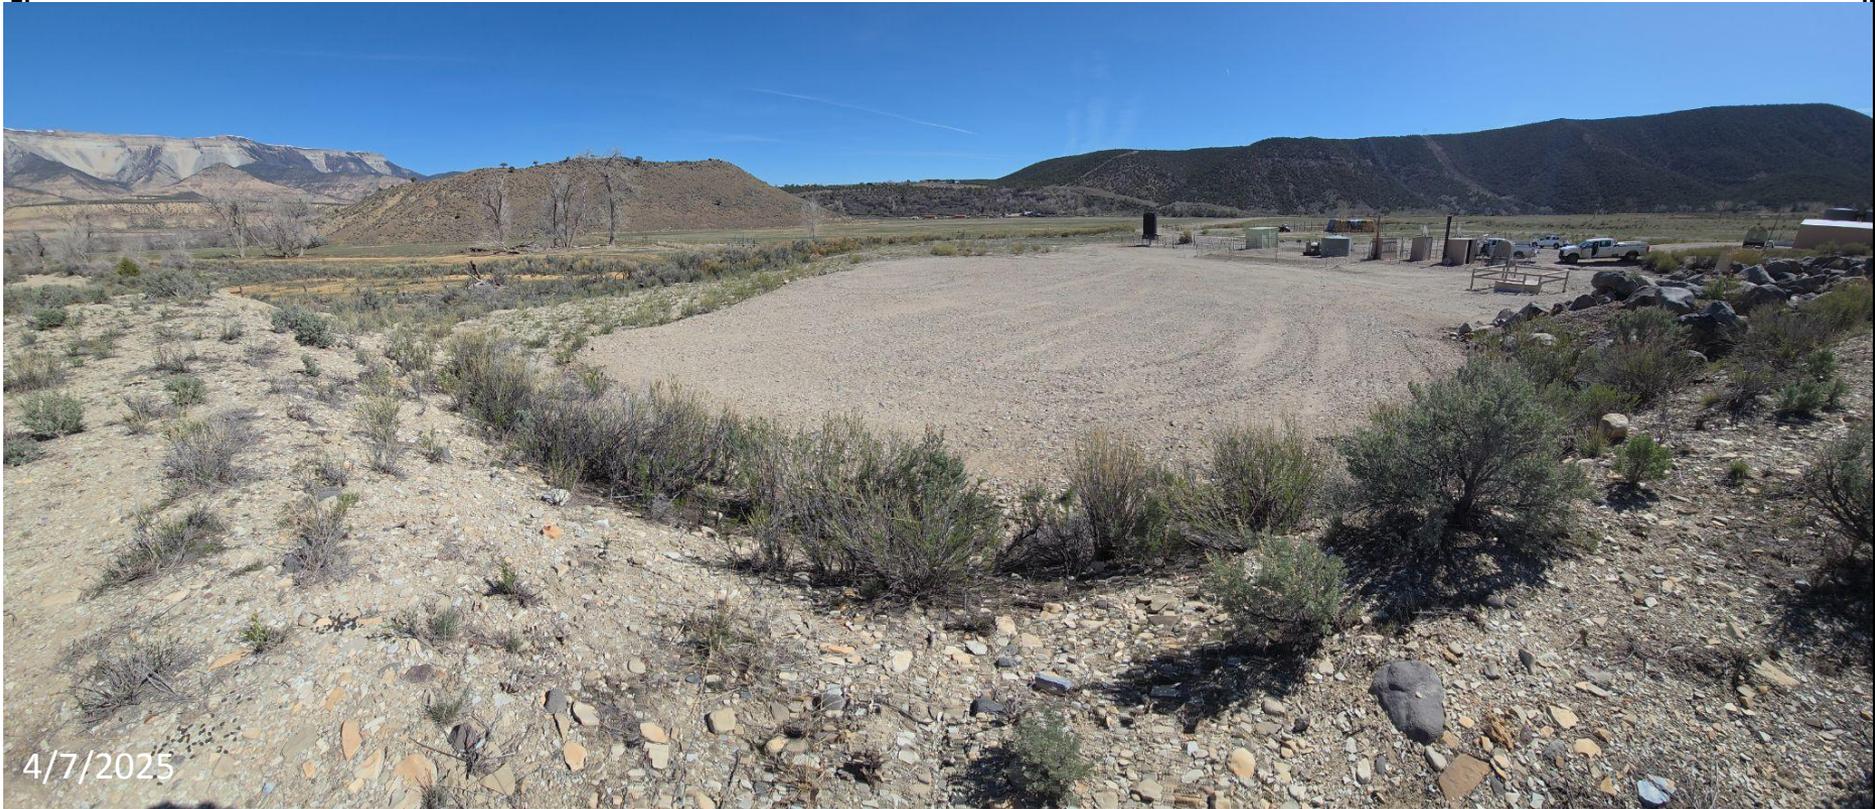
Photo 5: Photo taken from the east northwest end of the Location, facing east. Photo shows areas of the Location that are not necessary for production that require reclamation pursuant to 1003 requirements.

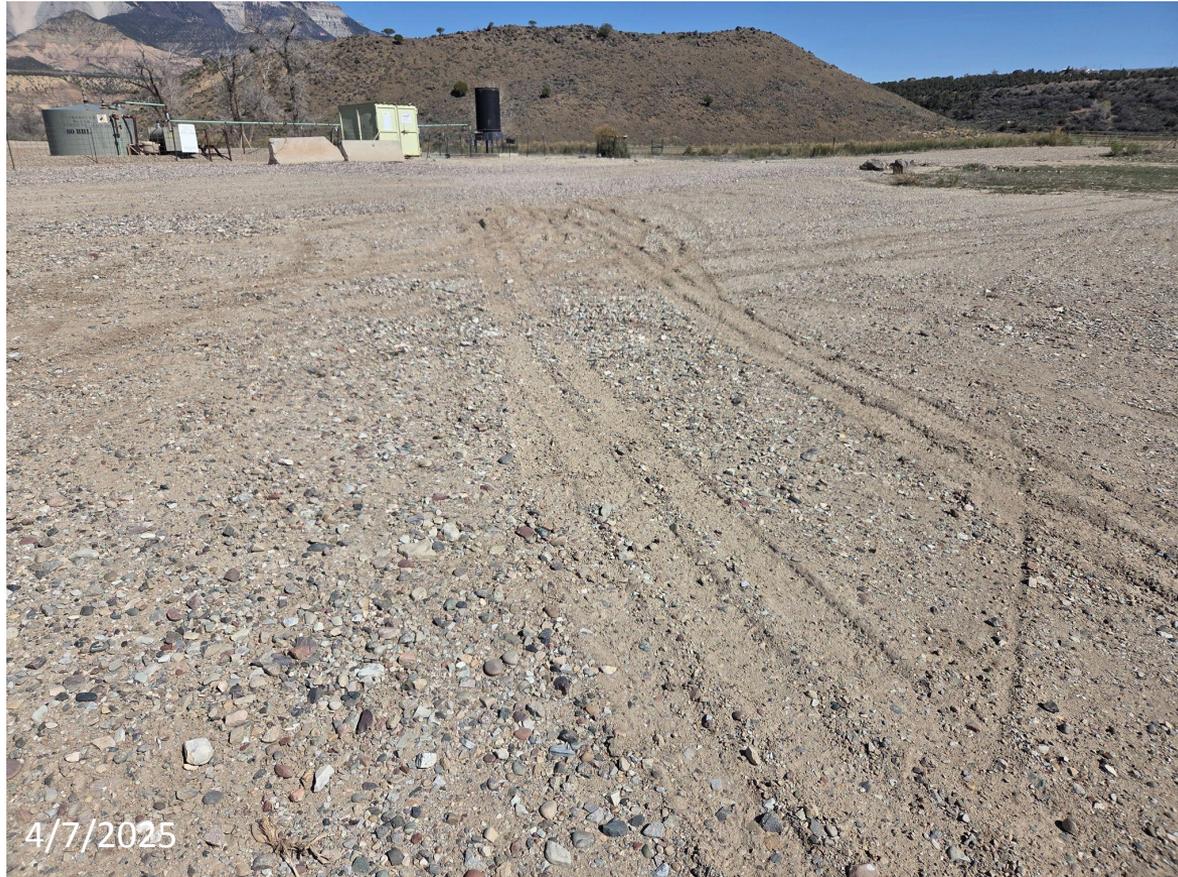
Photo 6: Photo example showing BMPs to stabilize the working pad surface show signs of disrepair.

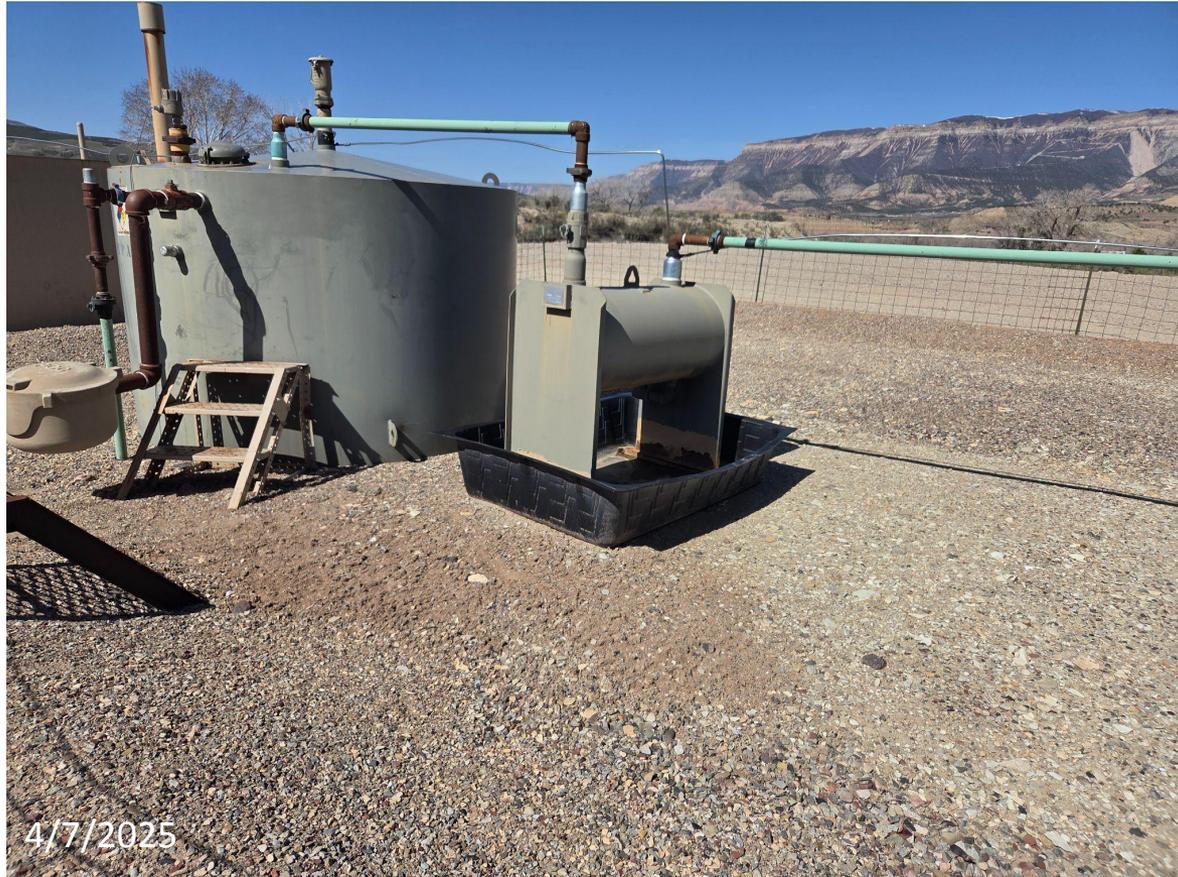
Photo 7: Wildlife protection measures at secondary containment are missing or insufficient.

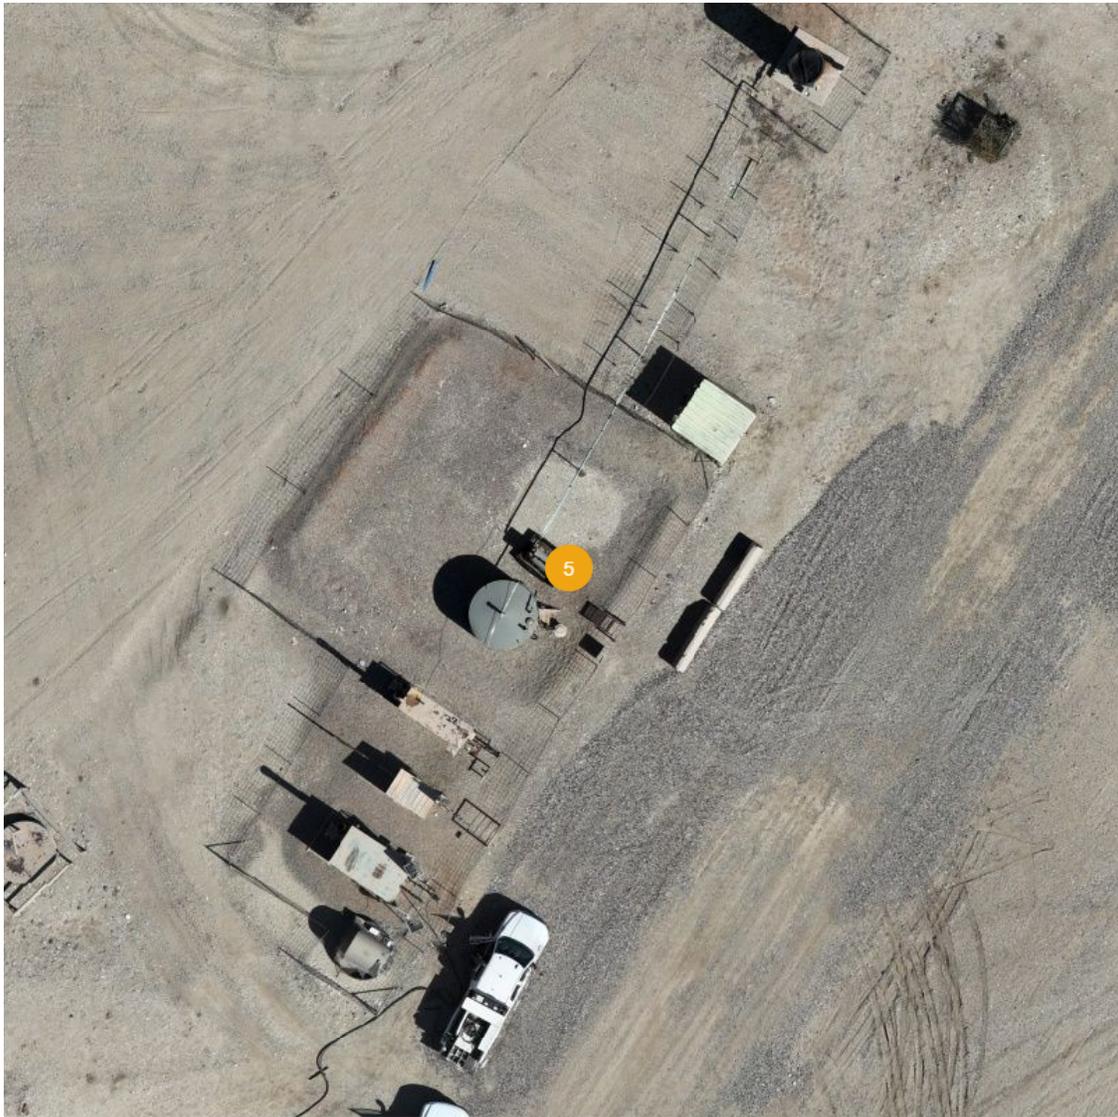
5 - Observation

Wildlife protection BMPs missing or insufficient.

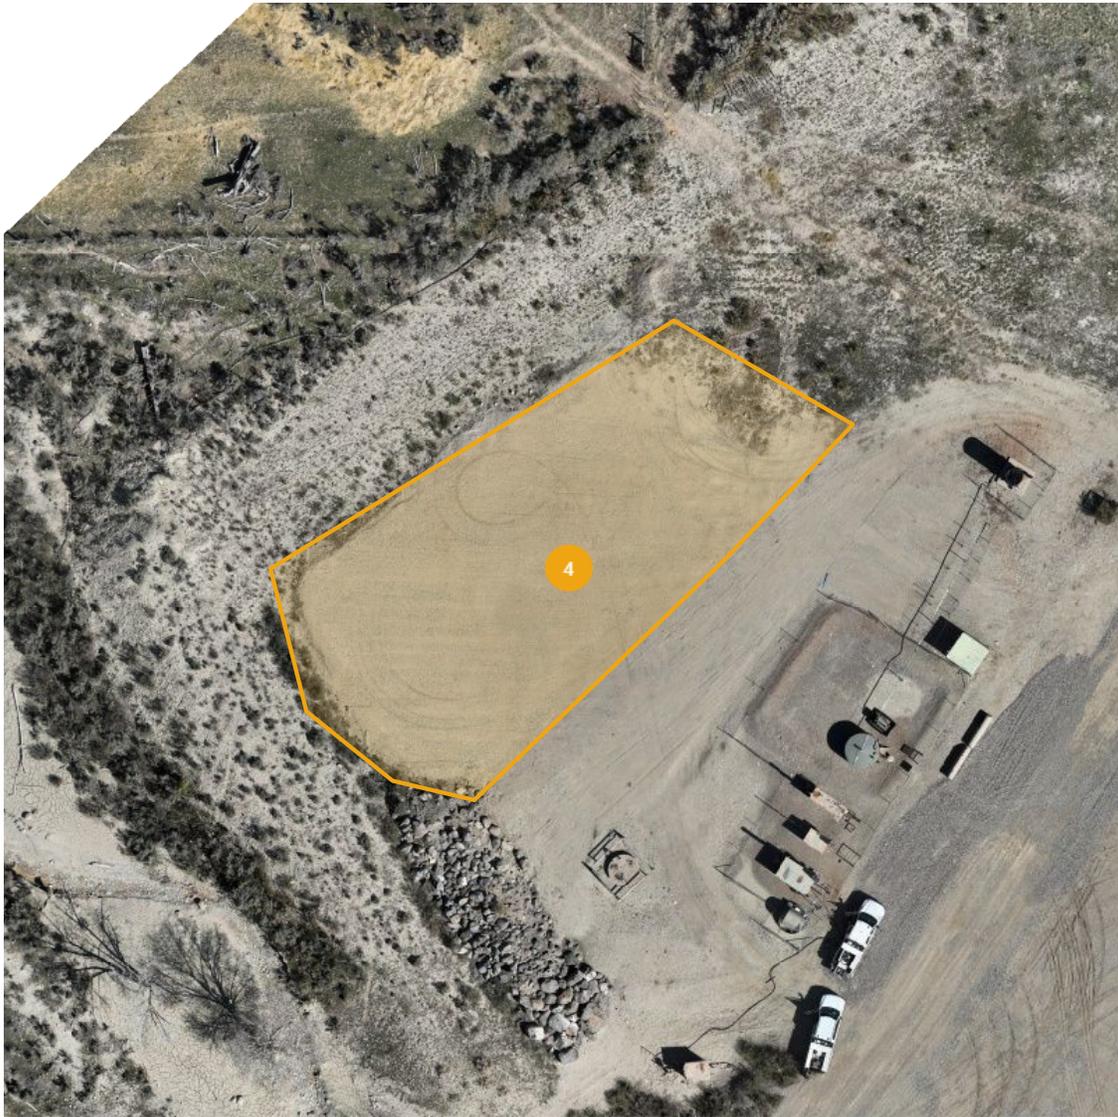
4 - Observation

Summary:	Areas not necessary for production operations are subject to 1003 requirements.
Created:	Apr 8, 2025, 8:44am by Aaron Trujillo
Cost of Repair:	—
Lat/Long:	39.49241, -107.86020
Area:	10349.00 ft ²
Surface area:	10419.00 ft ²

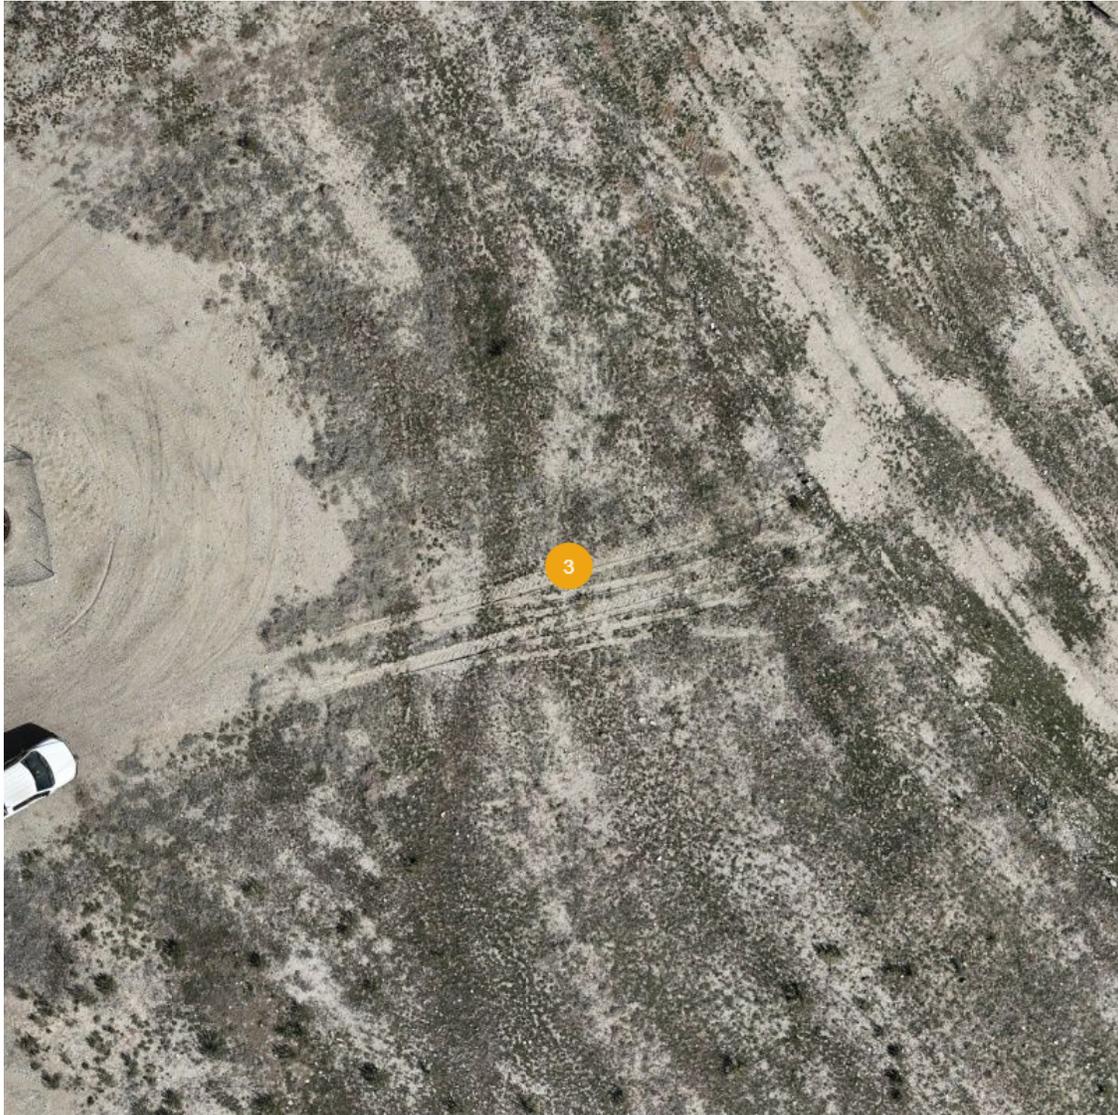
3 - Observation

Summary:	Vehicle travel beyond the designated access road, and working pad surface.
Created:	Apr 8, 2025, 8:21am by Aaron Trujillo
Cost of Repair:	—
Lat/Long:	39.4920518, -107.8592894
Northing:	1612754.1 US ft
Easting:	2334244.9 US ft
Elevation:	-3.84 US ft

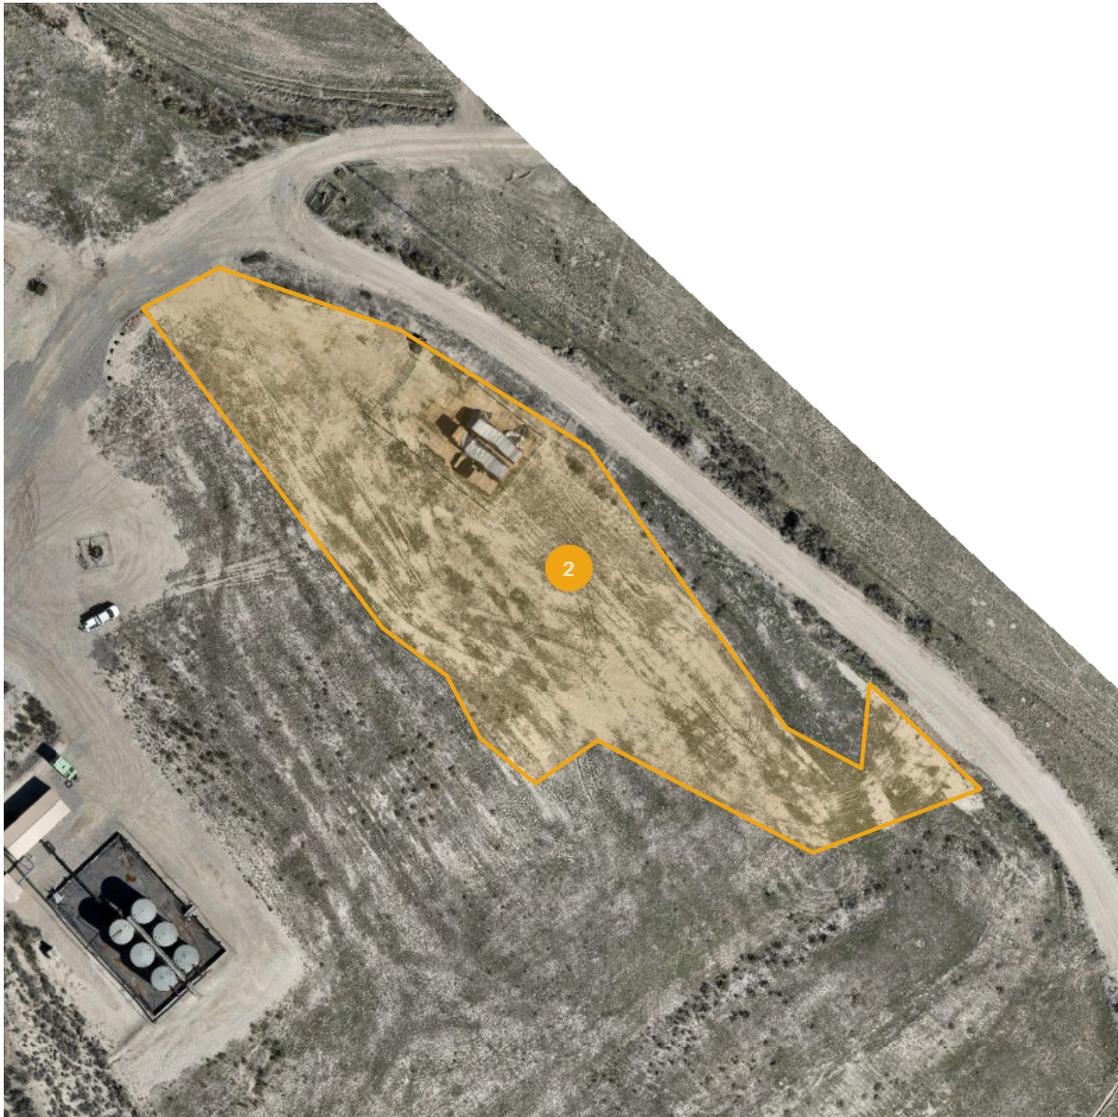
2 - Observation

Summary:	Approximate interim areas that don't meet 1003 requirements.
Created:	Apr 8, 2025, 8:20am by Aaron Trujillo
Cost of Repair:	—
Lat/Long:	39.49199, -107.85868
Area:	1.14 acres
Surface area:	1.18 acres

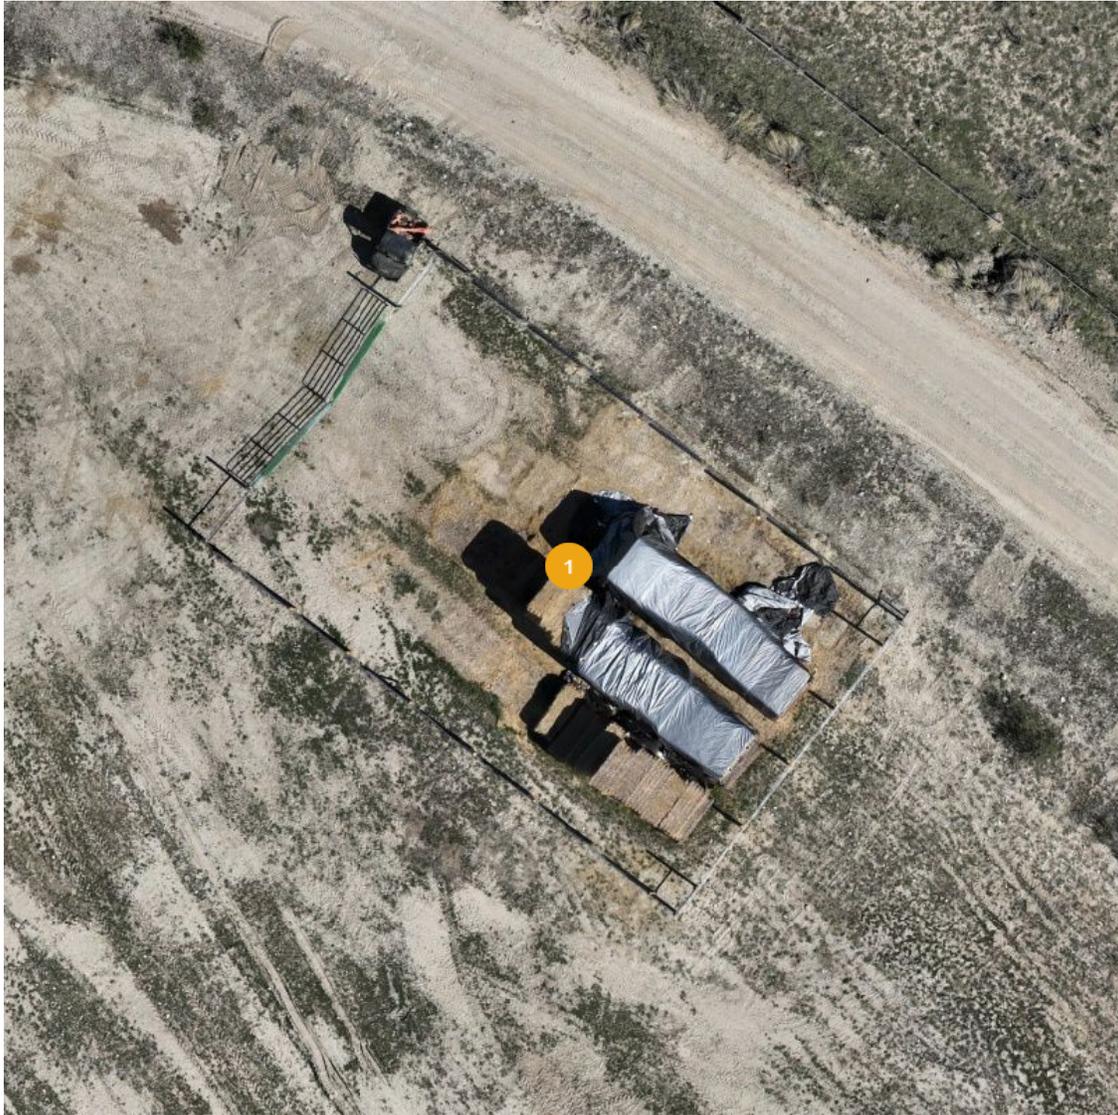
1 - Observation

Summary:	No 502.b variance to 1003 requirements has been submitted or approved
Created:	Apr 8, 2025, 8:19am by Aaron Trujillo
Cost of Repair:	—
Lat/Long:	39.4922546, -107.8588649
Northing:	1612824.9 US ft
Easting:	2334366.6 US ft
Elevation:	-1.49 US ft
