## Inspection/Audit Photos

Location Name: TEP ROCKY MOUNTAIN LLC CLOUGH RWF 44-18 pad

Location ID: 335146

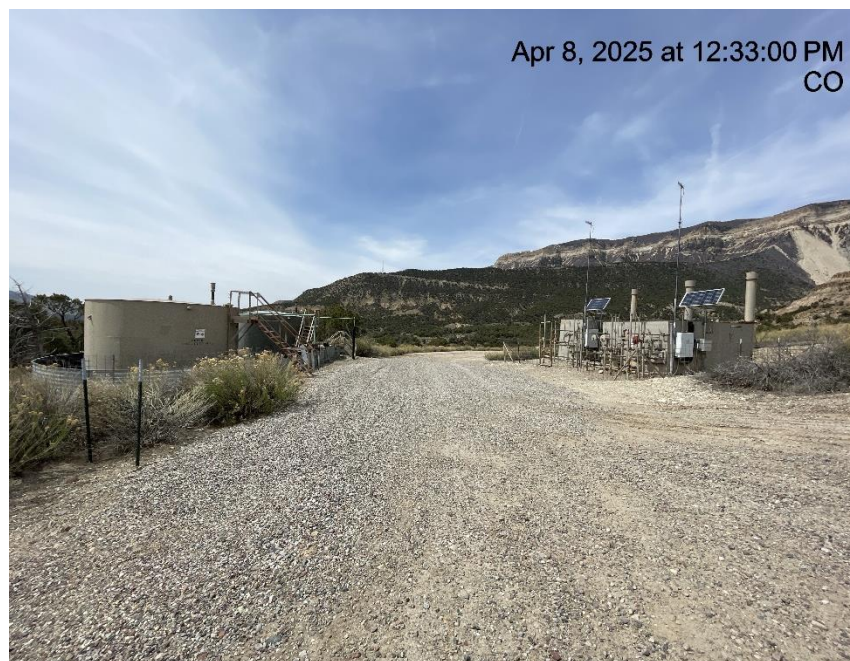
Photo # 9334 From entrance to location

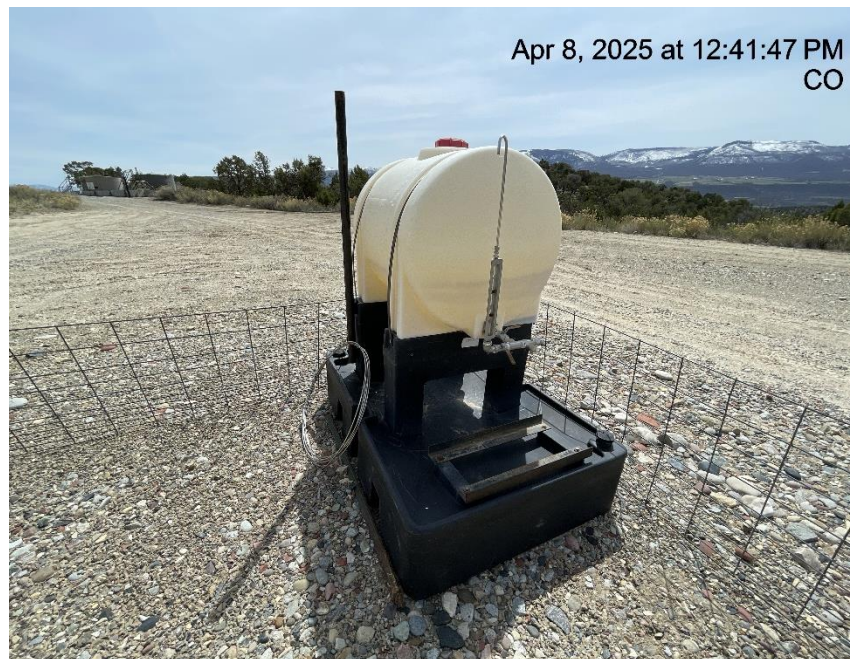
Photo # 9340 Unused equipment

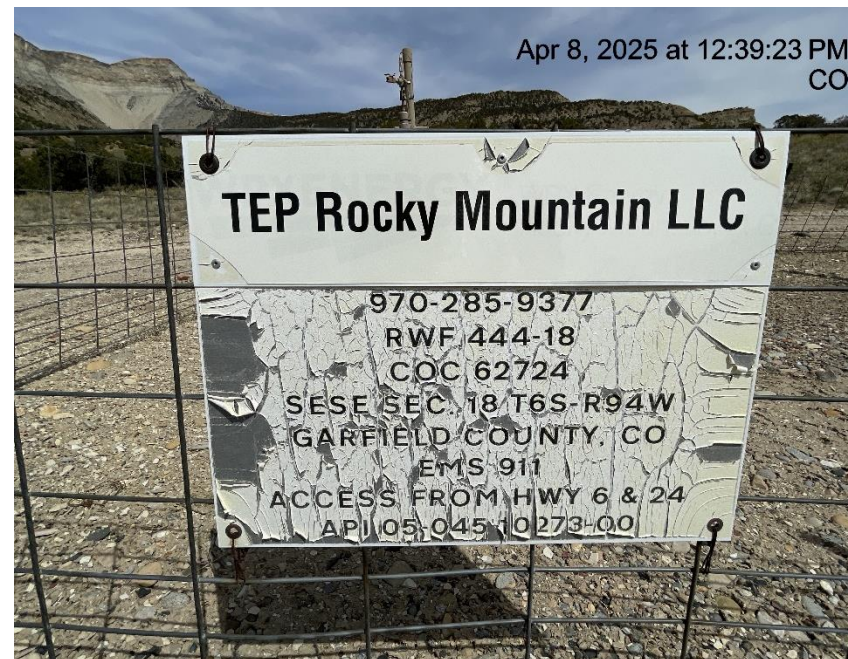
Photo # 9341 Wellhead sign weathered & peeling

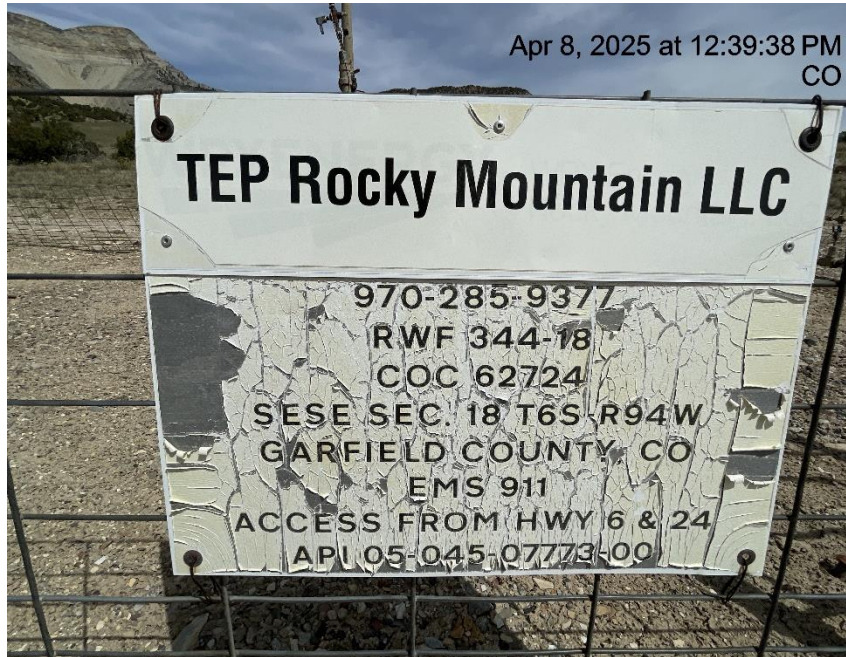
Photo # 9342 Wellhead sign weathered & peeling

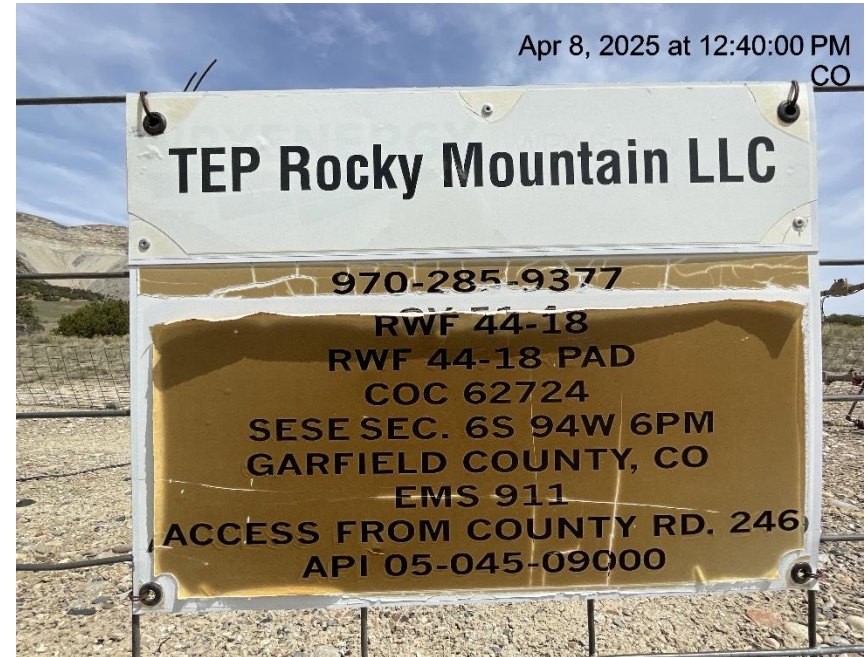
Photo # 9343 Wellhead sign weathered & starting to peel
