067-06141

Dakota Fee 1

4/7/2025 photos

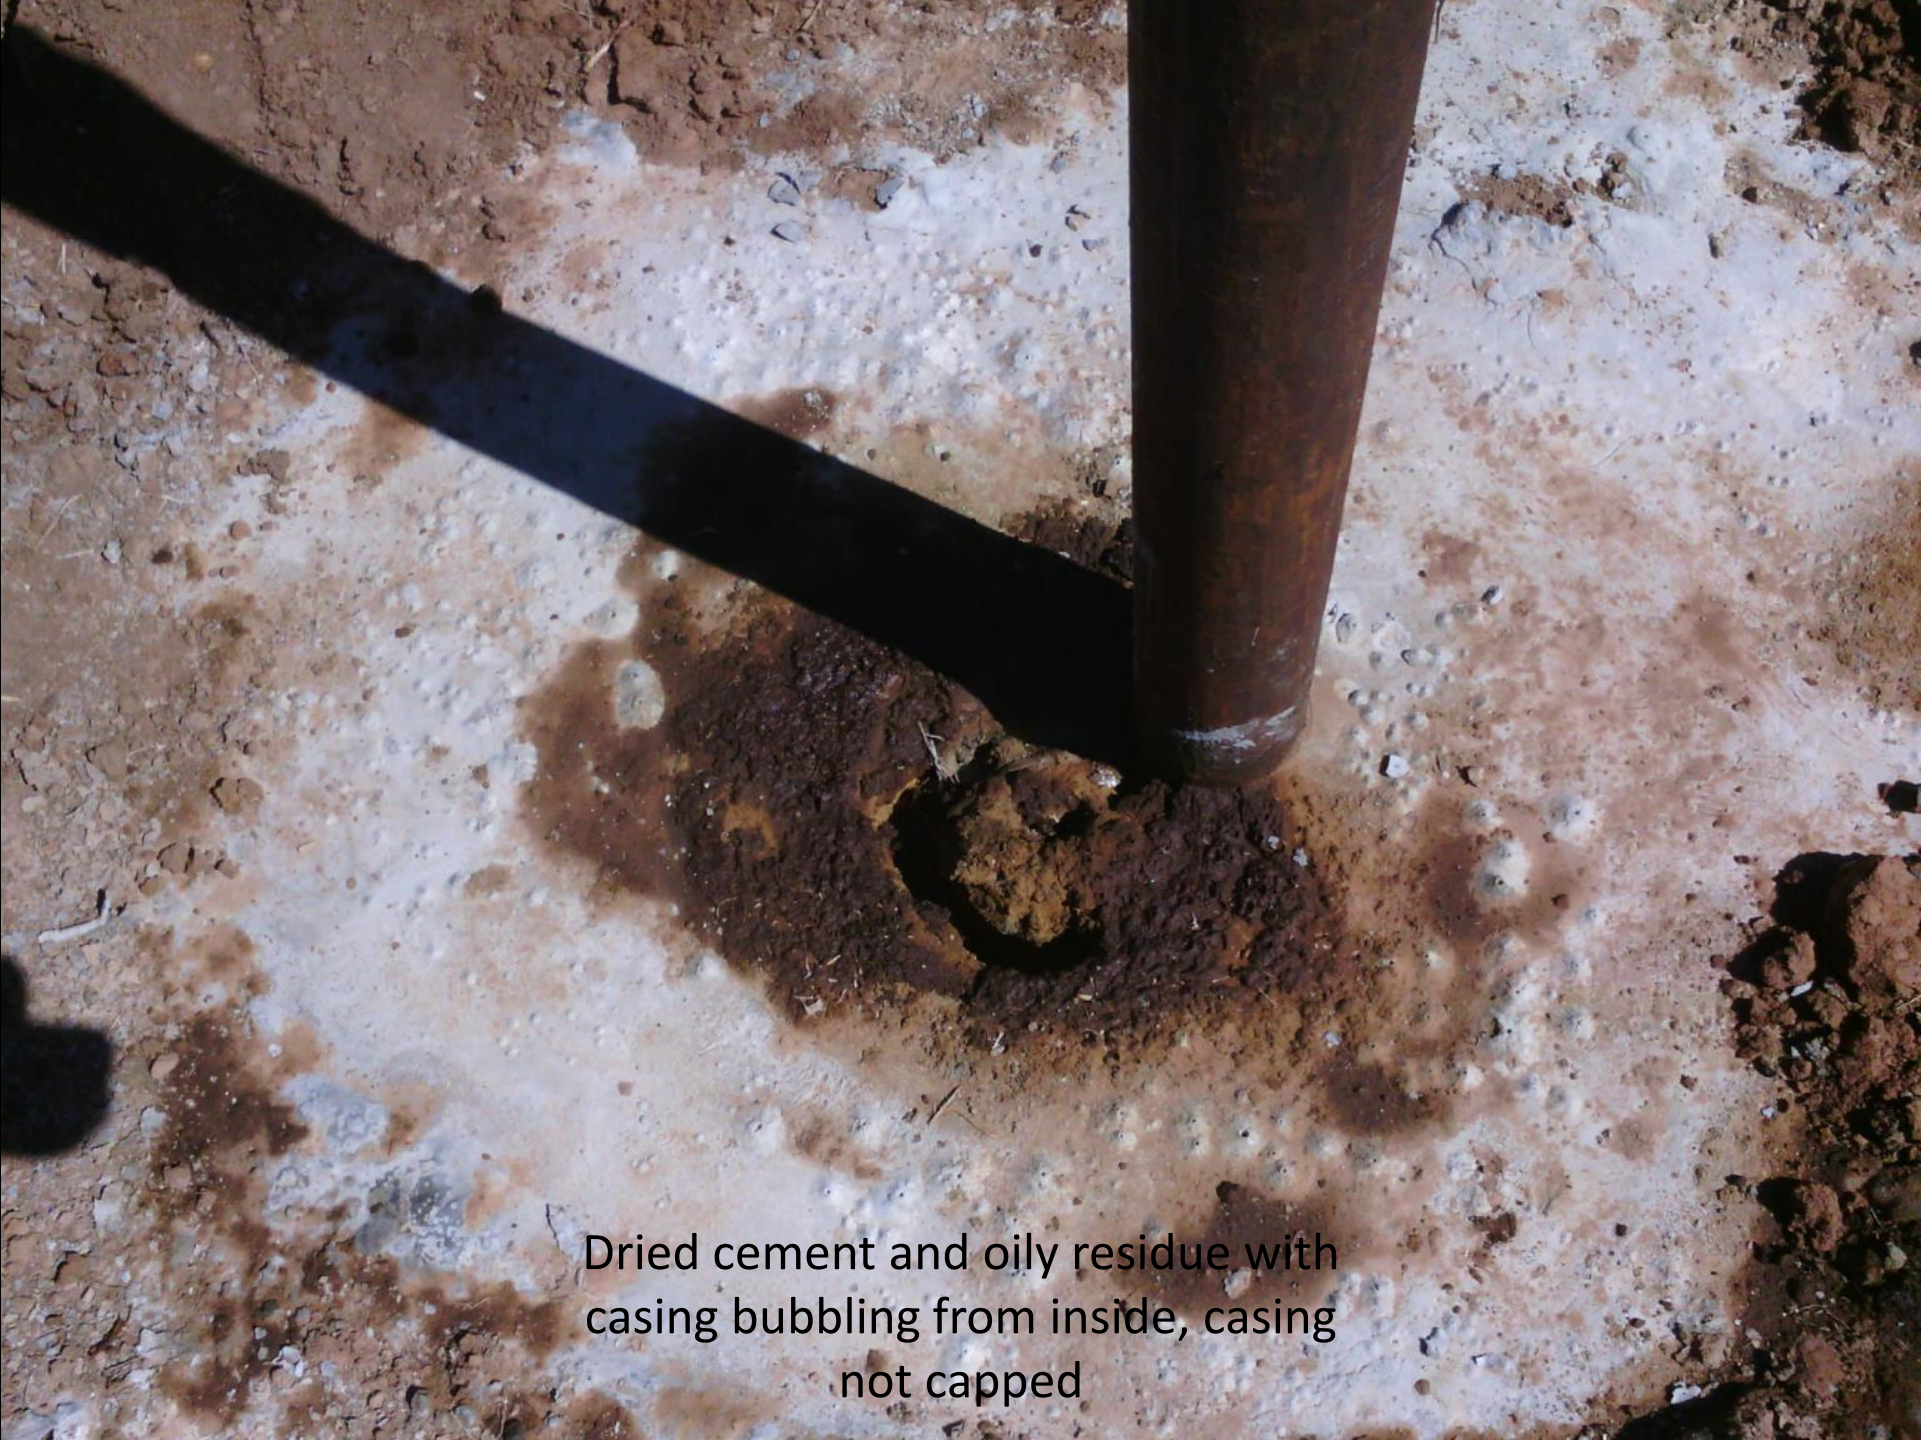
Dried cement and oily residue with
casing bubbling from inside, casing
not capped

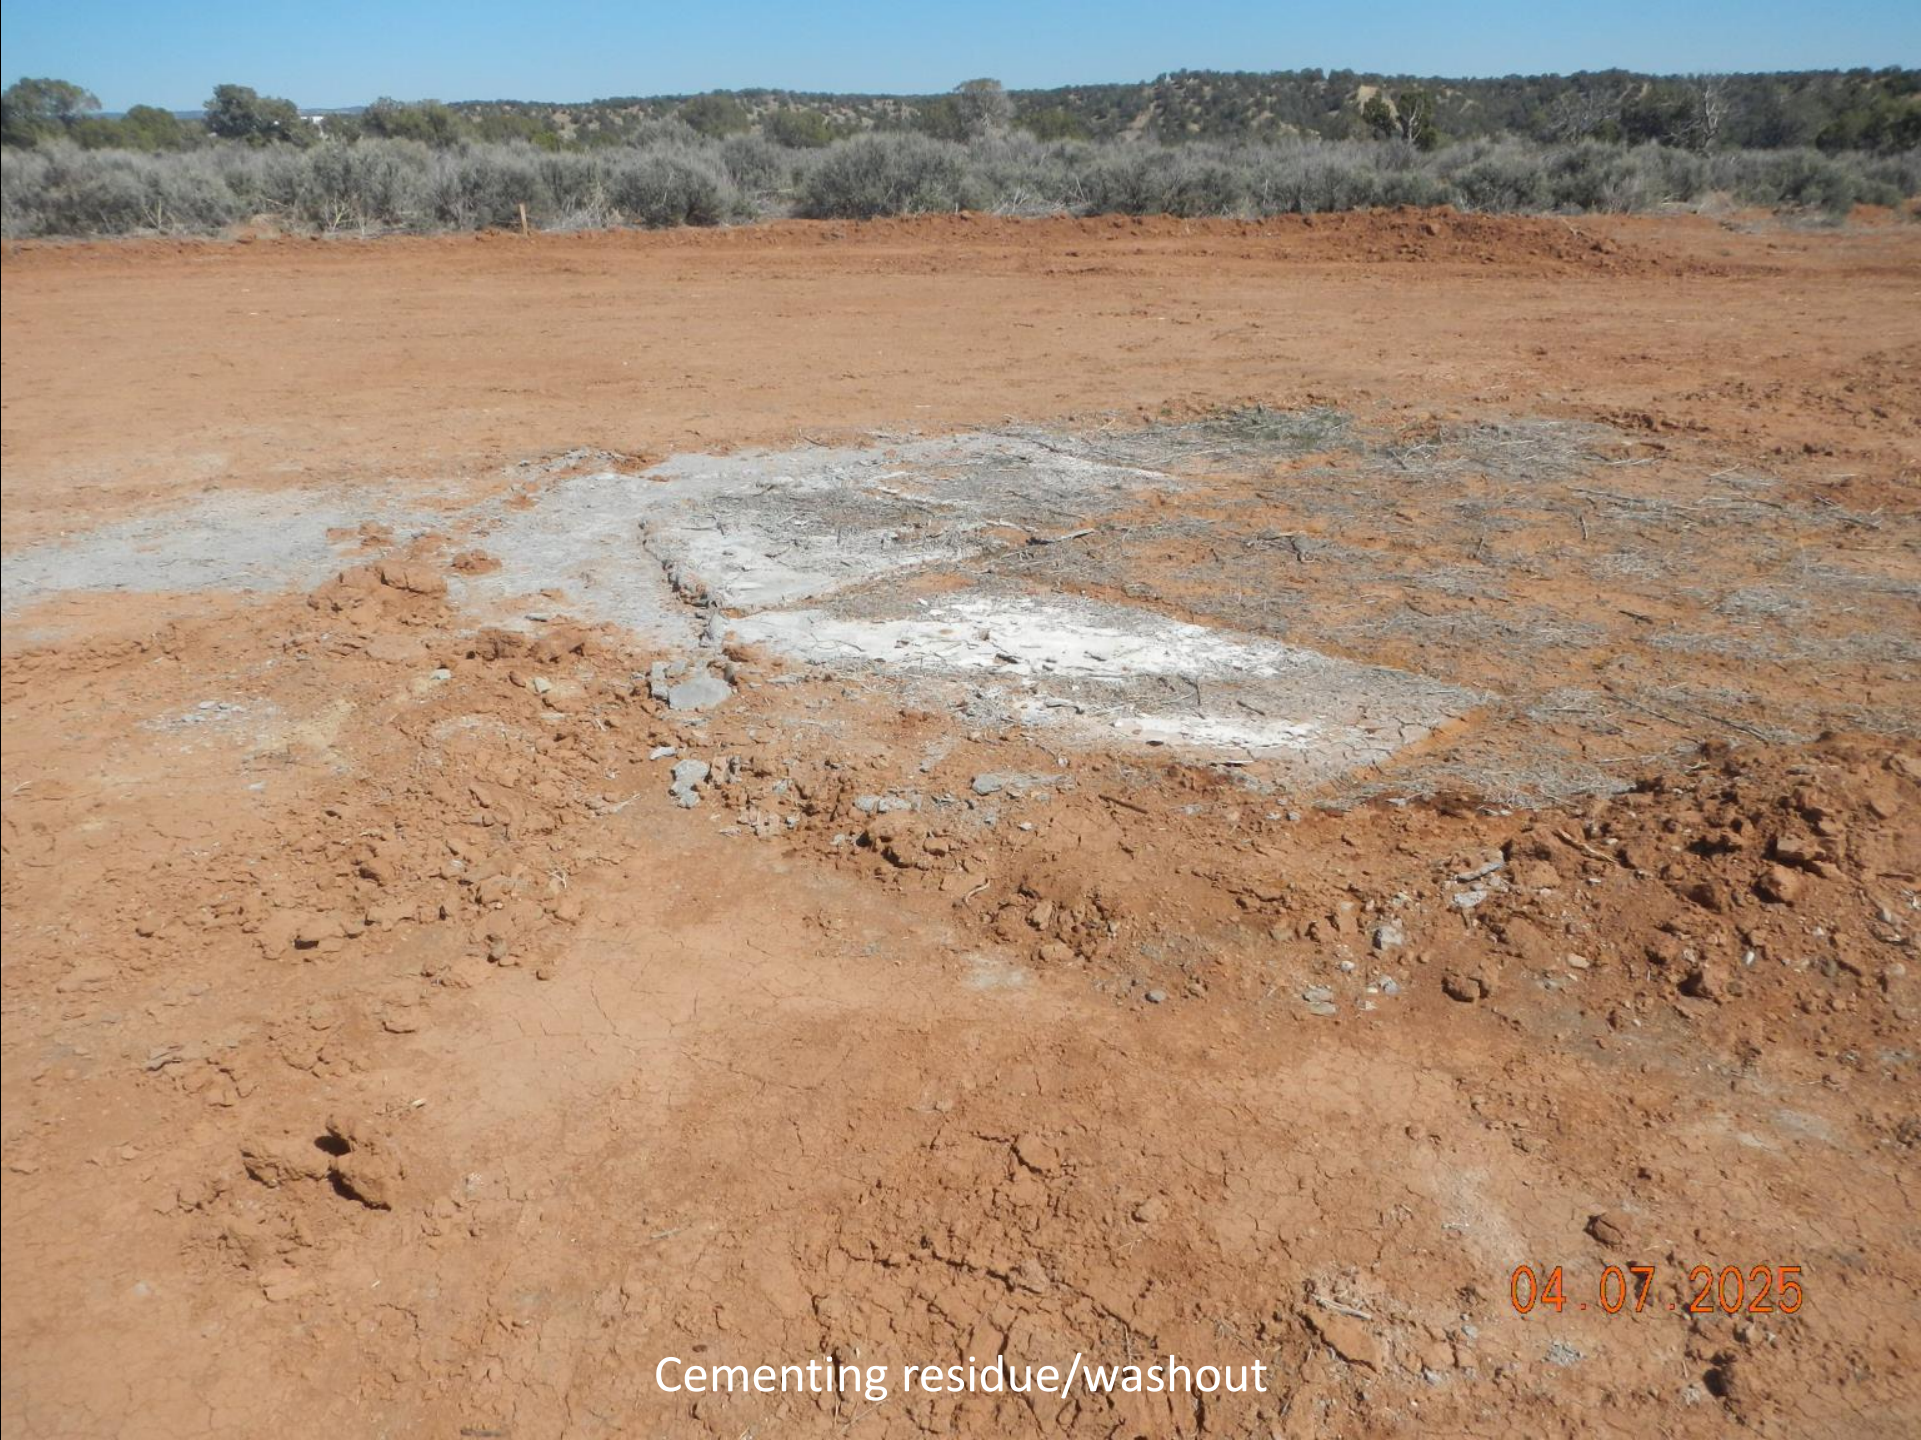
04.07.2025

Cementing residue/washout

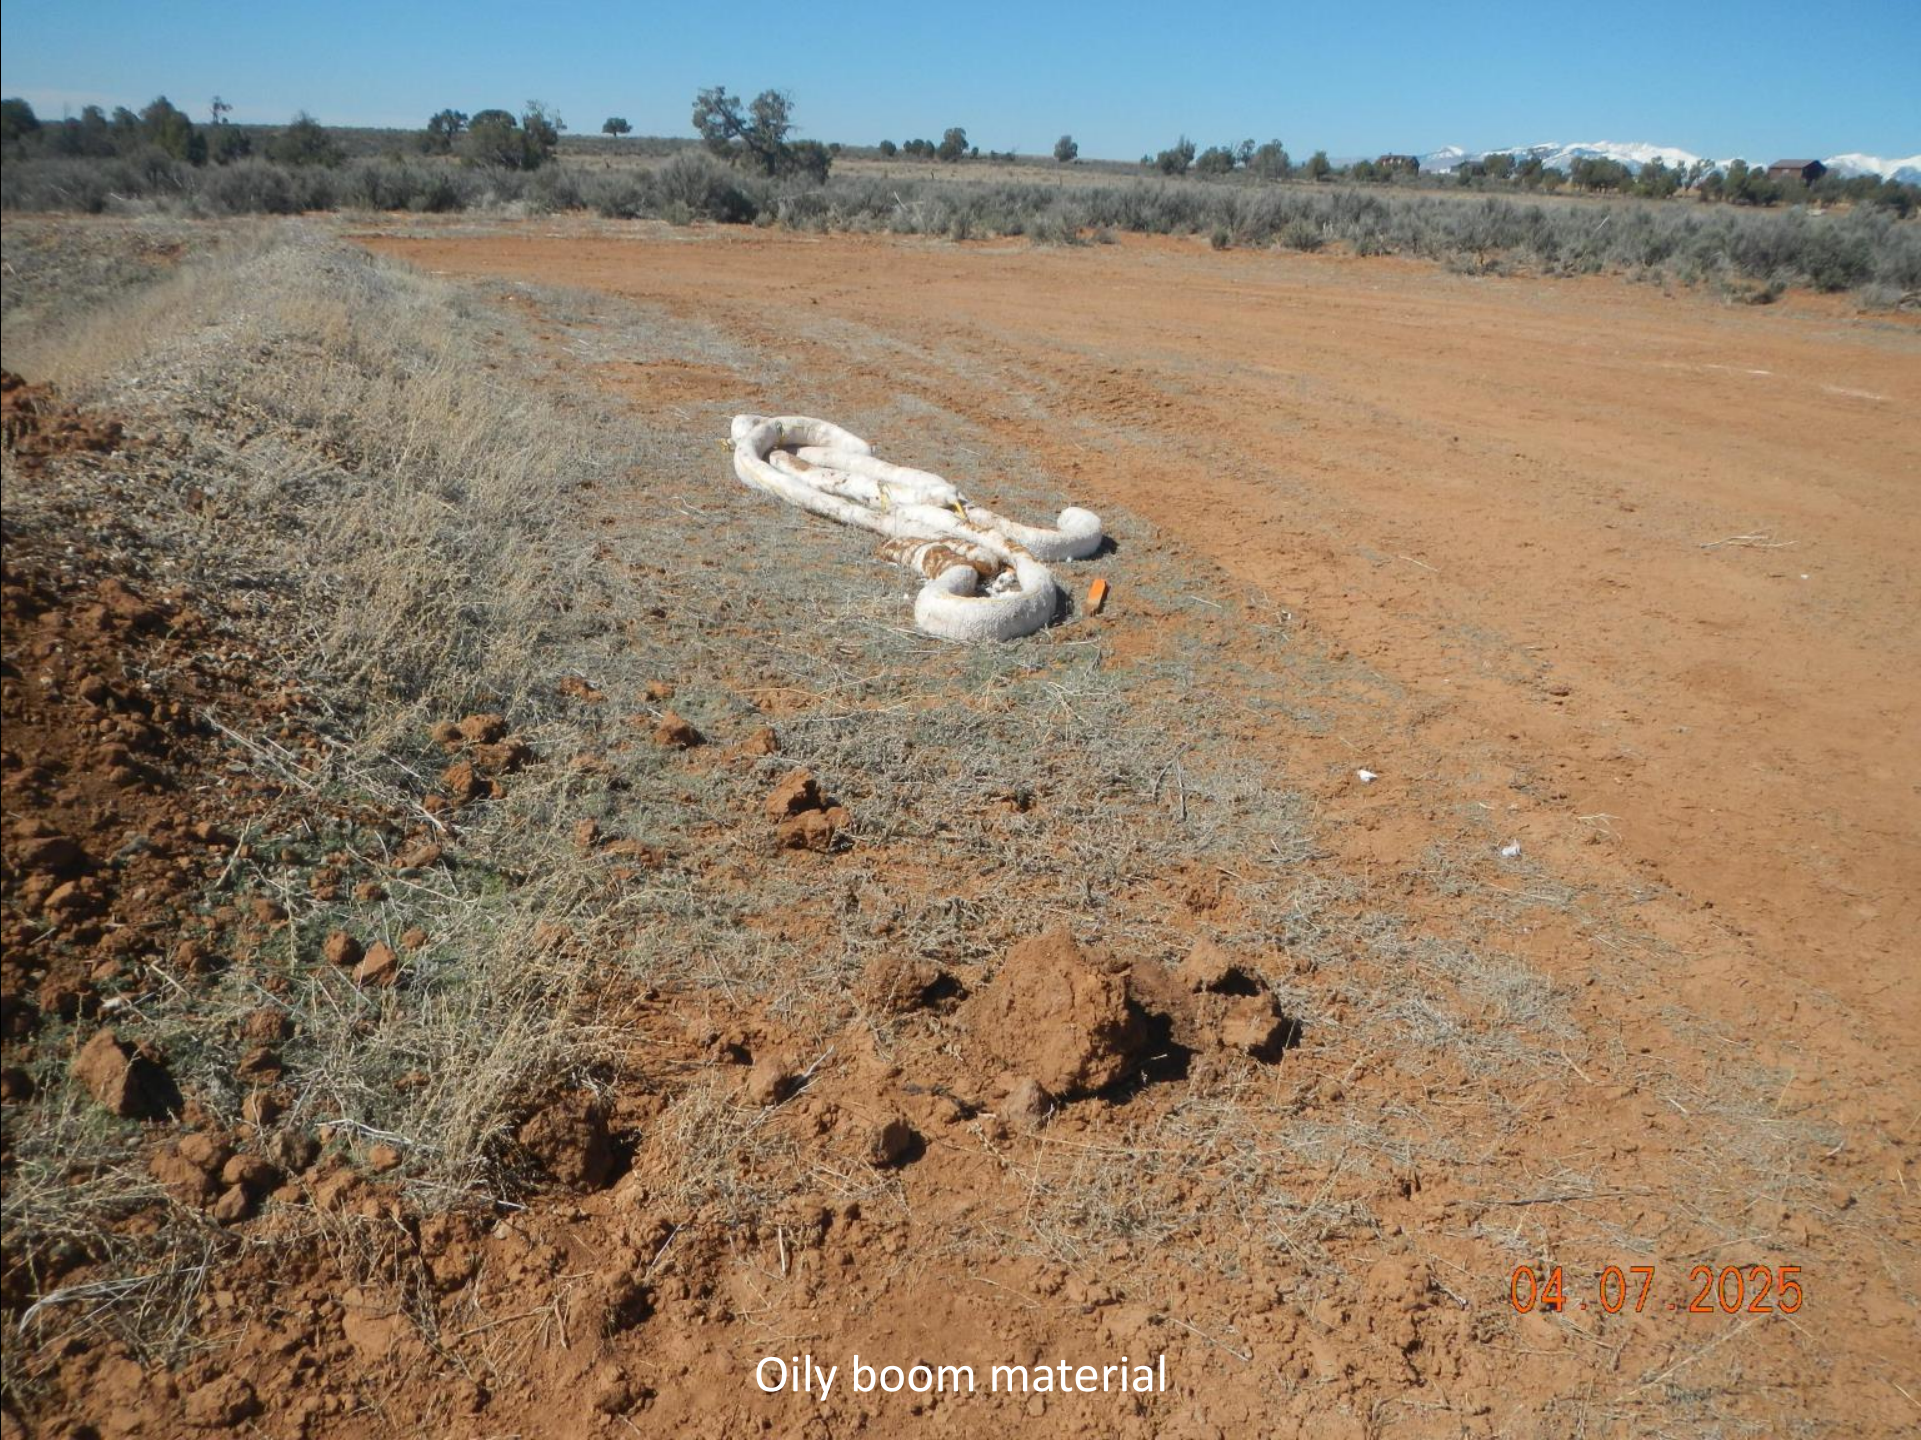
04.07.2025

Oily boom material

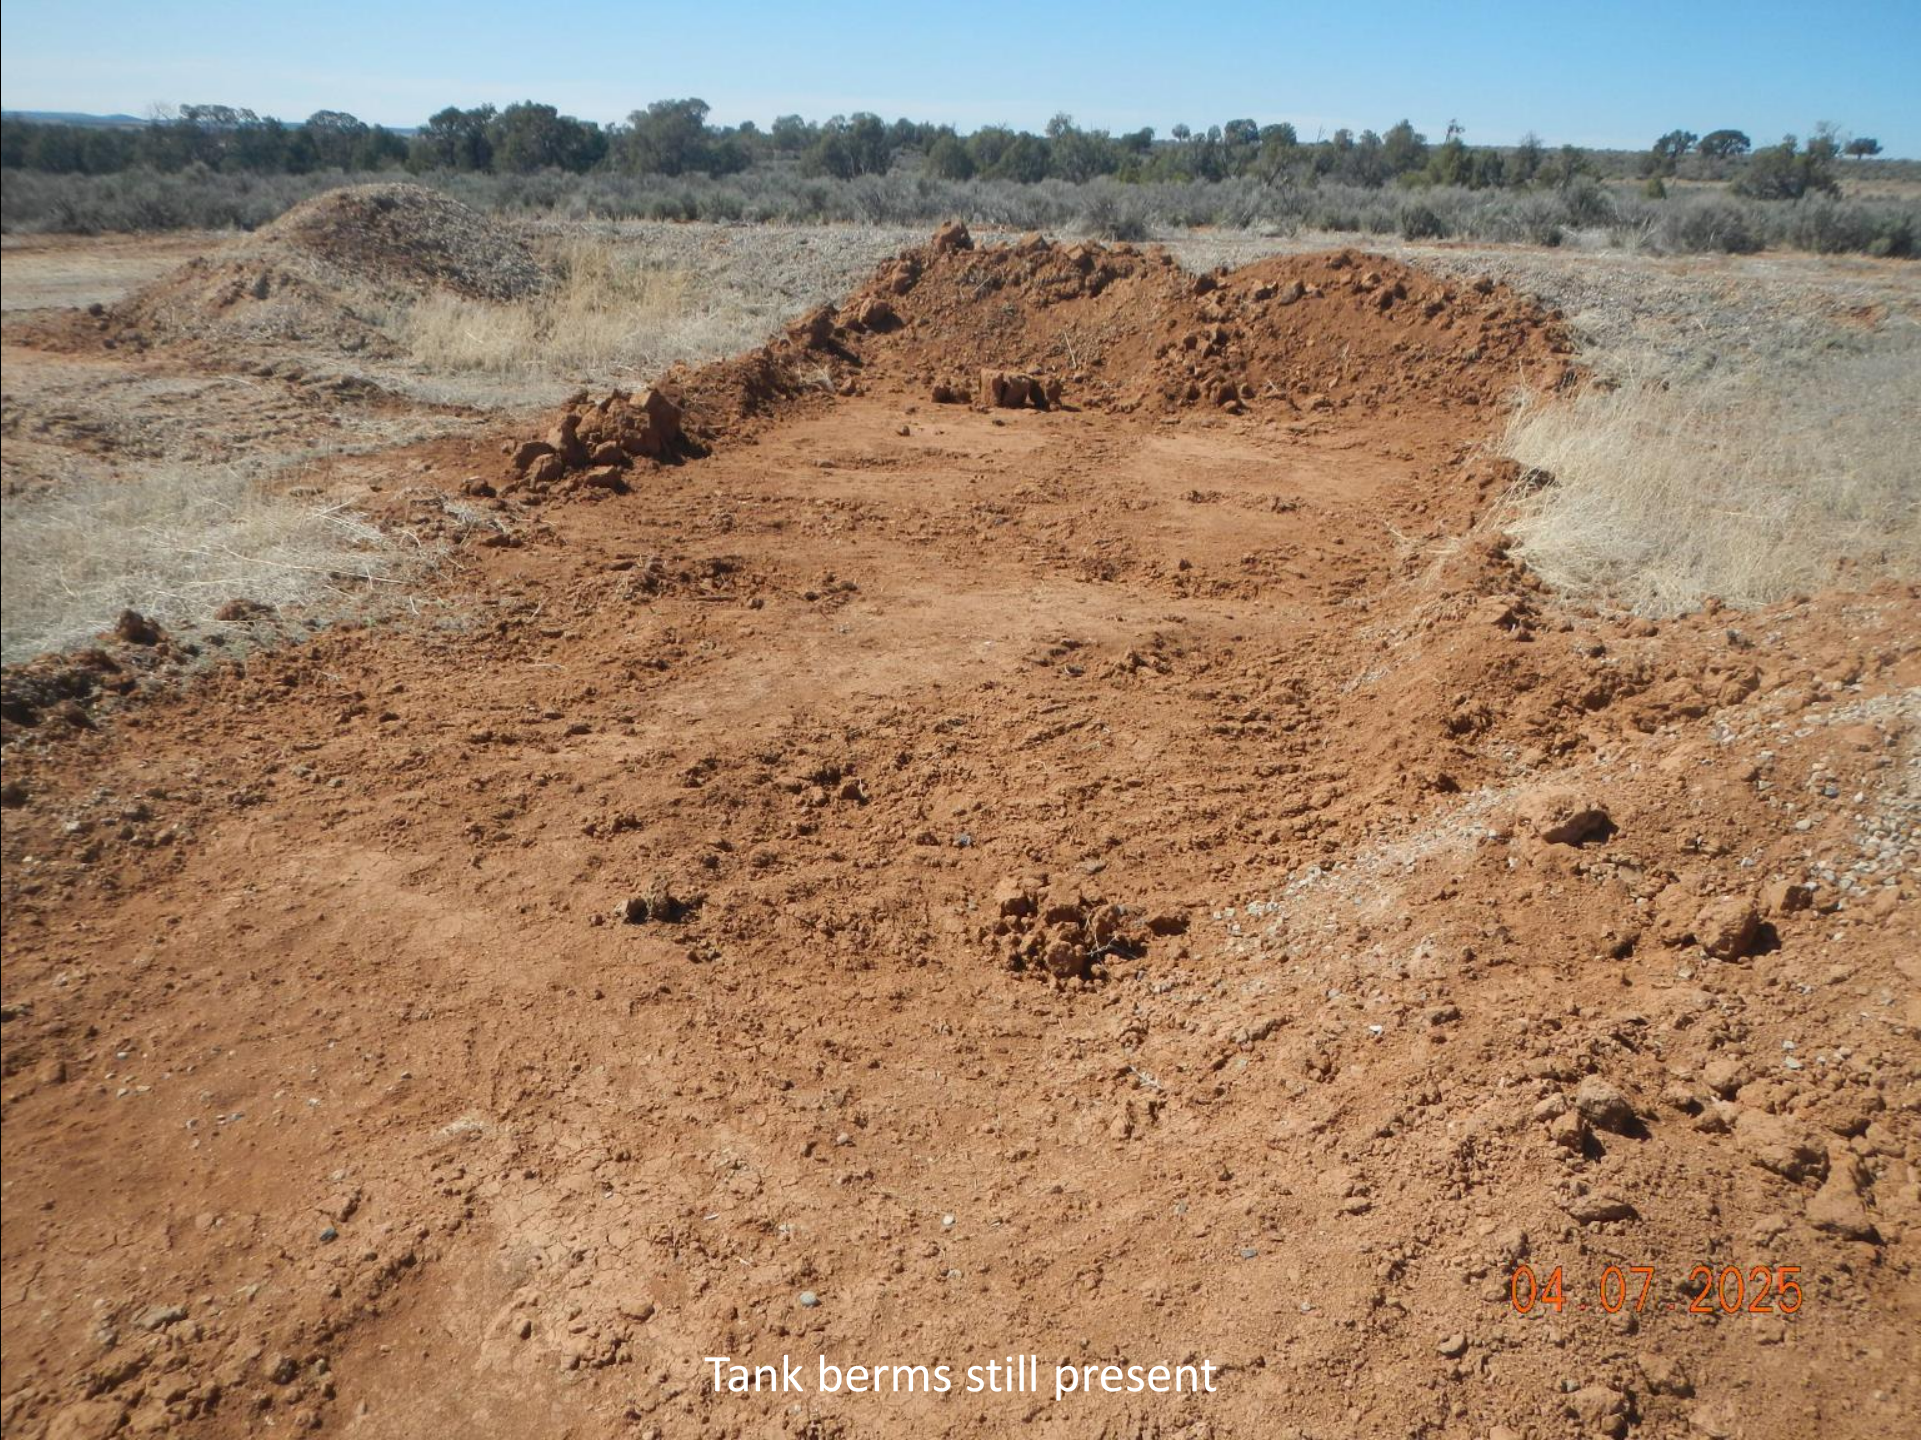
04.07.2025

Tank berms still present

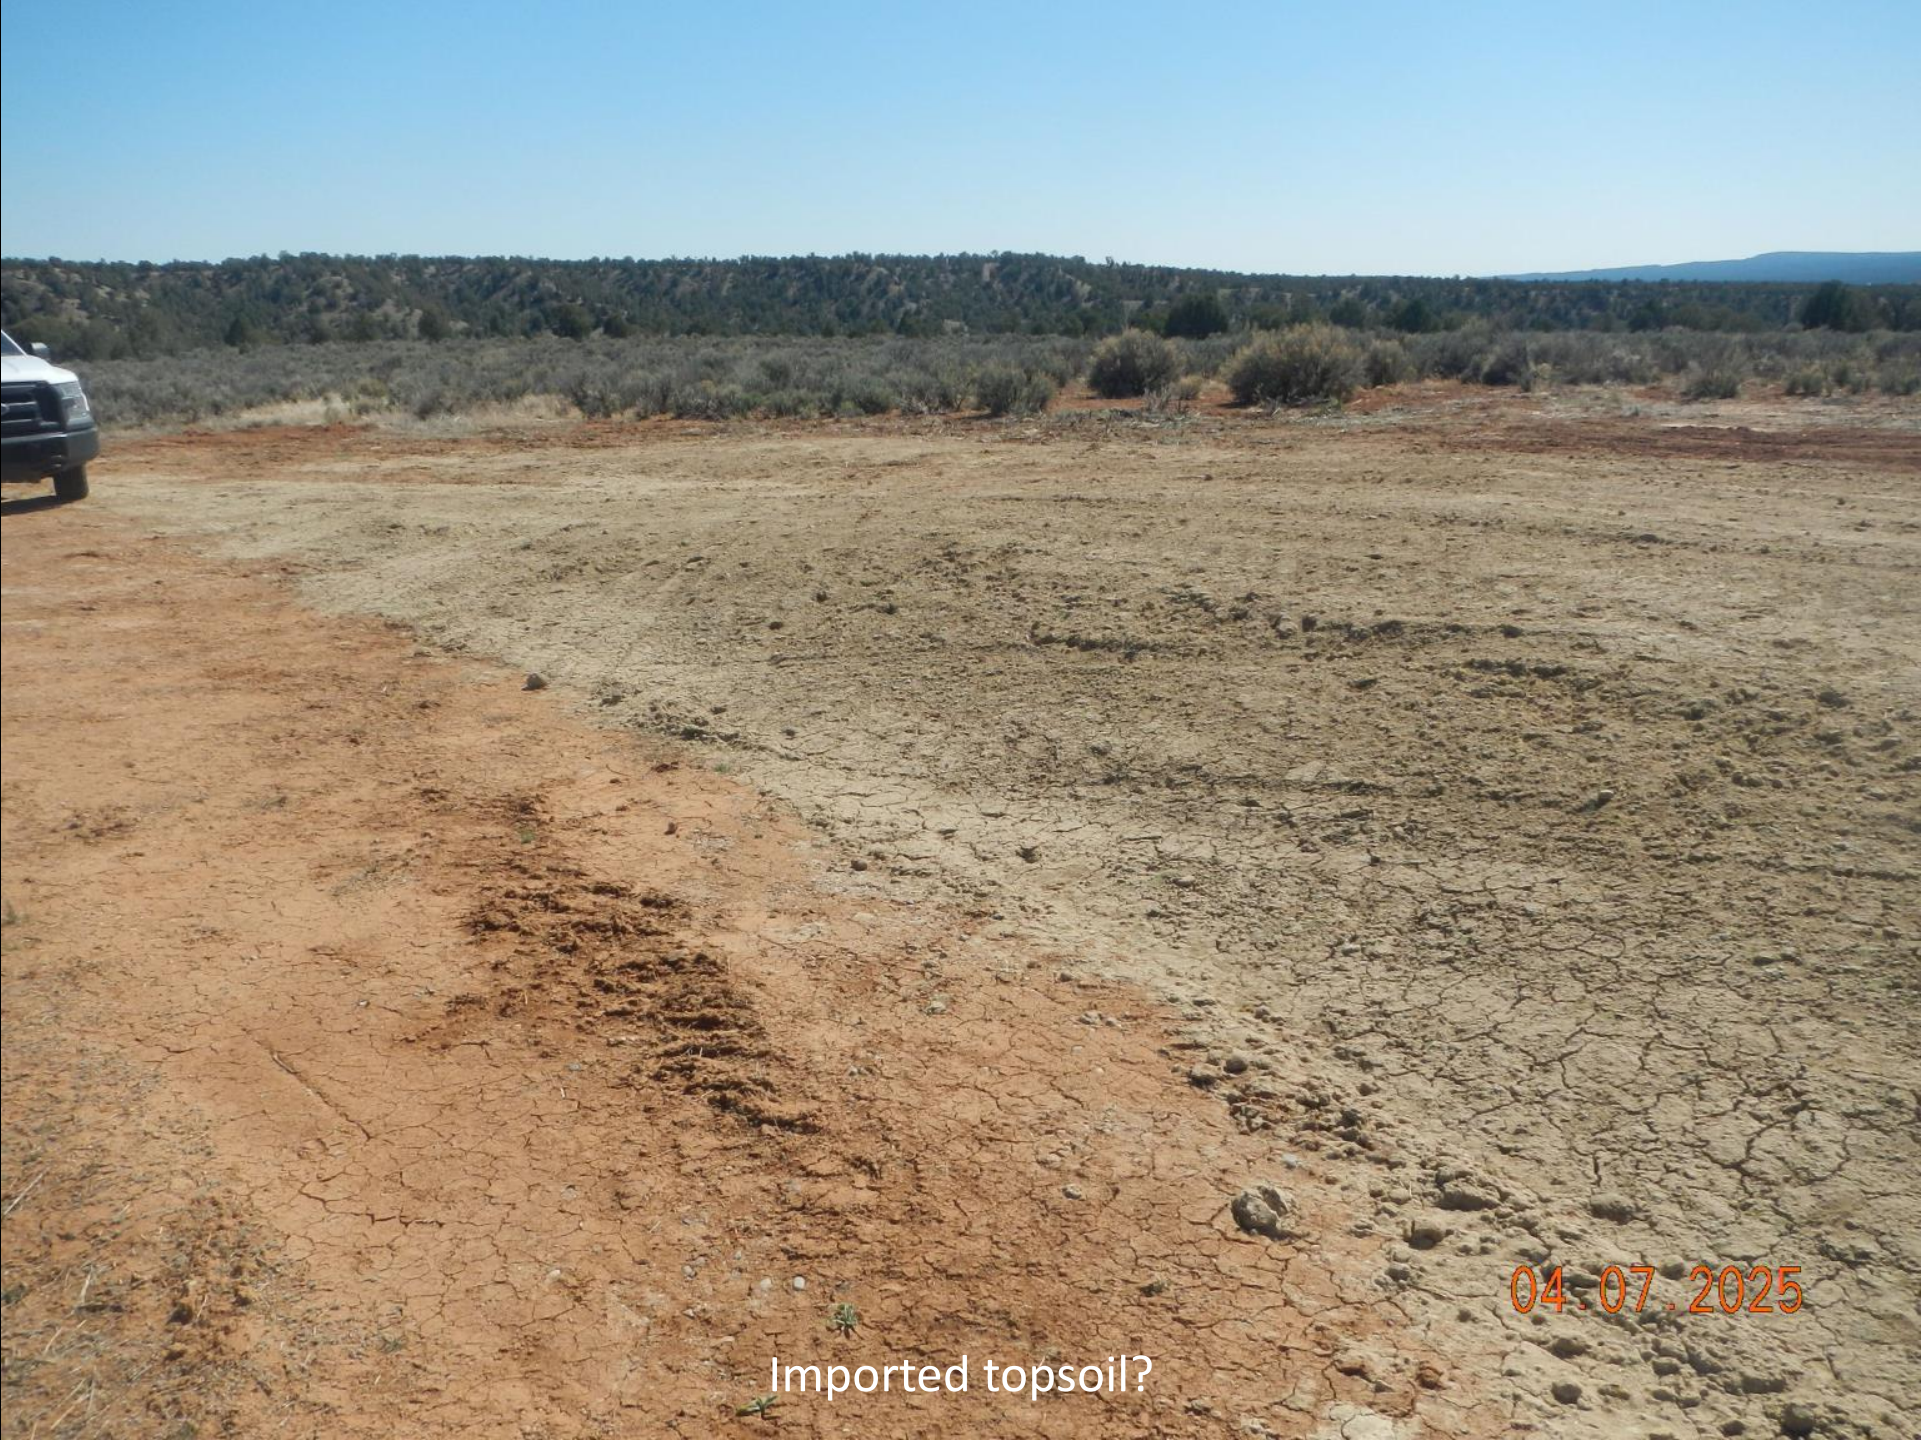
04.07.2025

Imported topsoil?

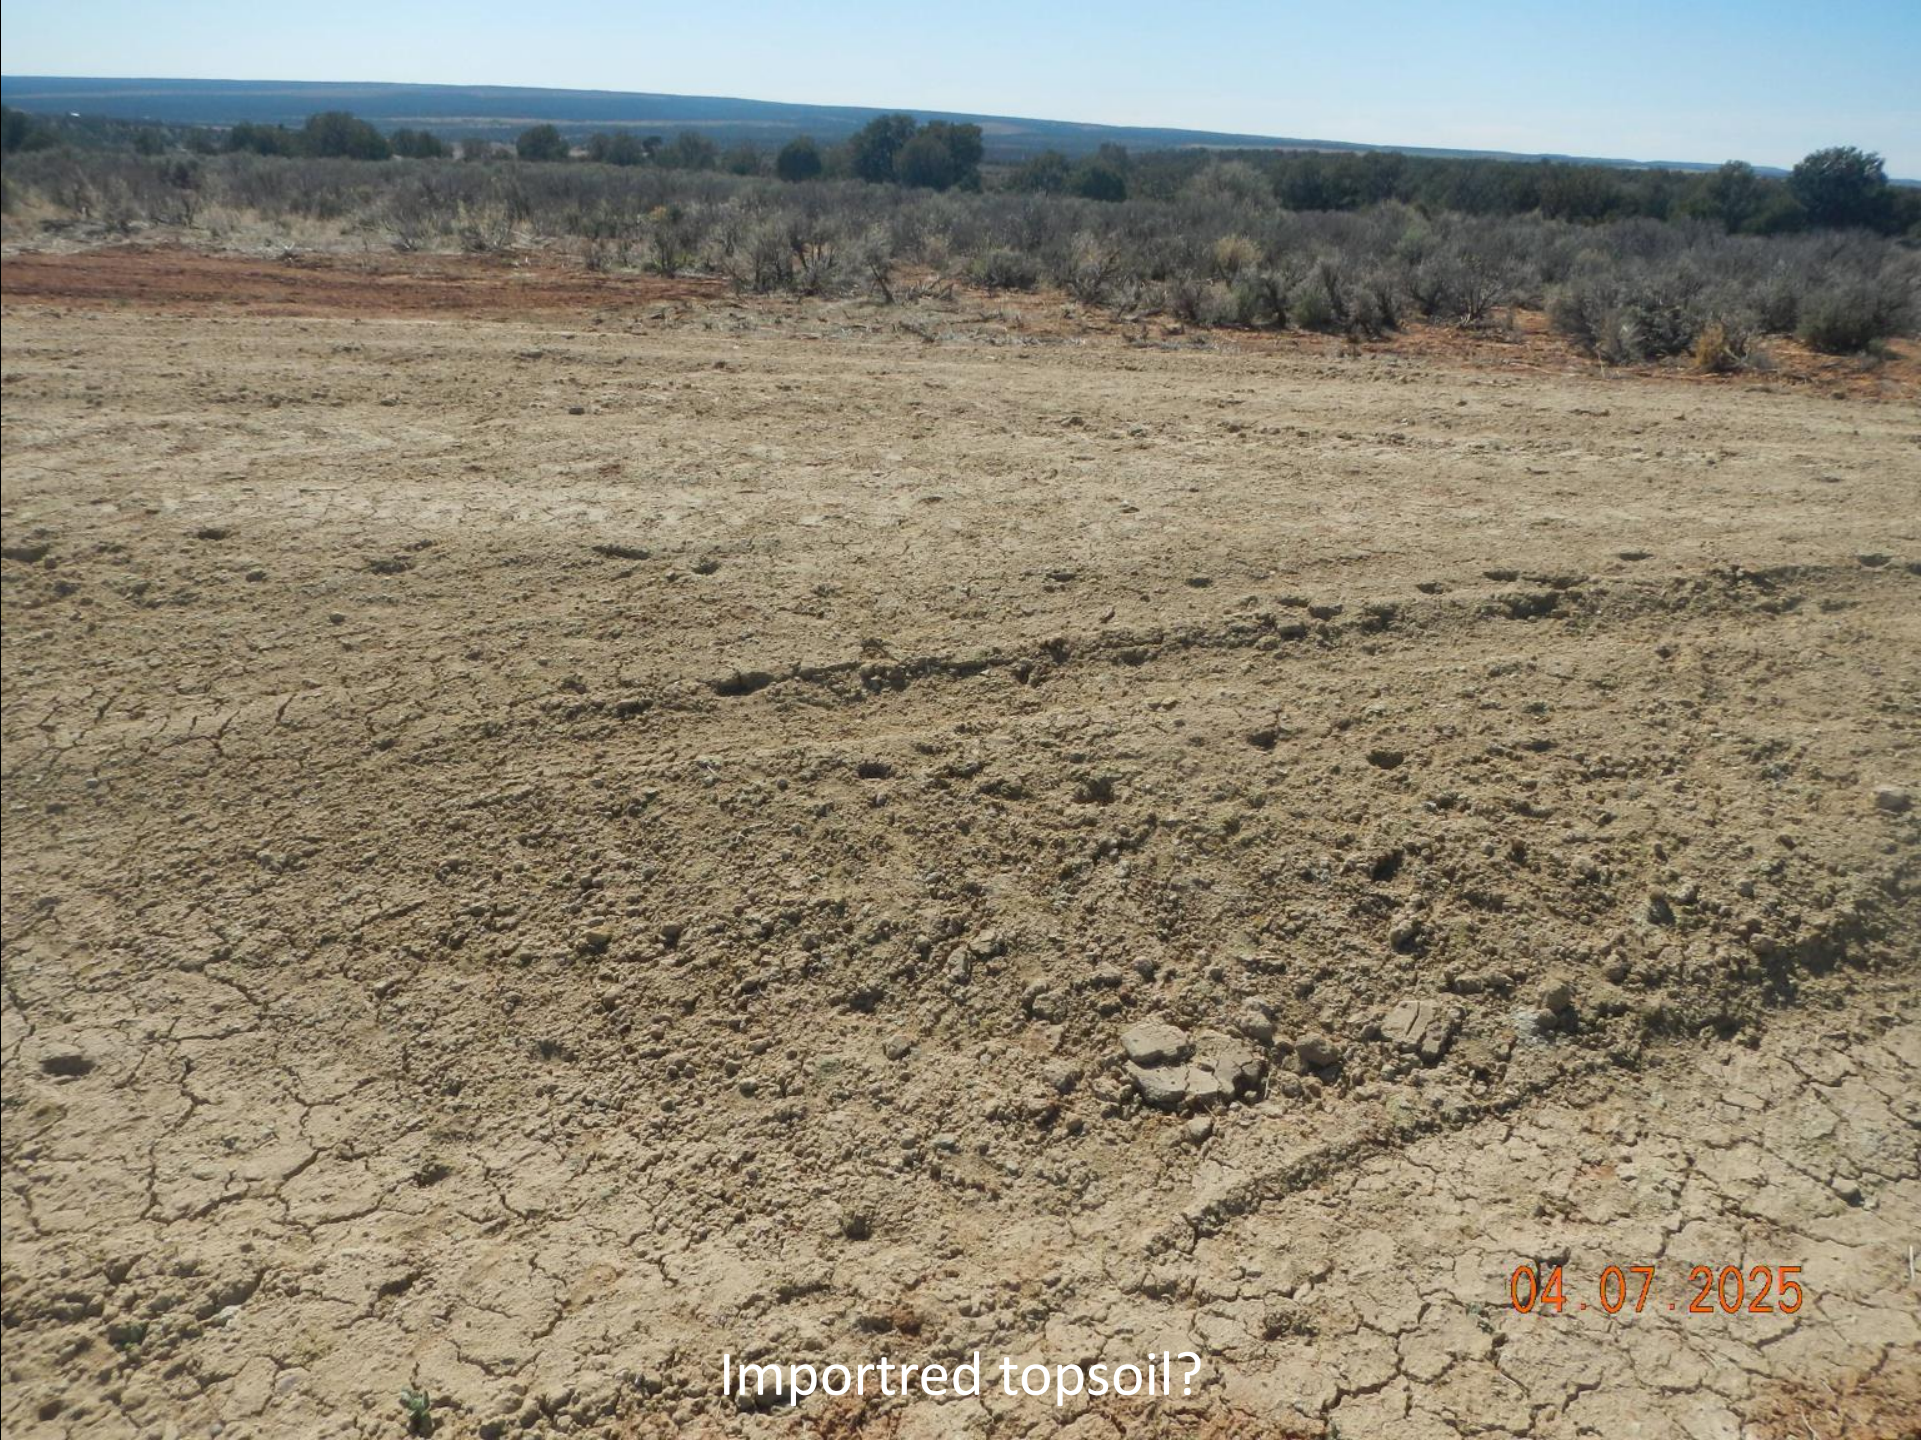
04.07.2025

Imported topsoil?
