## Inspection/Audit Photos

Location Name: TEP Rocky Mountain LLC GIBSON GULCH UNIT 12-28 Pad

Location # 335266

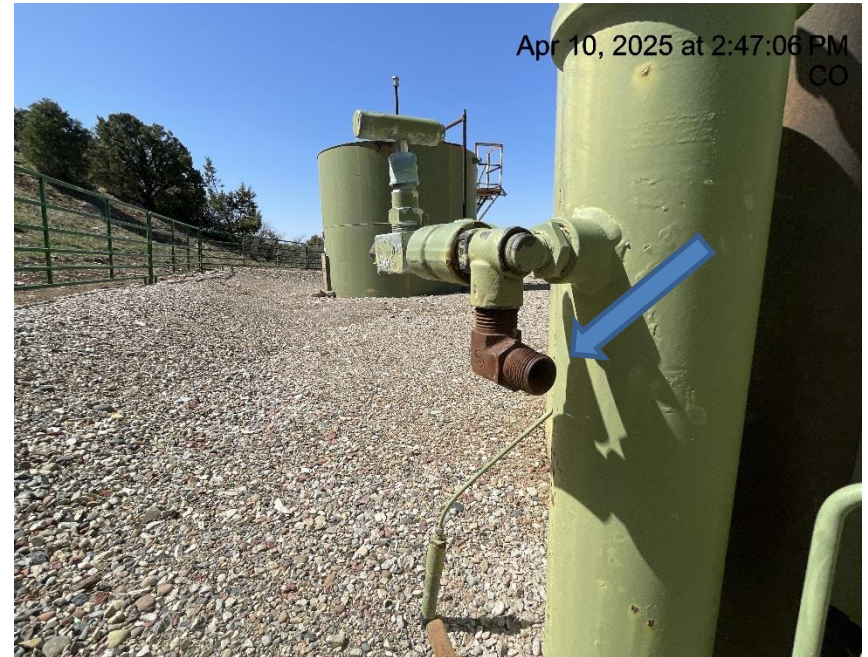
Photo # 622 PRV vent line does not comply with CECMC pressure safety device rules or general safety rules

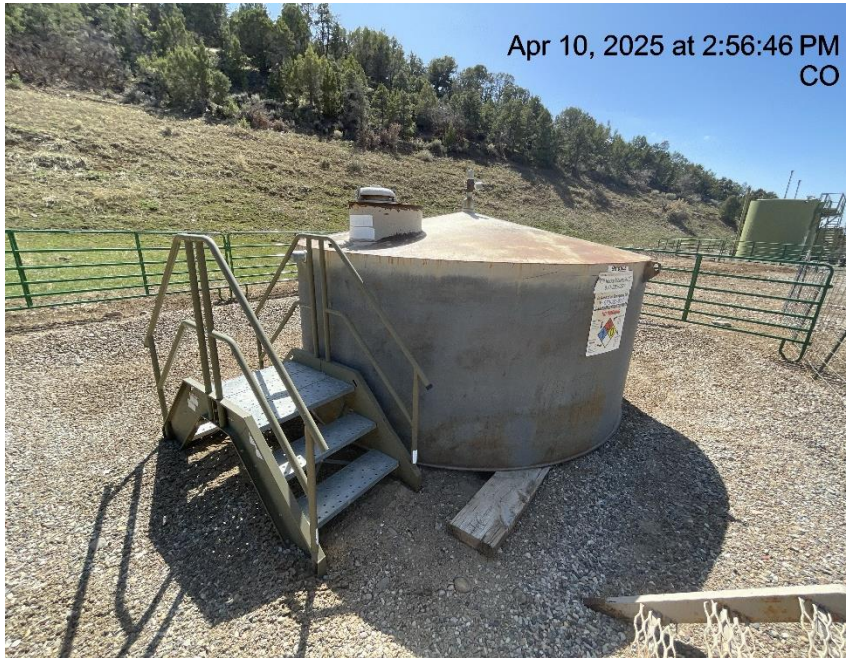
**Photo # 623 Tank is disconnected & not in use/unused equipment**

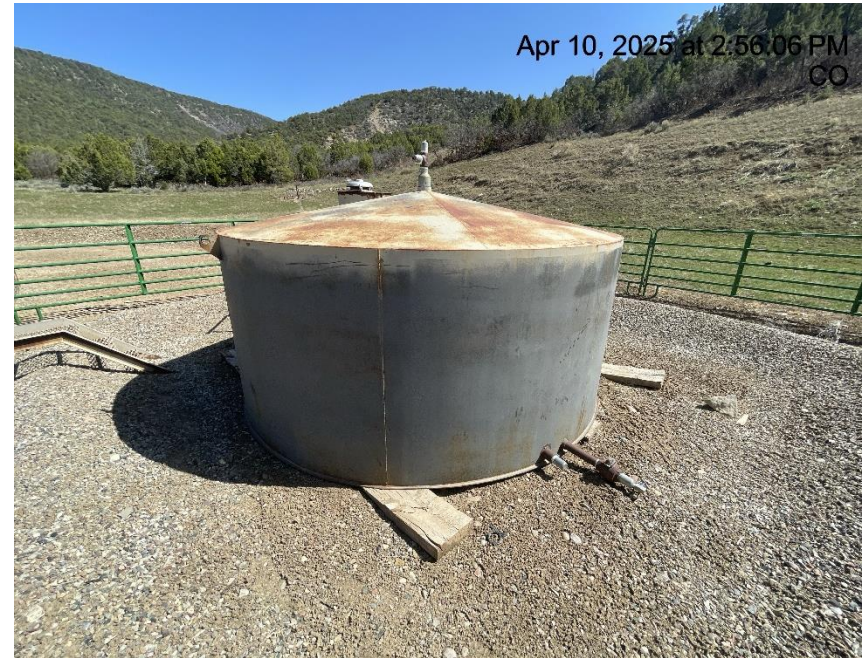
**Photo # 624 Tank is disconnected & not in use/unused equipment**

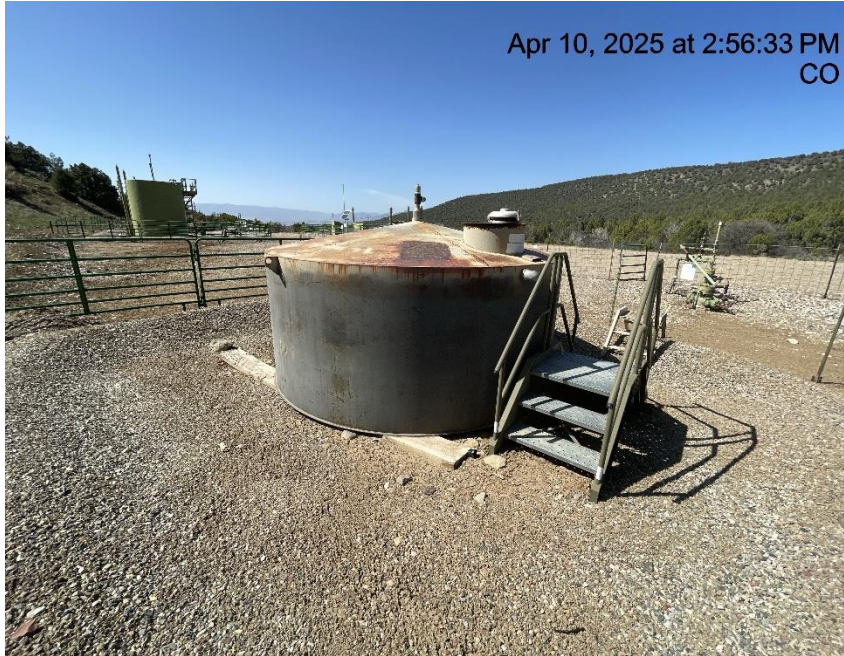
**Photo # 625 Tank is disconnected & not in use/unused equipment**

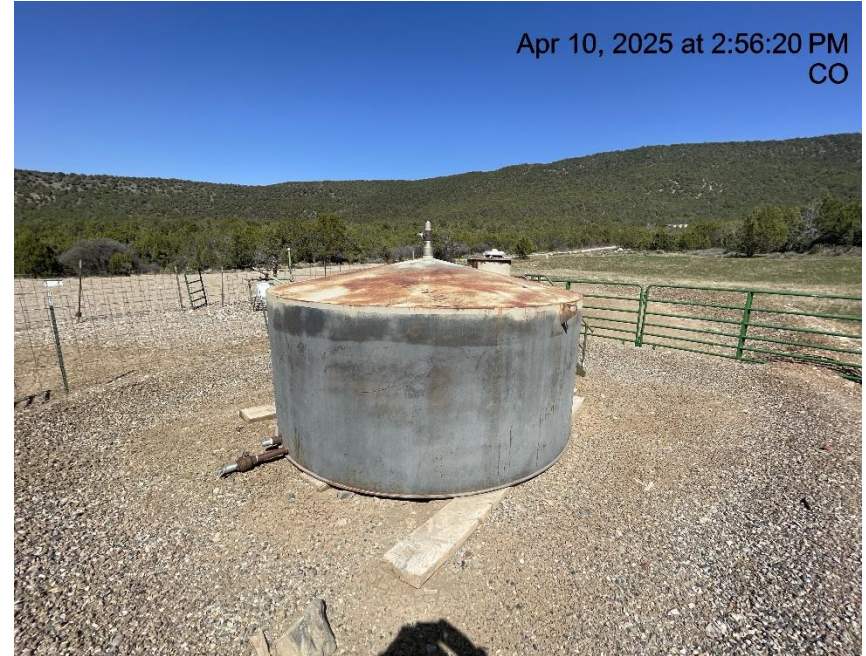
**Photo # 626 Tank is disconnected & not in use/unused equipment**
