Inspection Photos

Location Name: QB Energy SAVAGE 2-31 (RL2) Pad

Location #: 324005

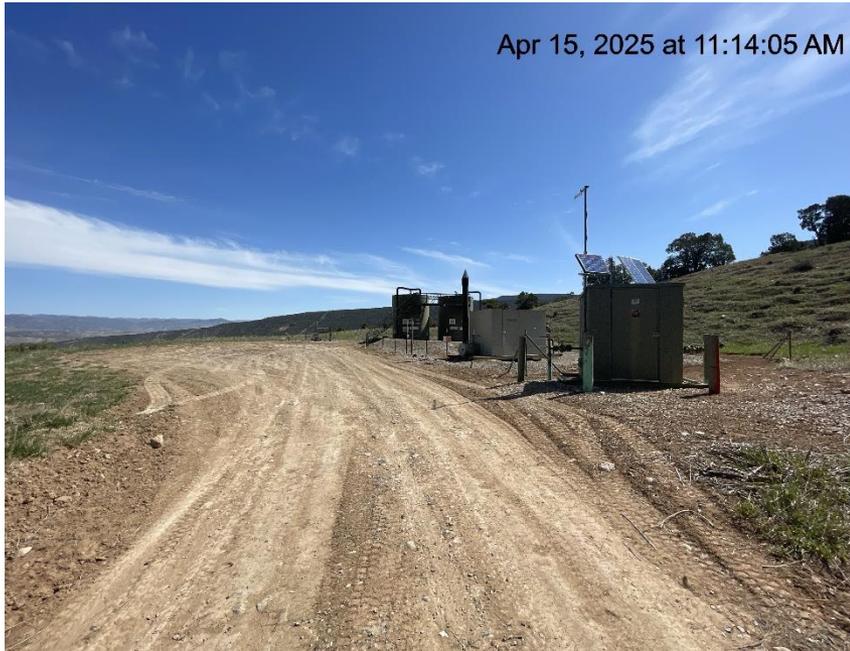
Photo # 1273 From Entrance to location

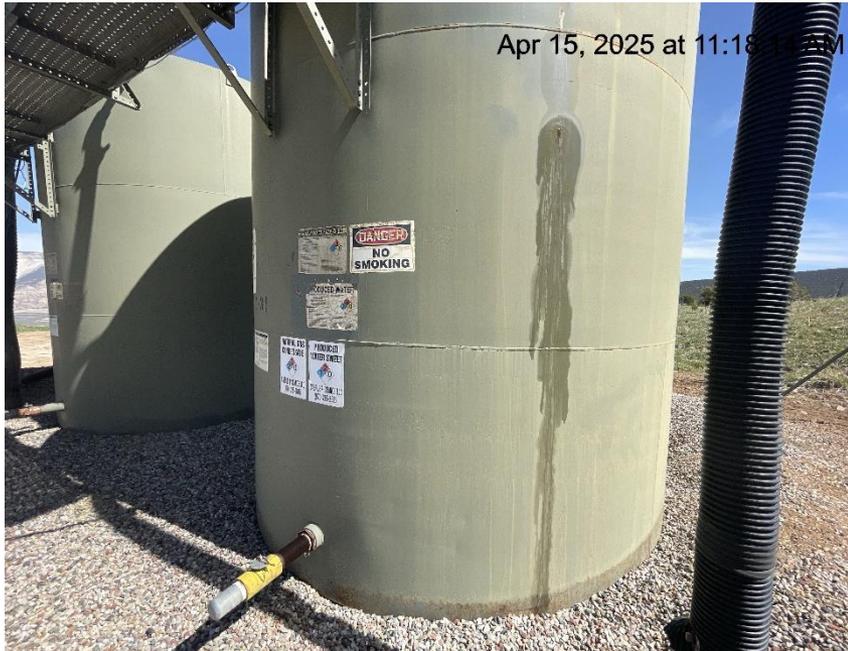
Photo # 1279 Possible tank failure - Suspected leak on production tank/tank appears to lack integrity

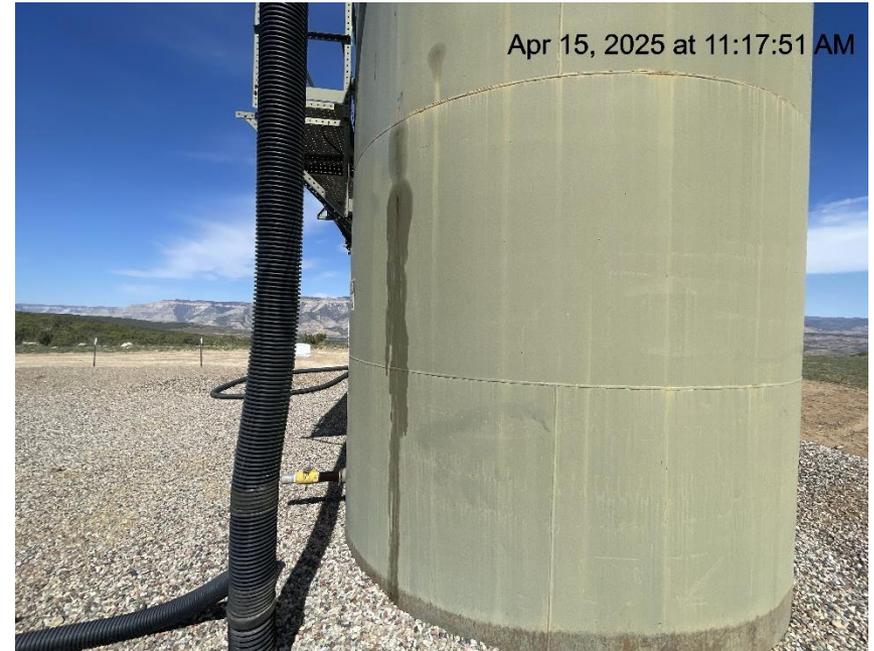
Photo # 1280 Possible tank failure - Suspected leak on production tank/tank appears to lack integrity

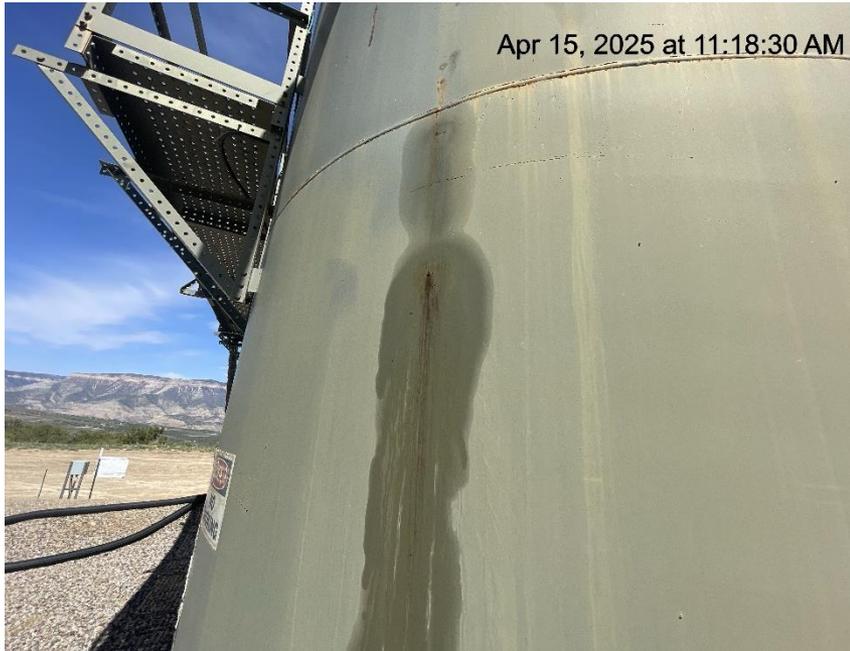
Photo # 1281 Possible tank failure - Suspected leak on production tank/tank appears to lack integrity

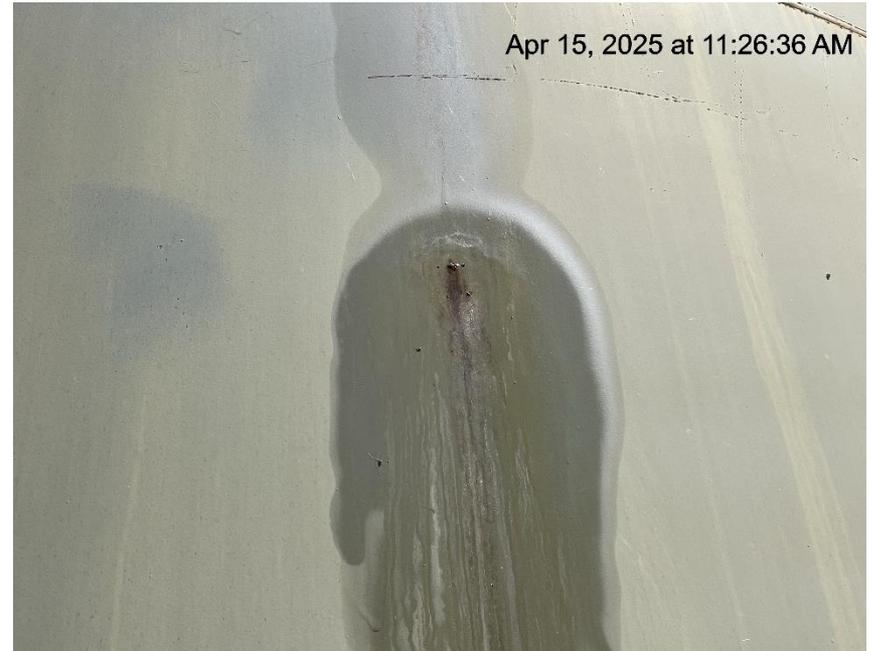
Photo # 1282 Possible tank failure - Suspected leak on production tank/tank appears to lack integrity

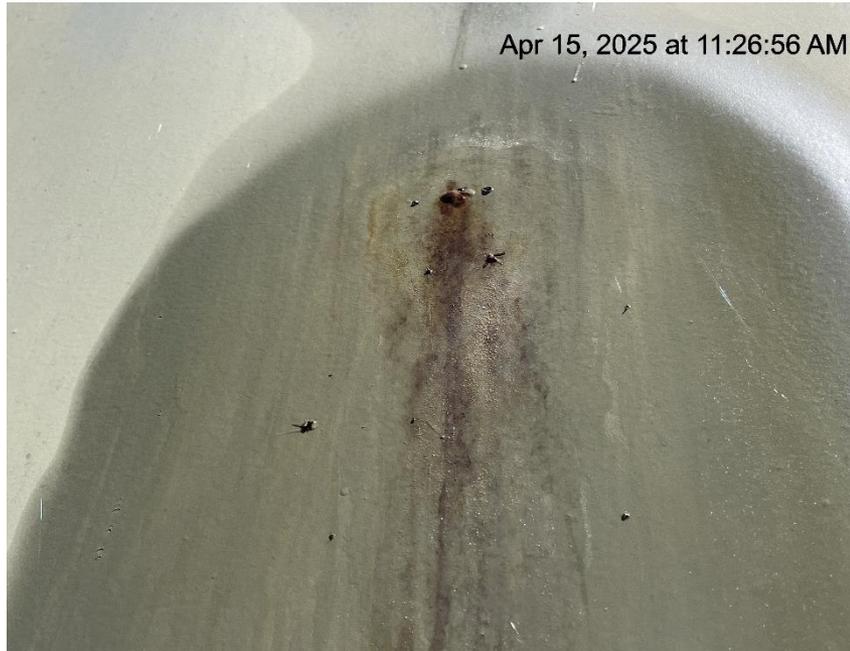
Photo # 1283 Possible tank failure - Suspected leak on production tank/tank appears to lack integrity
