**Operator:** CRESTONE PEAK RESOURCES OPERATING LLC

**Location Name:** PURITAN 4-4-34

**Loc ID:** 336332

**Inspection:** 718600249

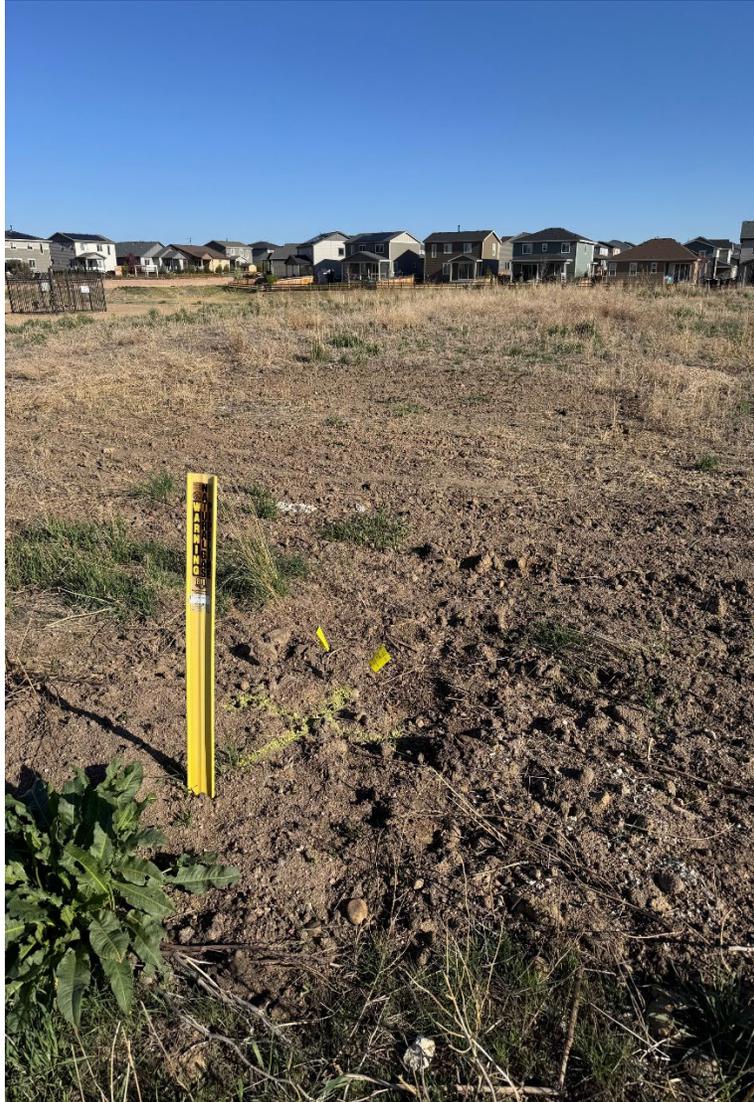
**Exhibit A**

**CA:** An in process Form 44 (Doc Id #402543661) submitted 12/01/2020 indicates the flowline between Puritan #33-34 (Loc ID #336332) and PURITAN/2N68W/34SESE (Loc ID #336413) was flushed and abandoned in place. There are three fenced open excavations around the wellbore. It appears the open excavations may be related to flowline abandonment. See attached photos. Continue to work with ECMC engineering staff for Form 44 approval. Fill and reclaim excavations according to Rule 1004.

**CA Resolution:** Operator has backfilled all holes on pad and addressed fencing in order to comply with Rule 1004.
