Inspection Photos

Location: #380893

Operator: WAVETECH HELIUM INC

Inspection Date: 4/10/2025

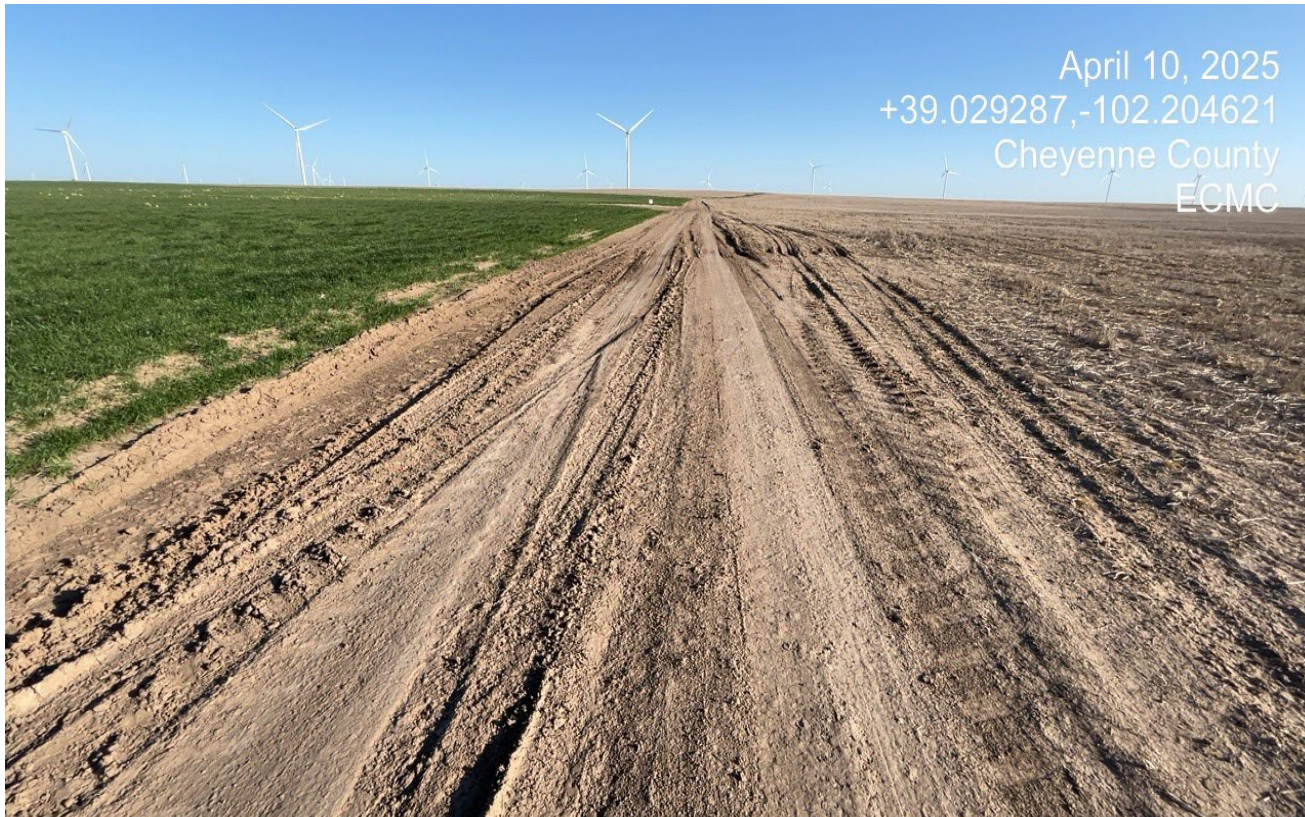
Photo 1. Facing north along the main road leading to the location. There is vehicle rutting and signs of vehicles going outside of the road causing unnecessary disturbance.

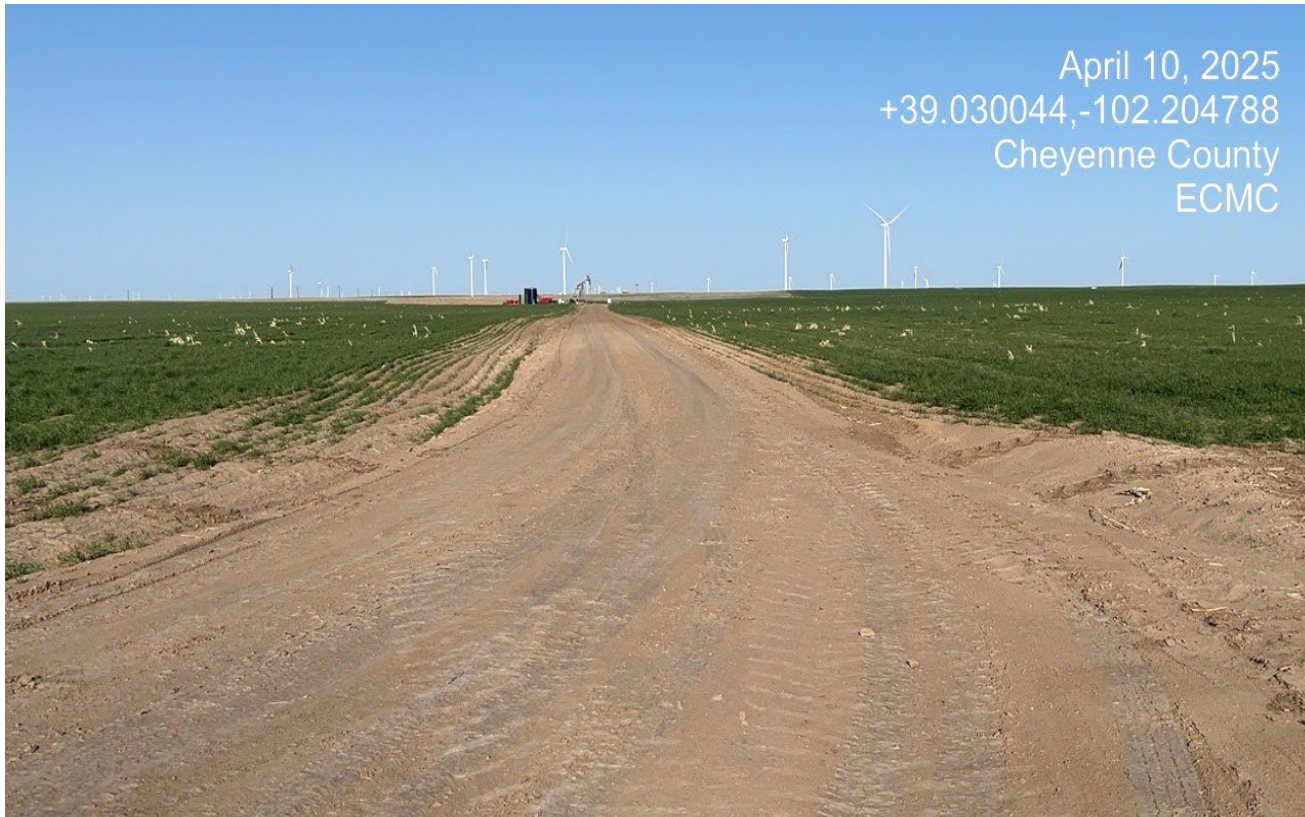
Photo 2. Facing west toward the access road.

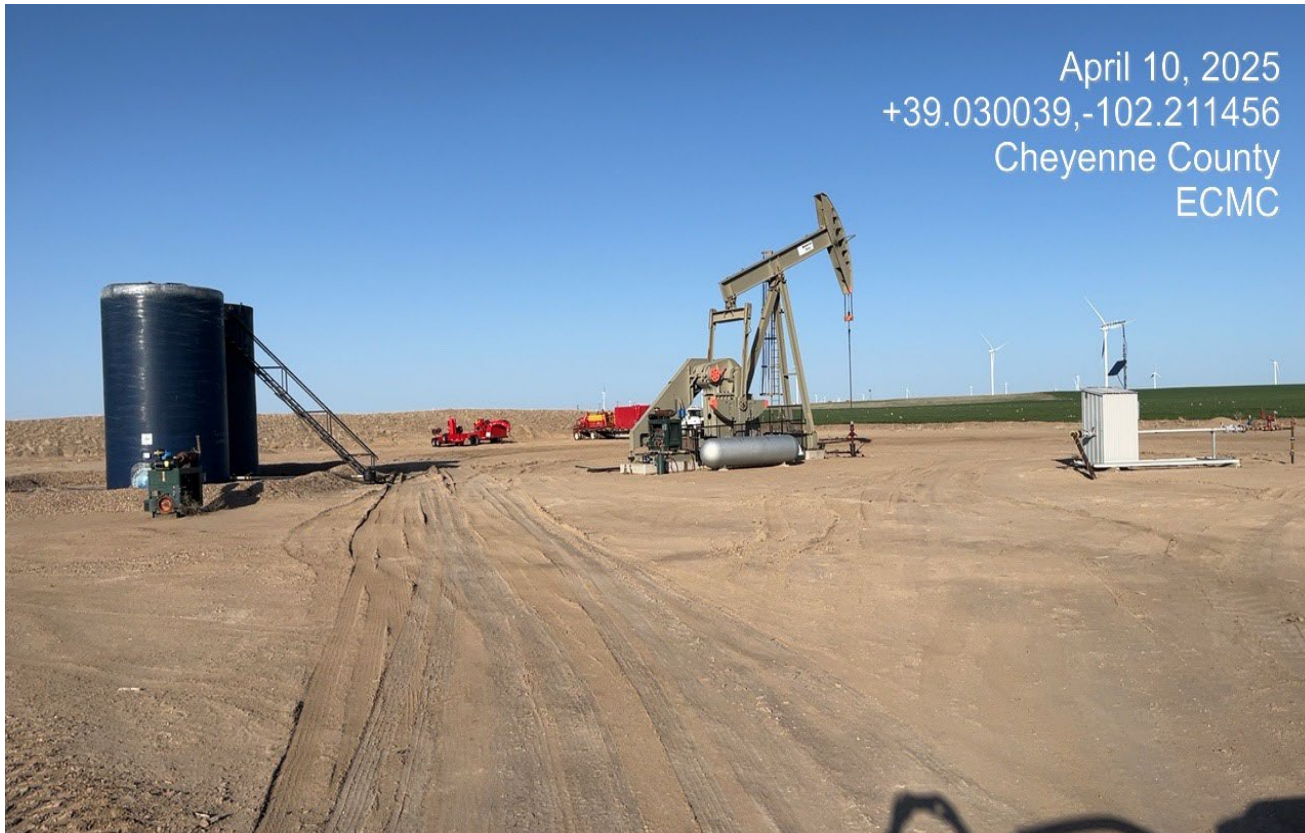
Photo 3. Facing west toward the wellsite.

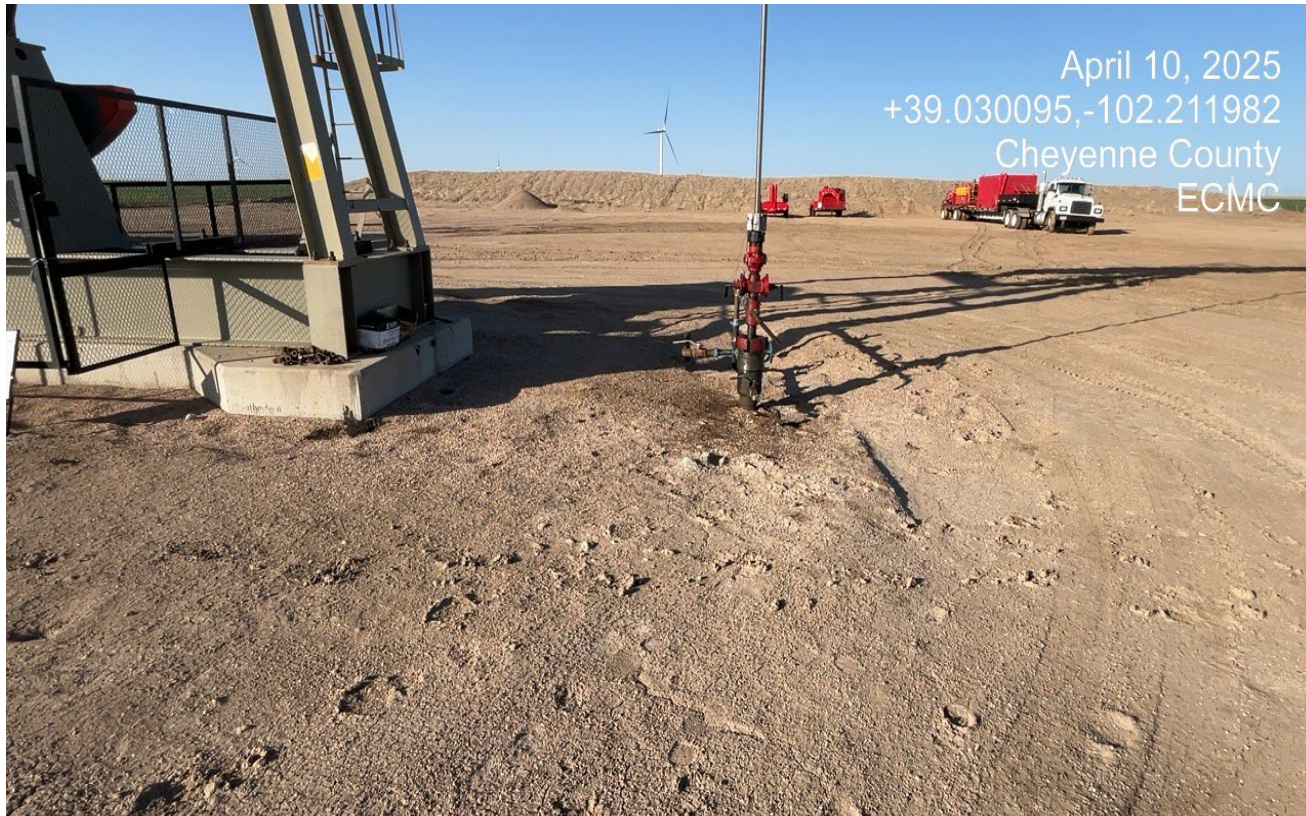
Photo 4. There is stained soils at the wellhead.

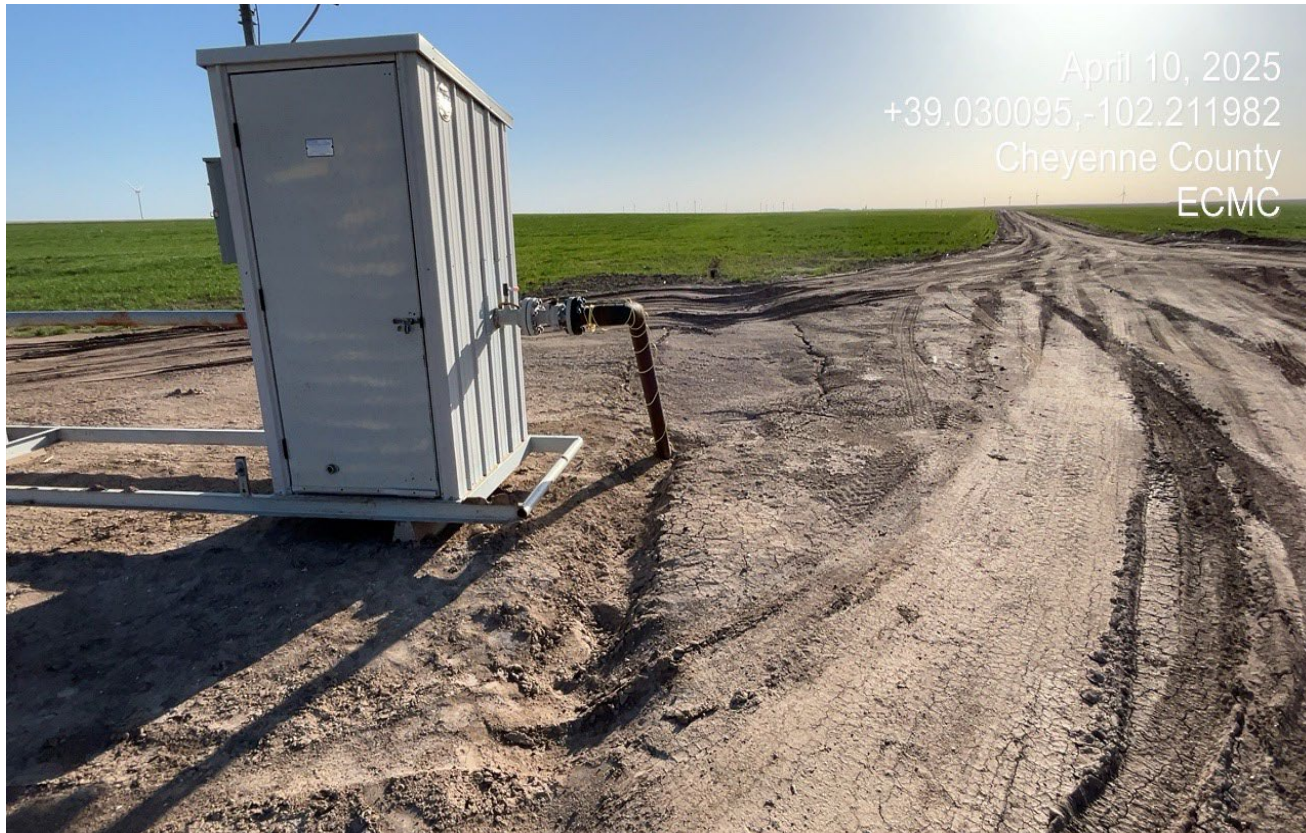
Photo 5. There is subsidence at the meter shed along the flowline.

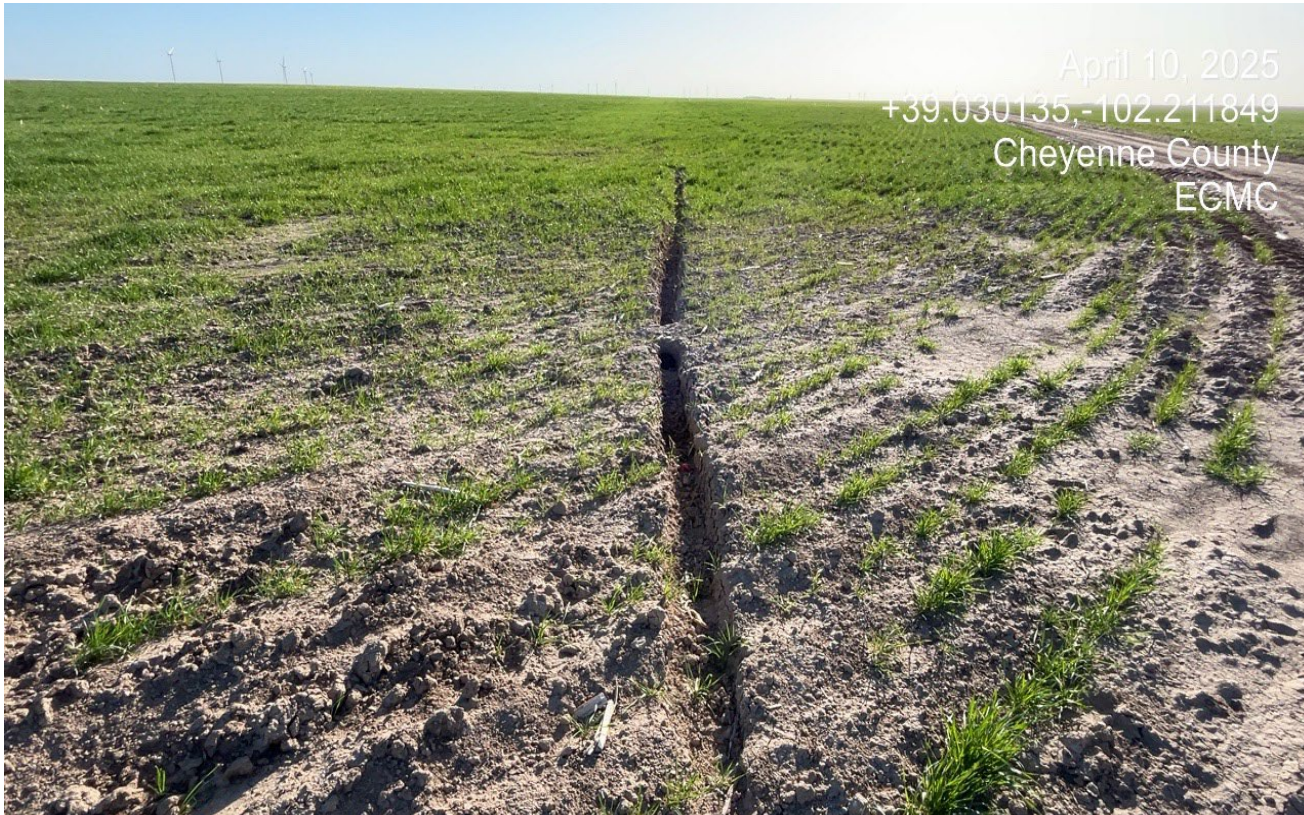
Photo 6. There is subsidence along the flowline.

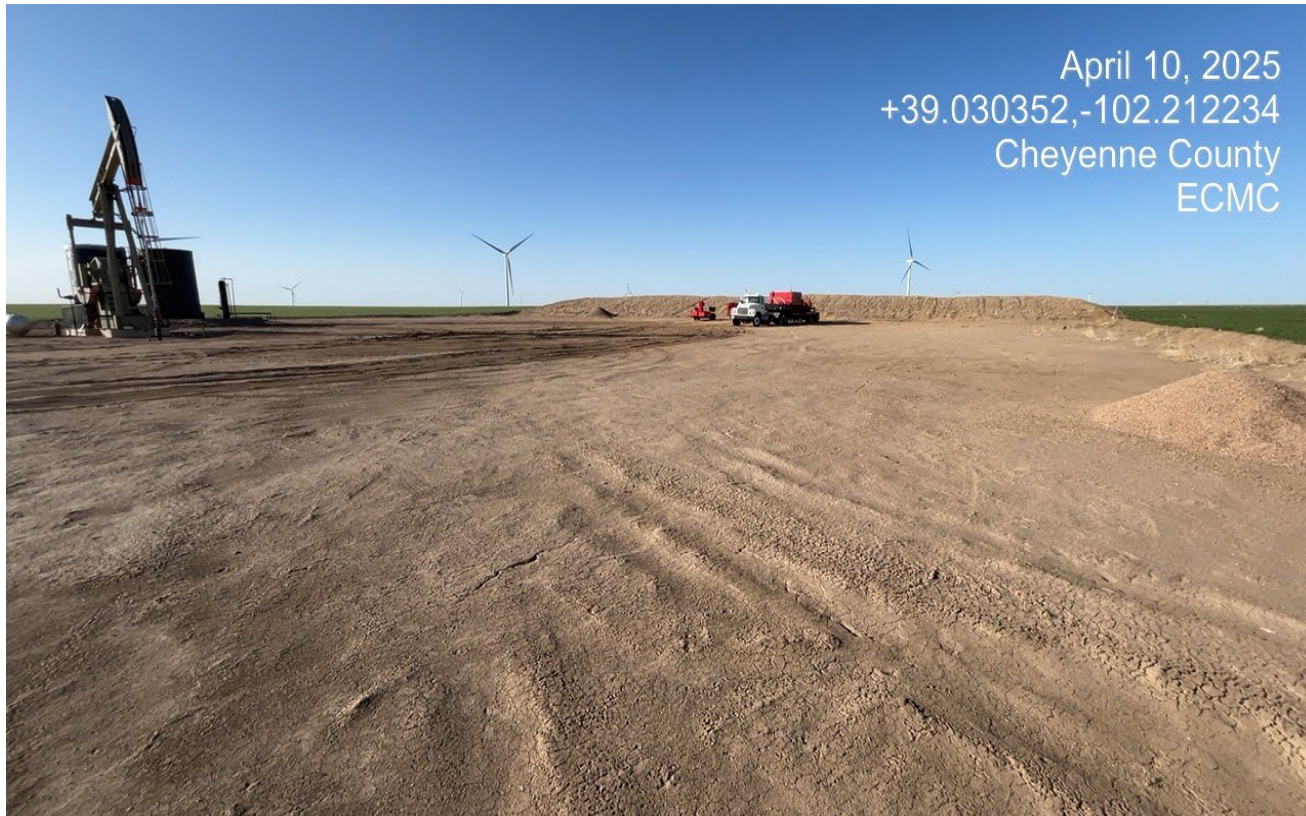
Photo 7. North side of the location facing west. Unused areas of the location have not been reclaimed.

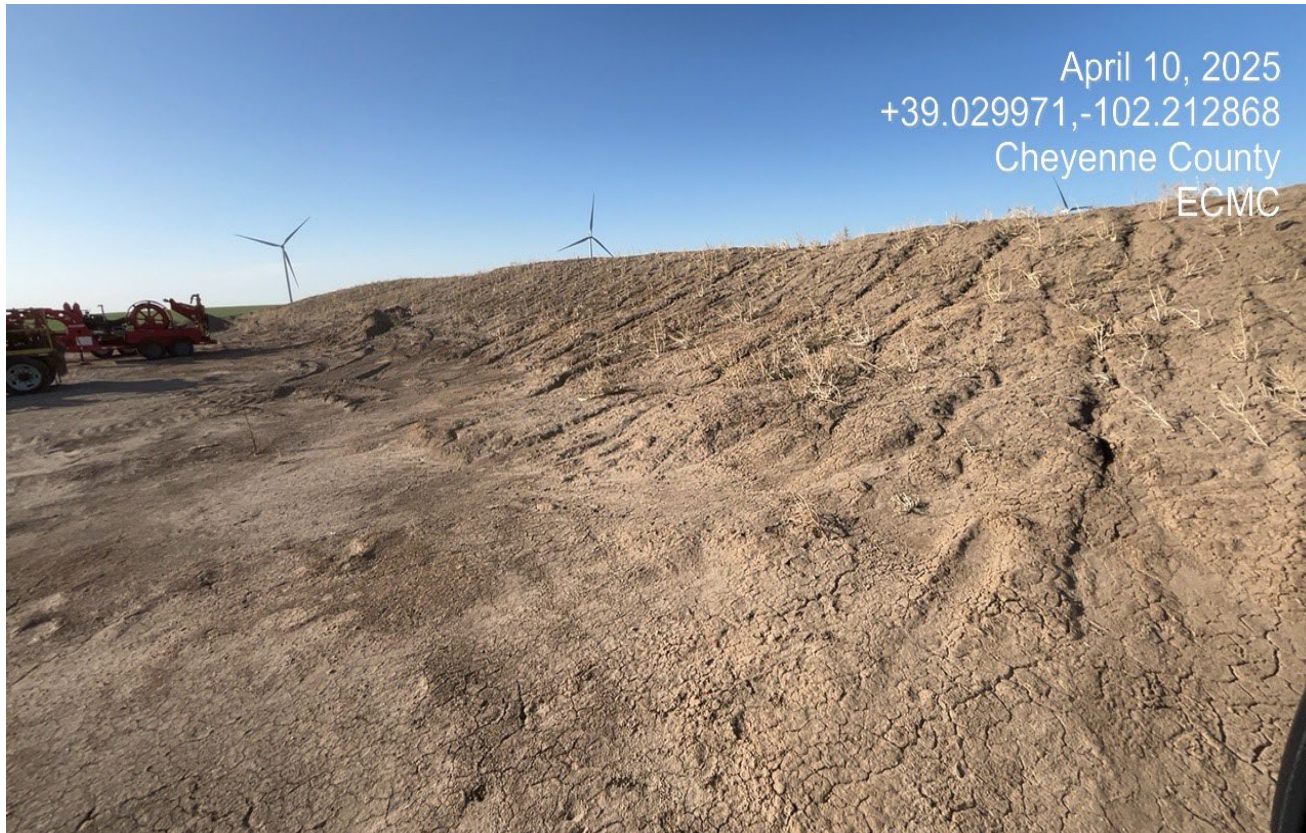
Photo 8. Facing toward the topsoil pile which is not stabilized and has not been replaced.

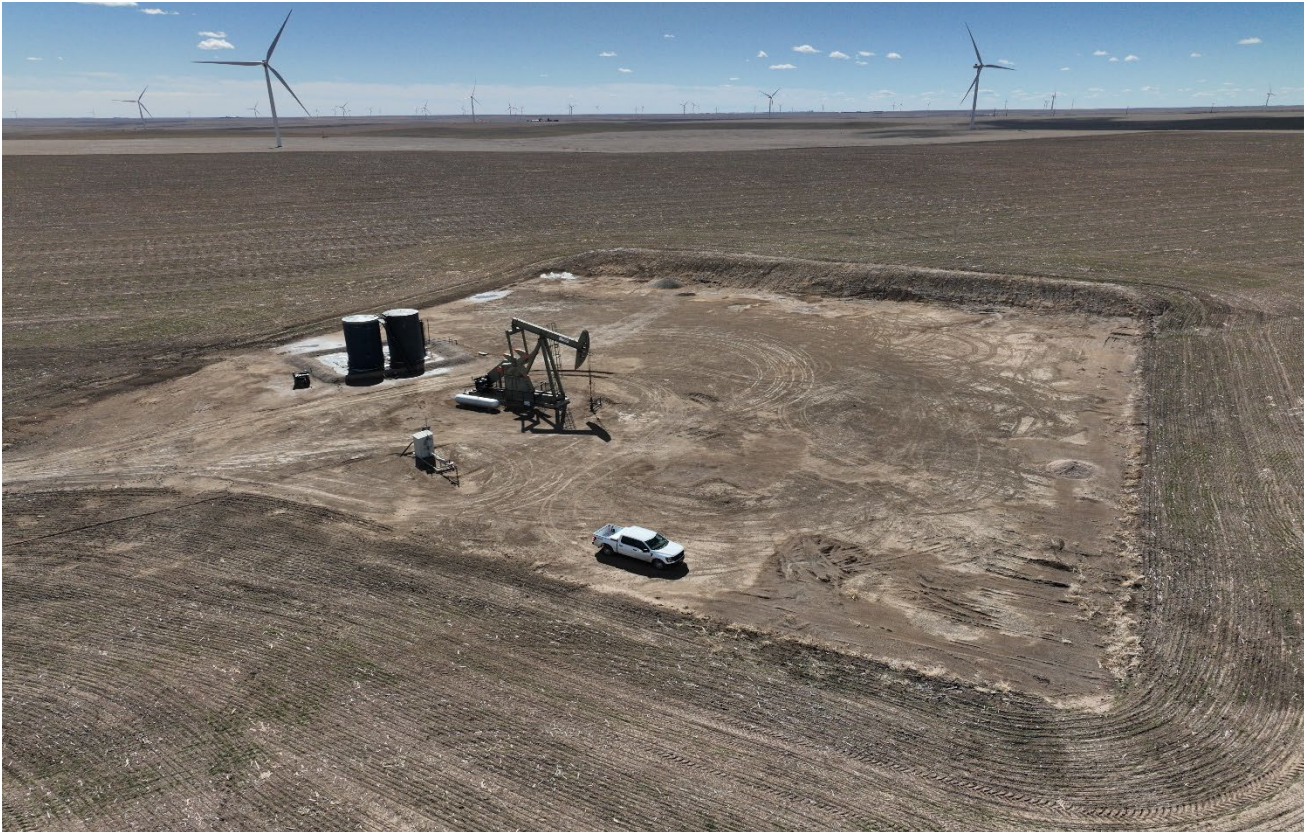
Photo 9. Drone aerial photo facing southwest toward the location.

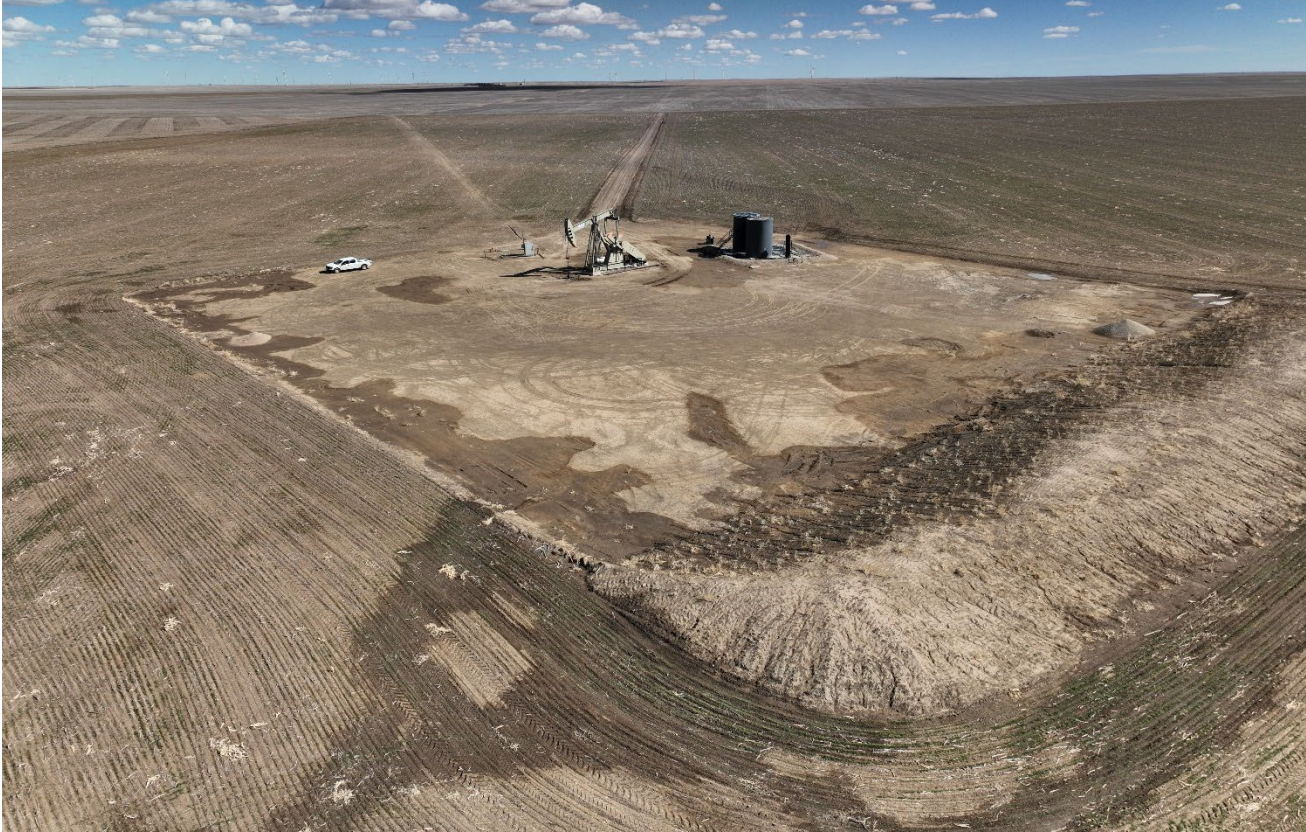
Photo 10. Drone aerial photo facing east toward the location.

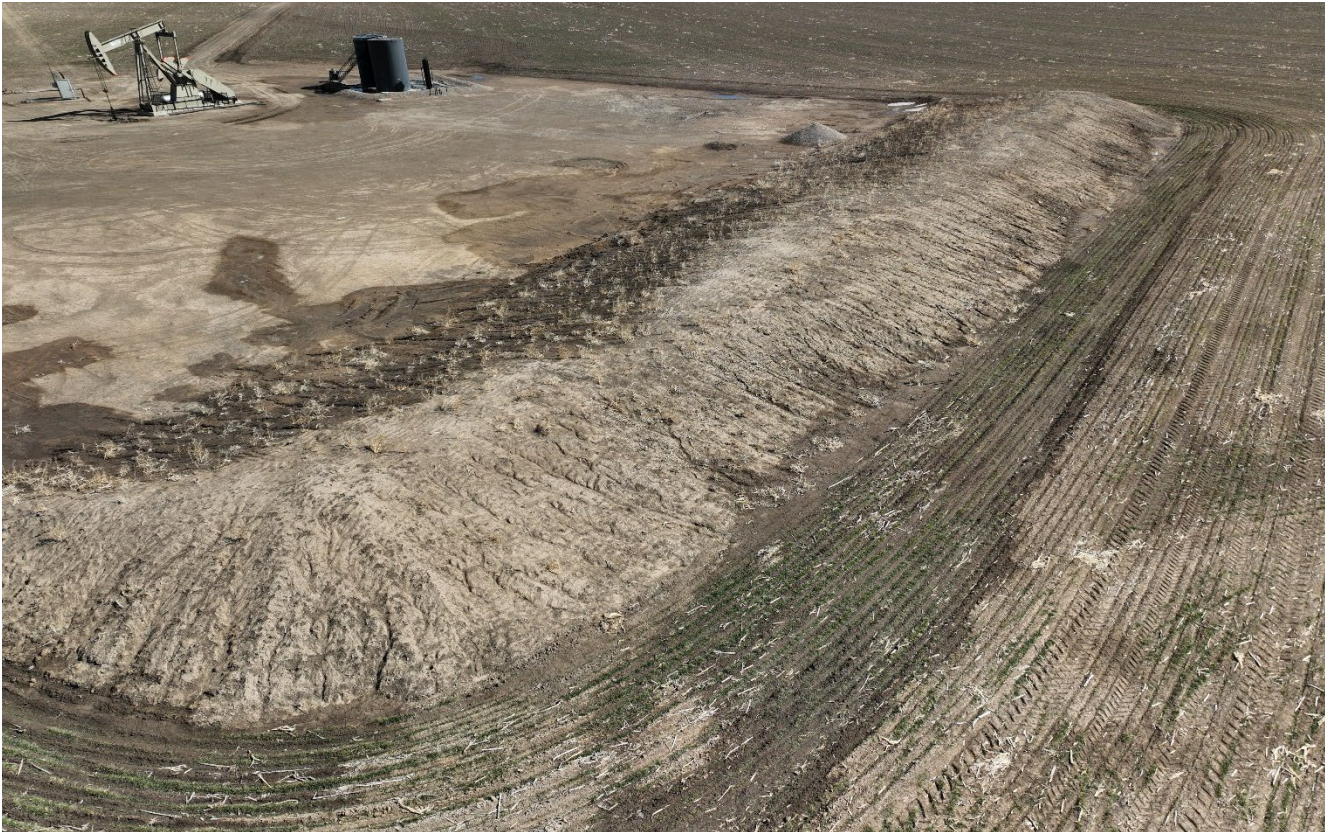
Photo 11. Drone aerial photo facing southeast toward the topsoil pile. There is erosion occurring along the topsoil pile.
