# Inspection/Audit Photos

Location Name: TEP ROCKY MOUNTAIN LLC JOLLEY # 4 Pad

Location ID: 335514

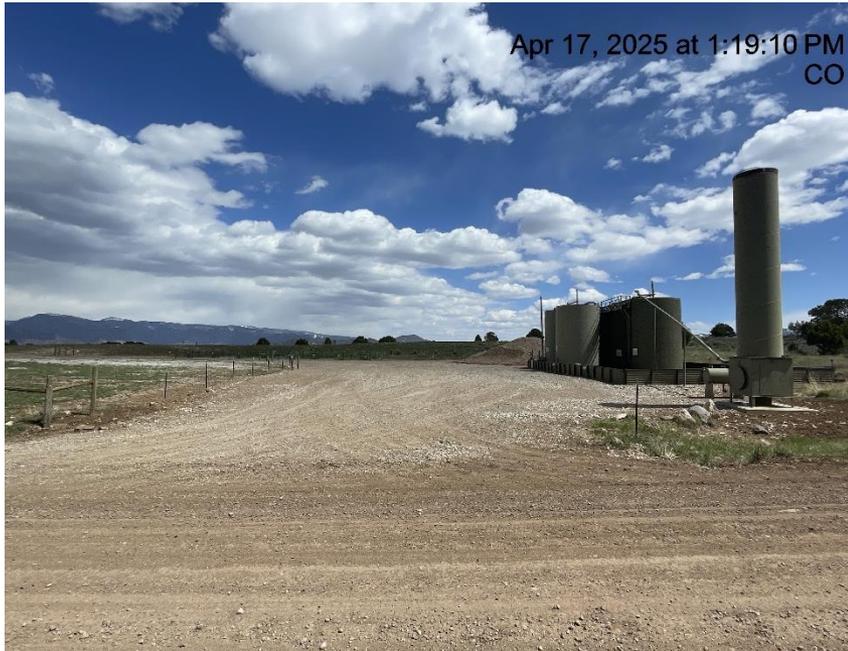
Photo # 2482 From entrance to location

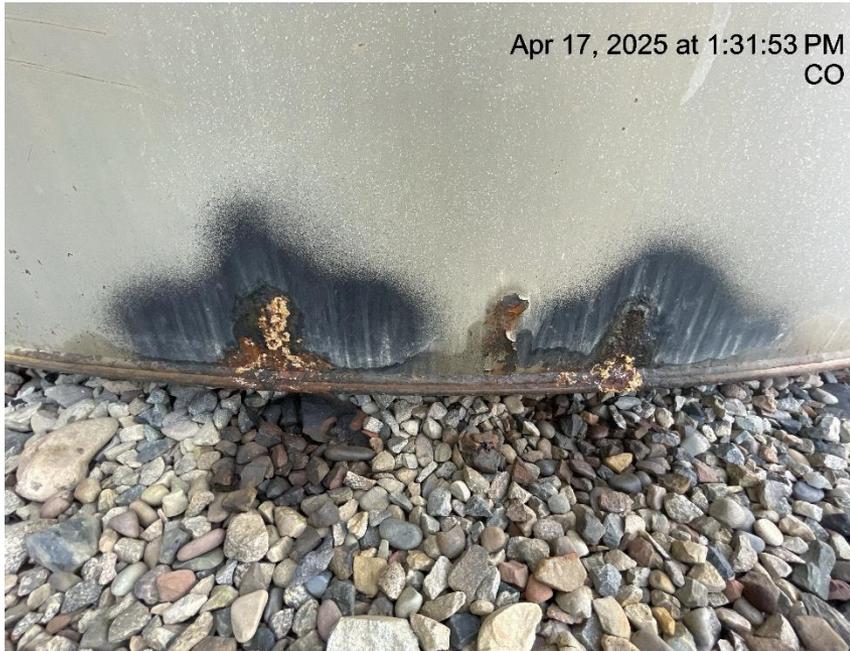
**Photo # 2488 Possible tank failure - Suspected leaks on production tank/tank appears to lack integrity**

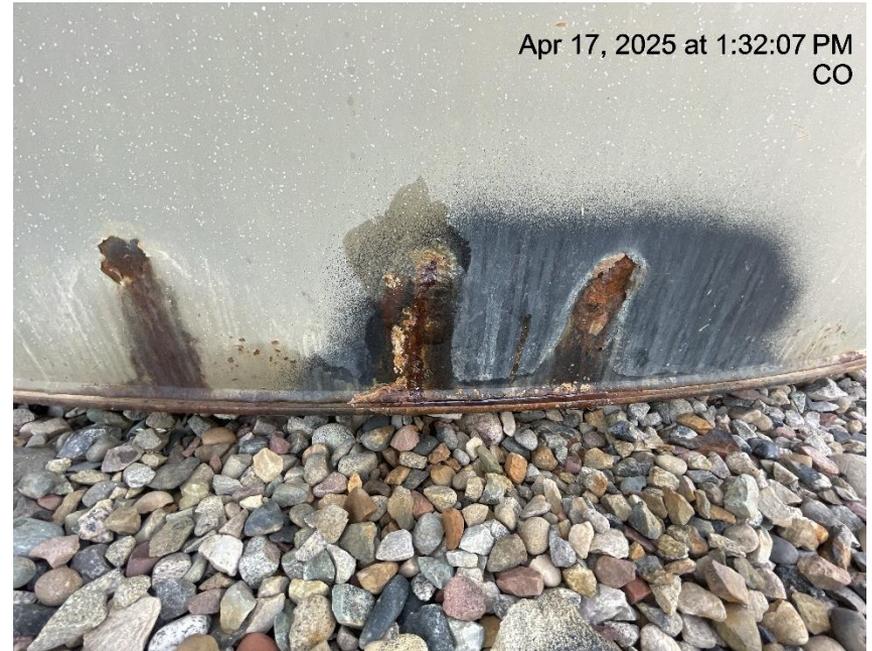
**Photo # 2489 Possible tank failure - Suspected leaks on production tank/tank appears to lack integrity**

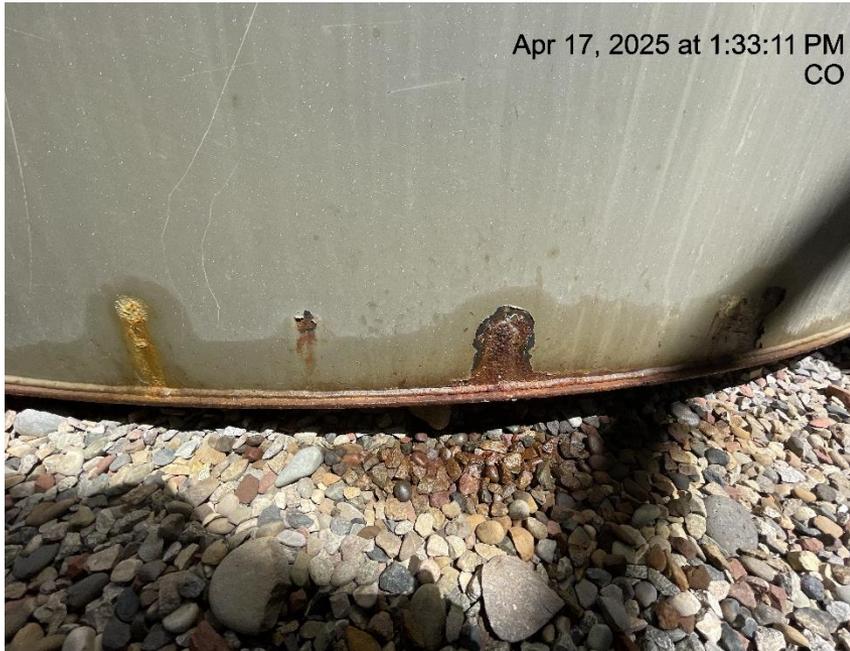
**Photo # 2490 Possible tank failure - Suspected leaks on production tank/tank appears to lack integrity**

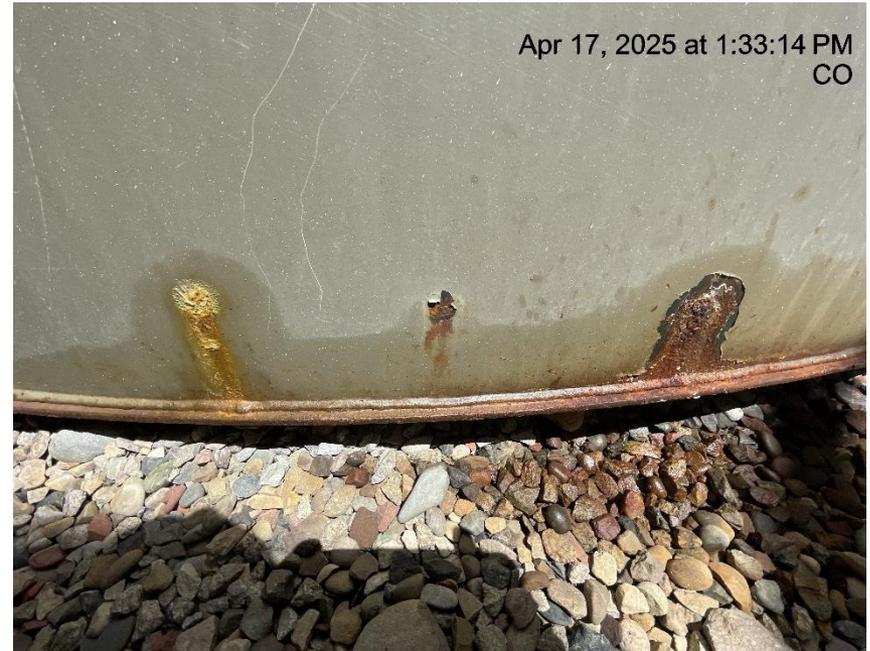
**Photo # 2491 Possible tank failure - Suspected leaks on production tank/tank appears to lack integrity**

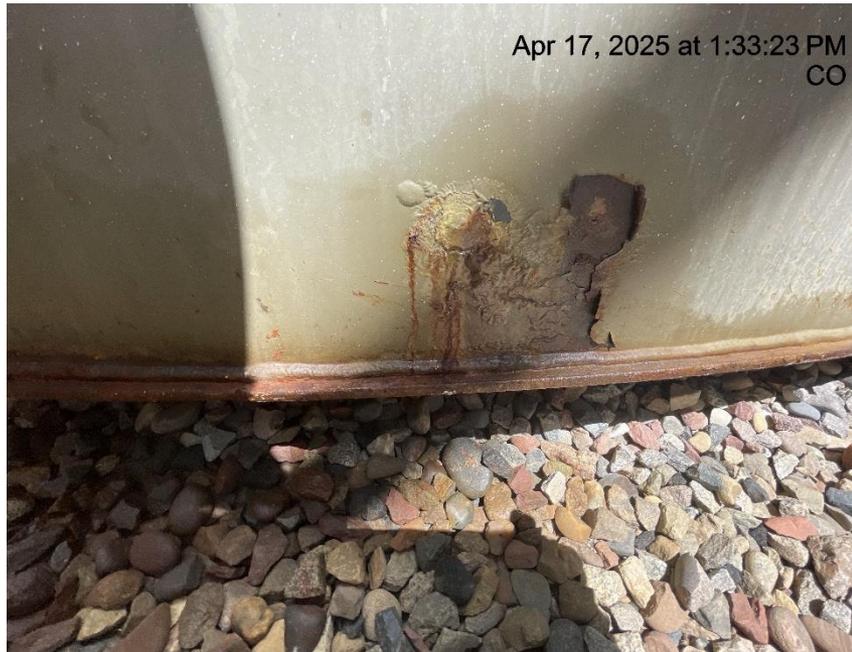
**Photo # 2492 Possible tank failure - Suspected leak on production tank/tank appears to lack integrity**

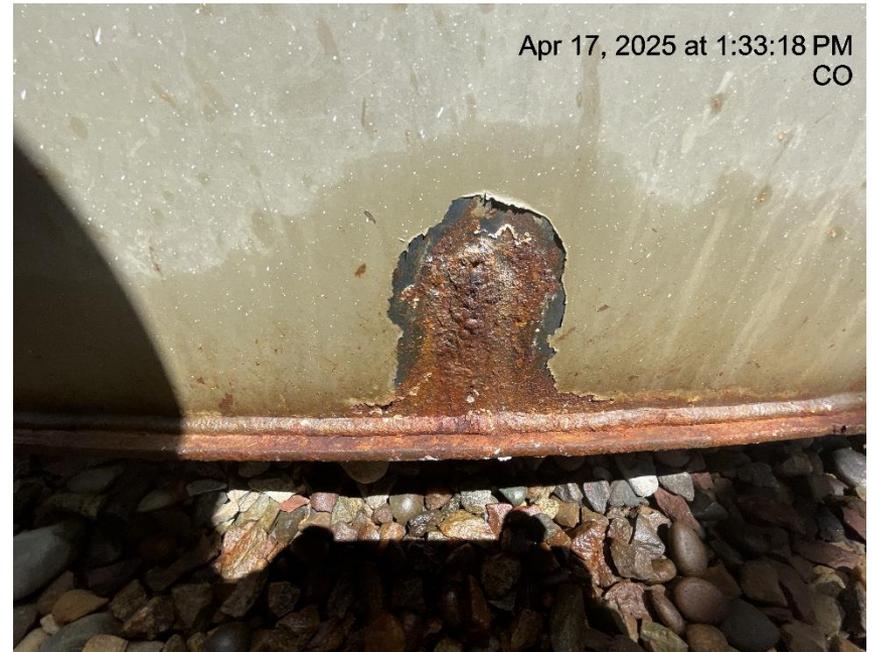
**Photo # 2493 Possible tank failure - Suspected leak on production tank/tank appears to lack integrity**

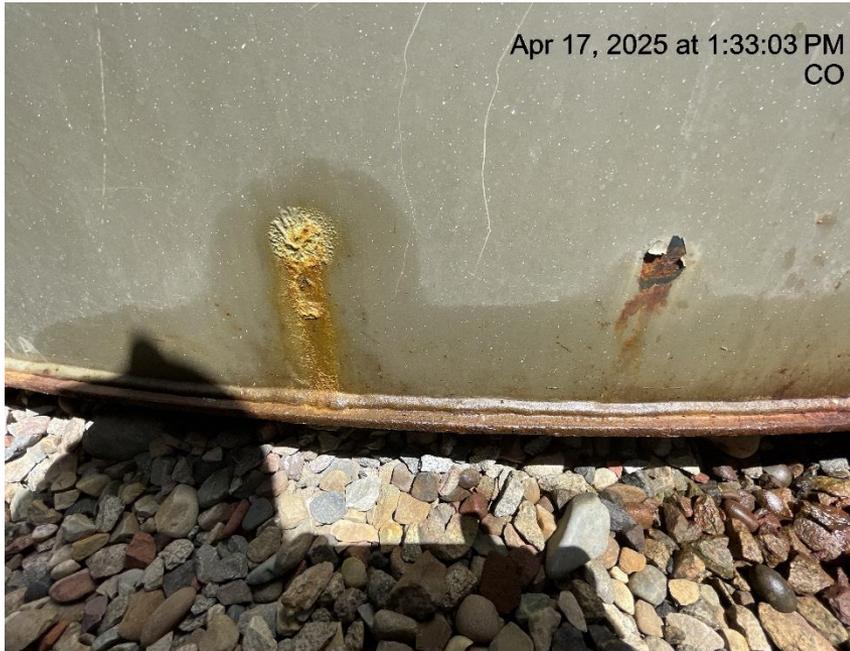
**Photo # 2494 Possible tank failure - Suspected leaks on production tank/tank appears to lack integrity**

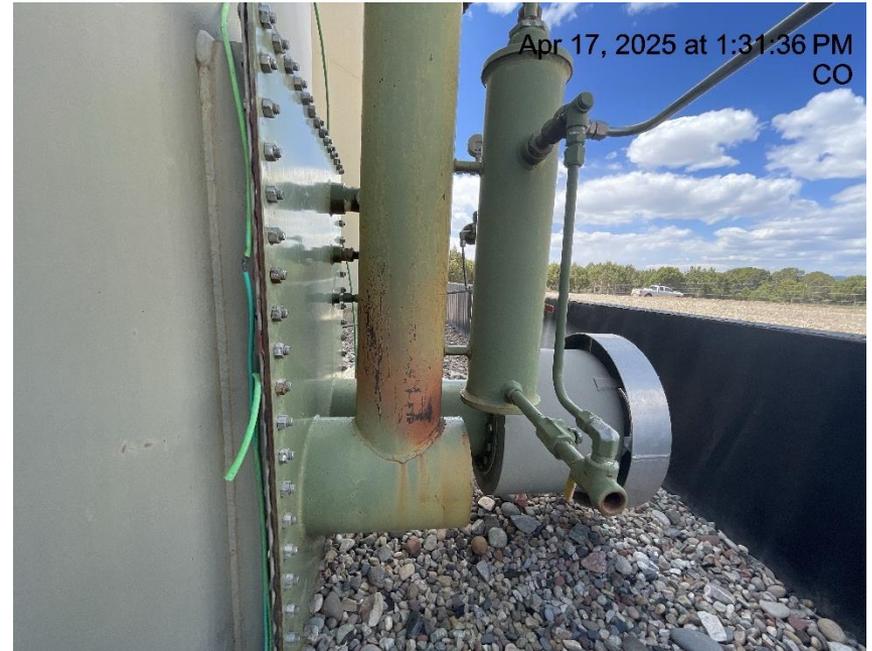
**Photo # 2495 PRV vent line does not comply with CECMC pressure safety device rules or general safety rules**
