Inspection/Audit Photos

Location Name: TEP ROCKY MOUNTAIN LLC JOLLEY KP 23-16 Pad

Location ID: 335447

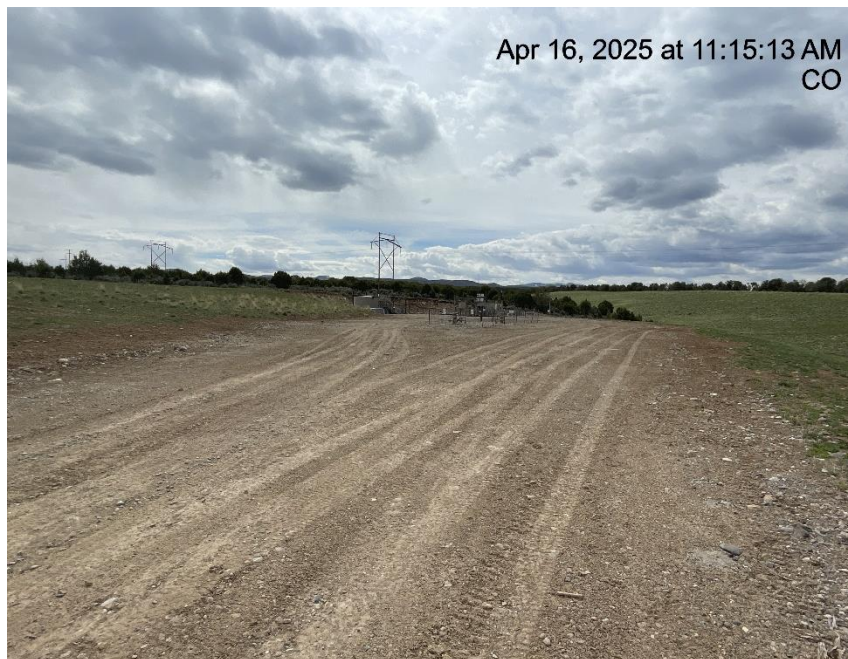
Photo # 1632 From entrance to location

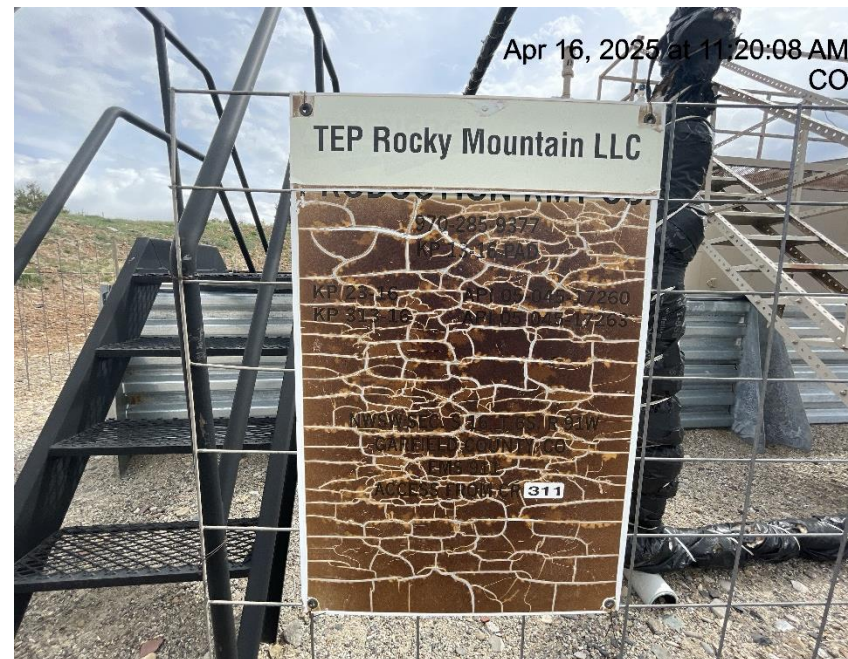
Photo # 1633 Location

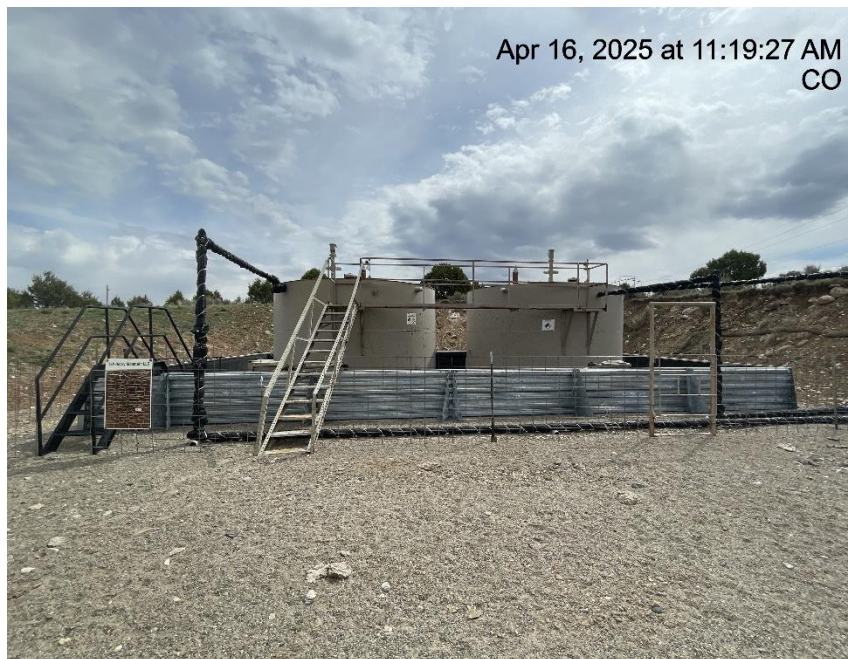
Photo # 1634 Location

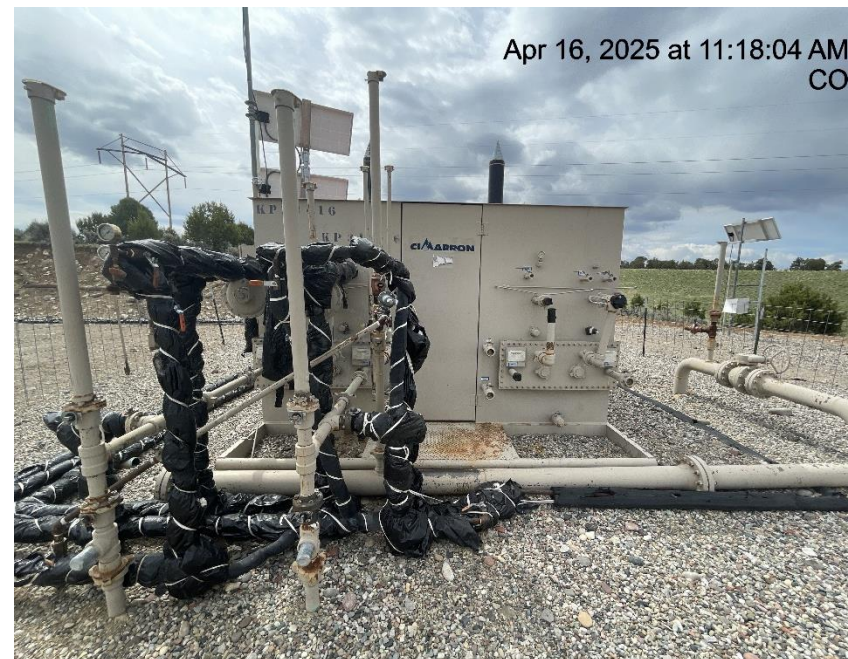
Photo # 1635 Location

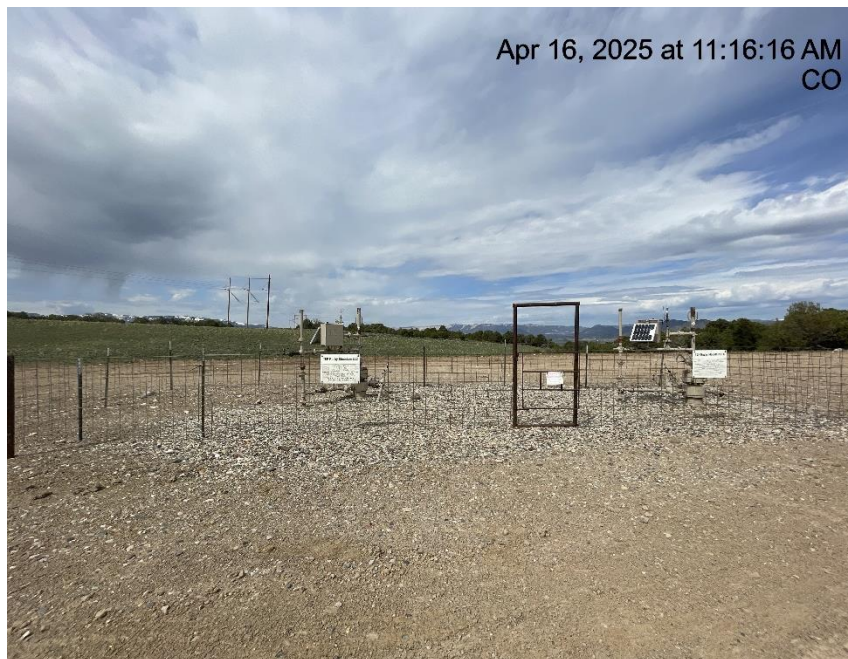
Photo # 1636 Location

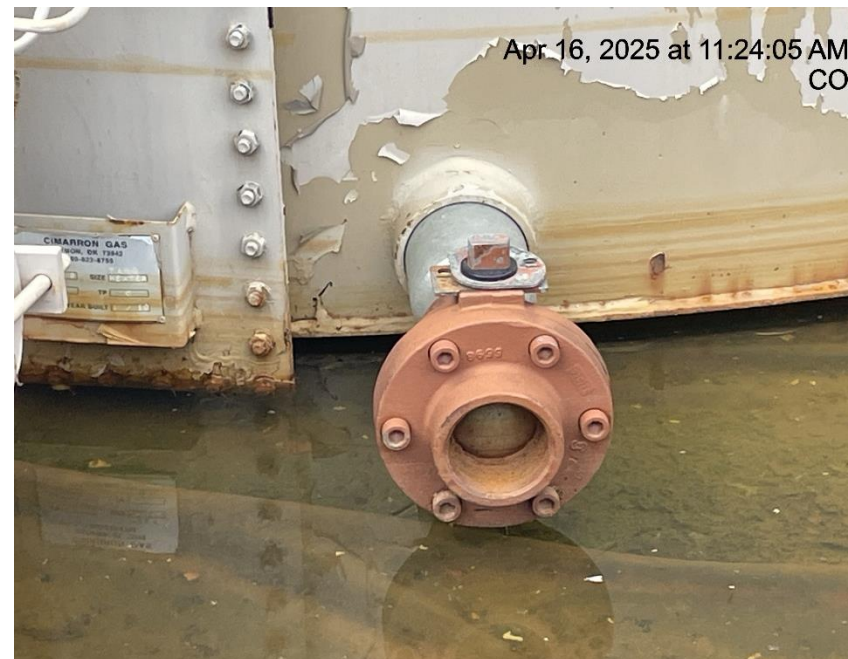
Photo # 1637 Open ended load line

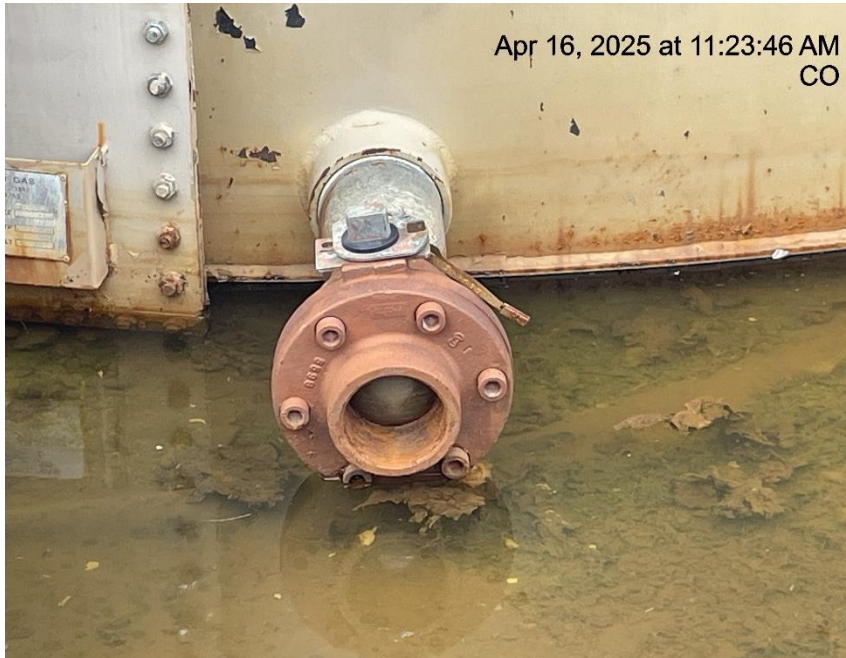
Photo # 1638 Open ended load line

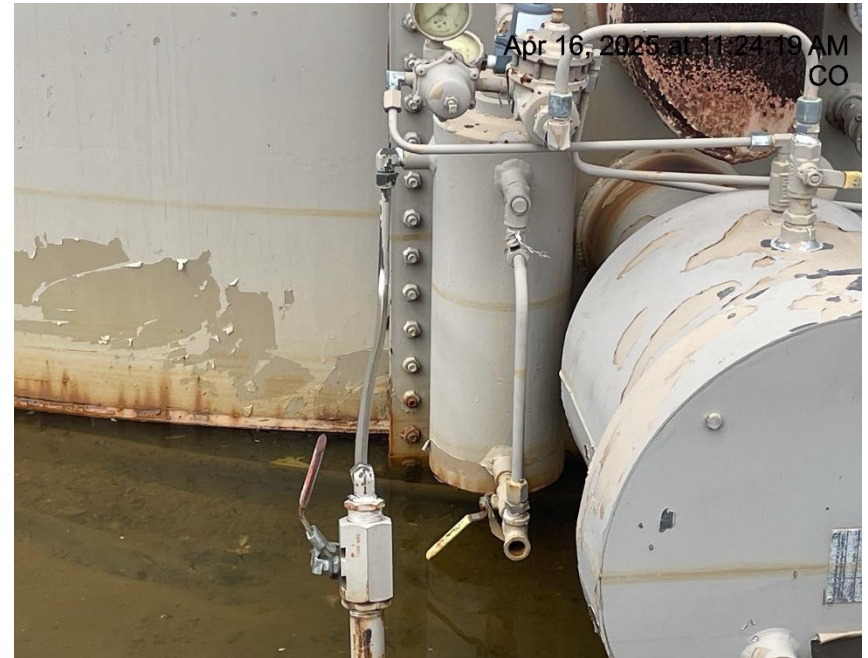
Photo # 1639 PRV vent line does not comply with CECMC pressure safety rules or general safety rules

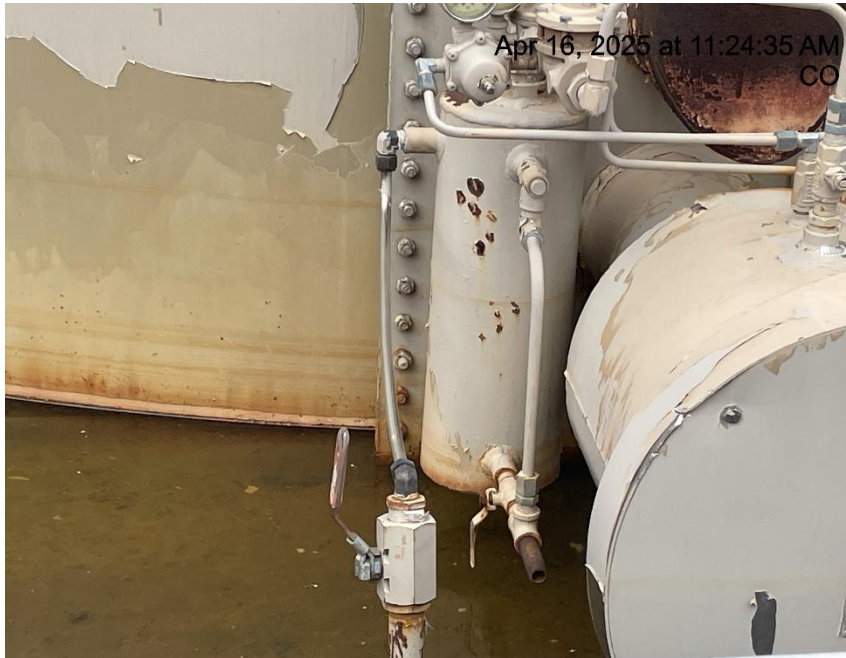
Photo # 1640 PRV vent line does not comply with CECMC pressure safety rules or general safety rules

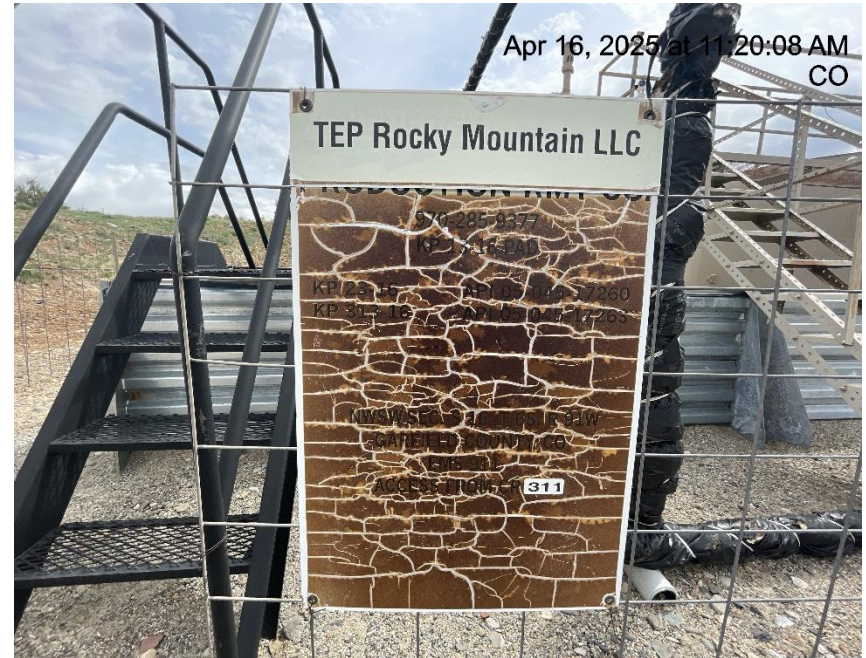
Photo # 1641 Battery sign weathered & illegible/not in compliance with CECMC rules
