Inspection/Audit Photos

Location Name: TEP ROCKY MOUNTAIN LLC JOLLEY KP 33-21 Pad

Location ID: 335507

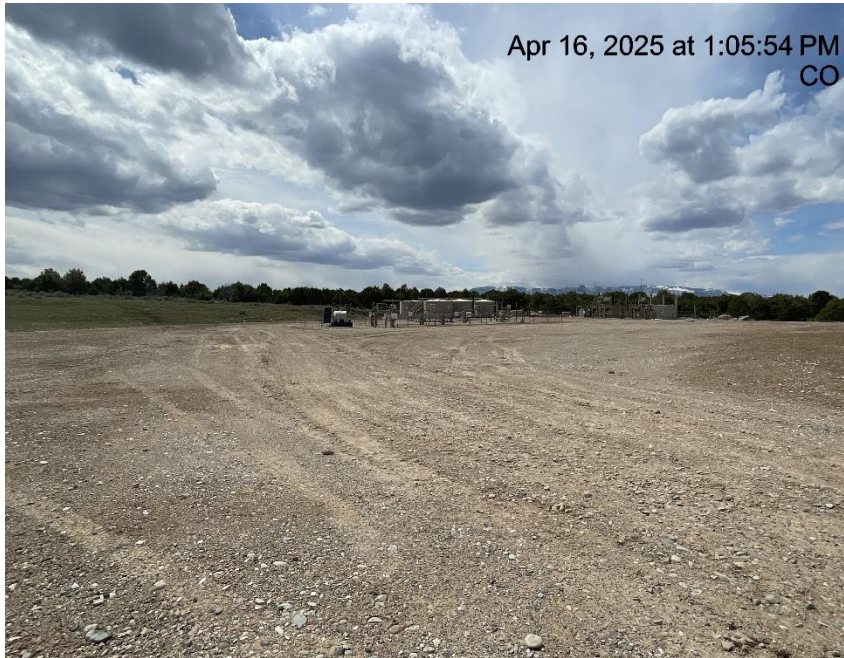
Photo # 1957 From entrance to location

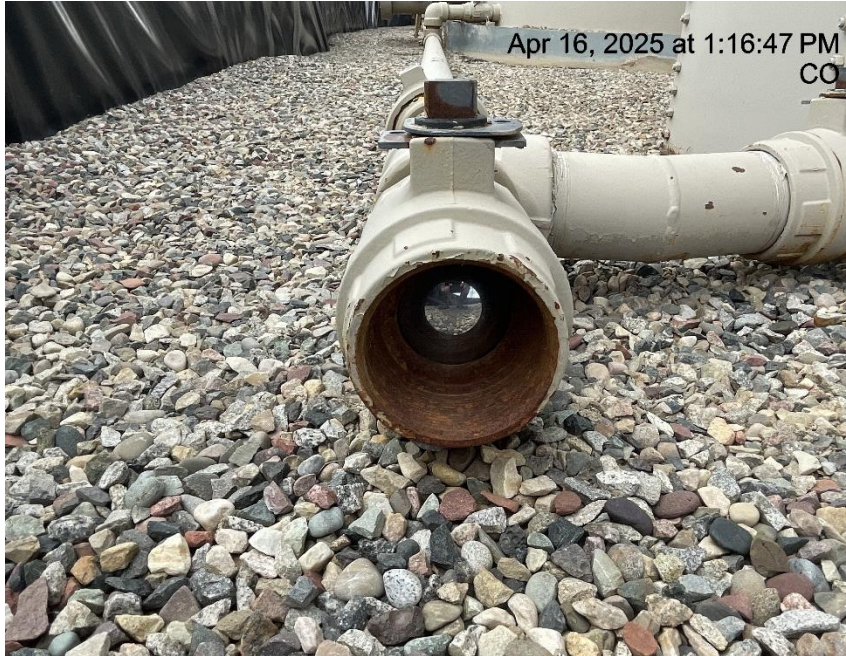
Photo # 1965 Open ended load line

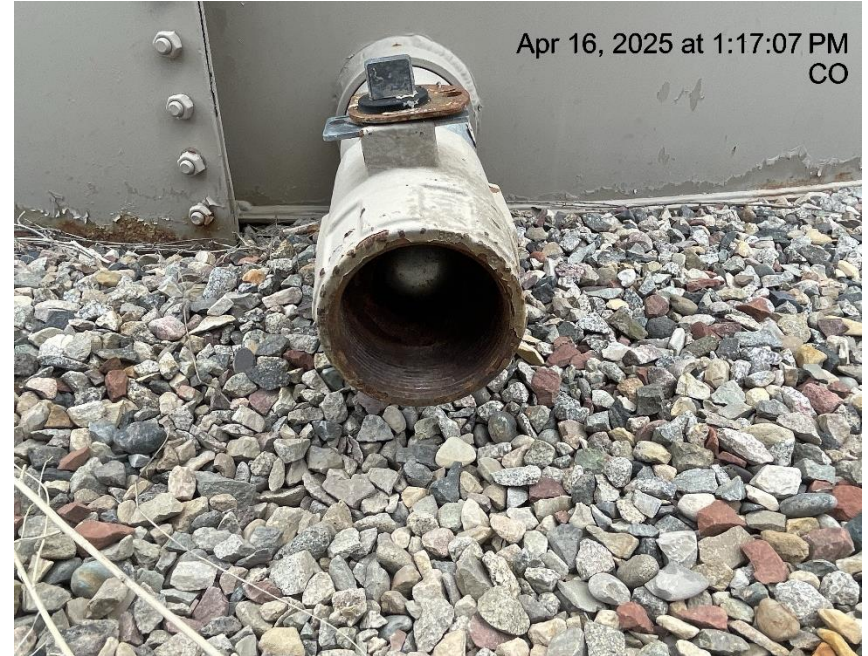
Photo # 1966 Open ended load line

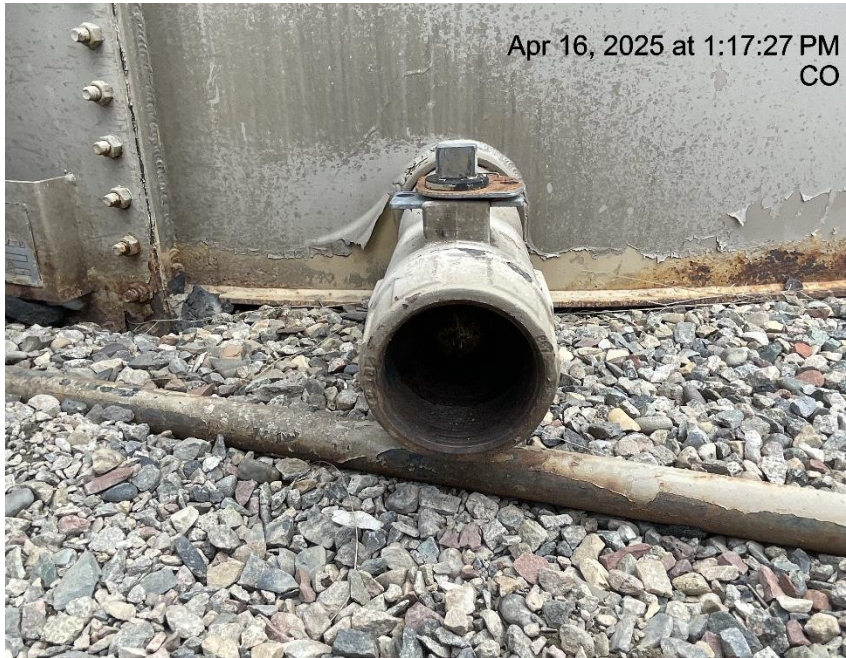
Photo # 1967 Open ended load line

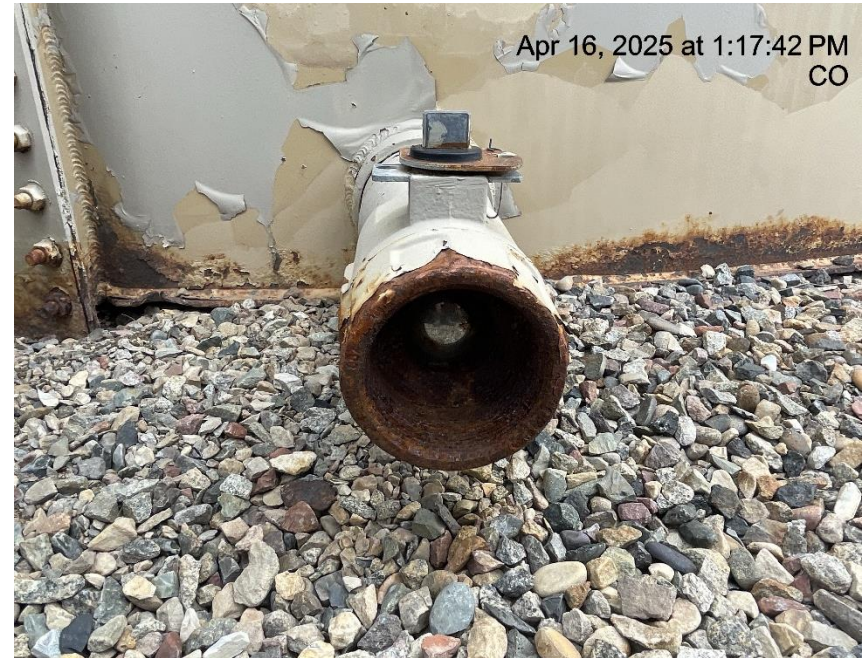
Photo # 1968 Open ended load line

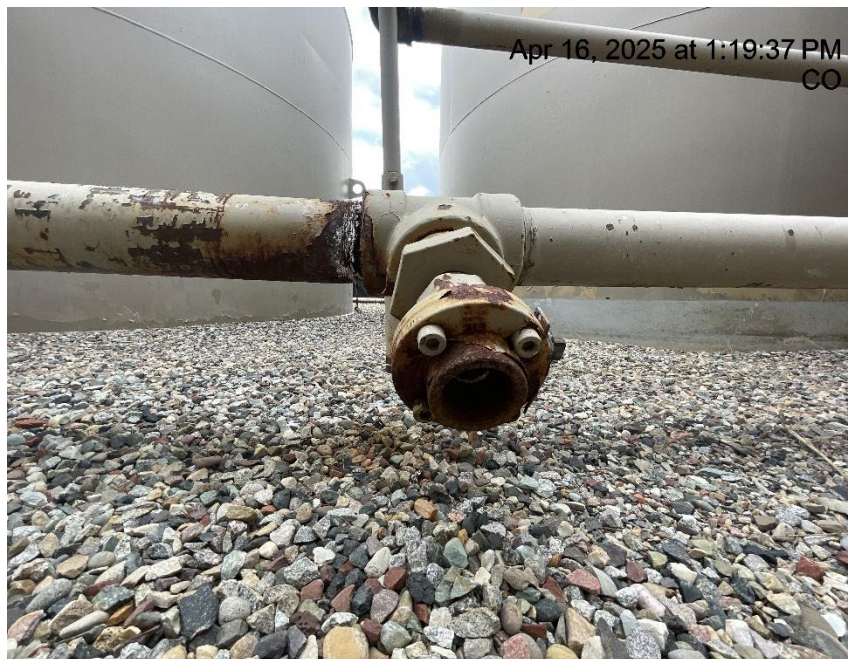
Photo # 1969 Open ended load line

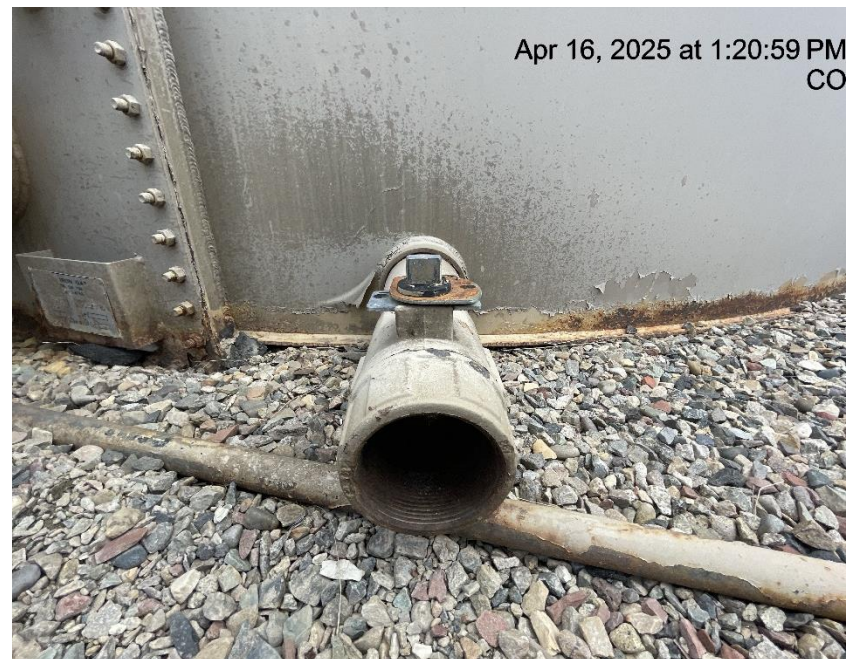
Photo # 1970 Open ended load line

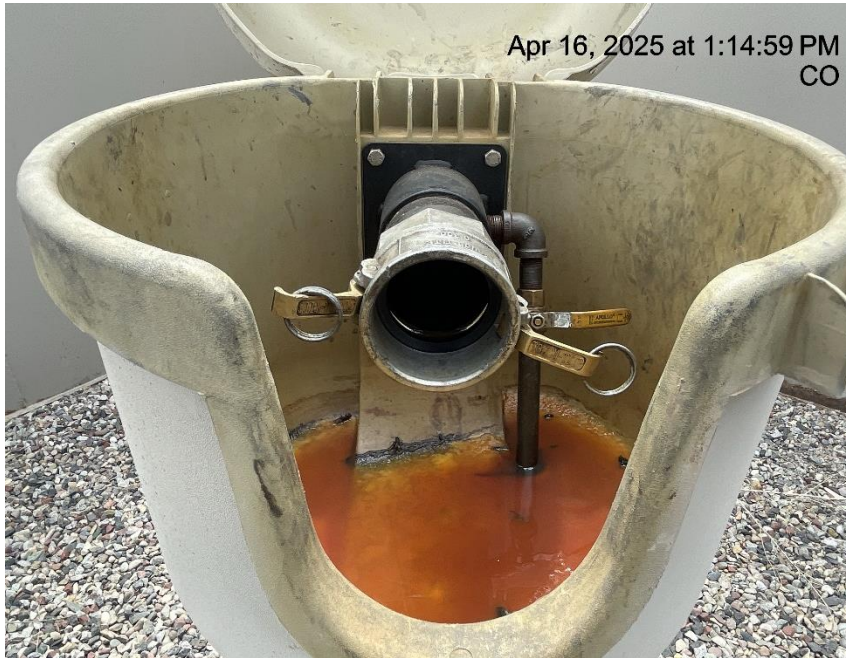
Photo # 1971 Open ended load line

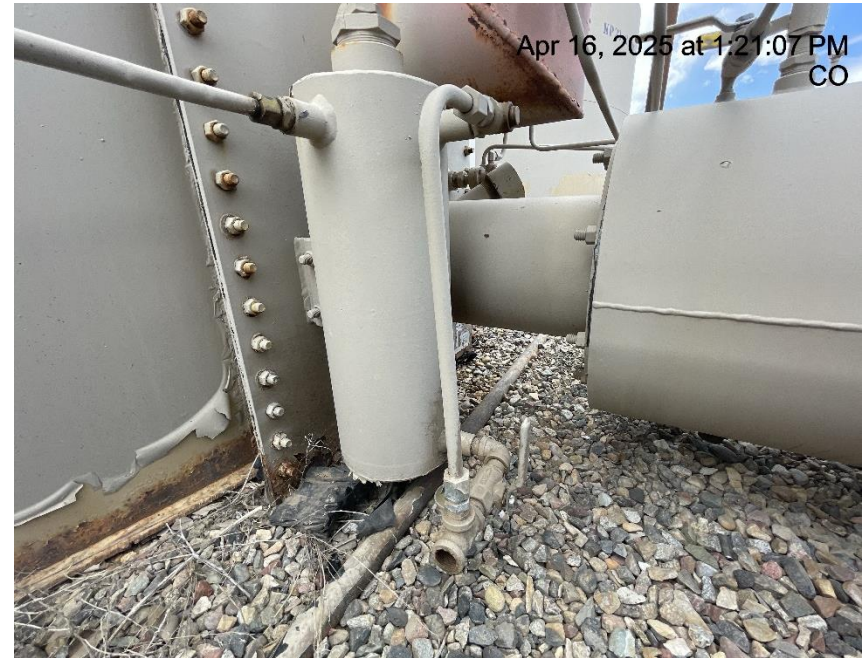
Photo # 1972 PRV vent line does not comply with CECMC pressure safety rules or general safety rules

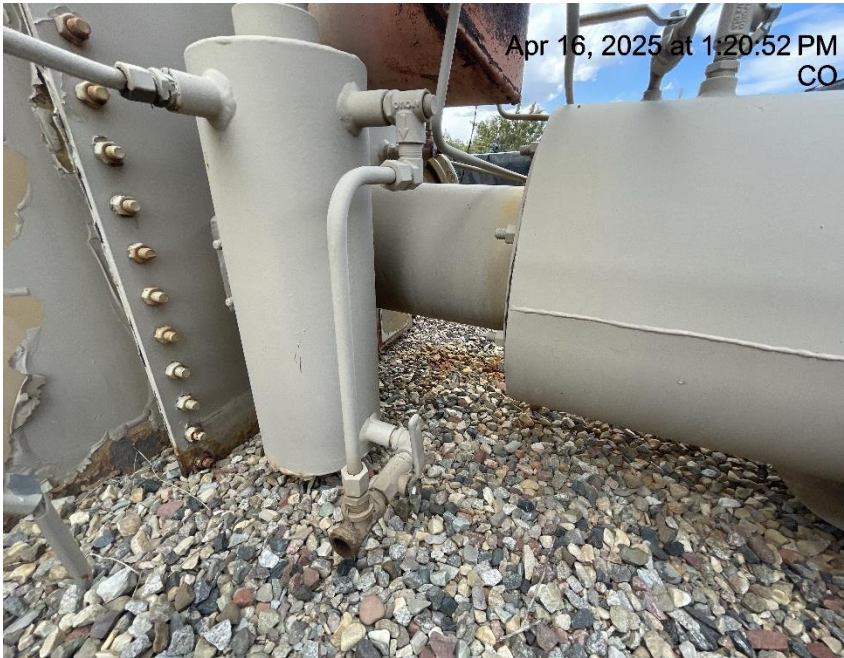
Photo # 1973 PRV vent line does not comply with CECMC pressure safety rules or general safety rules

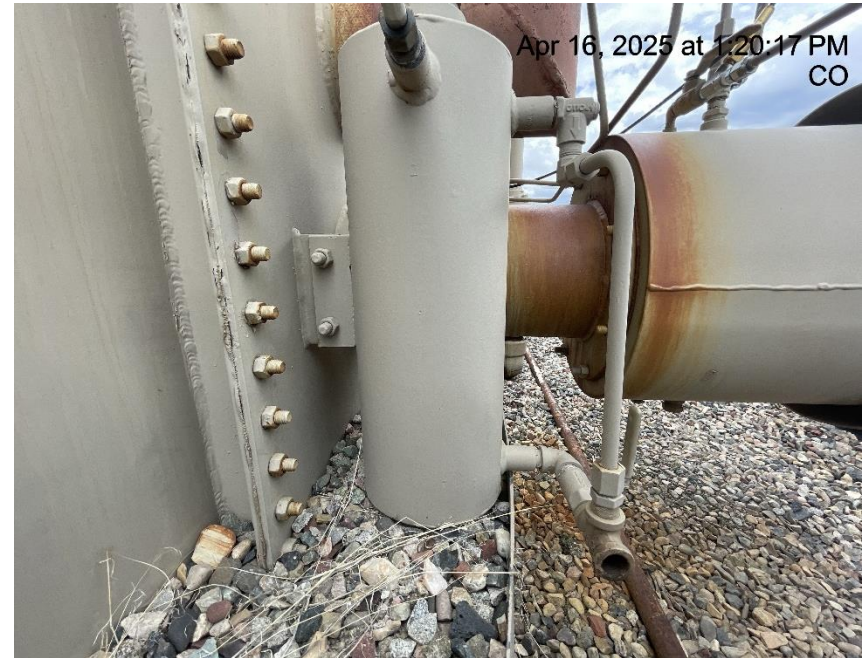
Photo # 1974 PRV vent line does not comply with CECMC pressure safety rules or general safety rules

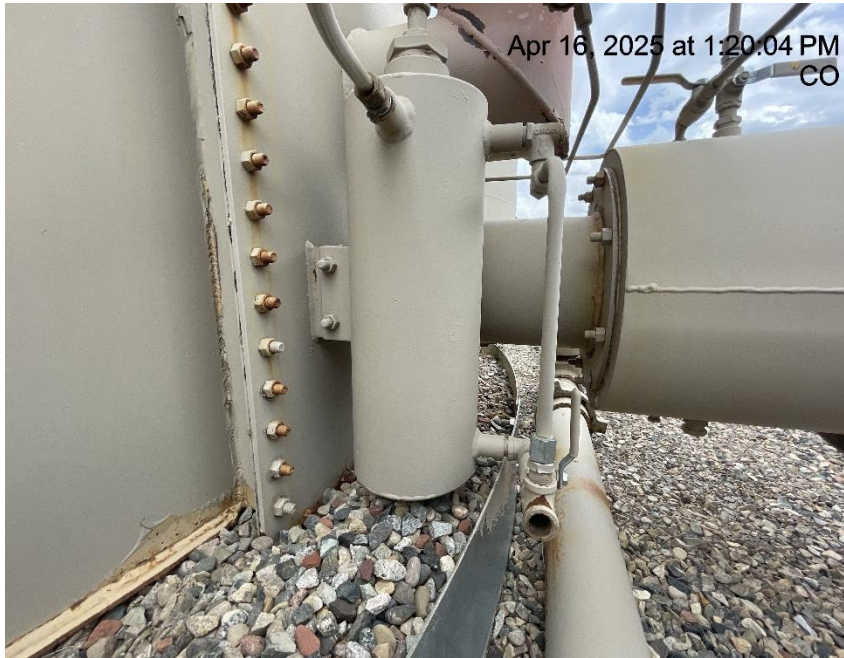
Photo # 1975 PRV vent line does not comply with CECMC pressure safety rules or general safety rules

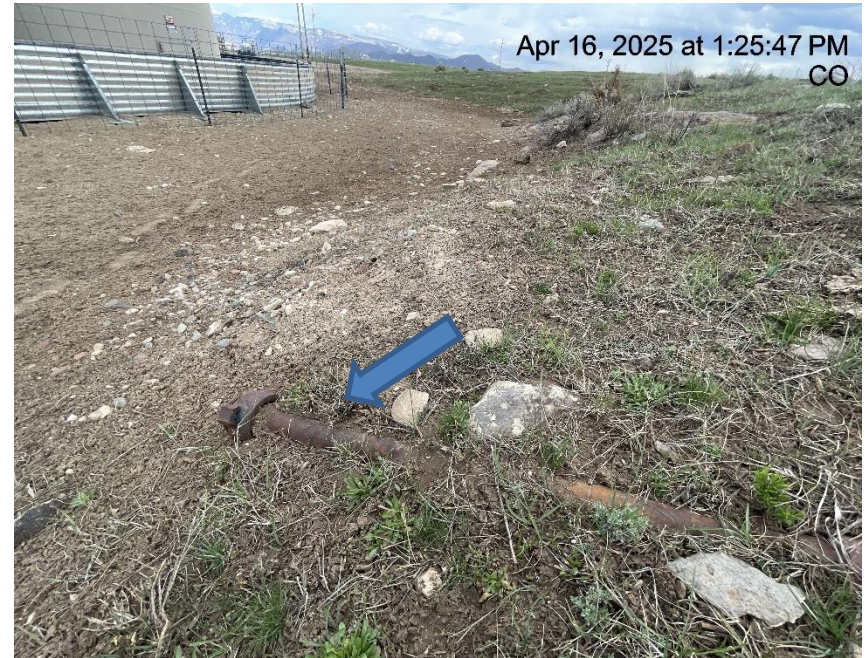
Photo # 1976 Rusted pup joint/debris
