067-07759

Crader 3-2 Photo document

4/15/2025

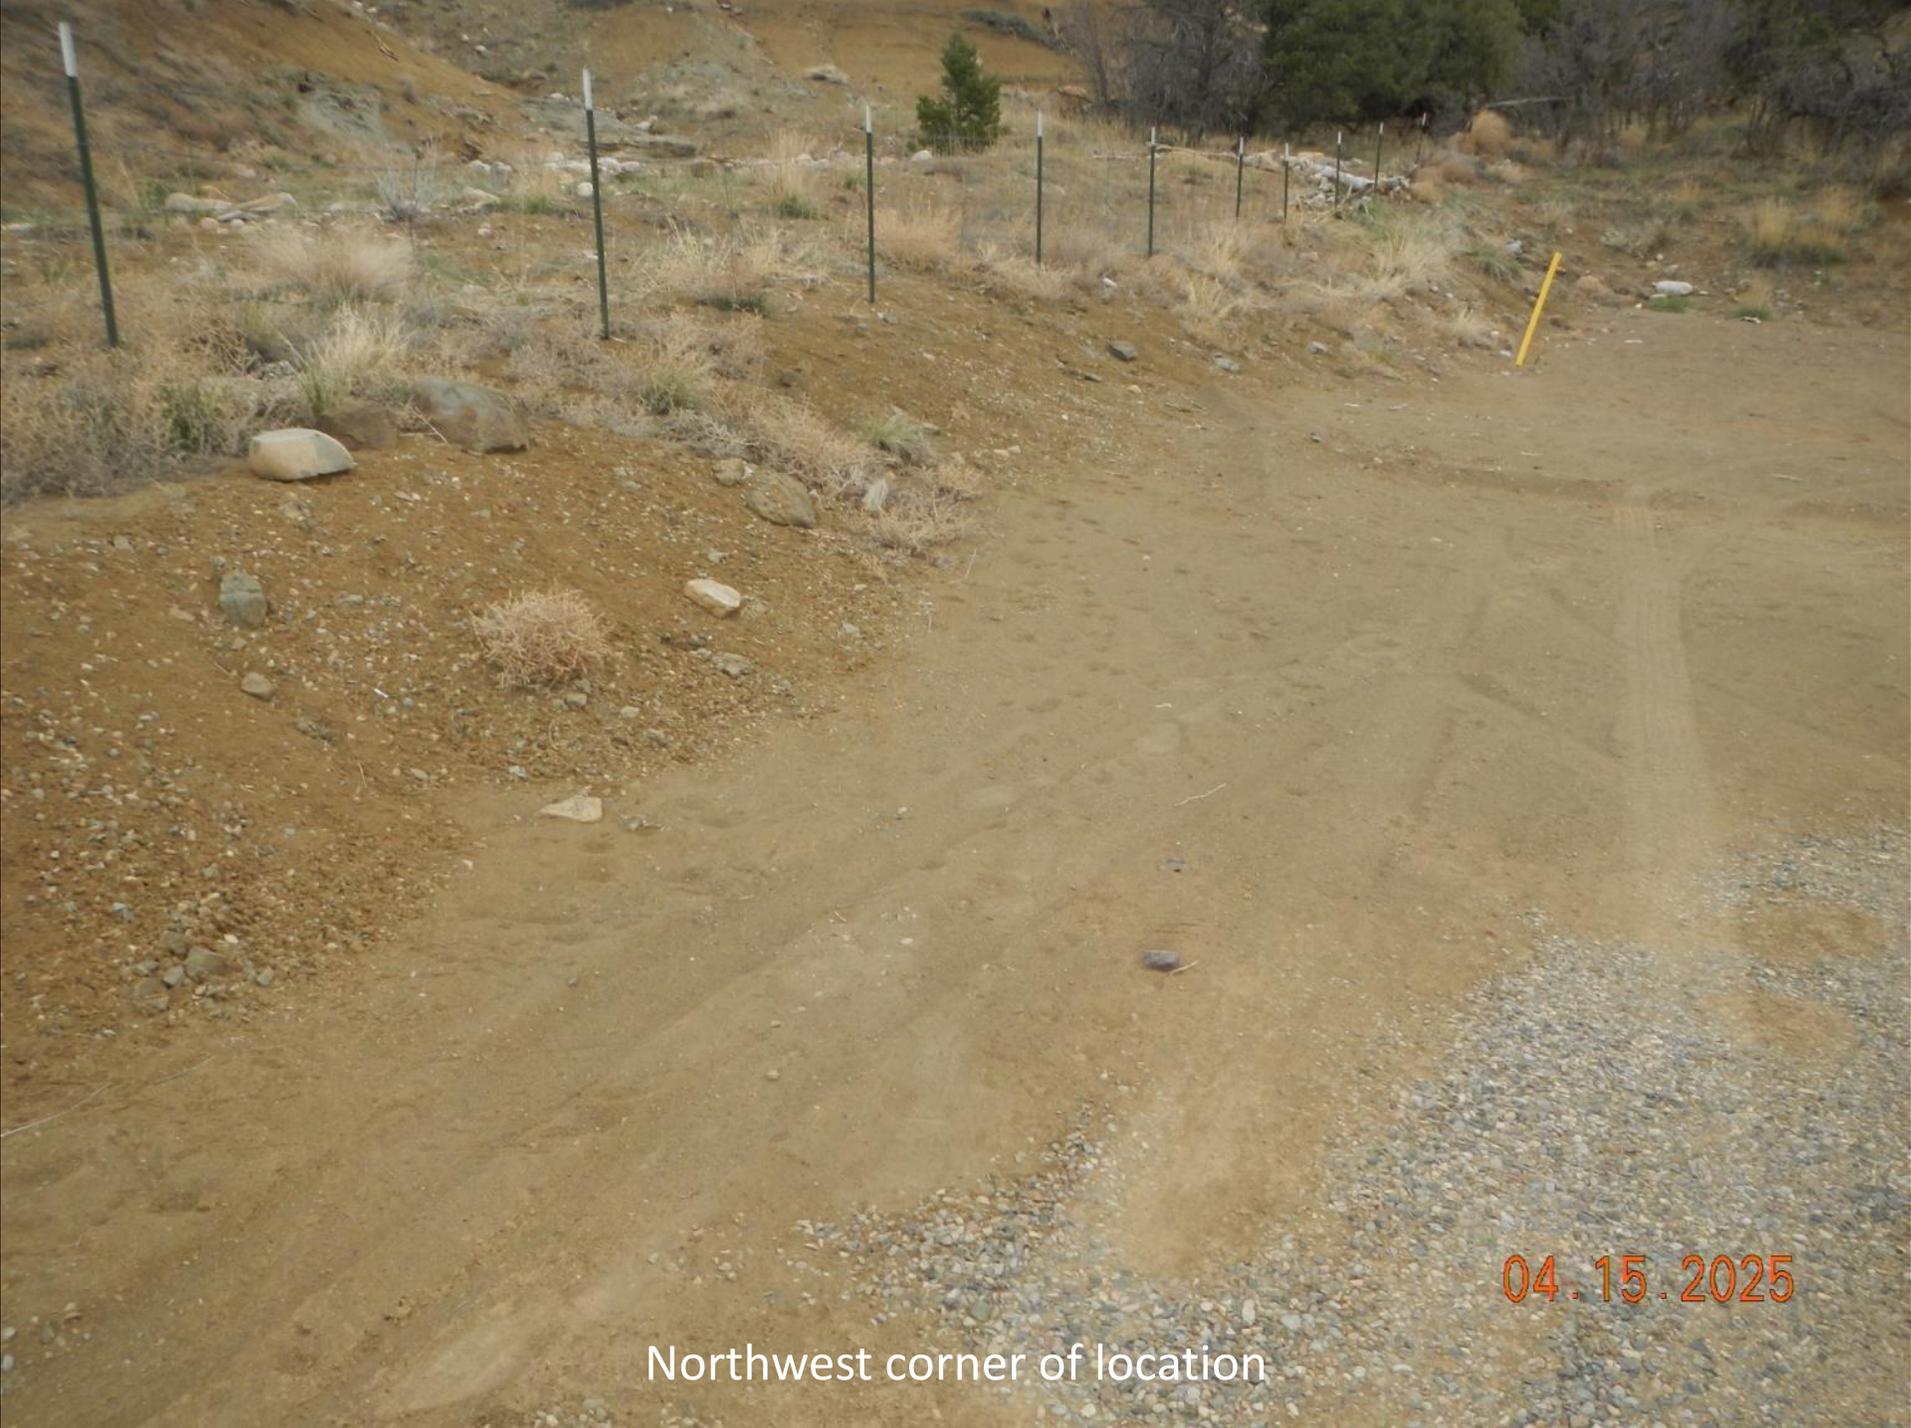
Northwest corner of location

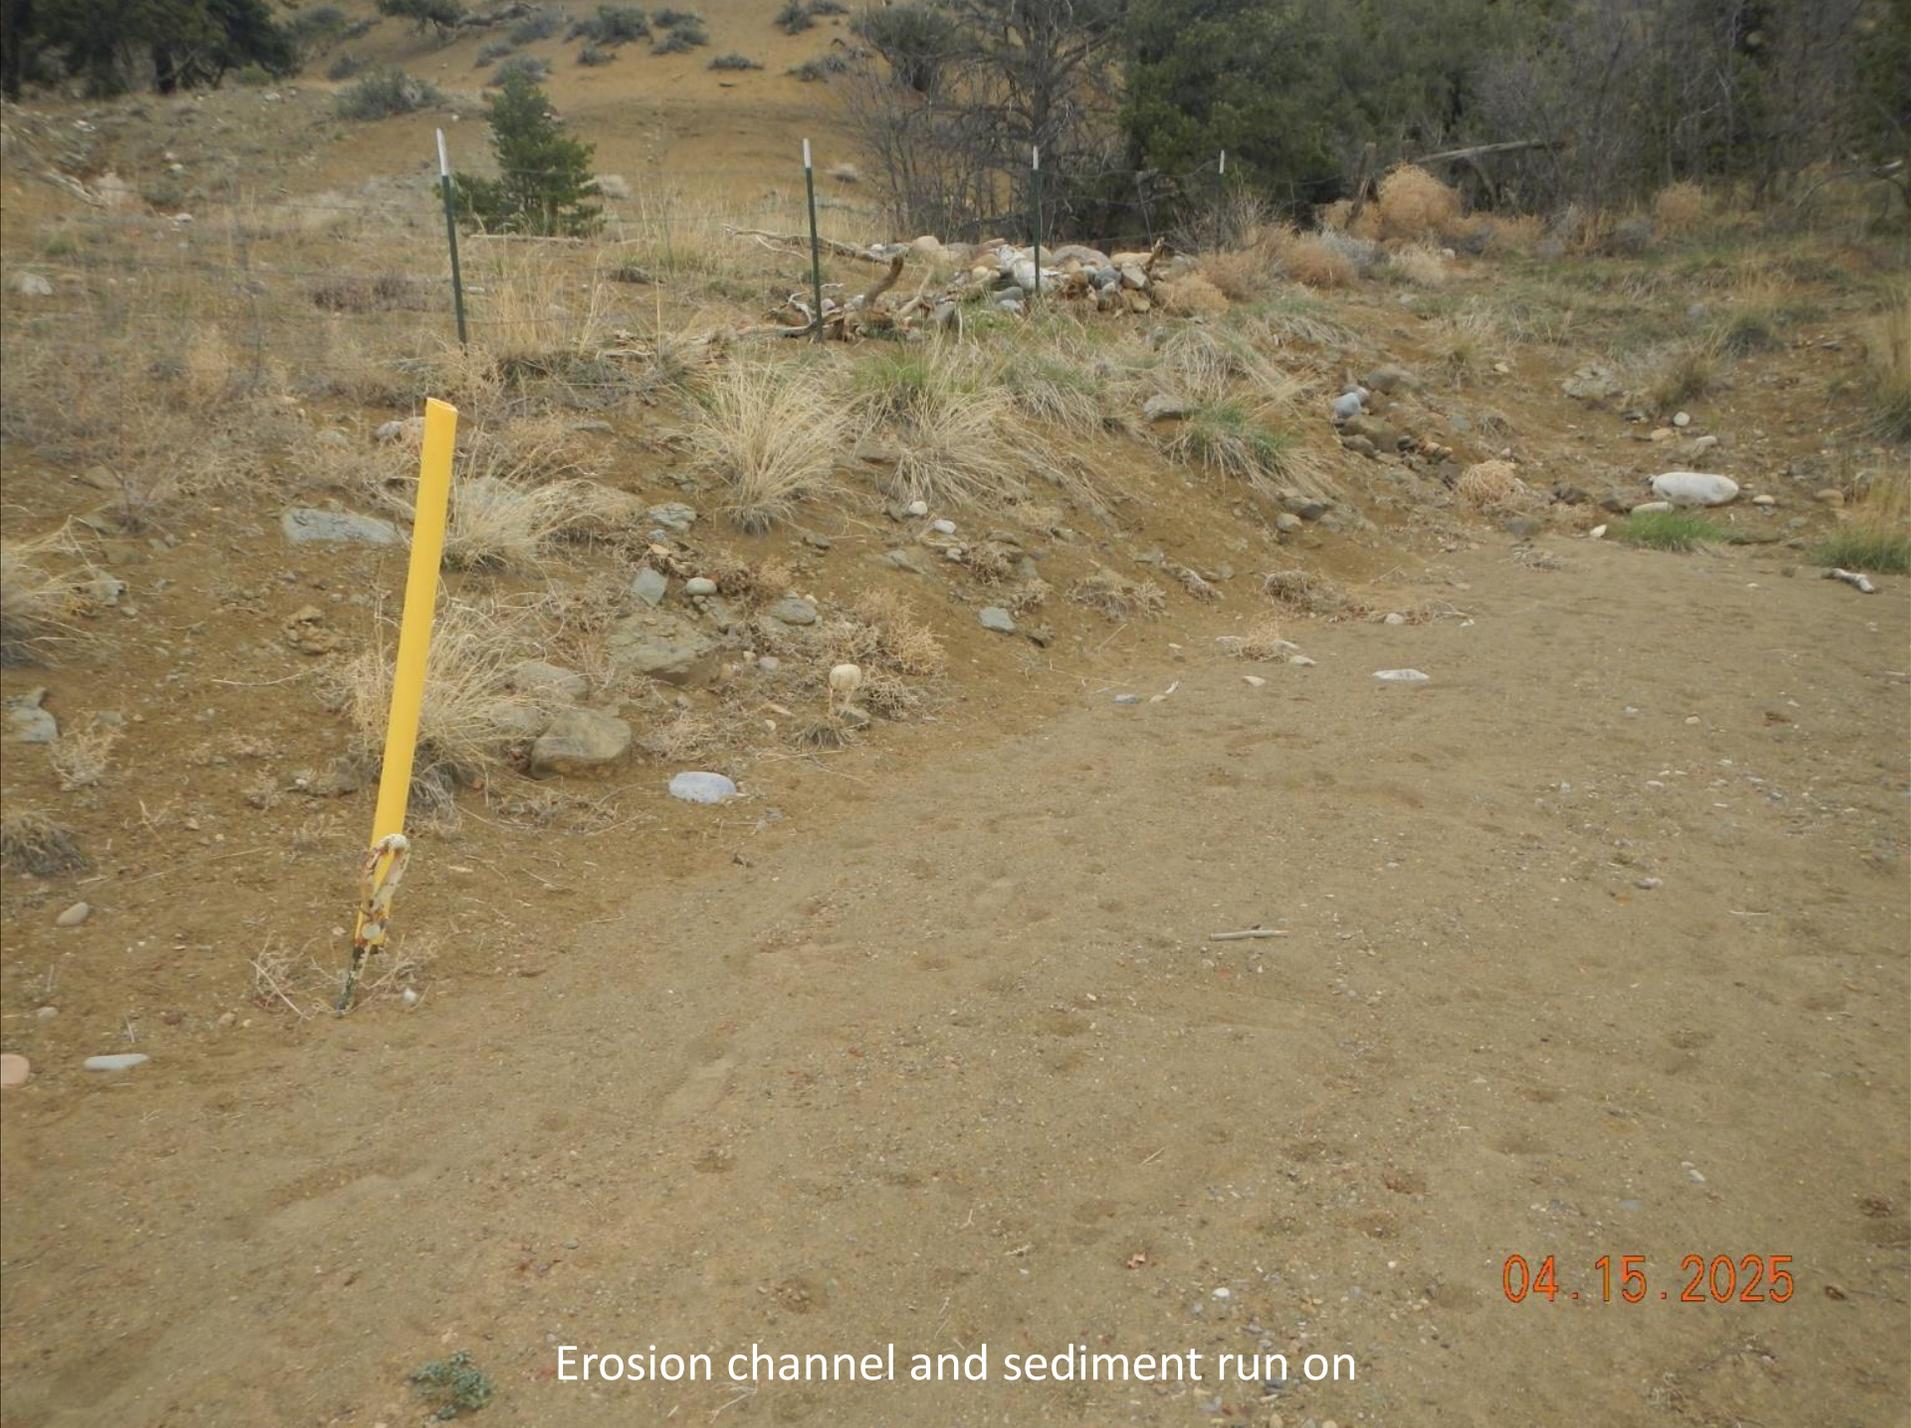
Erosion channel and sediment run on

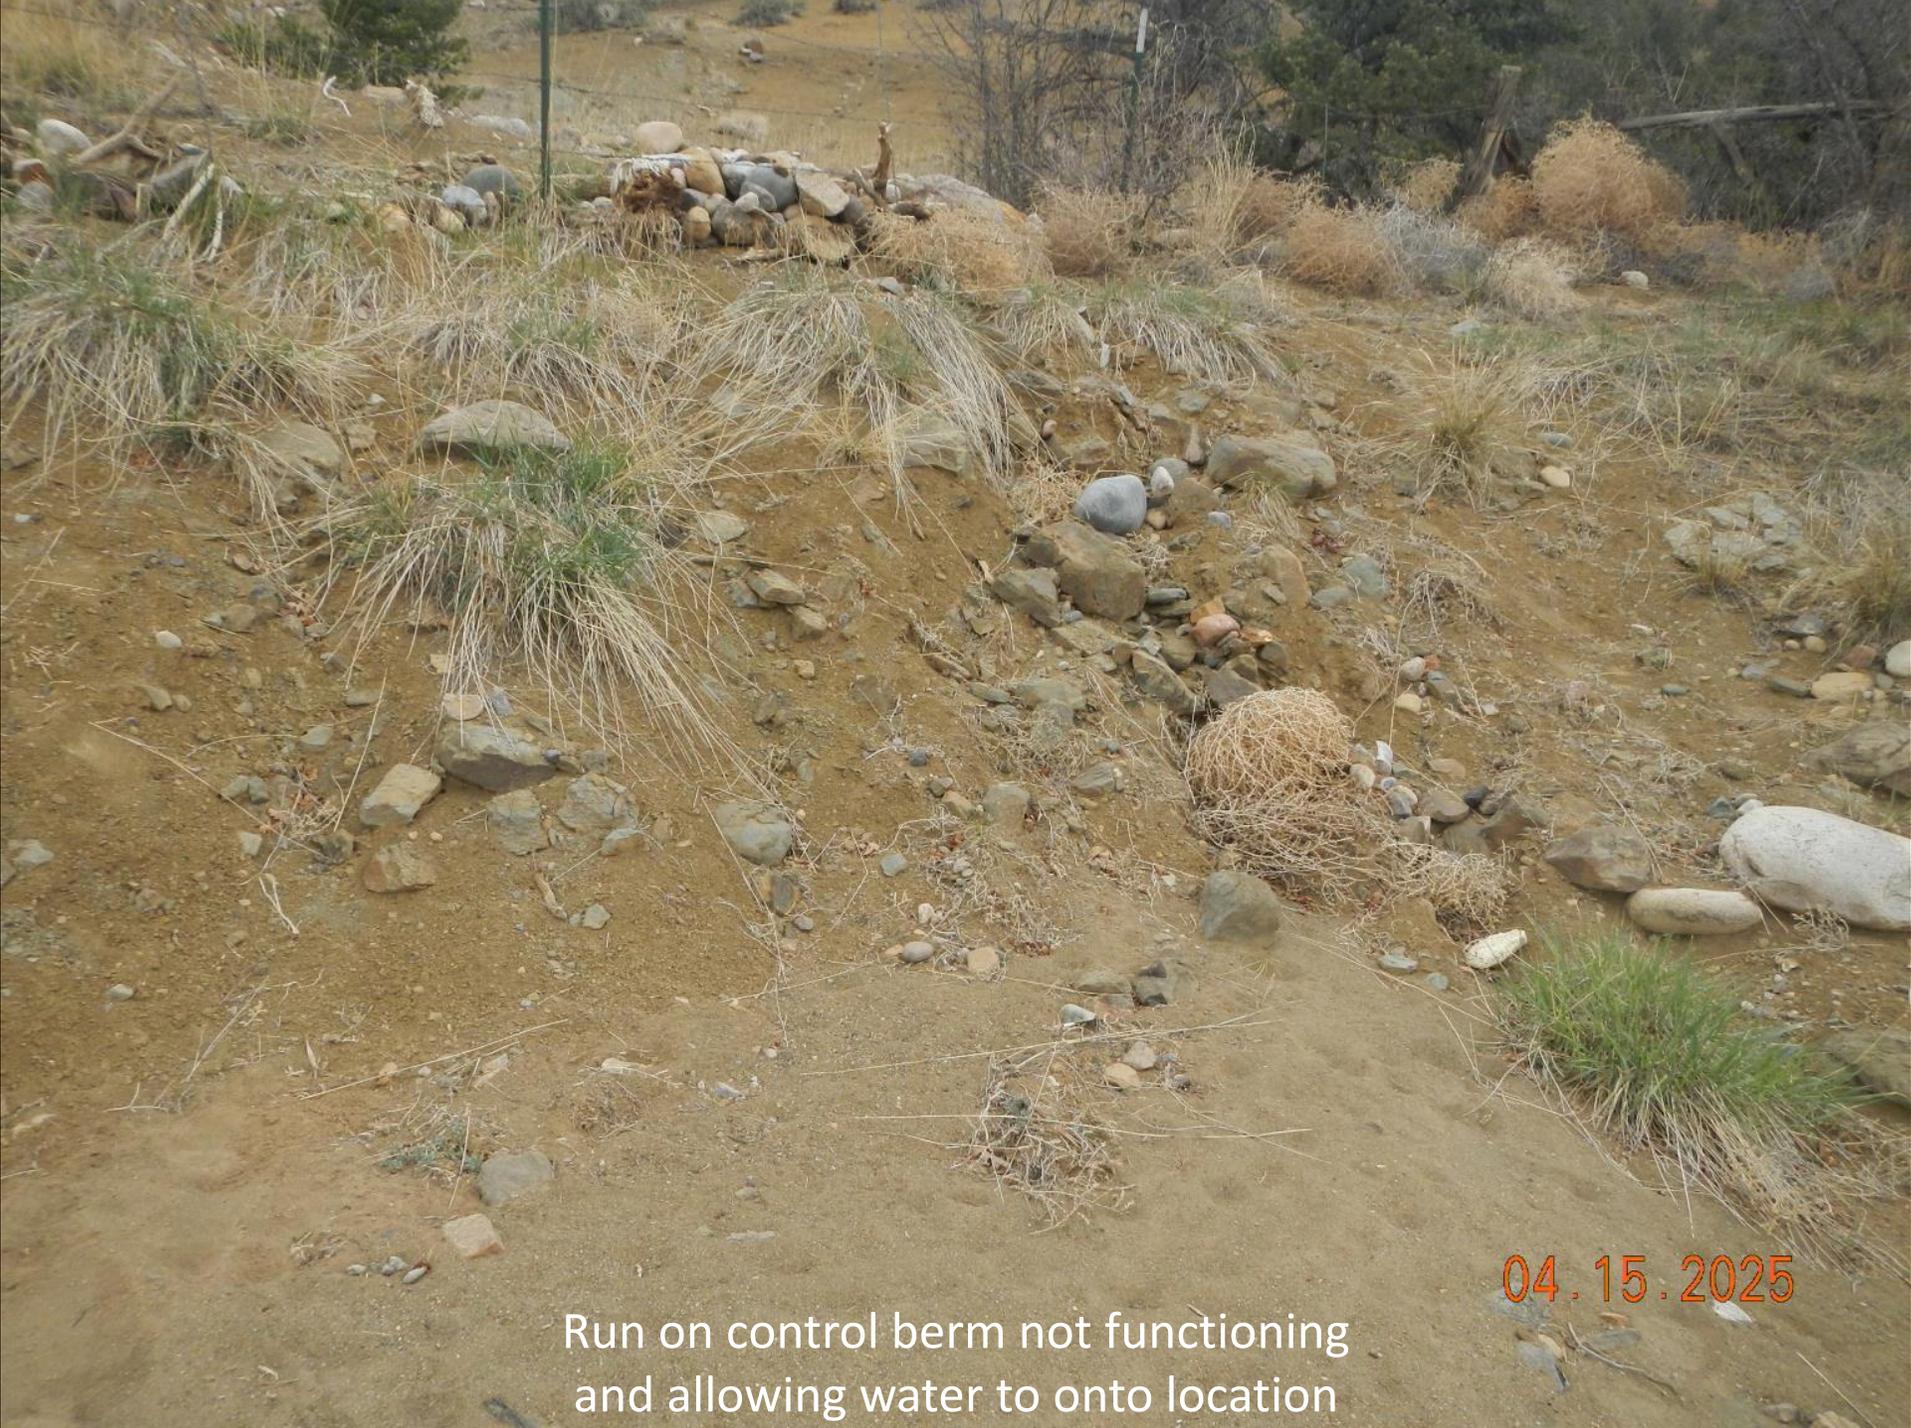
Run on control berm not functioning
and allowing water to onto location

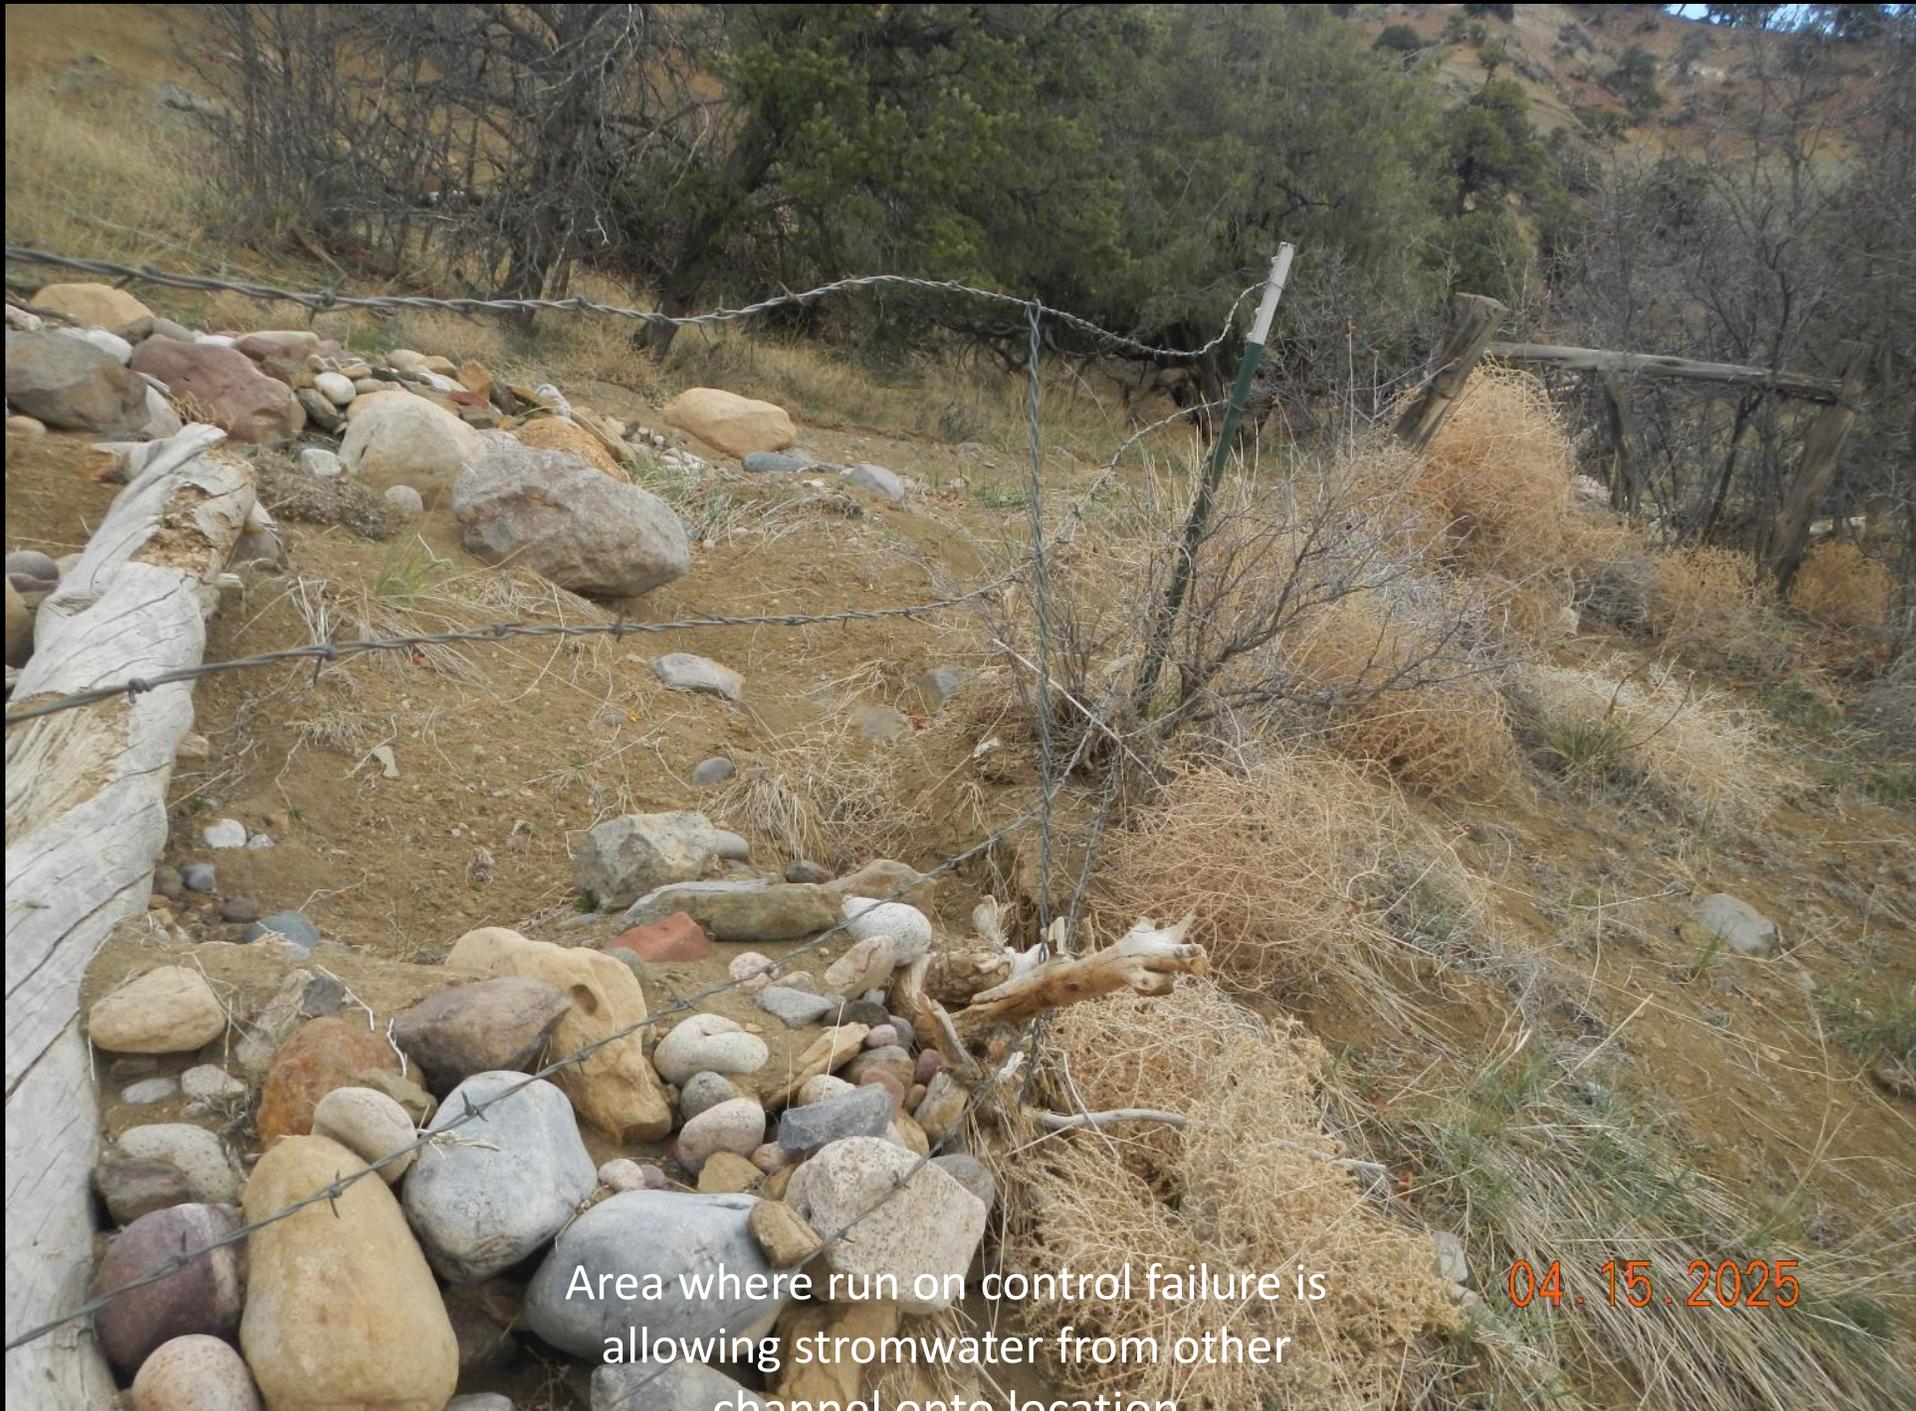
Area where run on control failure is allowing stormwater from other channel onto location

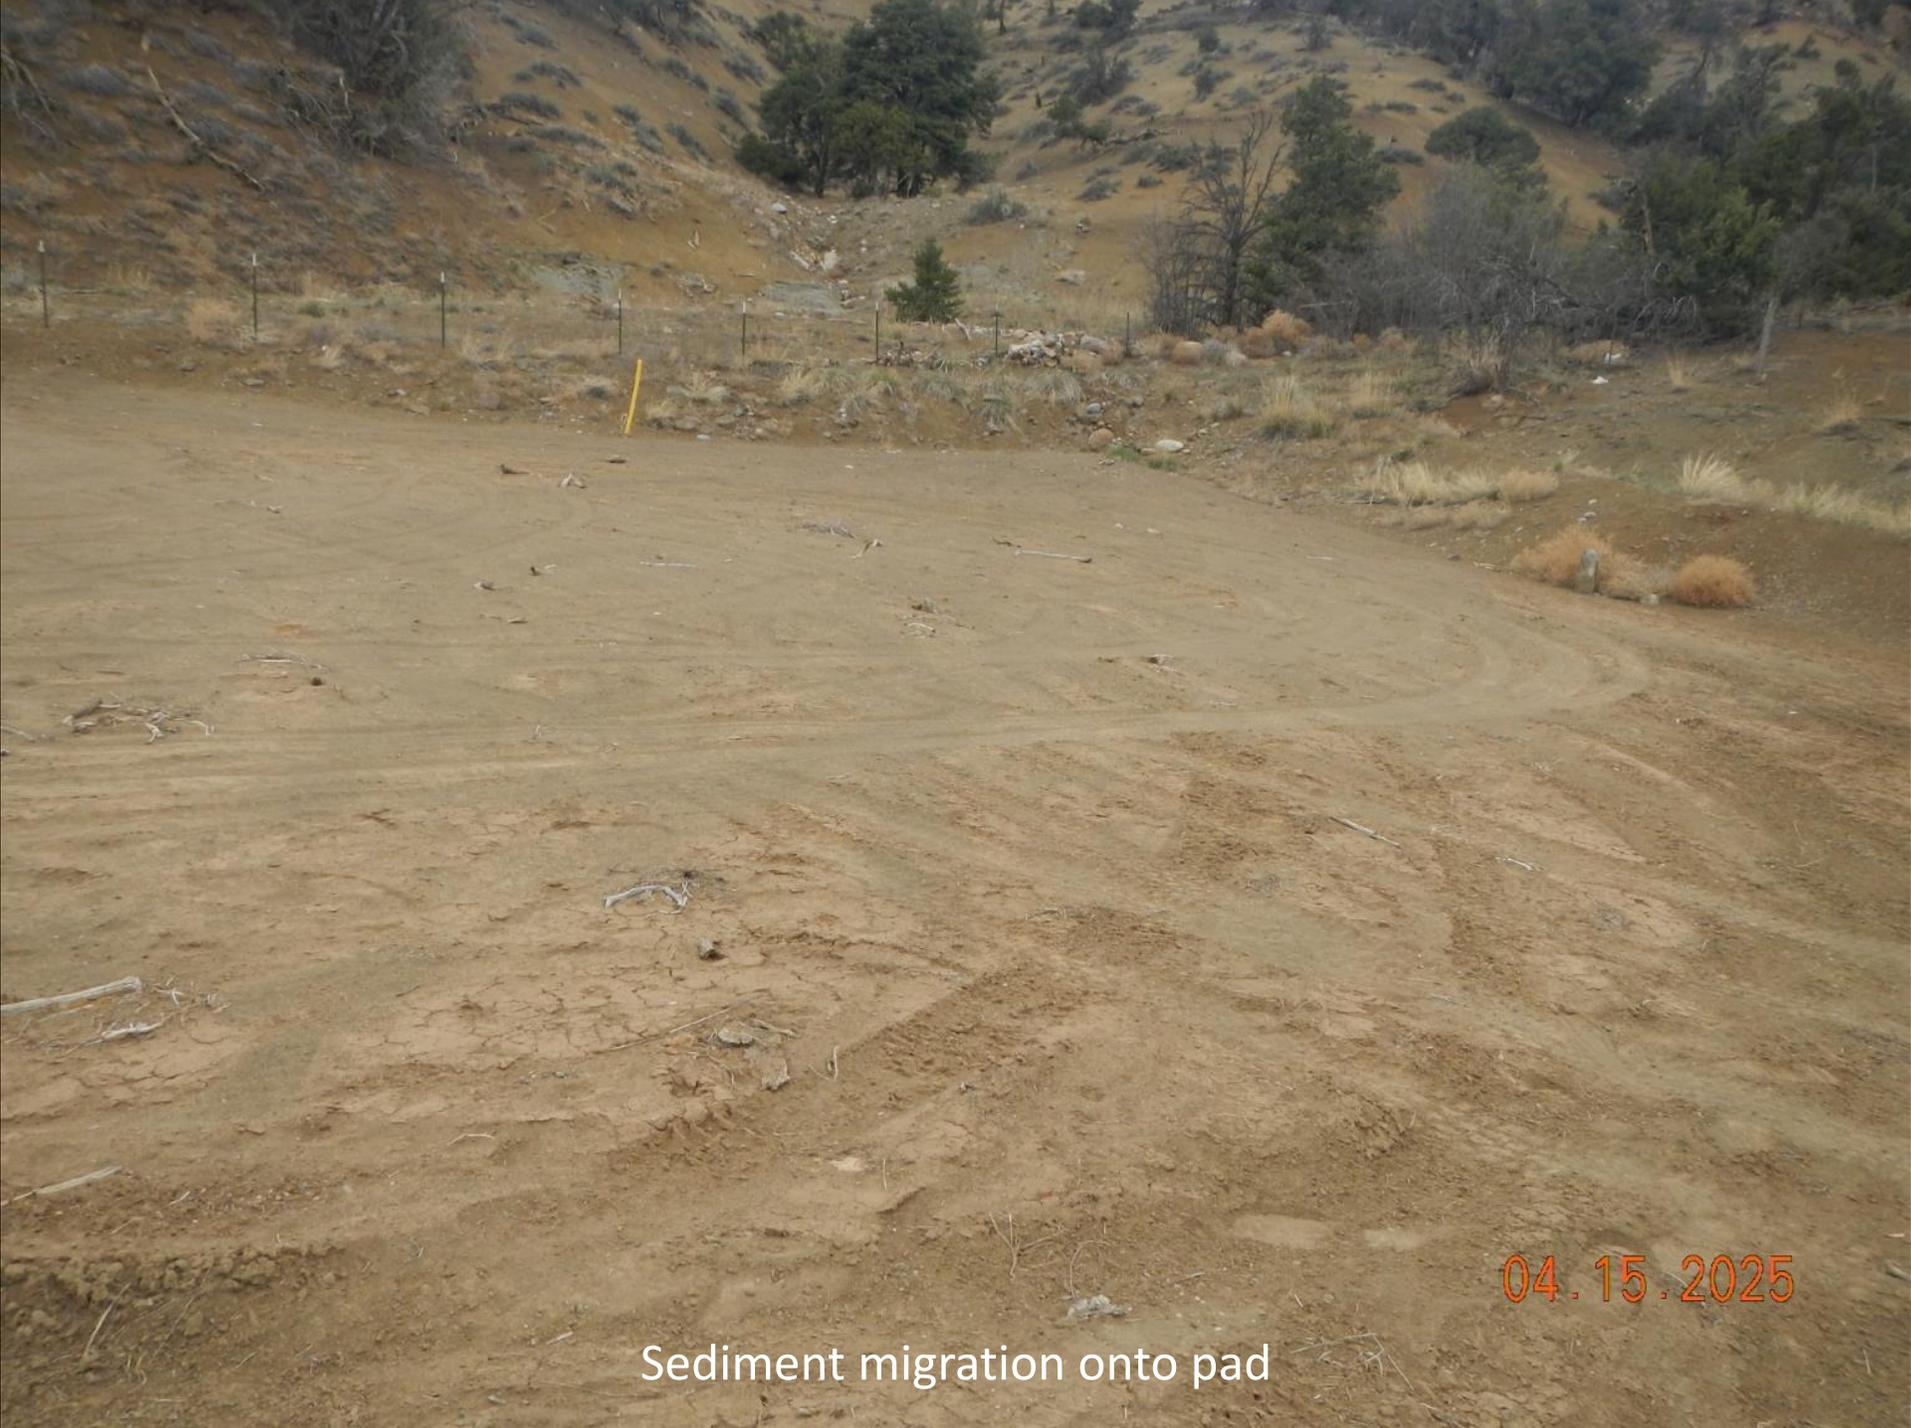
Sediment migration onto pad

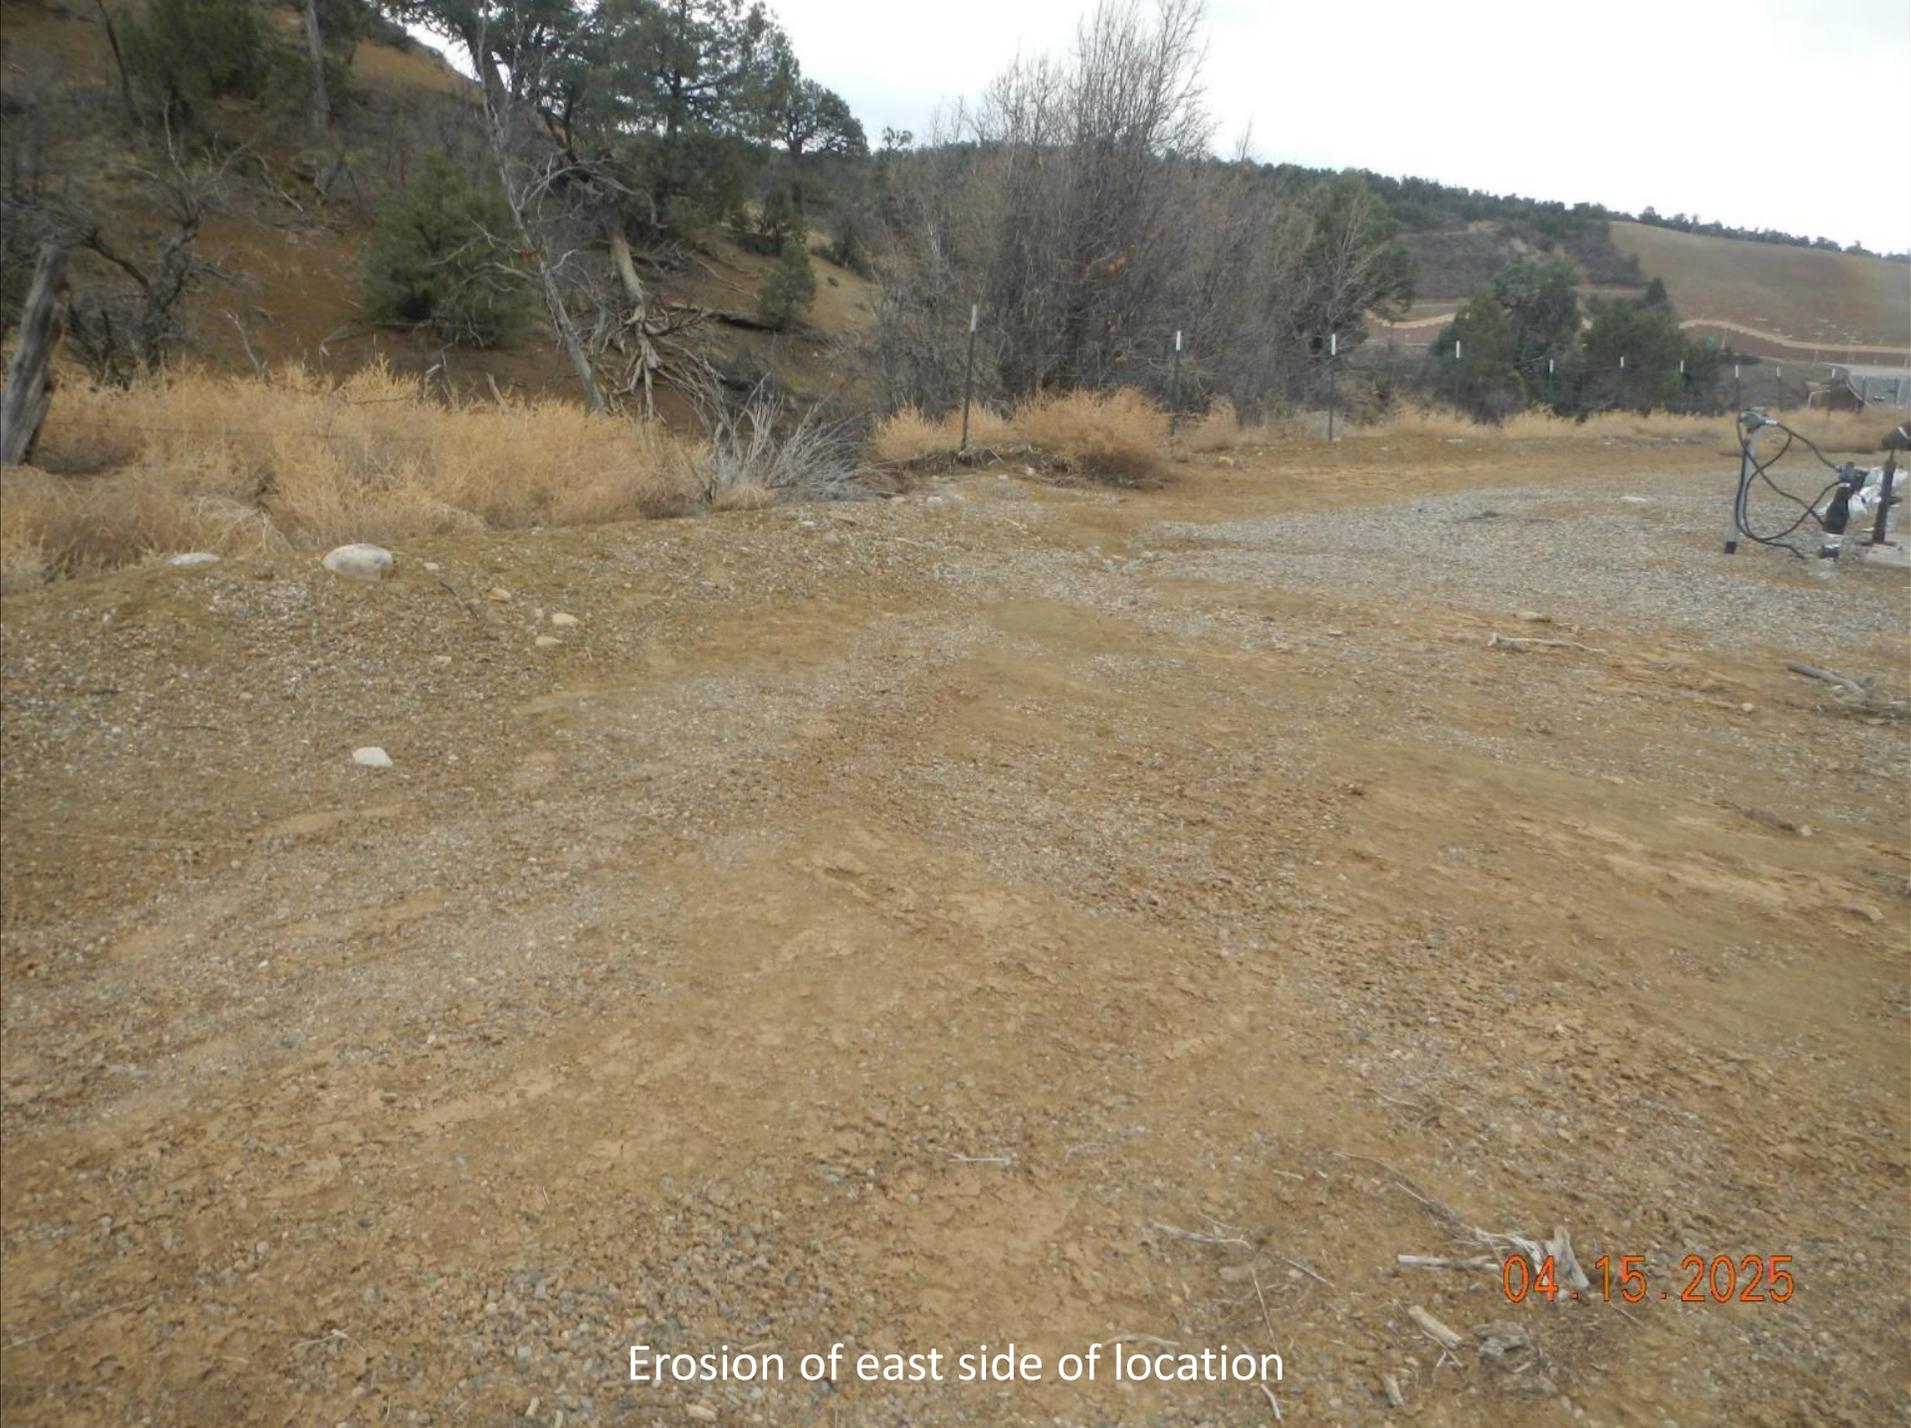
Erosion of east side of location

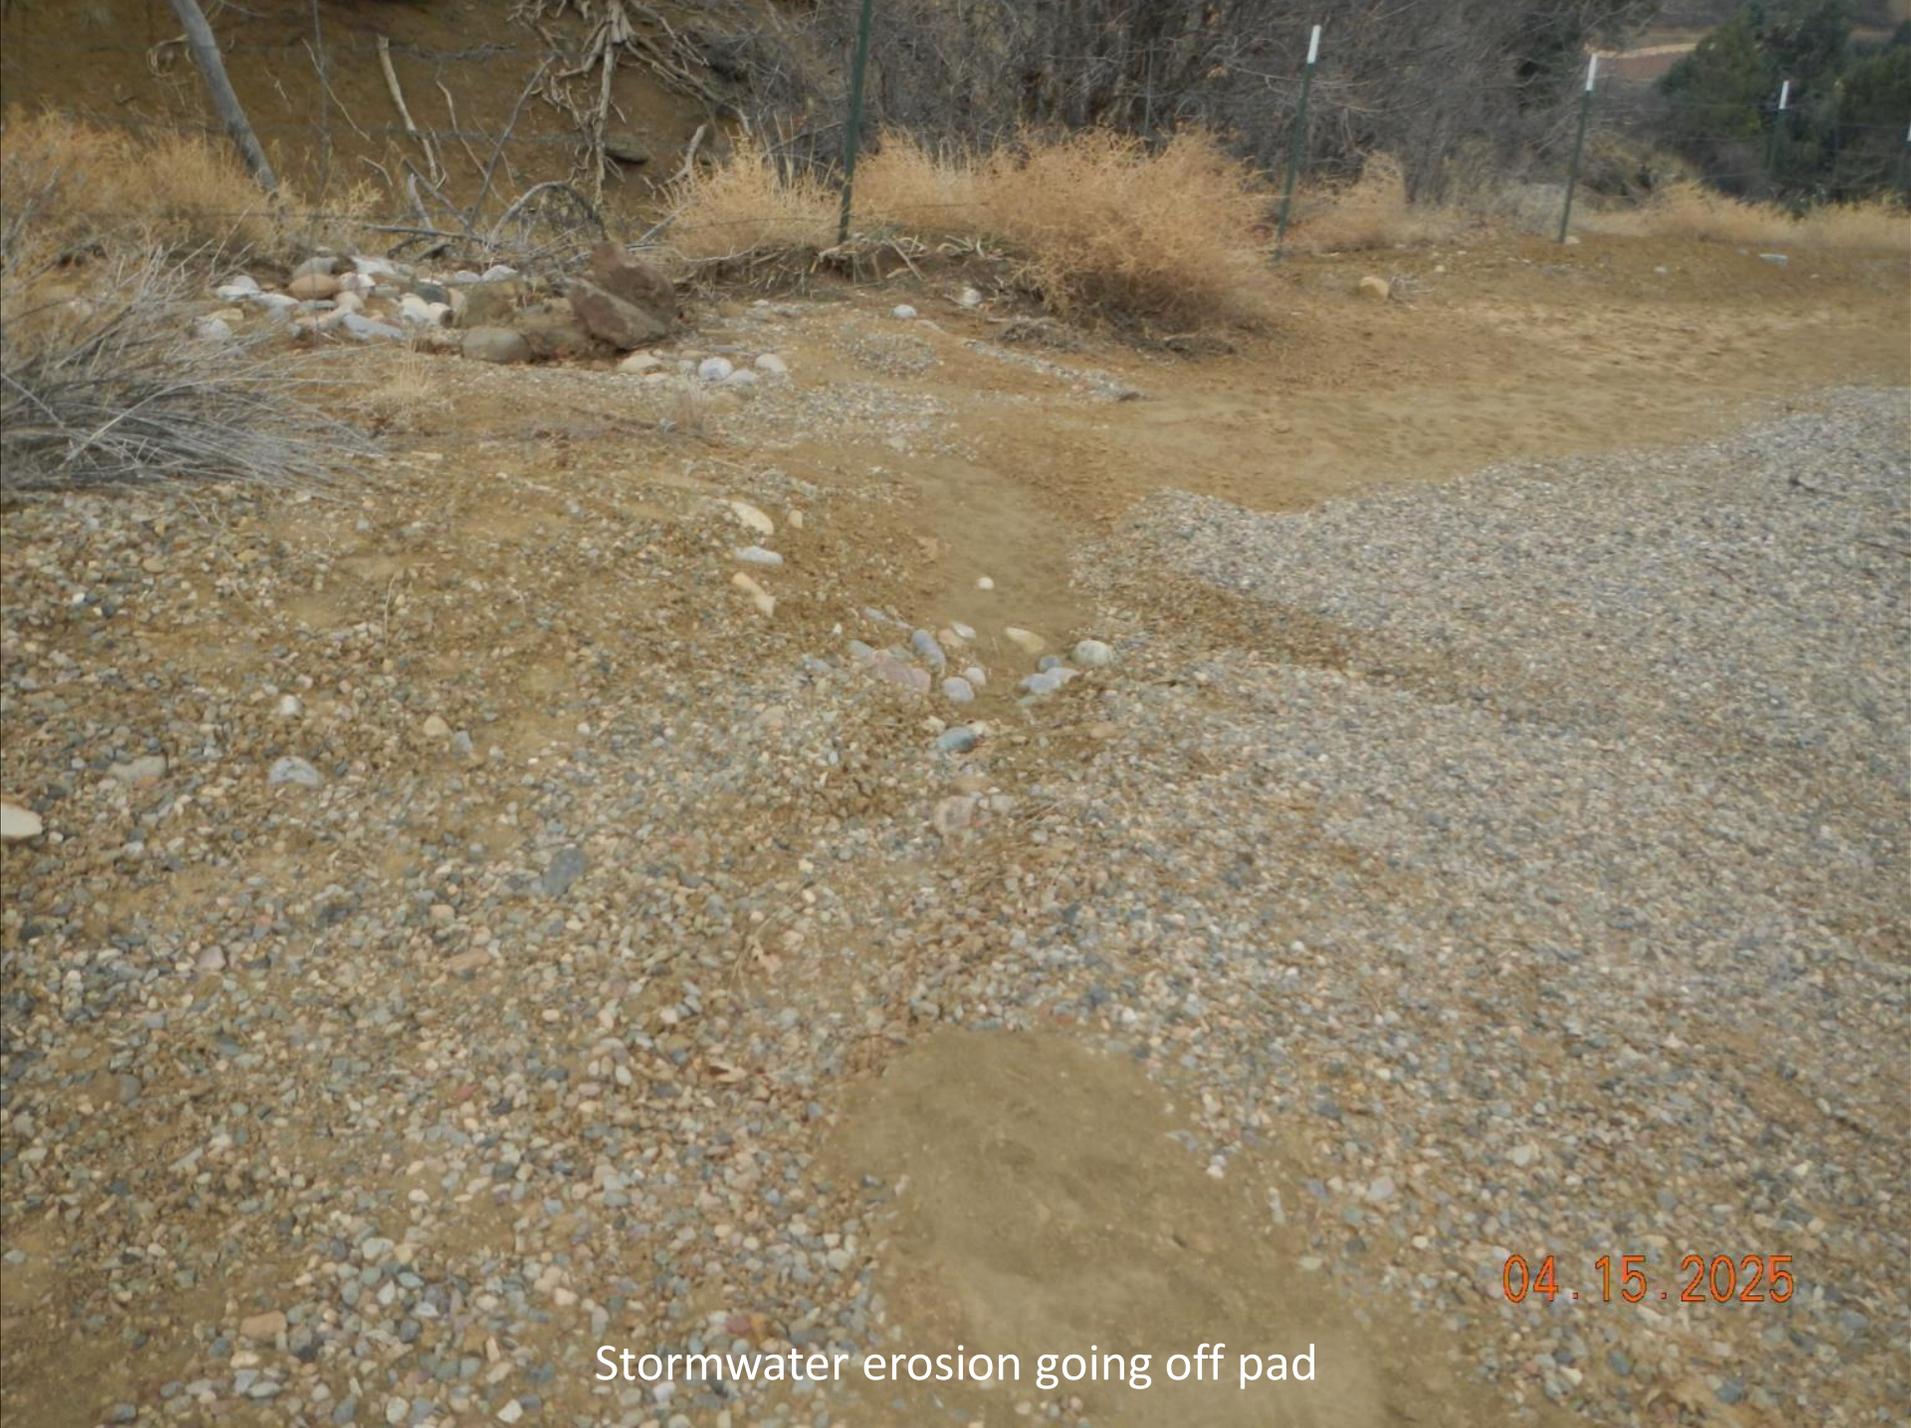
Stormwater erosion going off pad

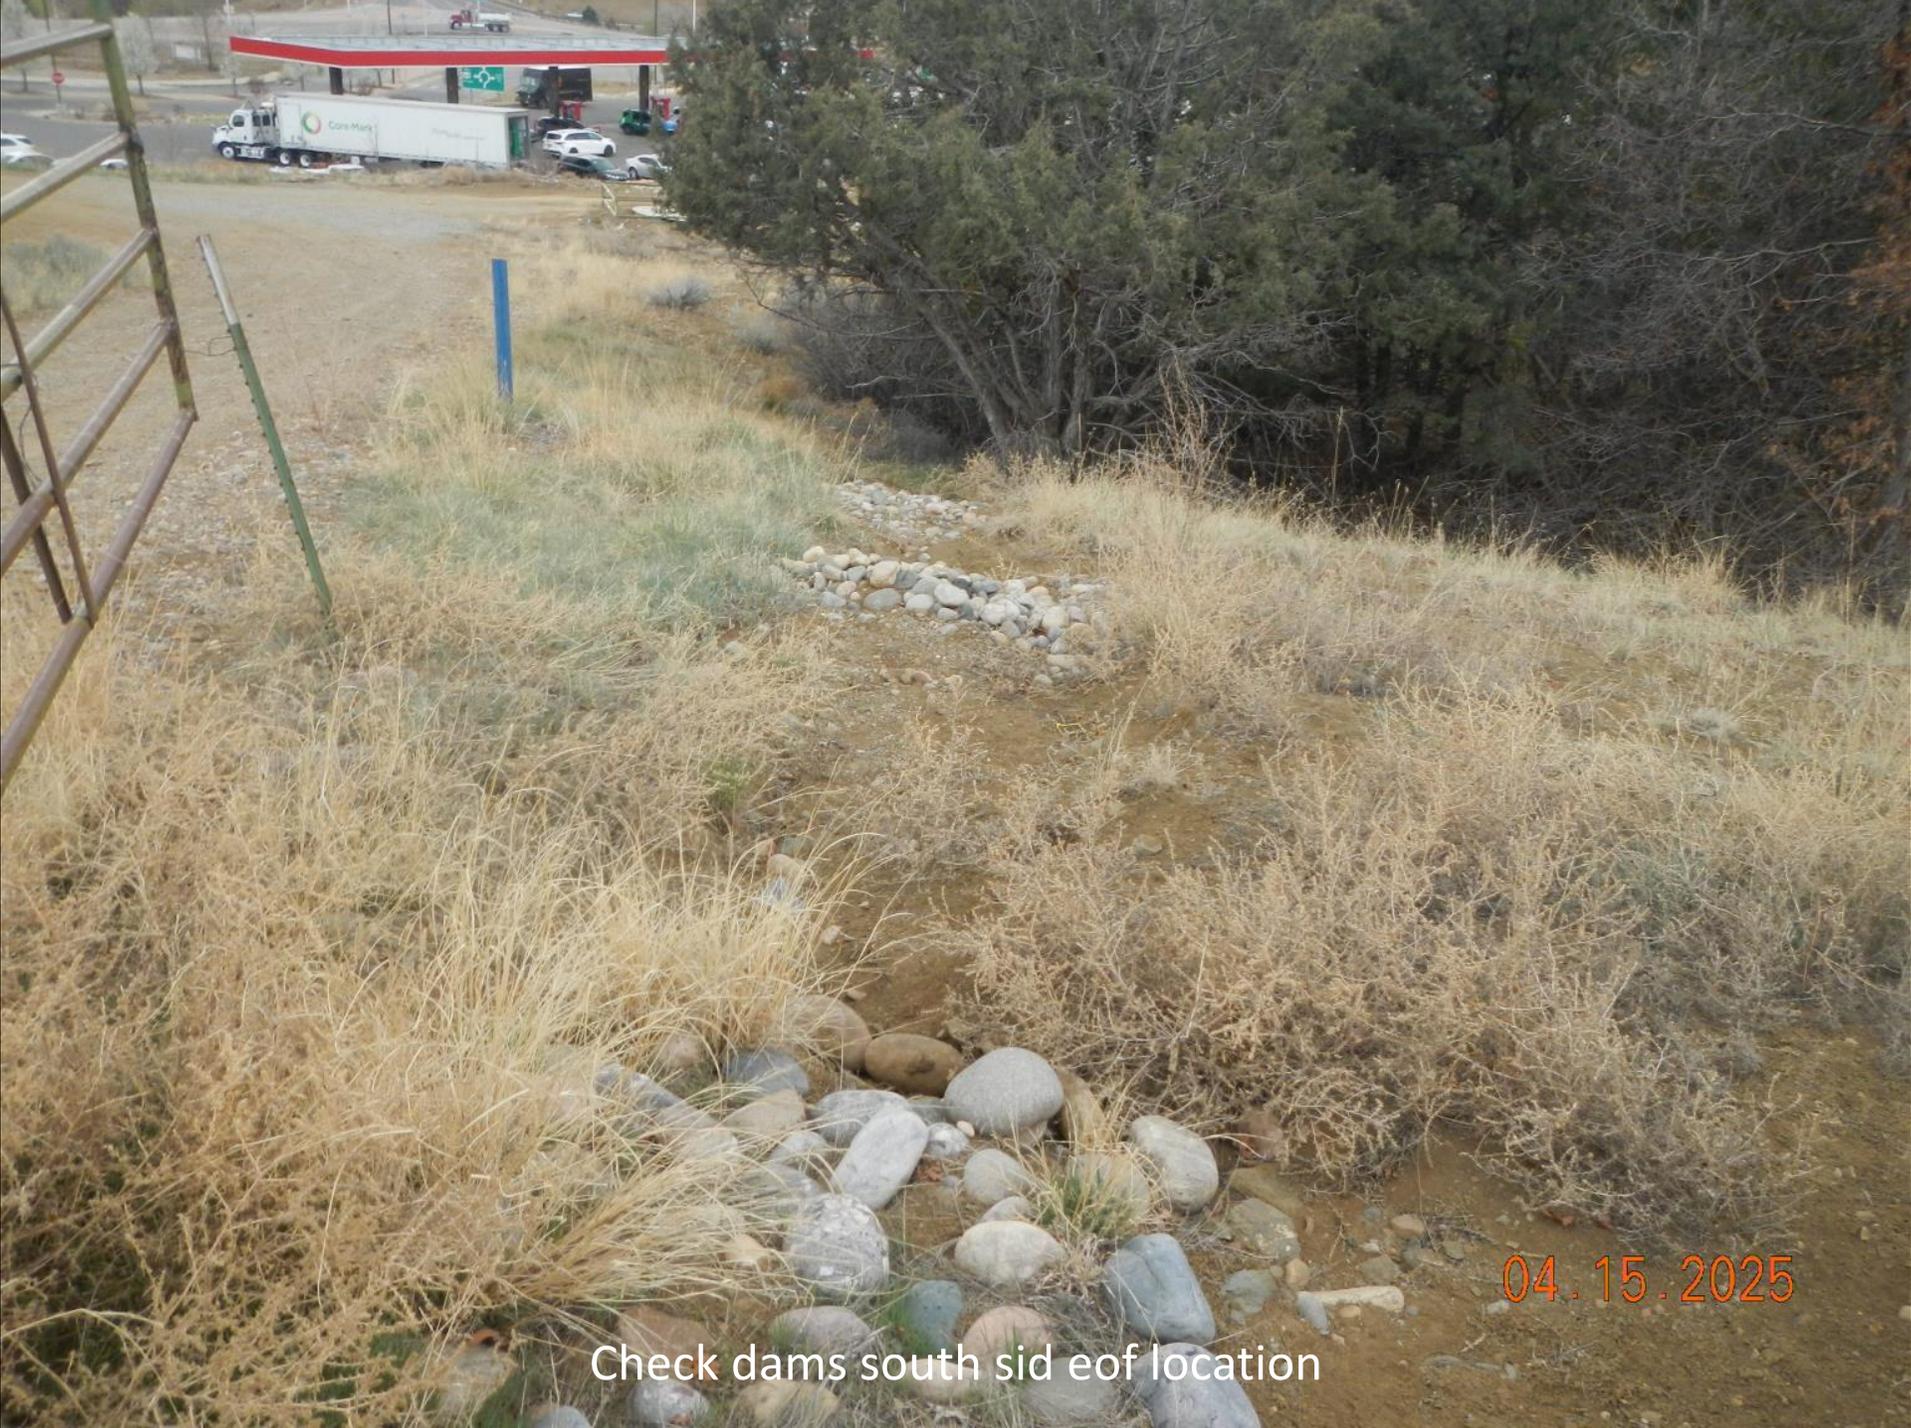
Check dams south side eof location
