067-07759

Crader 3-2 Photo document

4/15/2025

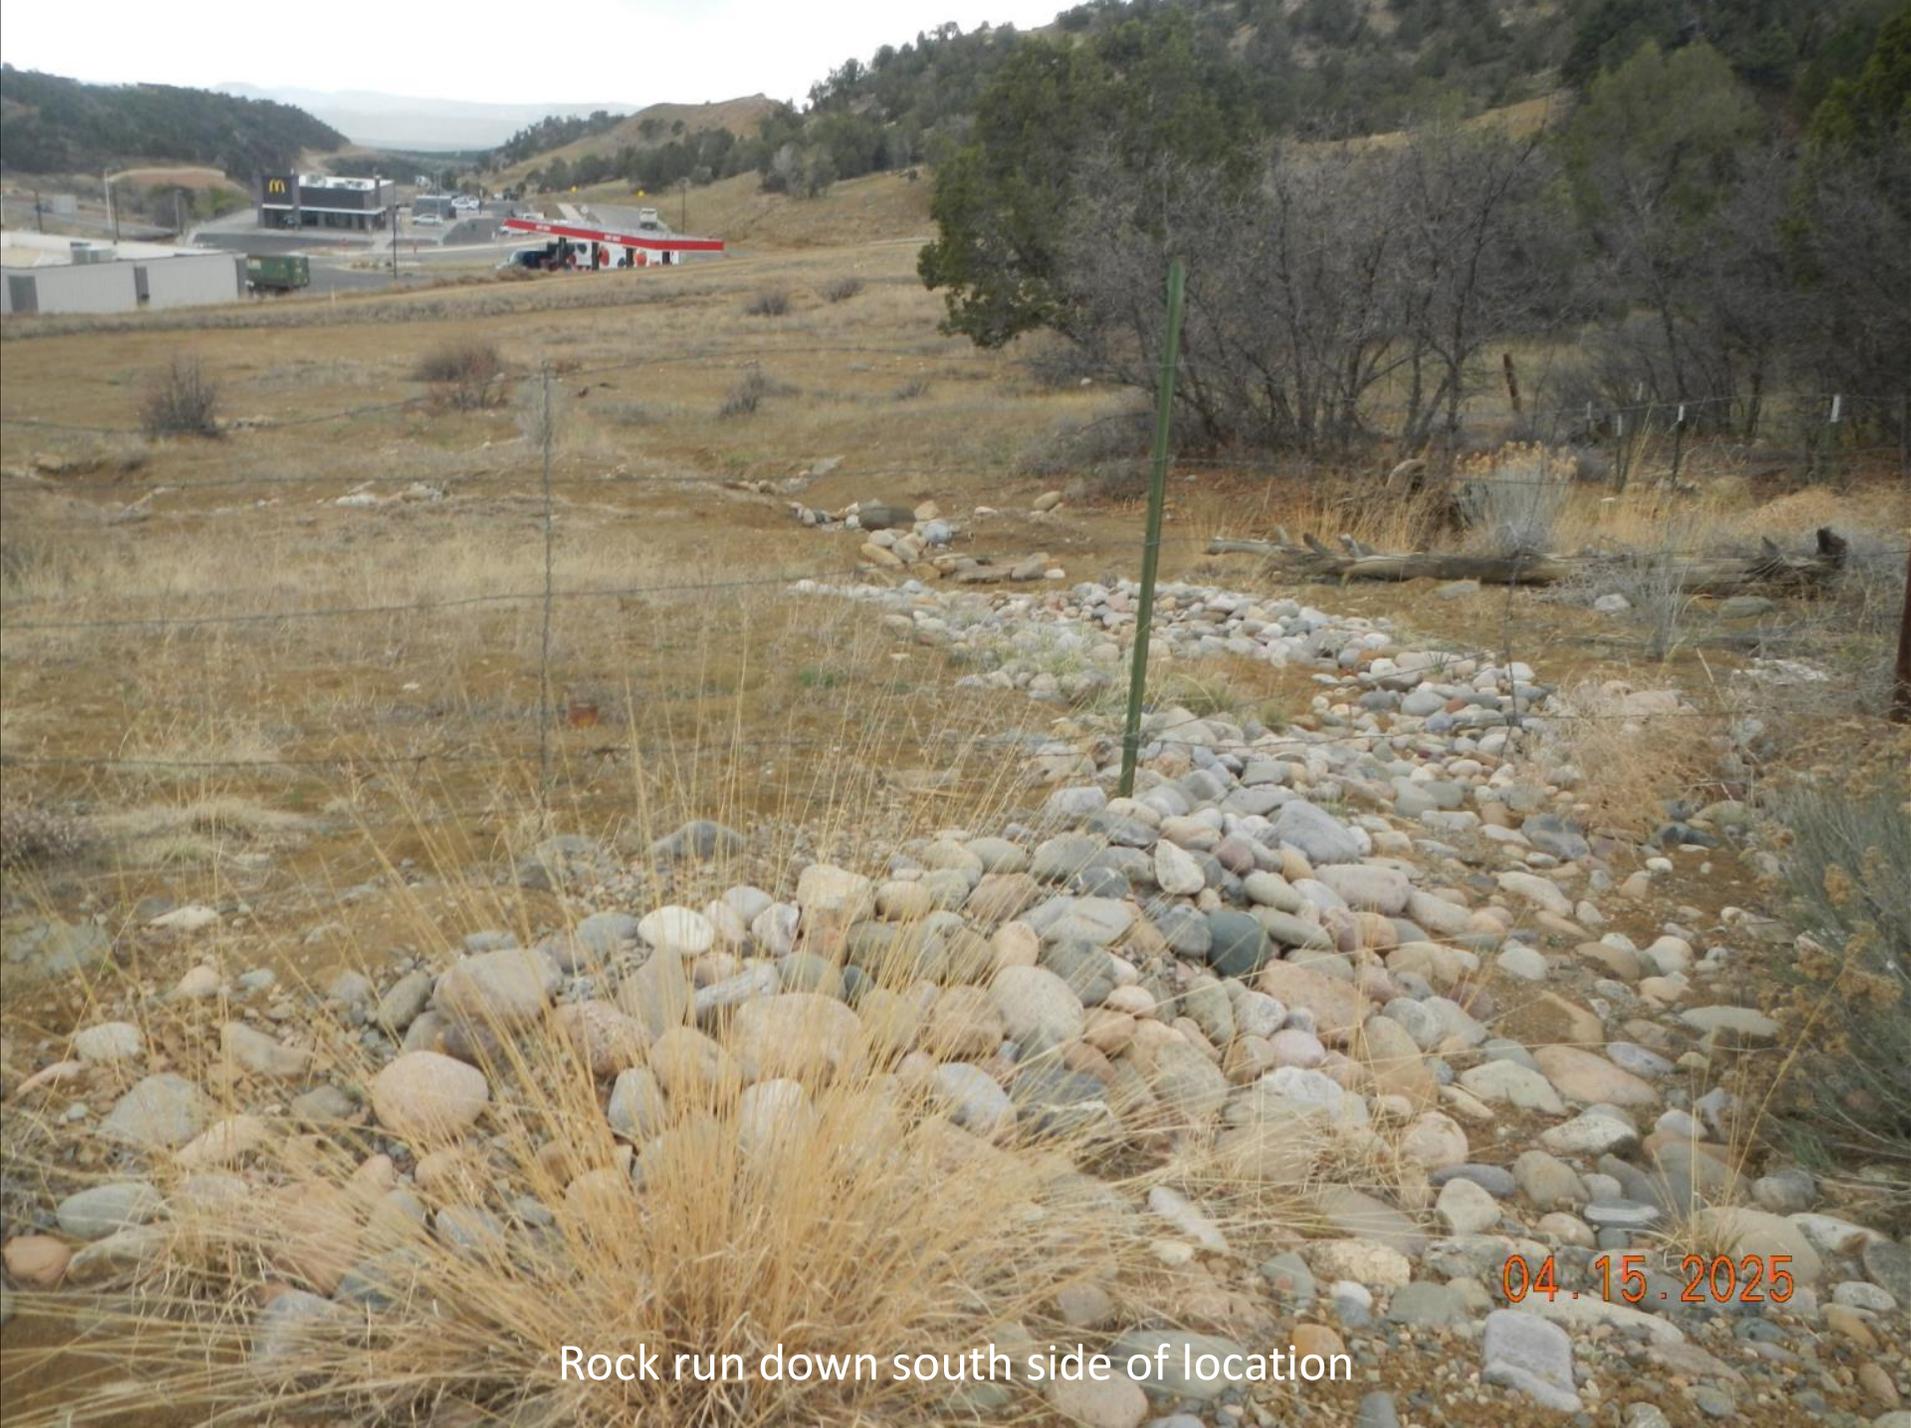
Rock run down south side of location

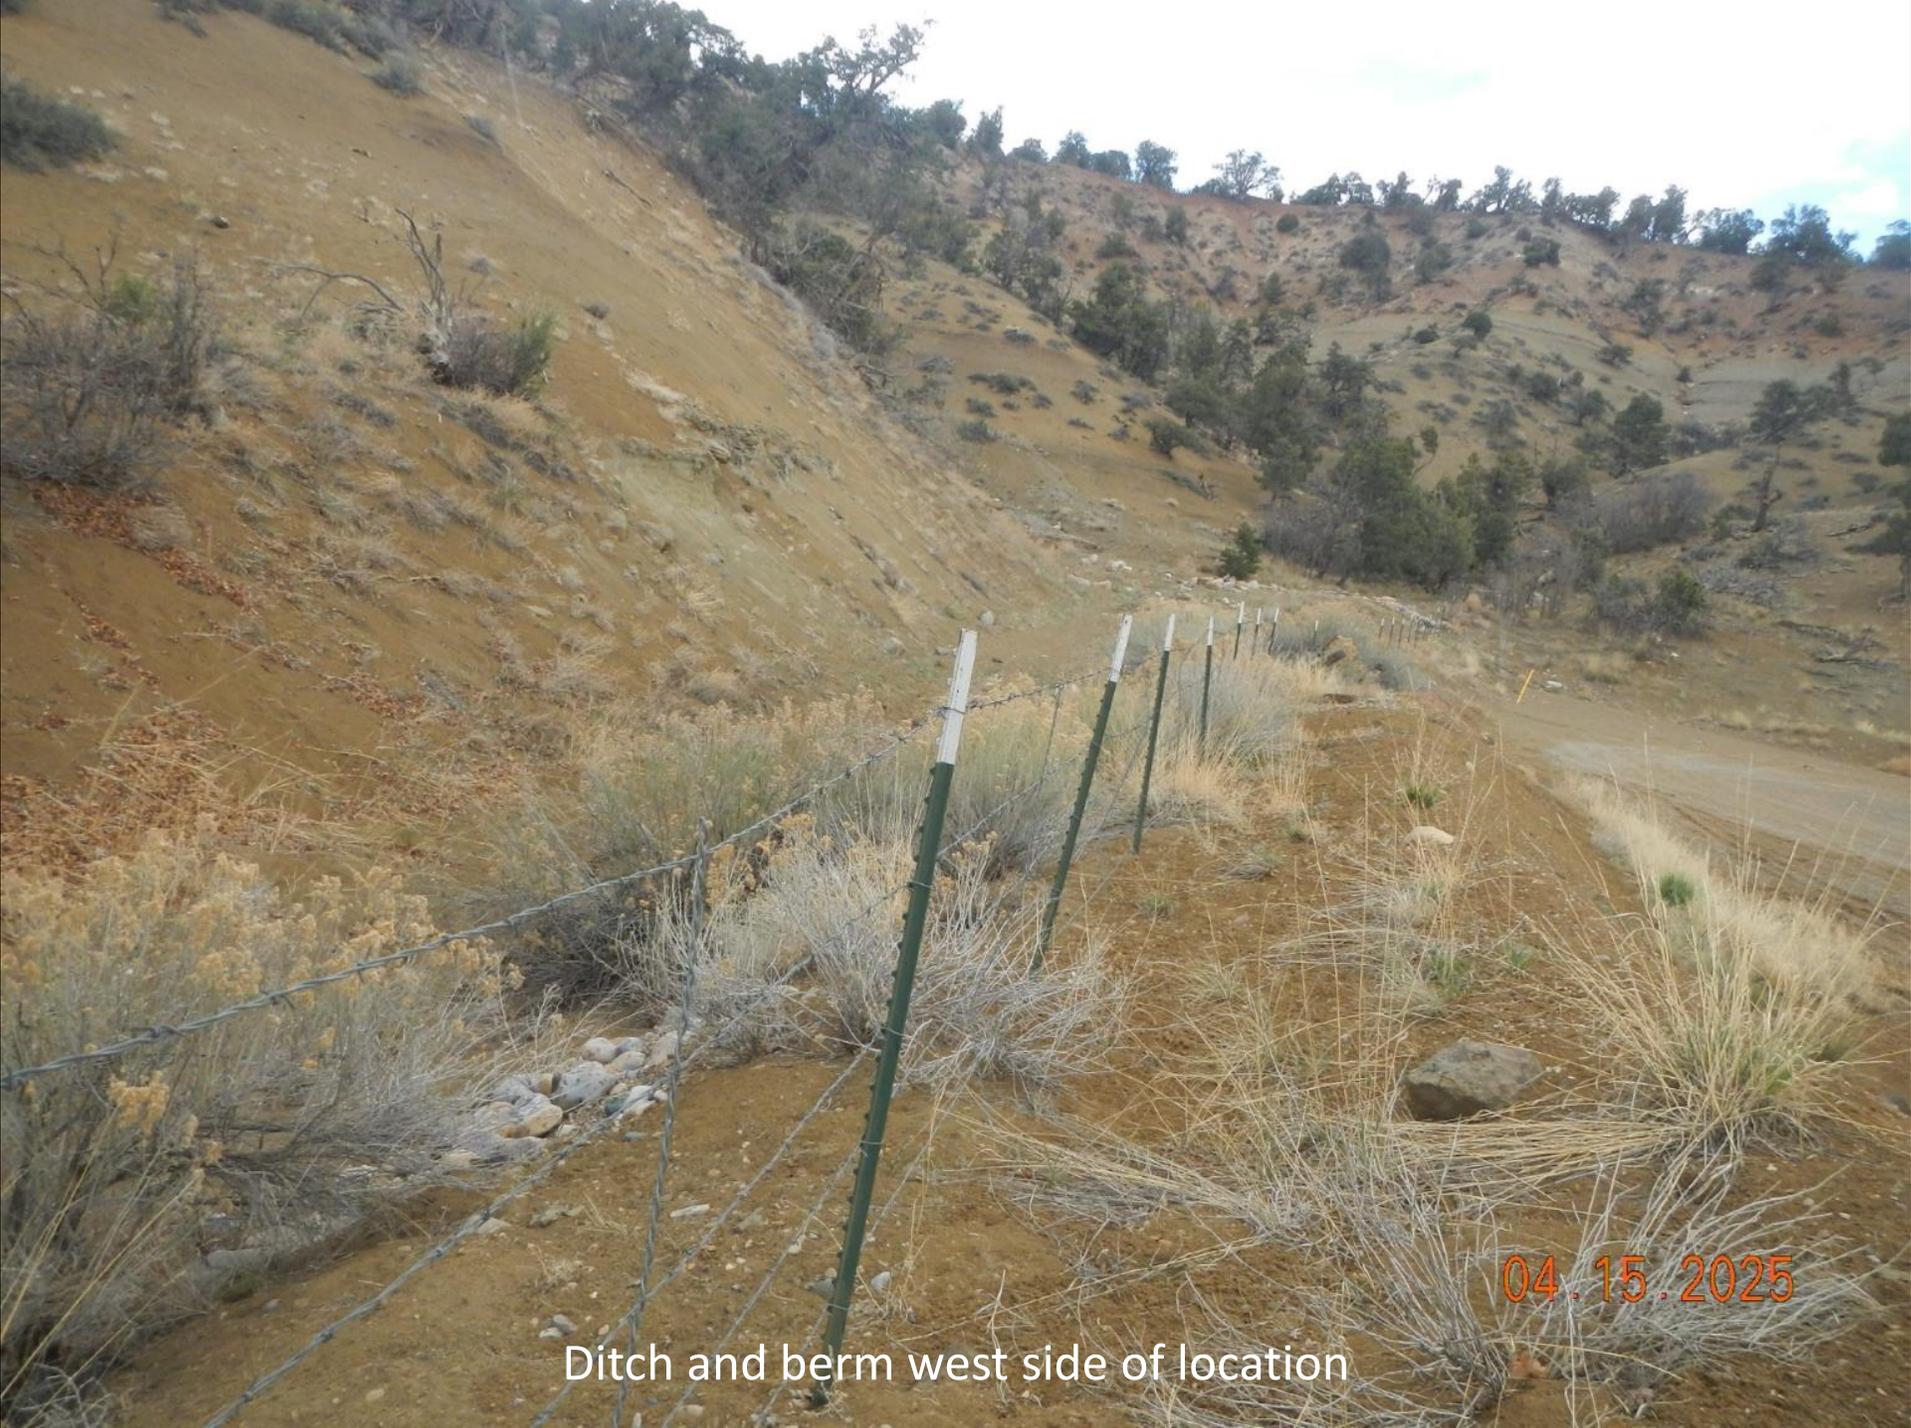
Ditch and berm west side of location
