# Final Reclamation and Stormwater Inspection

Operator: WESTERN OPERATING COMPANY - 95620

Location ID: 312263

Inspection Photos  
Location Name: Emerald Unit  
Location ID: 312263

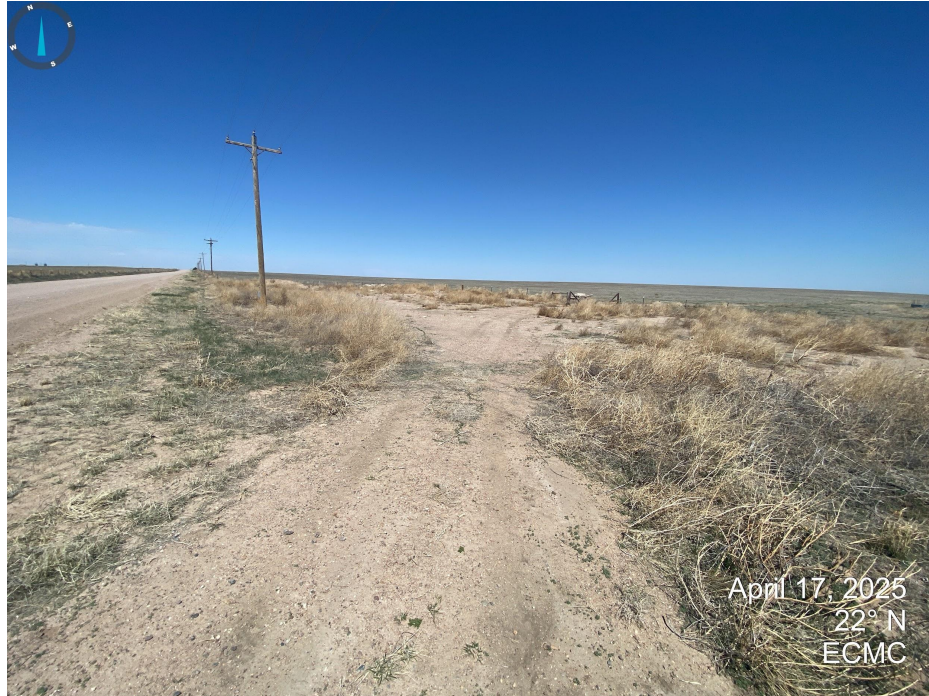
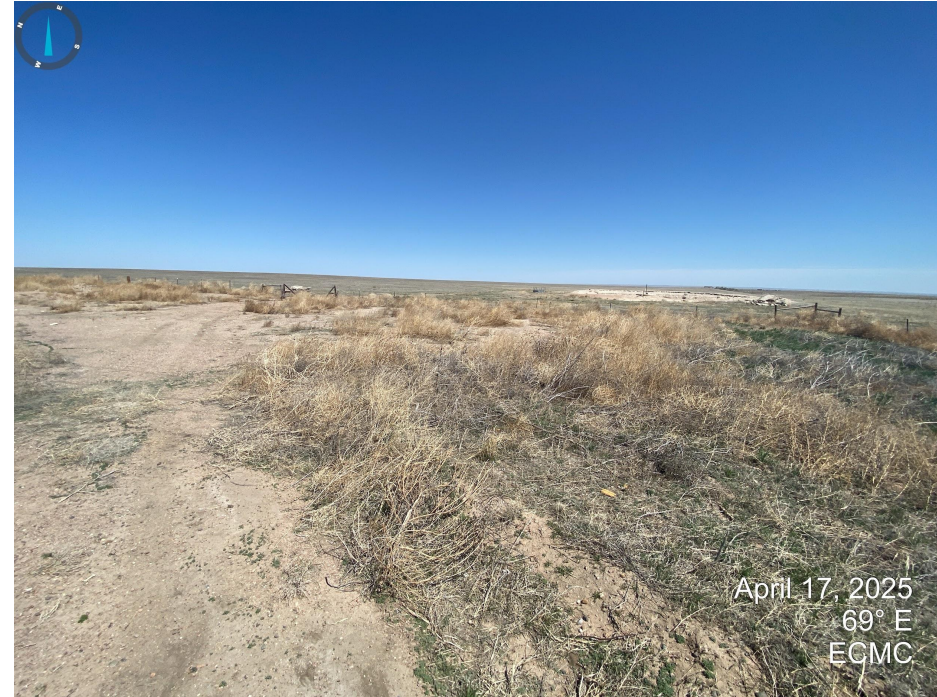
**Photos 1 & 2.** South side of the production facilities. It does not appear that the former tank battery has been reclaimed with evidence of undesirable vegetation and road base throughout.

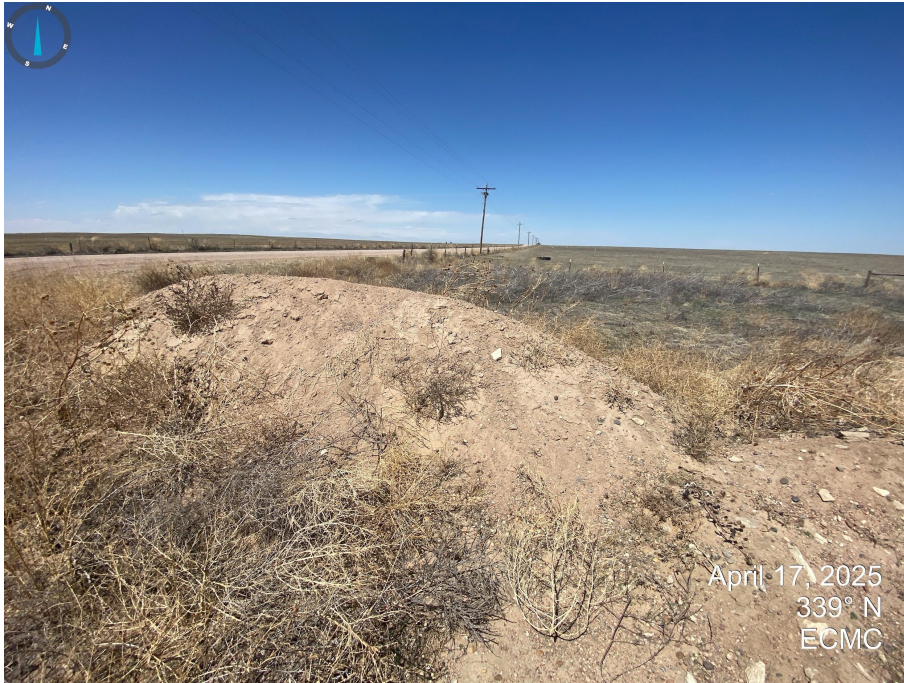
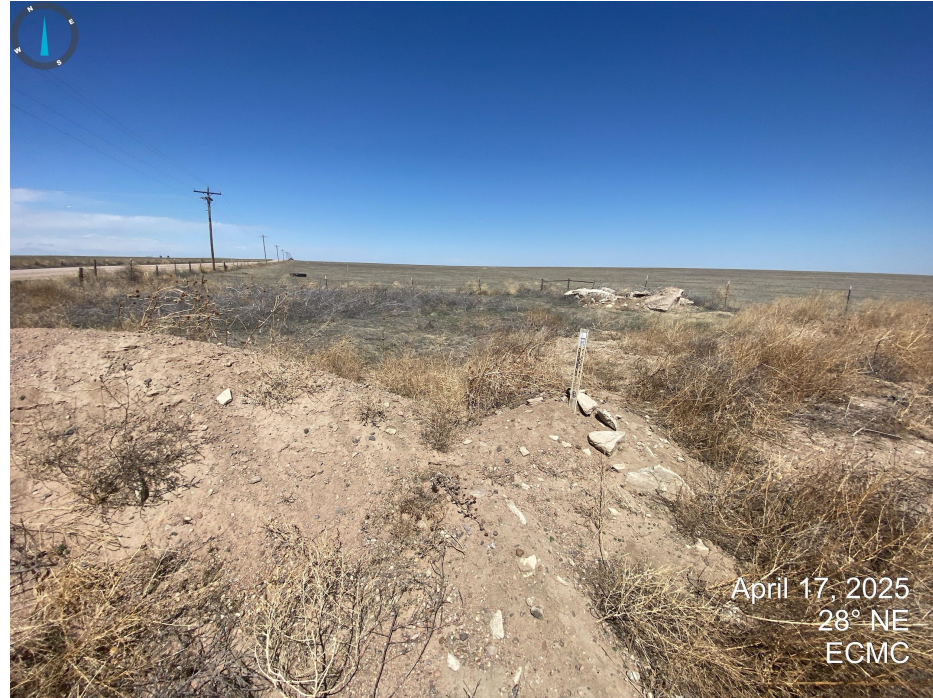
**Photos 3 & 4.** North side of the production facilities. It does not appear that the former tank battery has been reclaimed with evidence of undesirable vegetation and road base throughout.

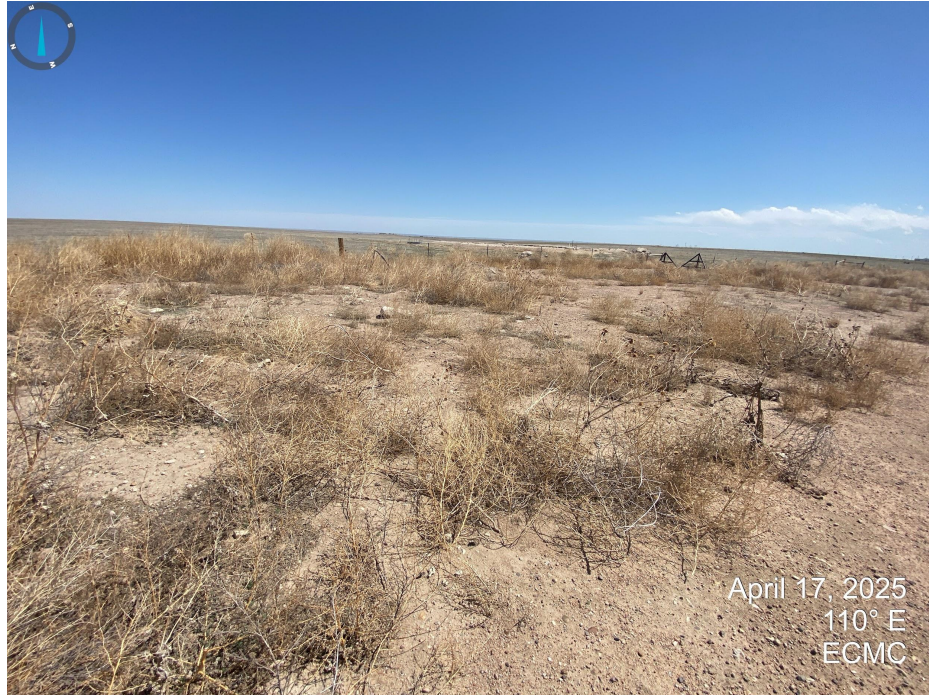
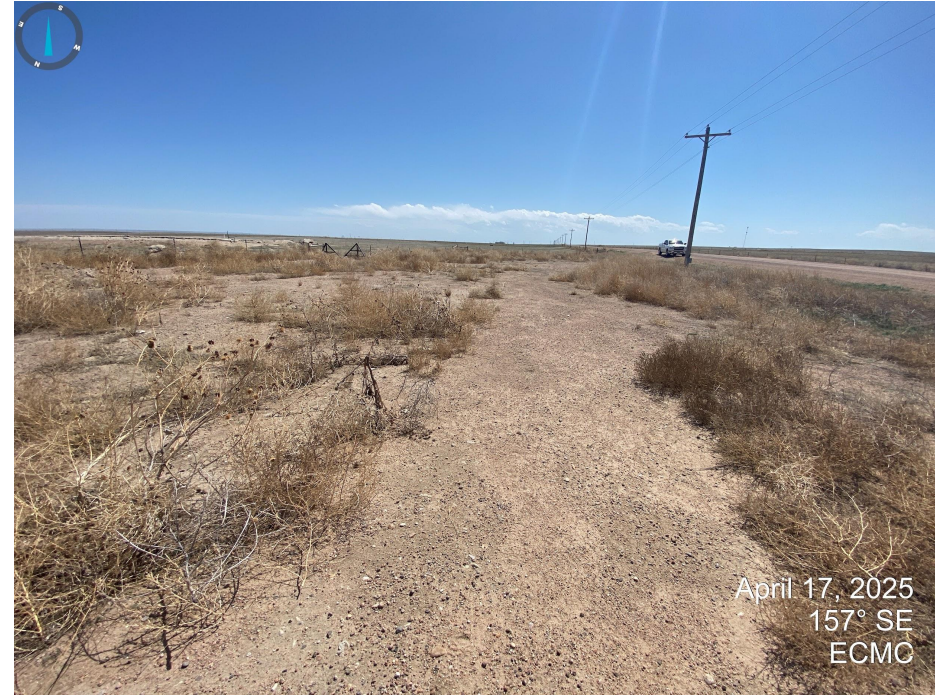
**Photos 5 & 6.** Middle/center portion of the production facilities. It does not appear that the former tank battery has been reclaimed with evidence of undesirable vegetation and road base throughout.

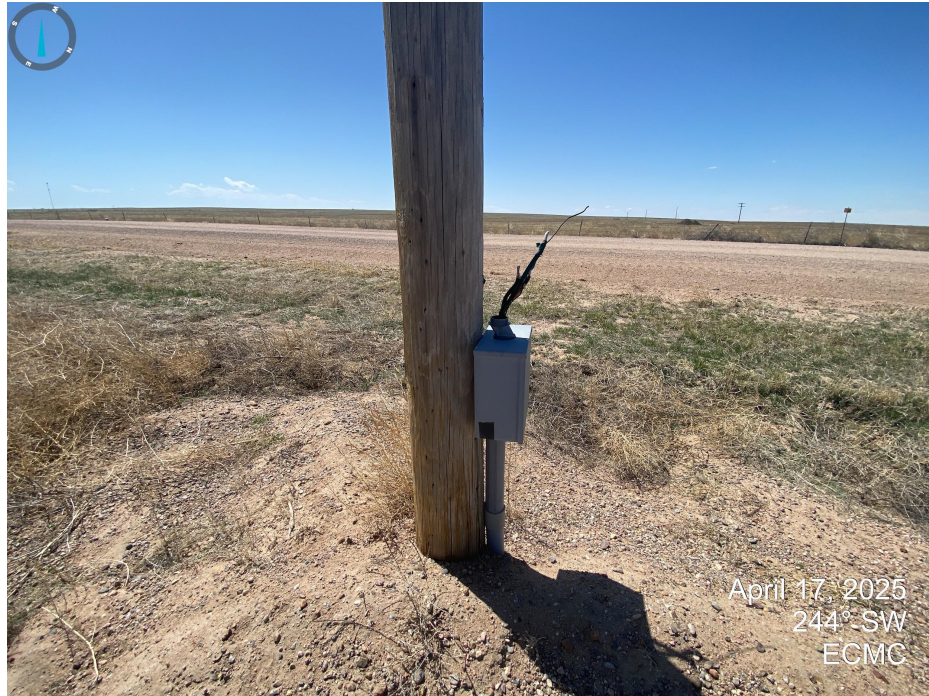
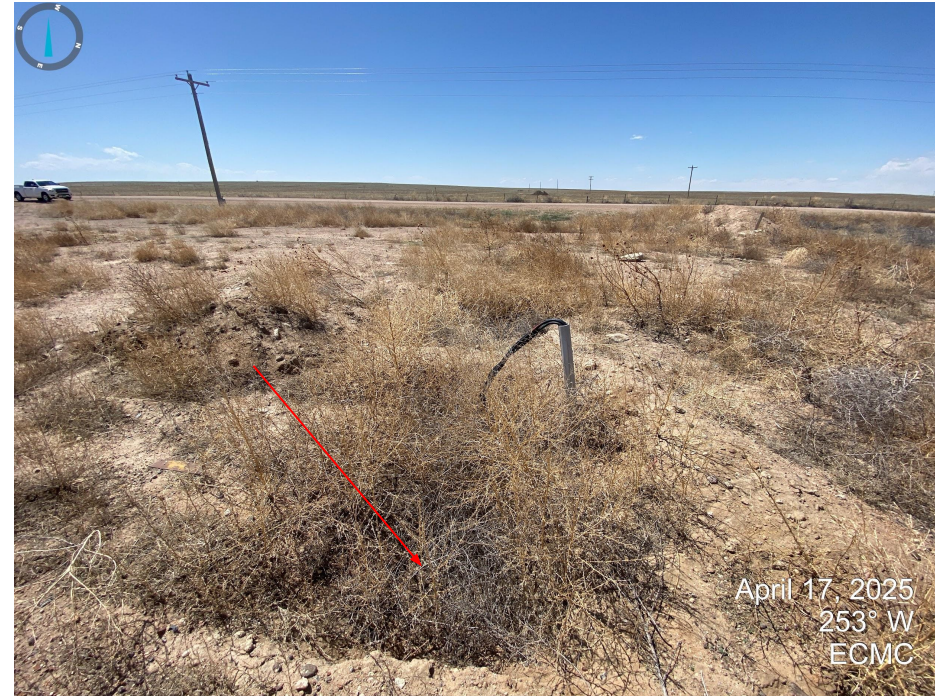
**Photos 7 & 8.** Utilities do not appear to have been removed at the former tank battery. Also pictured, open excavation near utilities (indicated by red arrow).

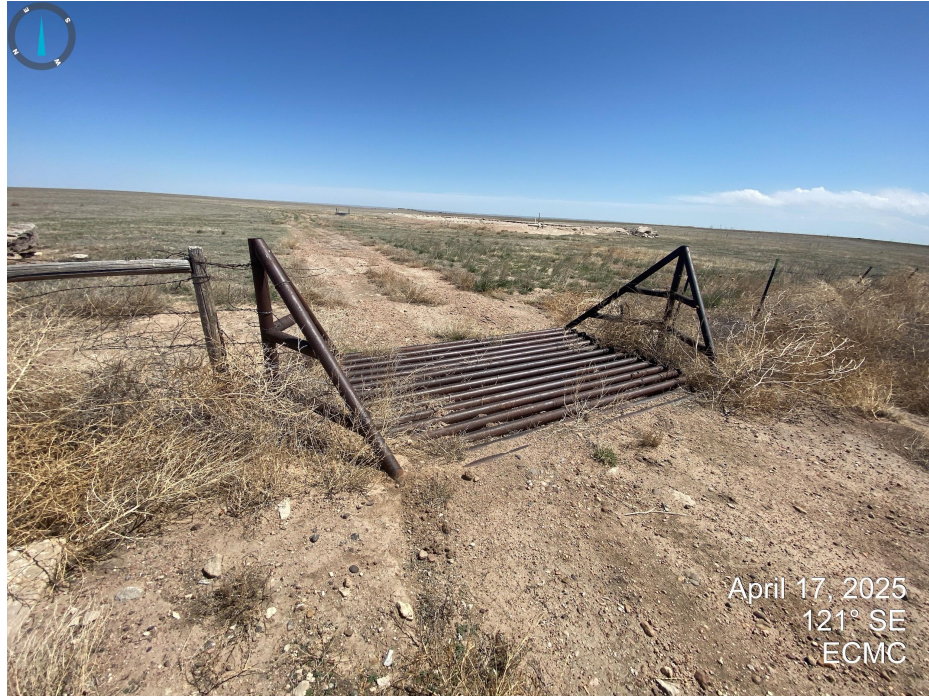
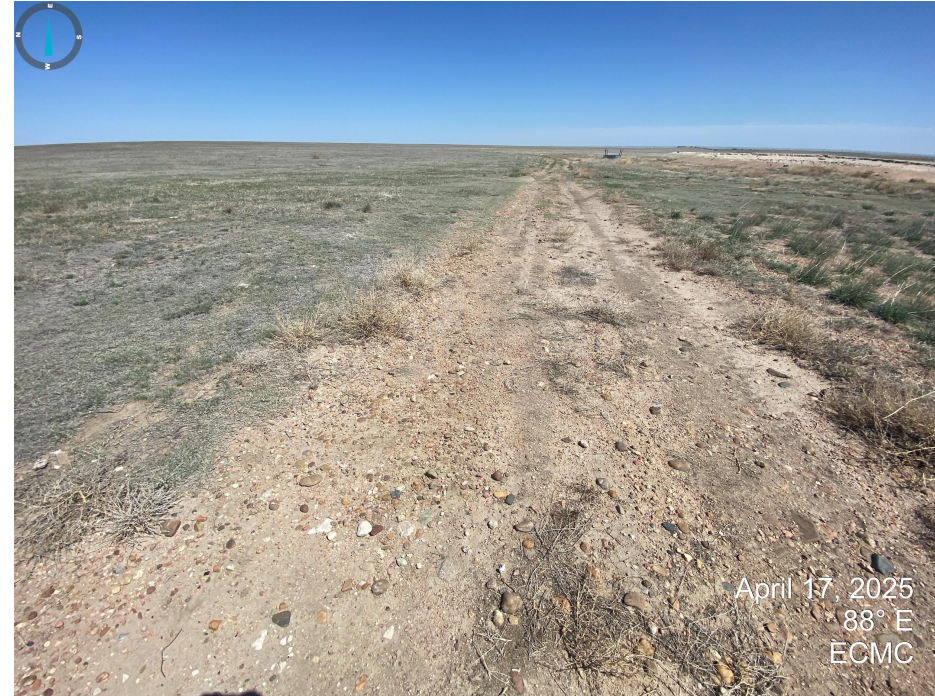
**Photos 9 & 10.** Cattle guard remains and access road to pit does not appear to have been reclaimed.

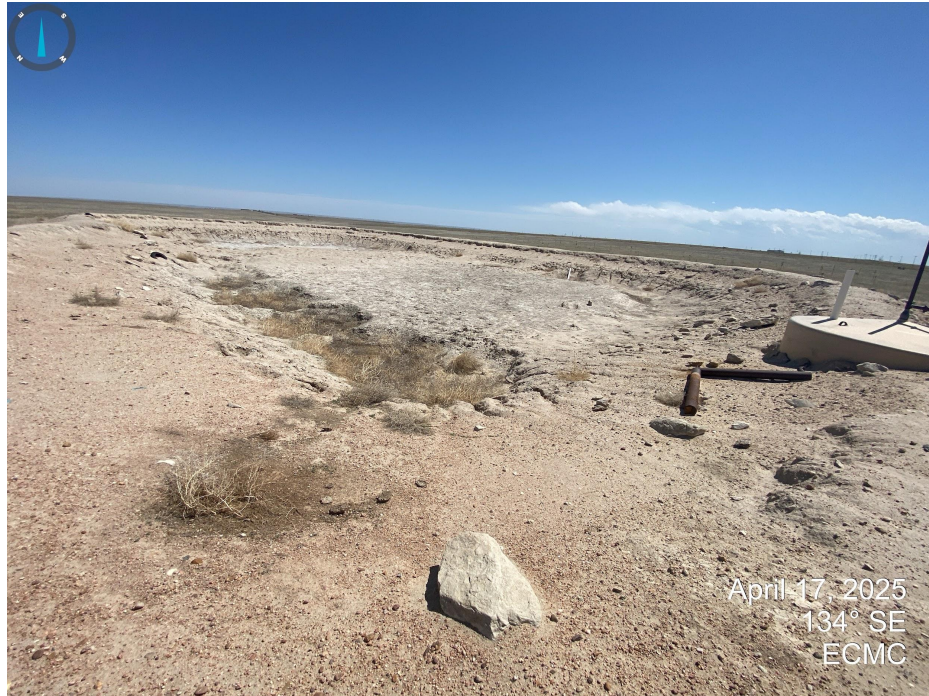
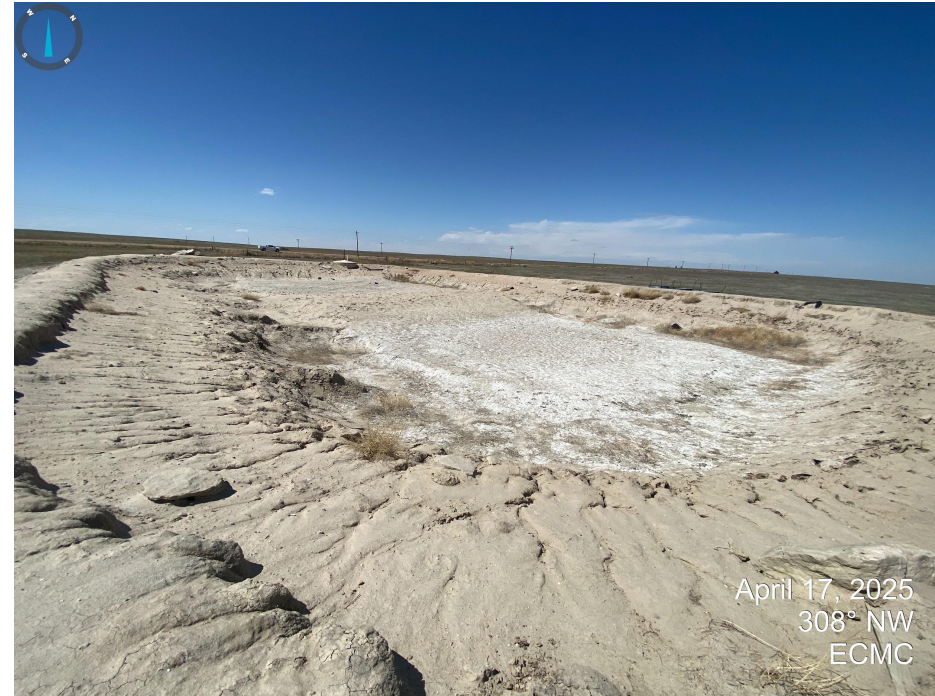
**Photos 11 & 12.** Produced water pit does not appear to be in active use and has not been reclaimed.

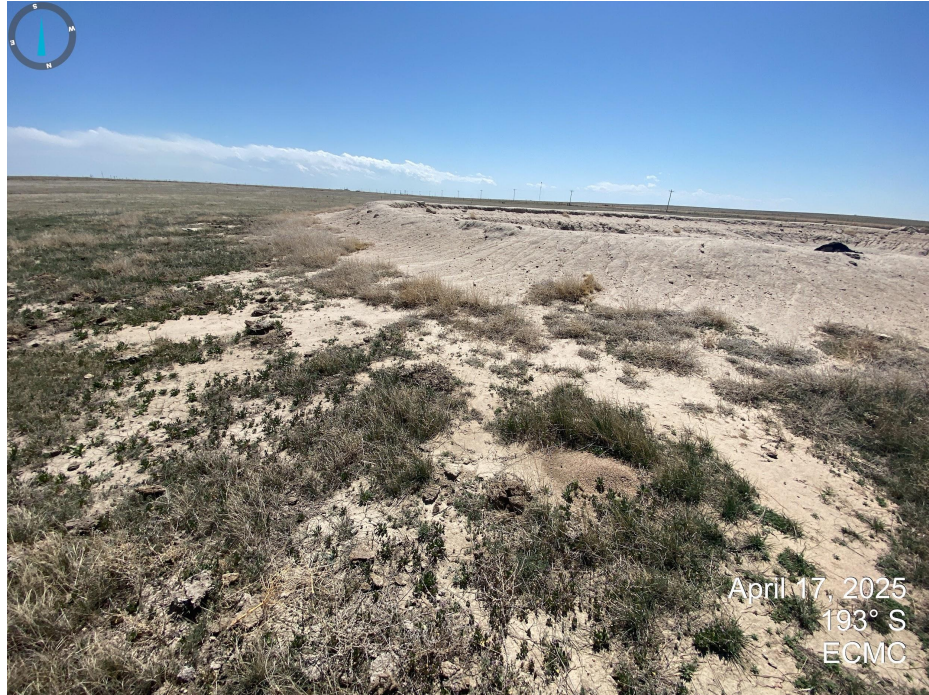
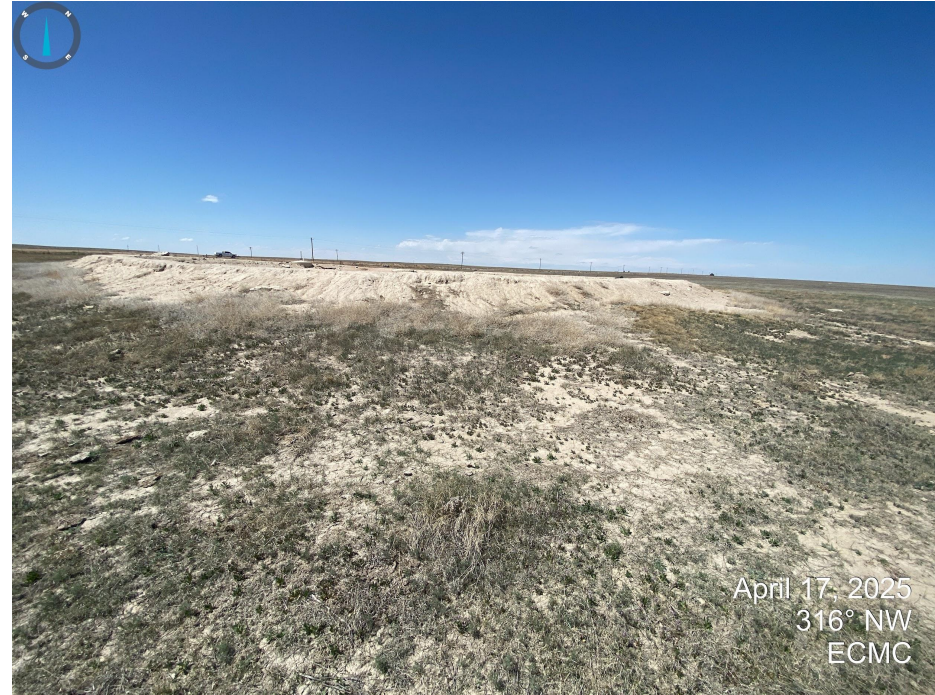
**Photos 13 & 14.** Erosion degradation and no observed stormwater control measures/BMPs around pit perimeter.

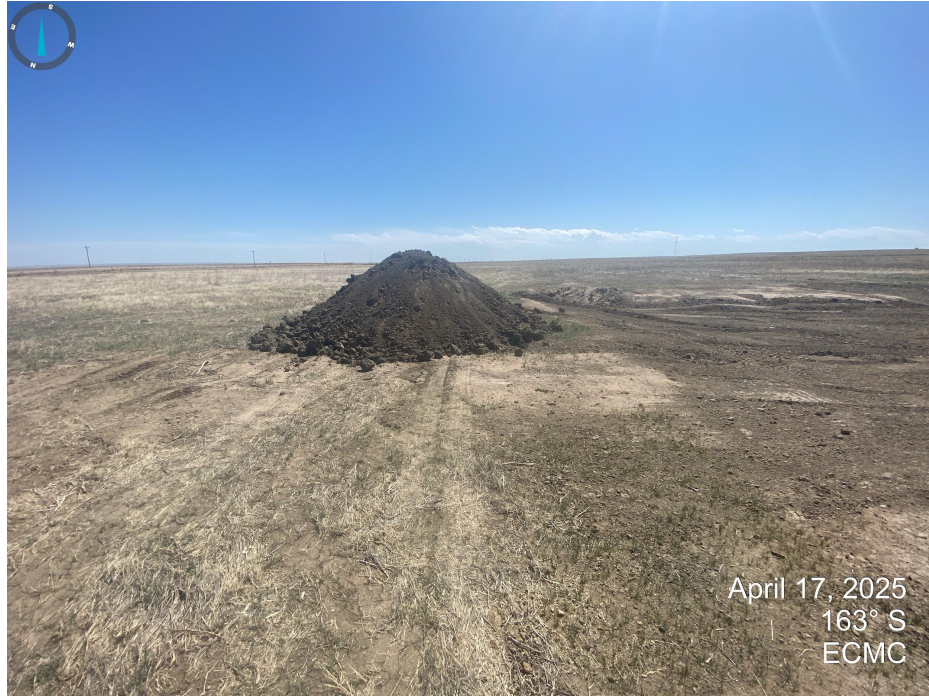
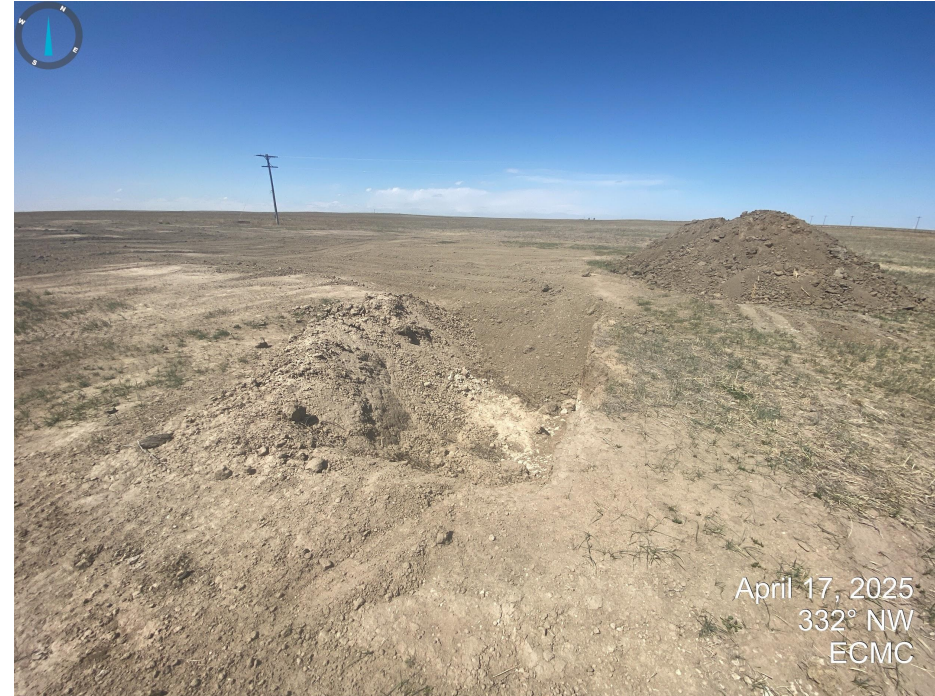
**Photos 15 & 16.** No perimeter stormwater control measures observed around the active remediation project near the former well location. Unknown stockpile does not have any stormwater control measures/BMPs.

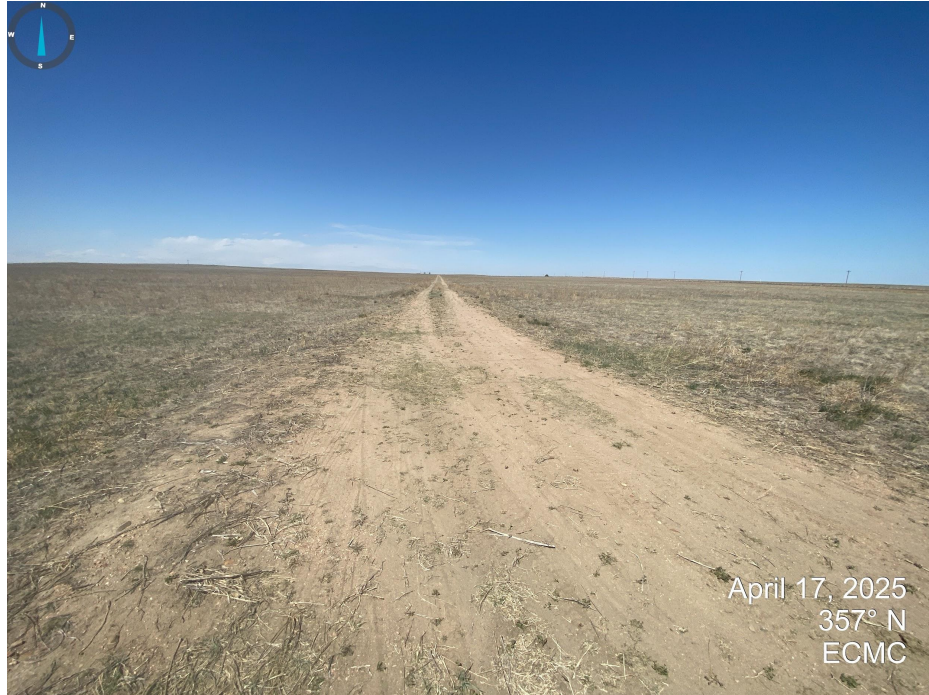
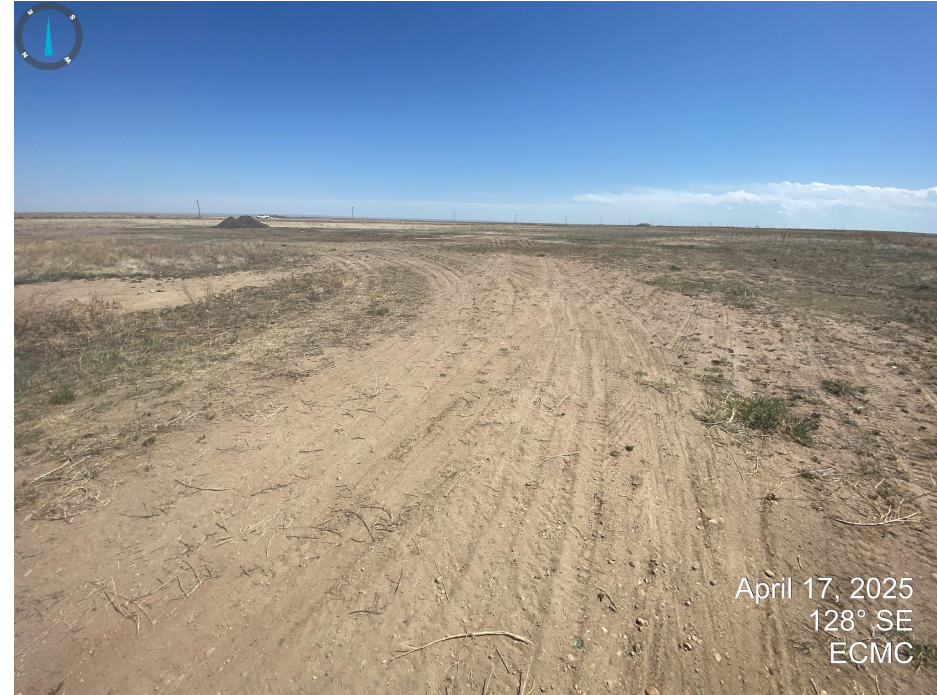
**Photos 17 & 18.** Former access road to the well location does not appear to have been reclaimed.

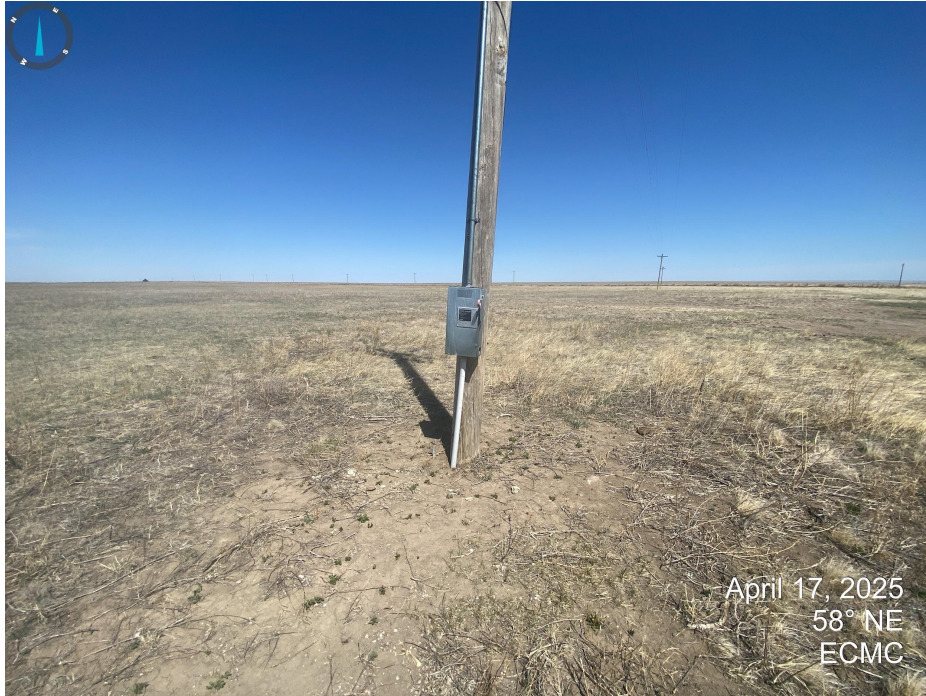
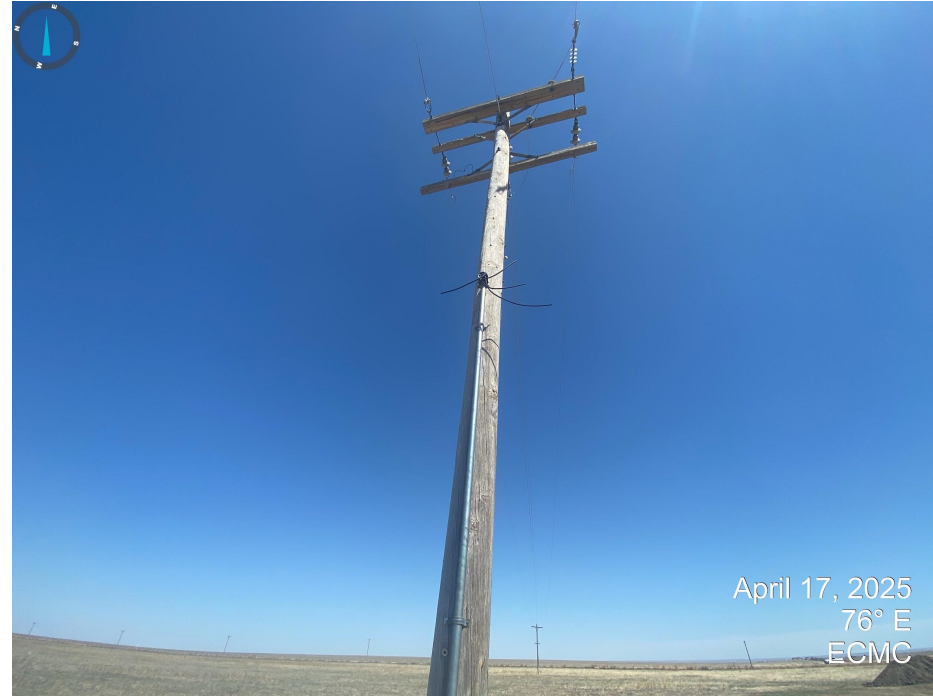
**Photos 19 & 20.** Utilities near the former well location do not appear to have been removed.

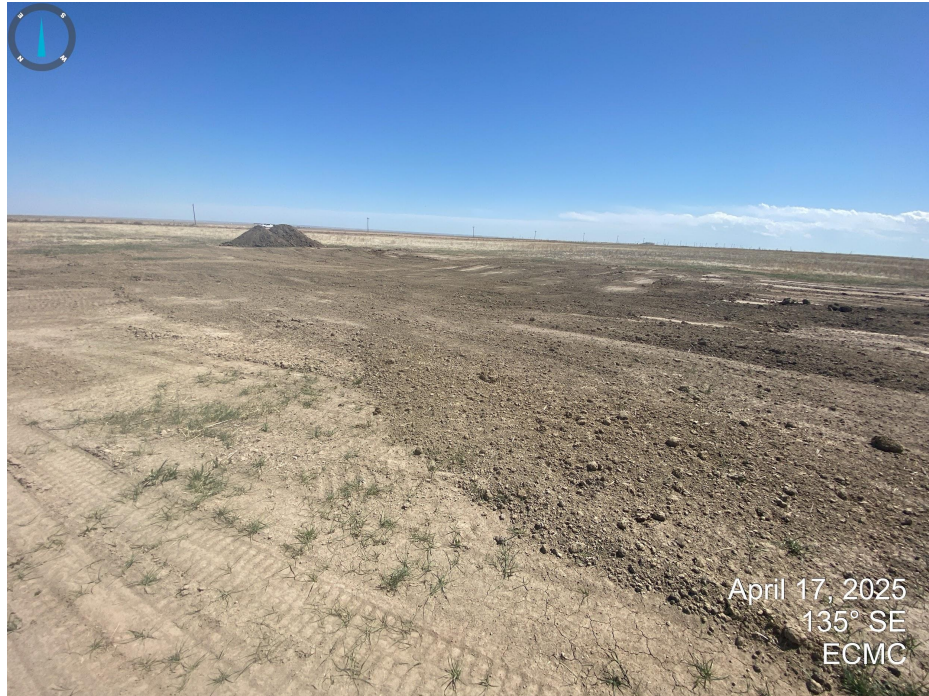
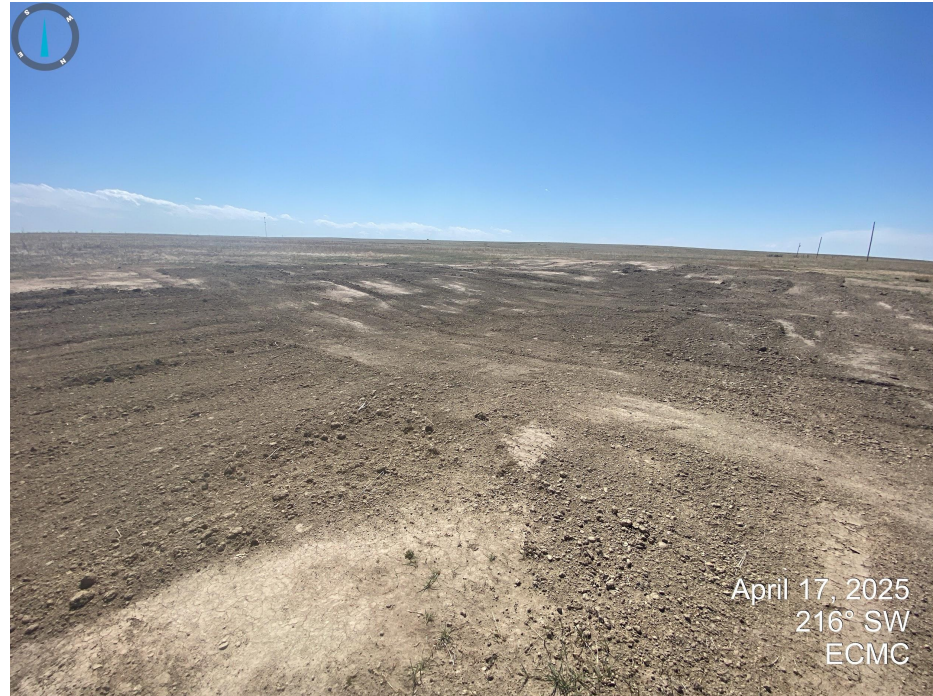
**Photos 21 & 22.** No perimeter stormwater control measures observed around the active remediation project near the former well location.
