Re: COGCC FIELD INSPECTION REPORT [Doc#714002070, Loc Id: 333602 Name: OLSON-SMITH UNIT-N33N8W 8SESE] SUBMITTED NOTICE

COGCC Field Inspection Report

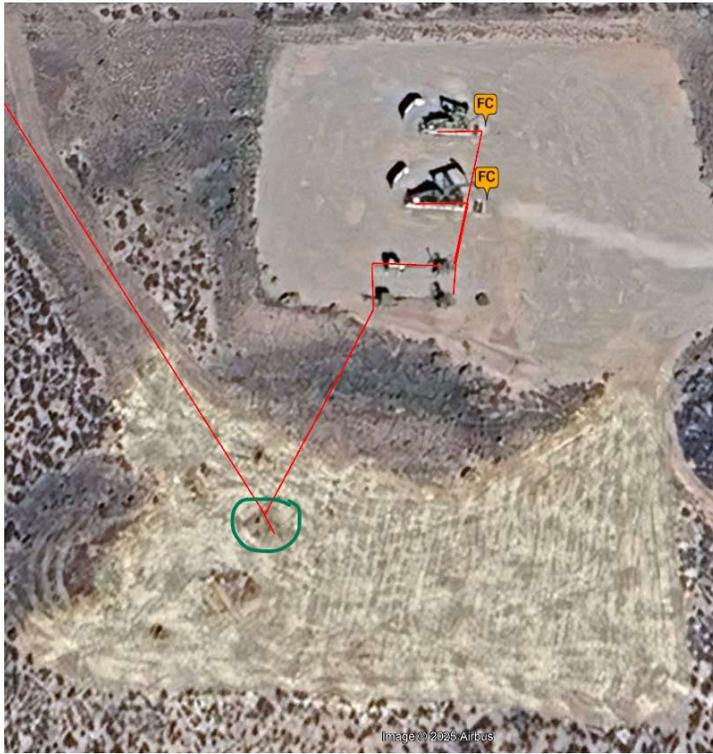
The riser is active as it is part of a pipeline from the well pad to the north. See image below and the original photo annotated to show the wells that are associated with the riser.

The mentioned gathering line riser is active (not abandoned) because it provides gathering for wells nearby and therefore cannot be removed at this time.

Sorry for the delayed response. I was able to speak with my team lead and where the gathering line is active, the riser is not and is associated with the plugged and abandoned well. All surface equipment would require removal, or a final reclamation variance would need to be submitted to leave any risers on the location.

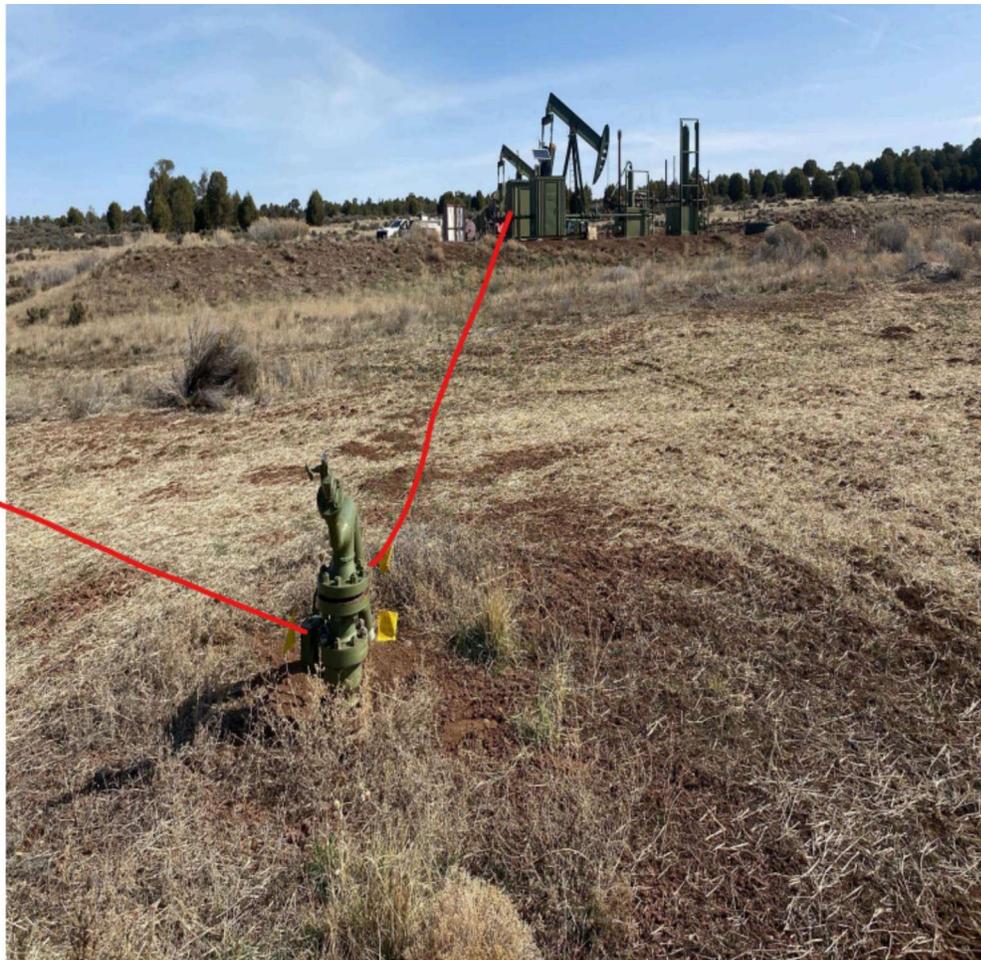
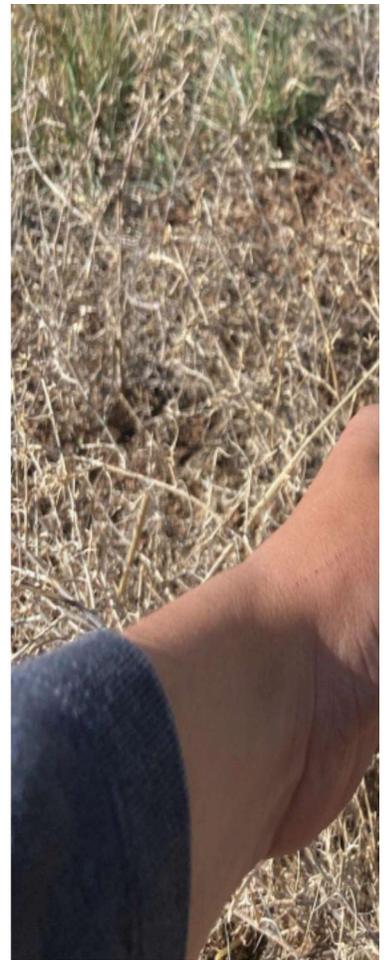
Photo 4. Gas line riser that remains in the northwest corner of the pi

Or compliance with 1004 reclamation rules and regulations, requiring removal (regardless of ownership) all debris, gathering line risers, flowline risers and equipment.
