Inspection Photos

API: 017-07804

Operator: **ANGUS NATURAL RESOURCES LLC**

Inspection Date: 4/10/2025

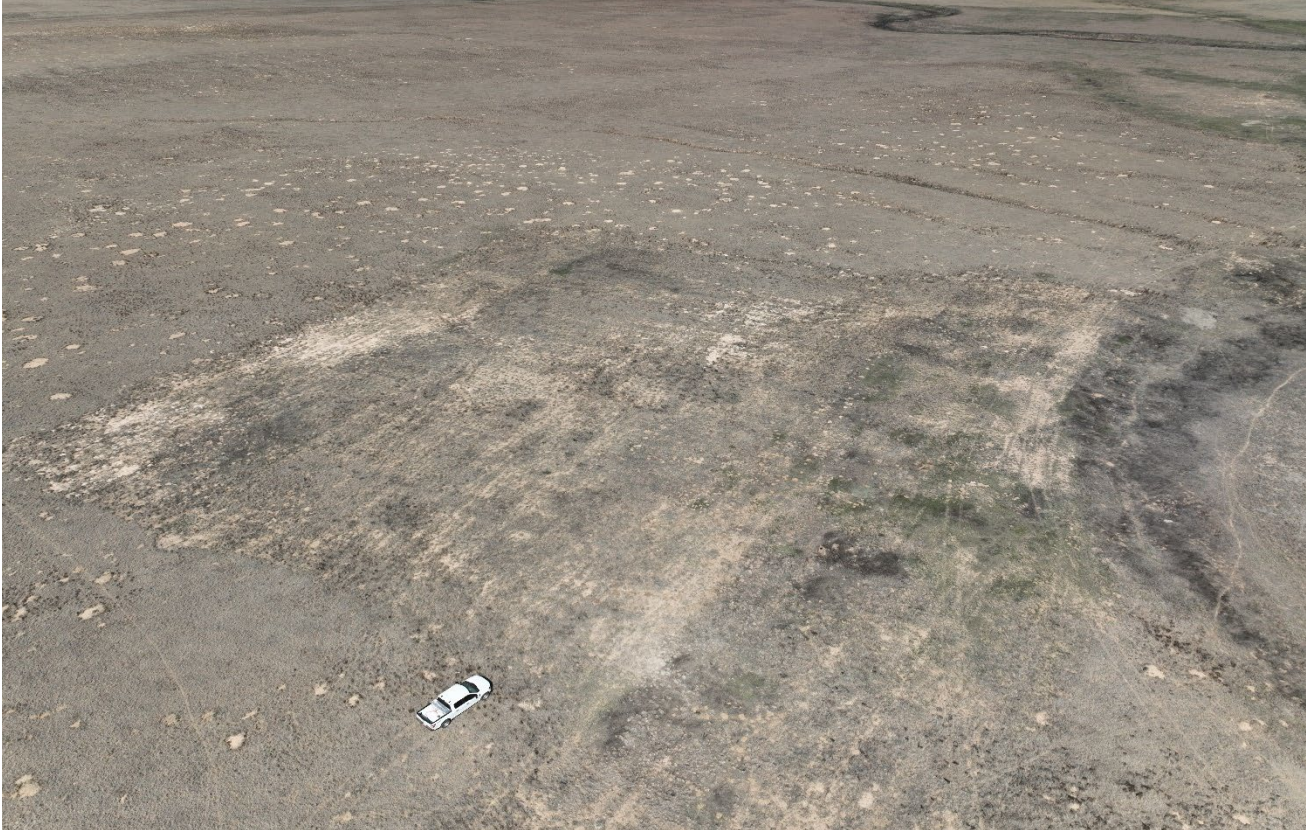
Photo 1. Drone aerial photo facing northwest overlooking the location

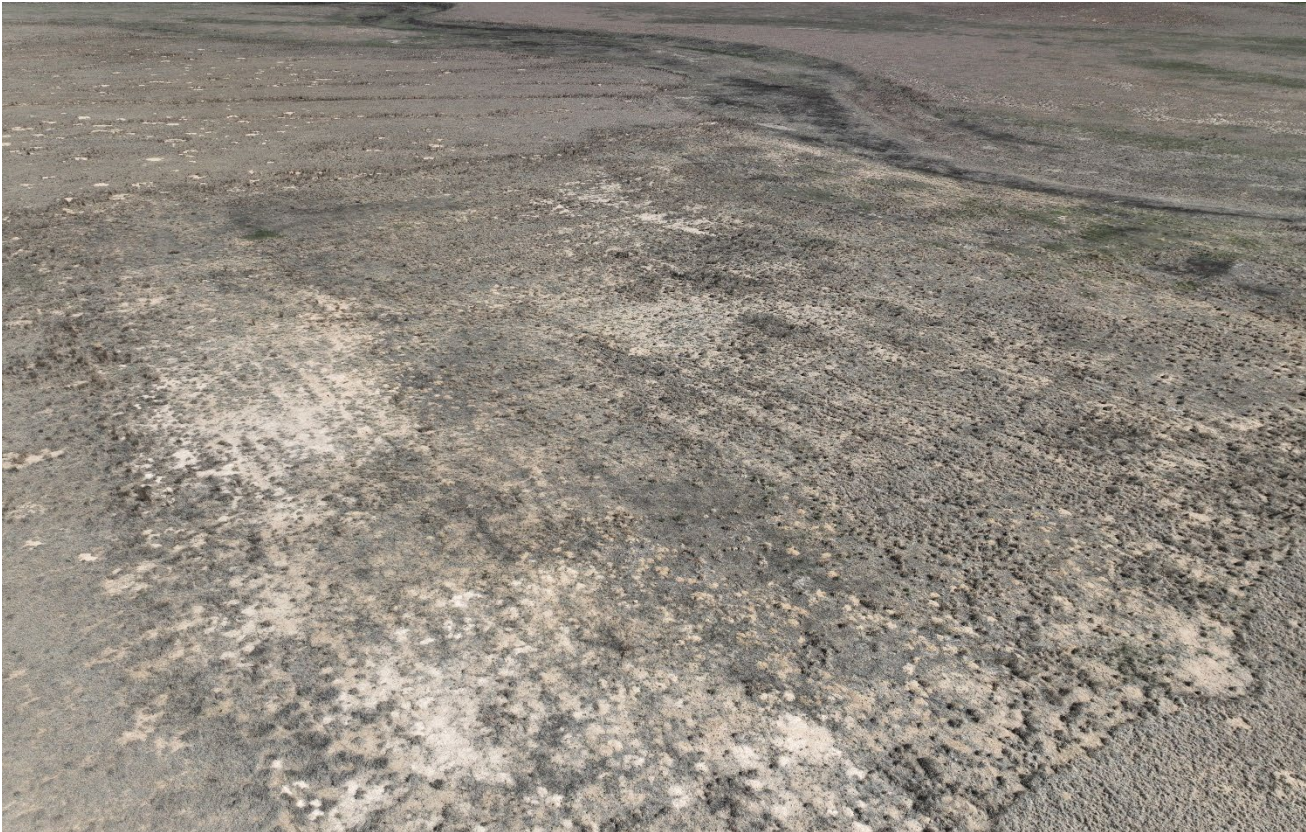
Photo 2. Drone aerial photo facing northeast toward the location. Red arrow points to the “green” weedy area shown in photo #4.

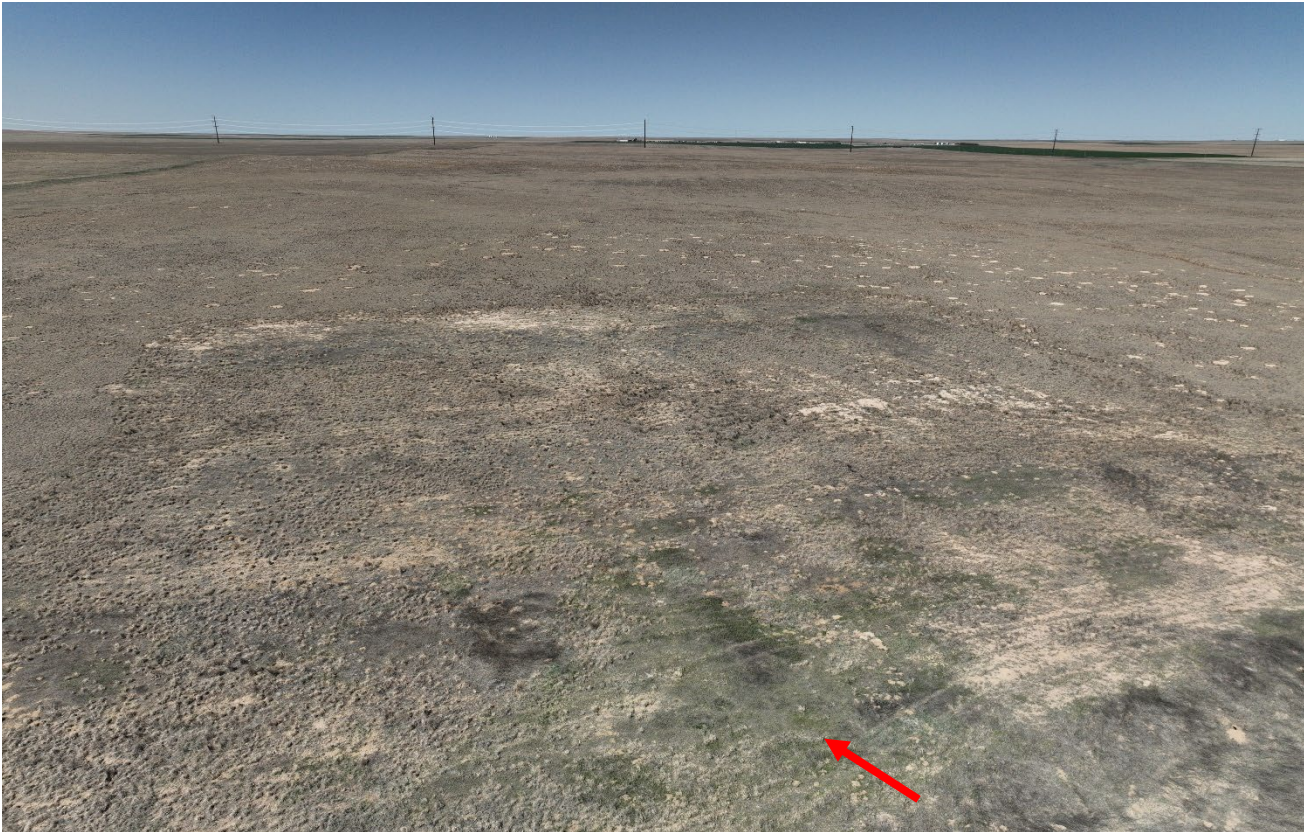
Photo 3. Drone aerial photo facing west at the location. Red arrow points to the “green” weedy area shown in photo #7.

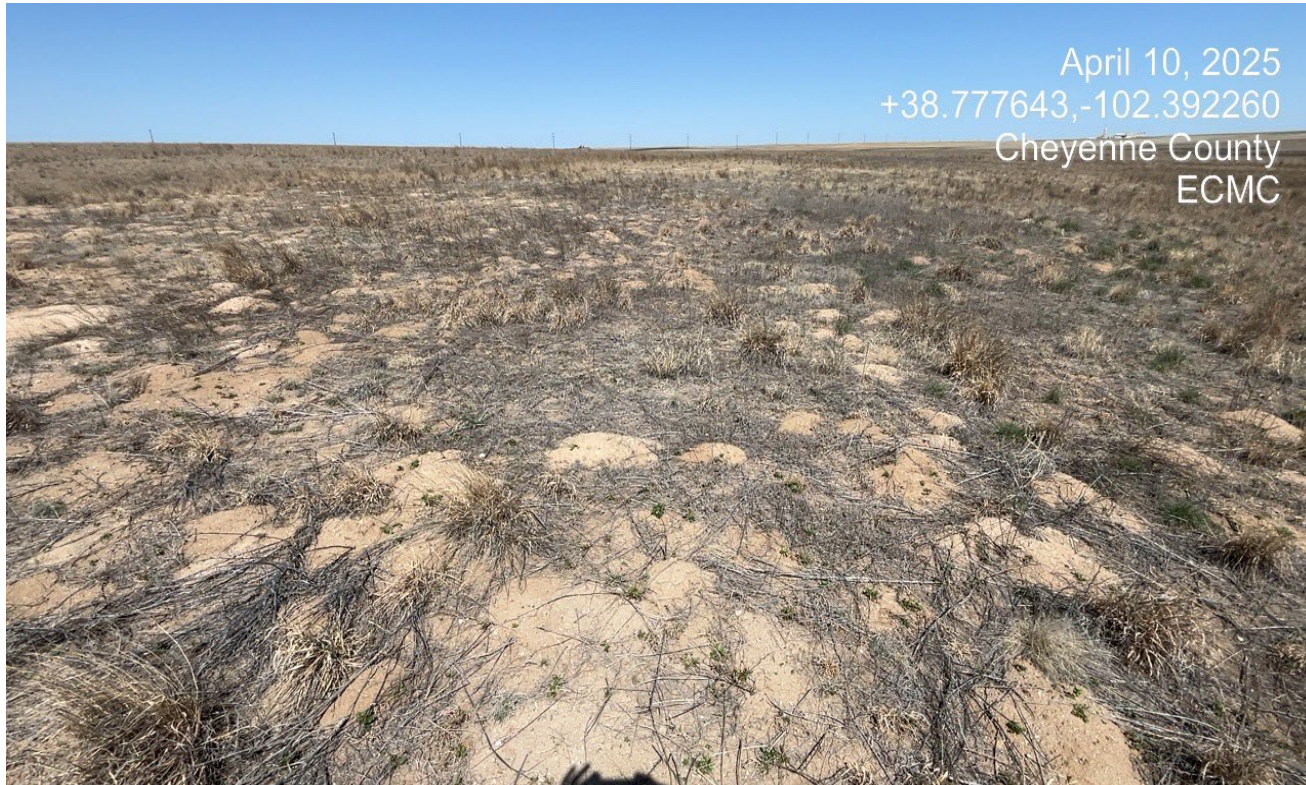
Photo 4. South side of the location facing northwest.

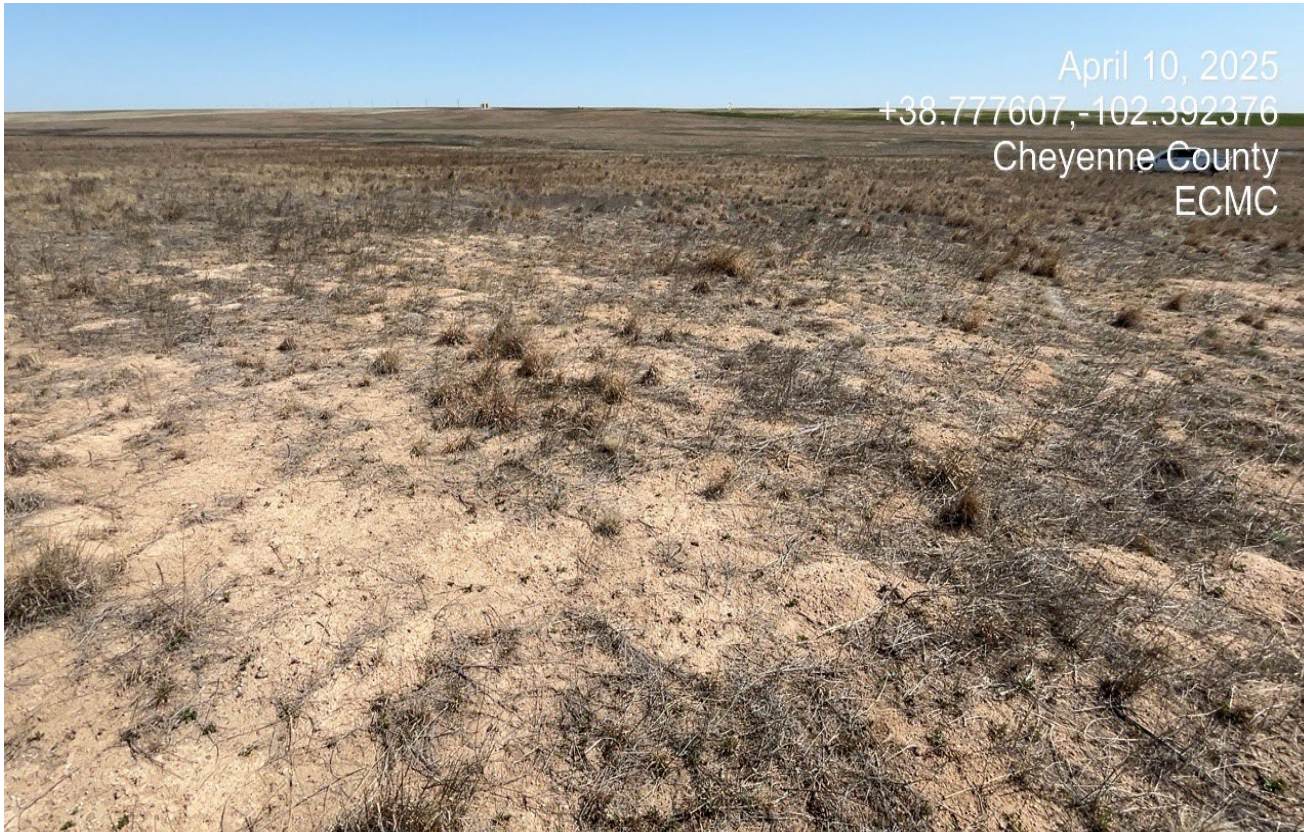
Photo 5. Southwest corner facing northeast. This area of the location has much lower perennial vegetation cover..

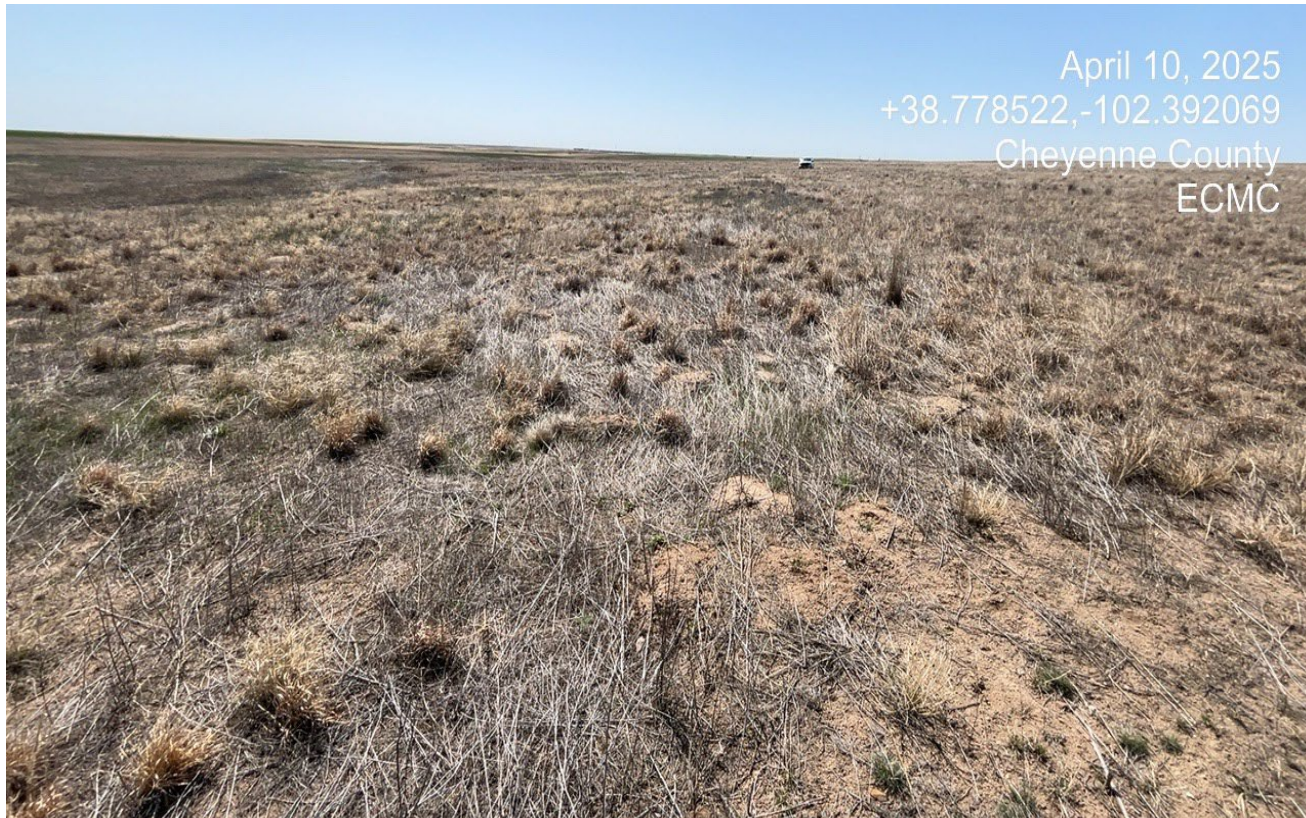
Photo 6. North side of the location facing southeast. The center and northern portion of the location has much better established perennial vegetation..

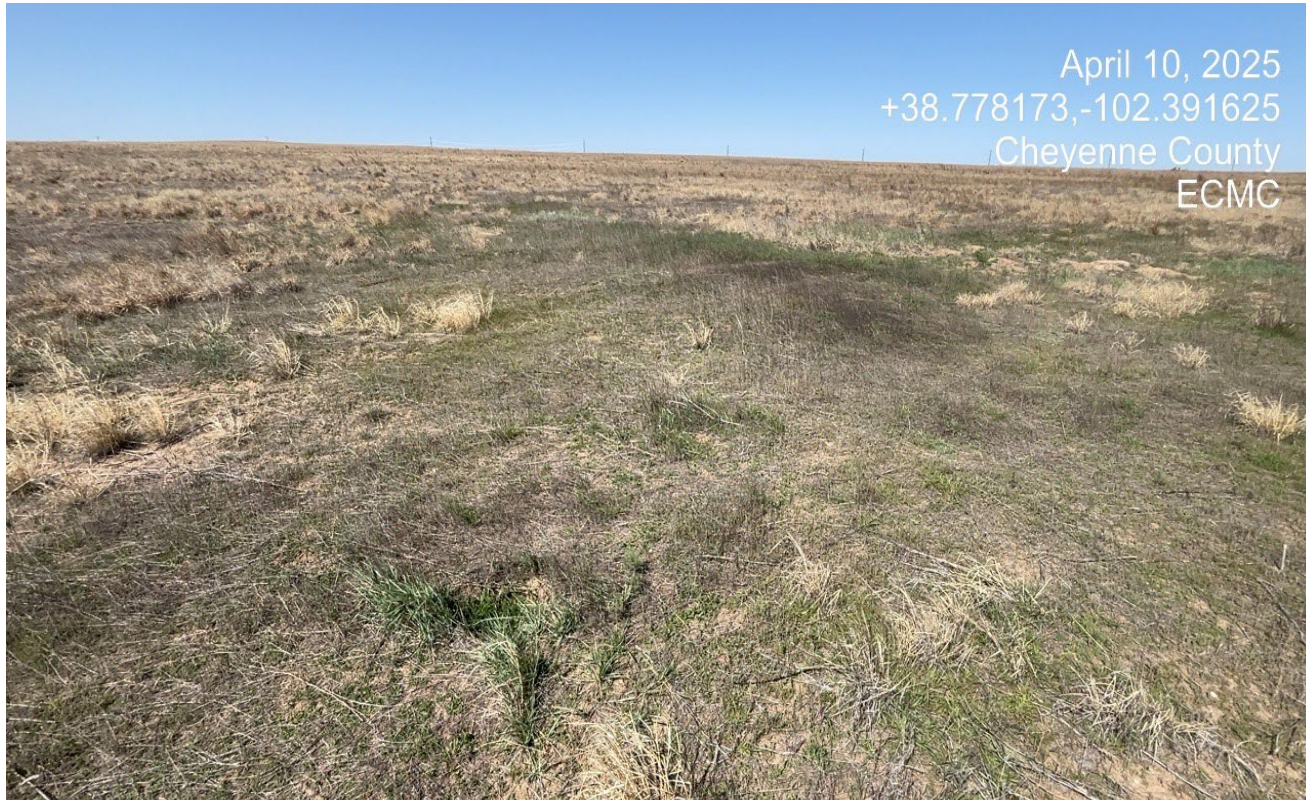
Photo 7. East side of the location facing northwest. This are consist mostly of weeds Cheat grass and Kochia.

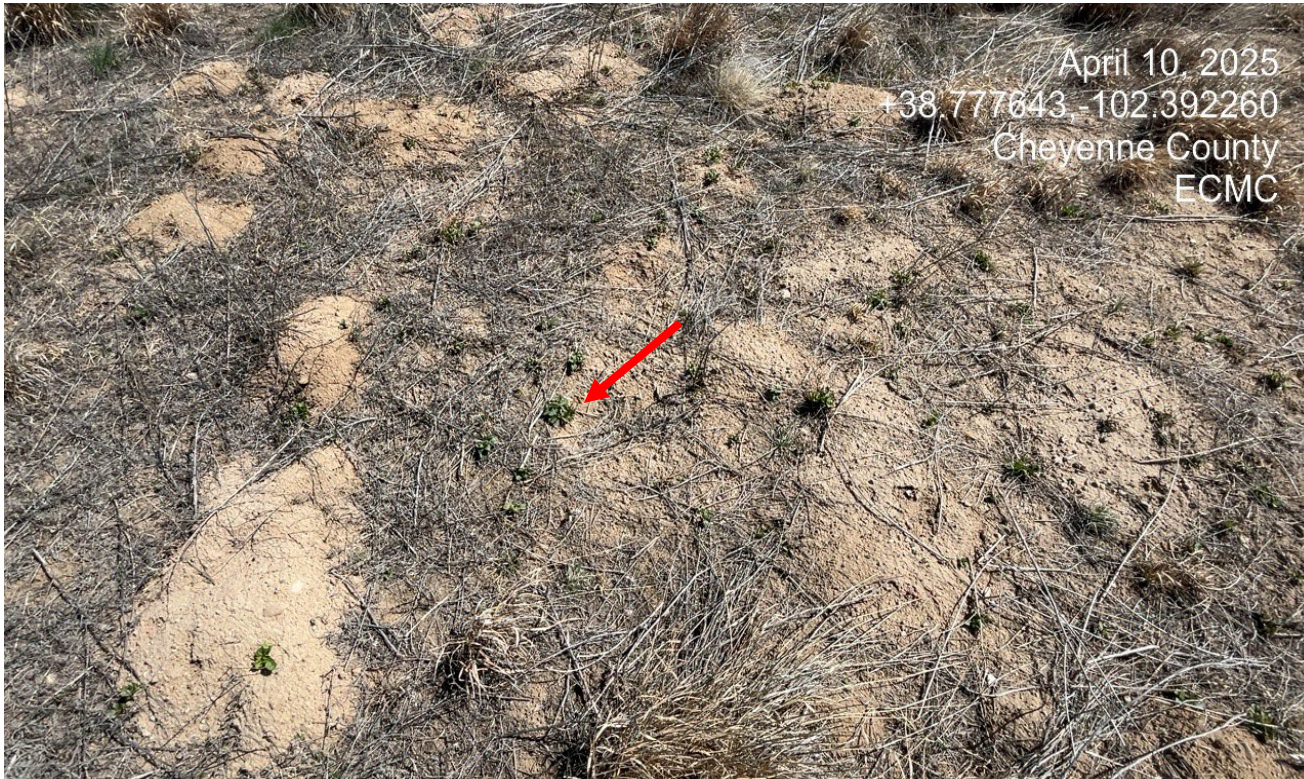
Photo 8. View of groundcover shows some noxious weed beginning to emerge. Red arrow points to Field bindweed..

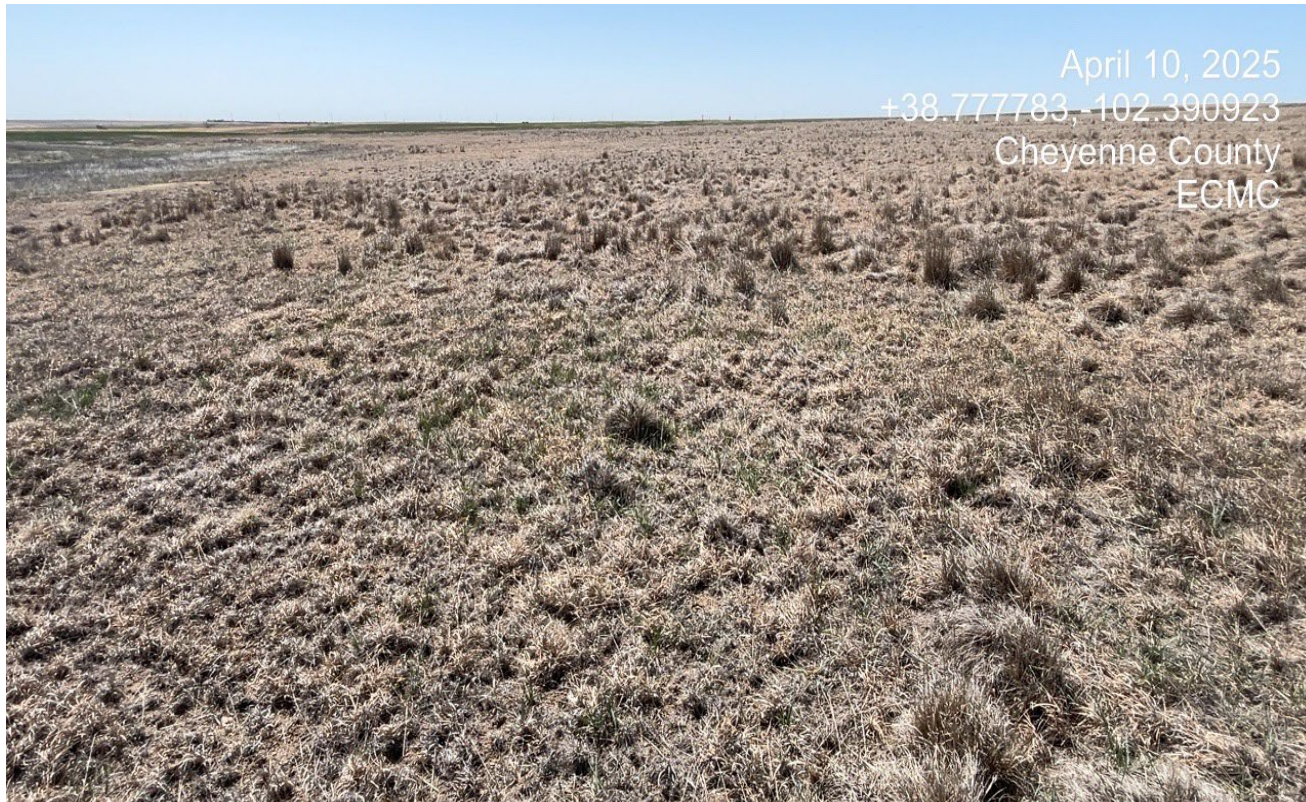
Photo 9. Facing southeast toward the surrounding reference CRP pasture..

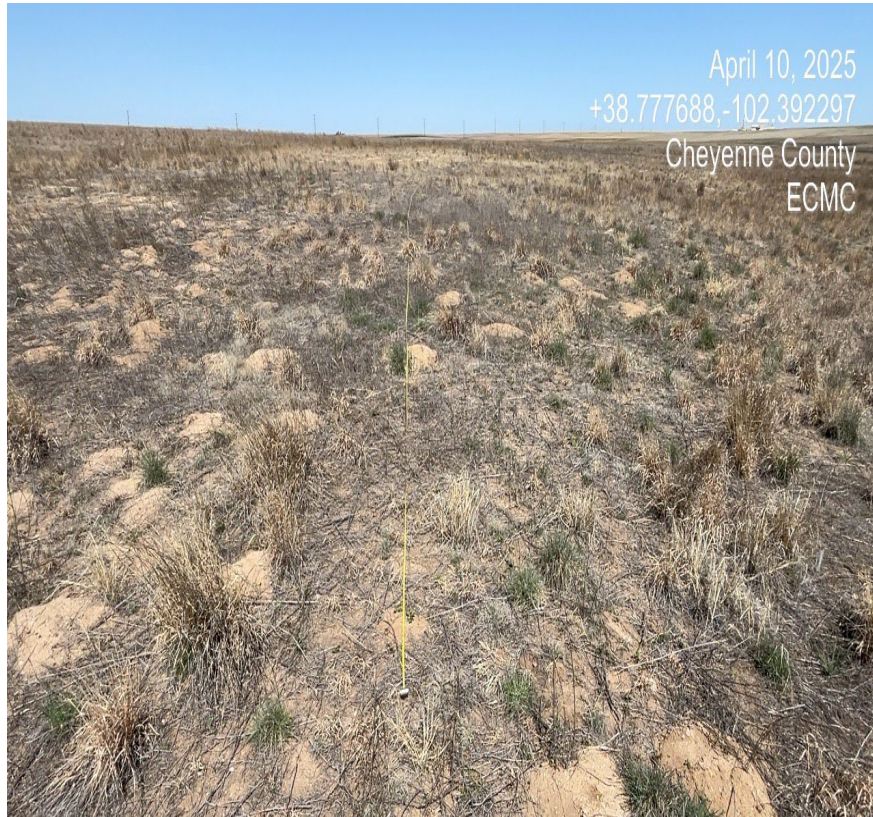
Photo 10. Facing northwest at the beginning of the transect at the location.

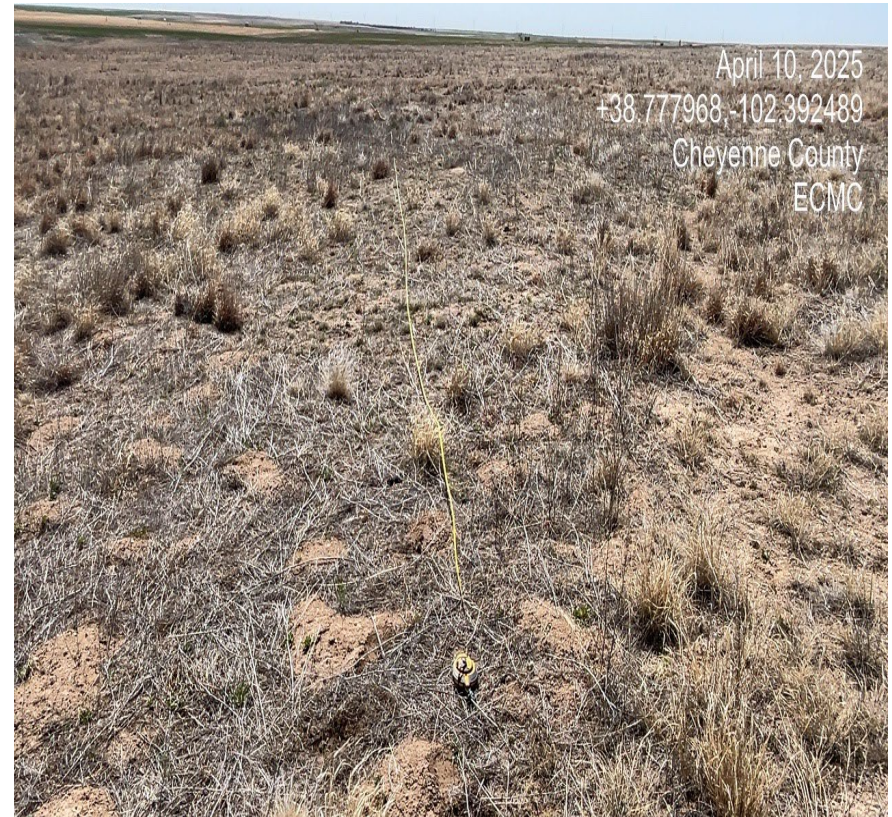
Photo 11. Facing southeast at the end of the transect at the location.

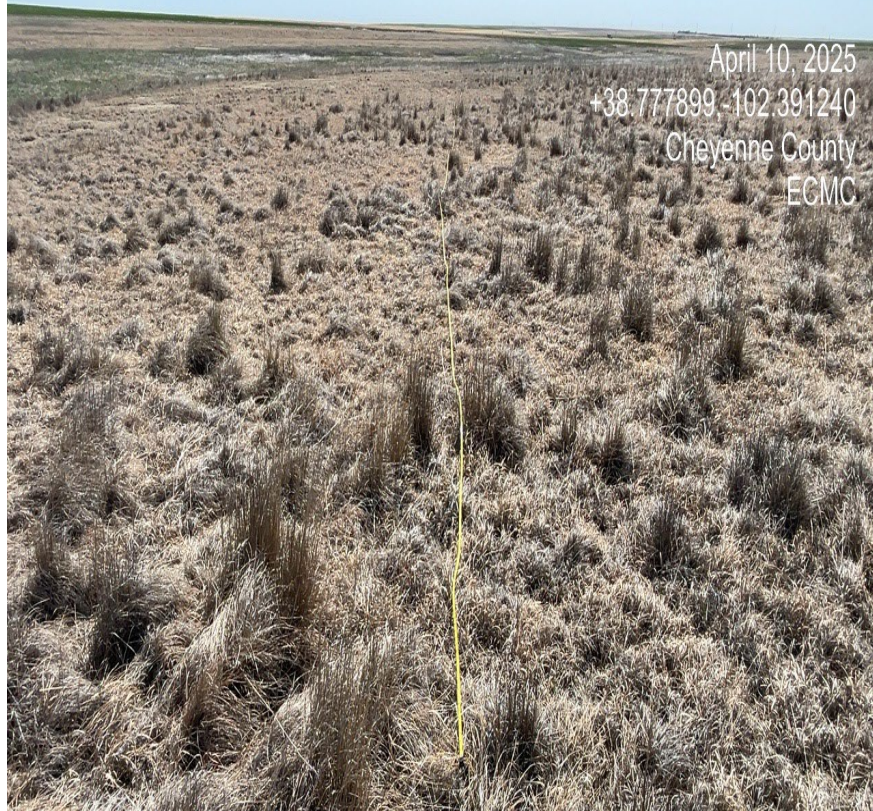
Photo 12. Facing southeast at the beginning of the transect at the reference area.

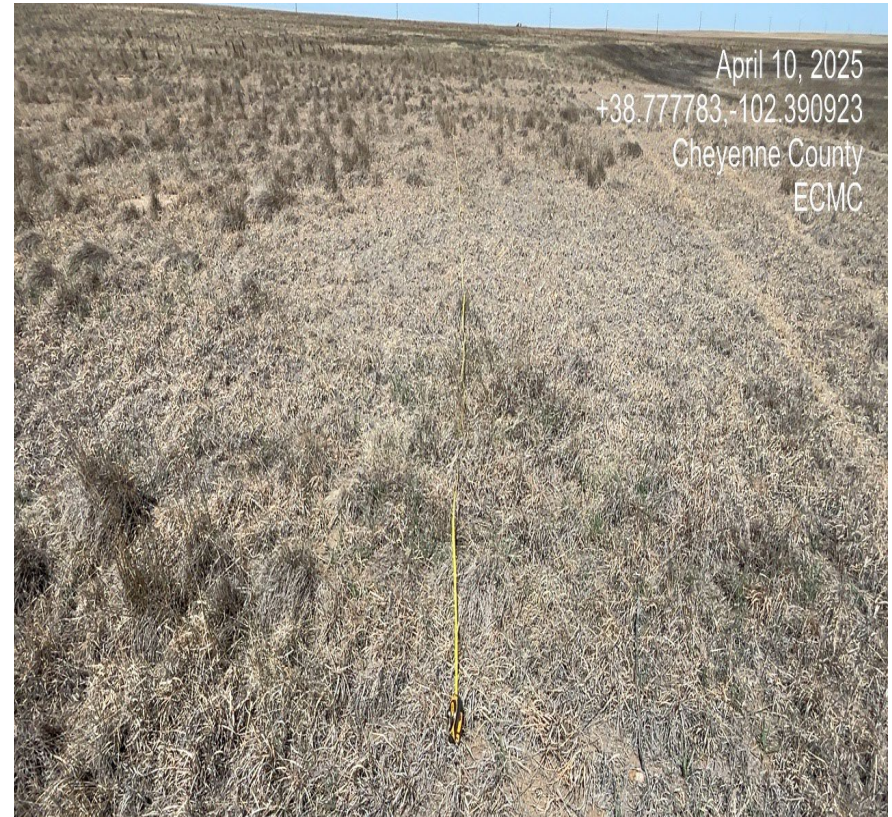
Photo 13. Facing northwest at the end of the transect at the reference area.
