Inspection Photos

Operator: BLACK HILLS PLATEAU
PRODUCTION LLC - 10150

Location ID: 312420

Inspection Doc: 718100478

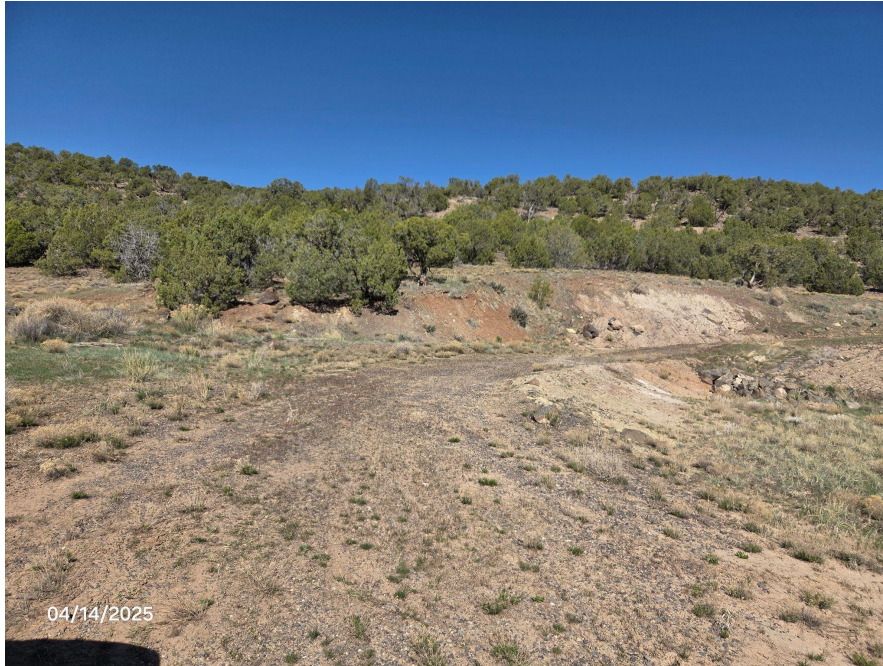
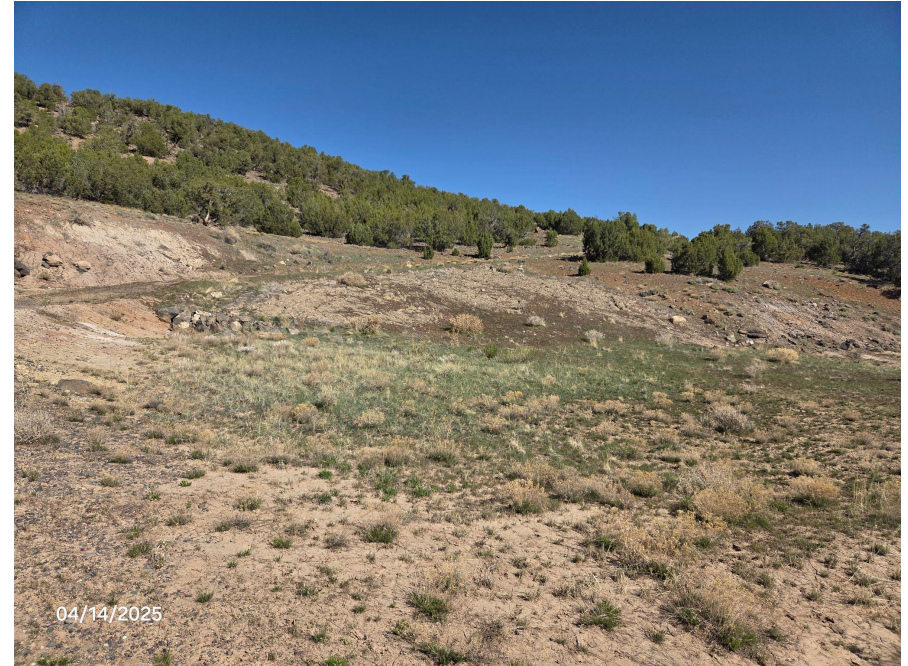
Photo 1: Photos 1-2 taken from the south end of the Location. Photos provide an overview of the Location from west, northwest, northeast to east. Photos also show that reclamation work, including but not limited to, removal of gravel/road base, compaction alleviation, recontouring/regrading and revegetation activities have not been performed on the Location.

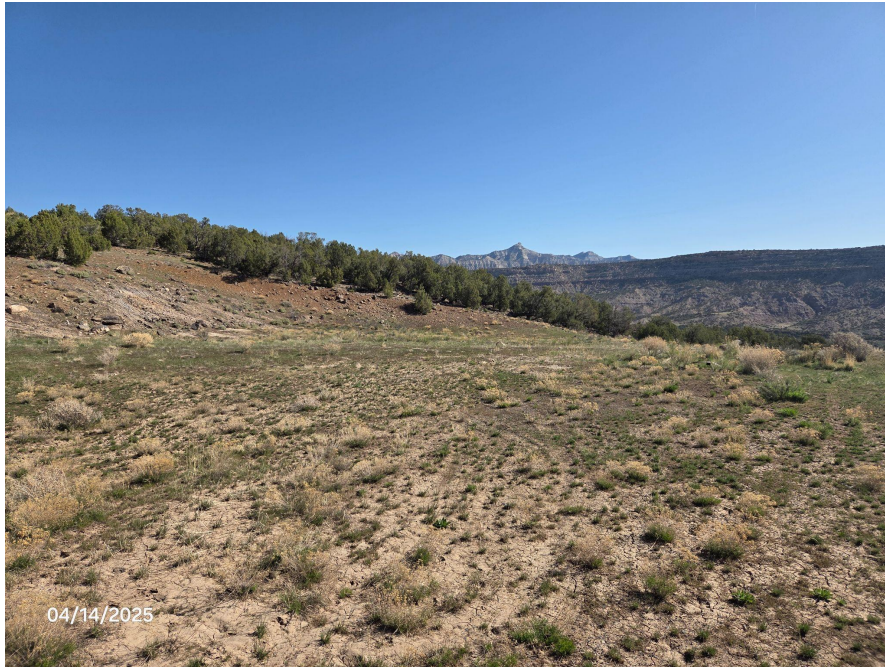
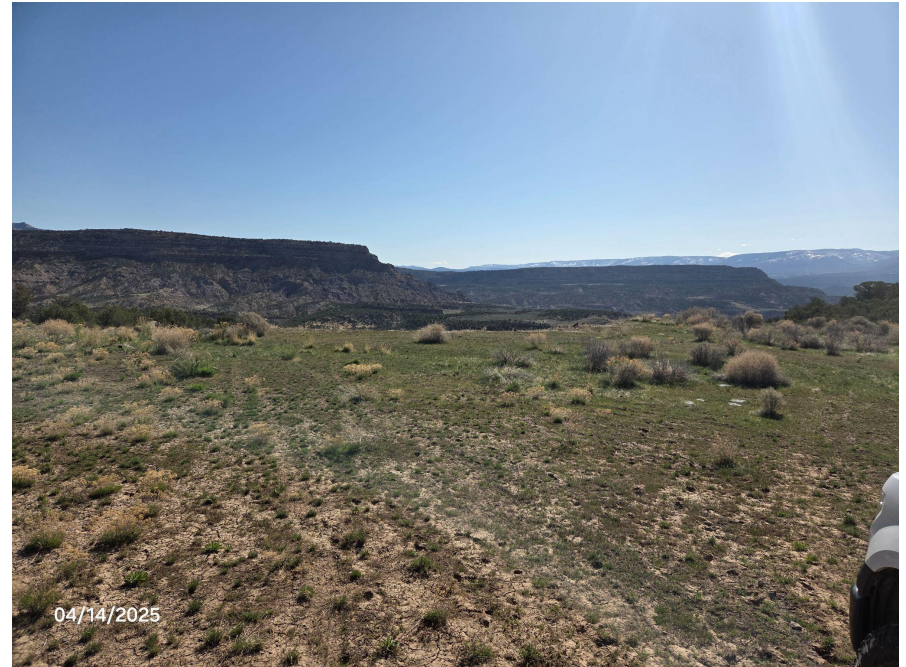
Photo 2: See comments under photo 1.

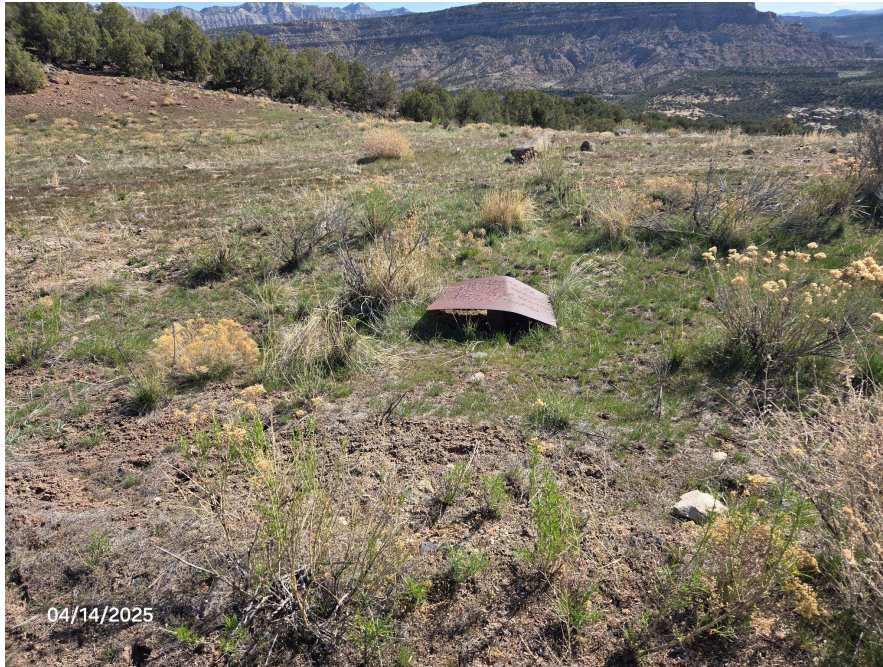
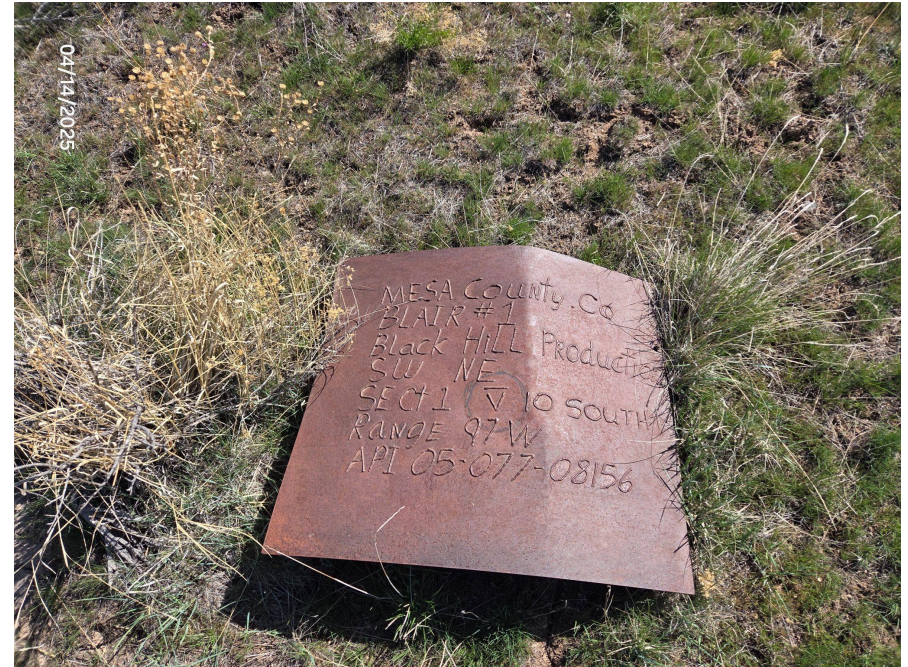
Photo 3: Photo shows welded plate representing the well marker left at the surface. Rules at time of plugging required permanent monuments marking well at surface was required to be a piece of pipe not less than 4 inches in diameter and not less than 10 feet in length, of which 4 feet shall be above the general ground level; monument left at surface does not comport with abandoned well marker requirements.

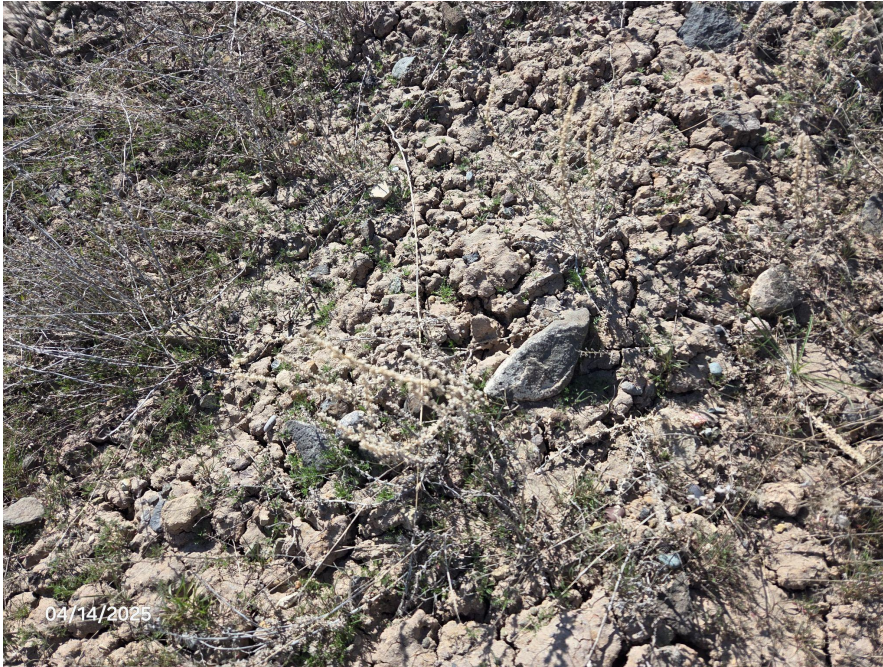
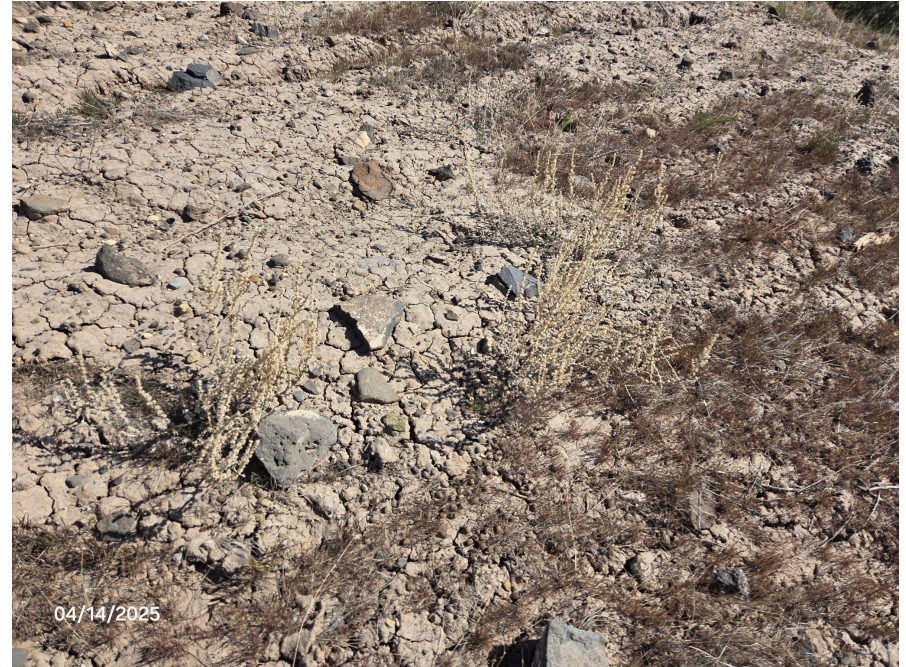
Photo 4: Photos examples showing patches of noxious weeds (halogeton) observed throughout the Location.

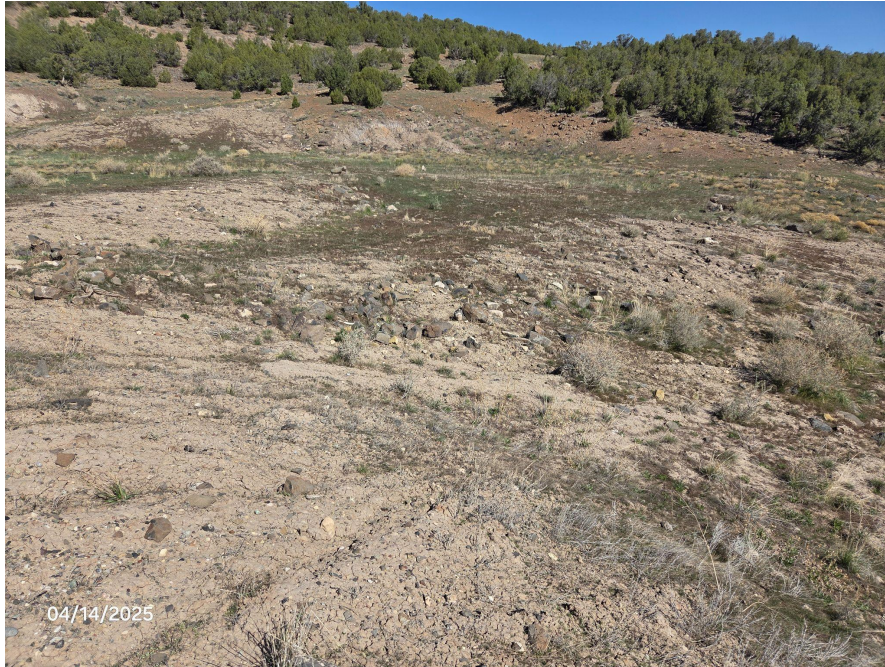
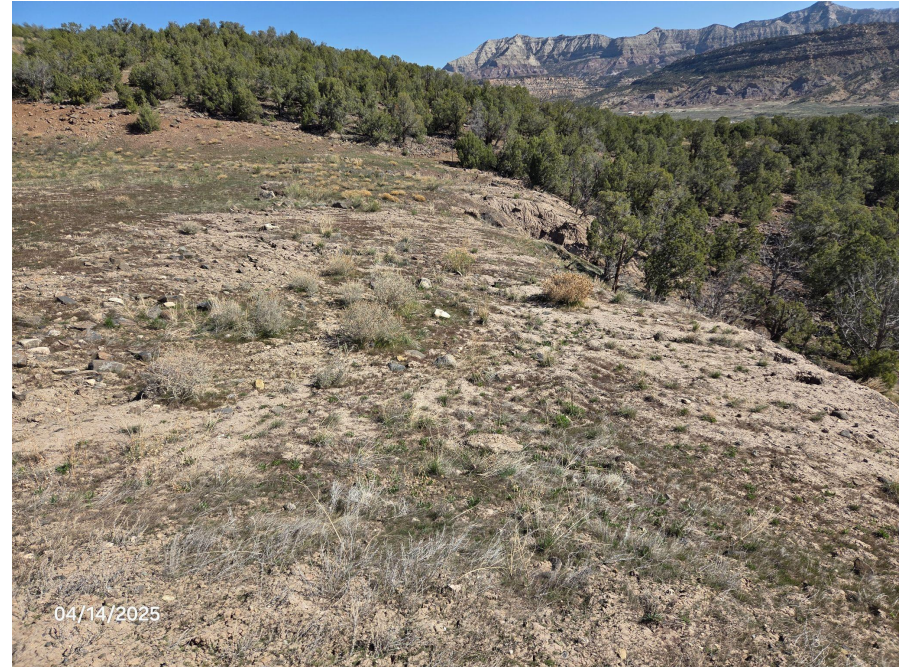
Photo 5: Photos taken from the southeast end of the Location, facing northwest and north. Photos show stormwater management, including BMPs to minimize erosion, degradation and sediment transport remain missing or insufficient - erosion, degradation and sediment transport have persisted throughout the Location. Vegetation observed in photo is predominantly weedy annual species such as cheatgrass, with some shrub establishment (Rabbitbrush, Fourwing saltbush).

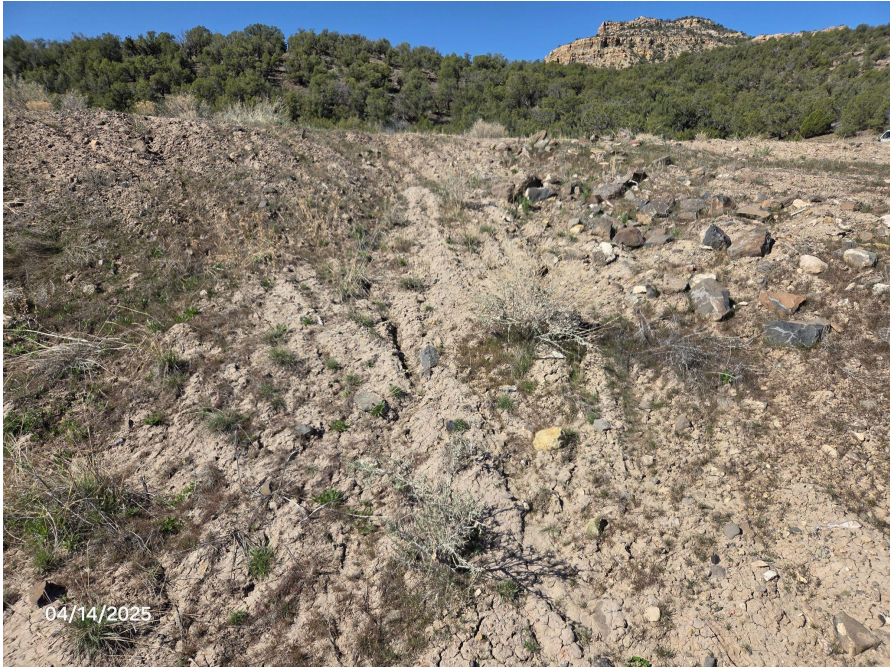
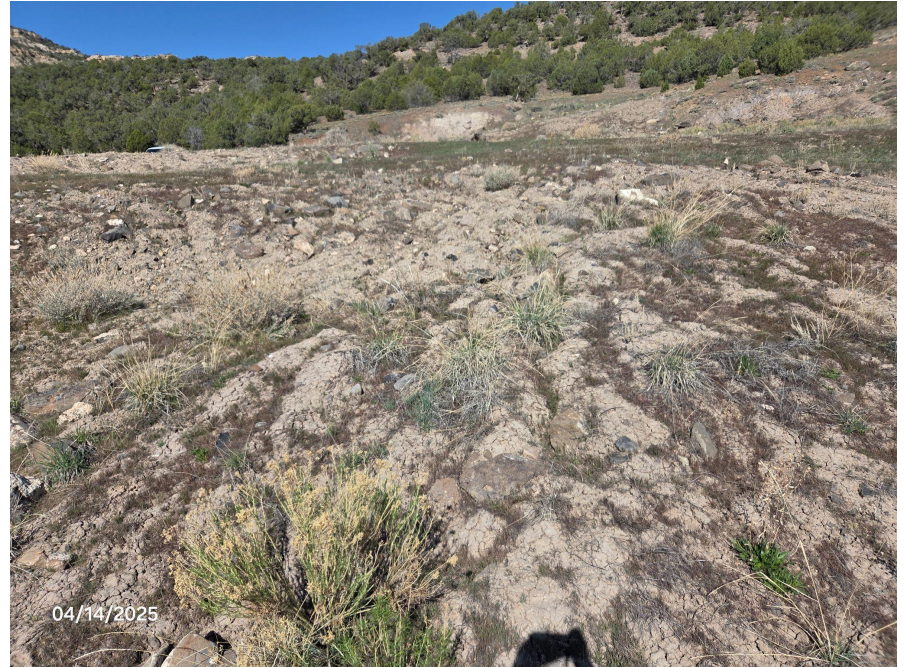
Photo 6: Photos taken from the east end of the Location, facing southwest and west. Photos show stormwater management, including BMPs to minimize erosion, degradation and sediment transport remain missing or insufficient - erosion, degradation and sediment transport have persisted throughout the Location. Vegetation observed in photo is predominantly weedy annual species such as cheatgrass, with some shrub establishment (Rabbitbrush, Fourwing saltbush).

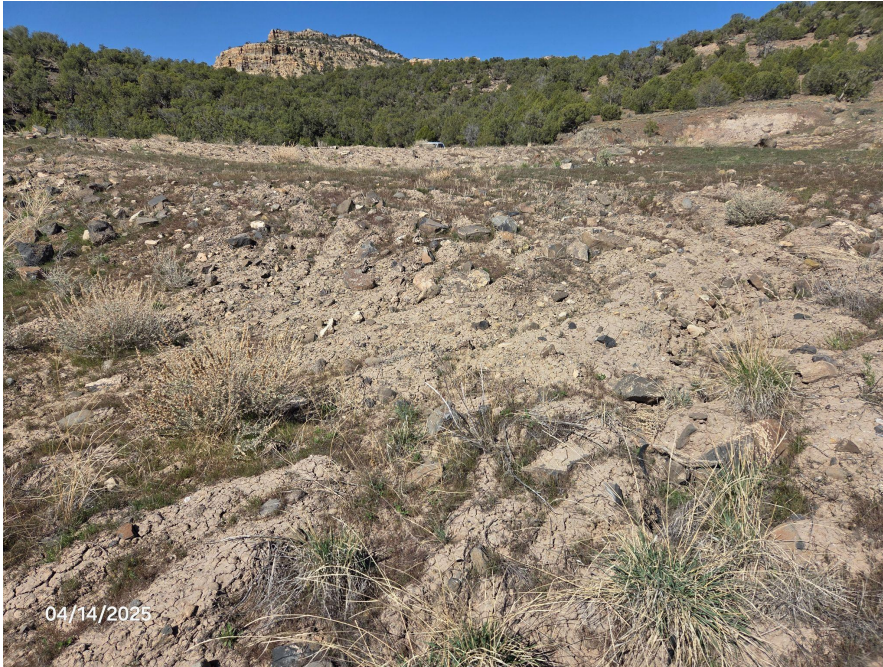
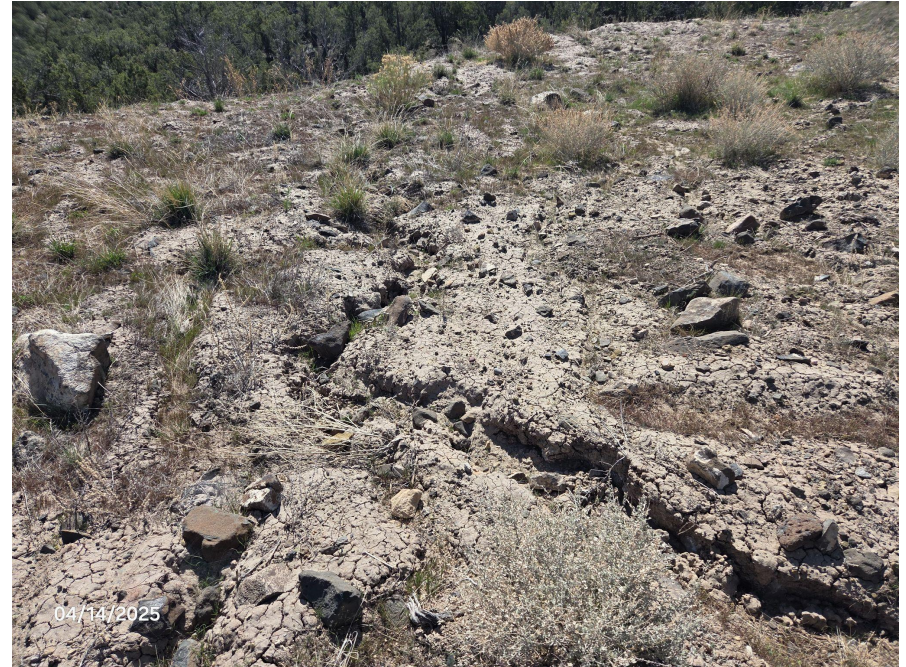
Photo 7: Photos taken from the northeast end of the Location facing southwest and southeast. Photos show stormwater management, including BMPs to minimize erosion, degradation and sediment transport remain missing or insufficient - erosion, degradation and sediment transport have persisted throughout the Location. Vegetation observed in photo is predominantly weedy annual species such as cheatgrass, with some shrub establishment (Rabbitbrush, Fourwing saltbush).

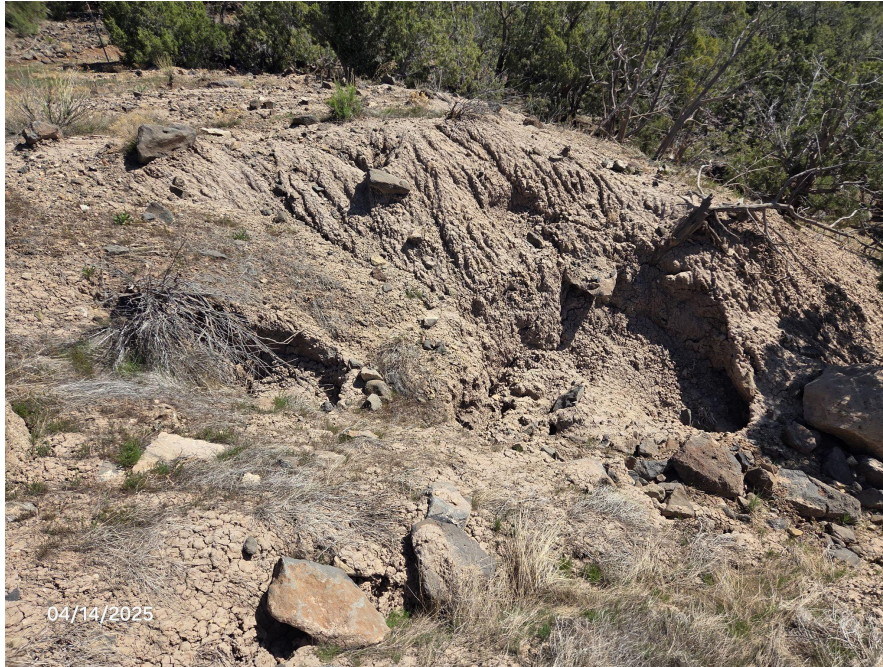
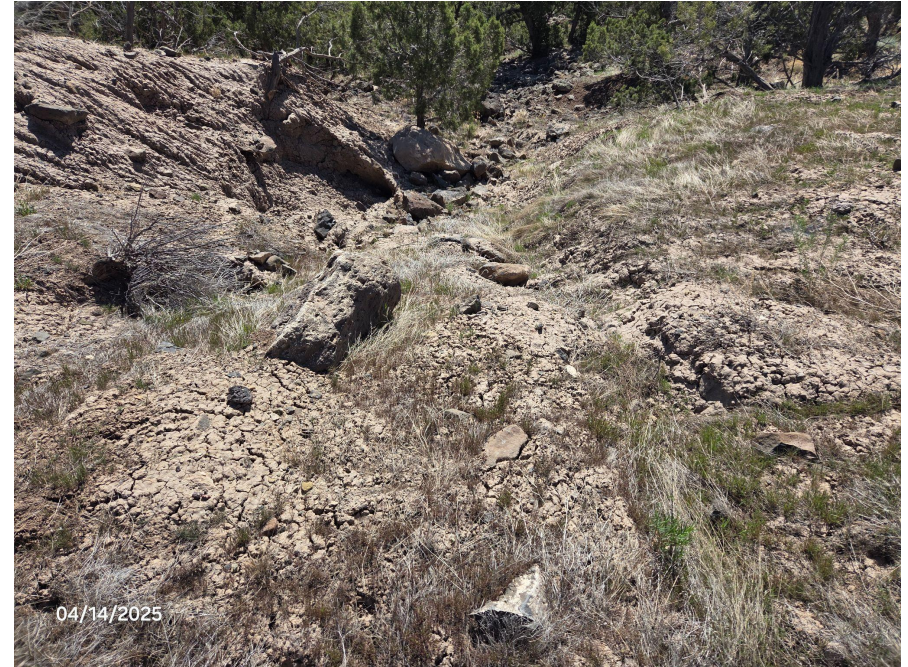
Photo 8: Photos taken from the fill slopes on the northeast end of the Location facing north and east. Location has not been recontoured/regraded and reclaimed. Photos also show stormwater management, including BMPs to minimize erosion, degradation and sediment transport remain missing or insufficient - erosion, degradation and sediment transport have persisted throughout the Location.

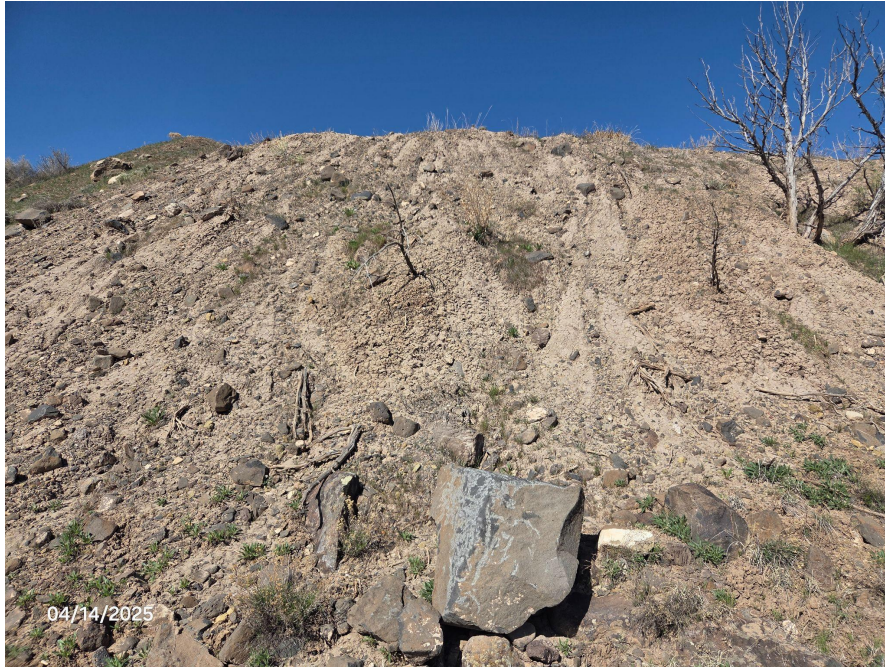
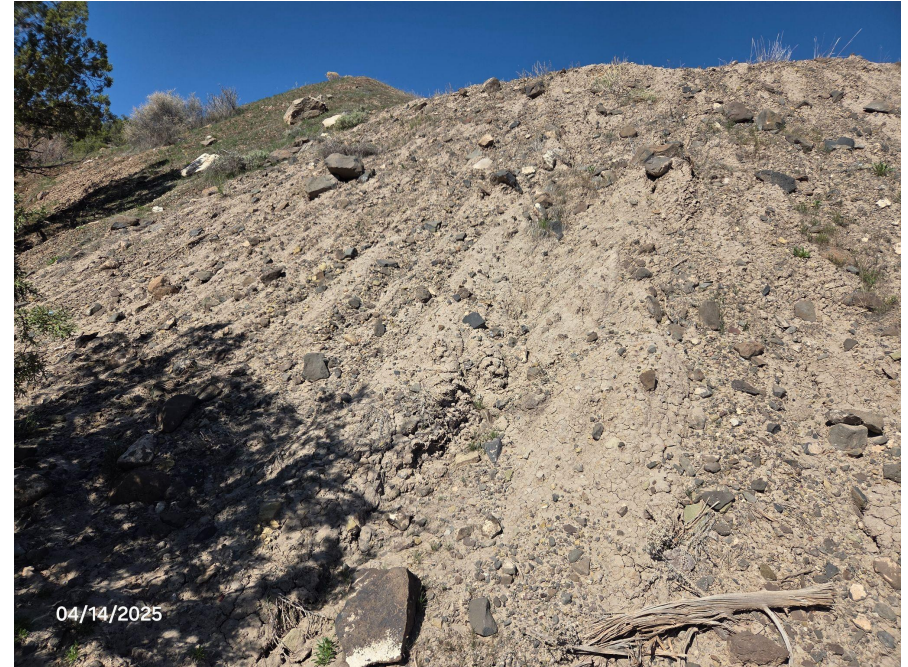
Photo 9: Photos taken from the fill slopes on the southeast end of the Location facing west. Location has not been recontoured/regraded and reclaimed. Photos also show stormwater management, including BMPs to minimize erosion, degradation and sediment transport remain missing or insufficient - erosion, degradation and sediment transport have persisted throughout the Location.

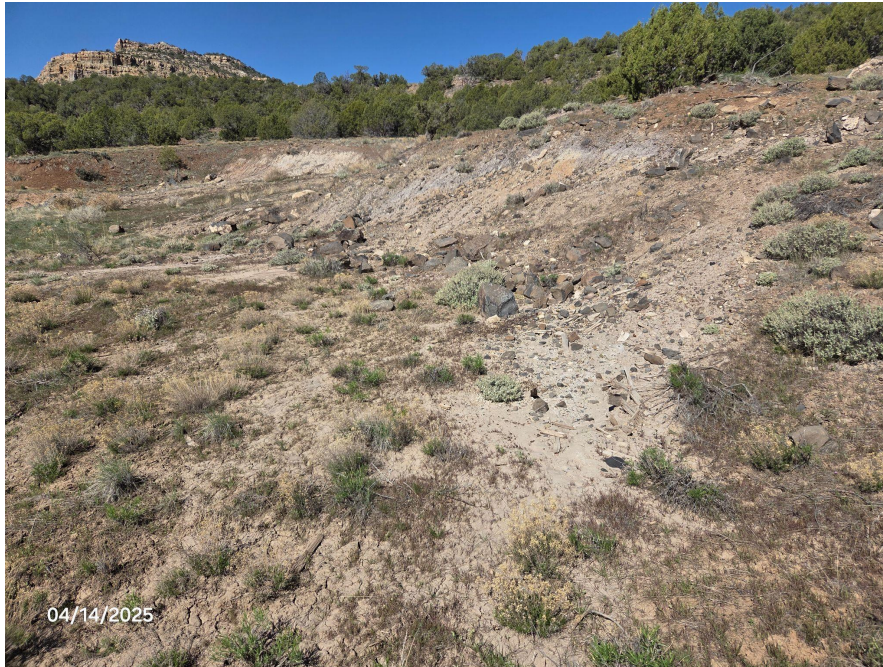
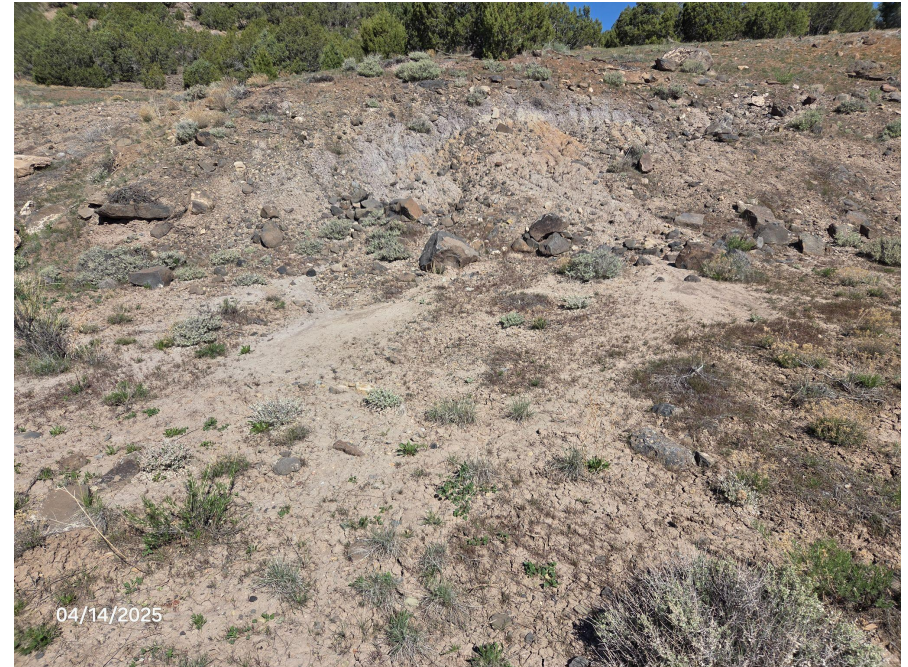
Photo 10: Photos taken from the cut slopes on the north end of the Location facing west and north. Location has not been recontoured/regraded and reclaimed. Photos also show stormwater management, including BMPs to minimize erosion, degradation and sediment transport remain missing or insufficient - erosion, degradation and sediment transport have persisted throughout the Location.

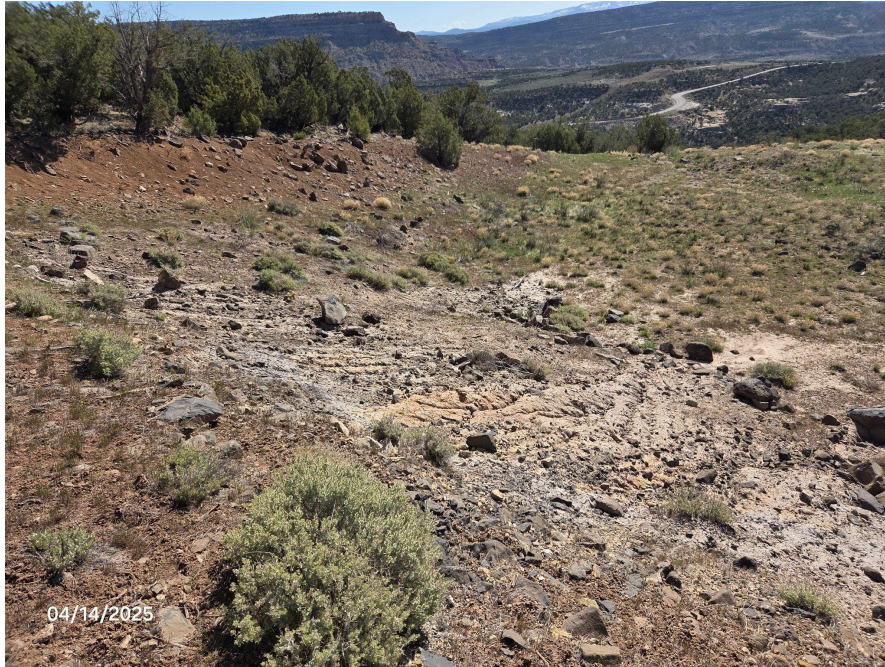
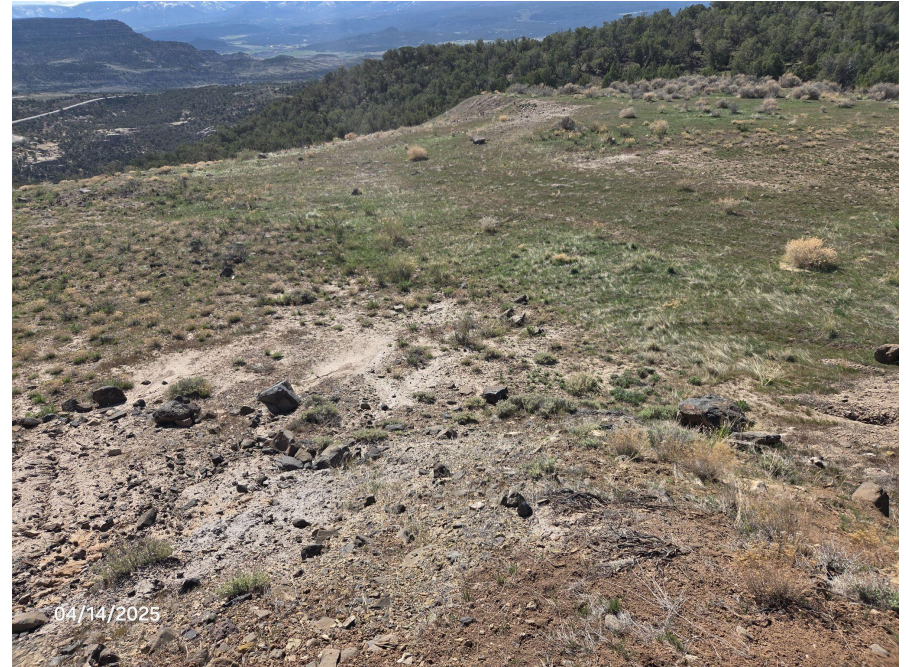
Photo 11: Photos taken from the above cut slopes on the north end of the Location facing east and southeast. Location has not been recontoured/regraded and reclaimed. Photos also show stormwater management, including BMPs to minimize erosion, degradation and sediment transport remain missing or insufficient - erosion, degradation and sediment transport have persisted throughout the Location.

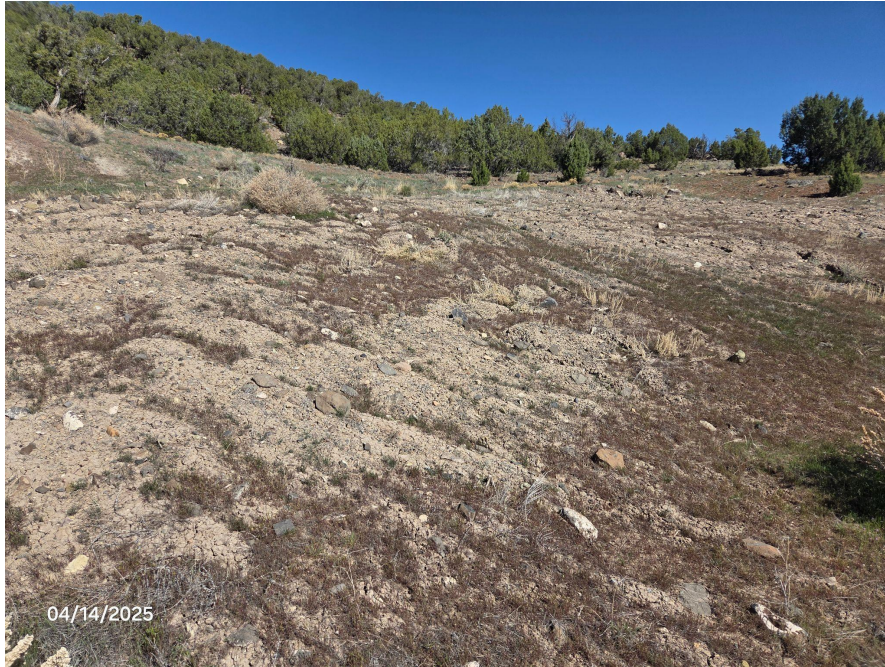
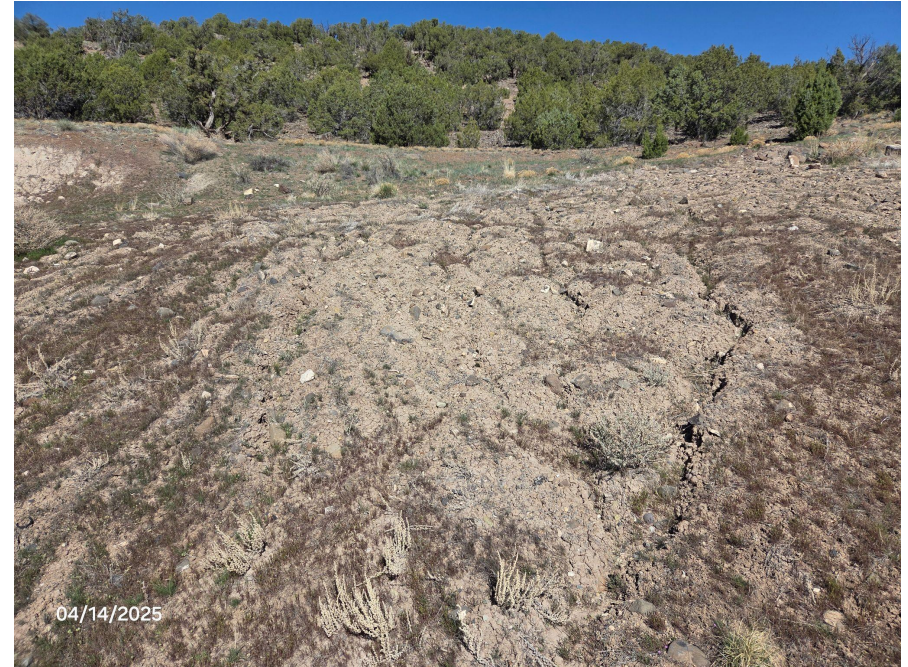
Photo 12: Photos taken from the cut slopes on the west end of the Location facing north and west. Location has not been recontoured/regraded and reclaimed. Photos also show stormwater management, including BMPs to minimize erosion, degradation and sediment transport remain missing or insufficient - erosion, degradation and sediment transport have persisted throughout the Location.

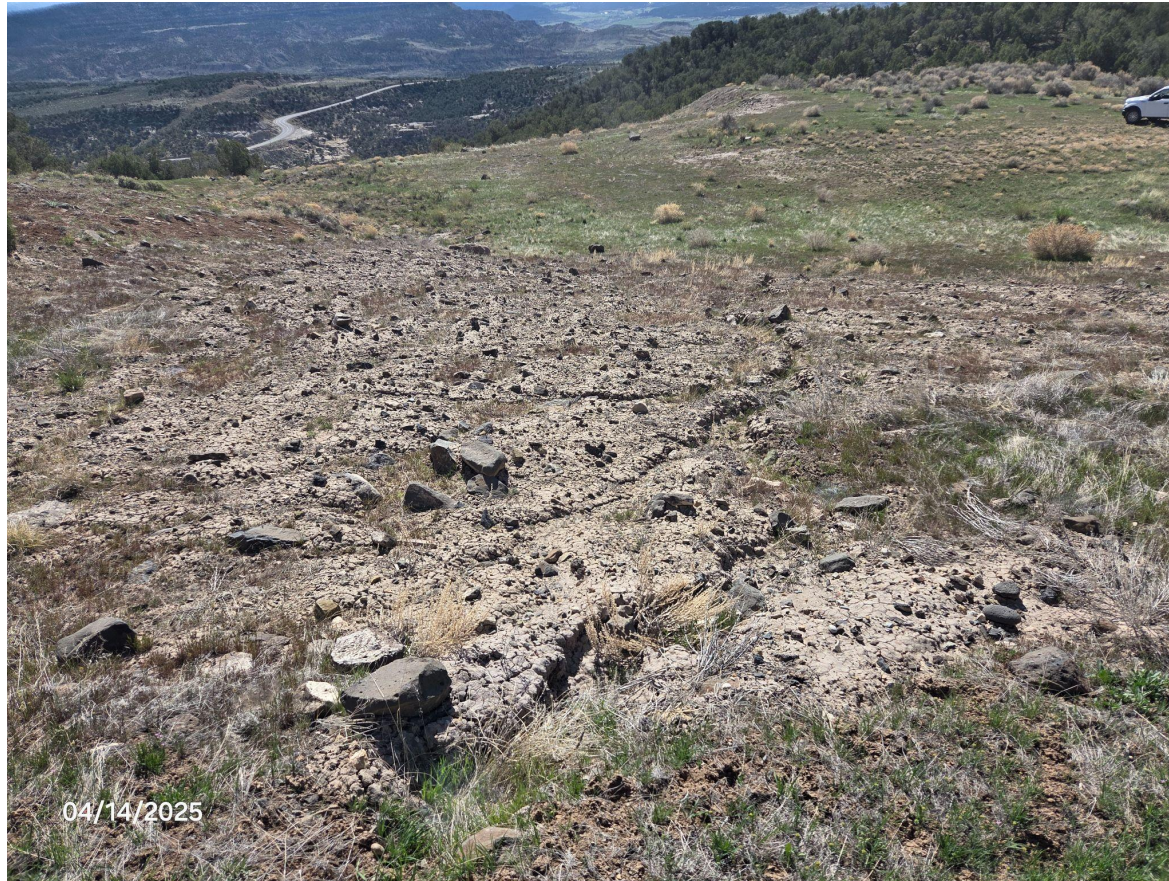
Photo 13: Photos taken from above the cut slopes on the west end of the Location facing southeast. Location has not been recontoured/regraded and reclaimed. Photos also show stormwater management, including BMPs to minimize erosion, degradation and sediment transport remain missing or insufficient - erosion, degradation and sediment transport have persisted throughout the Location.

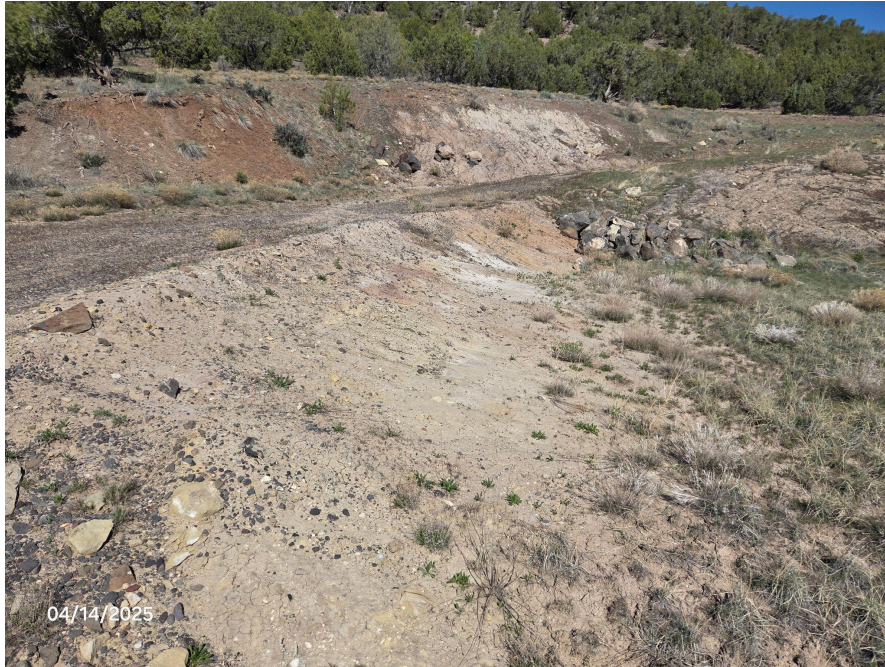
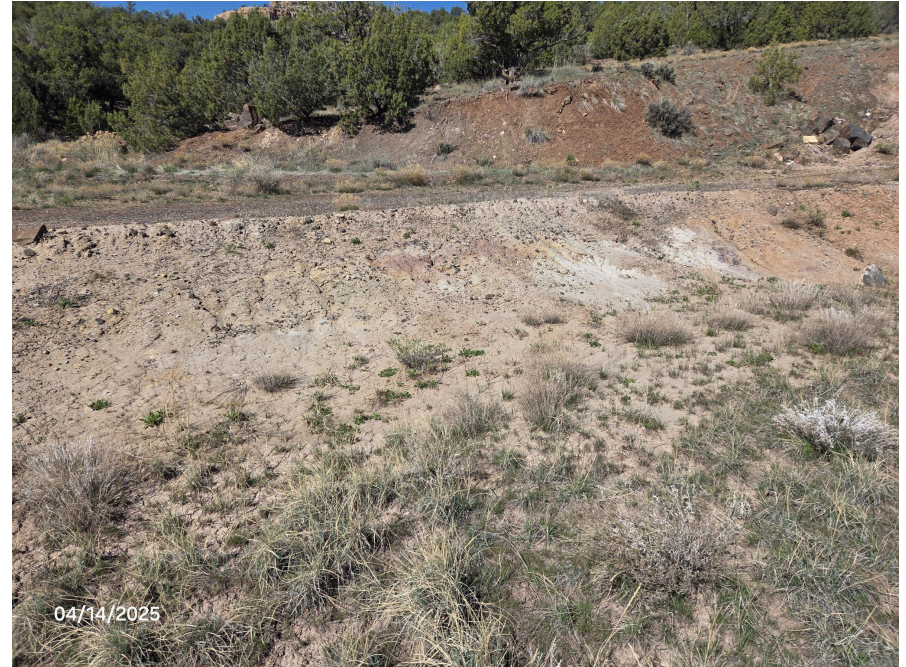
Photo 14: Photos taken from the cut slopes/access road on the west end of the Location facing north and west. Location has not been recontoured/regraded and reclaimed. Photos also show stormwater management, including BMPs to minimize erosion, degradation and sediment transport remain missing or insufficient - erosion, degradation and sediment transport have persisted throughout the Location.

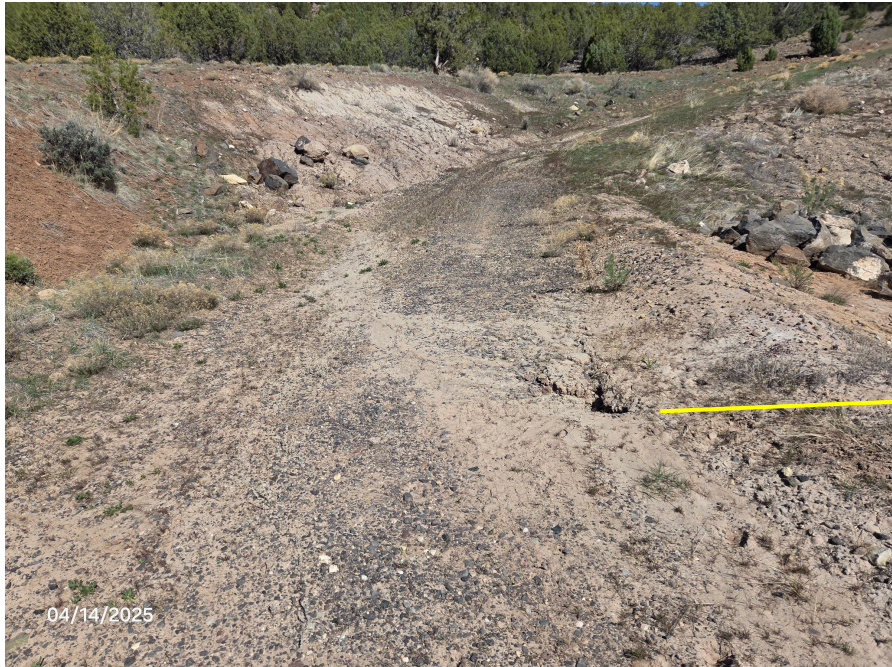
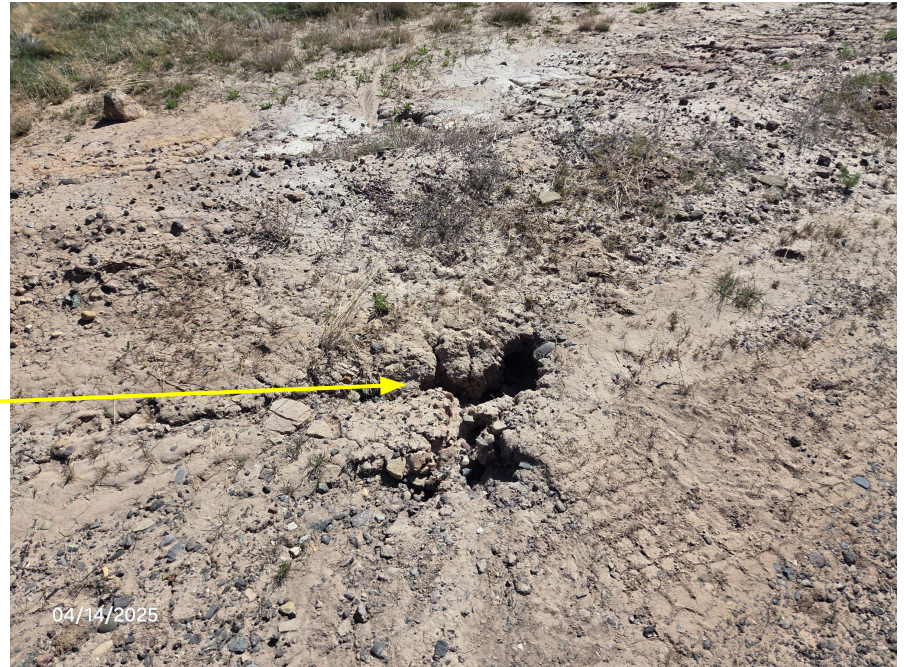
Photo 15: Photos taken from the cut slopes/access road on the west end of the Location facing north. See comments under photo 14. Photos also shows stormwater along the access road is beginning to travel and erode subsurface areas of the Location- stormwater is traveling into a crevice (photo right), moving subsurface and discharging from the cut slopes (photo 16).

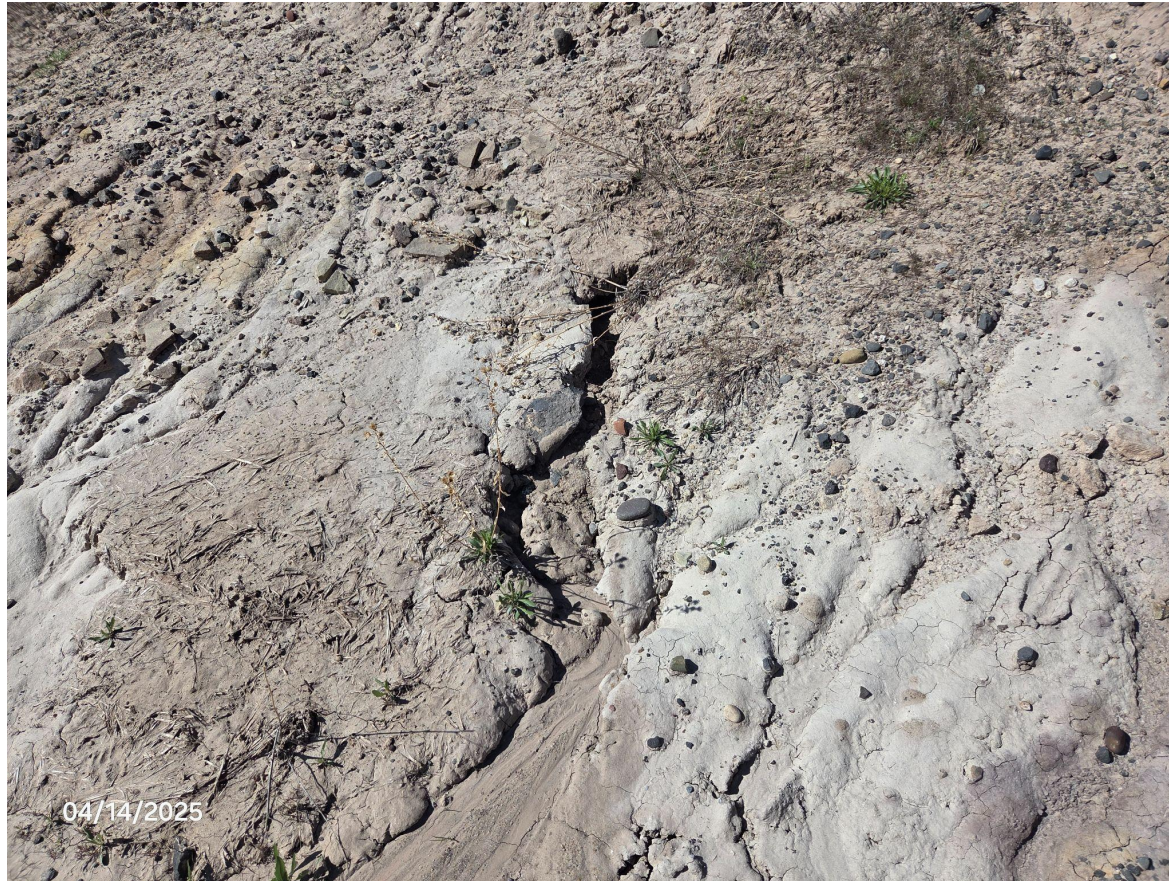
Photo 16: Continued from photo 15. Photo shows point along the cut slopes where subsurface stormwater discharges from the cut slopes.

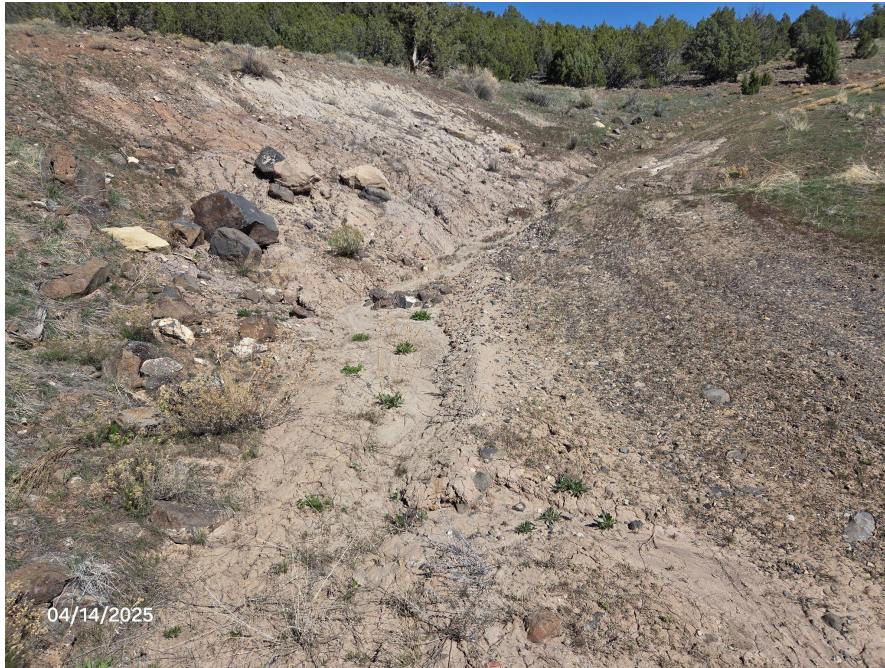
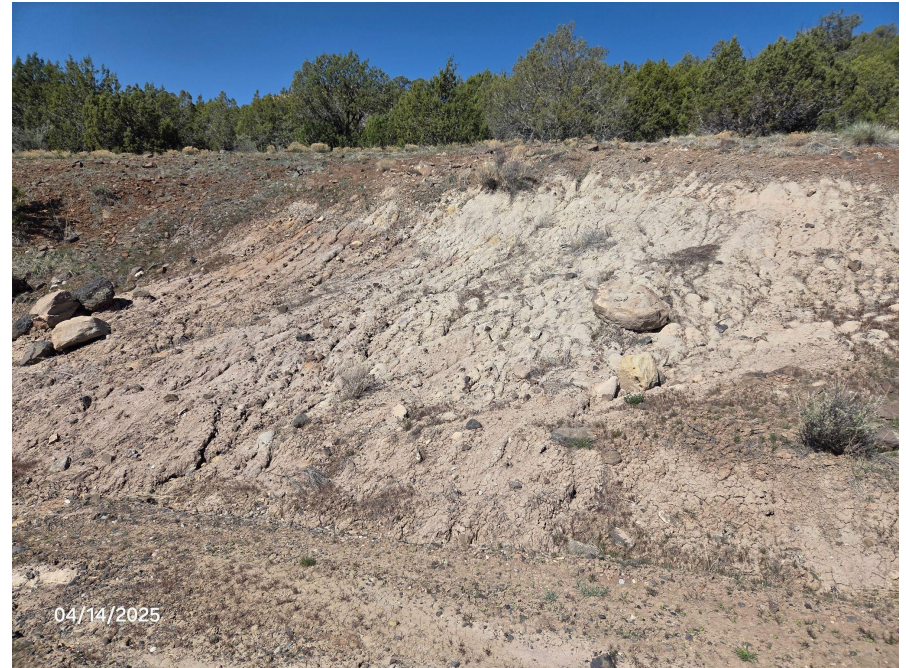
Photo 17: Photos taken from the cut slopes/access road on the west end of the Location facing north and west. Location has not been recontoured/regraded and reclaimed. Photos also show stormwater management, including BMPs to minimize erosion, degradation and sediment transport remain missing or insufficient - erosion, degradation and sediment transport have persisted throughout the Location.

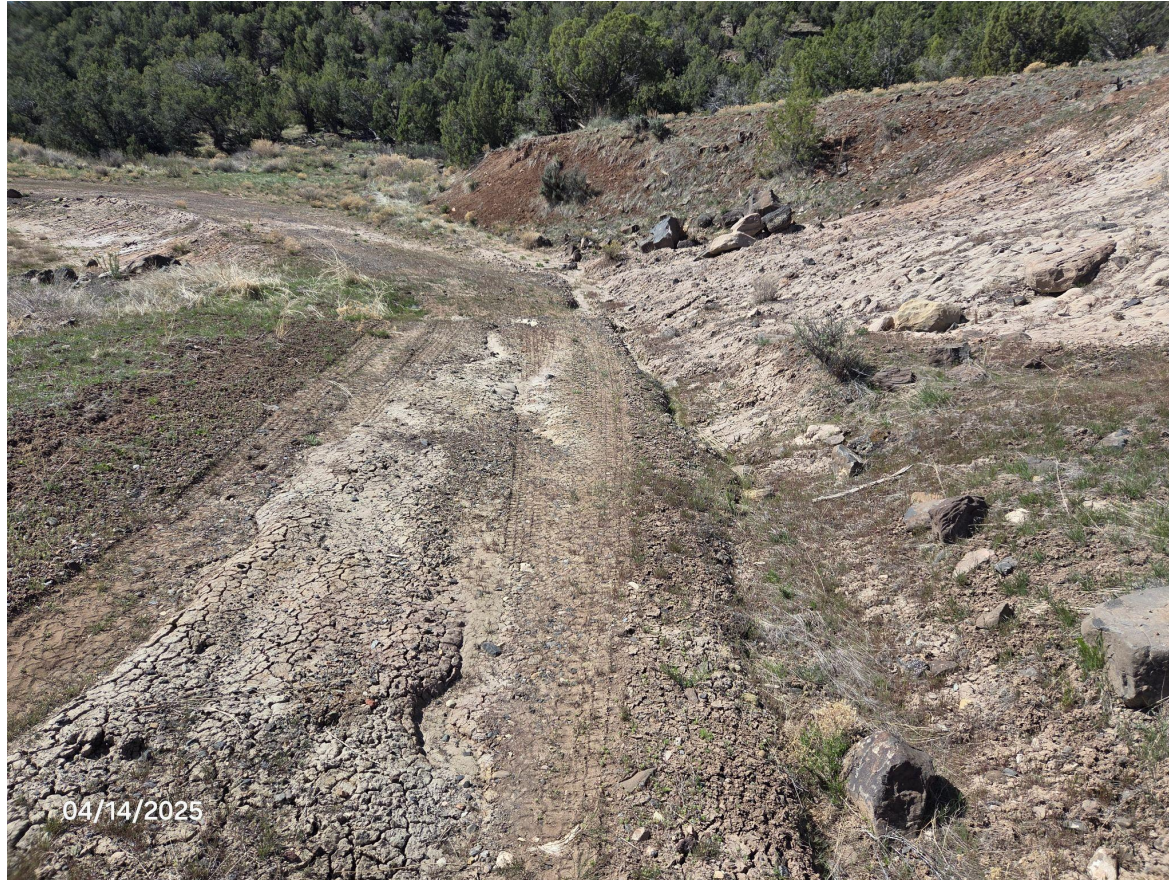
Photo 18: Photos taken from the cut slopes/access road on the west end of the Location facing south. Location has not been recontoured/regraded and reclaimed. Photos also show stormwater management, including BMPs to minimize erosion, degradation and sediment transport remain missing or insufficient - erosion, degradation and sediment transport have persisted throughout the Location.
