Inspection Photos

Operator: BLACK HILLS PLATEAU
PRODUCTION LLC - 10150

Location ID: 312420

Inspection Doc: 718100478

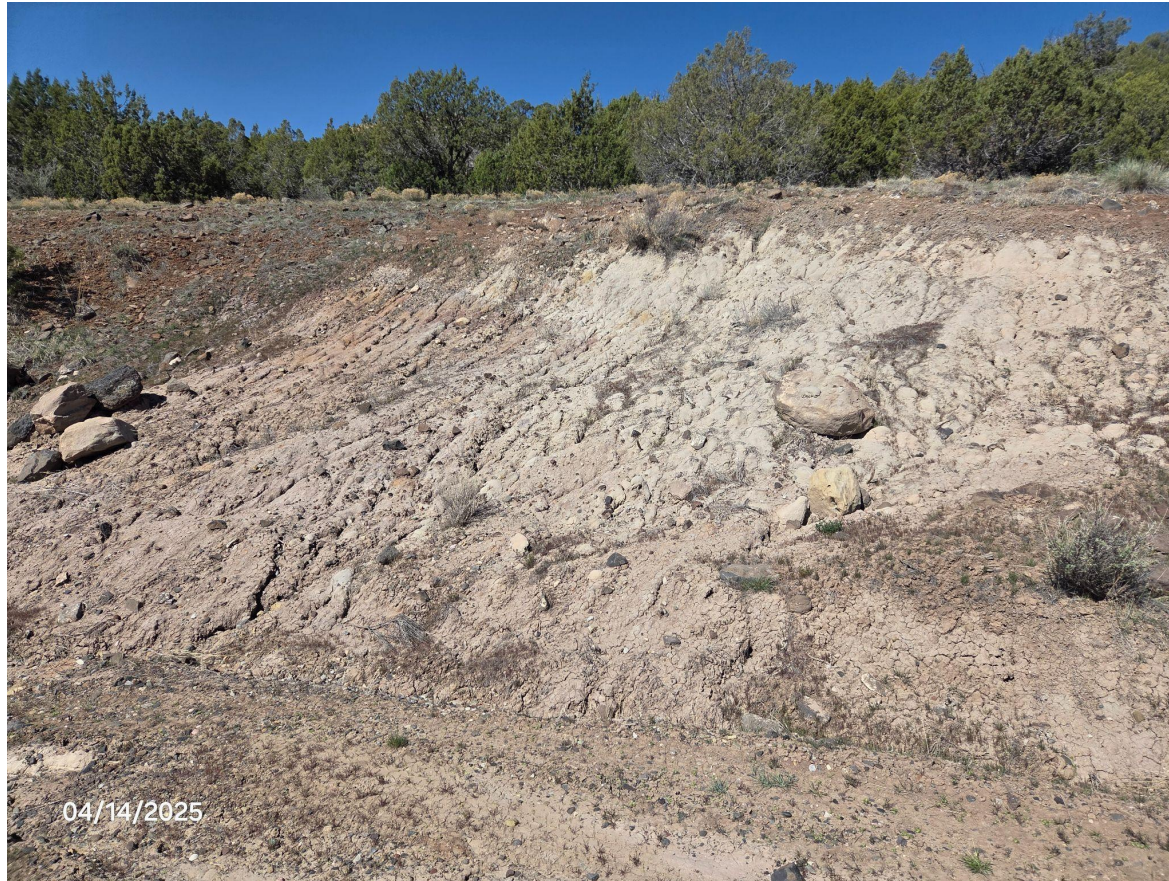
Photo 19: Photos taken from the cut slopes/access road on the west end of the Location facing west. Location has not been recontoured/regraded and reclaimed. Photos also show stormwater management, including BMPs to minimize erosion, degradation and sediment transport remain missing or insufficient - erosion, degradation and sediment transport have persisted throughout the Location.

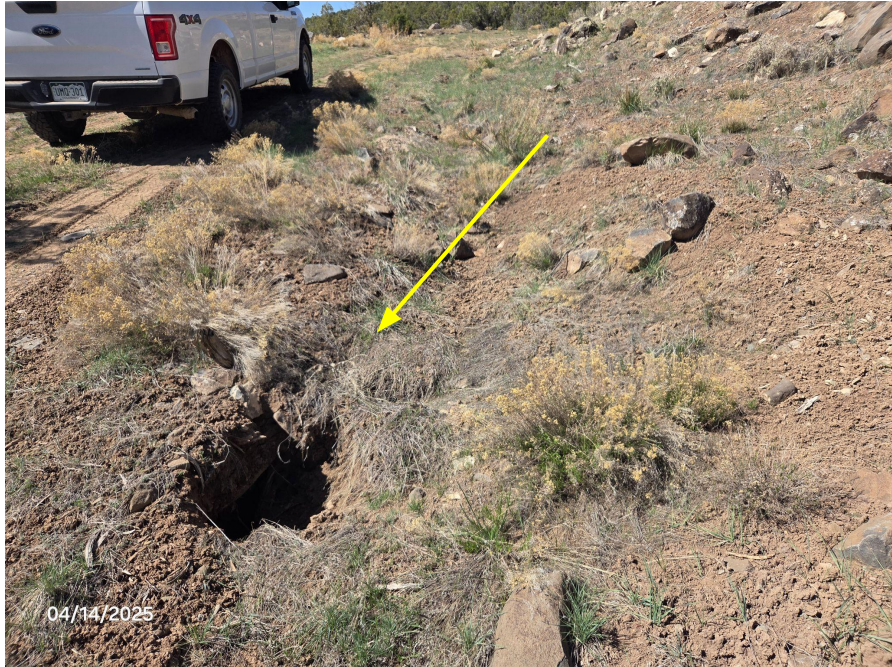
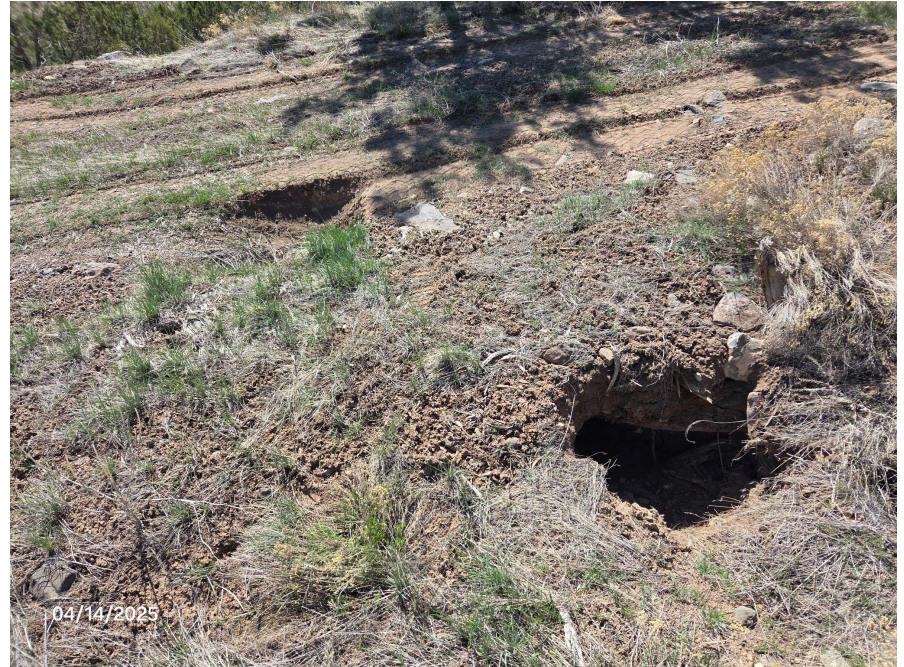
Photo 20: Photos taken from the access road west of the Location. Photos show stormwater along the access road has created sinkholes, resulting in stormwater travelling and eroding subsurface areas of the access road.

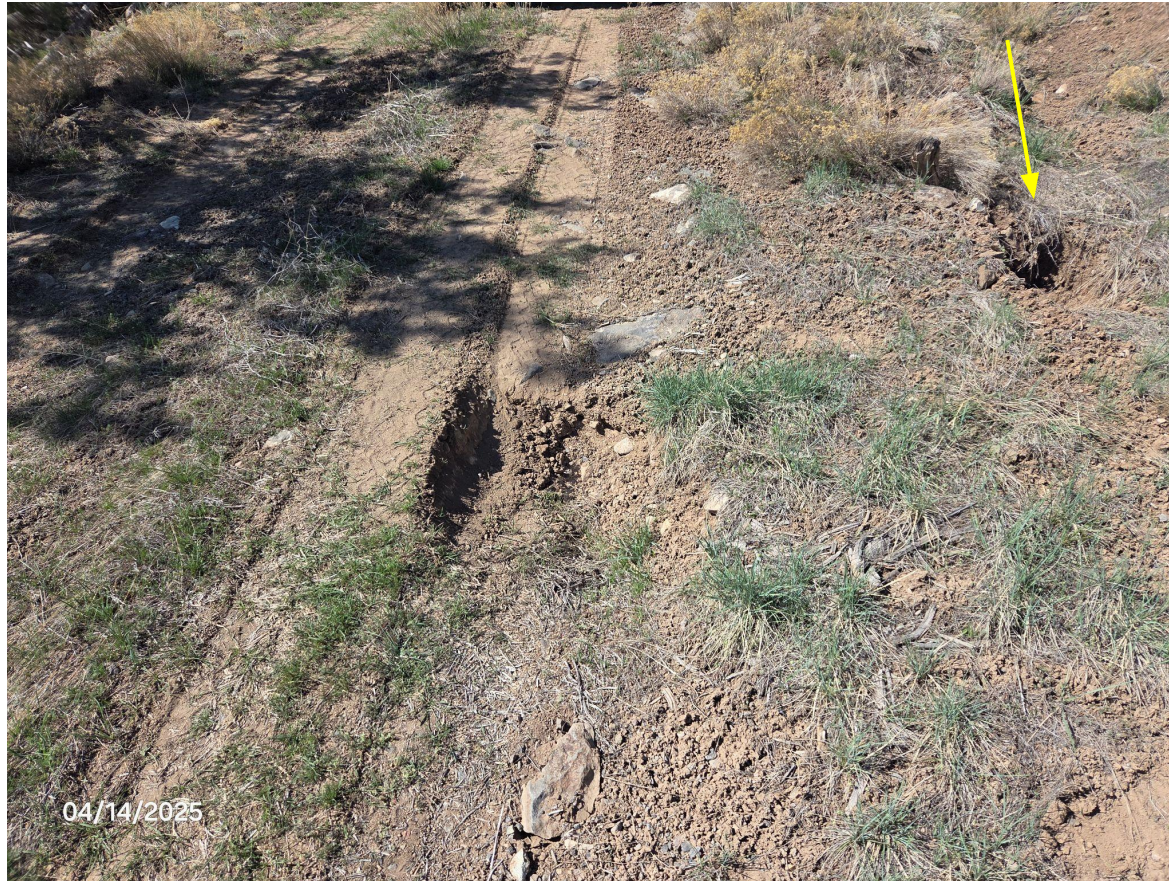
Photo 21: Continued from photo 20. Photo shows subsidence issues observed along the access road. Stormwater is traveling from the ditch into a sink, and continuing subsurface.

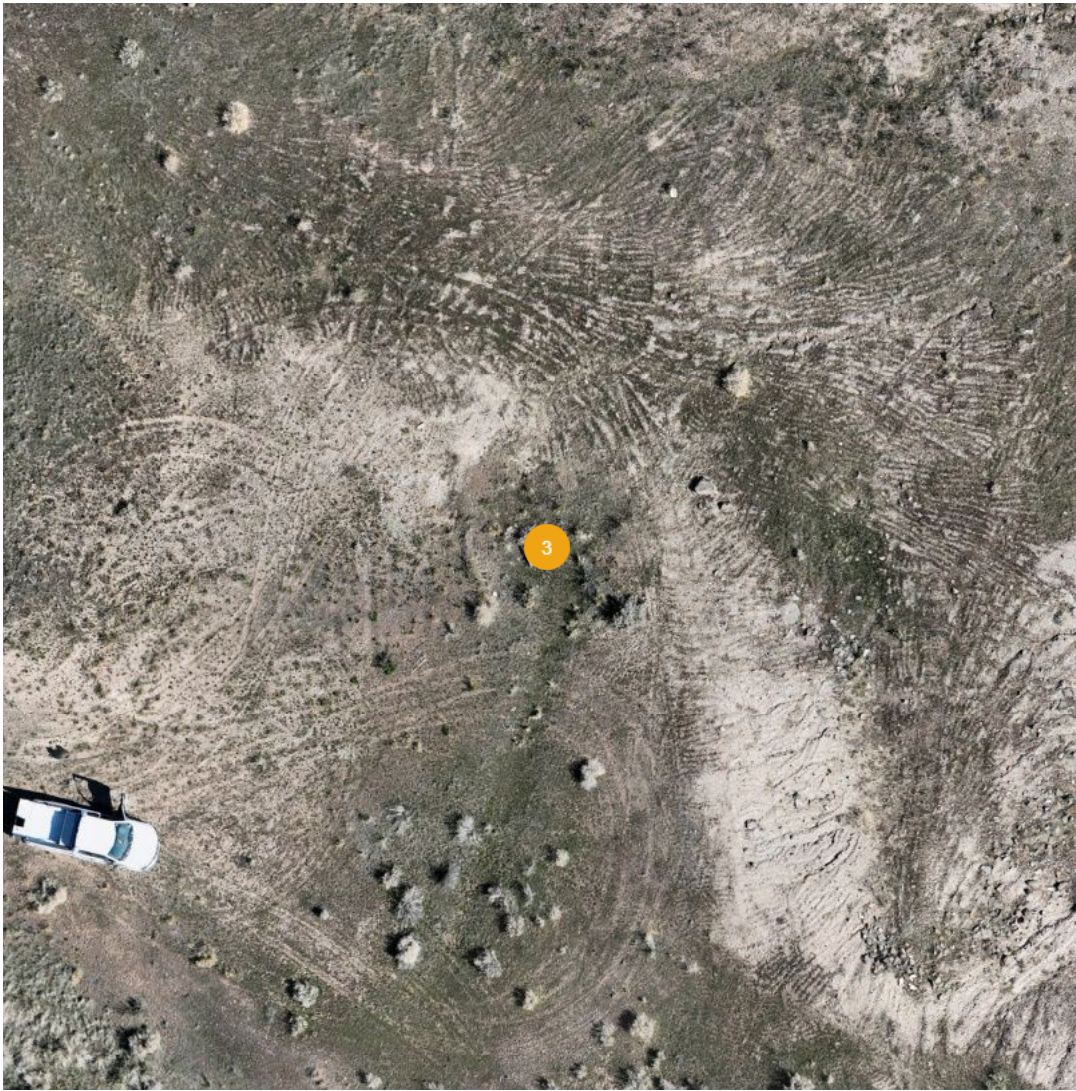
3 - Observation

Summary:	Marker does not comport with 434.a.(5) requirements
Created:	Apr 23, 2025, 10:56am by Aaron Trujillo
Cost of Repair:	—
Lat/Long:	39.2184914, -108.1646728
Northing:	1515541.9 US ft
Easting:	2245171.6 US ft
Elevation:	-5.16 US ft
NAD83(2011) / Colorado Central (ftUS) (US survey foot)

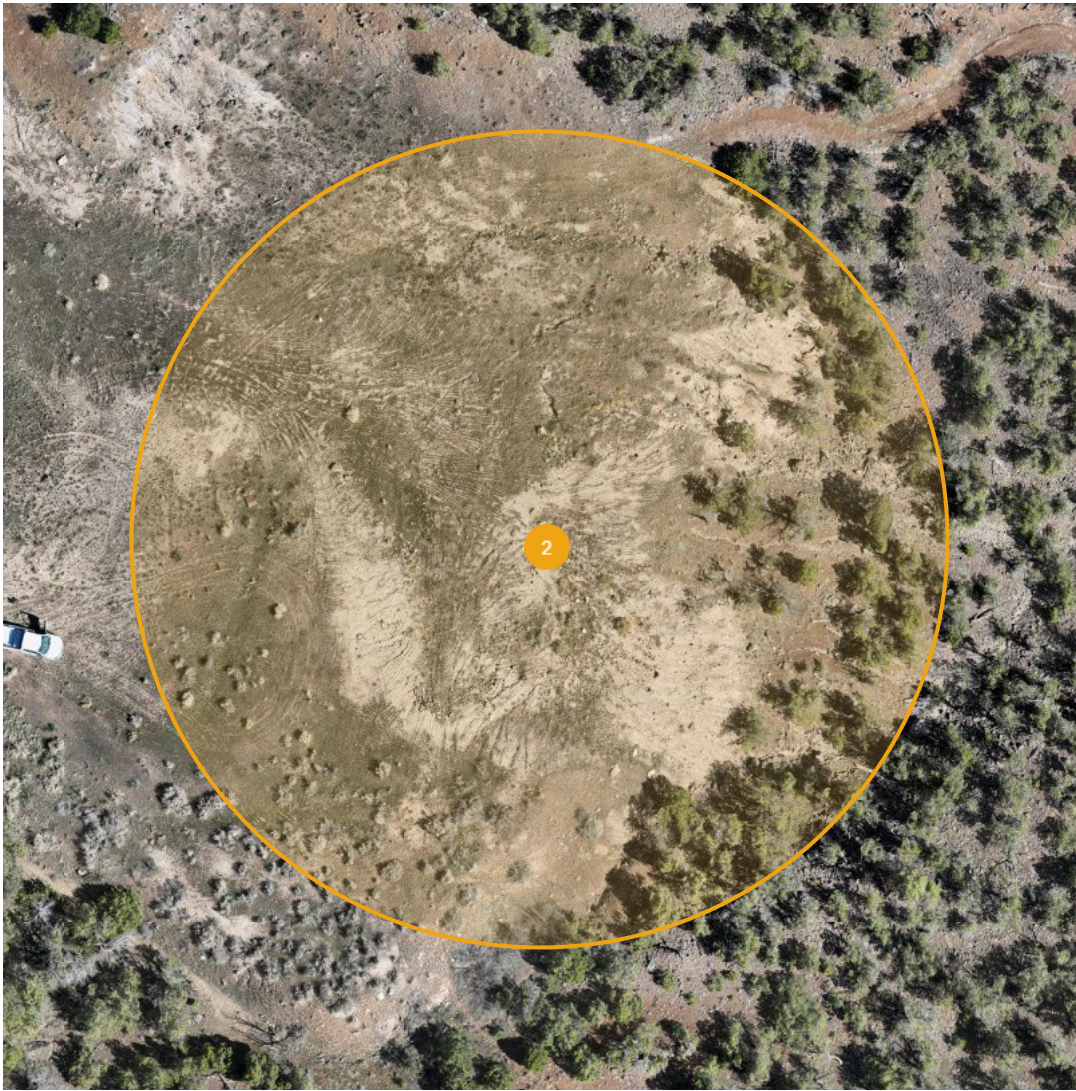
2 - Observation

Summary:	Persisting erosion, degradation and sediment transport throughout Location.
Created:	Apr 23, 2025, 10:56am by Aaron Trujillo
Cost of Repair:	—
Lat/Long:	39.21846, -108.16438
Area:	0.97 acres
Radius:	116.07 ft
Perimeter:	729.29 ft

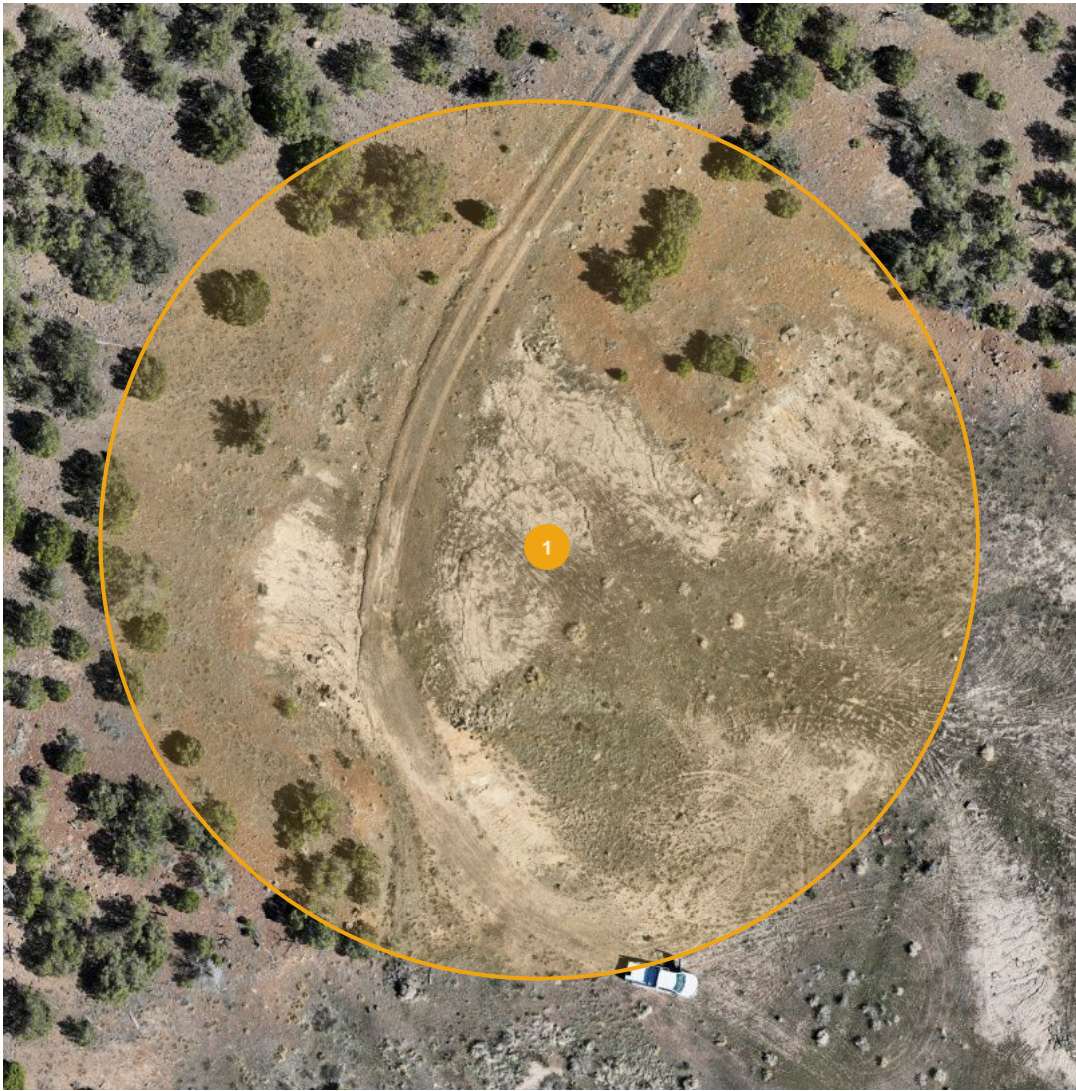
1 - Observation

Summary:	Persisting erosion, degradation and sediment transport throughout Location.
Created:	Apr 23, 2025, 10:55am by Aaron Trujillo
Cost of Repair:	—
Lat/Long:	39.21872, -108.16502
Area:	1.12 acres
Radius:	124.79 ft
Perimeter:	784.06 ft
