Inspection/Audit Photos
Location Name: QB Energy DUNN 32-16 (P32) Pad
Location ID: 334836

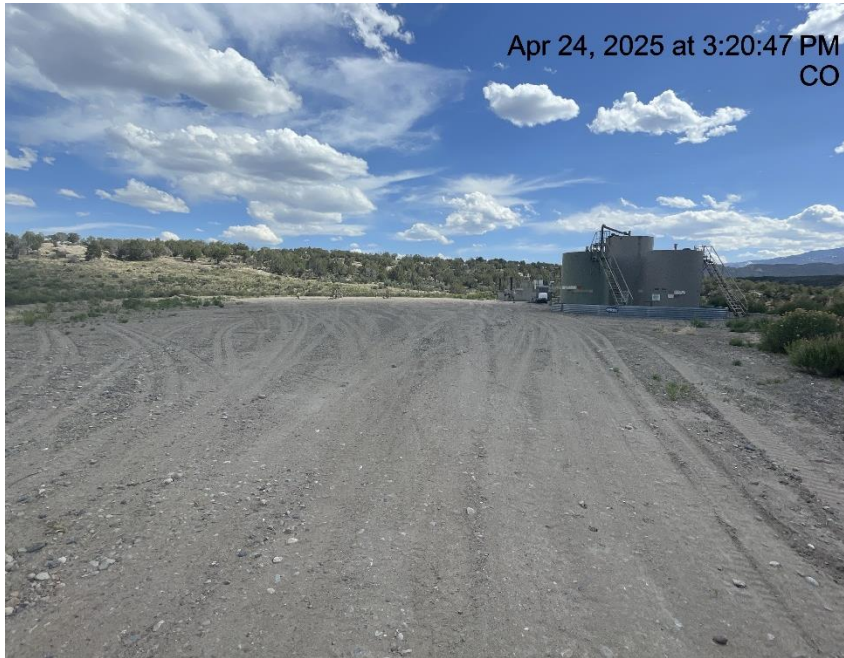
Photo # 6244 From entrance to location

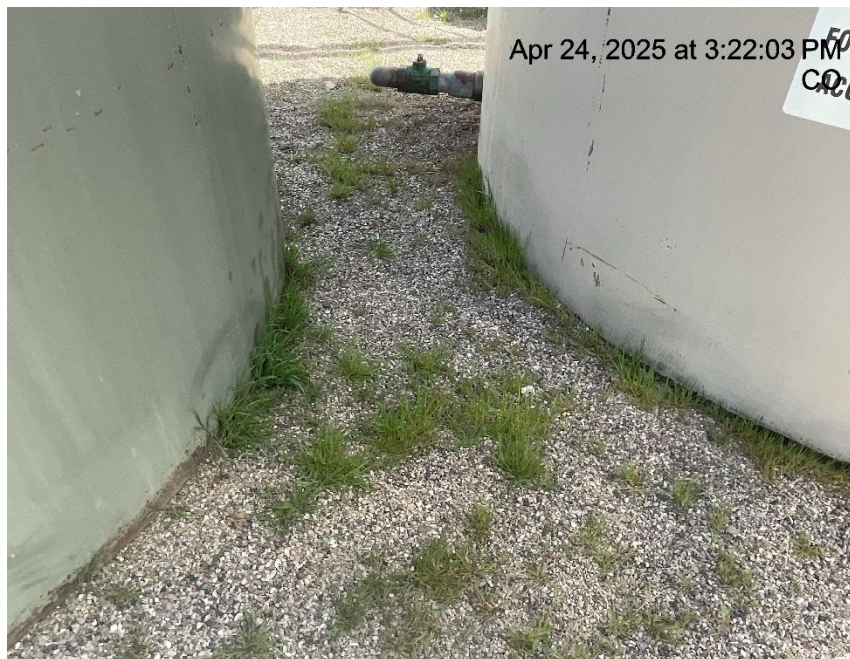
Photo # 6252 Weeds in secondary containment

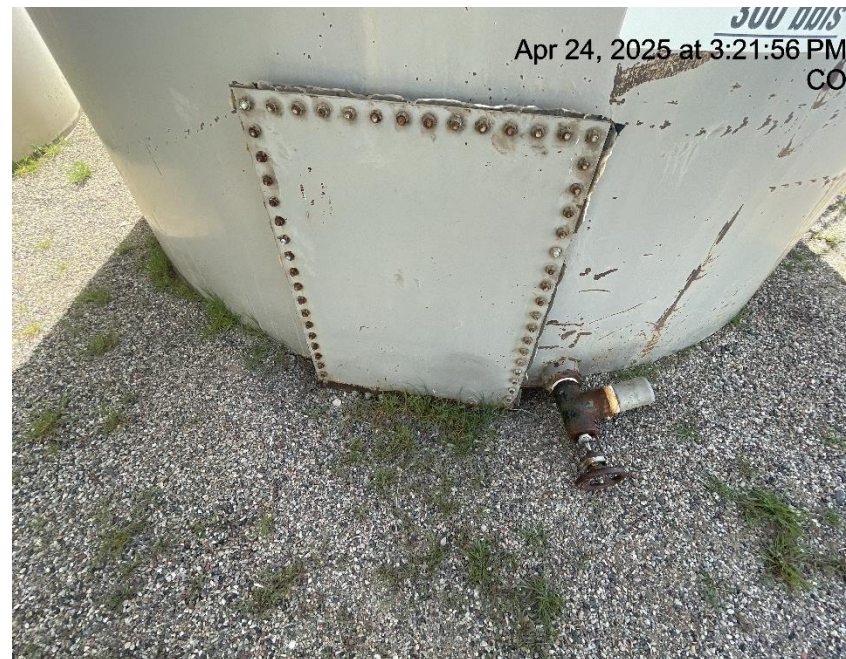
Photo # 6253 Weeds in secondary containment

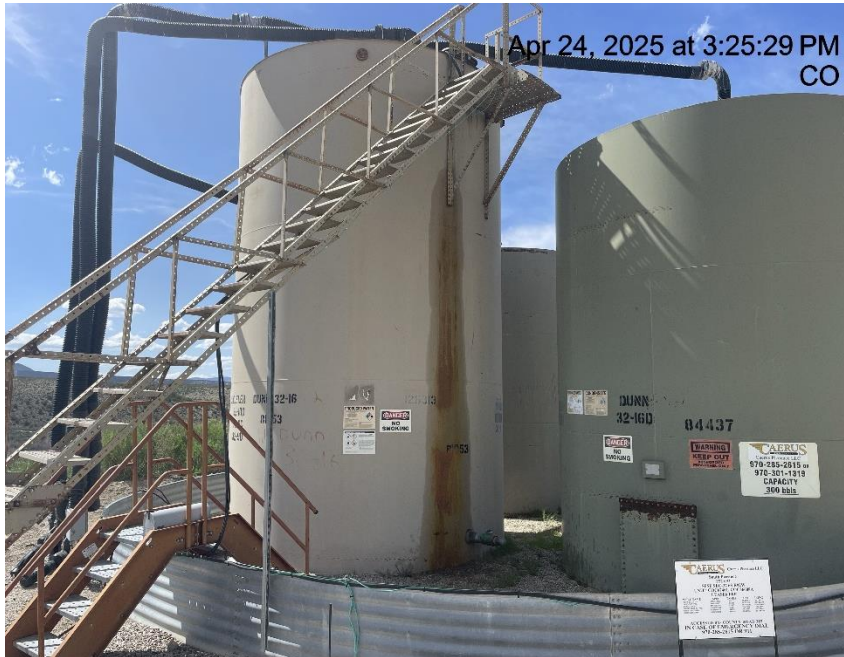
Photo # 6254 Possible tank failure - Suspected leak on production tank/tank appears to lack integrity

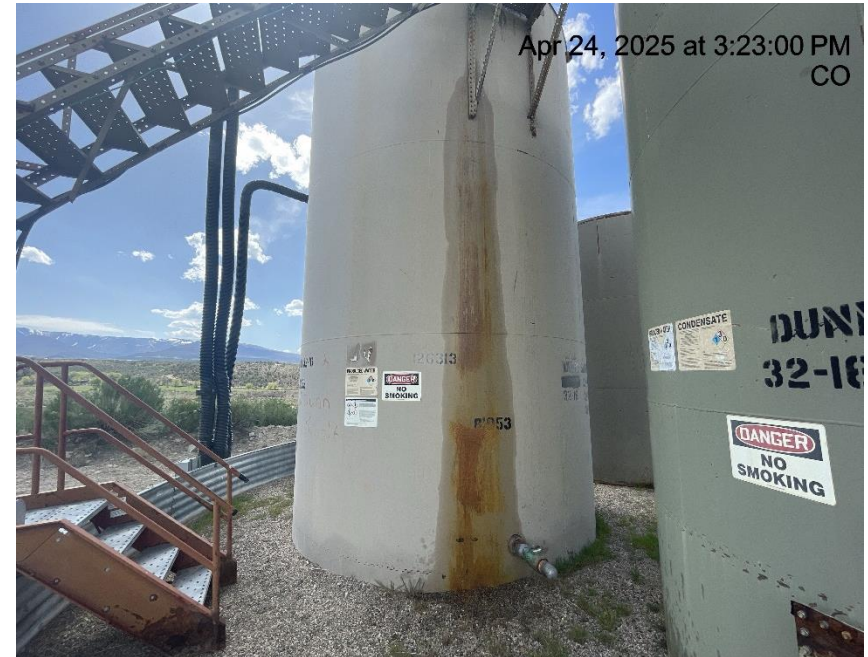
Photo # 6255 Possible tank failure - Suspected leak on production tank/tank appears to lack integrity

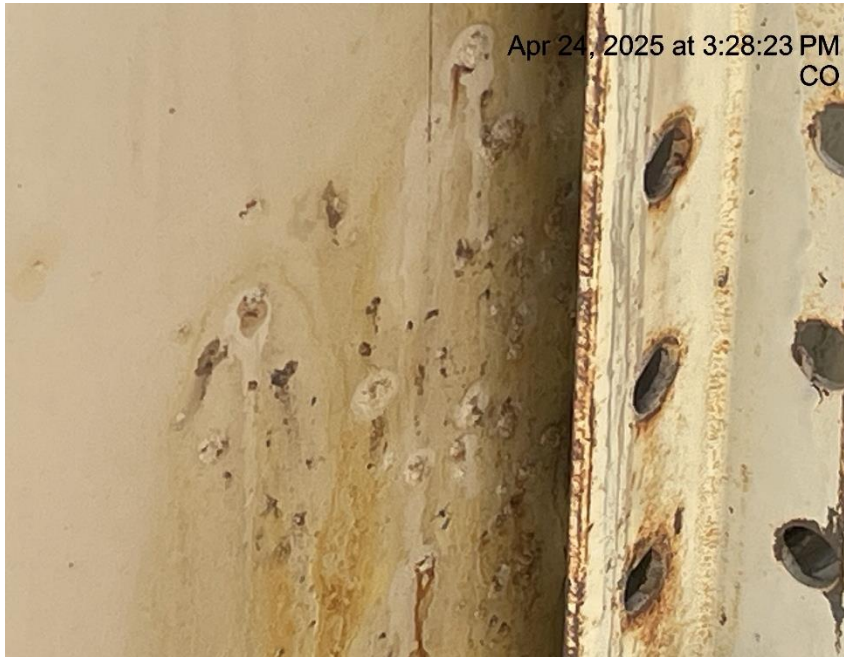
Photo # 6256 Possible tank failure - Suspected leak on production tank/tank appears to lack integrity

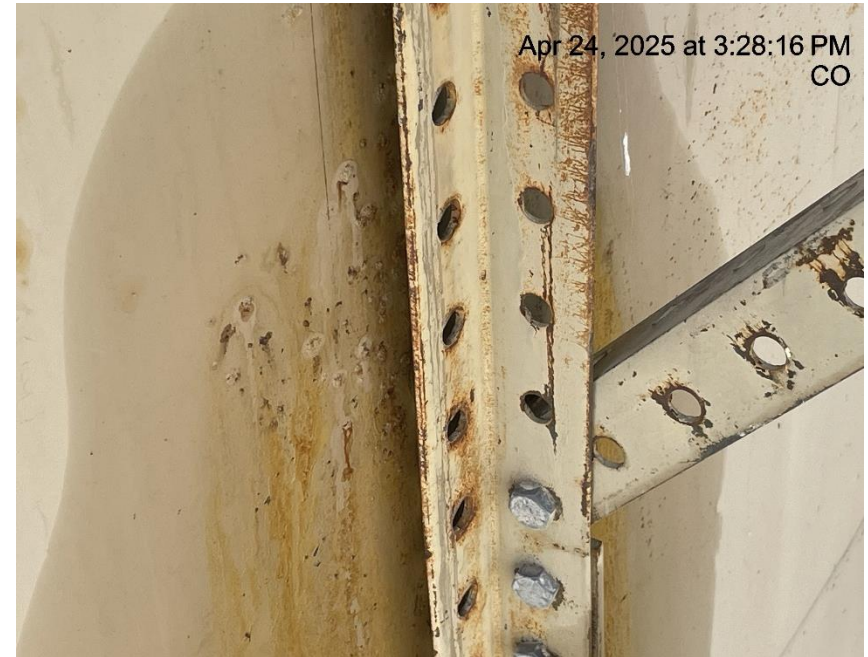
Photo # 6257 Possible tank failure - Suspected leak on production tank/tank appears to lack integrity

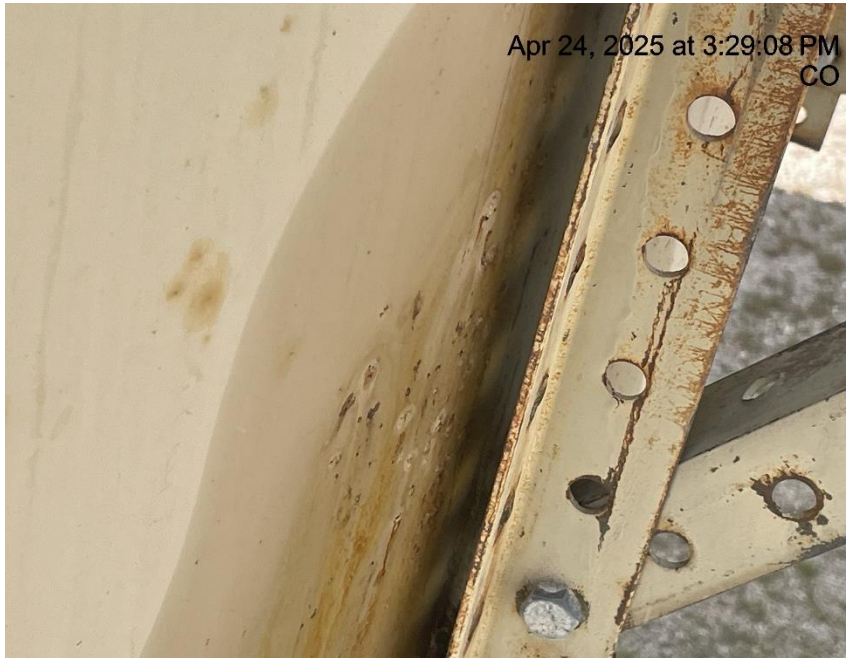
Photo # 6258 Possible tank failure - Suspected leak on production tank/tank appears to lack integrity

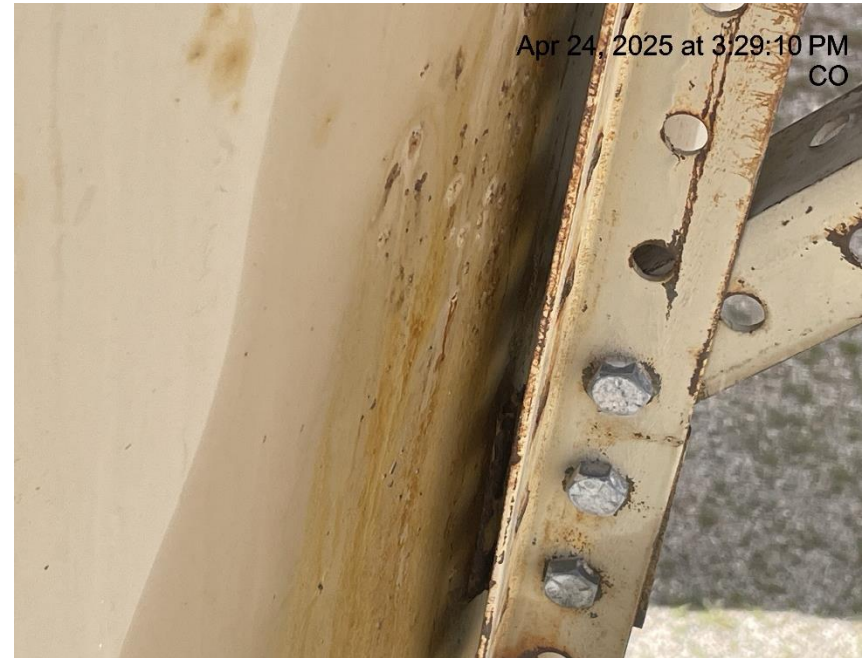
Photo # 6259 Possible tank failure - Suspected leak on production tank/tank appears to lack integrity

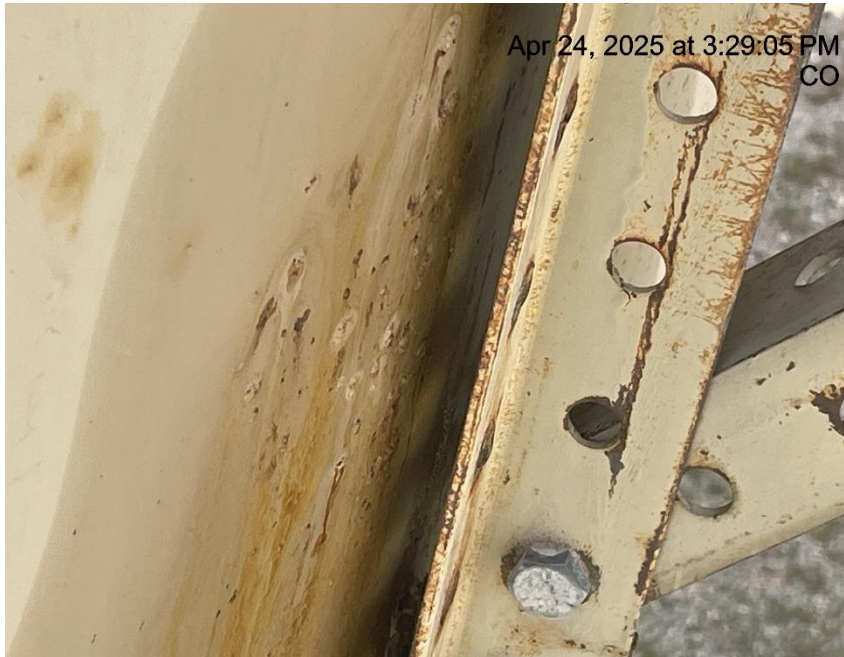
Photo # 6260 Possible tank failure - Suspected leak on production tank/tank appears to lack integrity

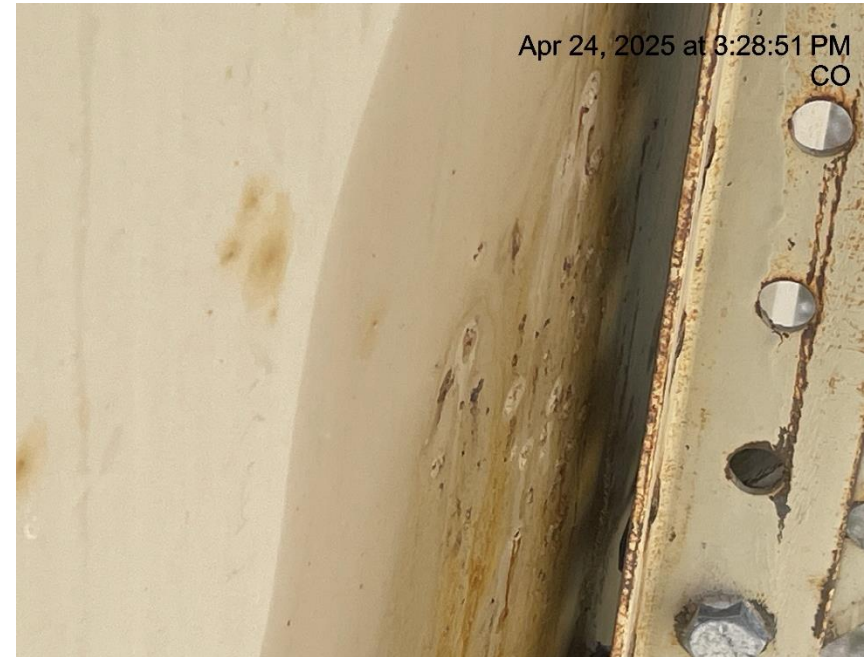
Photo # 6261 Possible tank failure - Suspected leak on production tank/tank appears to lack integrity

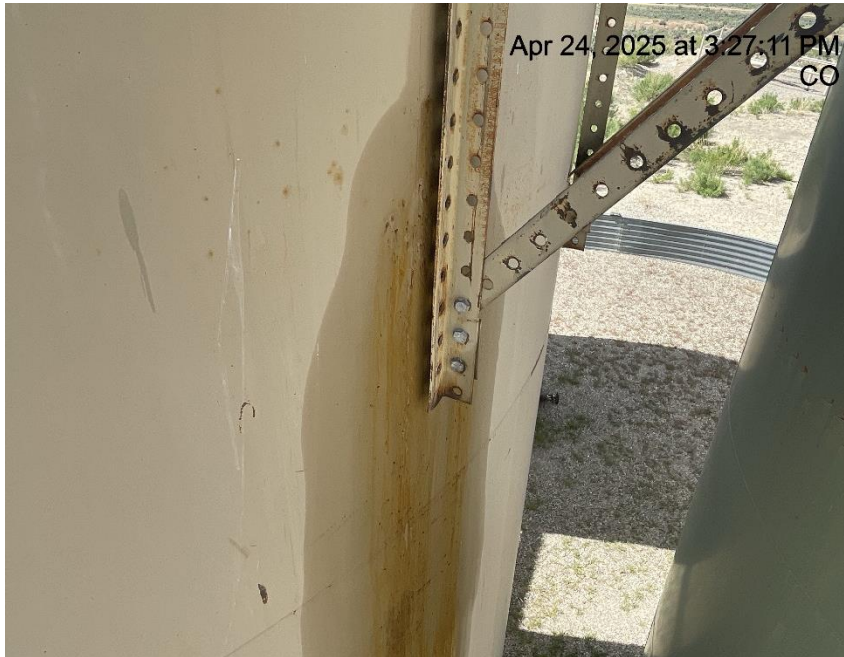
Photo # 6262 Possible tank failure - Suspected leak on production tank/tank appears to lack integrity

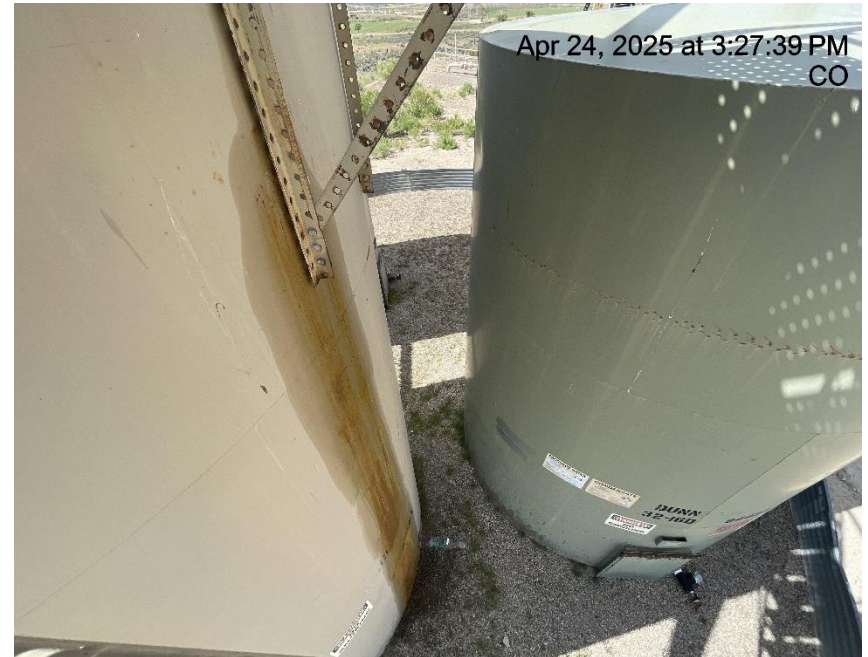
Photo # 6263 Possible tank failure - Suspected leak on production tank/tank appears to lack integrity

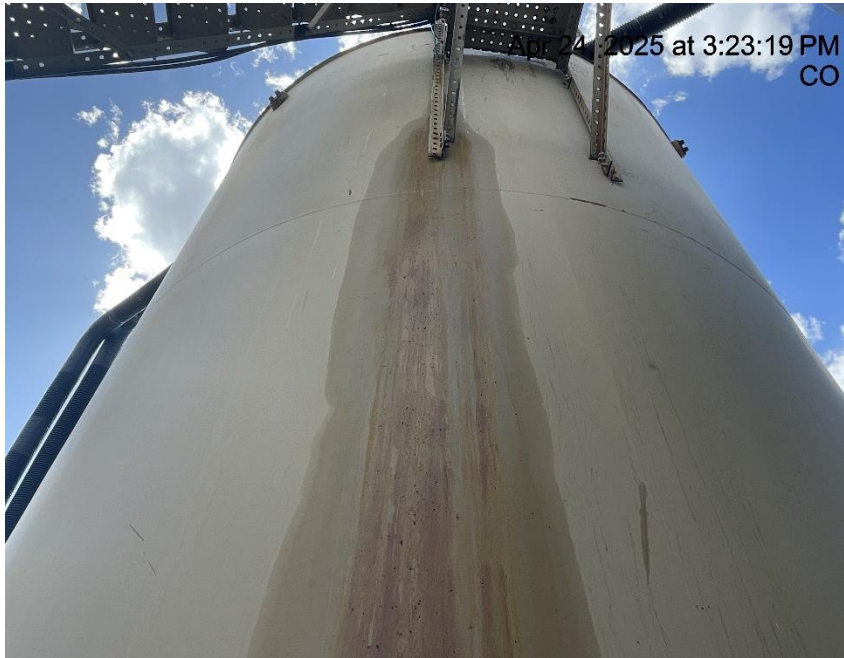
Photo # 6264 Possible tank failure - Suspected leak on production tank/tank appears to lack integrity

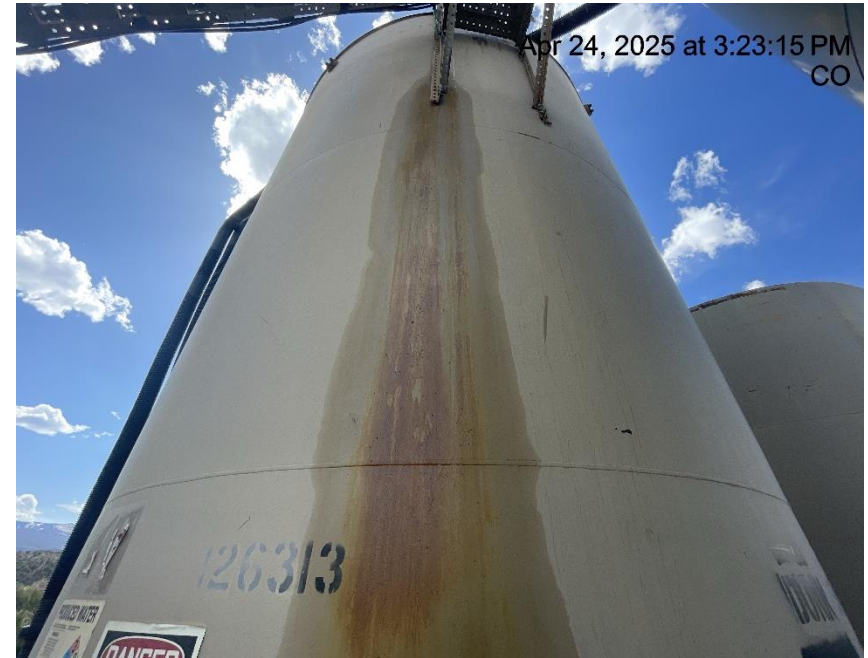
Photo # 6265 Possible tank failure - Suspected leak on production tank/tank appears to lack integrity

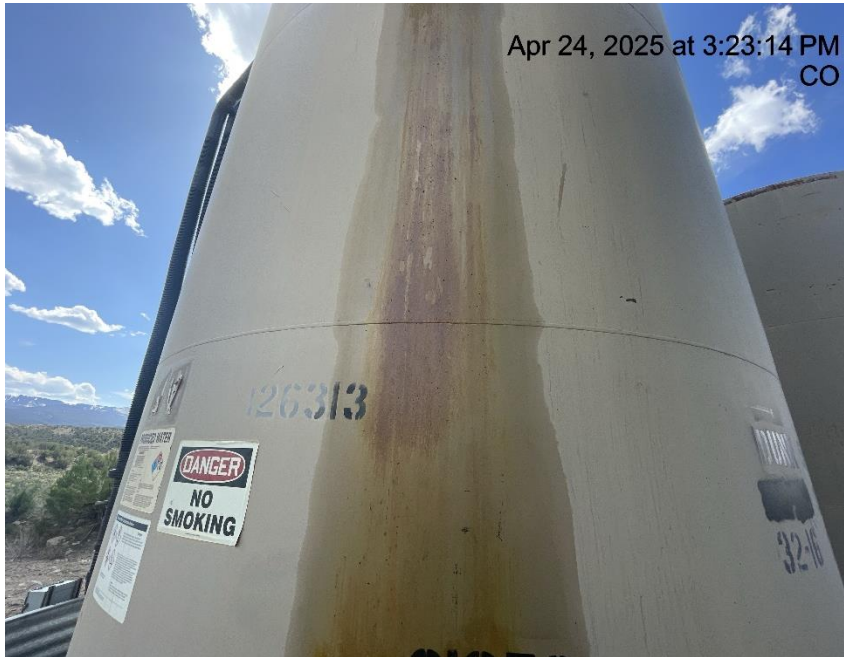
Photo # 6266 Possible tank failure - Suspected leak on production tank/tank appears to lack integrity

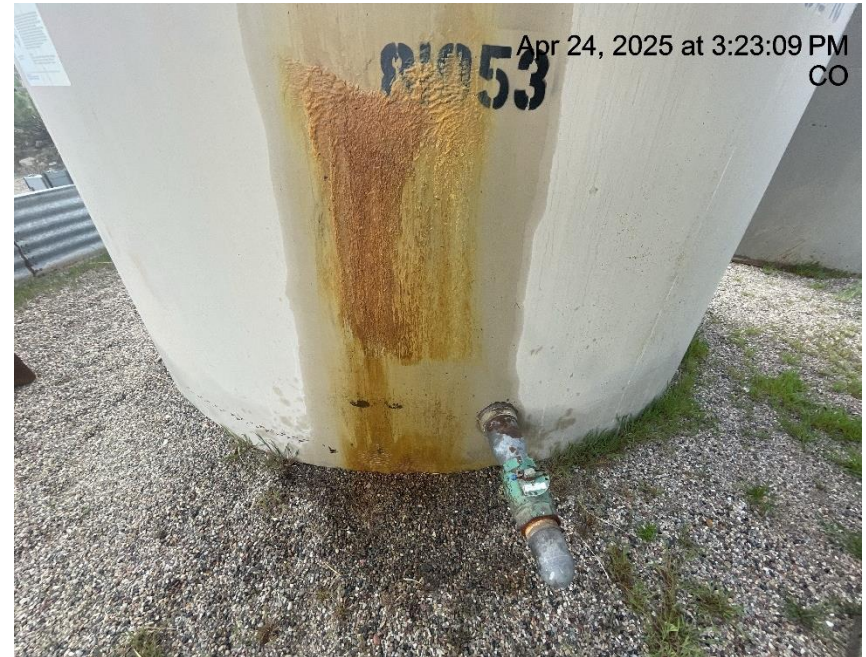
Photo # 6267 Possible tank failure - Suspected leak on production tank/tank appears to lack integrity
