Inspection/Audit Photos

Location Name: QB Energy SHIDELER 33-4D (E33NE) Pad

Location ID: 335019

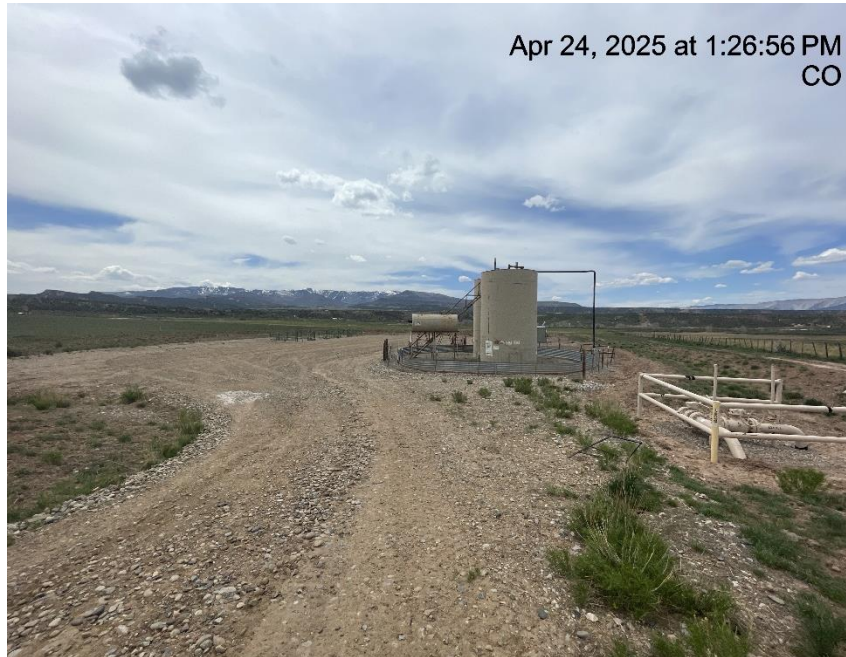
Photo # 5664 From entrance to location

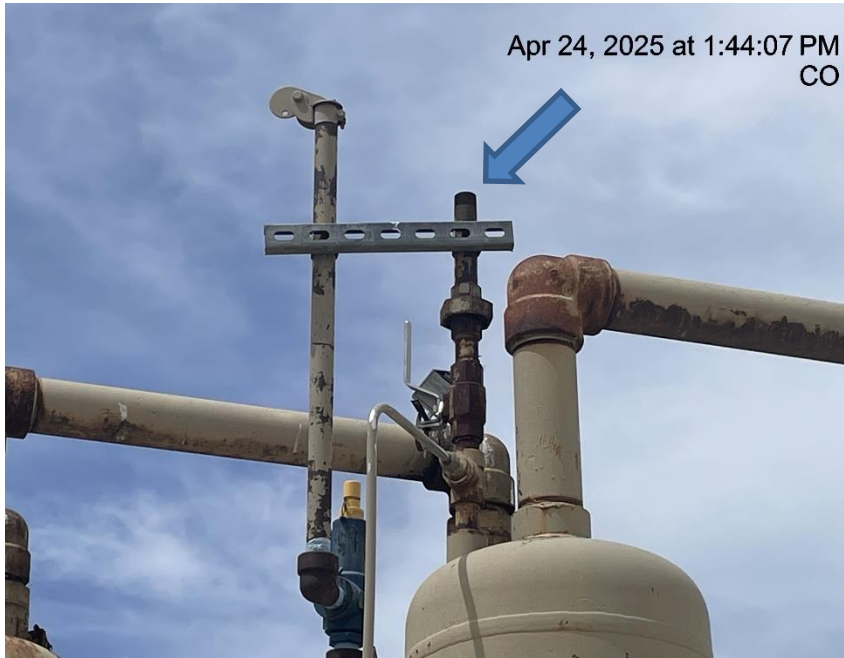
Photo # 5670 Rupture disc vent line does not comply with CECMC pressure safety device rules

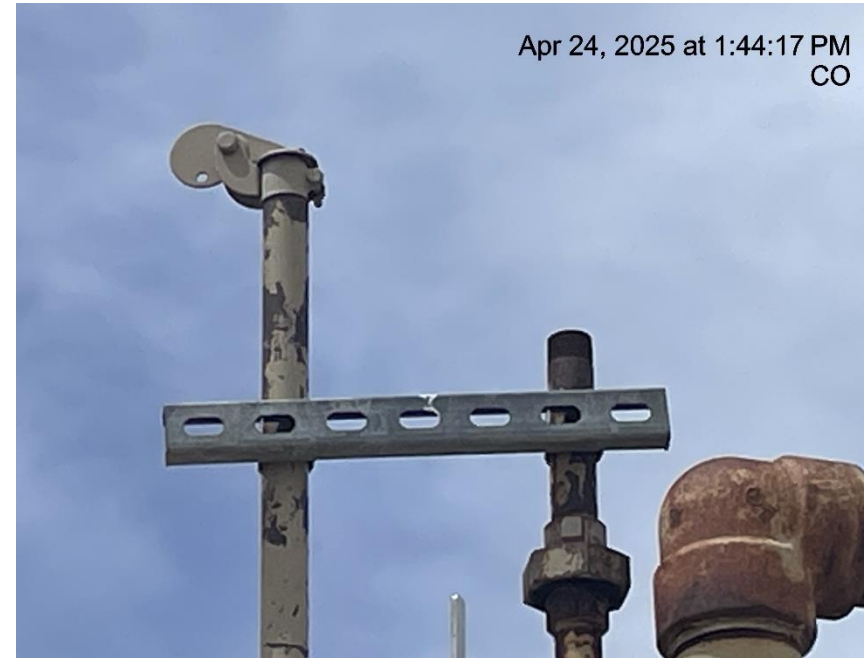
Photo # 5671 Rupture disc vent line does not comply with CECMC pressure safety device rules

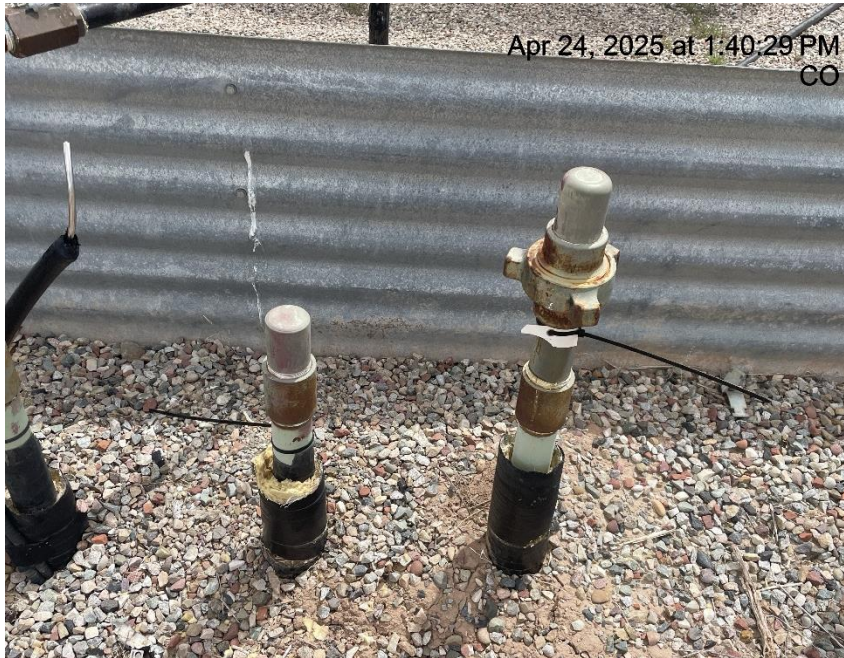
Photo # 5672 Unused flowlines lack lockout tagout (OOSLAT)

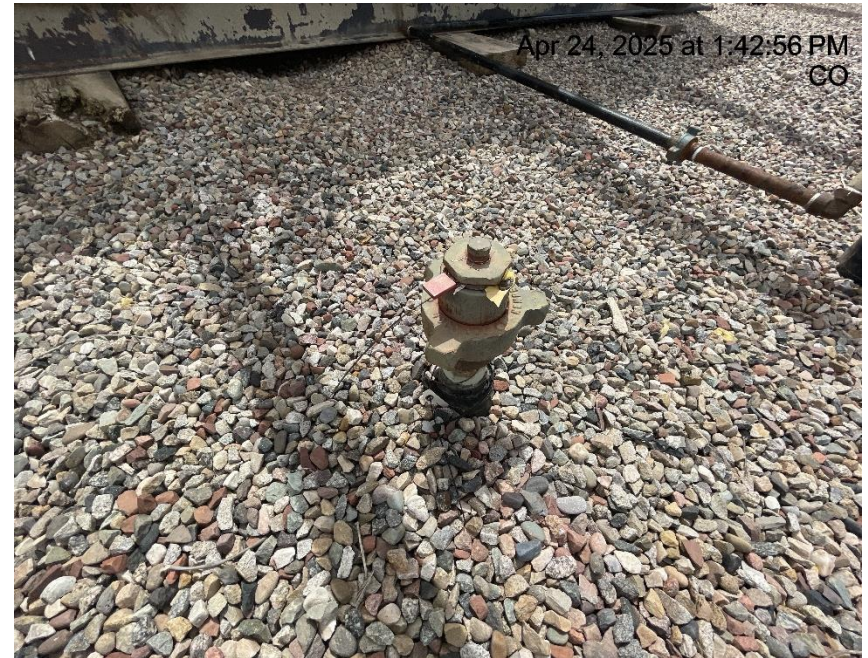
Photo # 5673 Unused flowline lacks lockout tagout (OOSLAT)

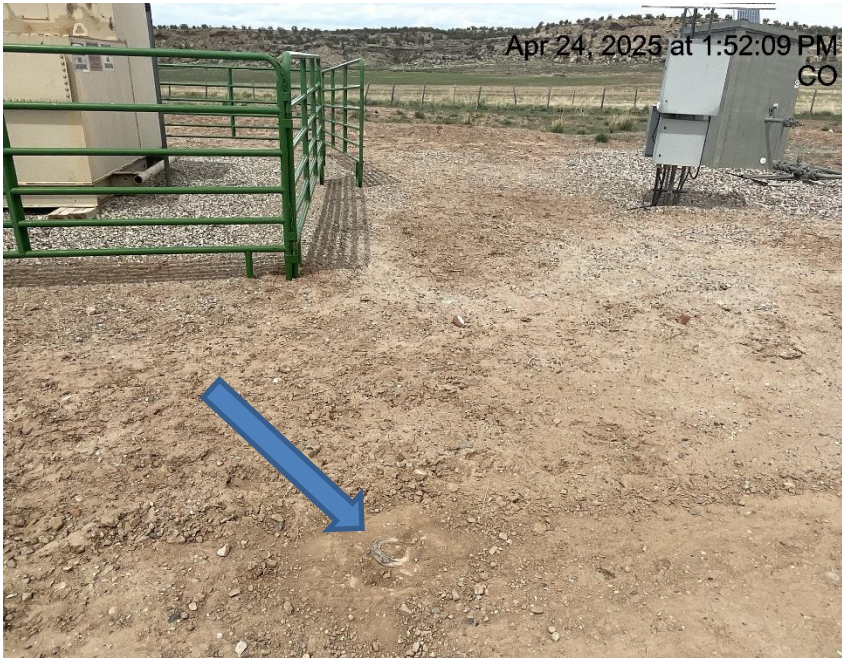
Photo # 5674 Unmarked deadman

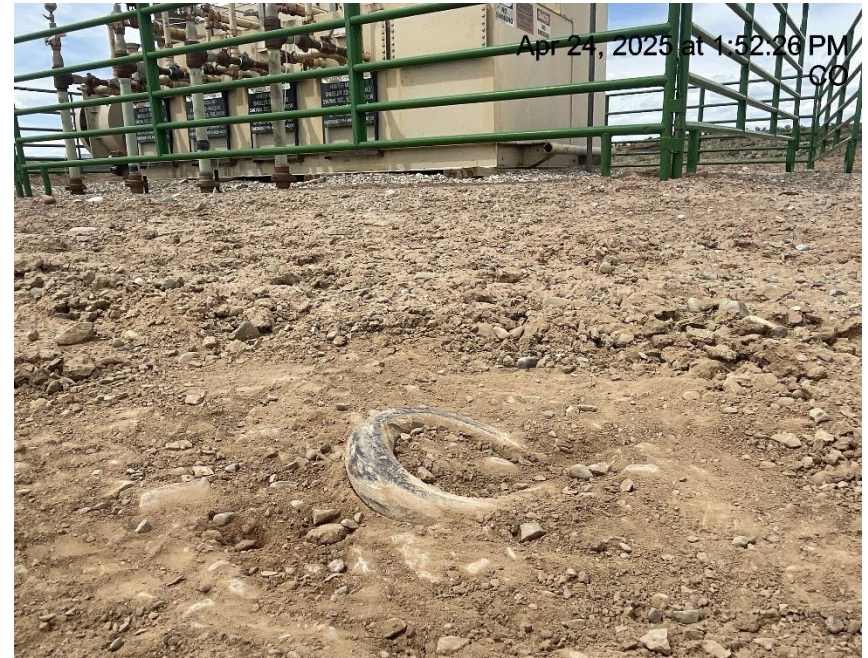
Photo # 5675 Same unmarked deadman

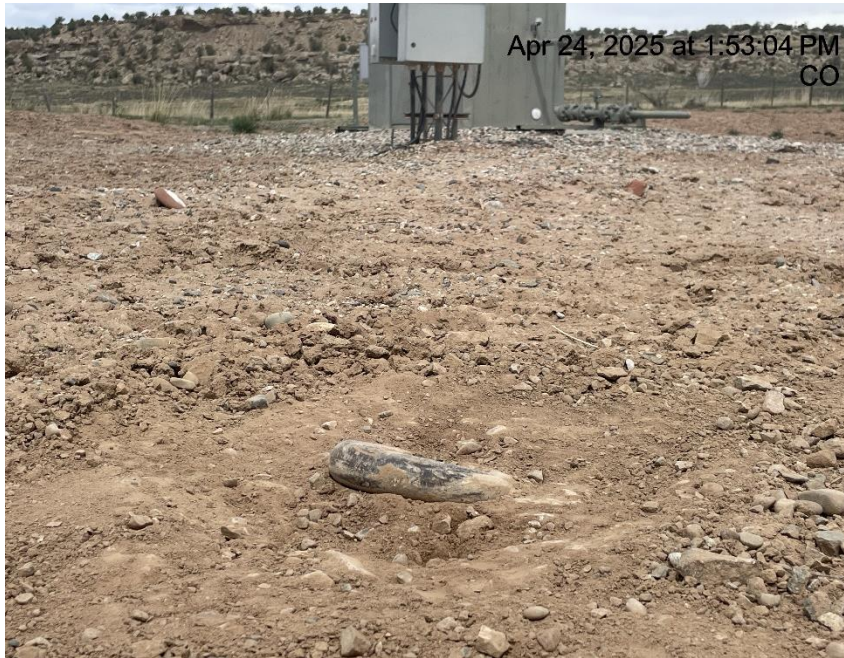
Photo # 5676 Same unmarked deadman from a different angle

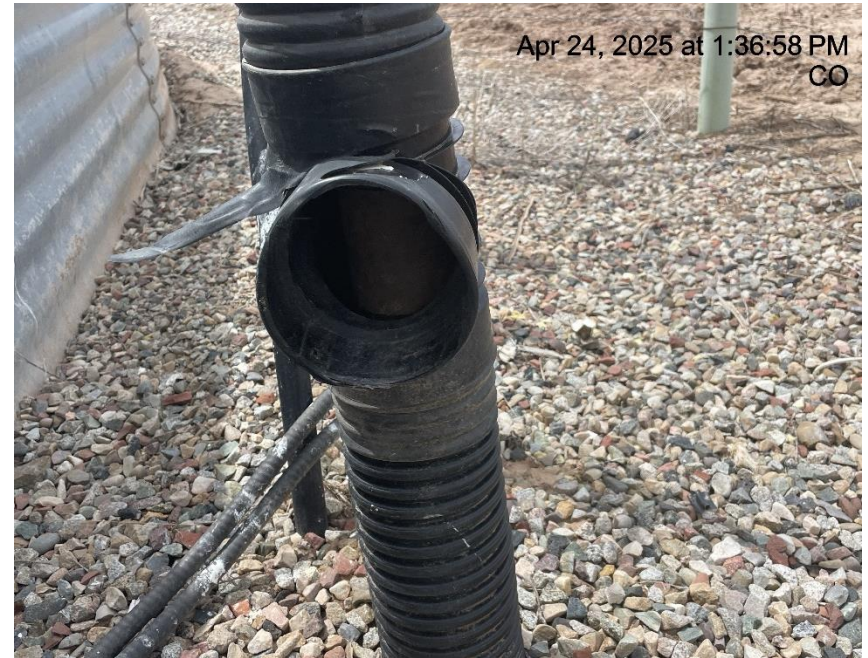
Photo # 5677 Flowline heating insulation open ended /wildlife hazard/available for entry by wildlife

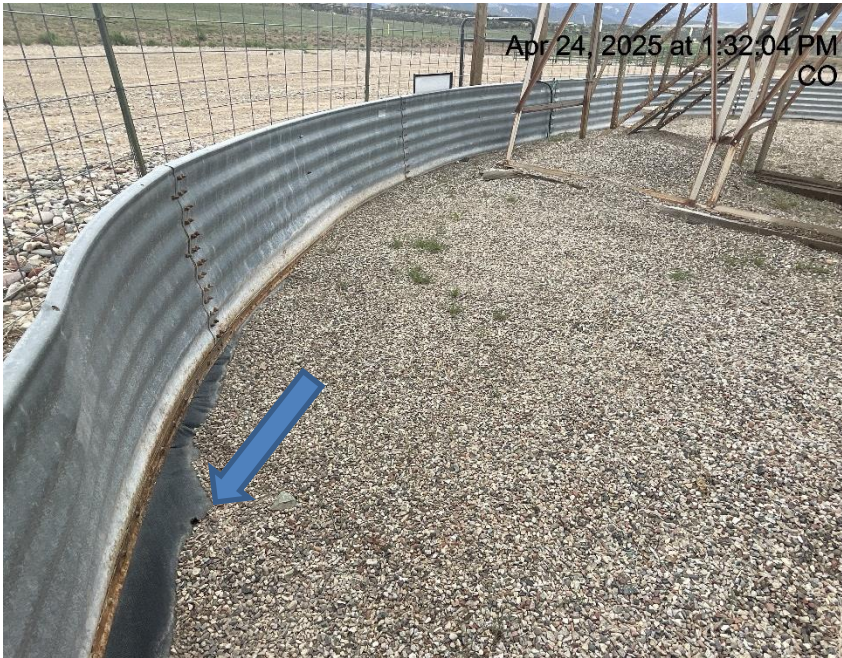
Photo # 5678 Hole in liner/liner needs maintenance

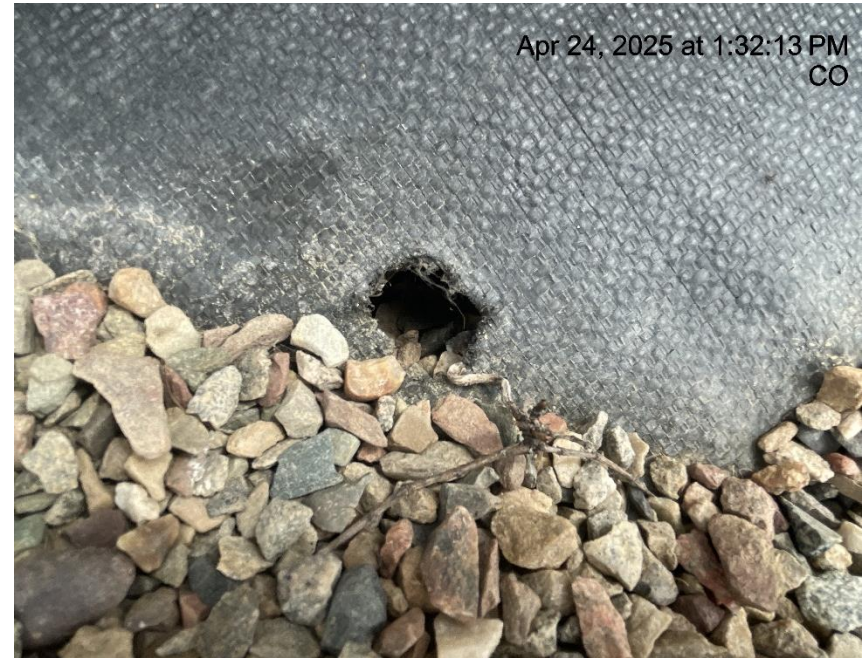
Photo # 5679 Hole in liner/liner needs maintenance

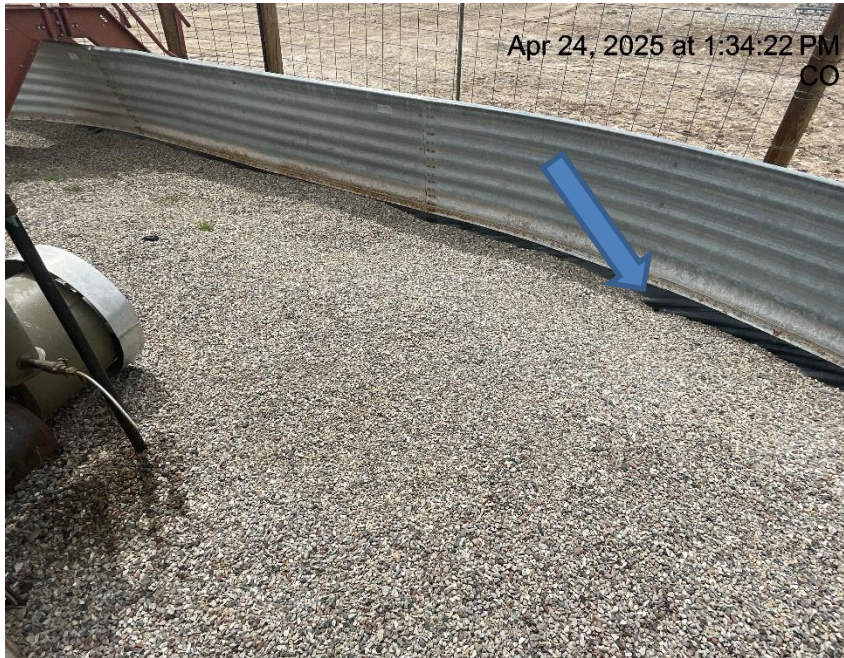
Photo # 5680 Hole in liner/liner needs maintenance

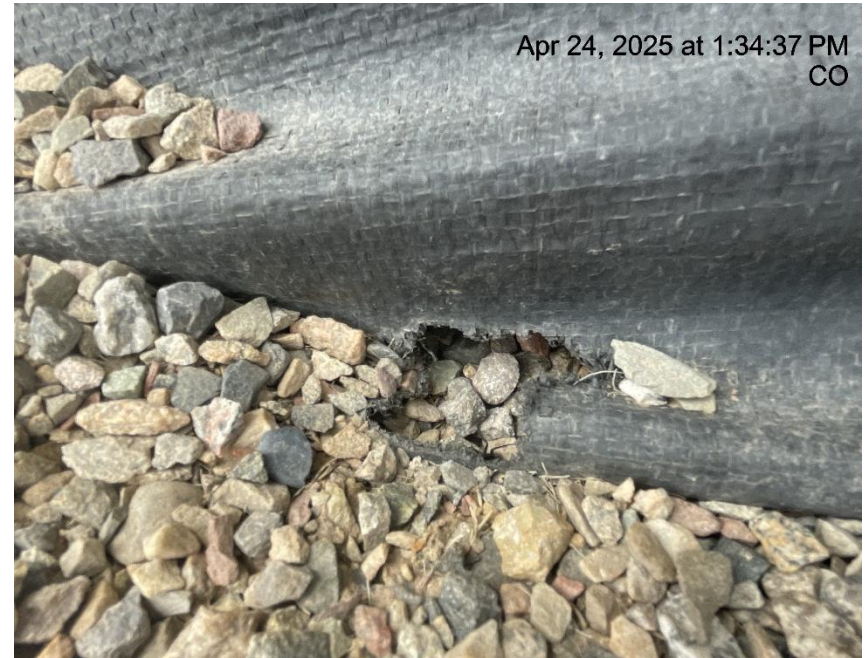
Photo # 5681 Hole in liner/liner needs maintenance

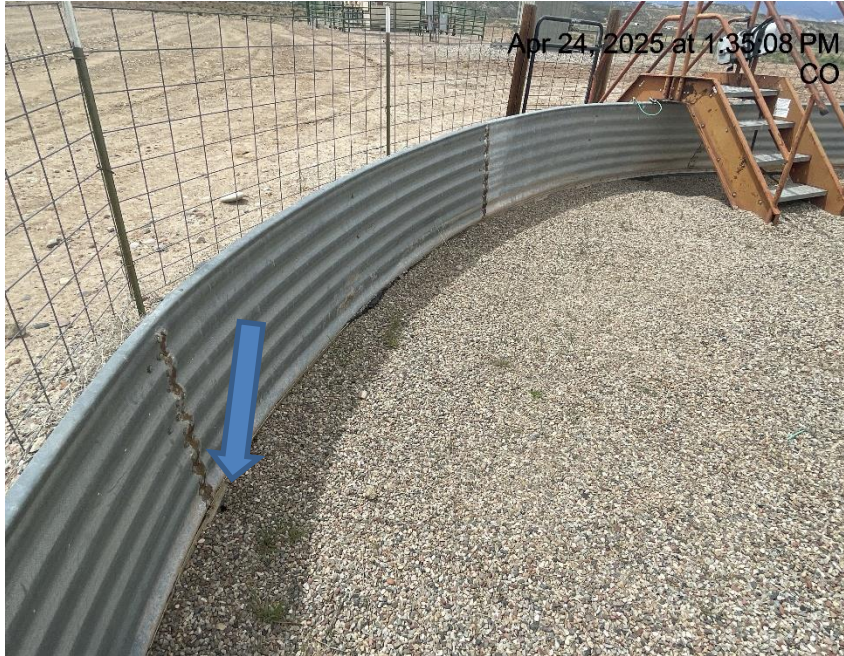
Photo # 5682 Hole in liner/liner needs maintenance

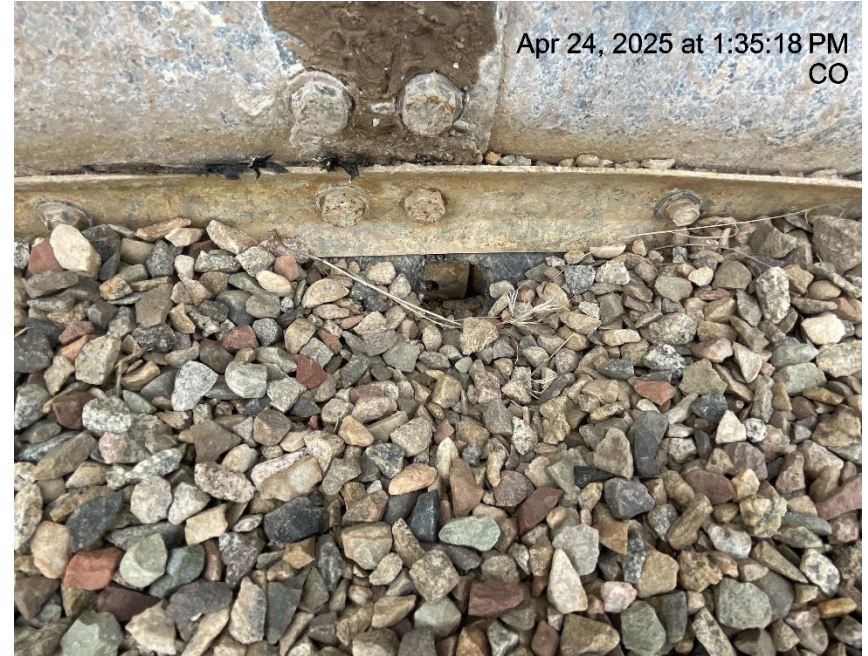
Photo # 5683 Hole in liner/liner needs maintenance

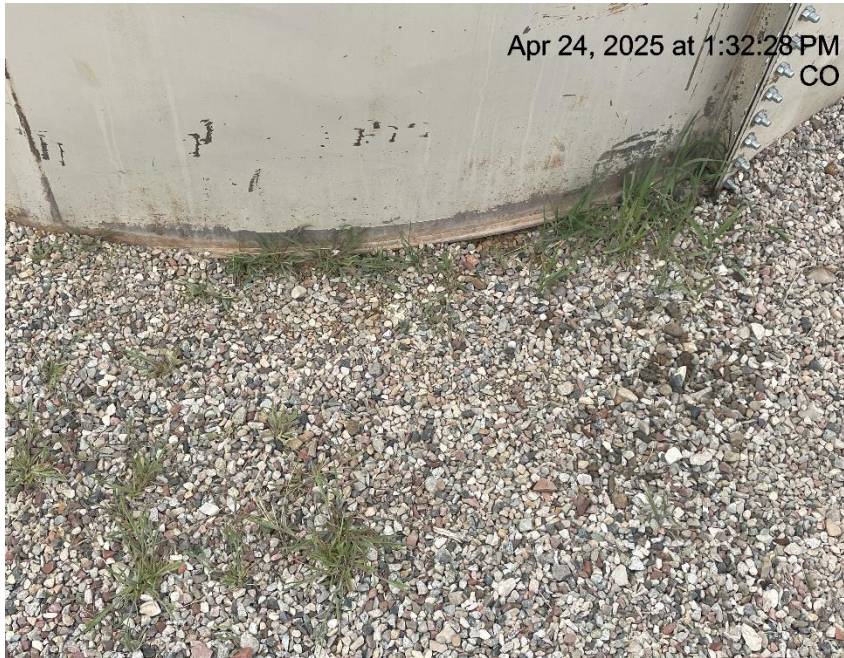
Photo # 5684 Weeds in secondary containment

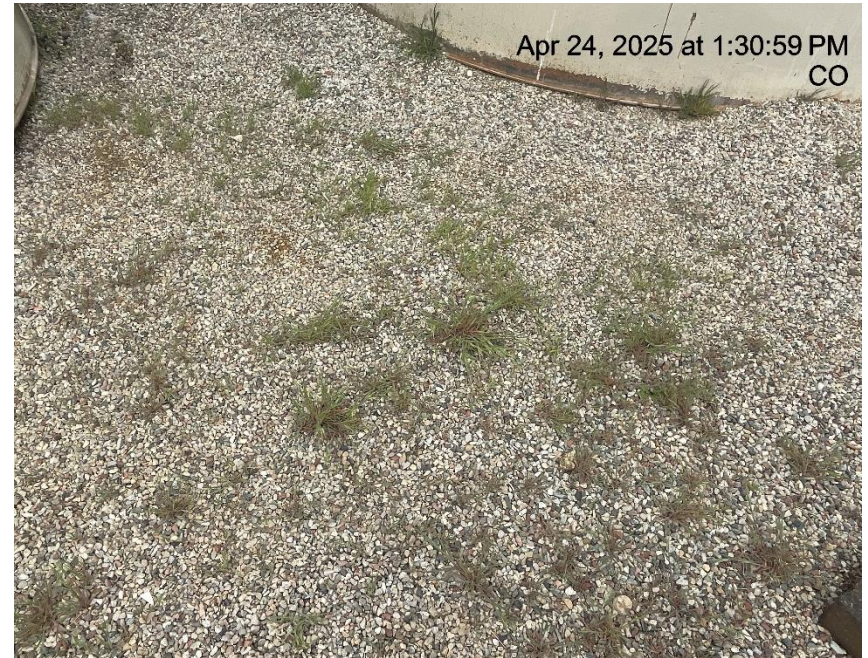
Photo # 5685 Weeds in secondary containment

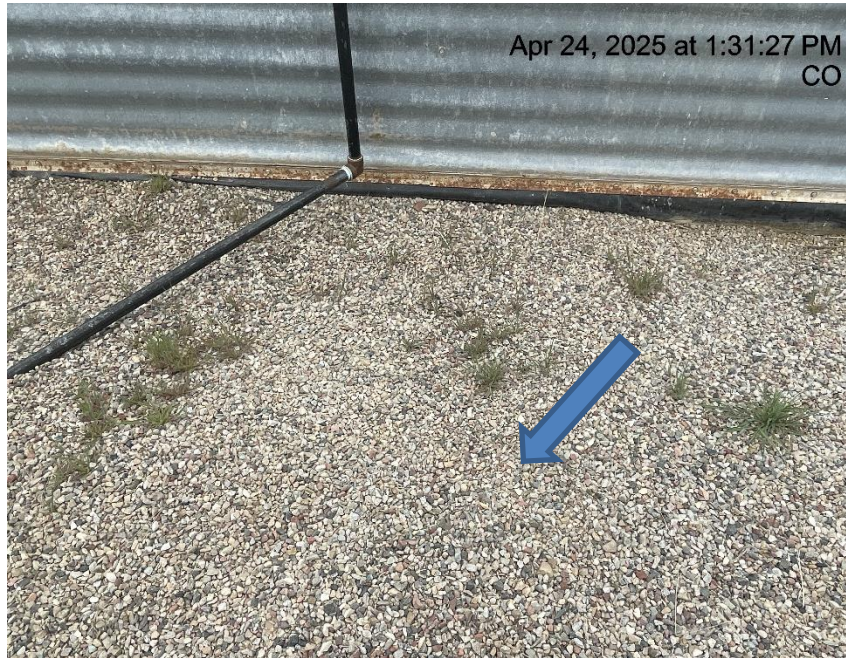
Photo # 5686 Weeds in secondary containment

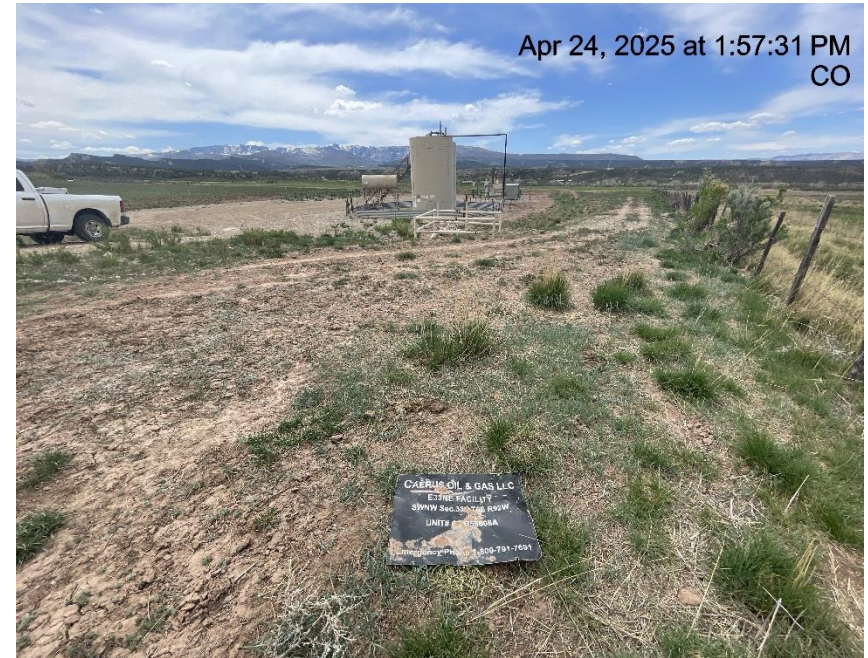
Photo # 5687 Entrance to location sign laying on the ground /not properly posted
