**Robert L Bayless Producer LLC
Weaver Ridge 23-14
Location #316493**

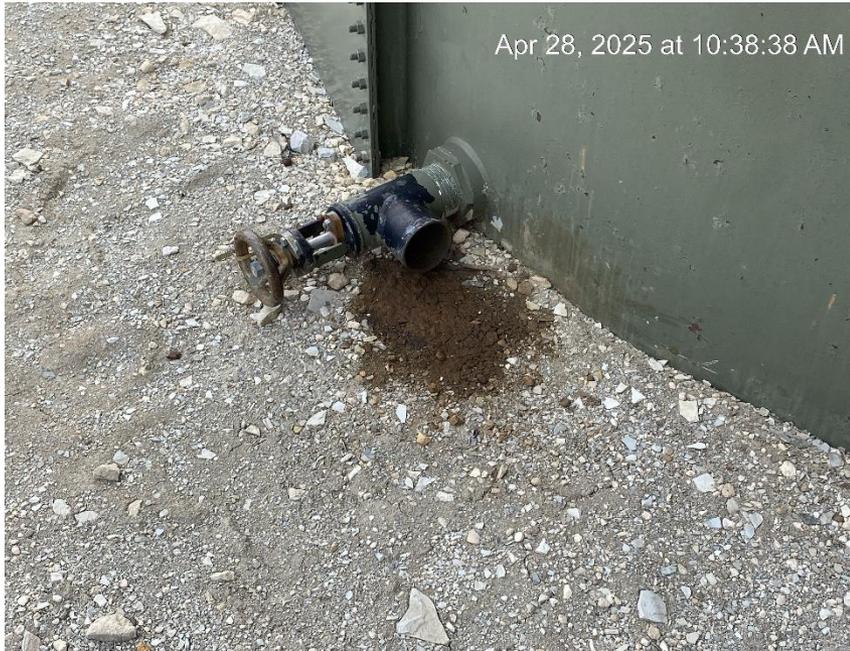
Open end tank valve. Oily waste and stained soil.

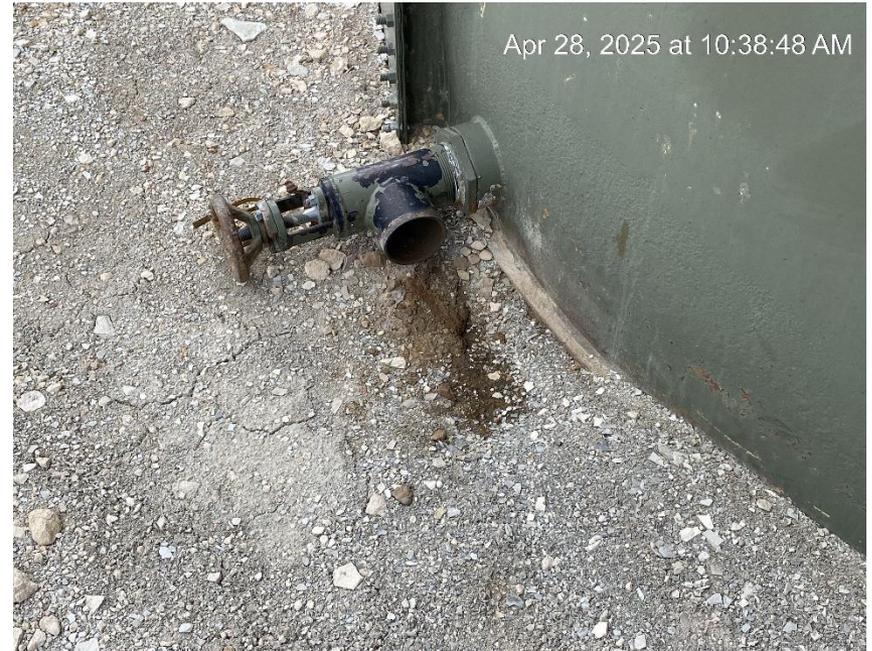
Open end tank valve. Oily waste and stained soil.

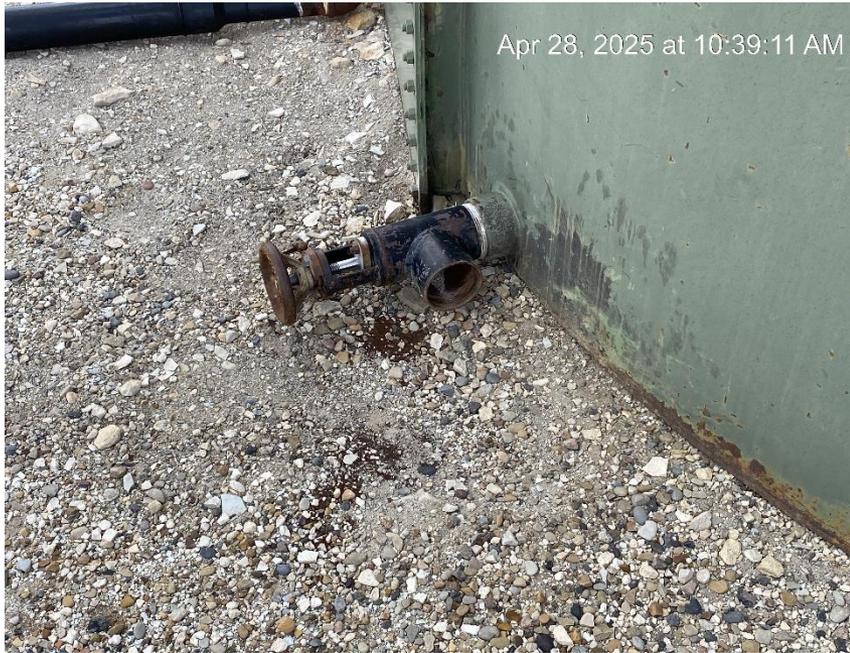
Covered staining. Open end tank valve.

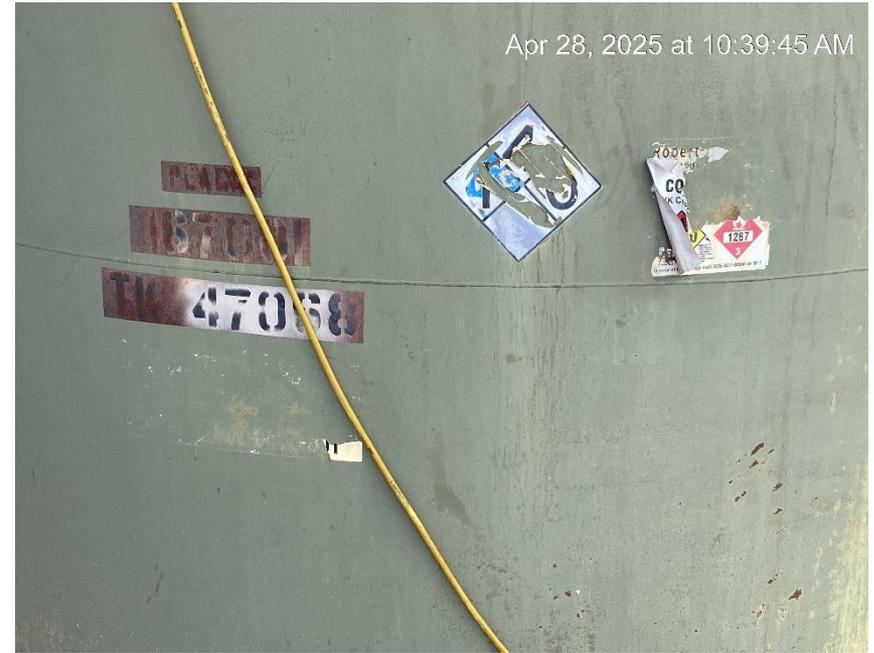
Damaged and incomplete tank labels

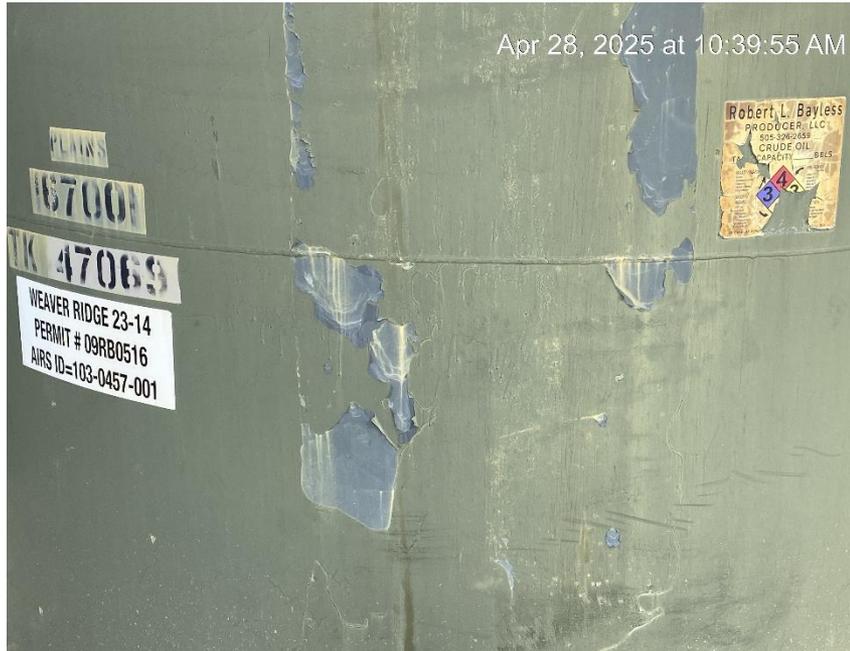
Damaged and incomplete tank labels

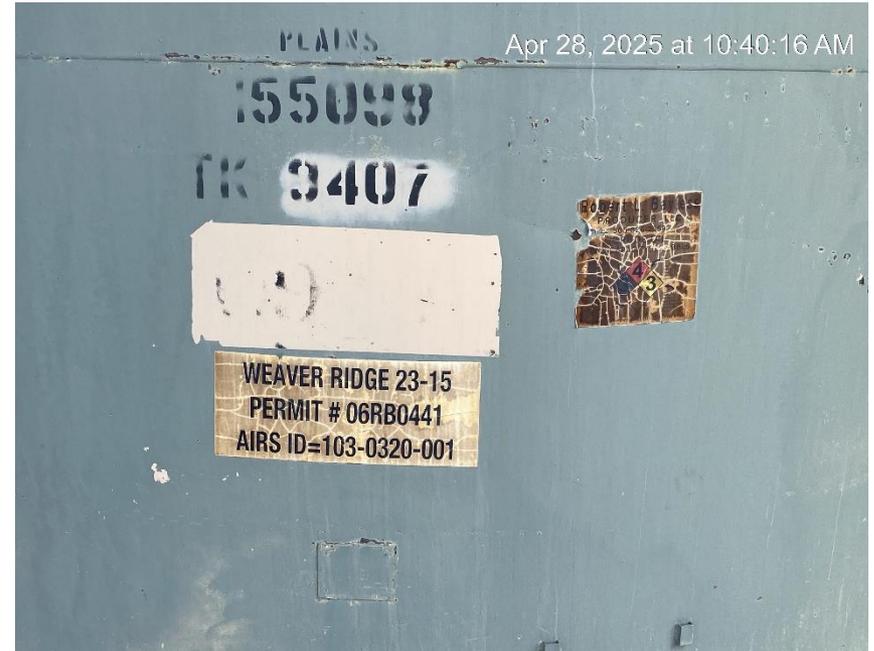
Damaged and incomplete tank labels

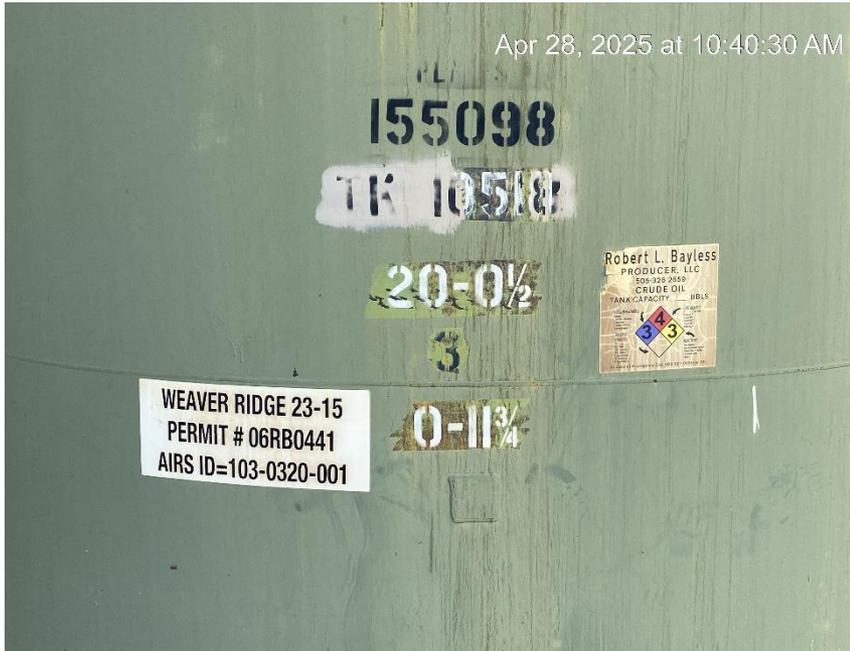
Damaged and incomplete tank labels

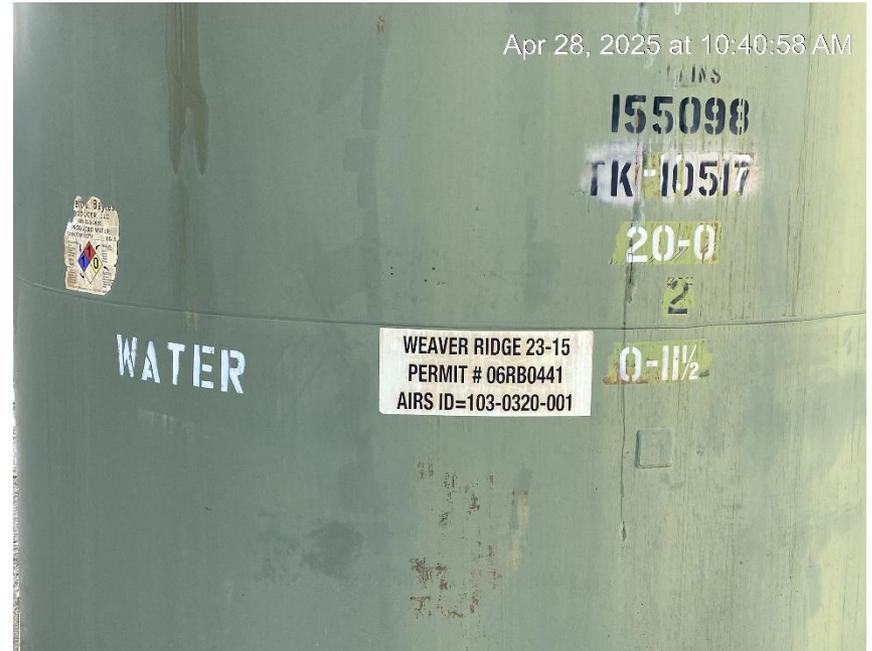
Damaged and incomplete tank labels

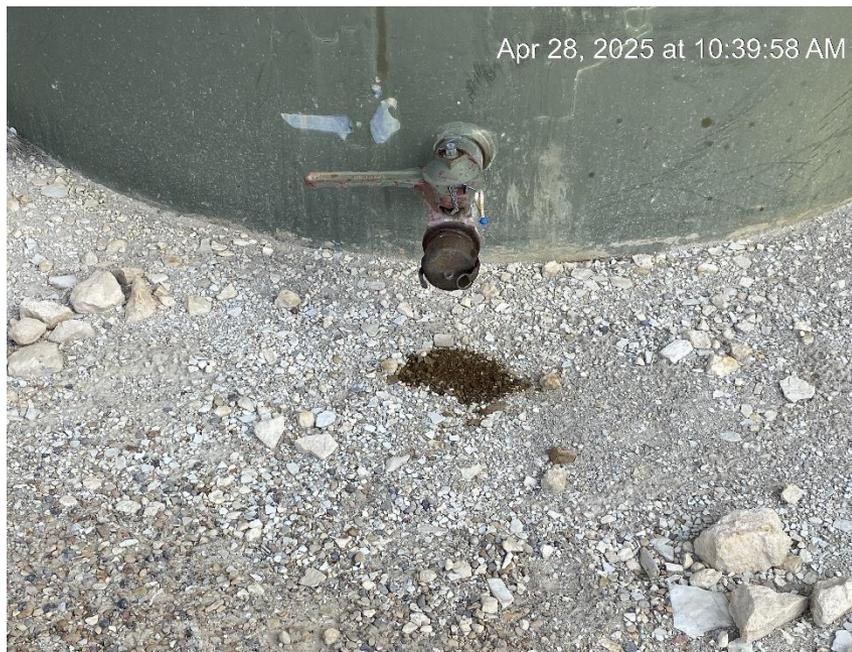
Oily waste and staining

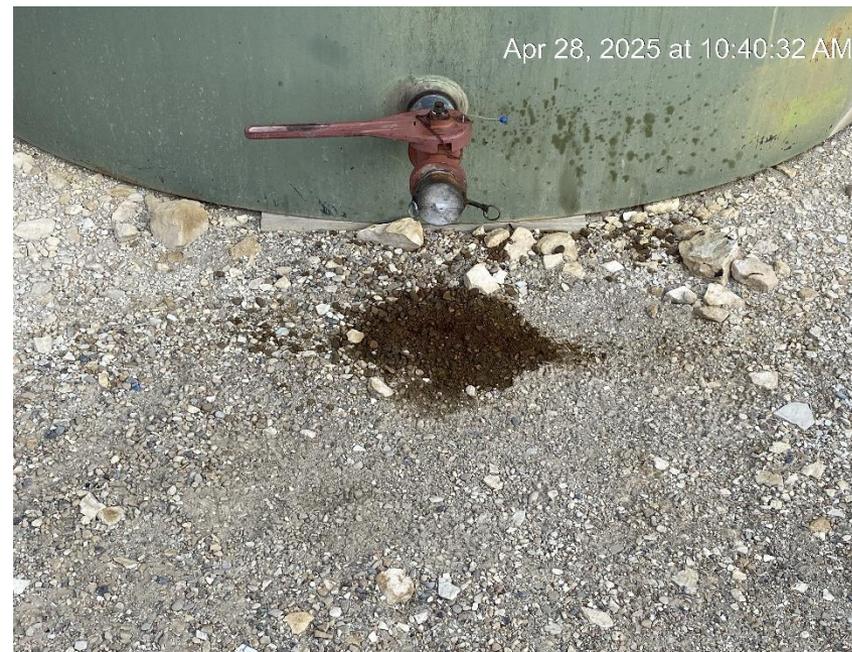
Oily waste and staining

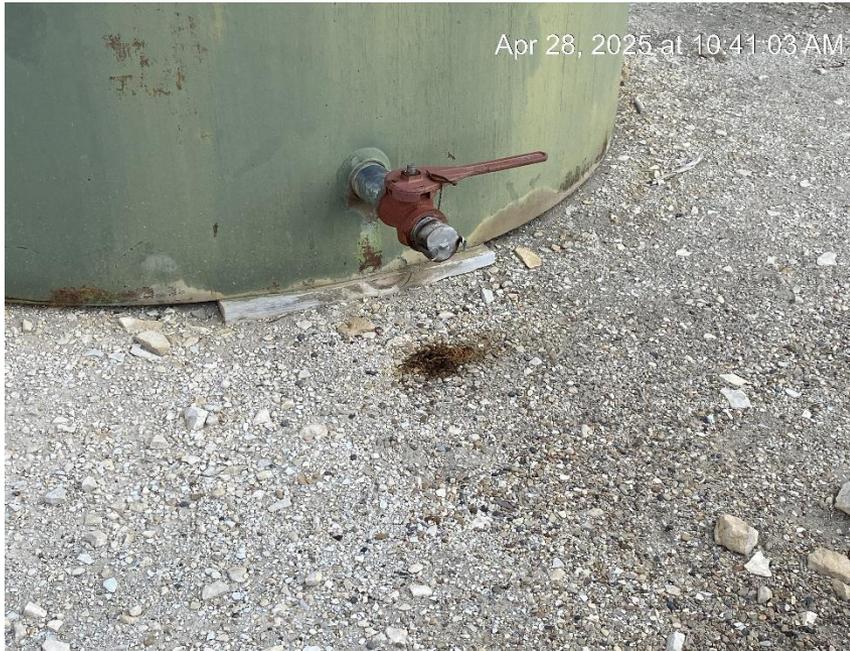
Oily waste and staining

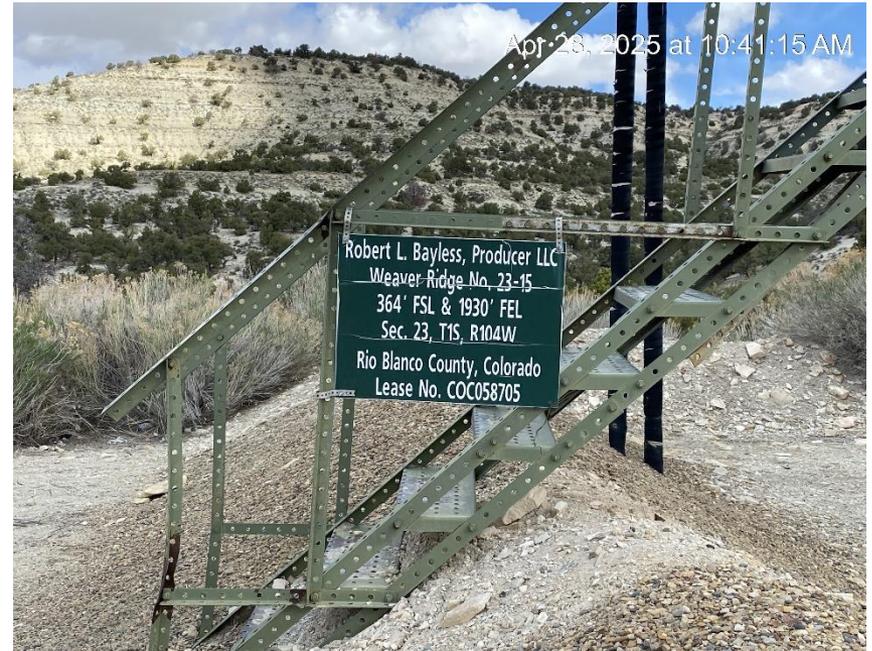
Missing required information

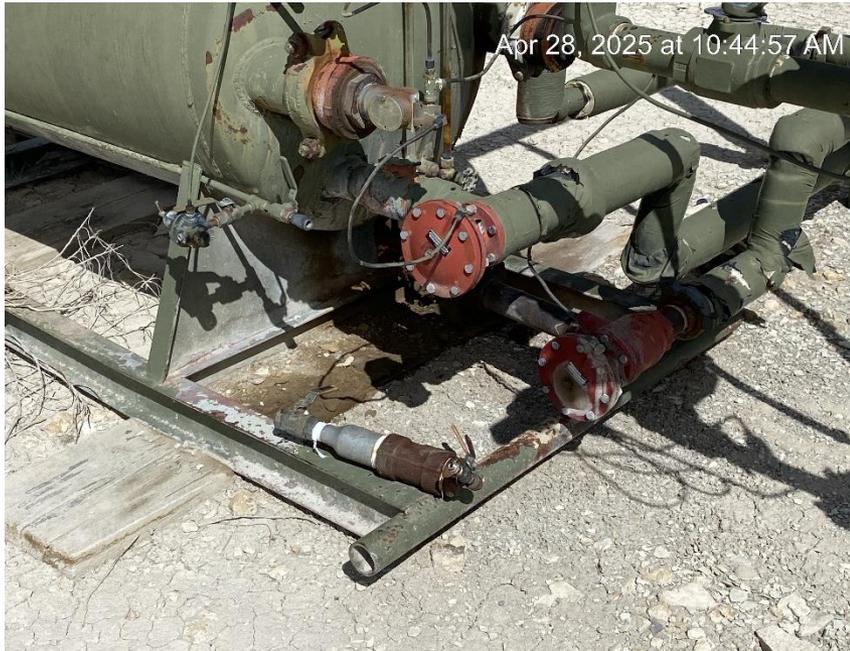
Debris. Staining.

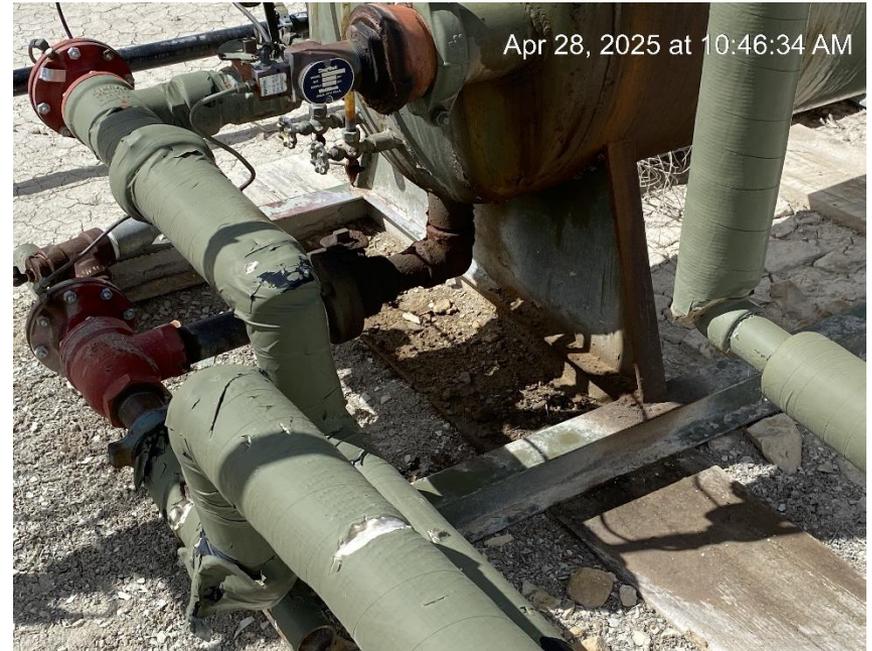
Leaking equipment. Staining

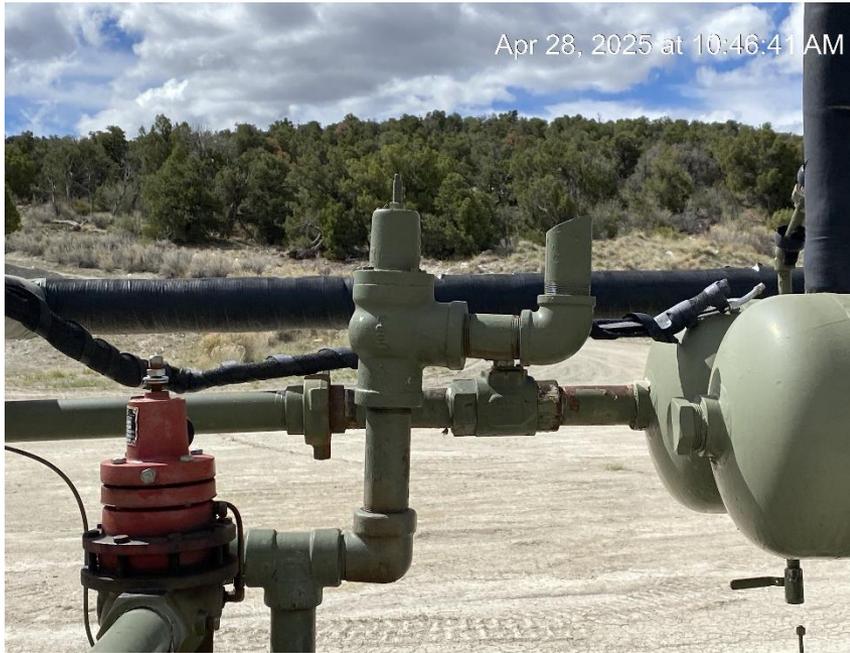
Unprotected riser

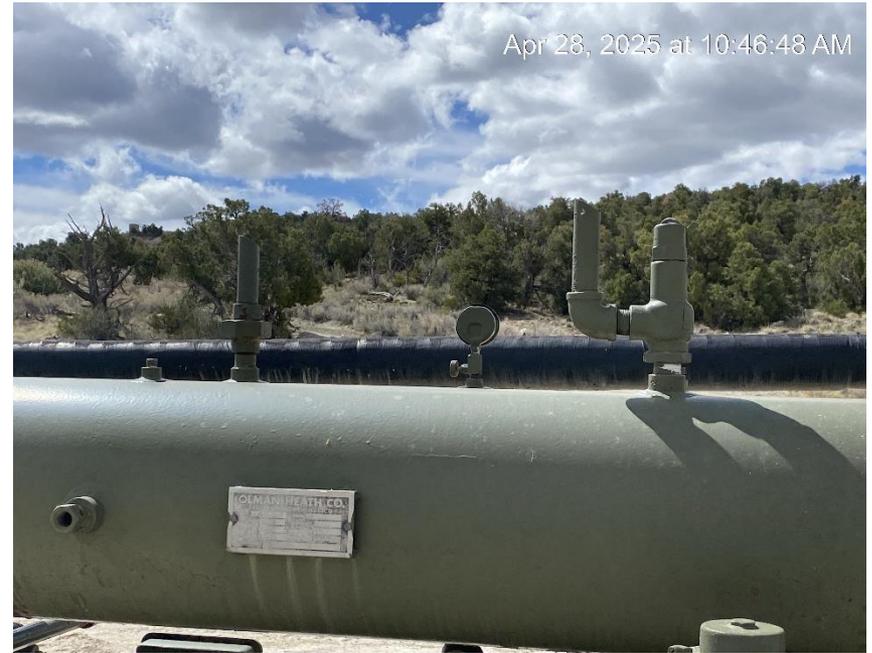
Unprotected risers

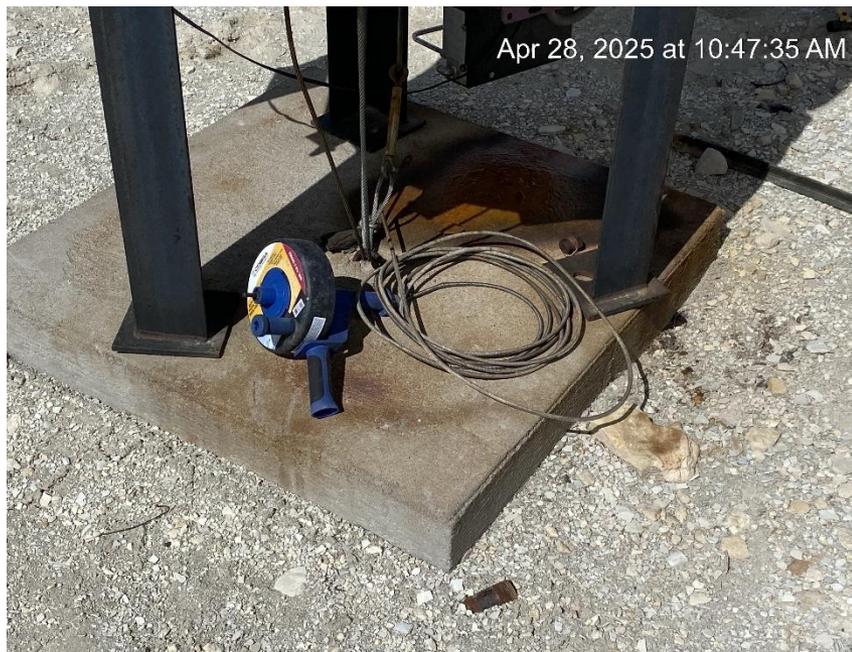
Debris and oily waste

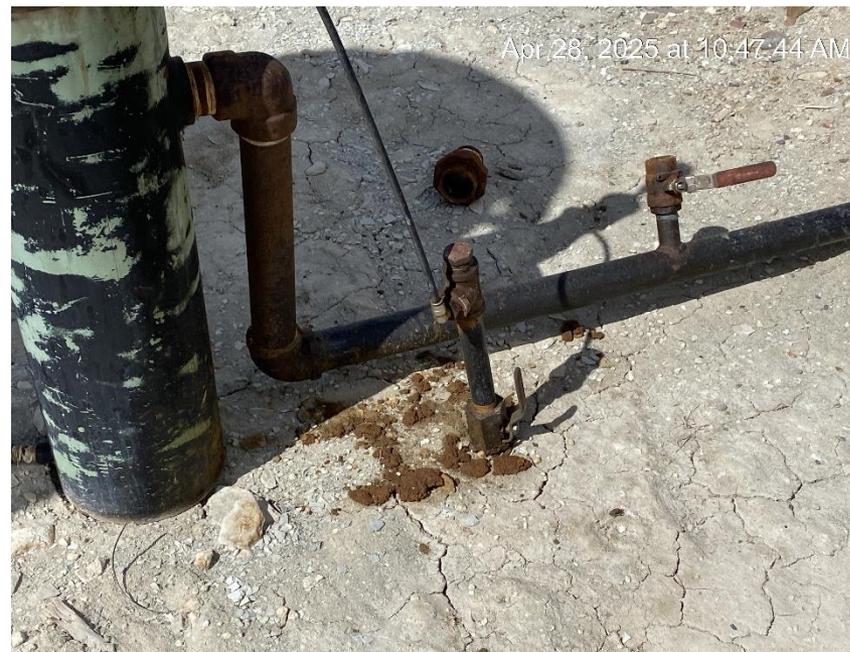
Oily waste

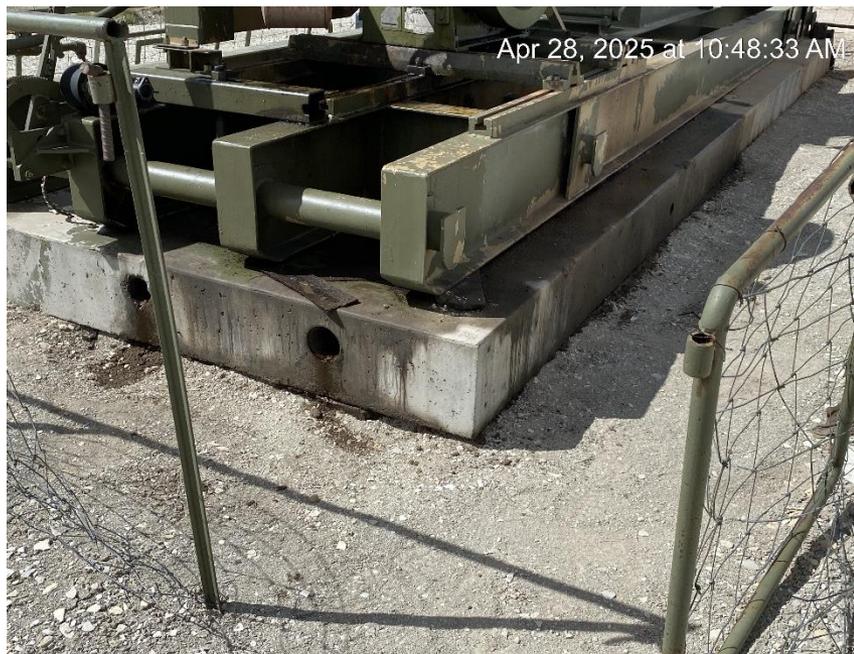
Oily waste and stained soil

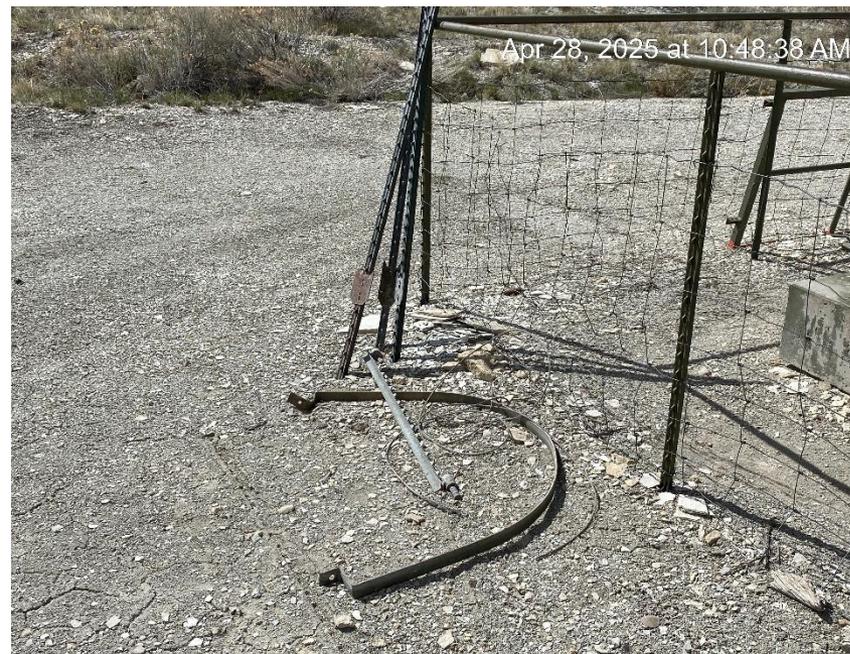
Debris

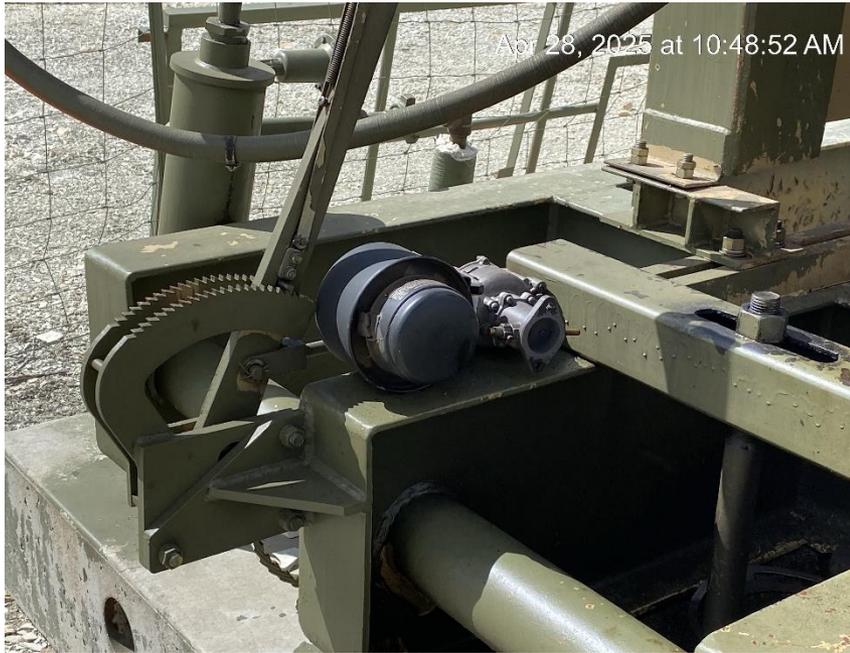
Debris

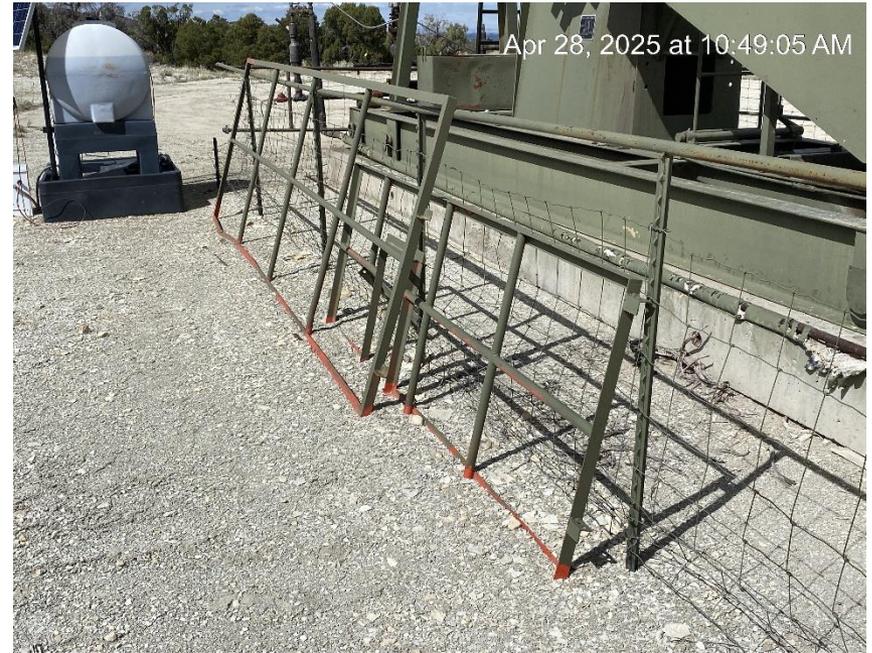
Debris

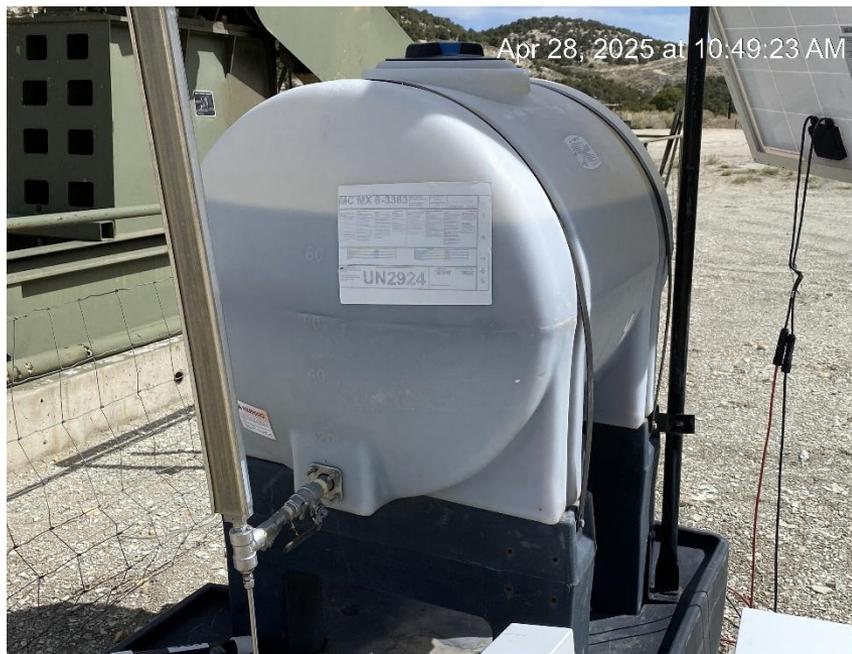
Faded and illegible label

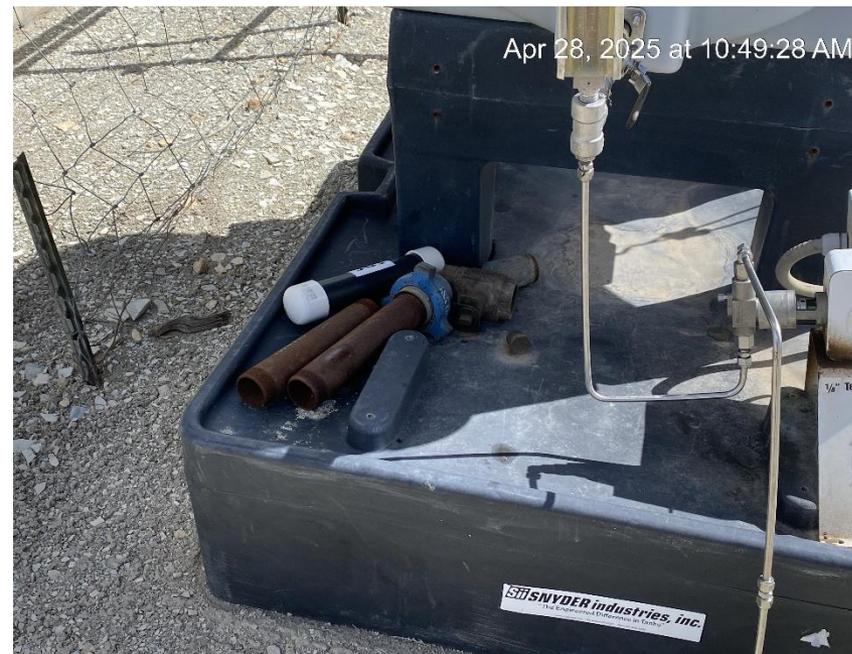
Debris

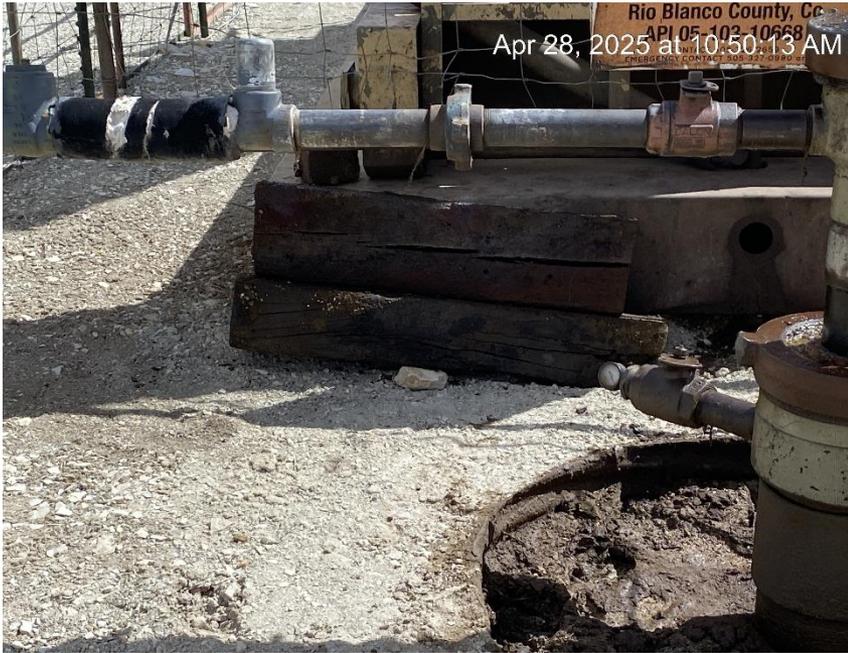
Debris

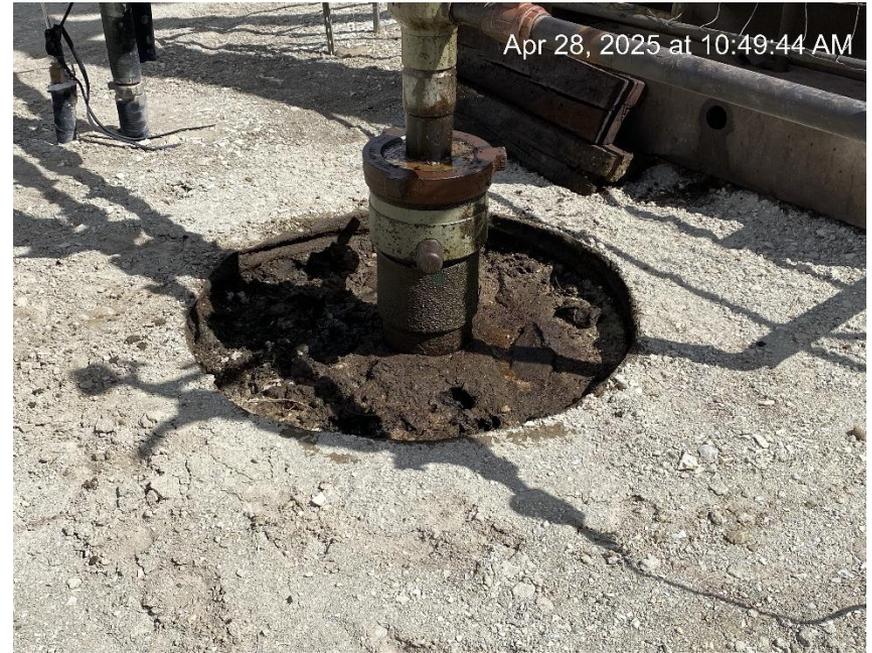
Oily waste. Safety hazard.
