Inspection Photos

Loc: 488235

Operator: BNL (ENTERPRISE) INC

Inspection Date: 5/1/2025

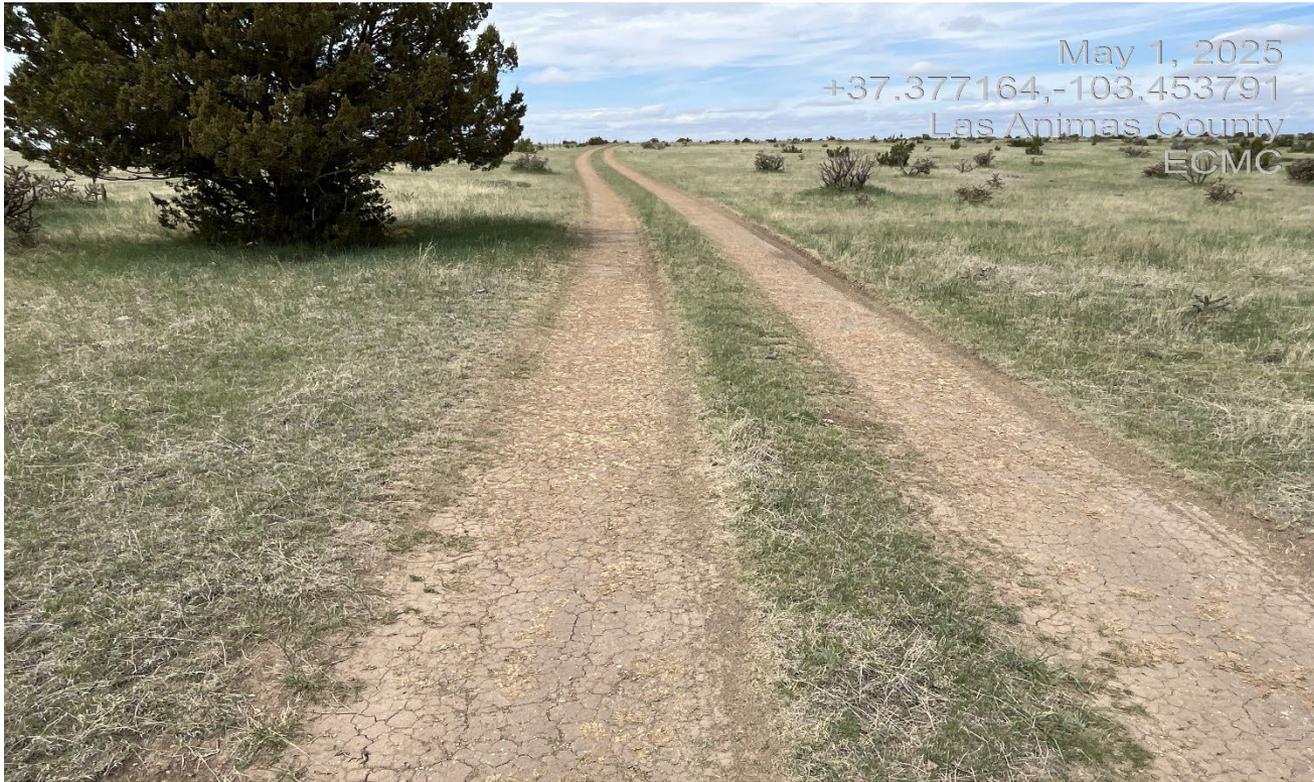
Photo 1. Facing east along the access road. The road will need to be maintained per 1002.f. rules.

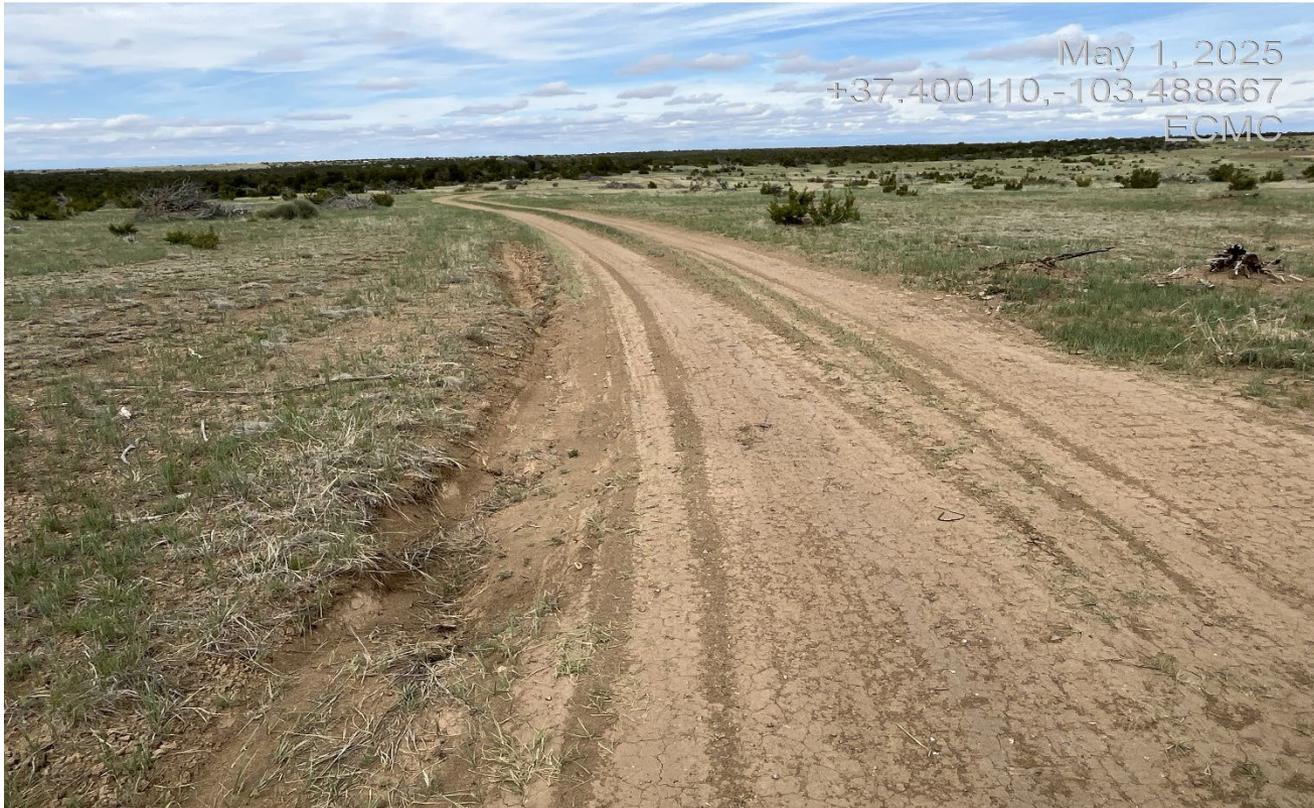
Photo 2. Facing northwest along the pre-existing access road. The road will need to be maintained per 1002.f. rules.

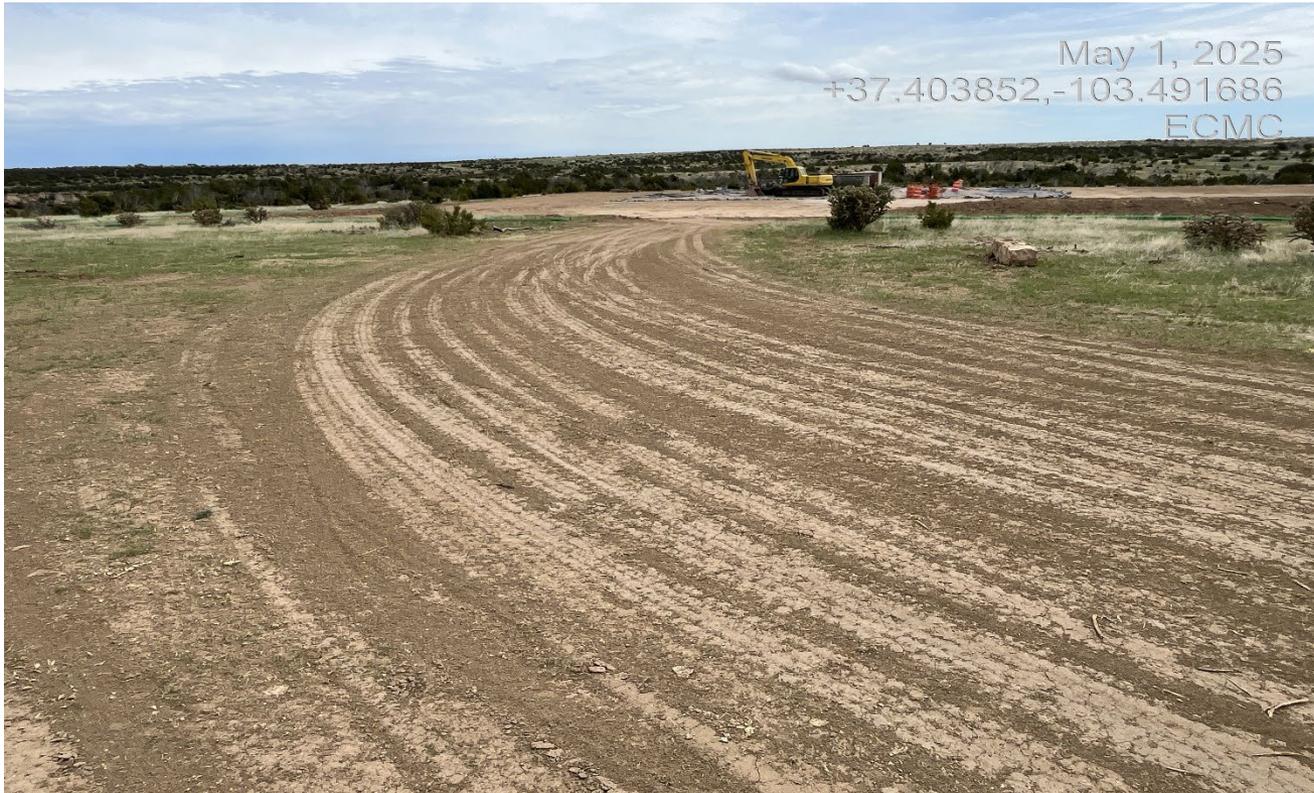
Photo 3. Facing east toward the access road and location. Topsoil was not salvaged along the road to the location approximately 100 yards. Soils are heavily compacted in this area..

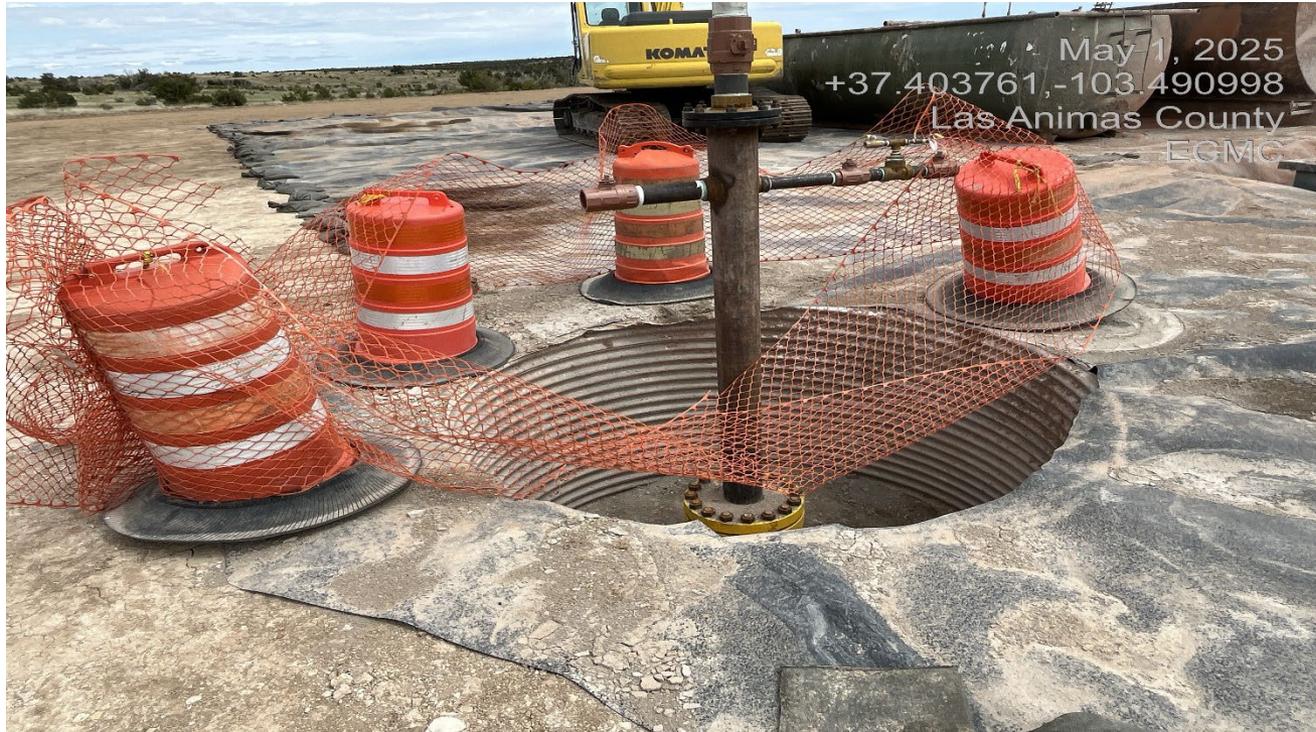
Photo 4. The well cellar does not have adequate fence installed to prevent livestock or wildlife entry.

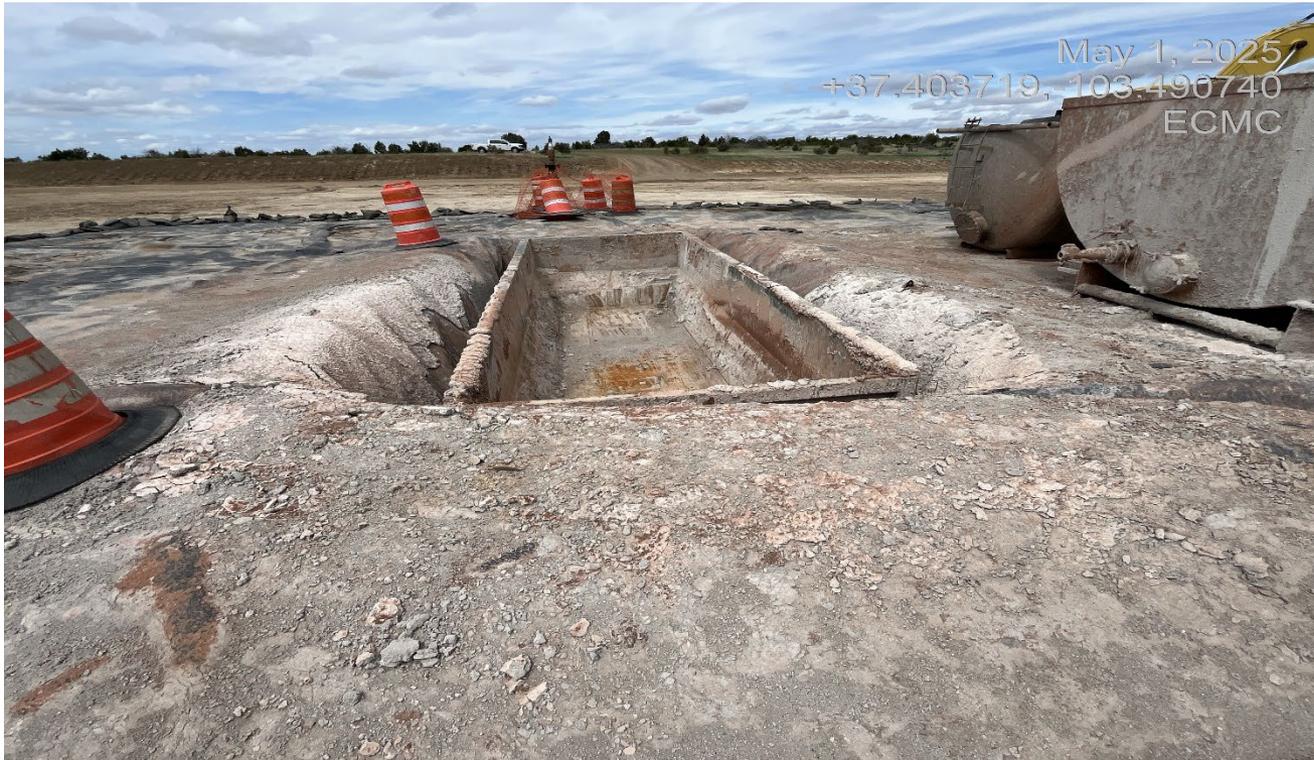
Photo 5. Facing toward the cuttings trench. The cutting material has been placed into the open top tanks at the right side of photo.

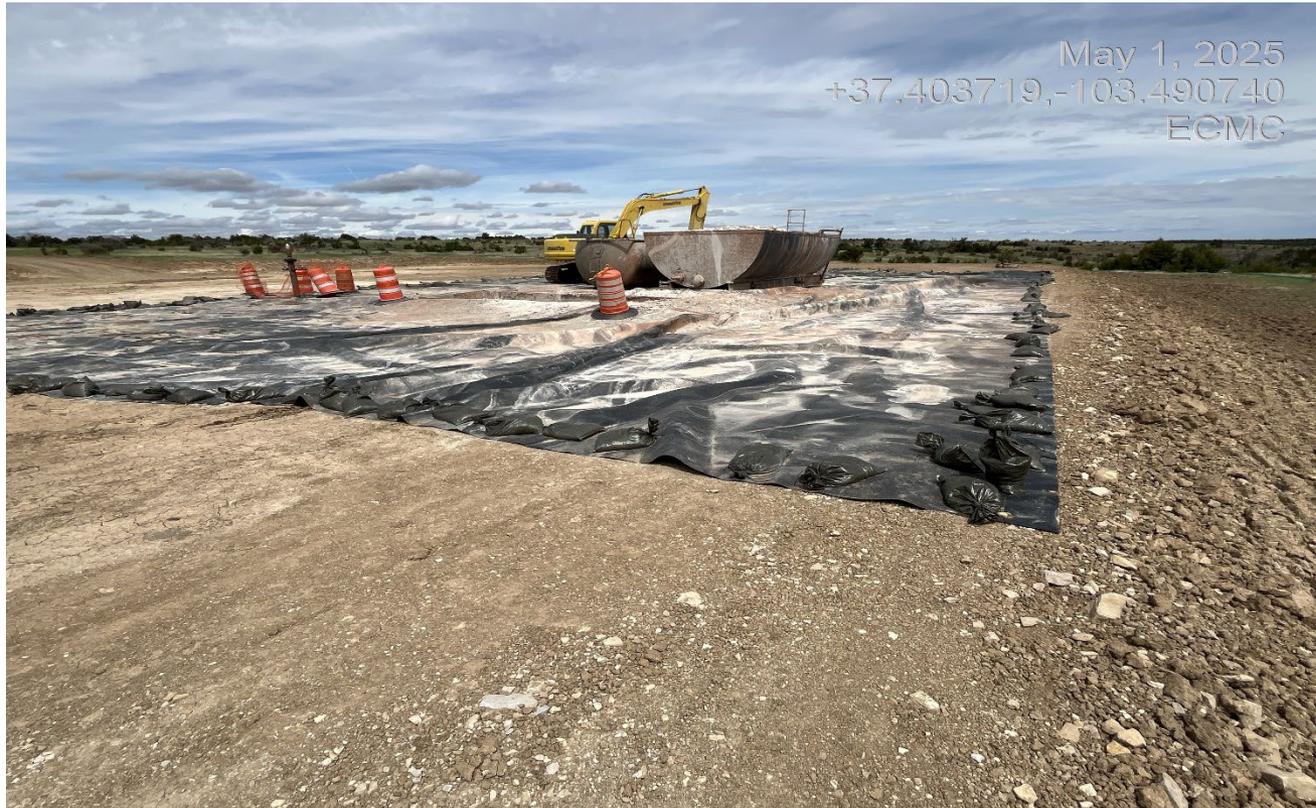
Photo 6. Facing northwest along the east side of the location. The liner with the drill cuttings material has no containment to prevent stormwater from washing the material off the liner.

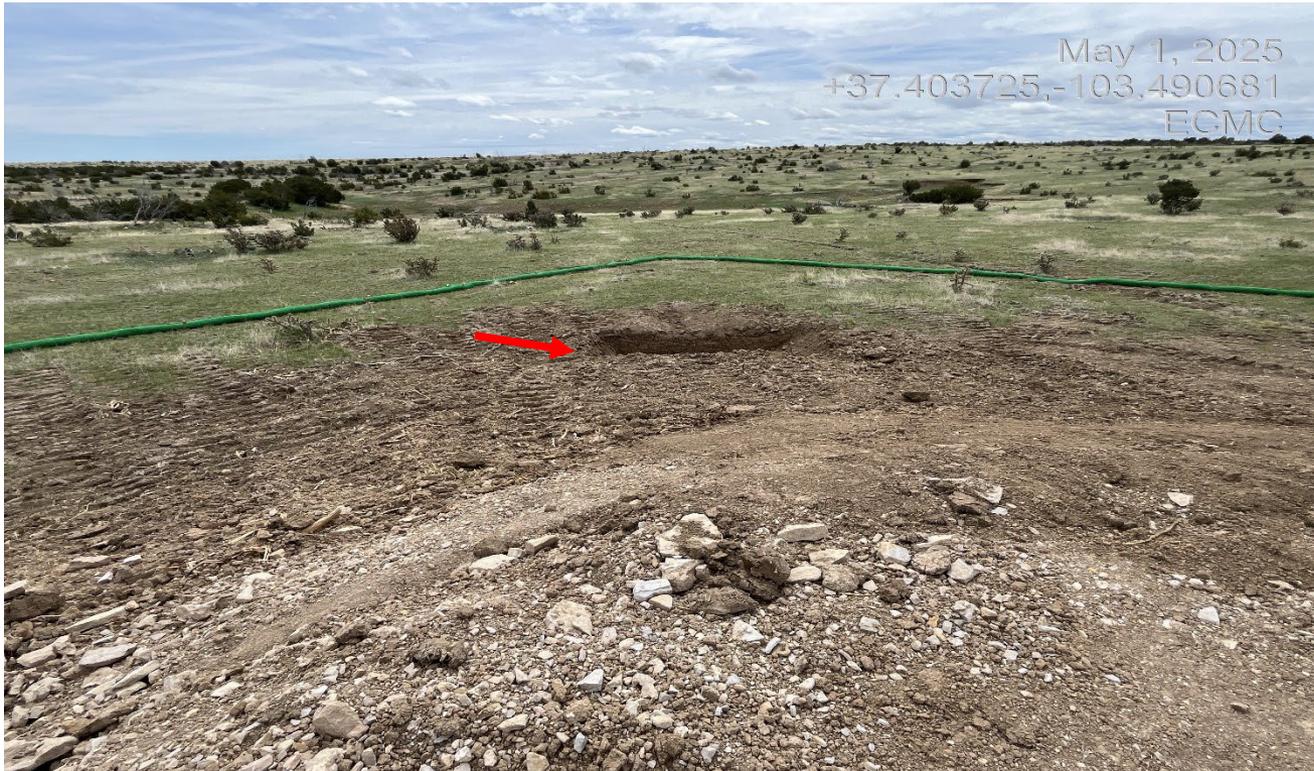
Photo 7. Facing southwest corner of the location. This is the down slope corner of the location. A sediment trap was dug out in this area but is no properly constructed.

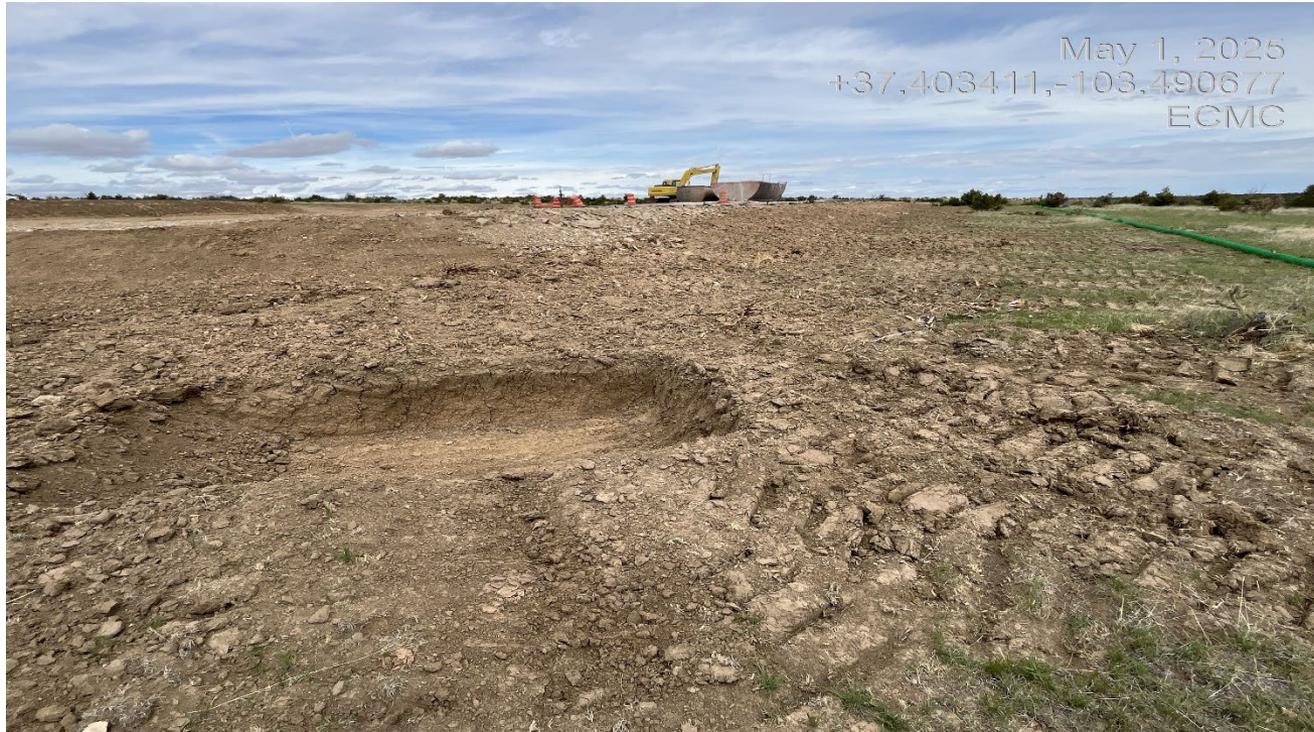
Photo 8. The sediment trap was dug out in this area has no diversion to direct flow to the sediment trap and does not have proper inlet/outlet.
