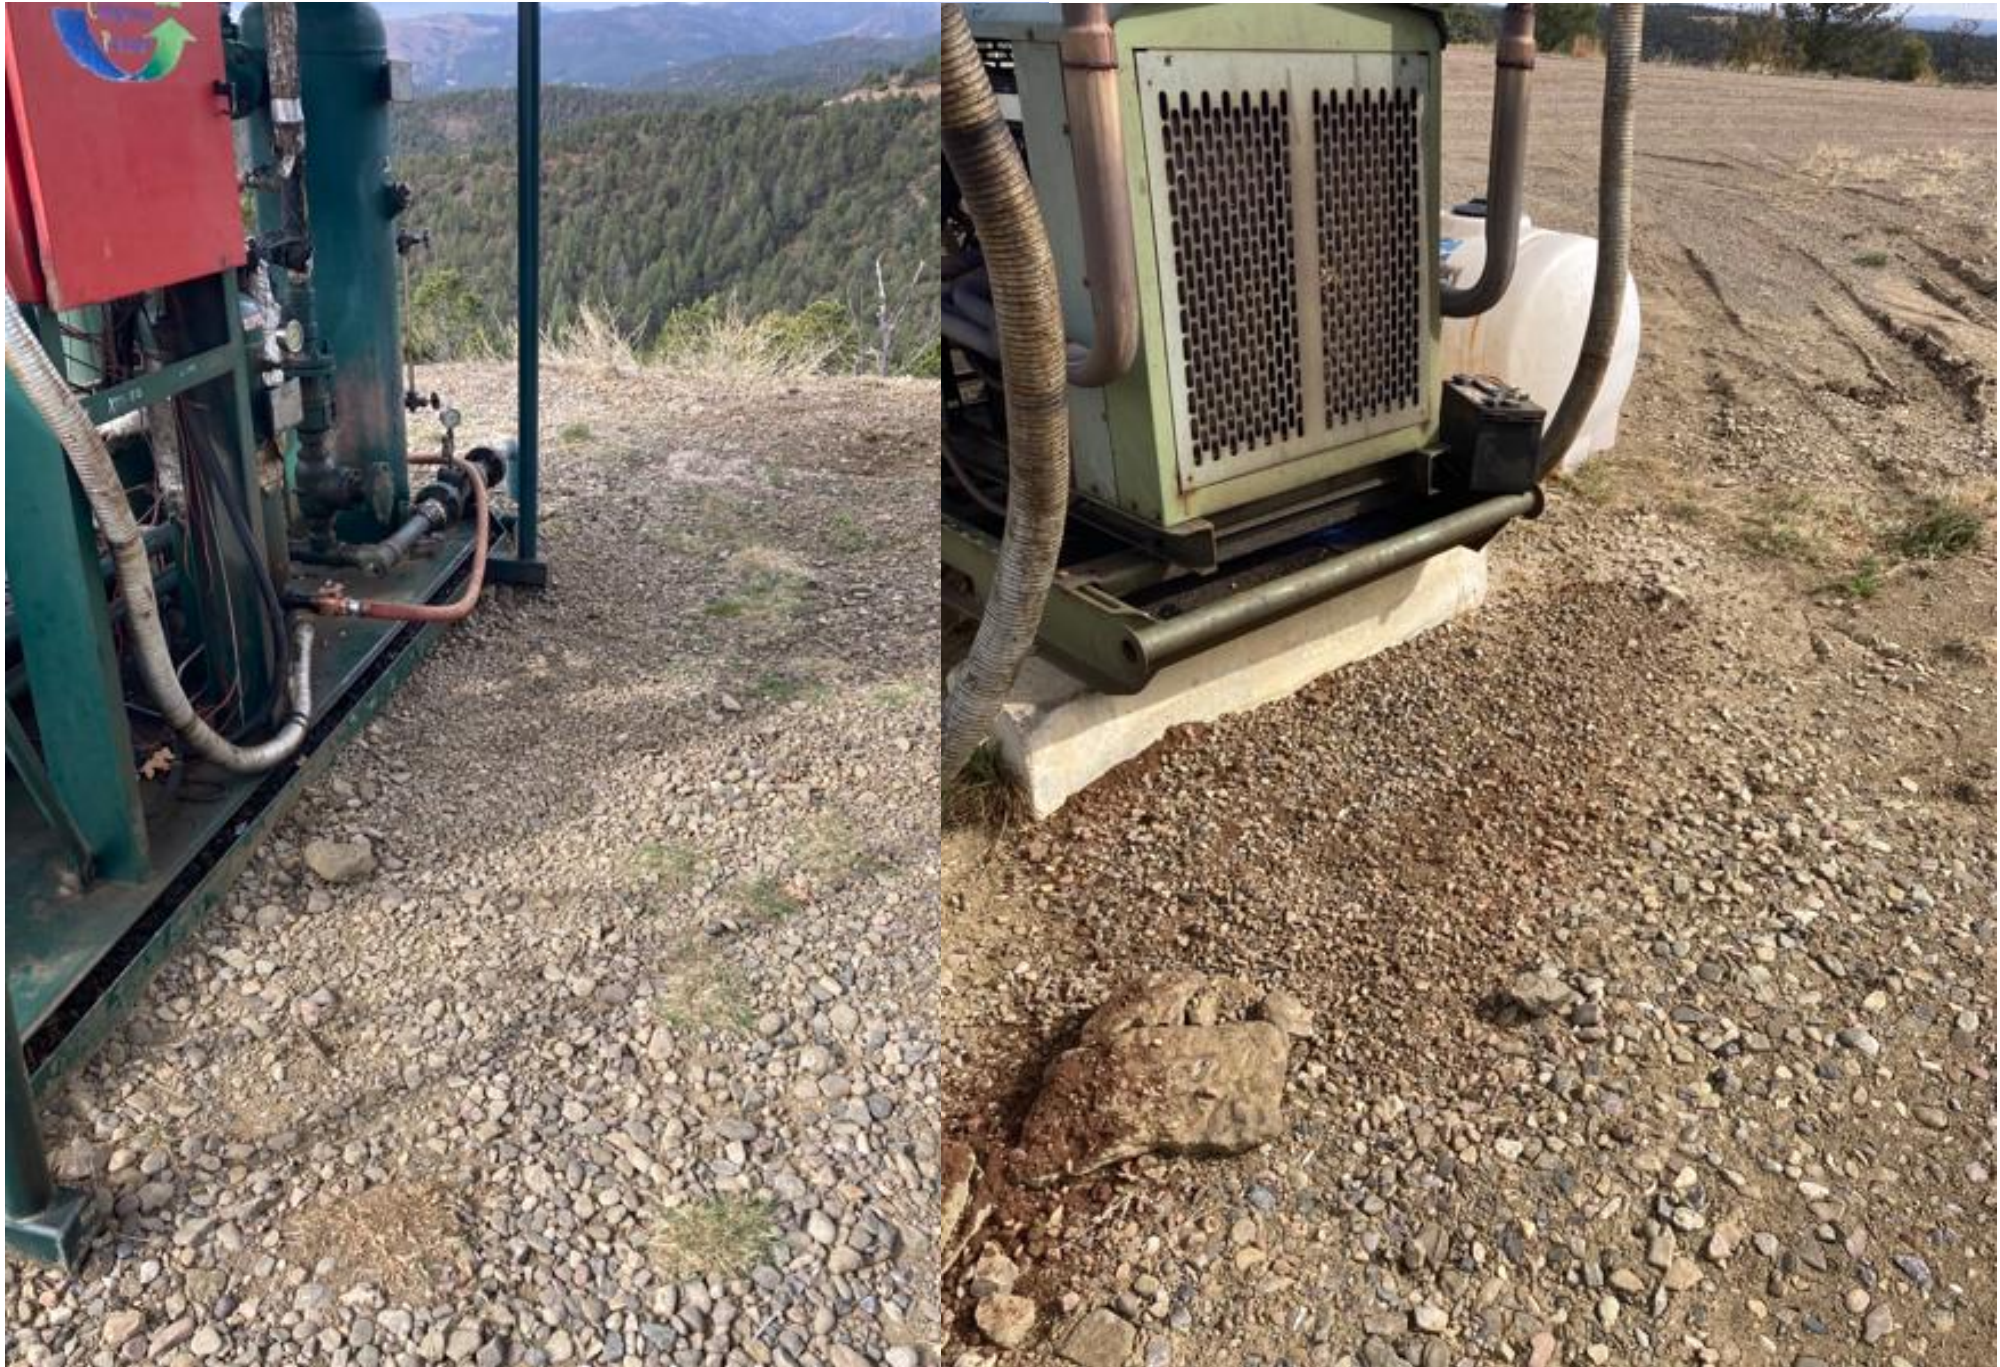
PHOTO 1: BOTH SKIDS HAVE BEEN CLEANED AND ALL OILY FLUIDS REMOVED. ALL OPERATING EQUIPMENT ON LOCATION HAS RECEIVED MECHANICAL MAINTENANCE. THE IMPACTED SOILS HAVE BEEN REMOVED AND THE SELF INSPECTION PROCESS REVIEWED.
