# Inspection Photos

Location Name: QB ENERGY OPERATING LLC ALP 25-9C (J25NW) Pad

Location #: 335321

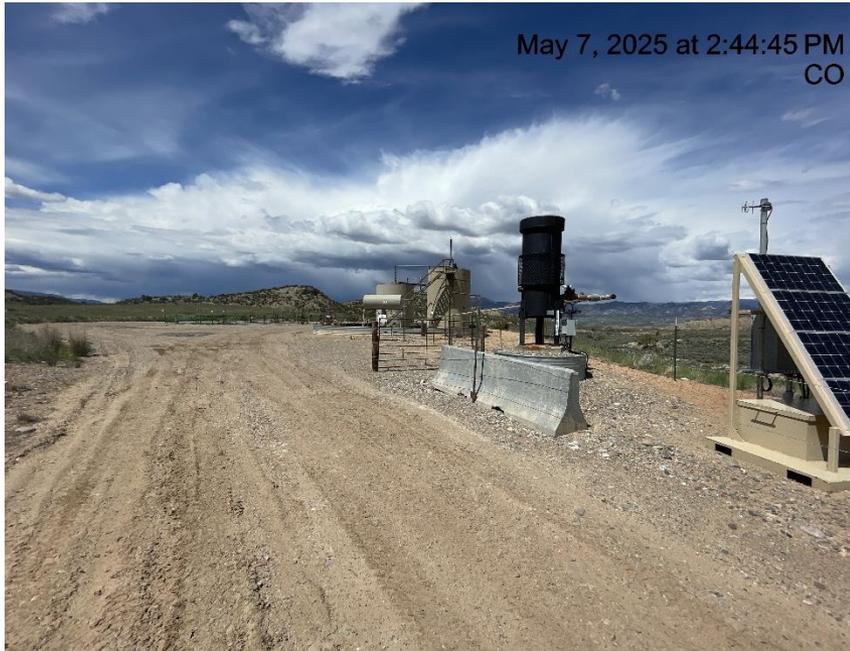
Photo # 9556 From Entrance to location

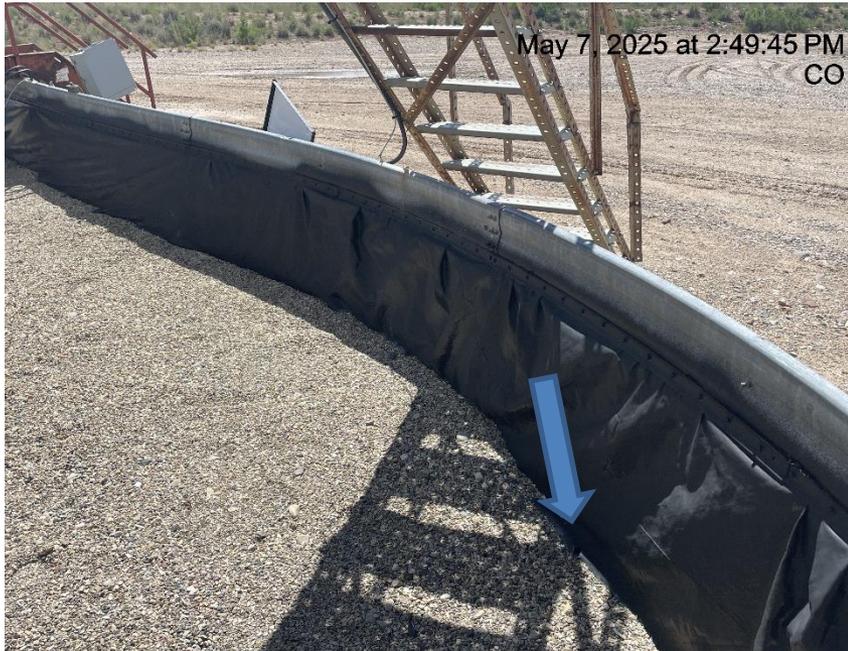
**Photo # 9564 Hole in secondary containment liner/liner needs maintenance**

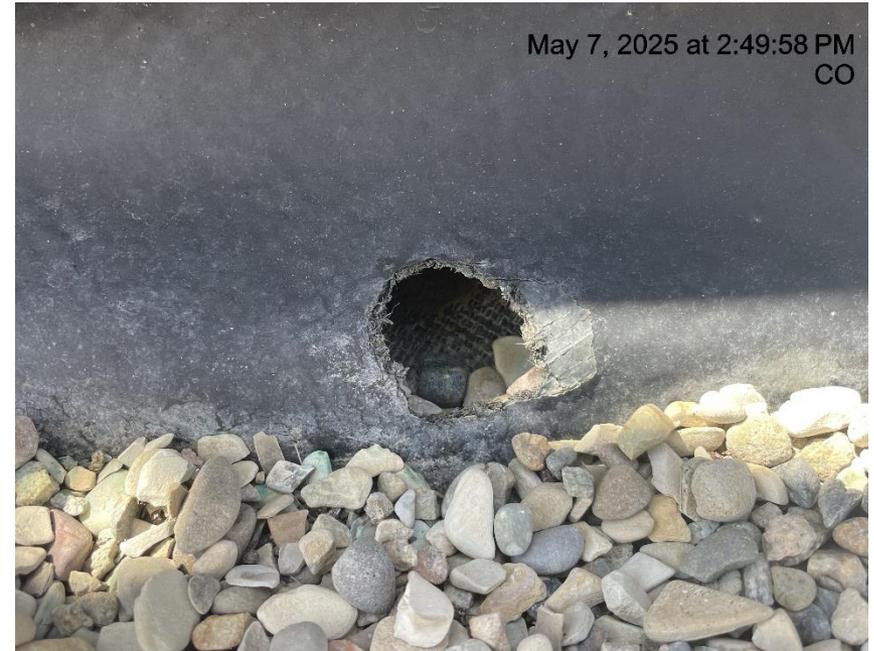
**Photo # 9565 Hole in secondary containment liner/liner needs maintenance**

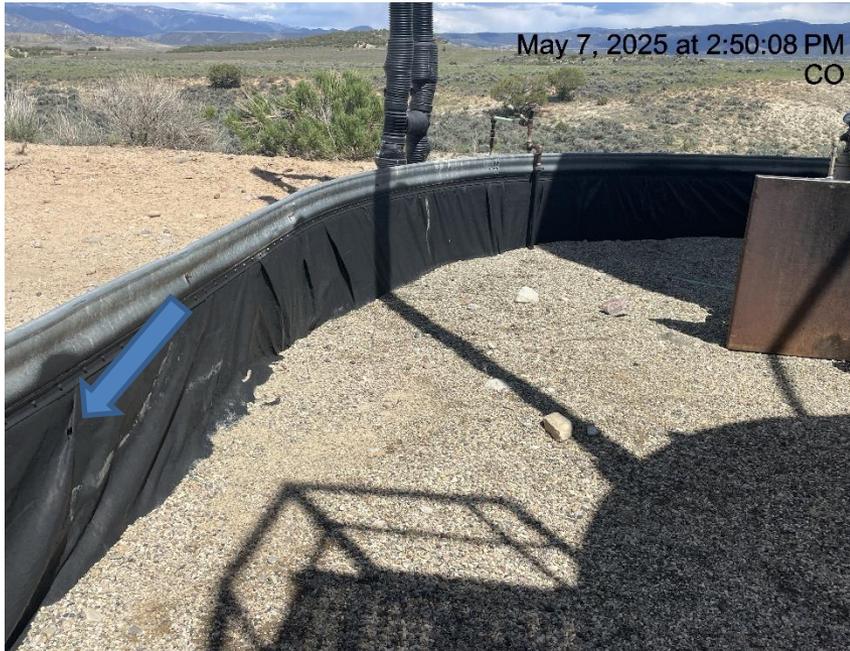
**Photo # 9566 Hole in secondary containment liner/liner needs maintenance**

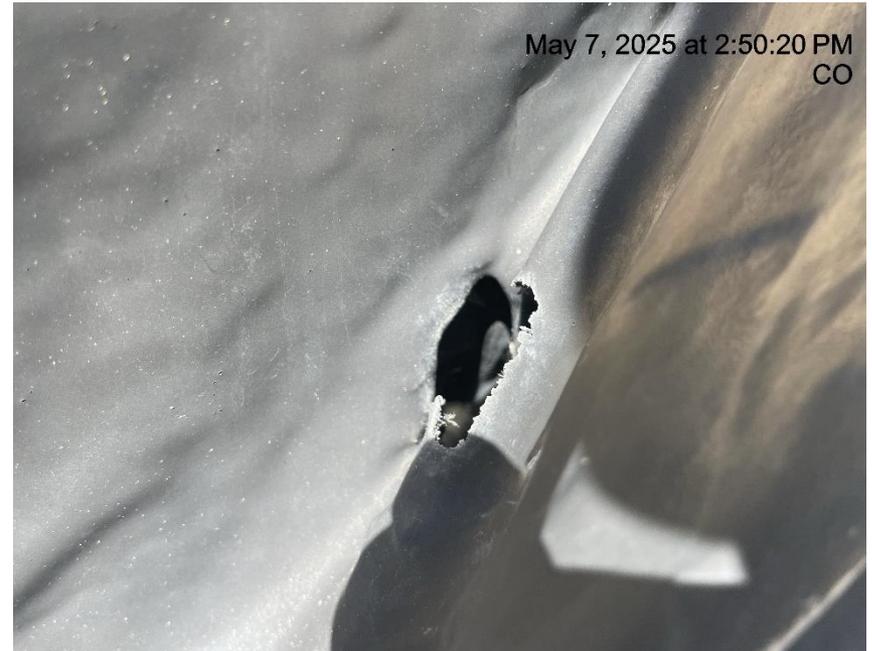
**Photo # 9567 Hole in secondary containment liner/liner needs maintenance**

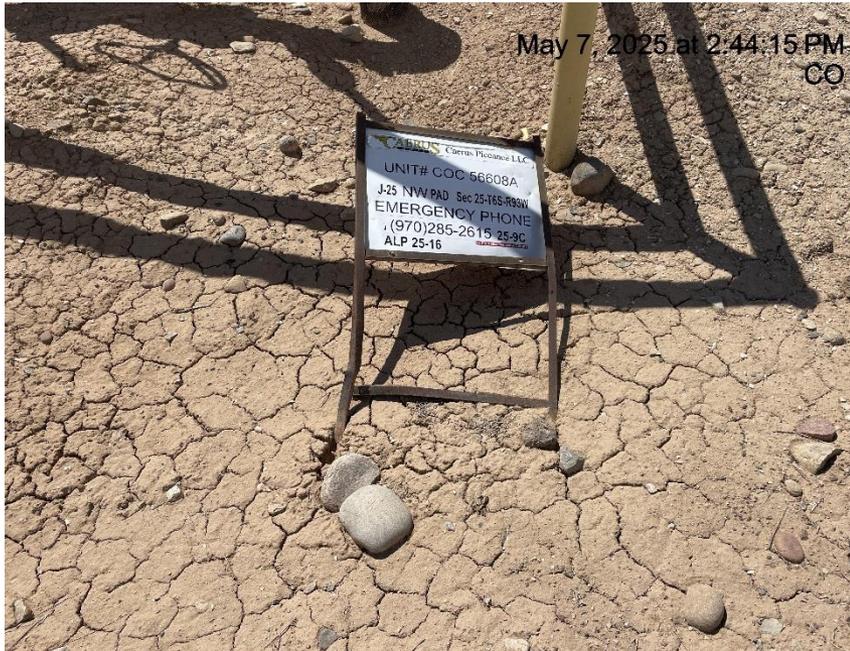
Photo # 9568 Sign at entrance to location laying on the ground
