# Inspection Photos

**Operator:** GUNNISON ENERGY LLC - 10515

**Location ID:** 334446

**Inspection Doc:** 718100505

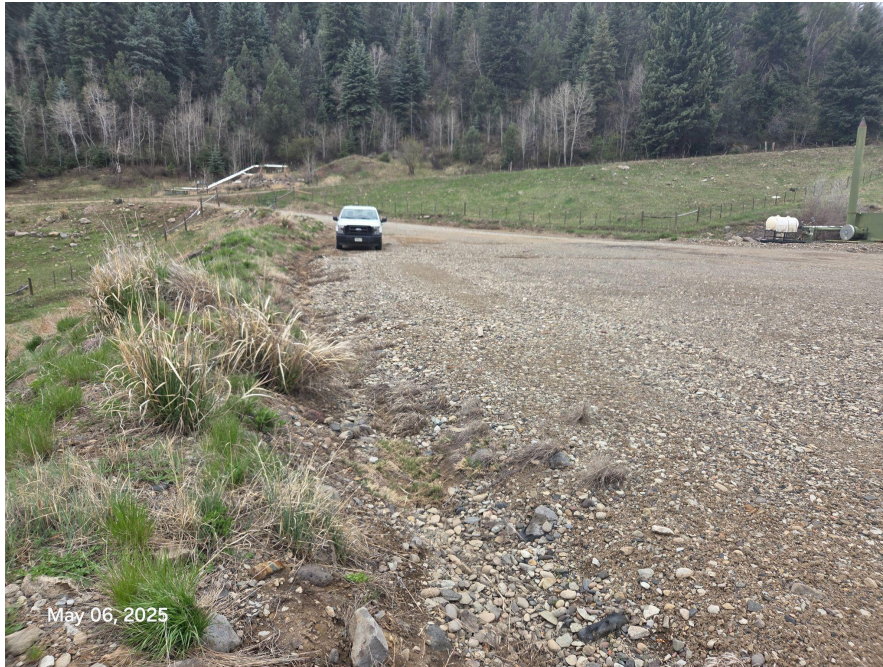
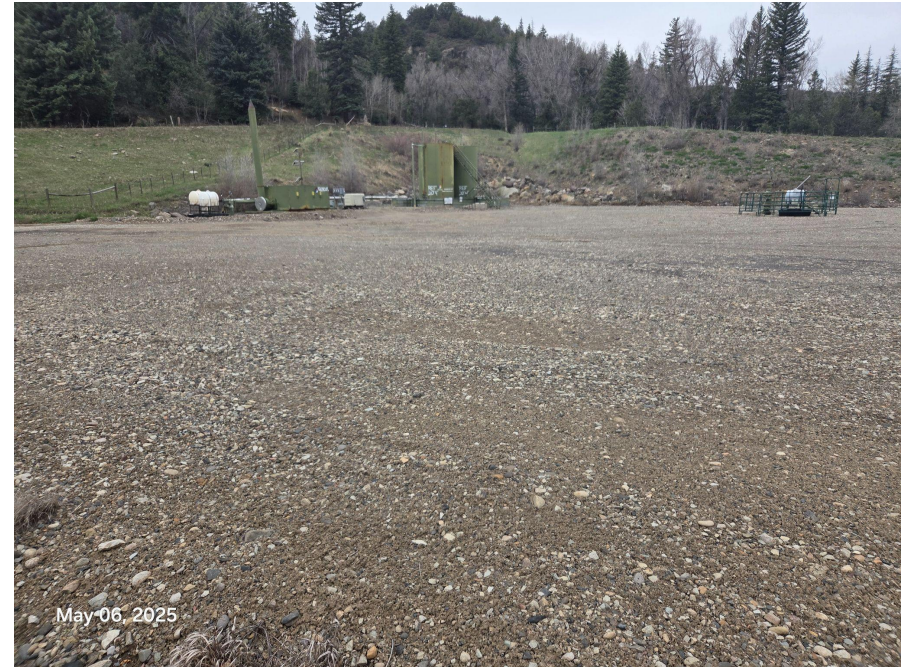
**Photo 1:** Photos 1-2 taken from the east end of the Location. Photos provide an overview of the Location from south, southwest, northwest to north. Photos examples showing interim reclamation to reduce the Location to areas only needed for production has not been performed in accordance with 1003 Rules and Form 4 Variance COAs.

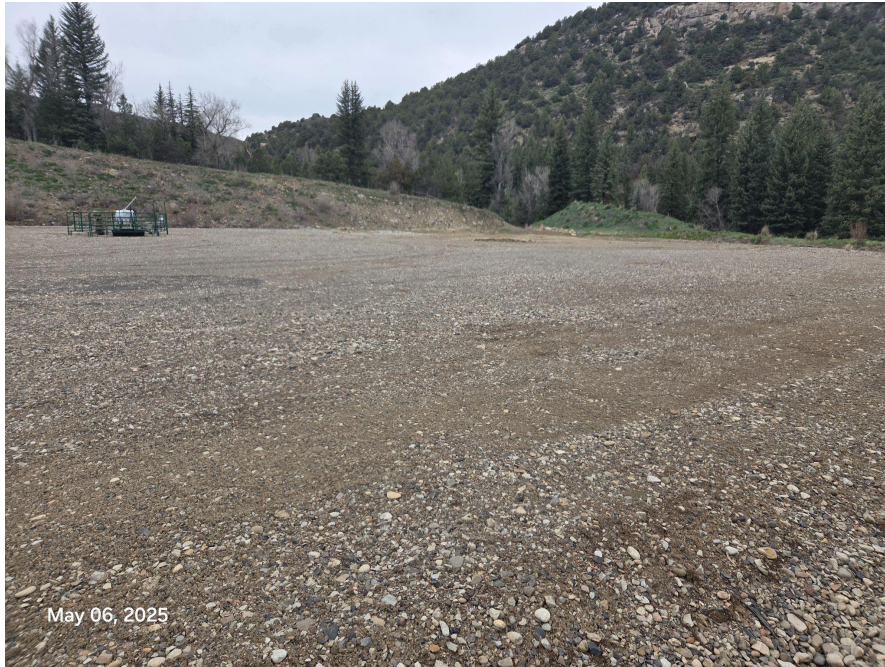
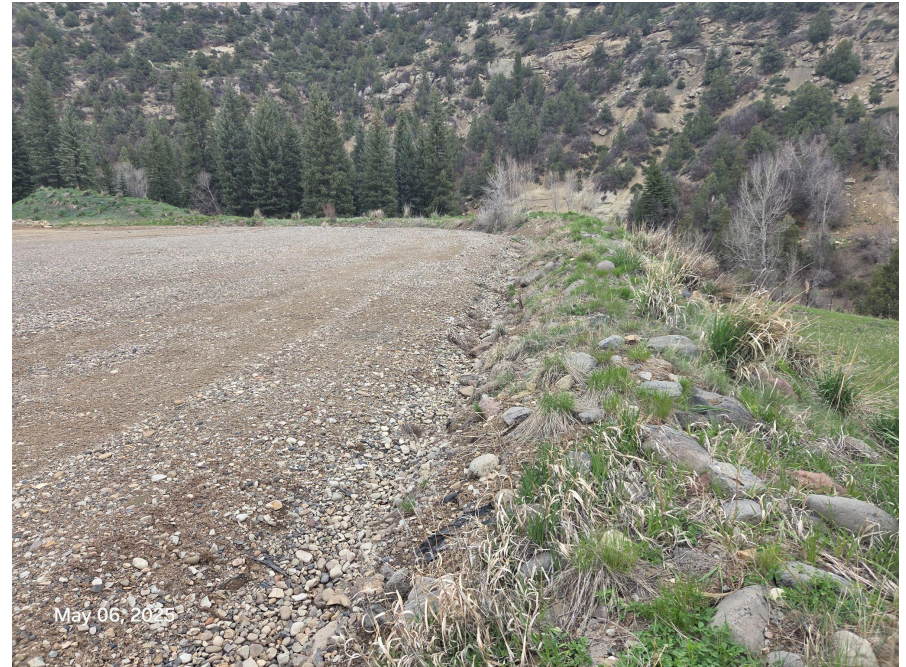
**Photo 2:** See comments under photo 2.

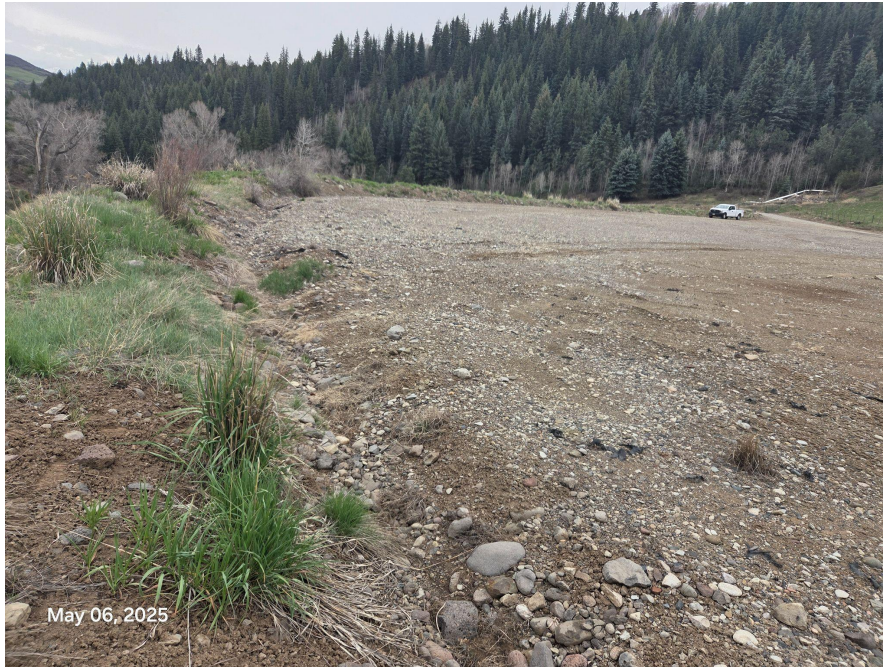
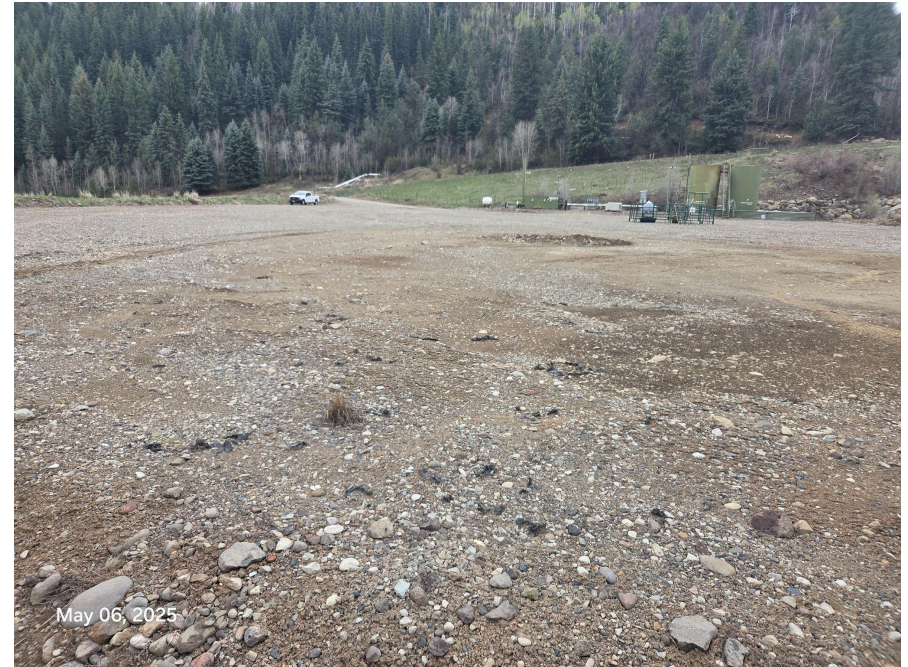
**Photo 3:** Photos 3-4 taken from the north end of the Location. Photos provide an overview of the Location east, southeast, southwest to west. Photos examples showing interim reclamation to reduce the Location to areas only needed for production has not been performed in accordance with 1003 Rules and Form 4 Variance COAs.

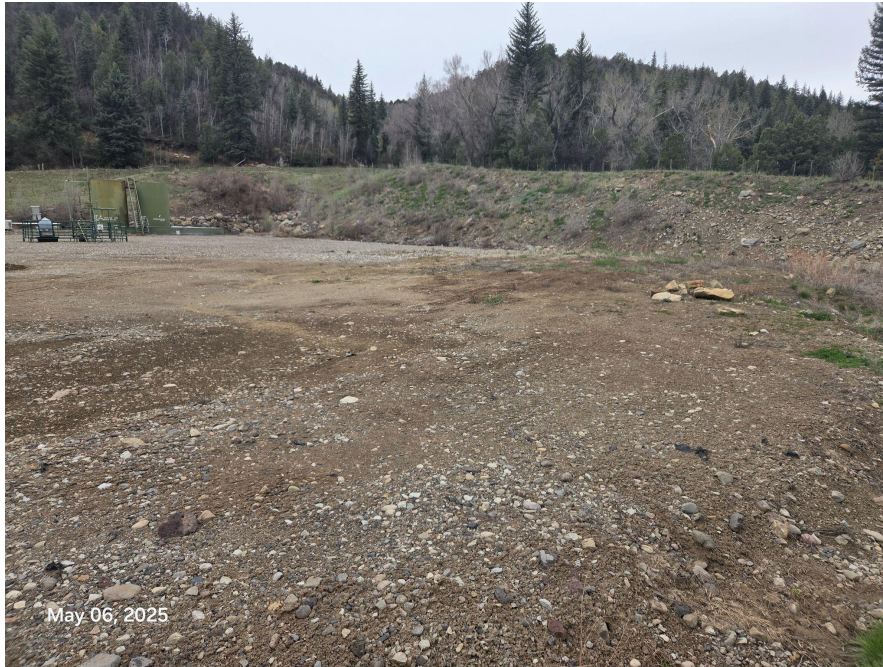
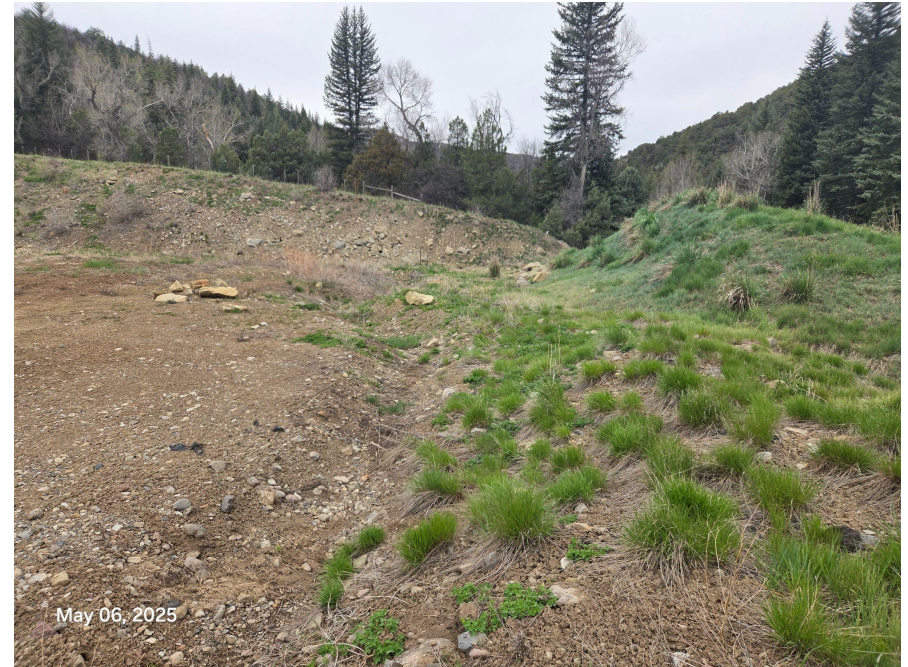
**Photo 4:** See comments under photo 3

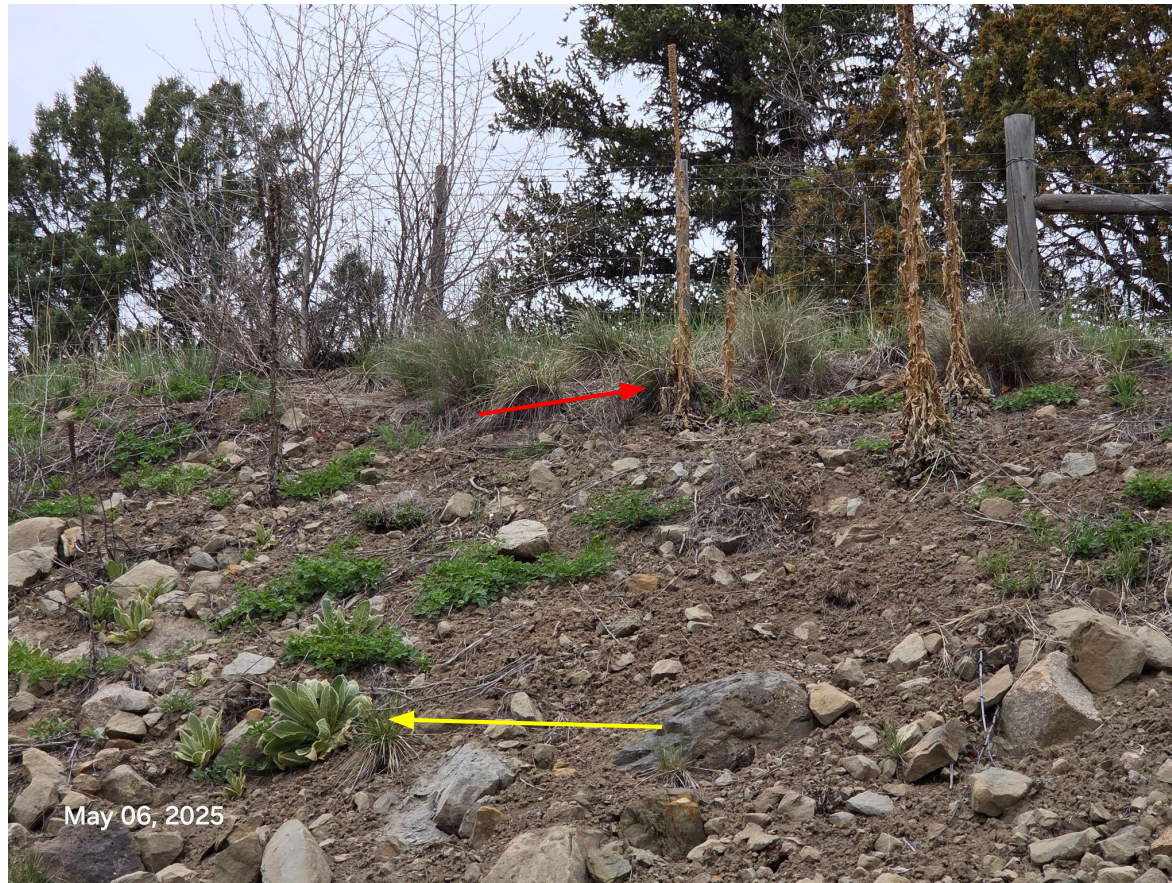
**Photo 5:** Photo taken from the cut slopes on the west end of the Location. Photos show Noxious weed (Common Mullein) establishment on the Location. Common mullein is a biennial plant that produces a basal rosette in the first year of growth (Yellow arrow); the plant bolts with an erect stem during its second year of growth (Red Arrow). Weed management efforts to prevent Undesirable Plant Establishment have not occurred, or have been inadequate over the past few years.

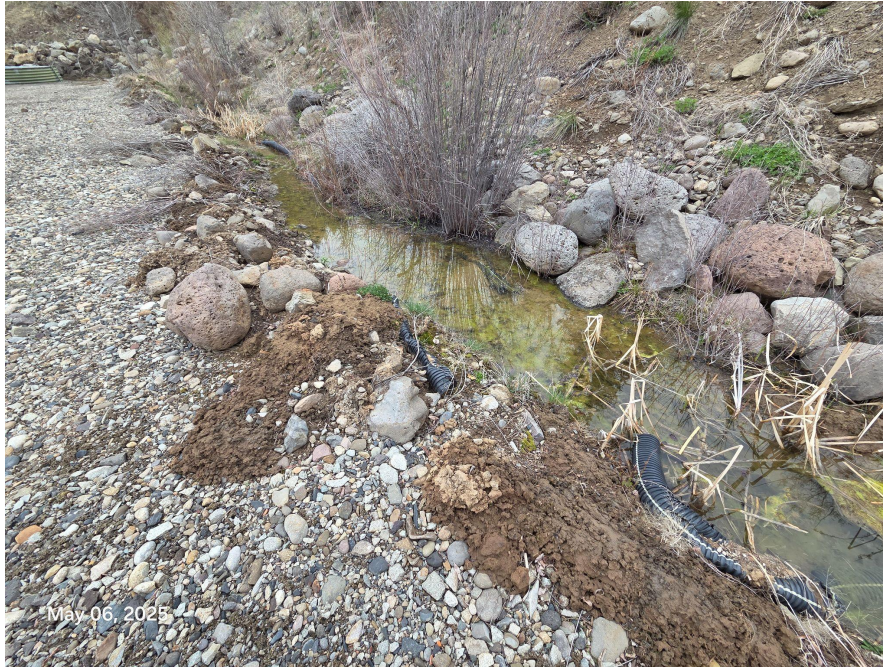
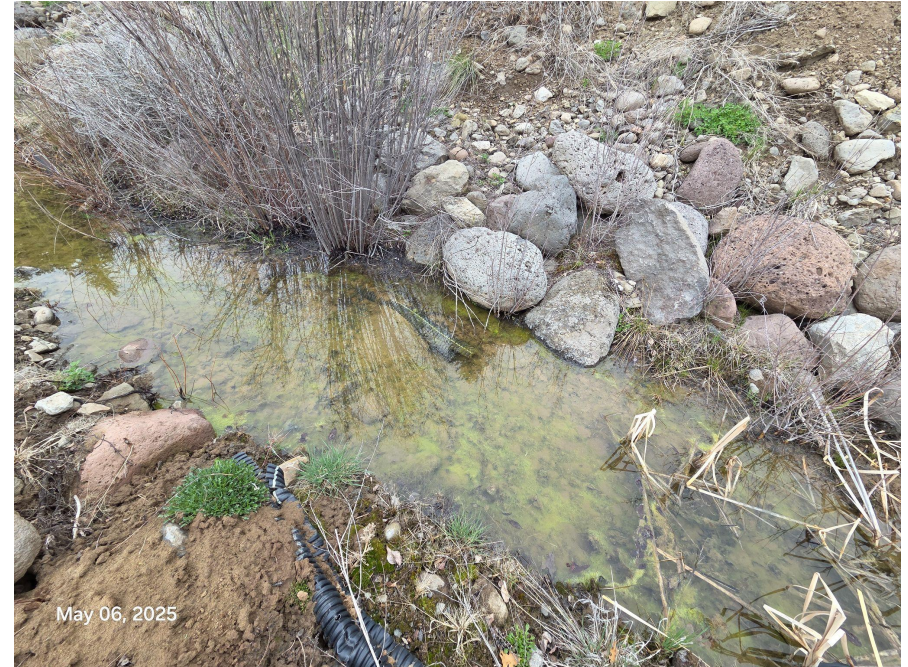
**Photo 6:** Photos 6-7 taken from the cut slopes on the west end of the Location. Photos examples showing plastic corrugated pipe/hose observed within the stormwater ditch; hose is in disrepair considered debris.

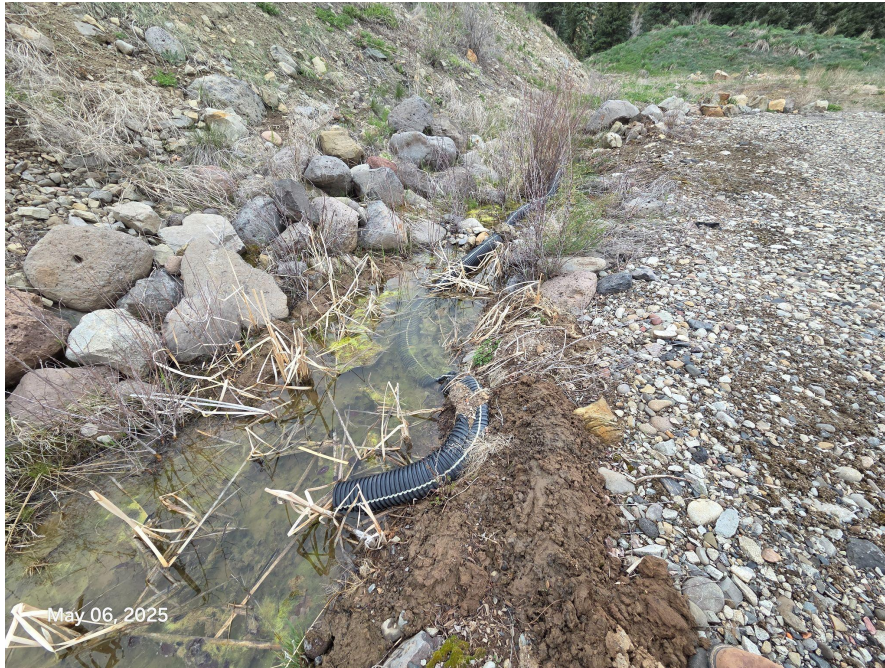
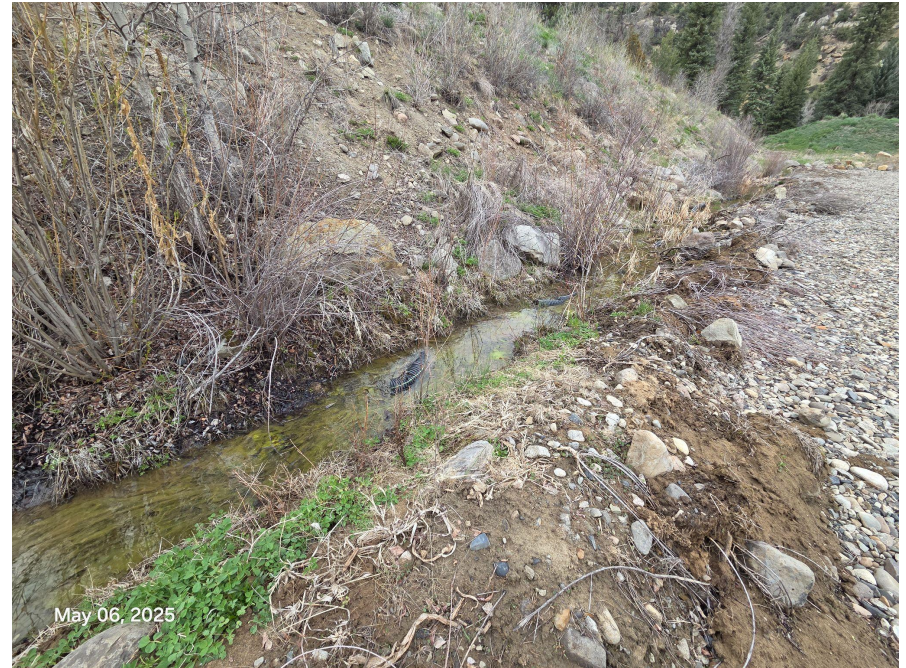
**Photo 7:** See comments under photo 6.
