# Inspection Photos

Loc: 476137

Operator: **WILLIFORD ENERGY COMPANY**

Inspection Date: 5/13/2025

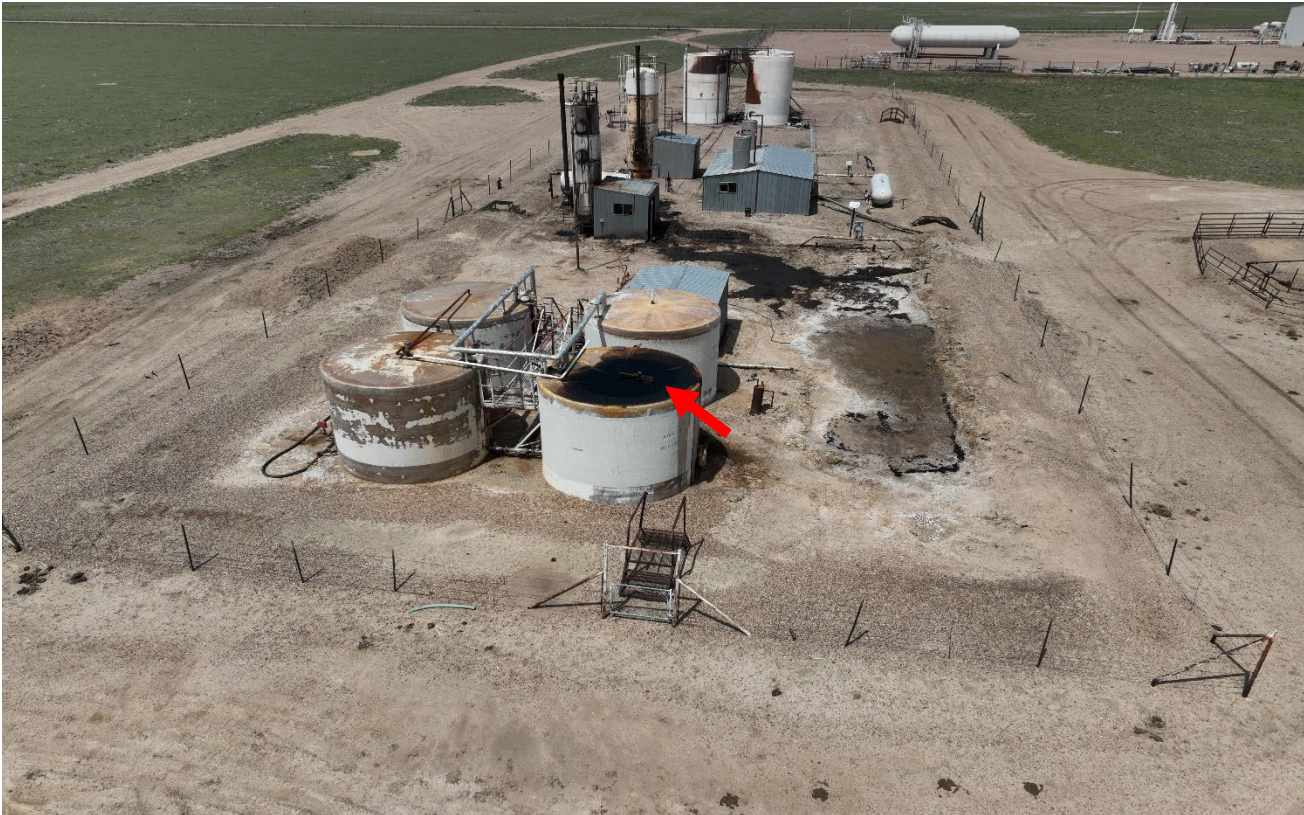
**Photo 1.** Drone aerial photo facing northeast toward the tank battery facility. There is a new spill that has recently occurred in addition to previous spills. The top of the tank shown at red arrow still has oily fluids that have not been cleaned up.

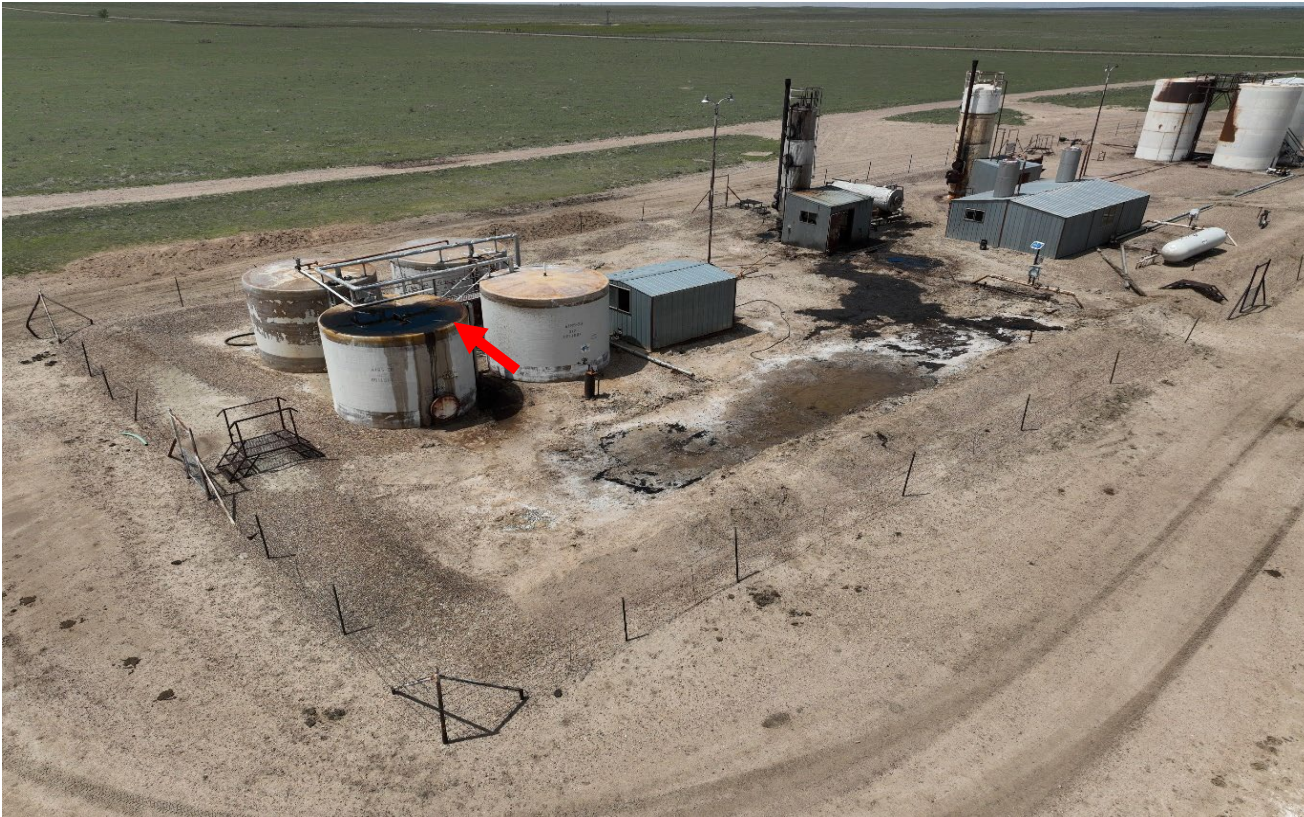
**Photo 2.** Drone aerial photo facing northwest toward the tank battery. There is oily liquid shown on top of the tank at red arrow which need to be cleaned up and properly disposed. Previous corrective action was not completed.

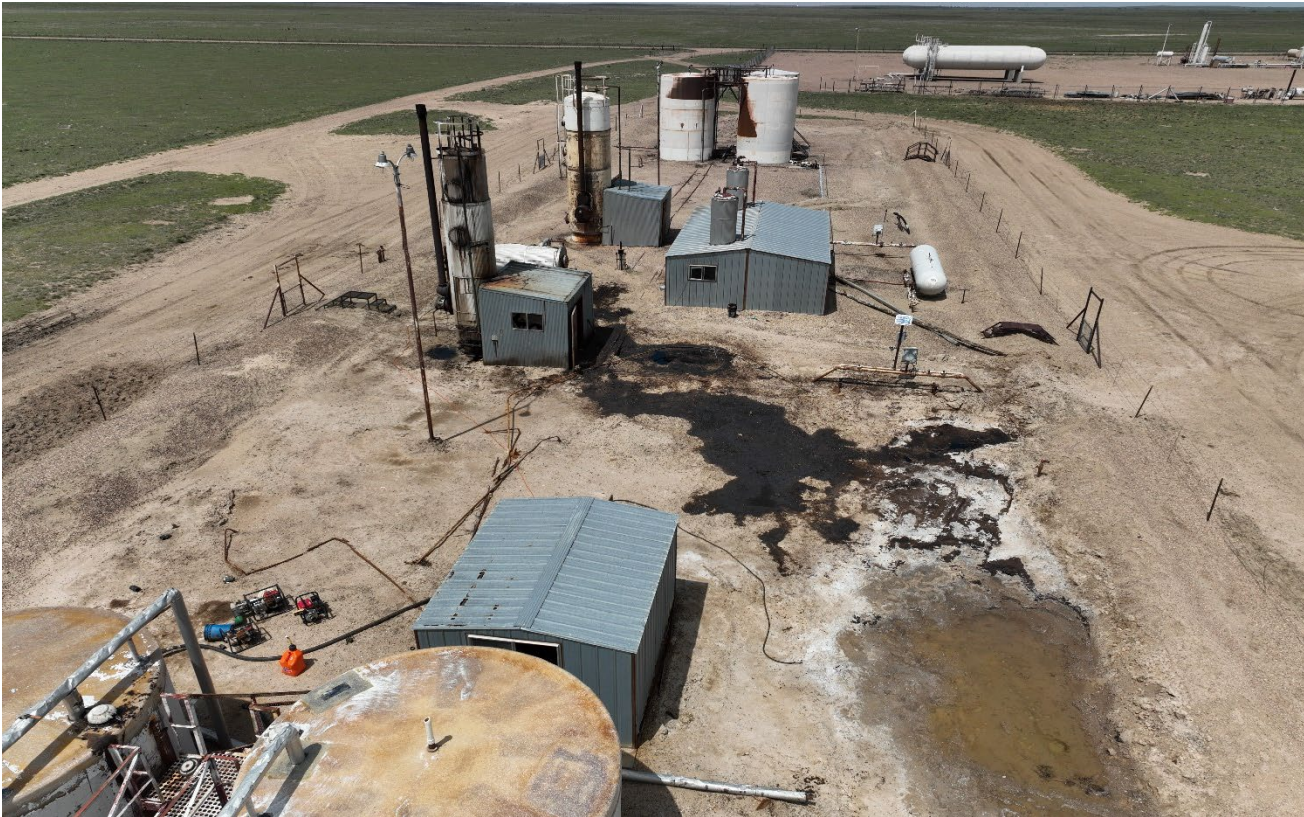
**Photo 3.** Drone aerial photo facing northwest toward the tank battery facility. There is a new spill that has recently occurred in addition to previous spills at this same area and at the same equipment.

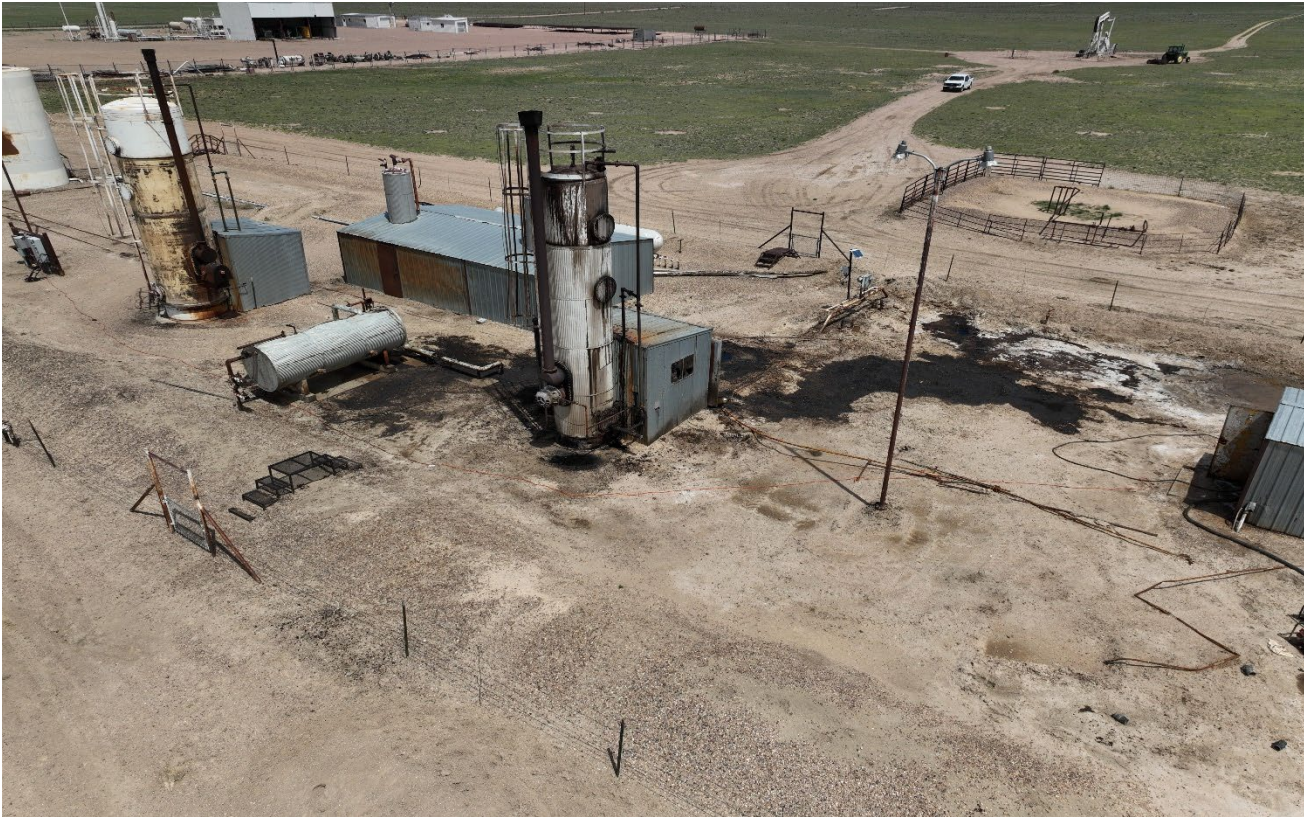
**Photo 4.** Drone aerial photo facing toward the heater treater where spill occurred.

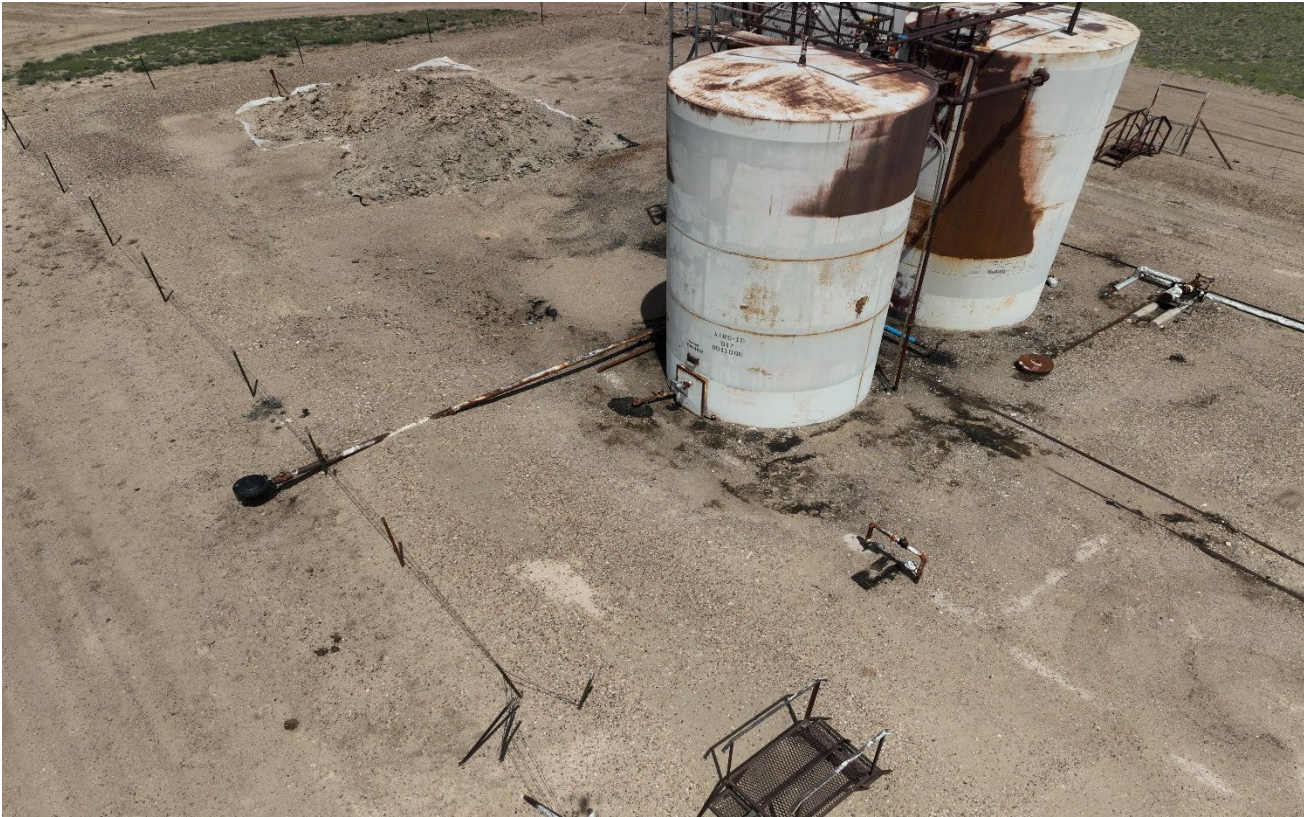
**Photo 5.** Drone aerial photo facing down toward the north side of the tank battery. Oil stained soils still remain around the tanks and have not been cleaned up.

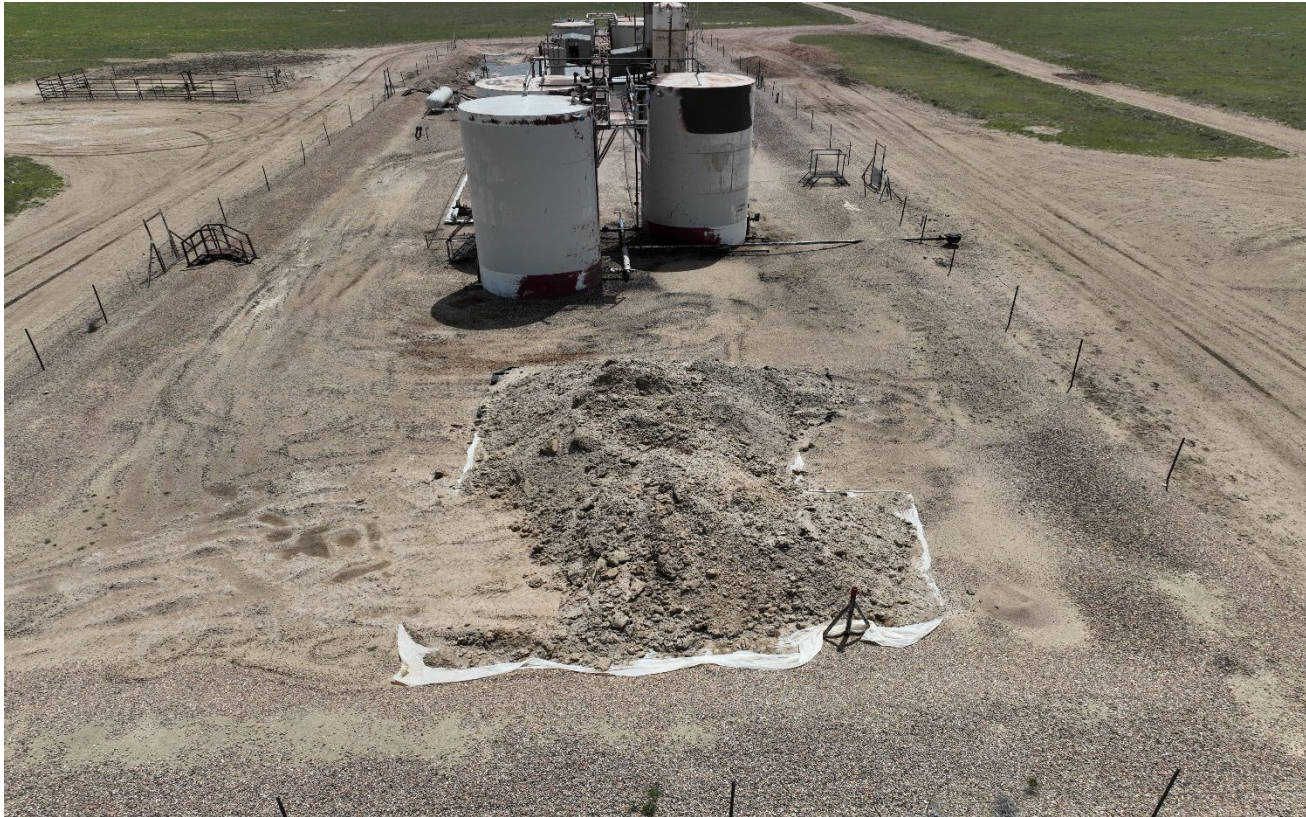
**Photo 6.** Drone aerial photo facing south toward the tank battery facility. E&P waste material remains on plastic liner at this area.

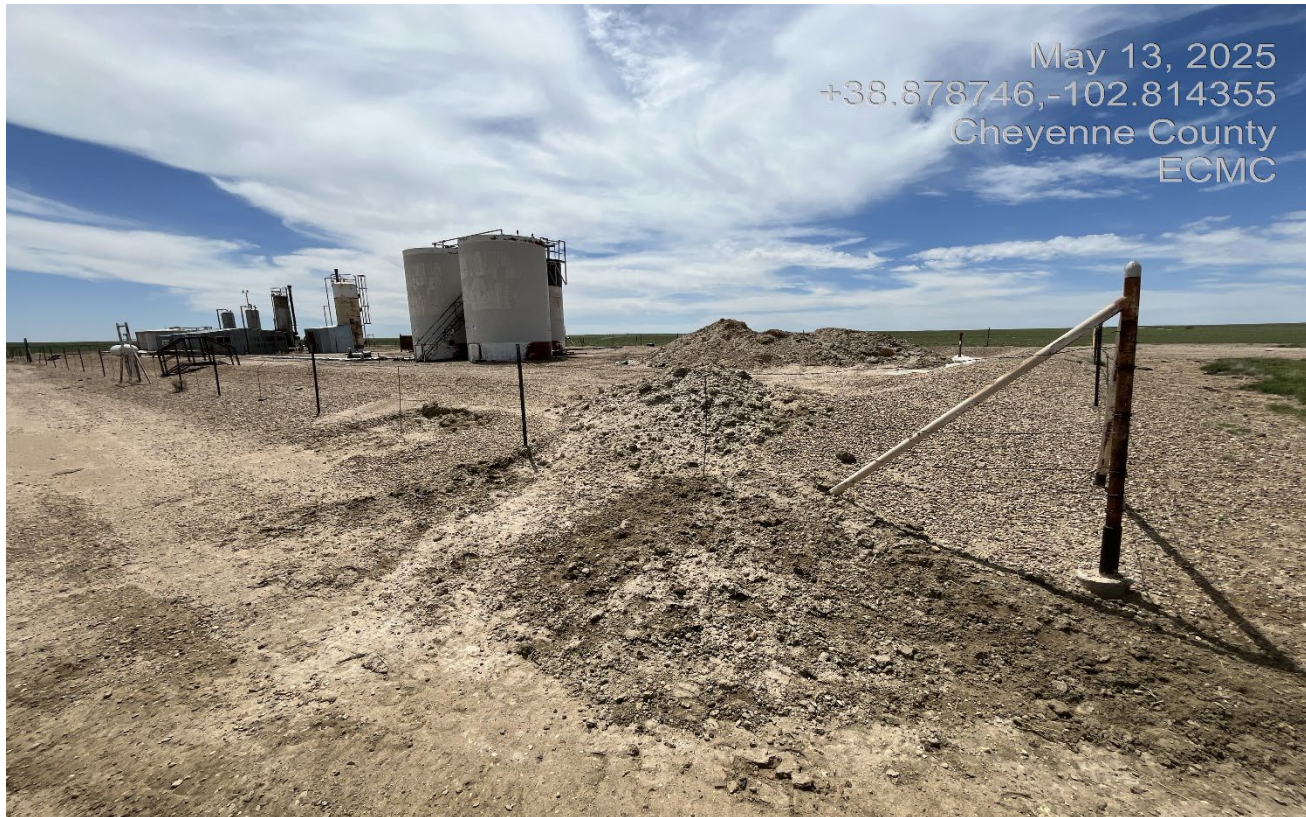
**Photo 7.** Facing southwest toward the tank battery. The E&P waste from the previously observed spill remains at the north side of the tank battery.

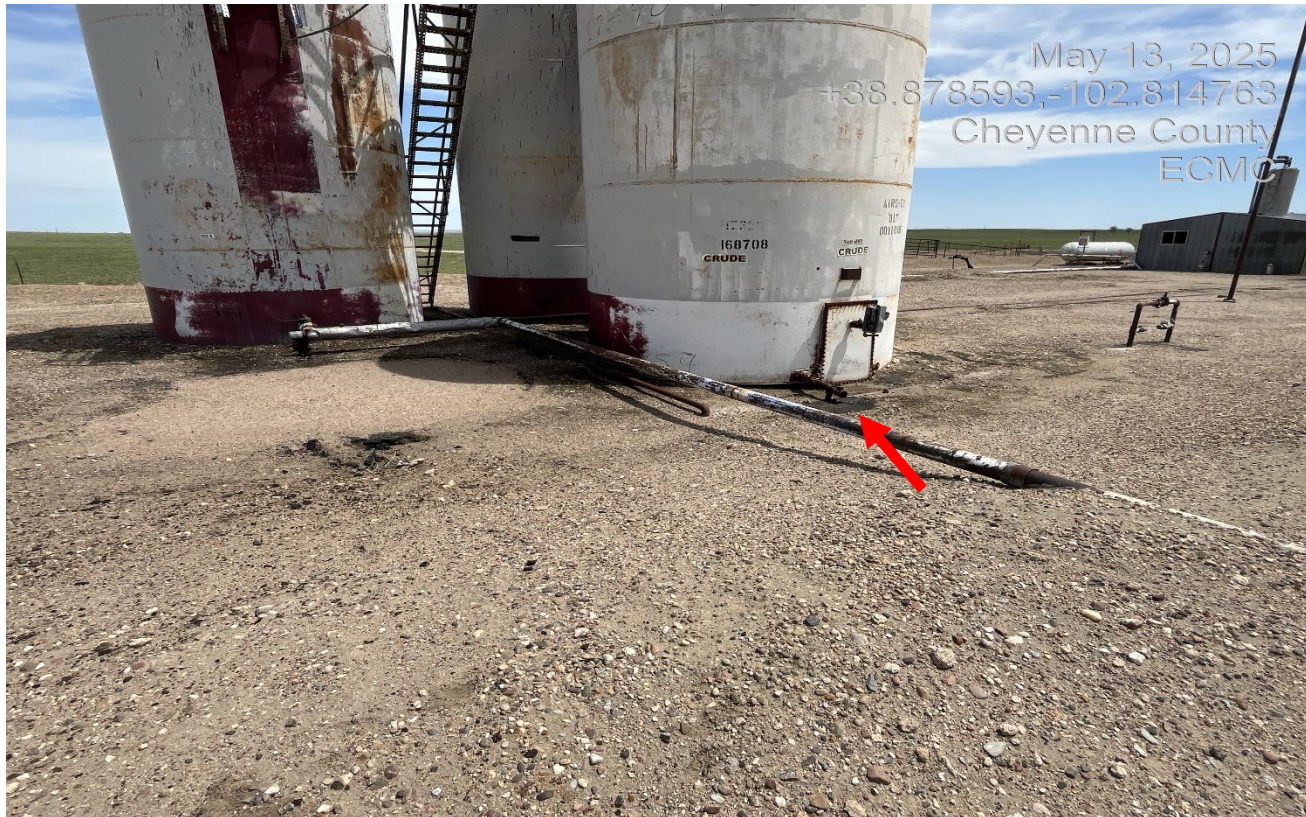
**Photo 8.** Facing southeast toward the tank battery. The oil stained waste remains around the tanks. Some of the tanks were removed since the previous inspection.

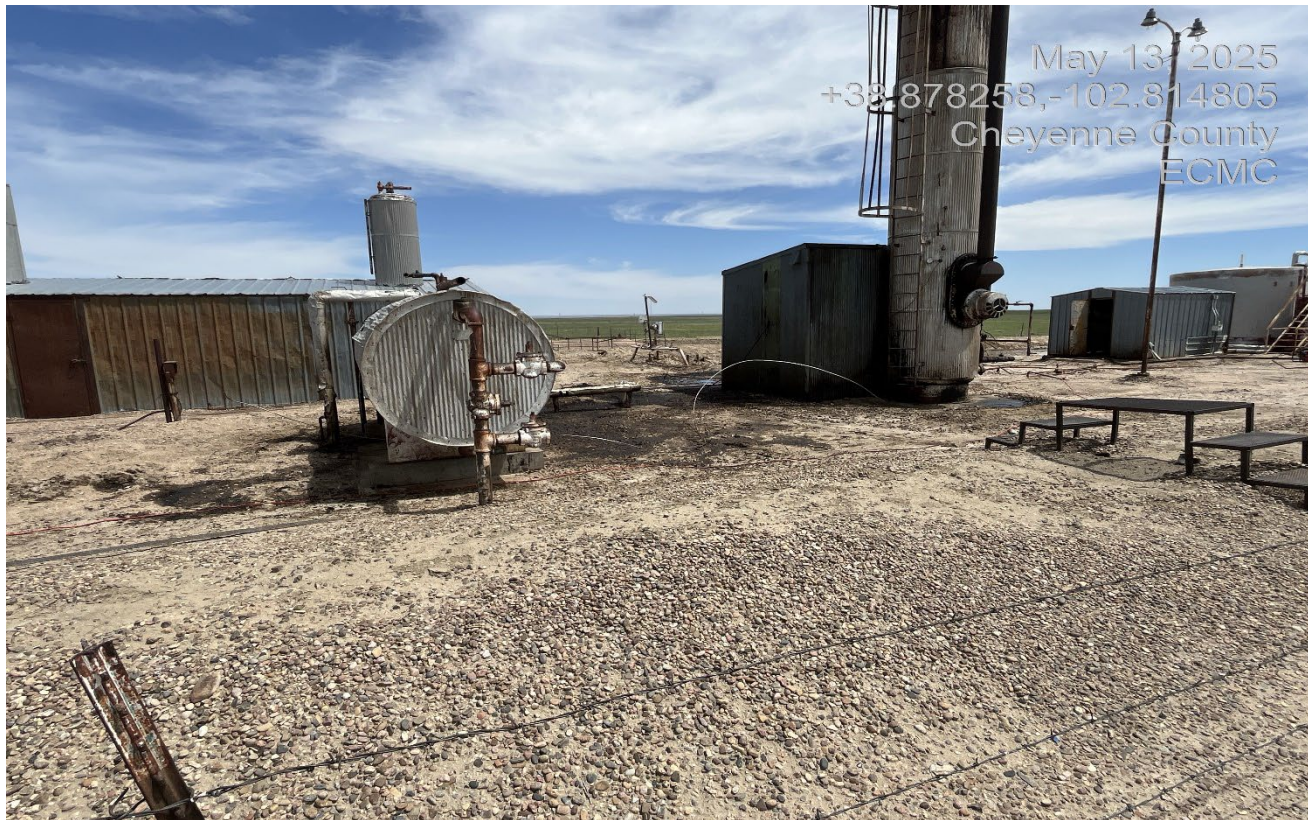
**Photo 9.** Facing southeast toward the area where new and additional spill recently occurred.

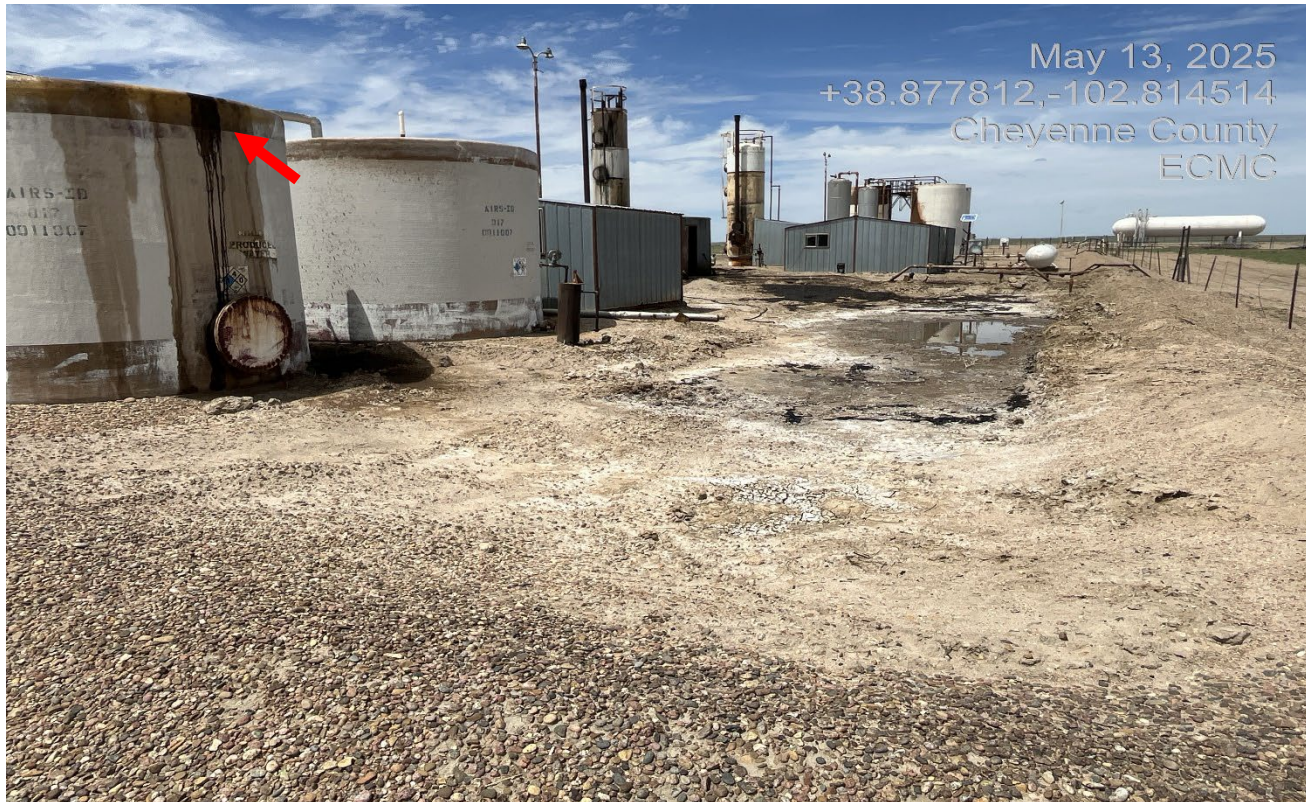
**Photo 10.** Southeast corner of the location facing northwest toward the tank battery facility. There are signs of a leak at the top of the fiberglass tank shown at red arrow.

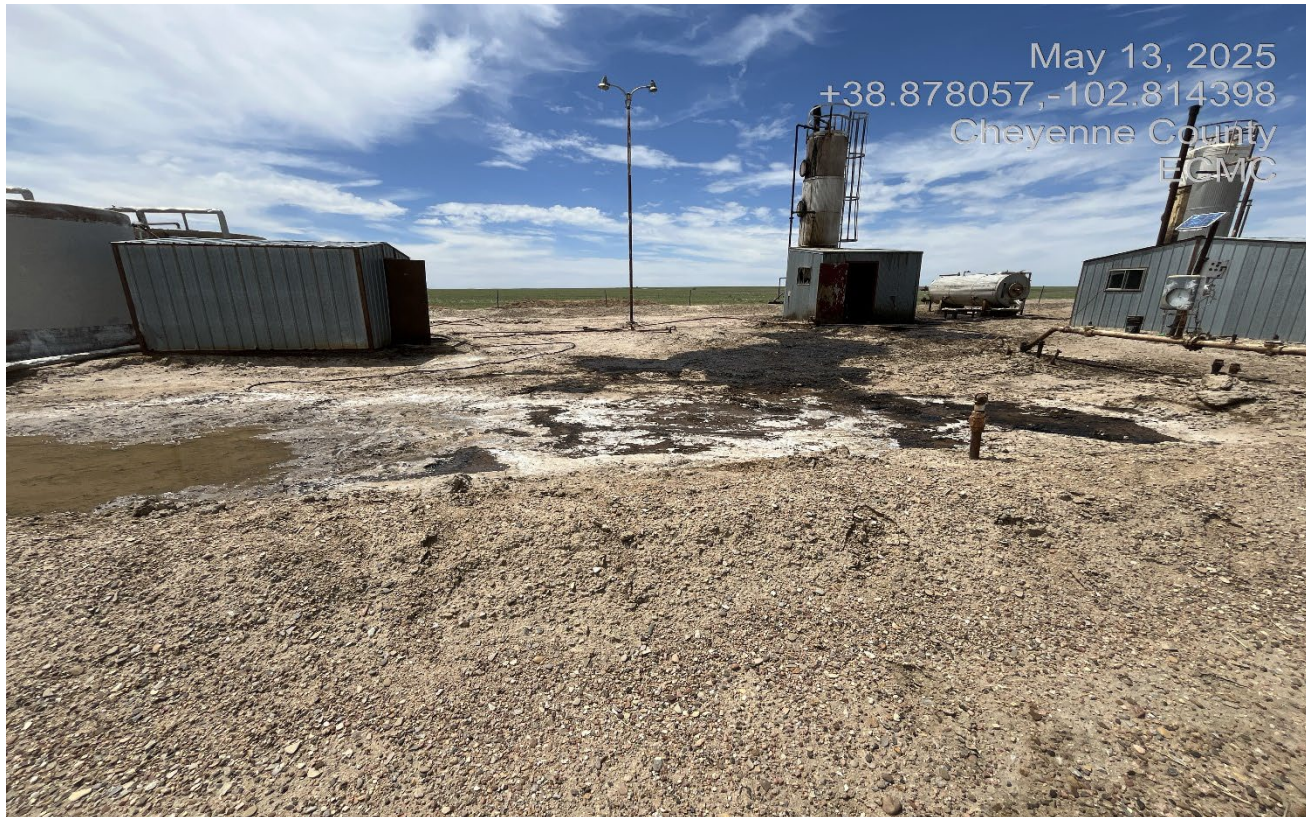
**Photo 11.** Facing west toward the area where new and additional spill recently occurred.

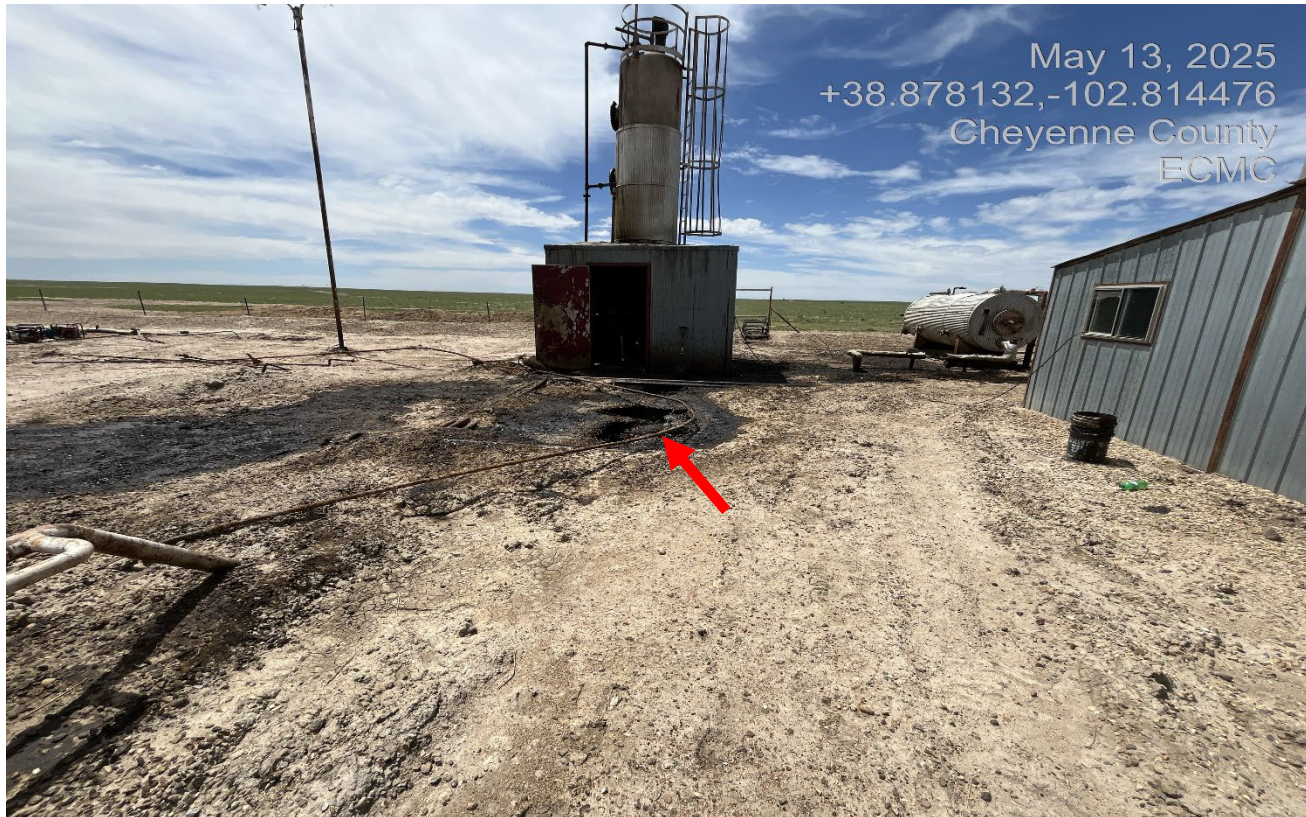
**Photo 12.** There is puddled oil free fluids shown at red arrow that needs immediate clean up.
