Inspection/Audit Photos

Location Name: QB ENERGY OPERATING LLC COUEY 32-14 (N32) Pad

Location #: 334856

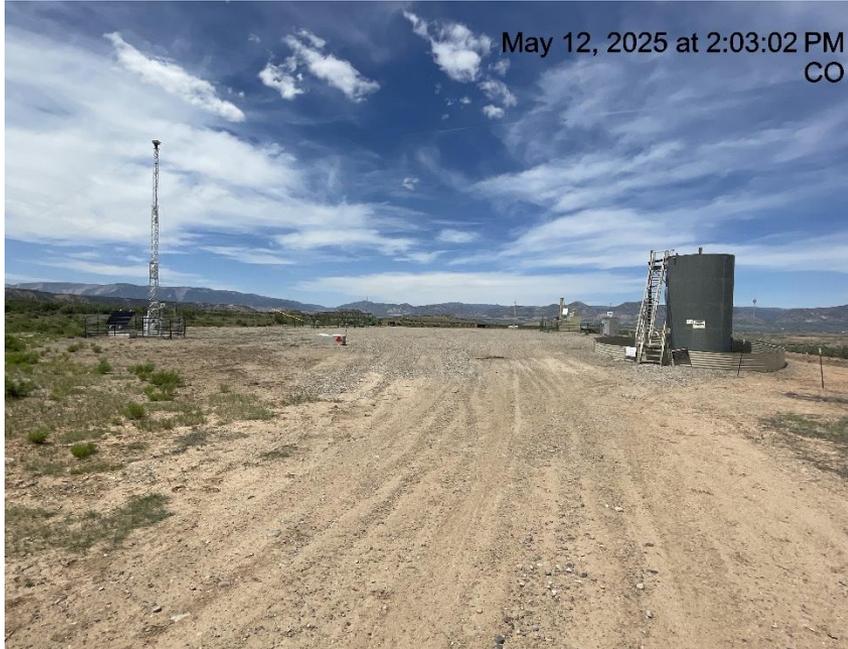
Photo # 315 From entrance to location

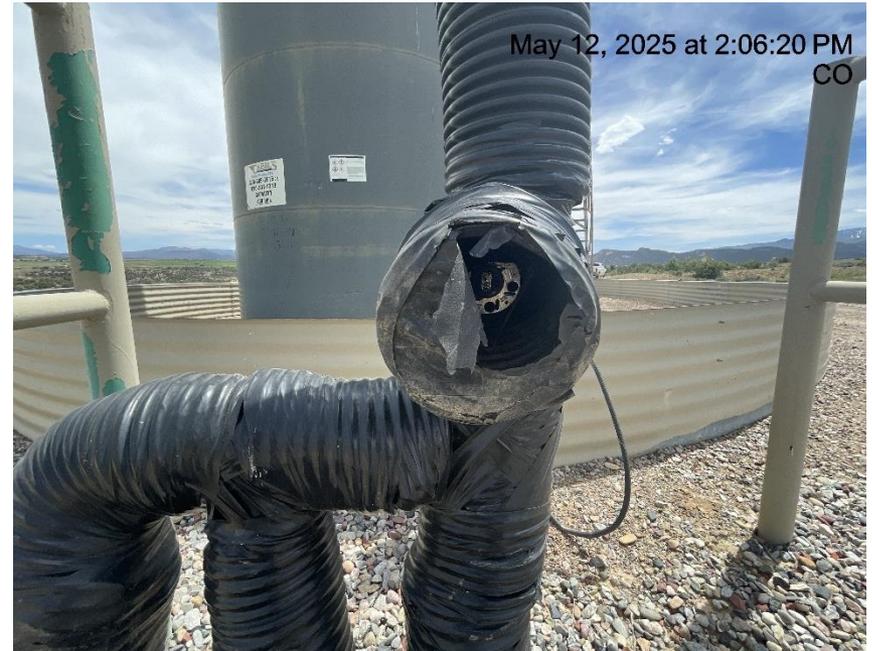
Photo # 322 Flowline heating insulation open ended/wildlife hazard/available for entry by wildlife

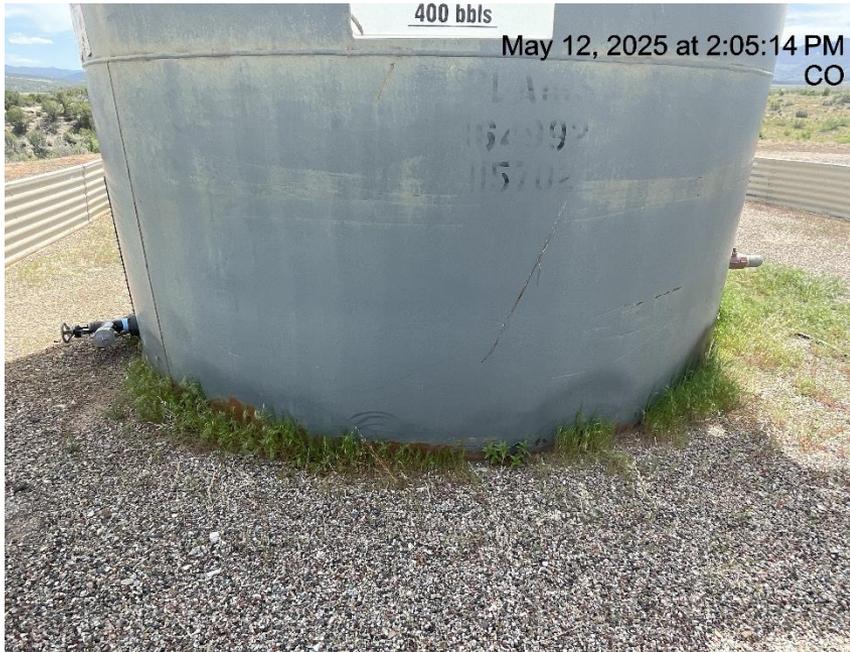
Photo # 323 Weeds in secondary containment

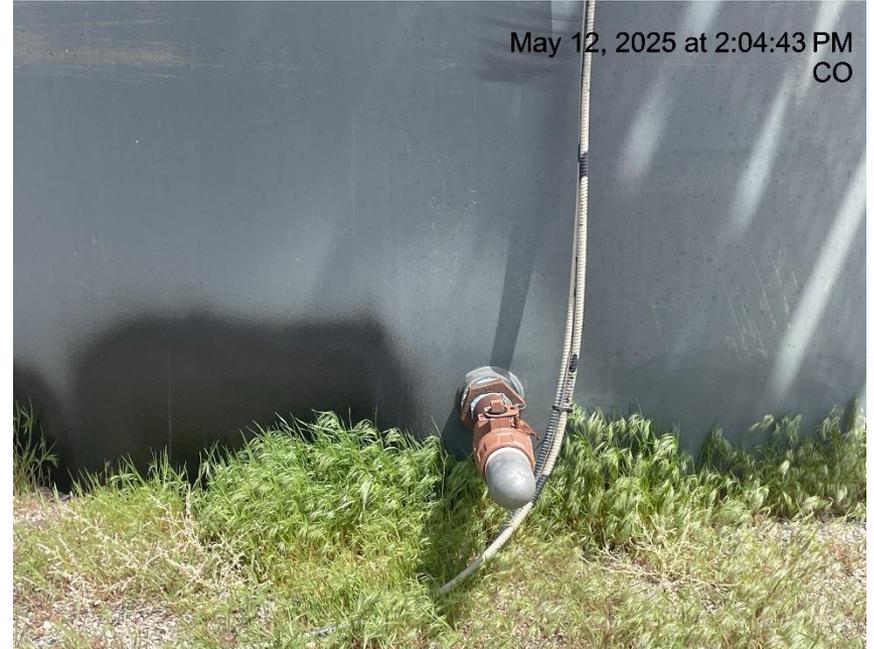
Photo # 324 Weeds in secondary containment

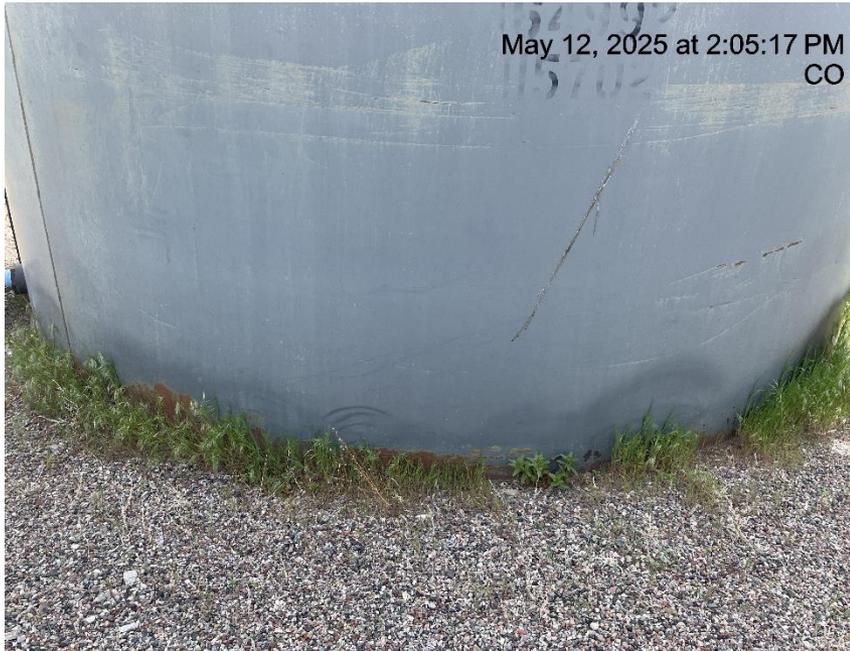
Photo # 325 Weeds in secondary containment

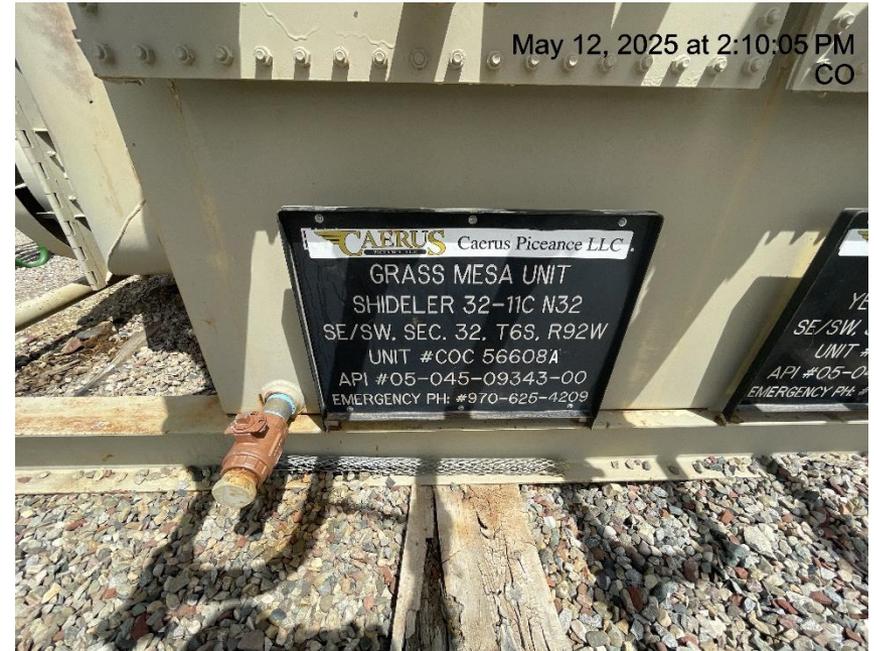
Photo # 326 Emergency contact # on wellhead signs incorrect/# is disconnected & not in service

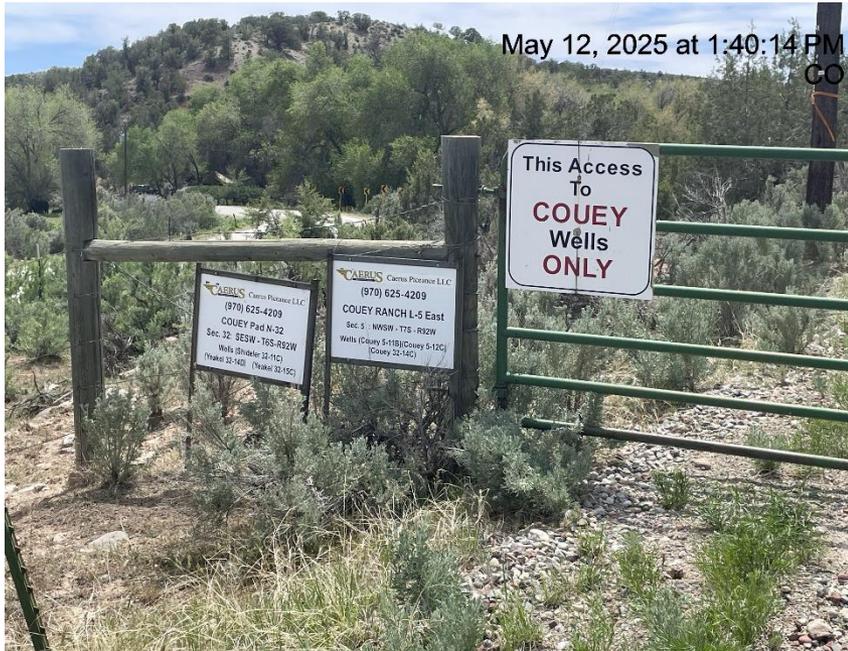
Photo # 327 Emergency contact # on signs at intersection of Mamm Creek Road & start of lease road incorrect/# is disconnected & not in service
