Inspection Photos

API: 017-06625

Operator: **WILLIFORD ENERGY COMPANY**

Inspection Date: 5/13/2025

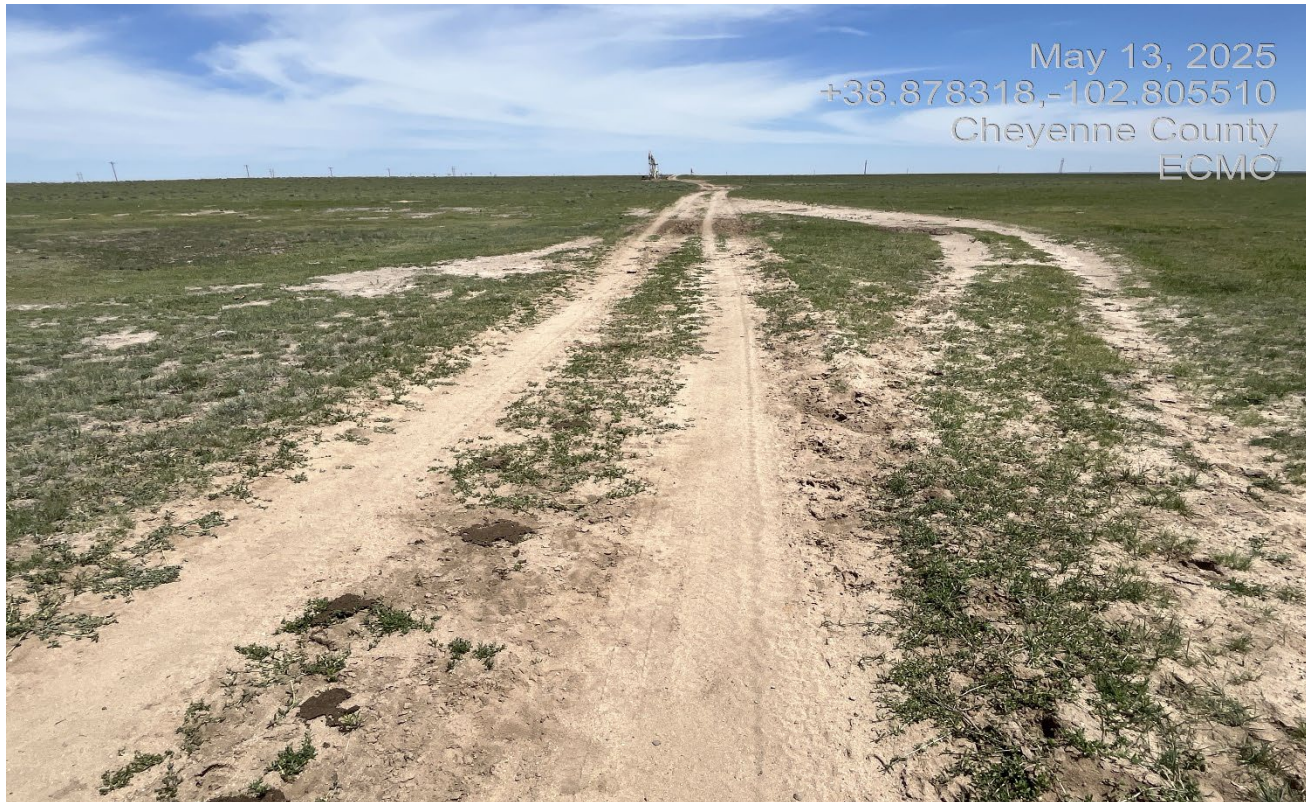
Photo 1. Facing east along the access road. Vehicles caused unnecessary disturbance driving outside of the access road due to stormwater pooling on the road. BMP's have not been installed to stabilize the road and the disturbance has not been reclaimed.

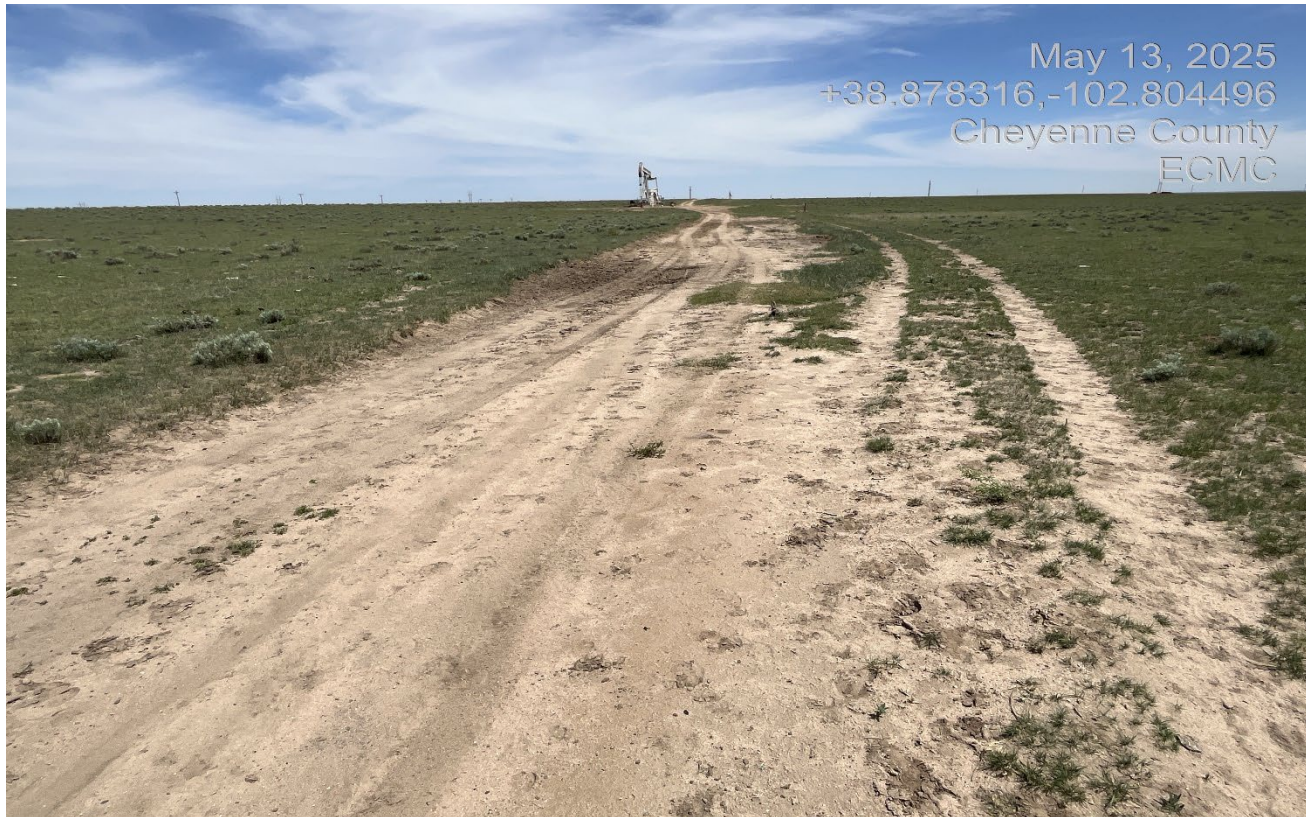
Photo 2. Facing east along the access road. Another area where vehicles caused unnecessary disturbance driving outside of the access road due to stormwater pooling on the road. BMP's have not been installed to stabilize the road and the disturbance has not been reclaimed.

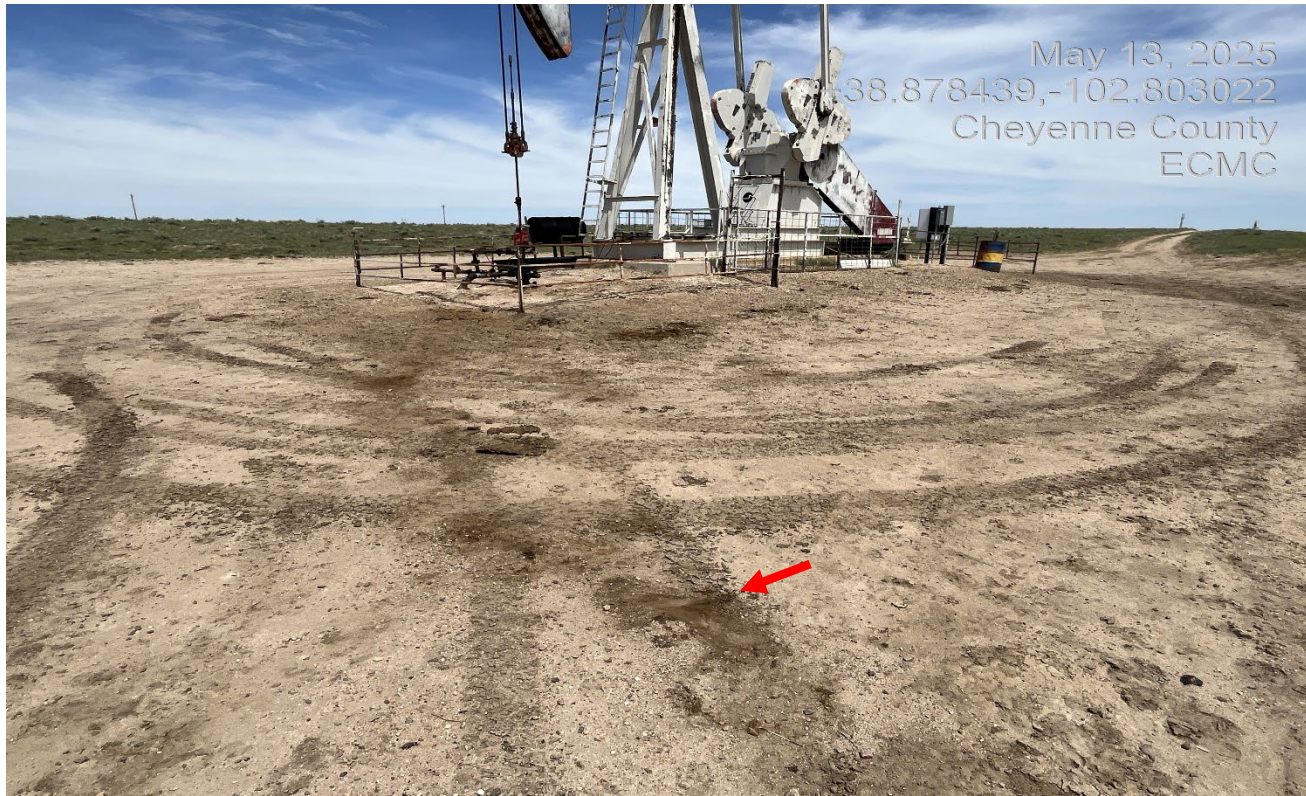
Photo 3. Facing northeast toward the wellsite. There are oil stained soils near the wellhead that have not been cleaned up since the previous inspection. The previous leak observed had flowed approximately 50 ft. to the southwest of the wellhead.

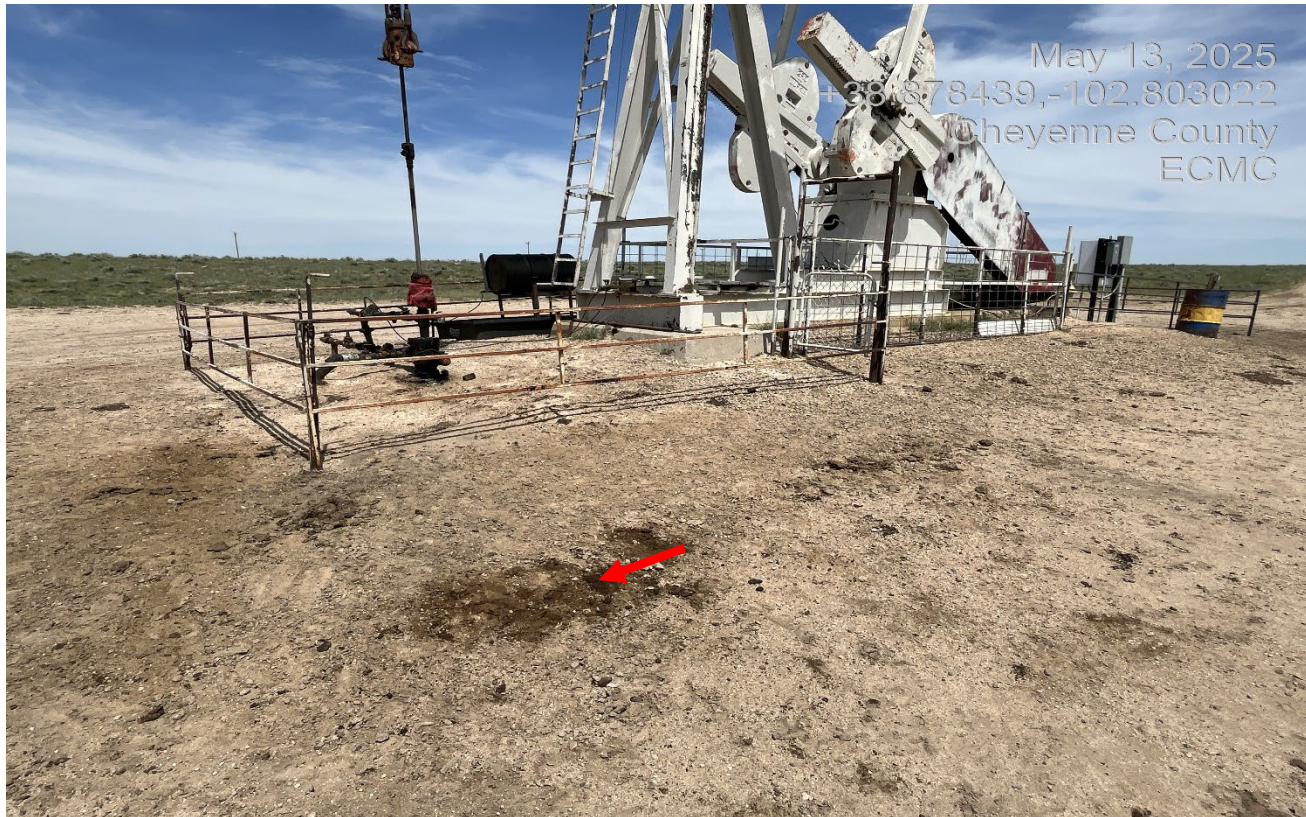
Photo 4. There are stained oily soils from a leak at the wellhead. Stained soils have not been cleaned up since the previous inspection.

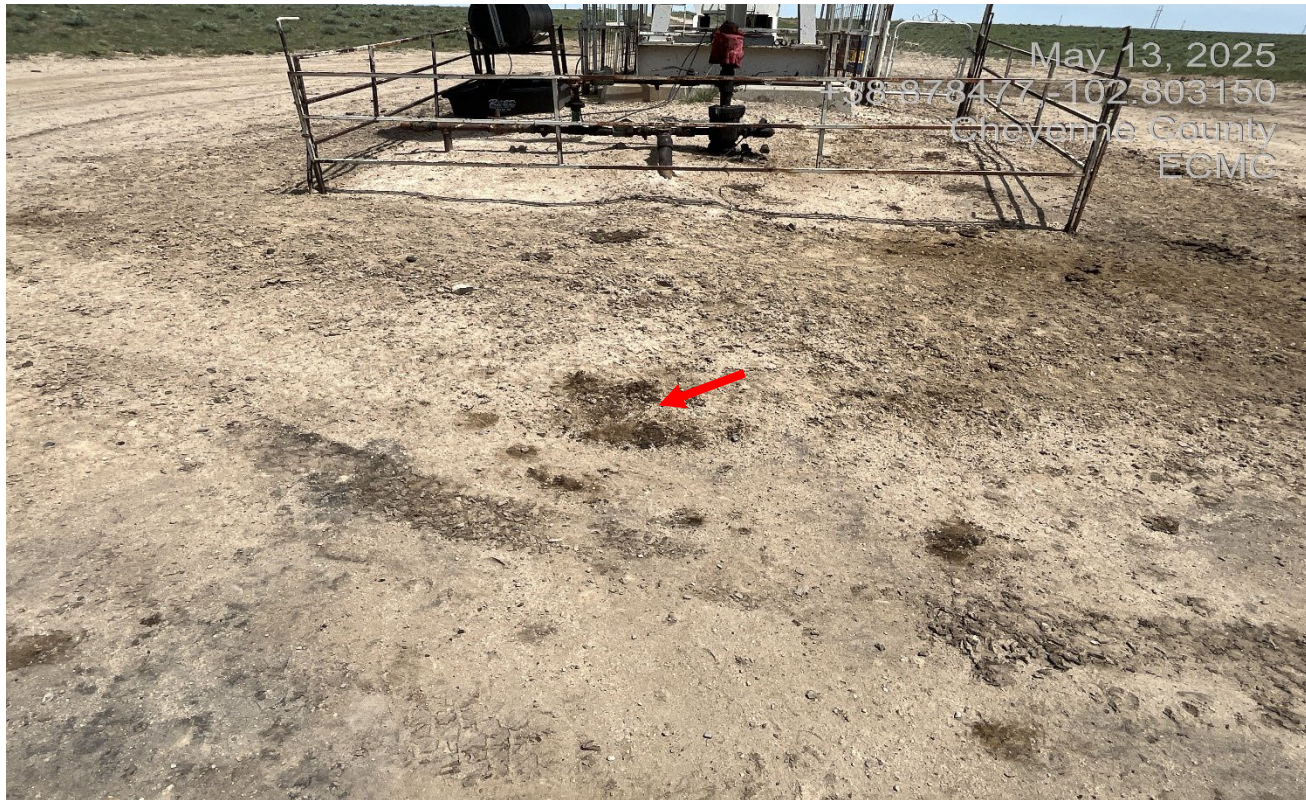
Photo 5. Facing east toward the wellhead. There are still oil stained soils which have not been cleaned up since the previous inspection.

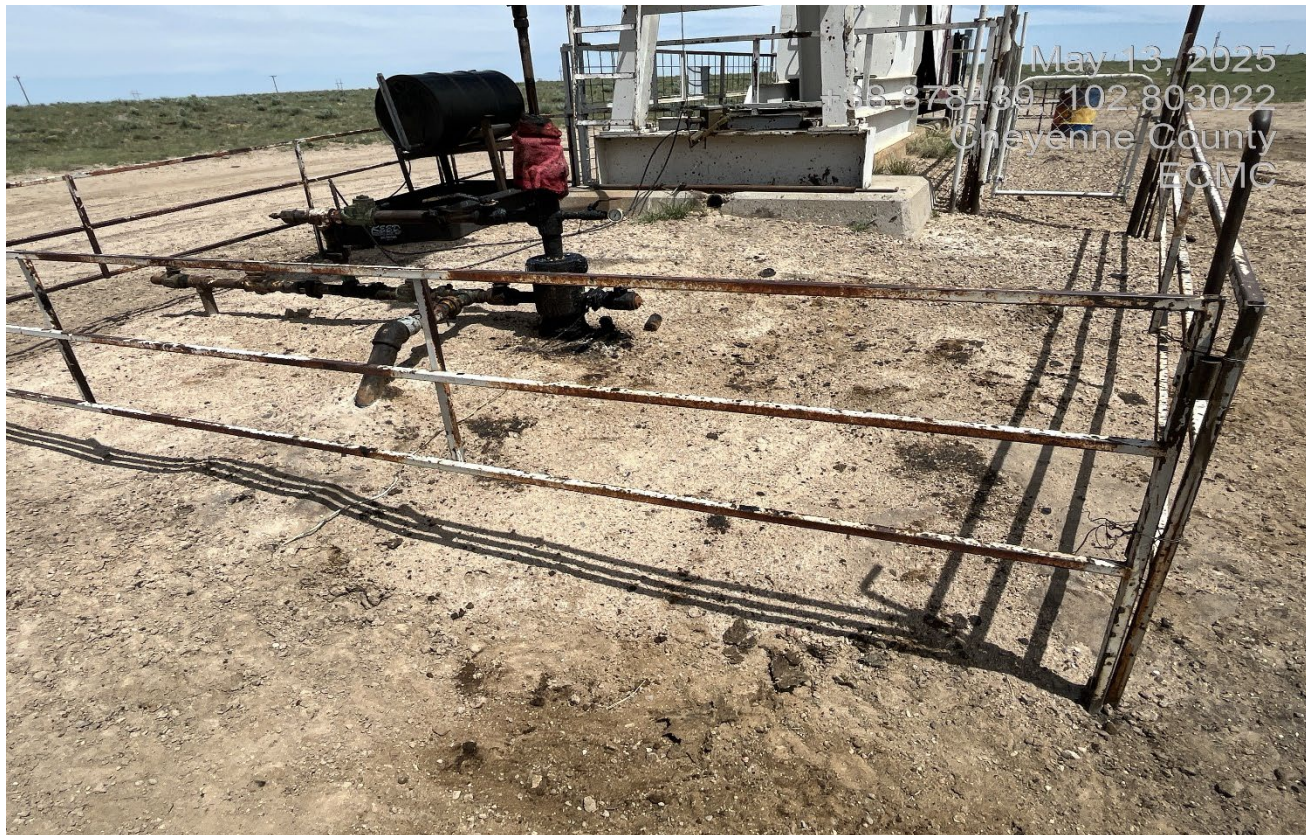
Photo 6. View of wellhead shows stained soils which were previously covered up with sand. Stained soils have not been cleaned up since the previous inspection. The well still appears to be dripping oil.

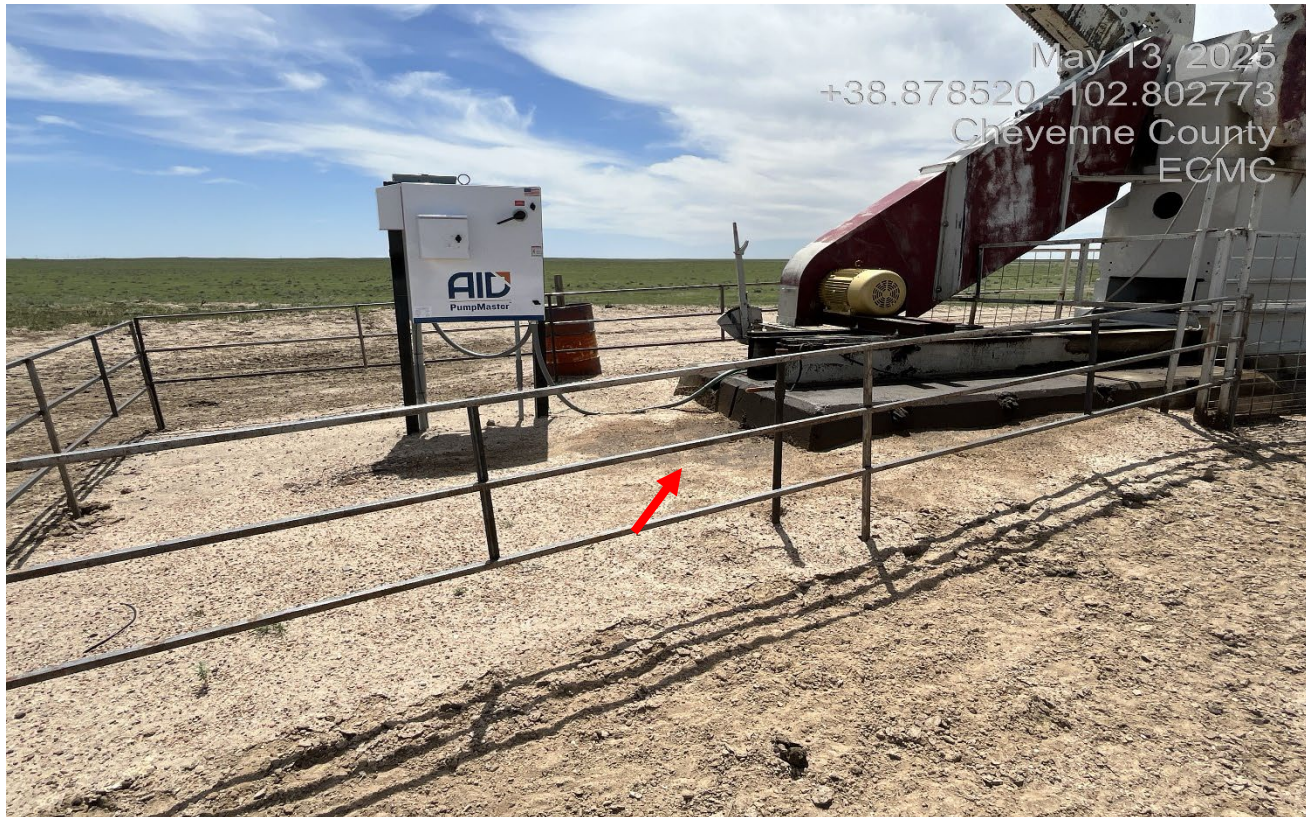
Photo 7. There are still oil stained soils at the pumpjack that have not been cleaned up. Previous corrective action was not completed.

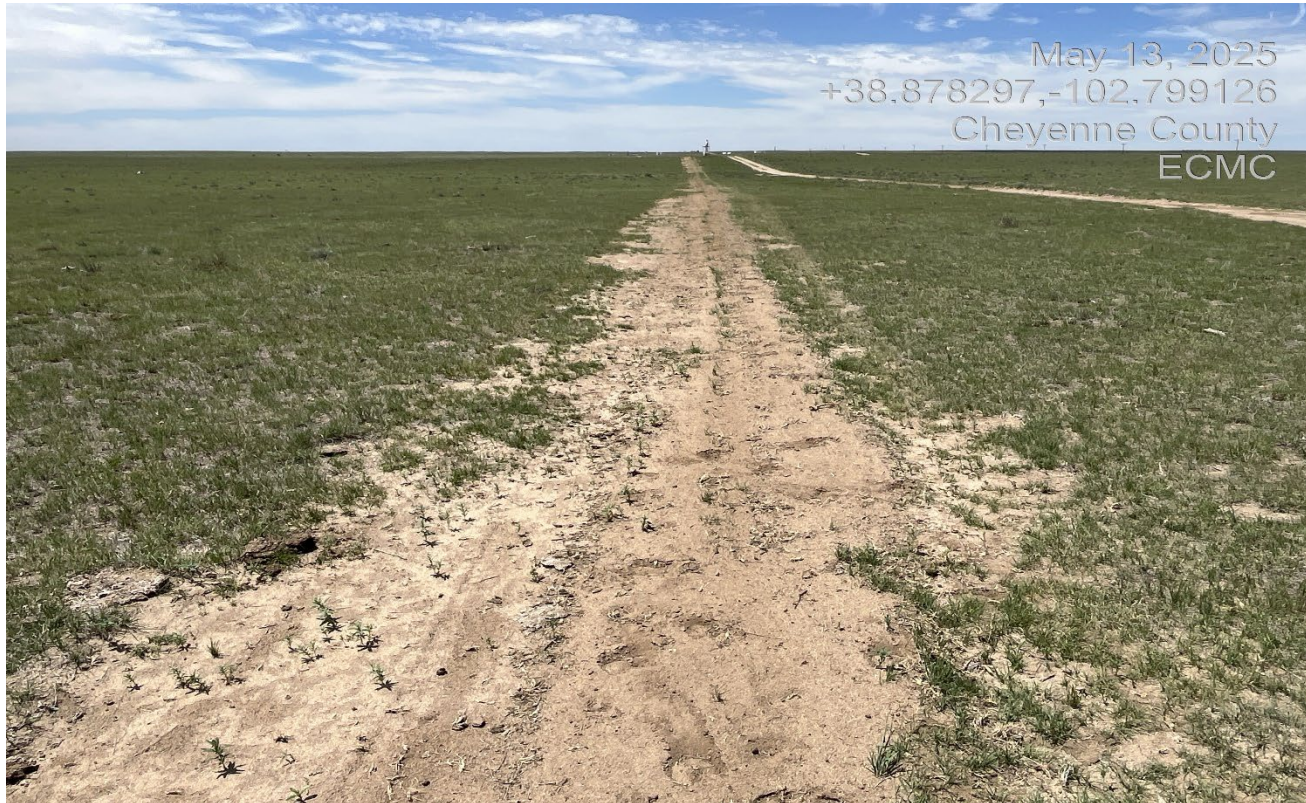
Photo 9. There has been new disturbance from a buried electric line to service the new electric motor at the pumpjack. The disturbed area will need to be reclaimed. Previous corrective action was not completed.
