Inspection Photos
Location Name: Hazel McHale #2 Flowline
Spill ID: 489684

COLORADO
Energy & Carbon Management
Commission
Department of Natural Resources

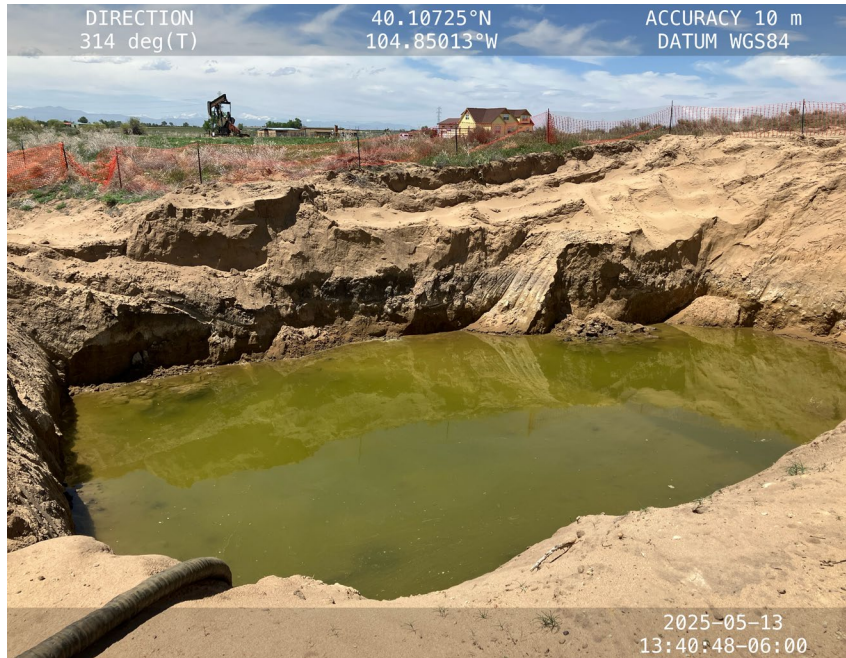
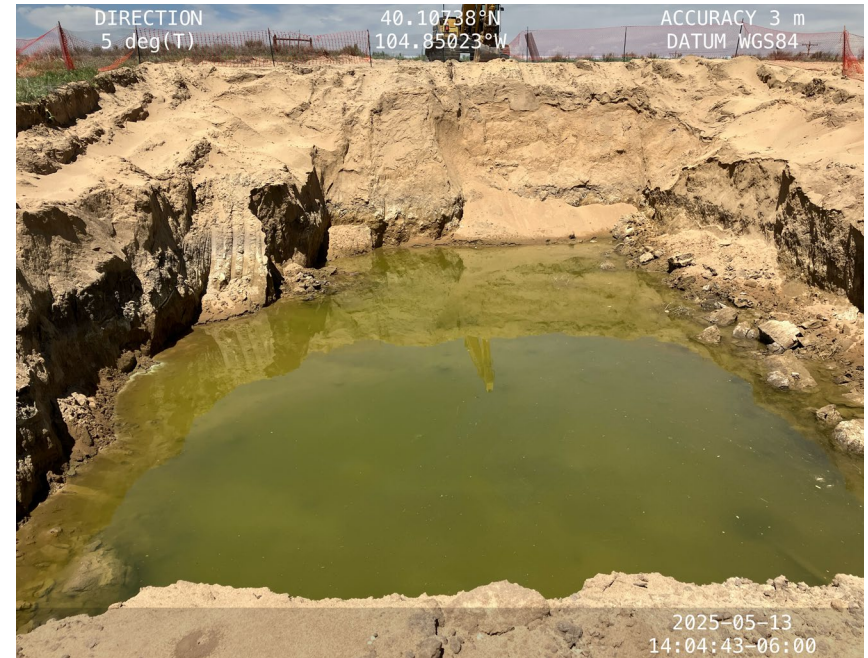
Excavation with Groundwater observed

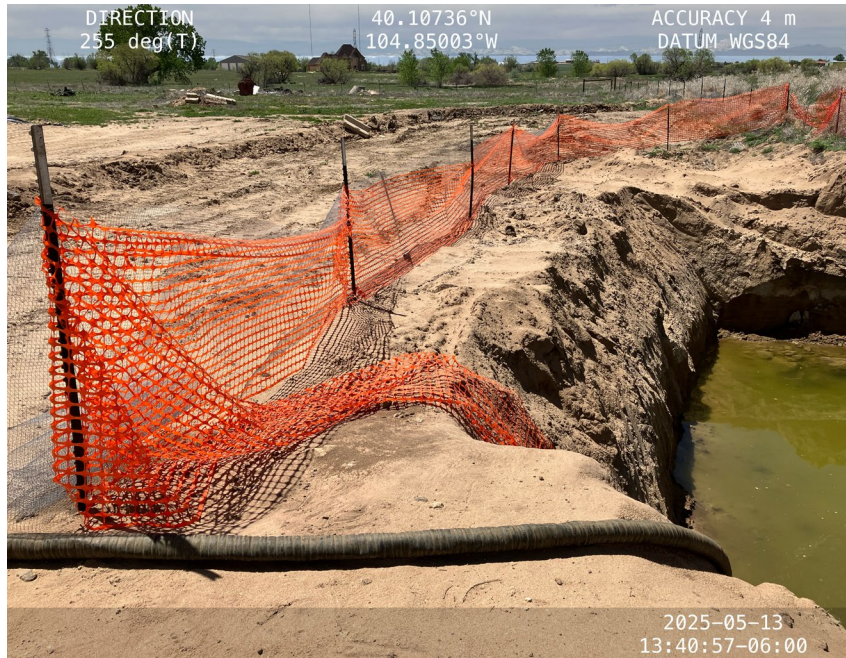
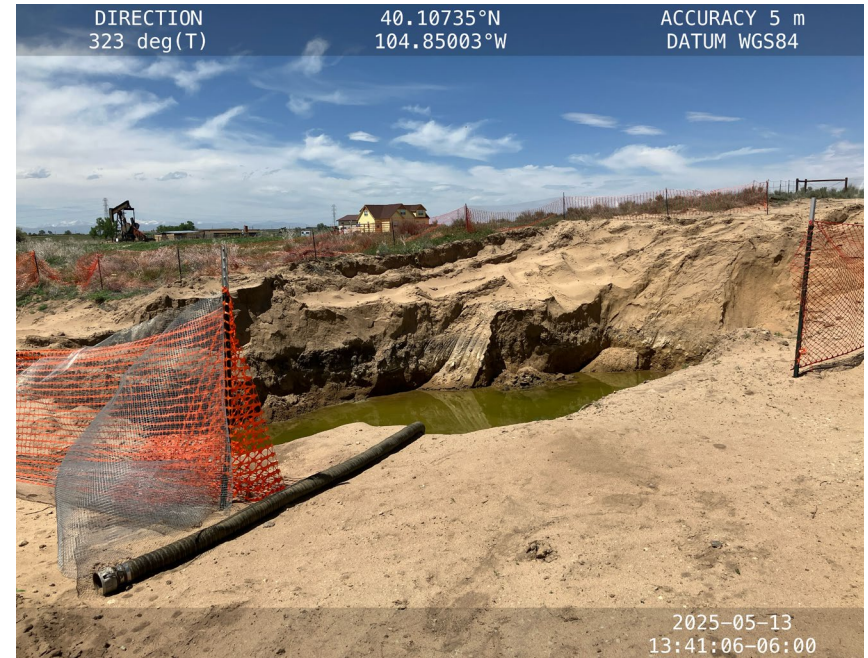
Excavation fencing has fallen

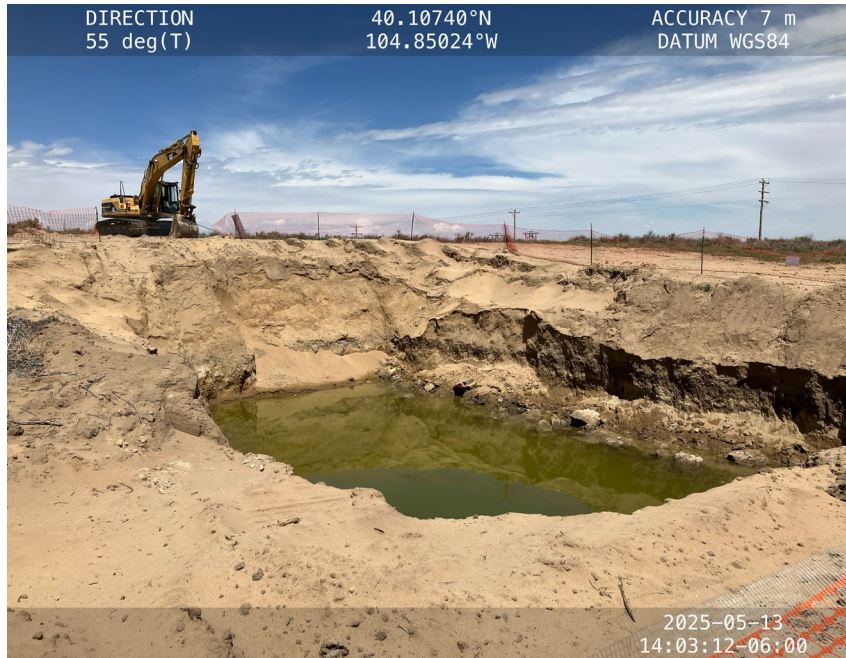
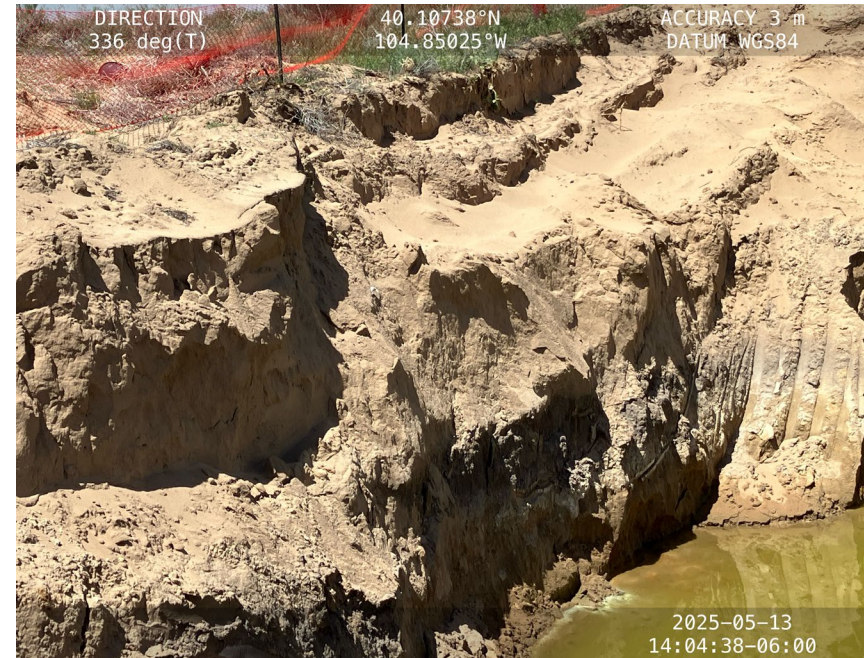
Excavation photos. No benching or sloping.

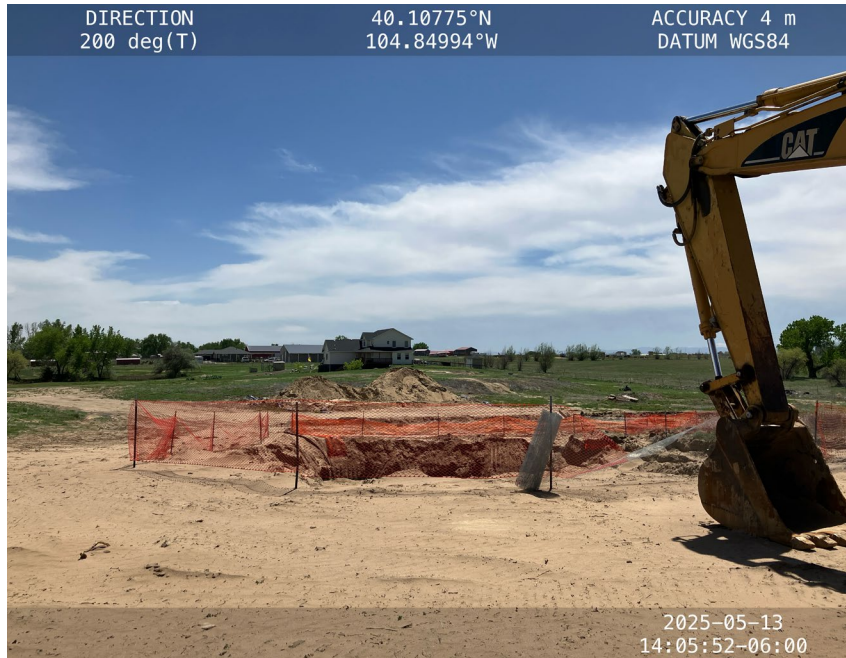
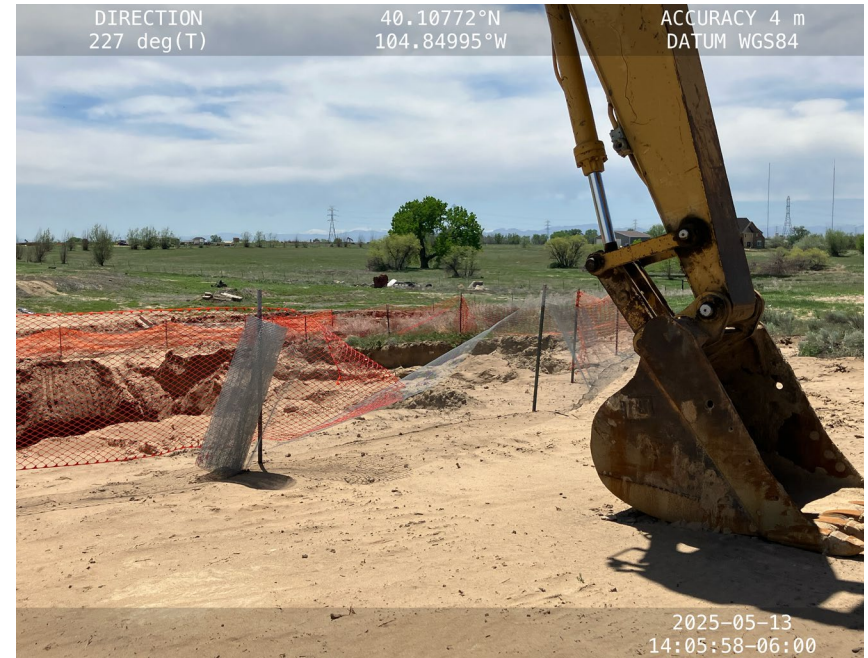
Excavation and fencing photos

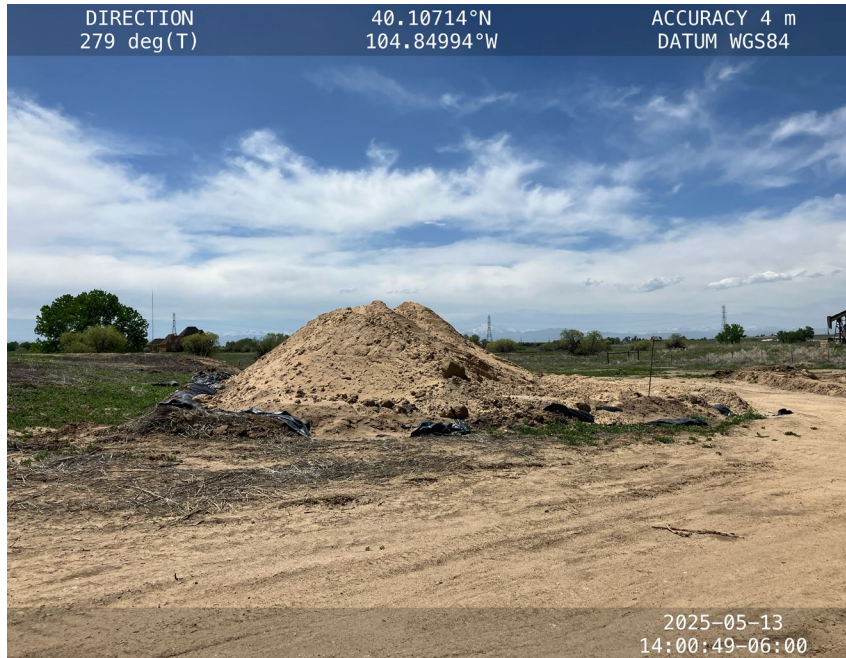
Contaminated Stockpile

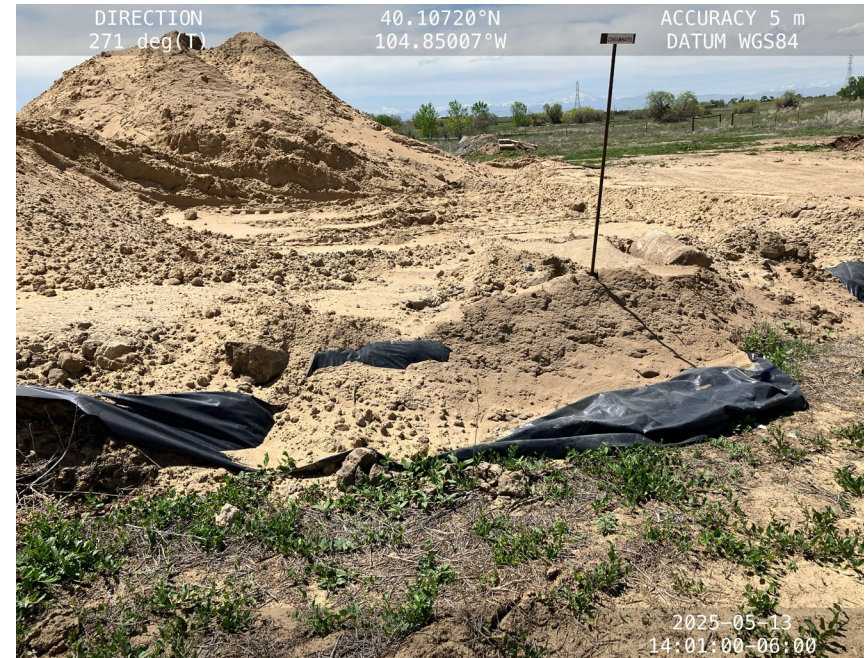
Contaminated soil is overflowing onto the ground past the liner

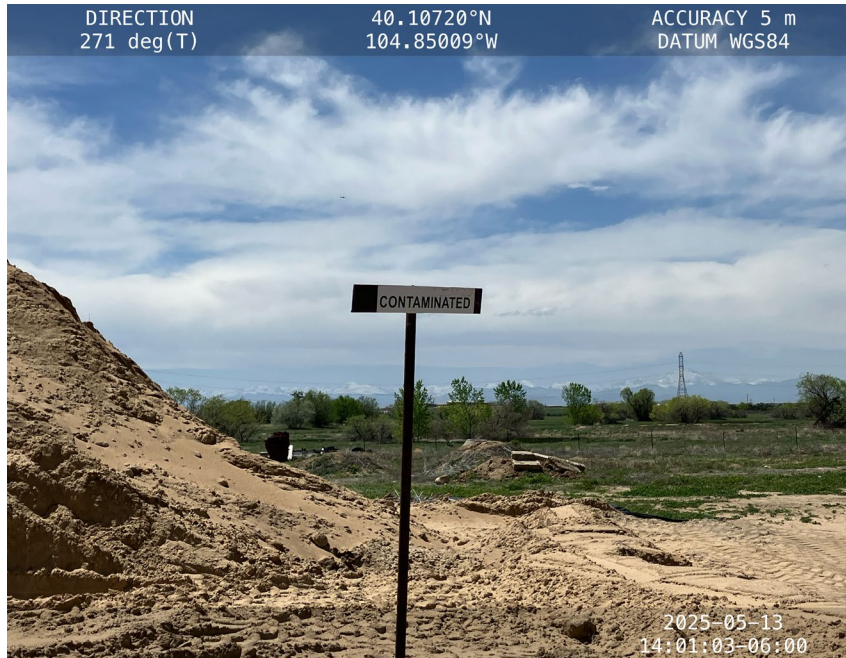
Contaminated Stockpile

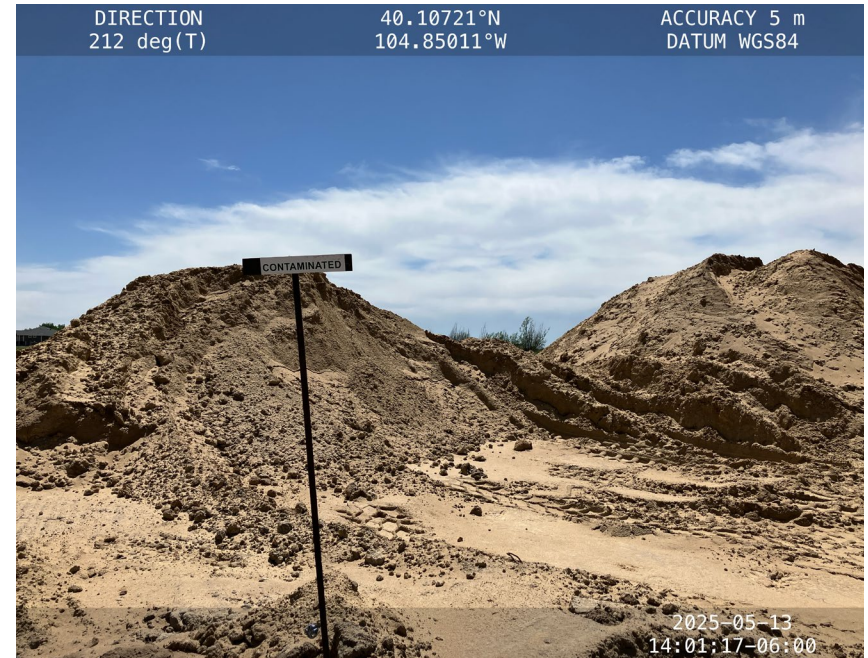
Contaminated Stockpile

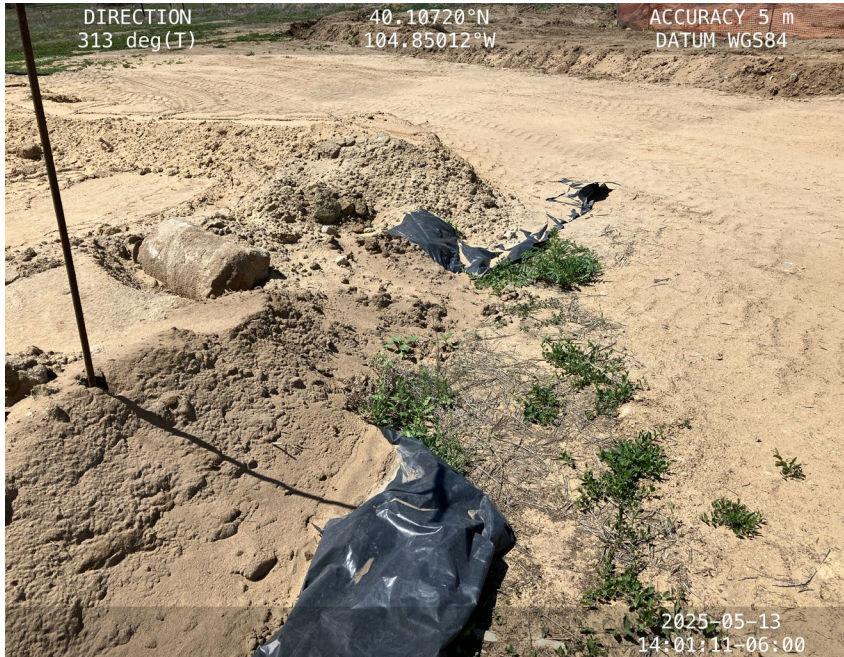
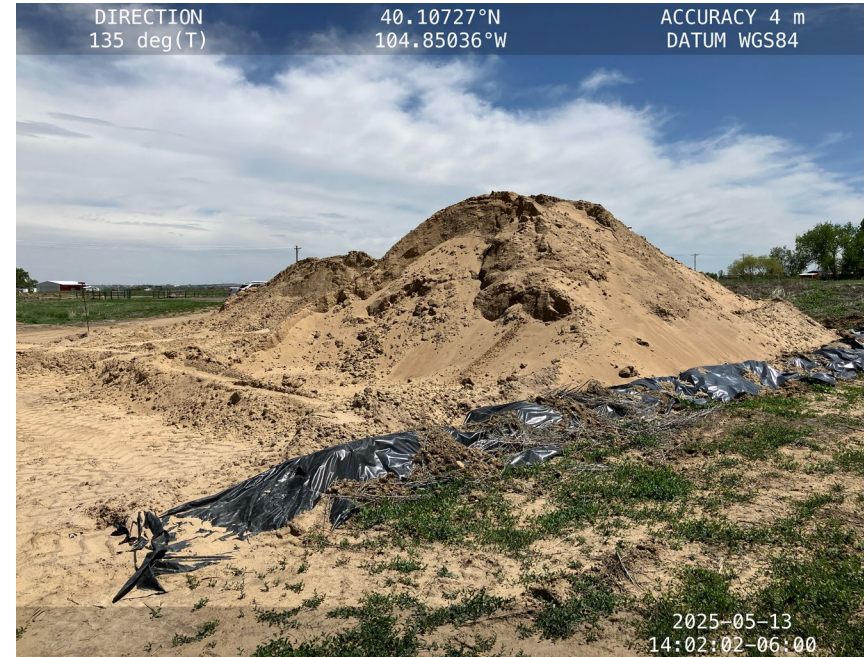
Contaminated soil is overflowing onto the ground past the liner

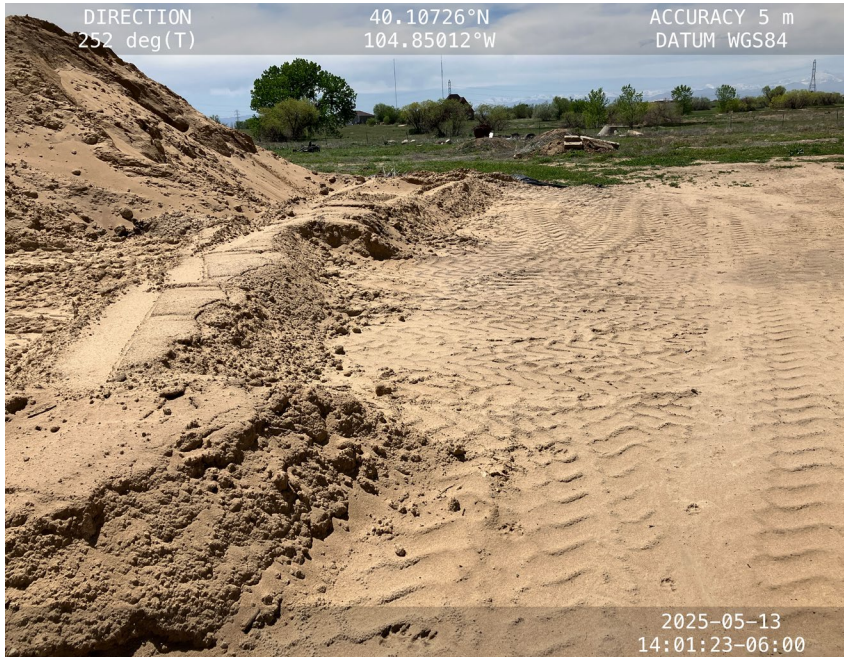
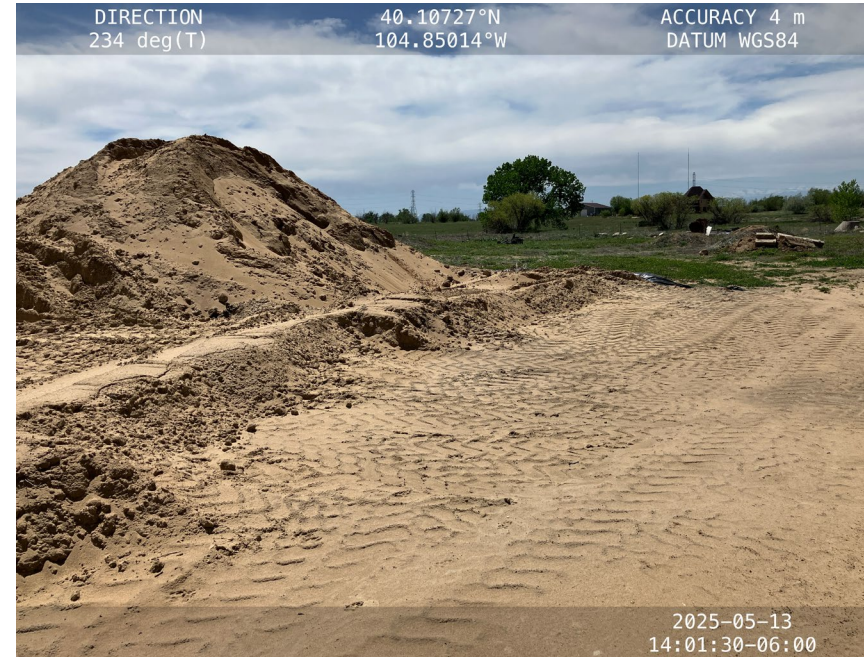
Stockpile soil has runoff to the ground beyond the liner

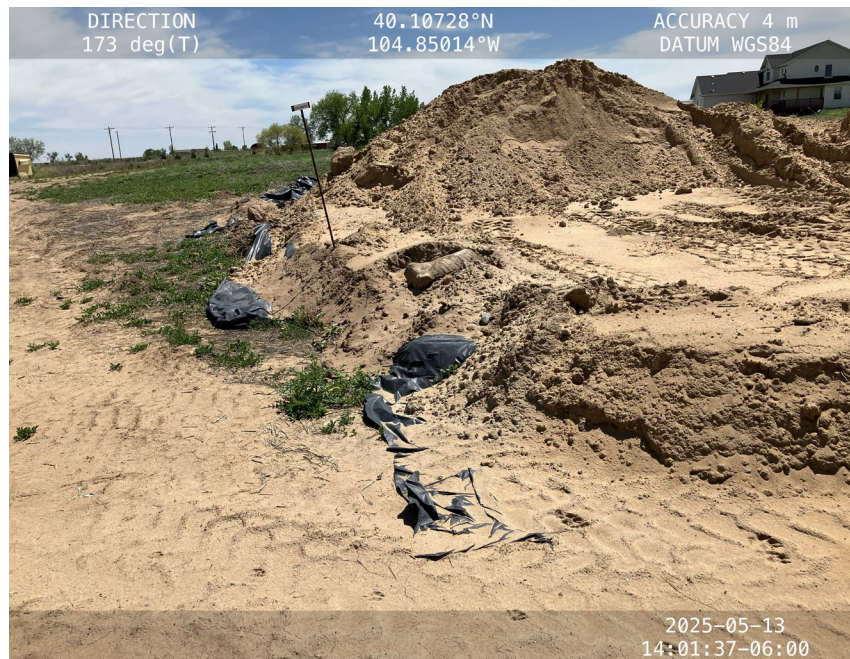
Contaminated stockpile

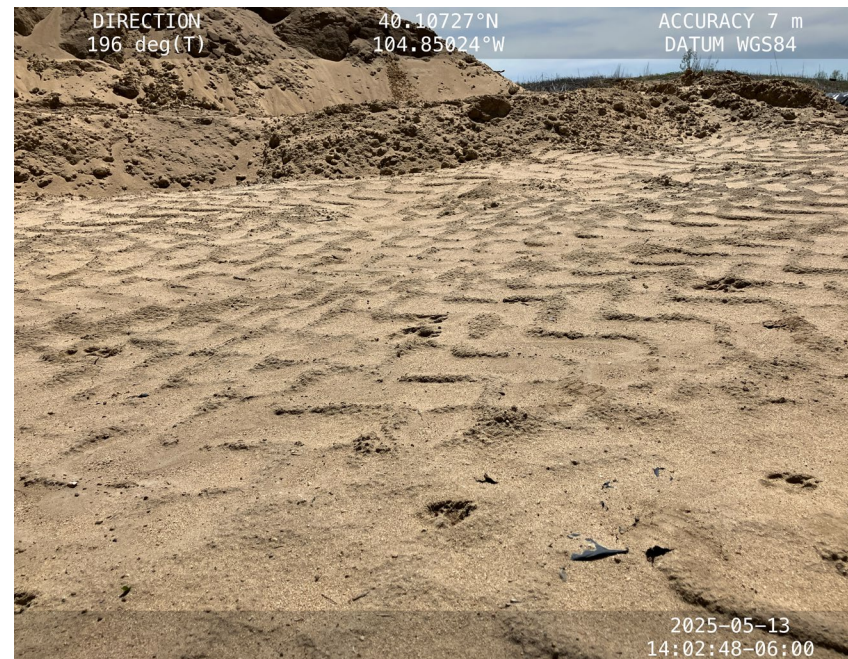
Liner issues

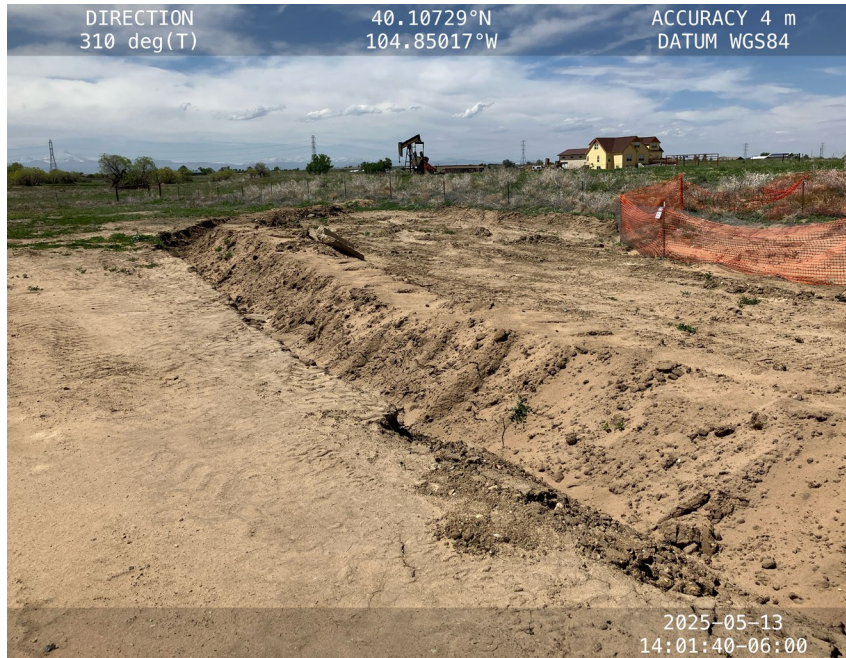
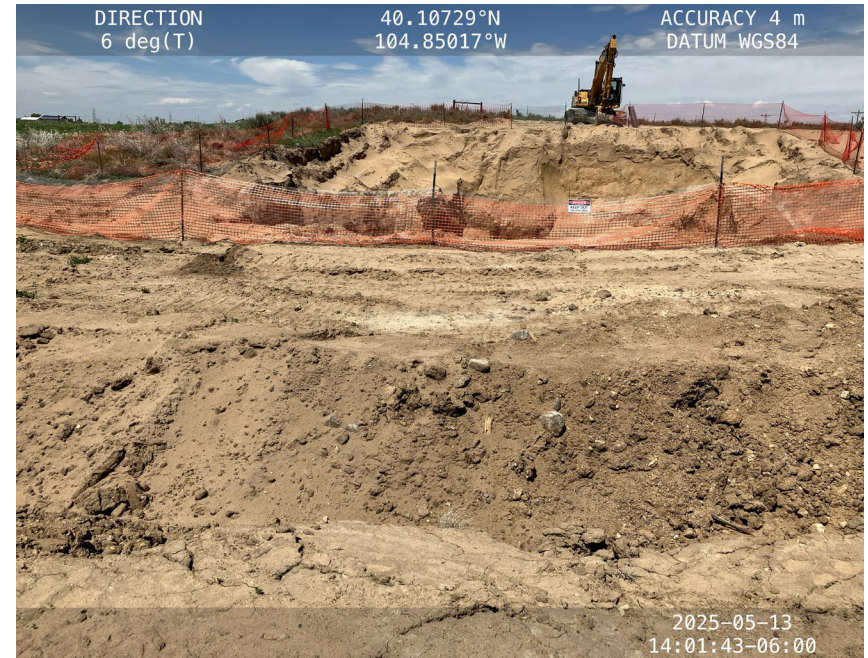
Inadequate trench to prevent stormwater runoff
