# Inspection Photos

API: 017-07717

Operator: **VECTA OIL & GAS LTD**

Inspection Date: 5/19/2025

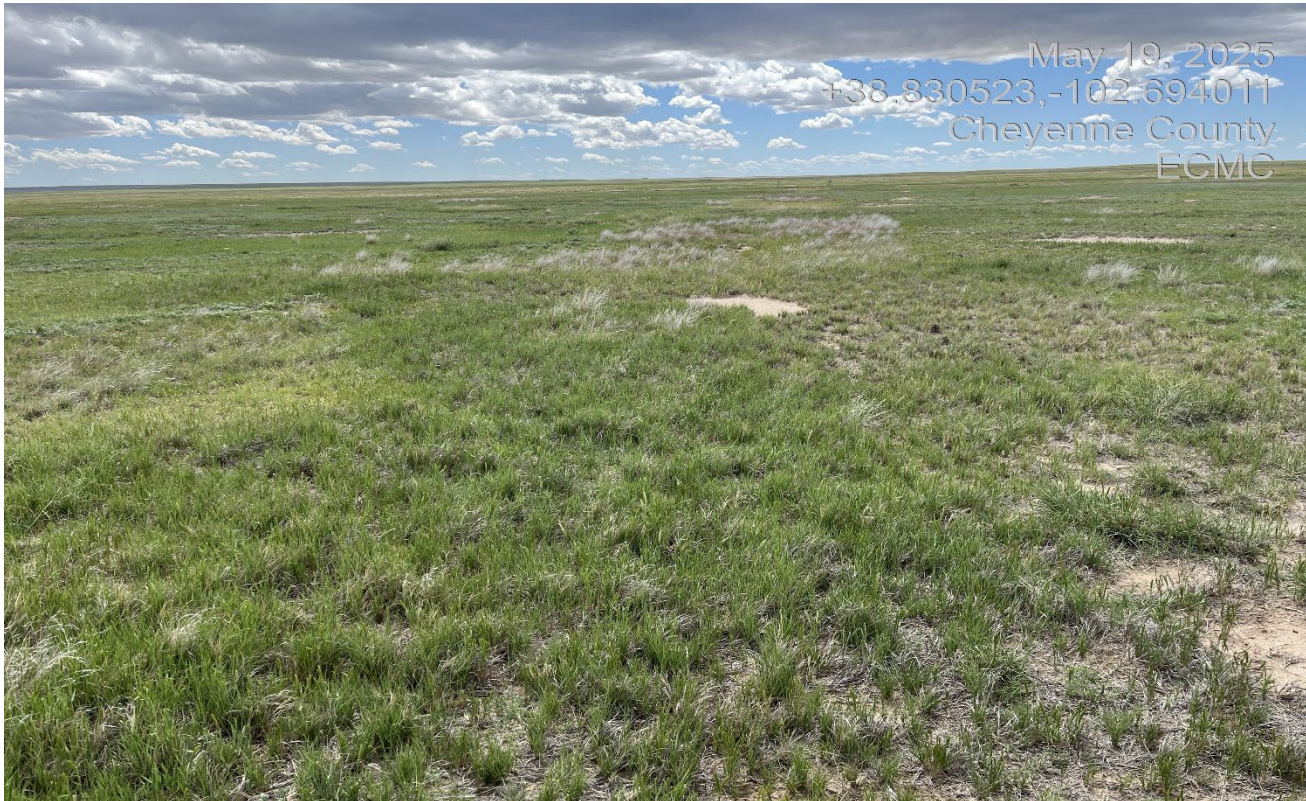
**Photo 1.** Facing southeast toward the access road which has revegetated.

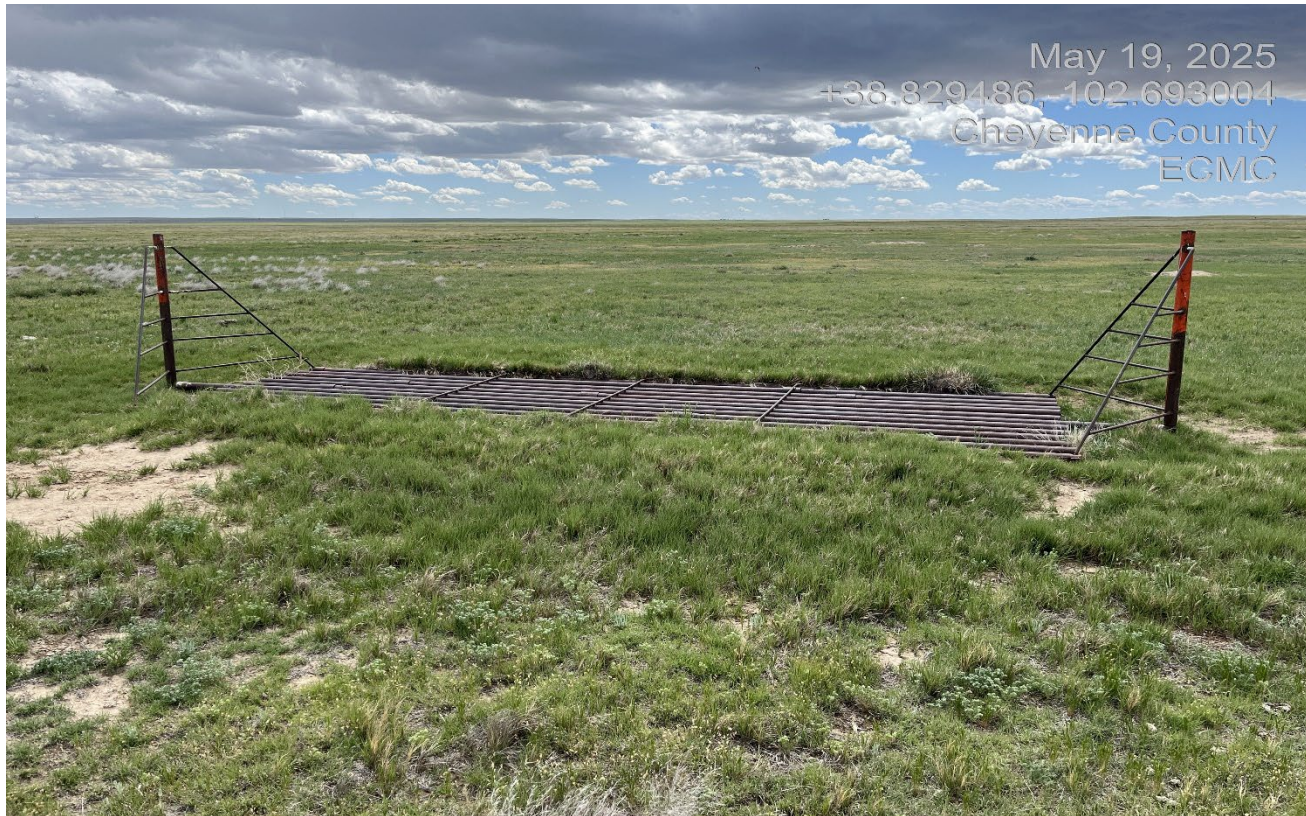
**Photo 2.** Facing southeast at the location. The cattleguard has not been removed from the location. The perimeter fence was removed but not the cattleguard.

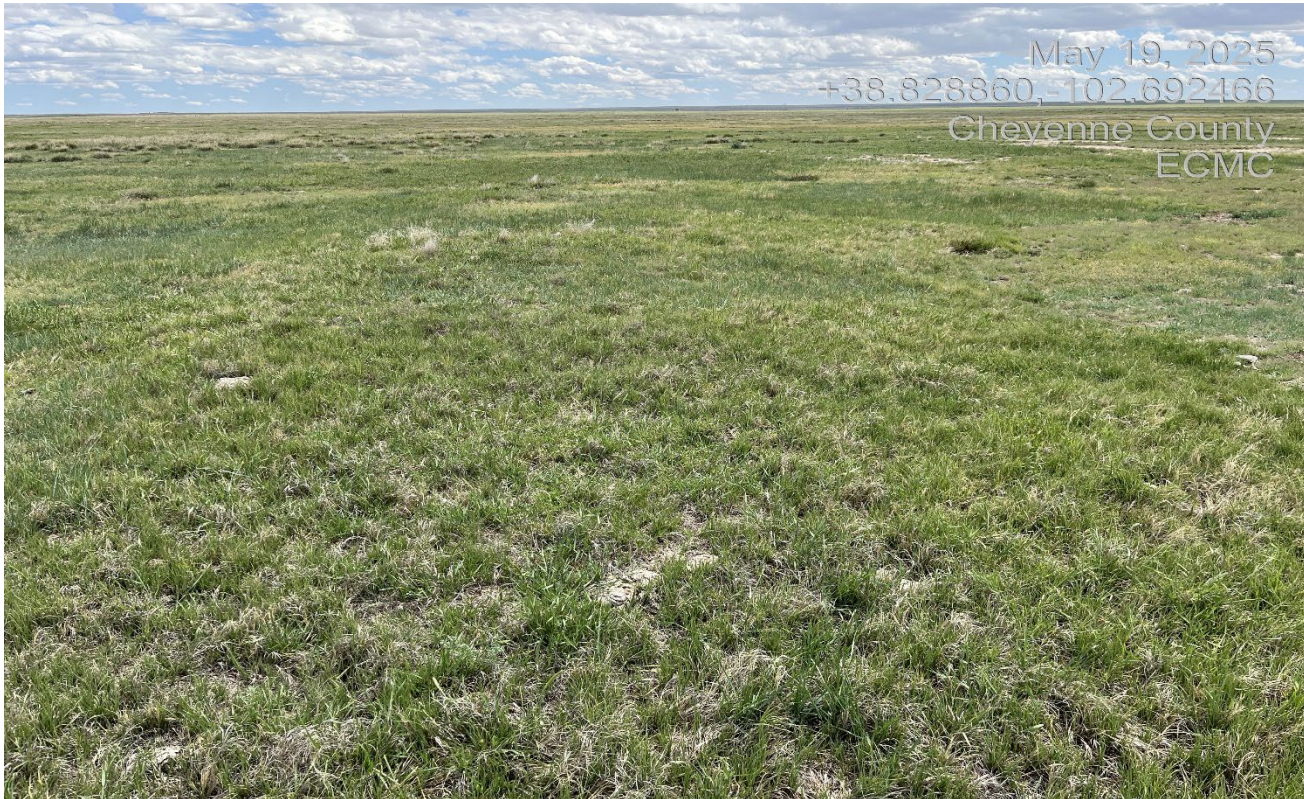
**Photo 3.** Center of the location facing north. Perennial vegetation is progressing throughout the location.

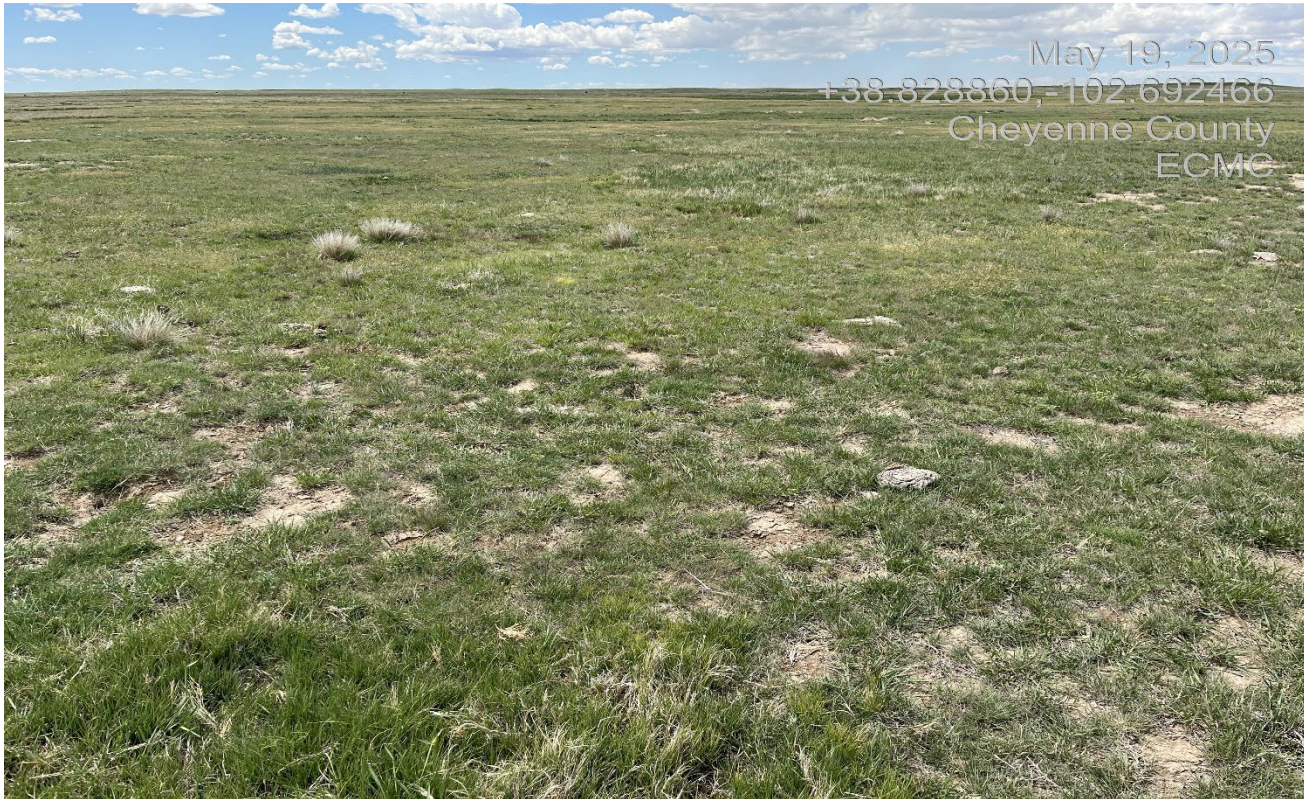
**Photo 4.** Center of the location facing west. Perennial vegetation is progressing throughout the location.

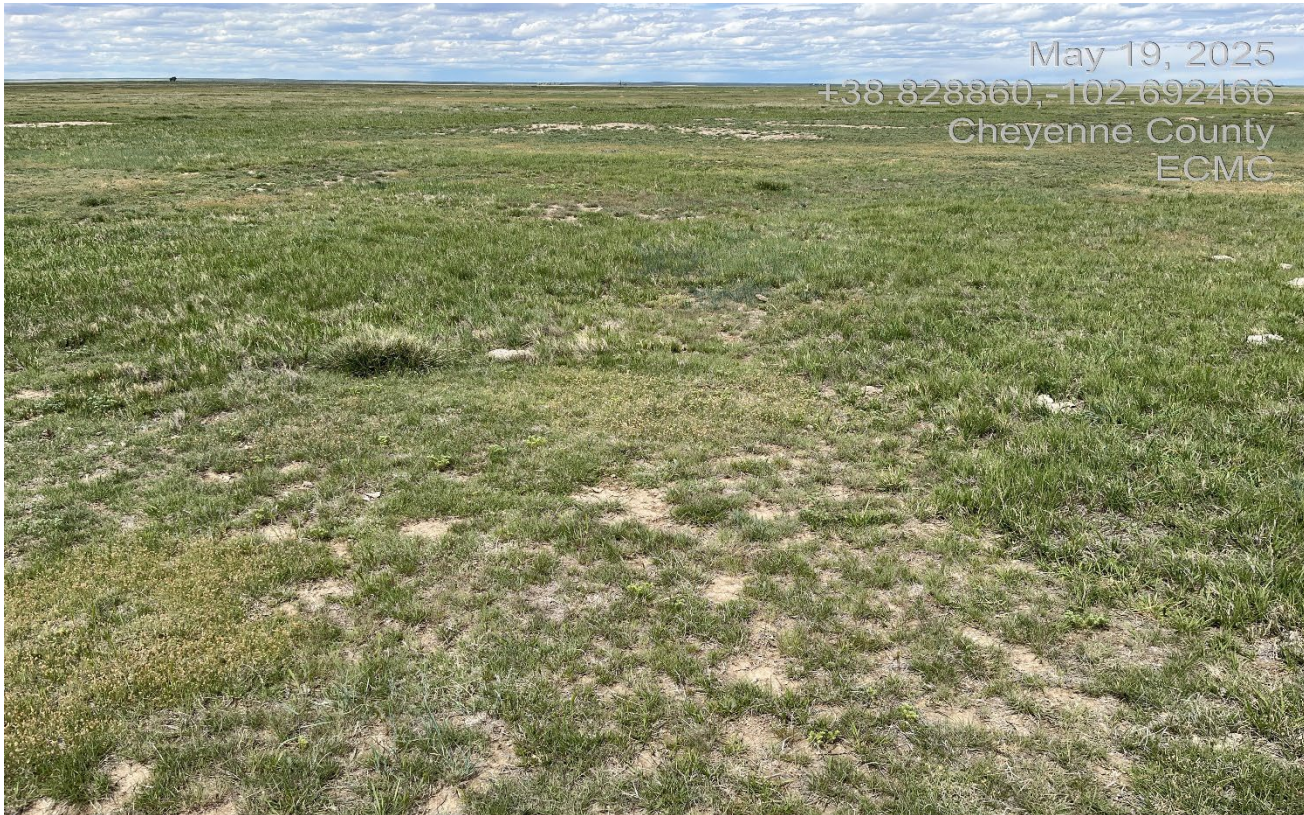
**Photo 5.** Center of the location facing south. Perennial vegetation is progressing throughout the location.

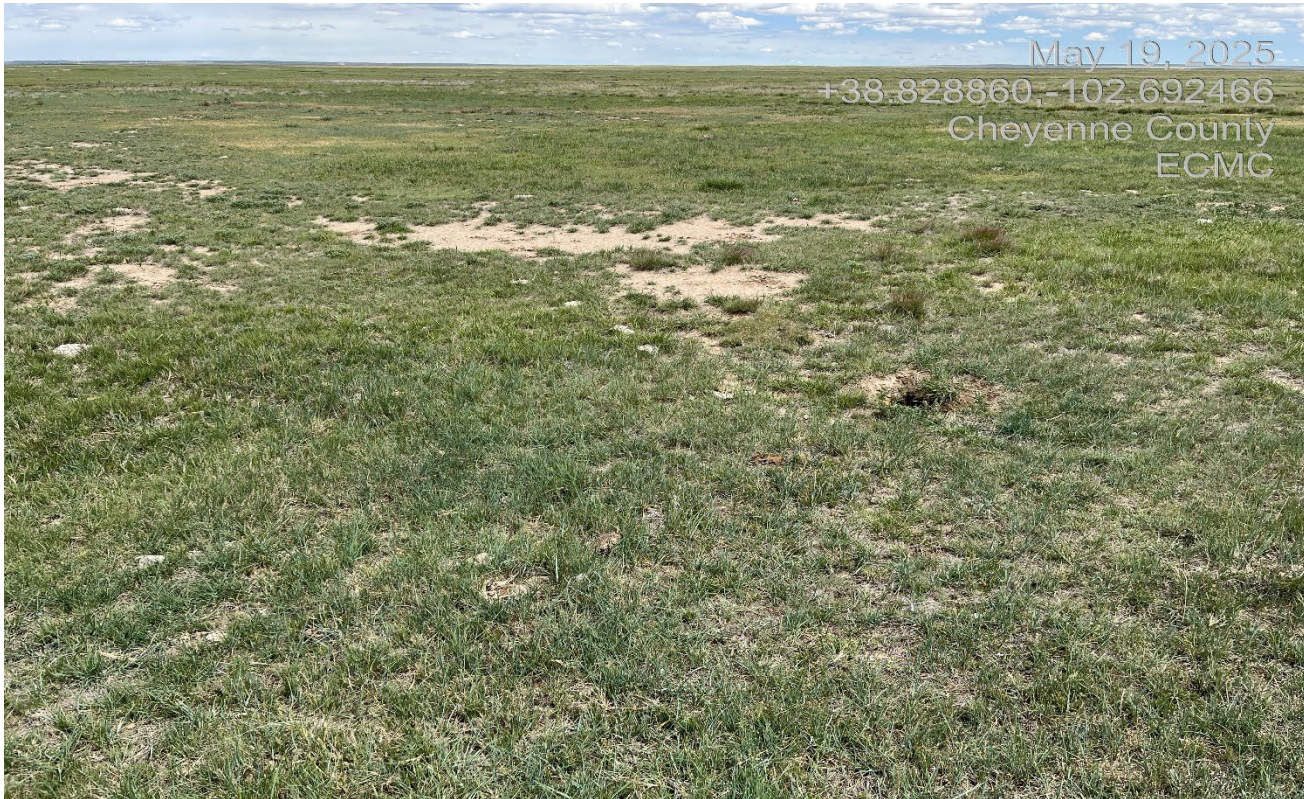
**Photo 6.** Center of the location facing east. Perennial vegetation is progressing throughout the location.
