Inspection Photos

API: 017-06611

Operator: **MULL DRILLING COMPANY INC**

Inspection Date: 5/19/2025

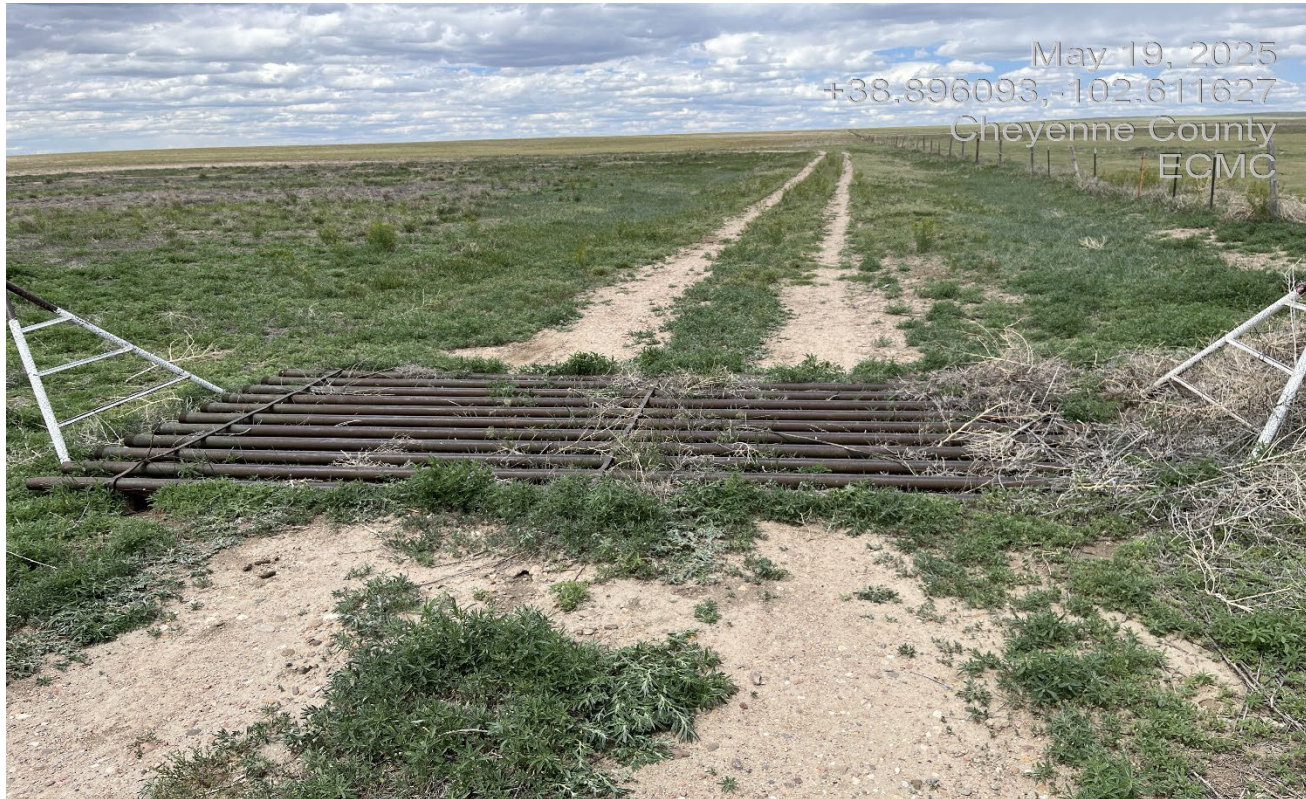
Photo 1. Facing north at beginning of the access road. The cattleguard has not been removed and two track road remains.

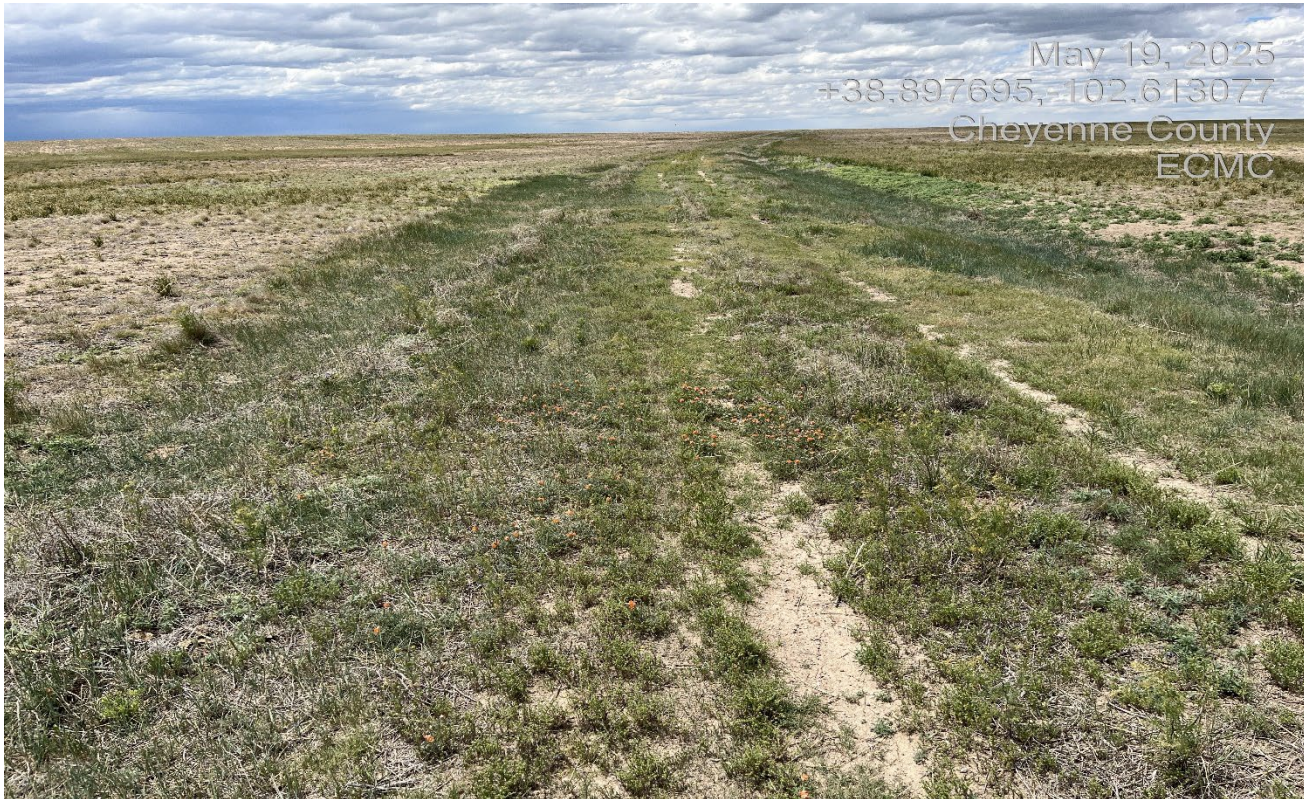
Photo 2. Facing northwest along the access road which remains elevated and crowned. The road must be regraded and contoured.

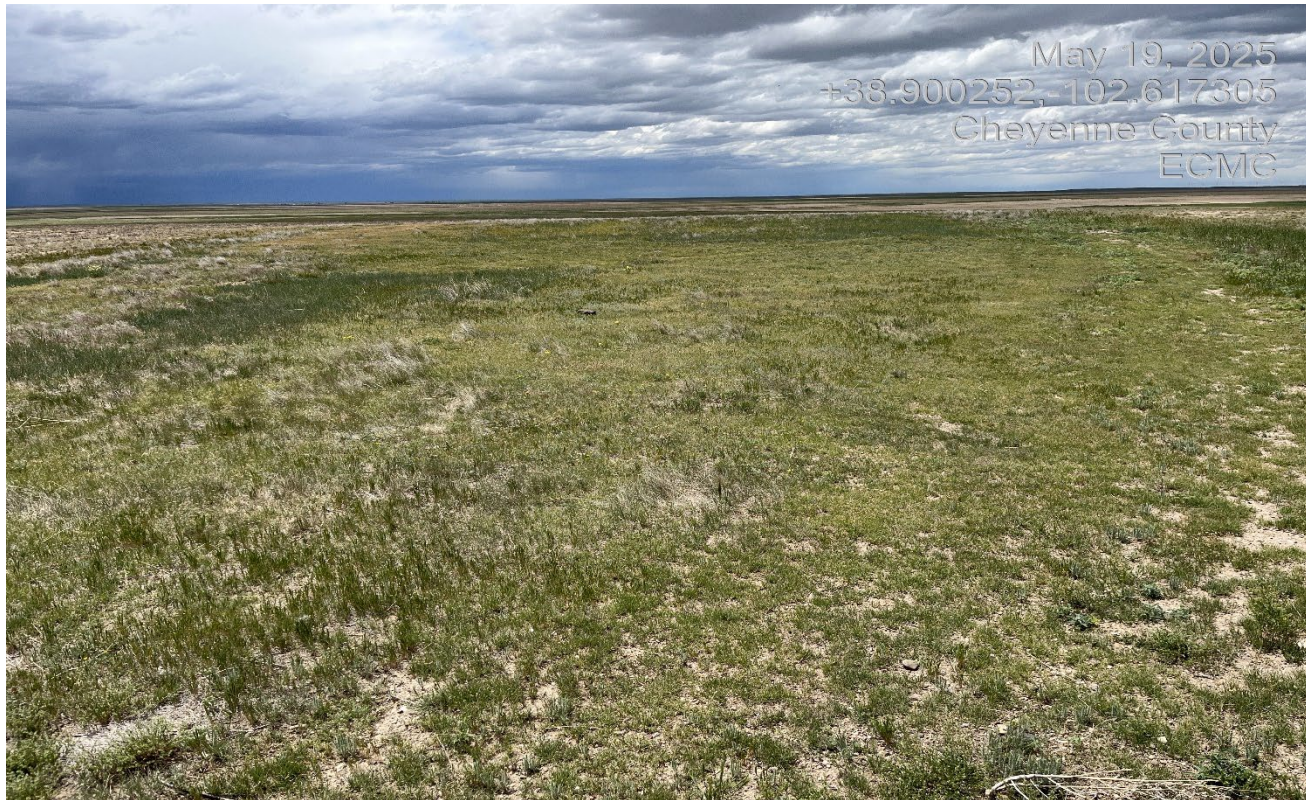
Photo 3. Facing northwest toward the associated tank battery location.

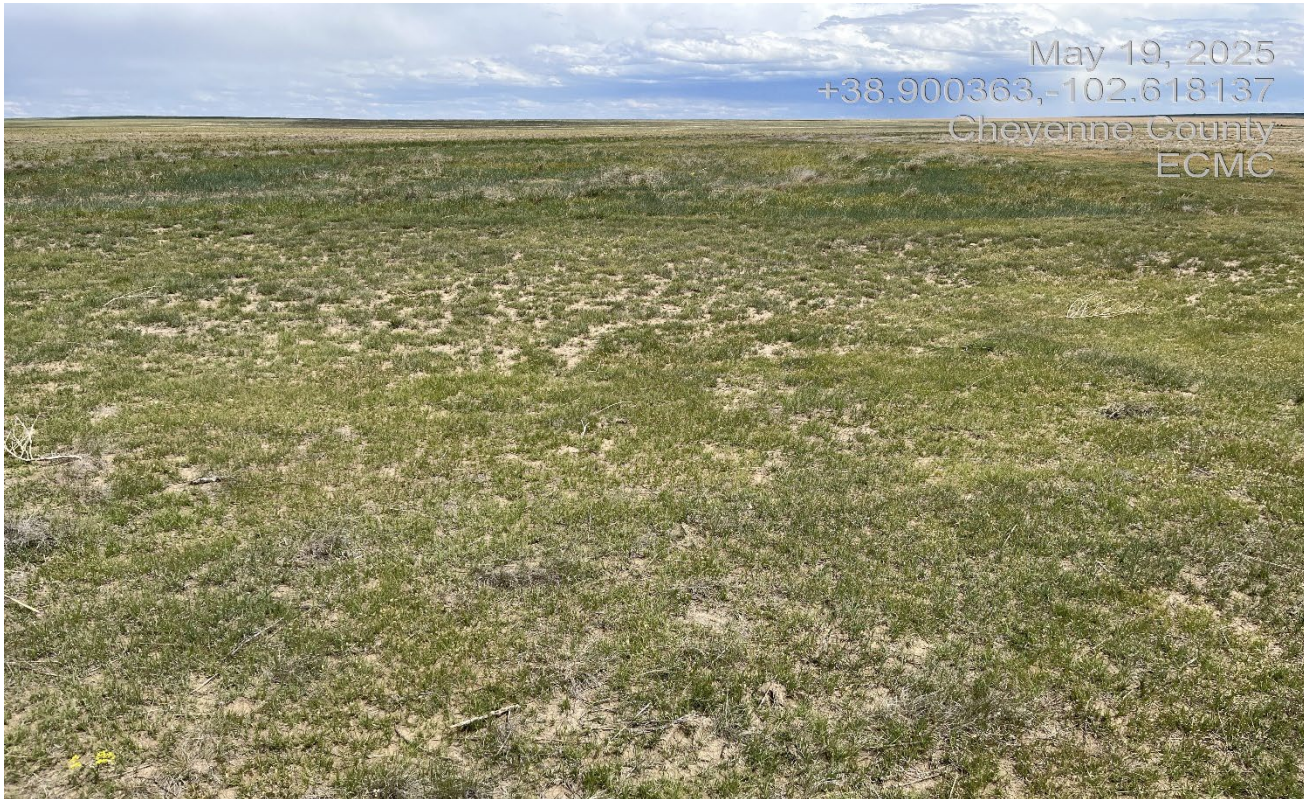
Photo 4. Facing southeast at the tank battery location.

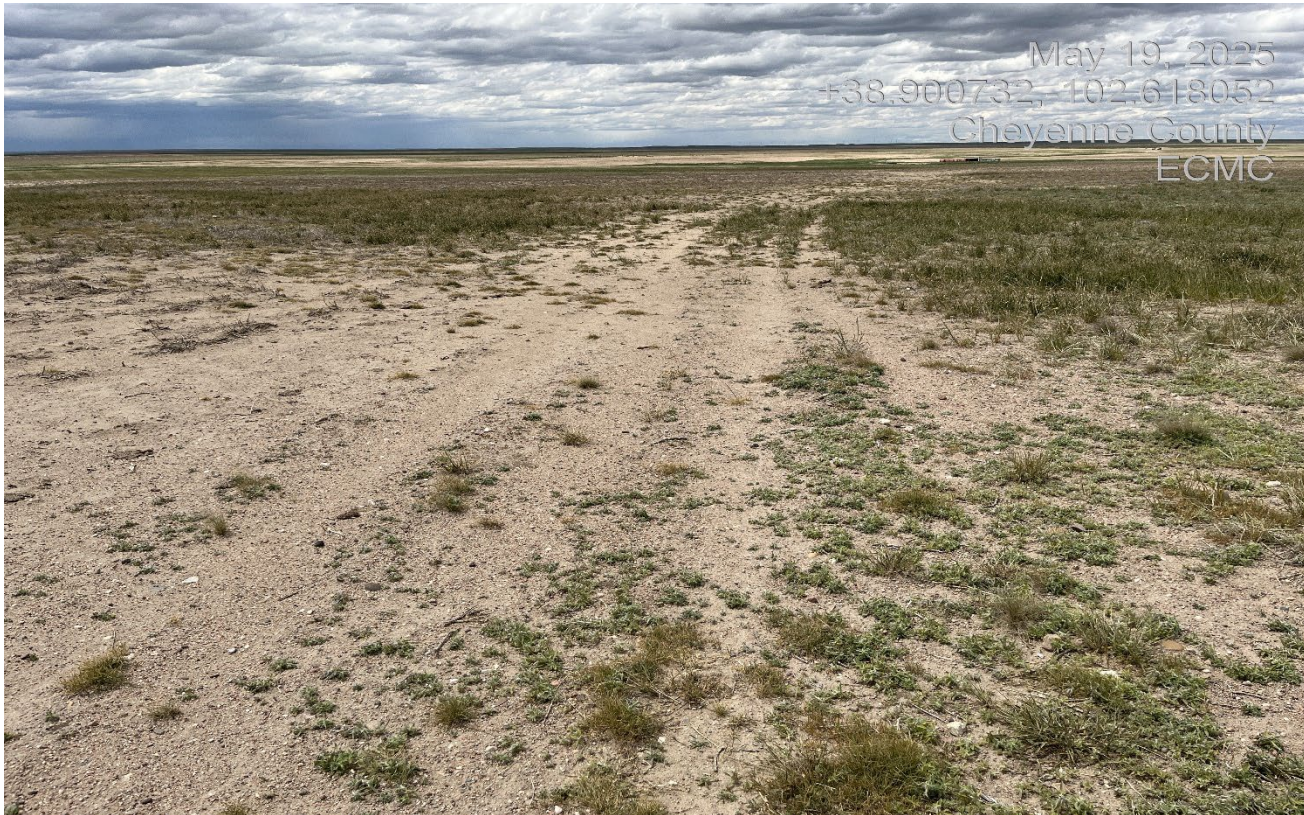
Photo 5. Facing northwest toward the wellsite.
