**Inspection Photos**  
**Location: State 16 SWSE 3054**  
**Location ID: 483008**  
**API # 05-071-09922**

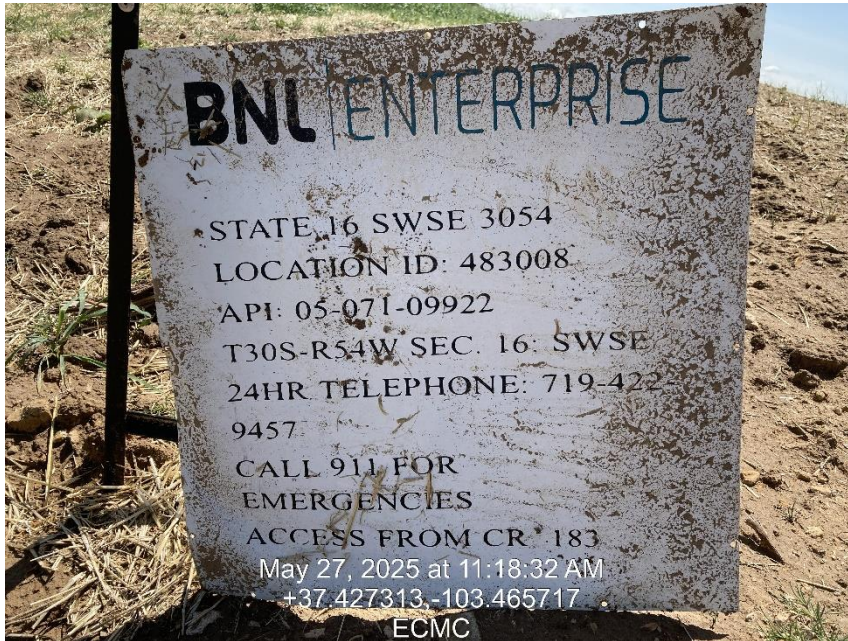
**Photo 1 –Well placard**

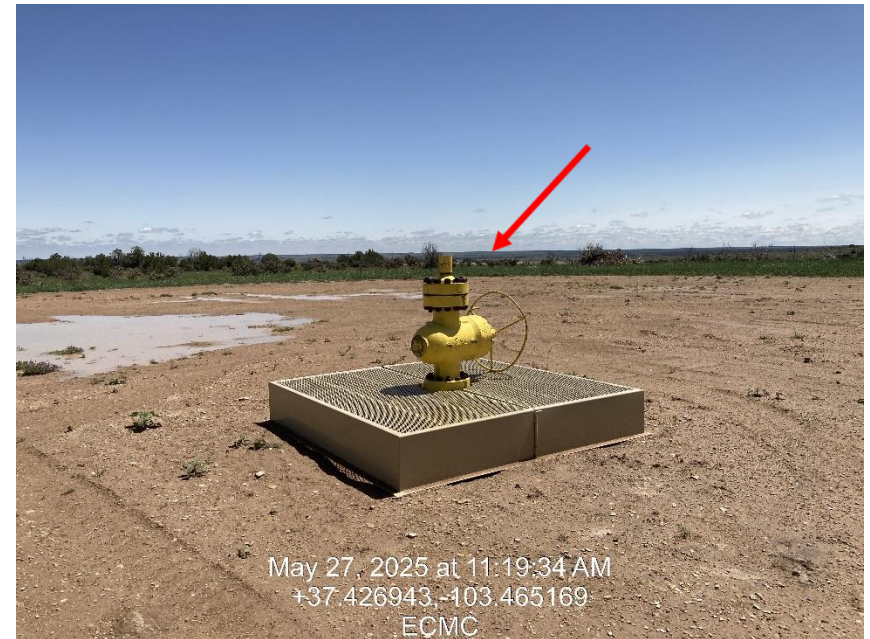
**Photo 2 – Wellhead**

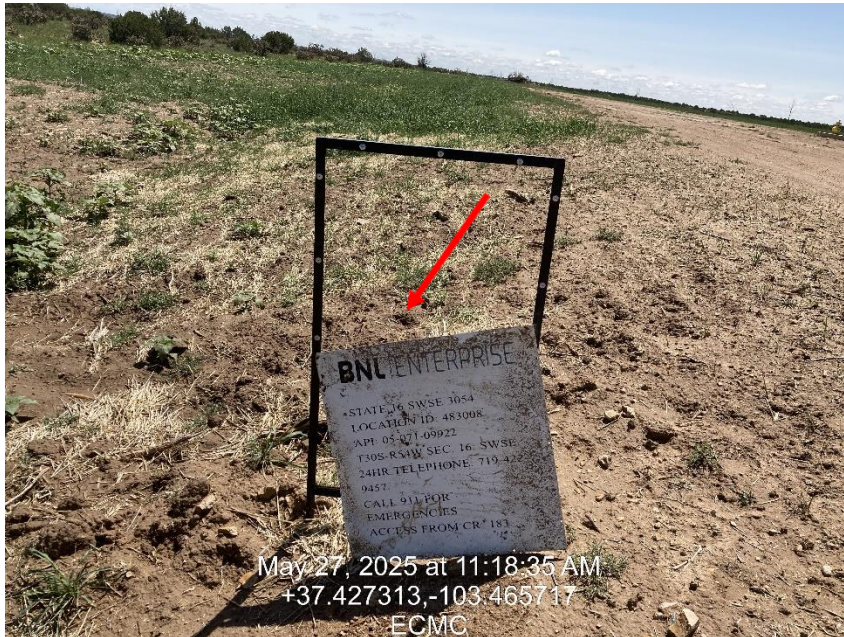
**Photo 3 – Well placard has not secured to frame**

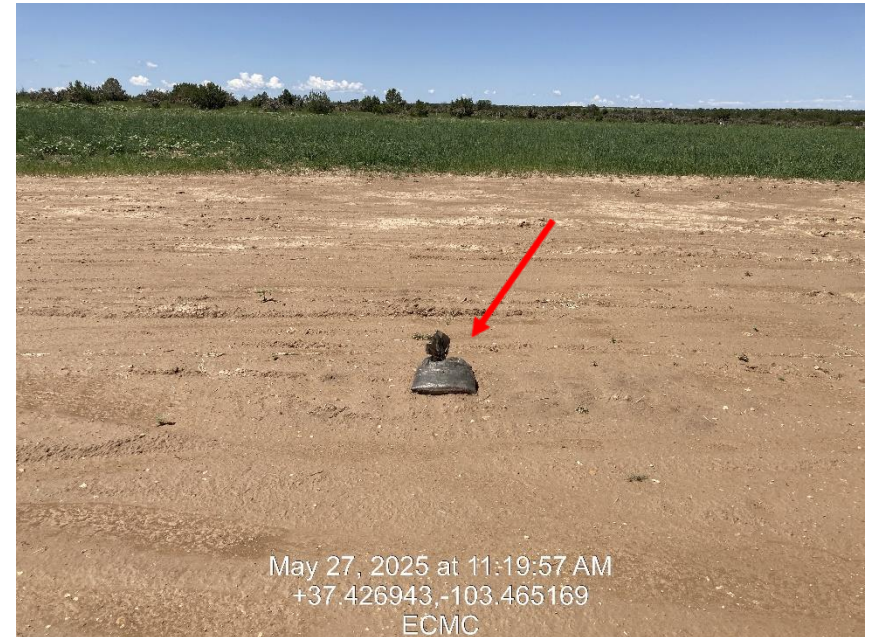
**Photo 4 – Sandbag/debris on location**
