Inspection/Audit Photos

Location Name: TEP ROCKY MOUNTAIN LLC HICKS PA 24-6 Pad

Location ID: 437097

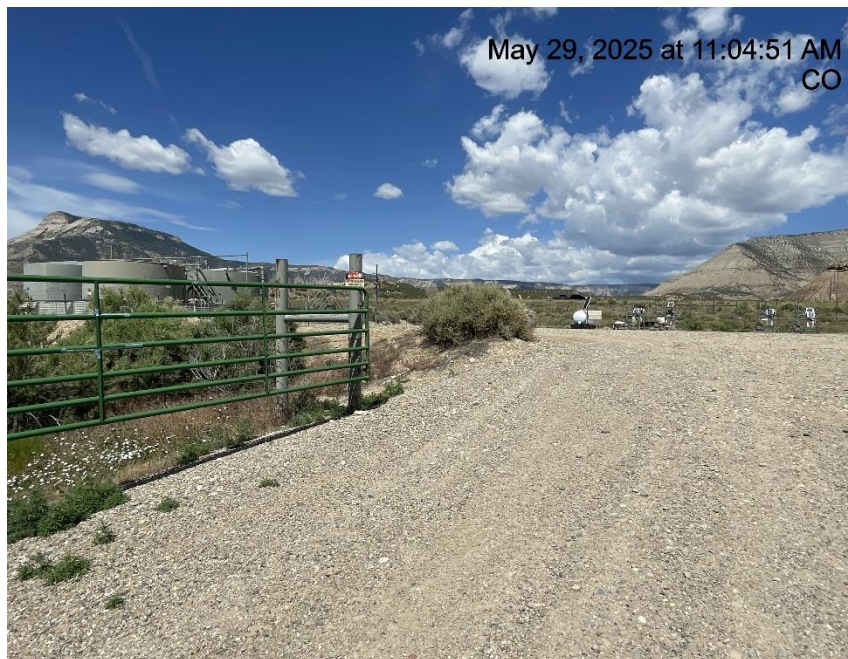
Photo # 4387 From entrance to location

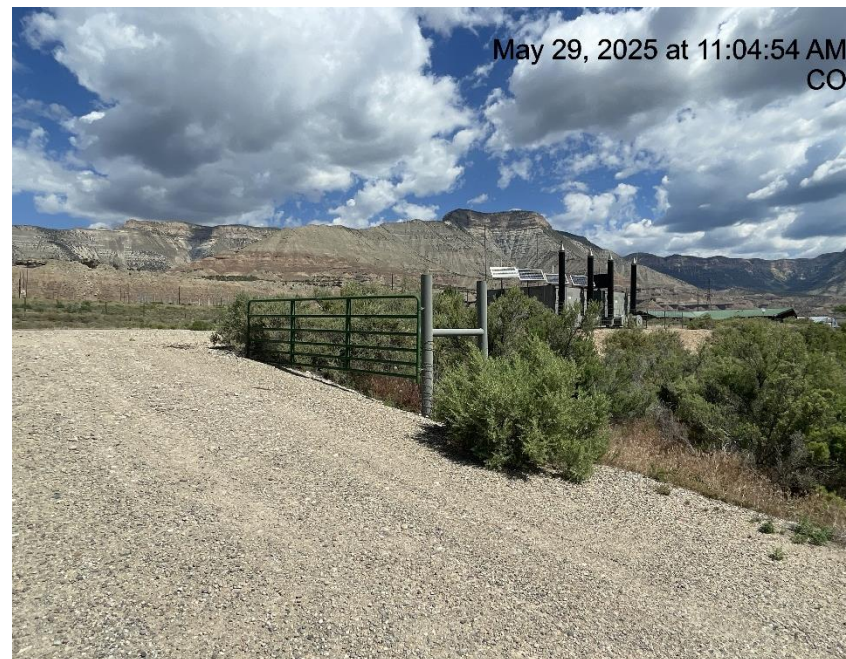
Photo # 4388 From entrance to location

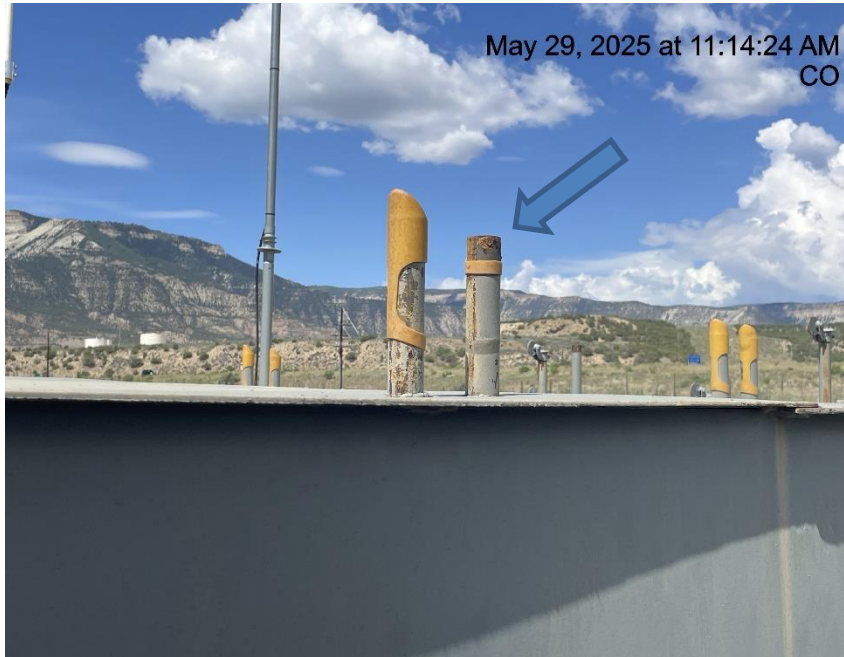
Photo # 4395 Rupture disc vent line does not comply with CECMC pressure safety device rules

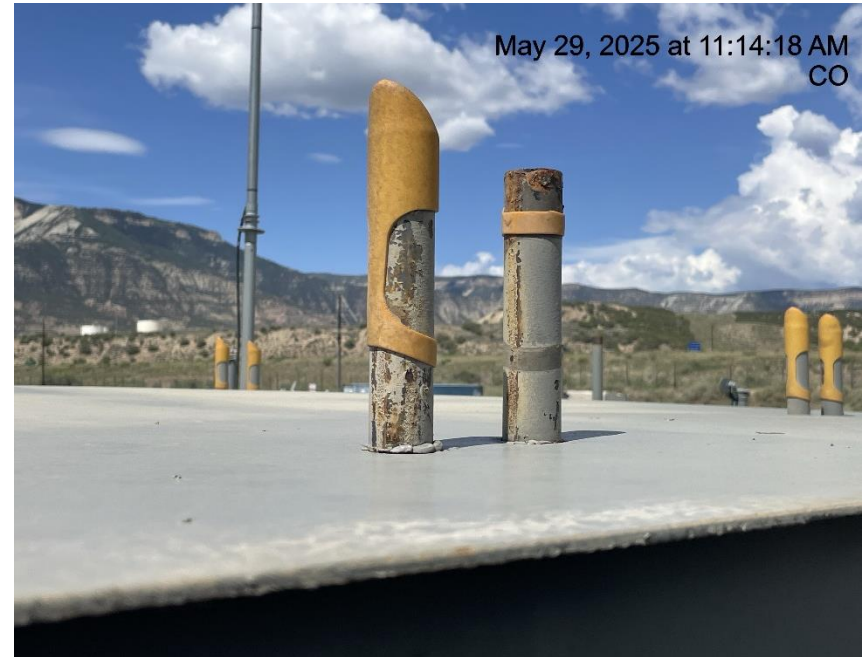
Photo # 4396 Rupture disc vent line does not comply with CECMC pressure safety device rules

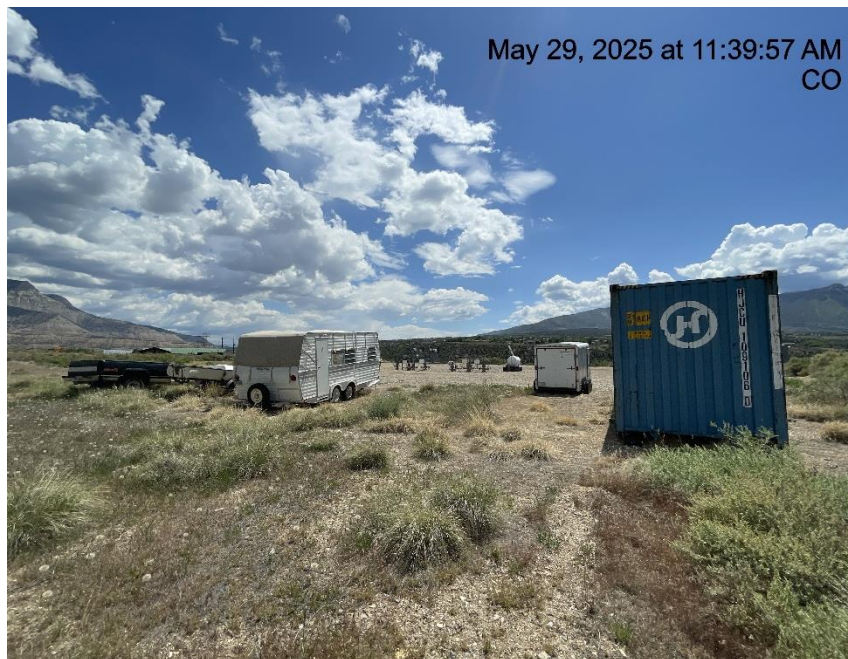
Photo # 4397 Stored shipping container, camper, trailer, boat & truck bed

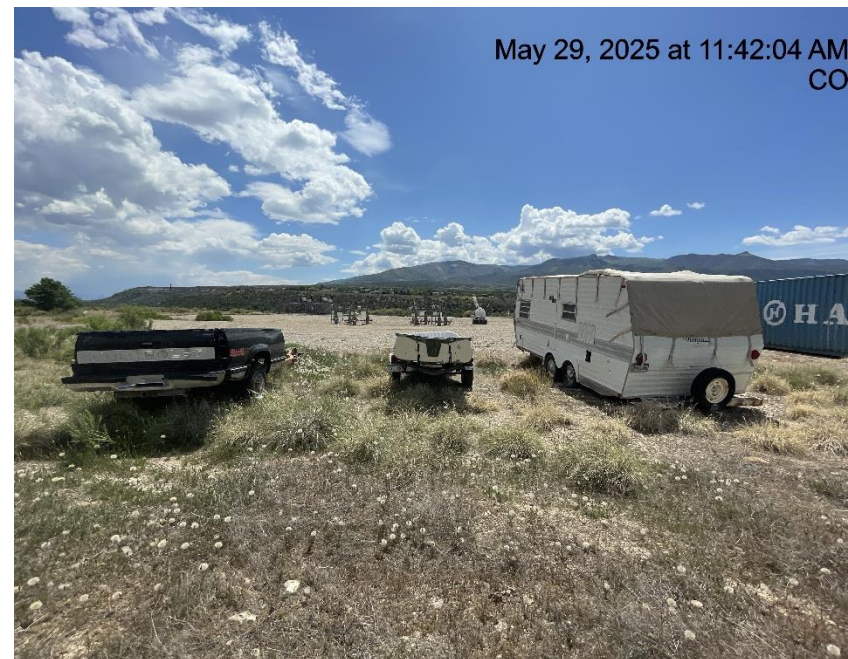
Photo # 4398 Stored shipping container, camper, boat & truck bed

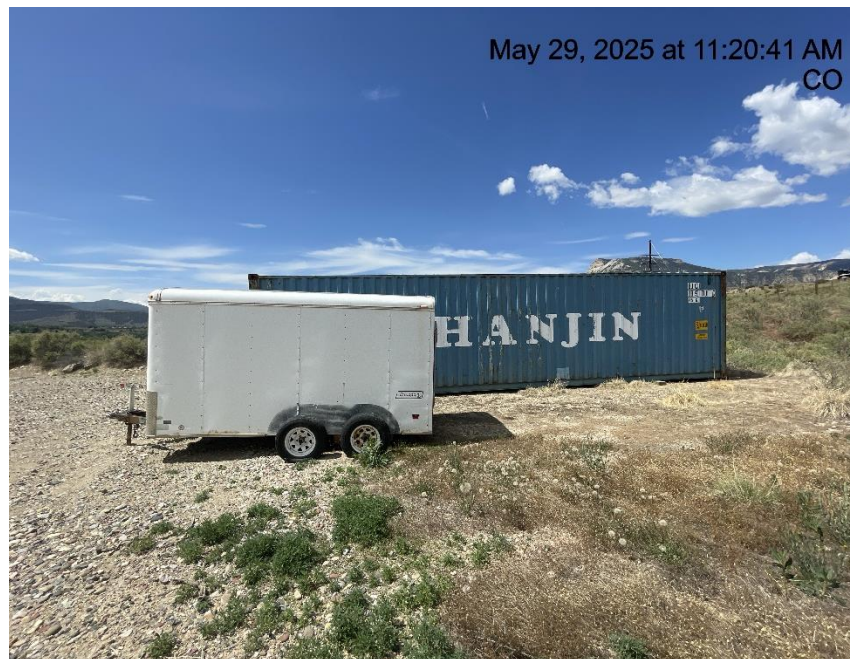
Photo # 4399 Stored shipping container & trailer

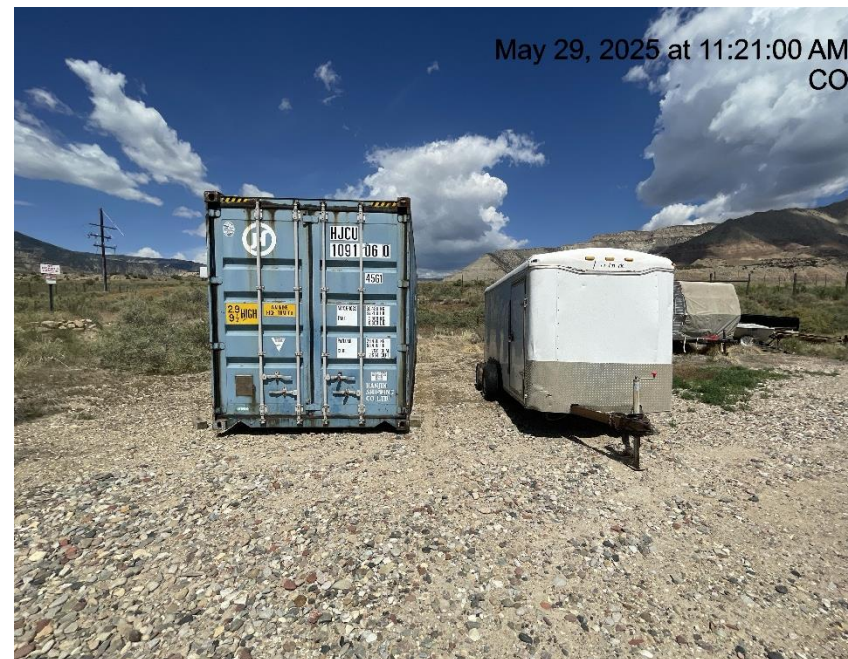
Photo # 4400 Stored shipping container & trailer
