Inspection/Audit Photos

Location Name: QB ENERGY OPERATING LLC N. PARACHUTE WF I25 596 Pad

Location #: 335590

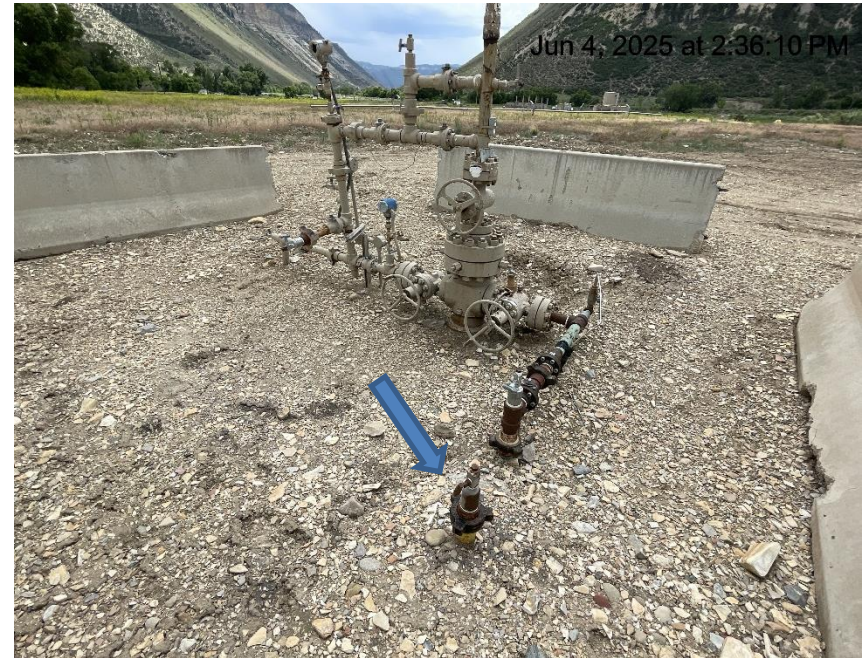
Photo # 6390 Unused flowline does not comply with CECMC rules

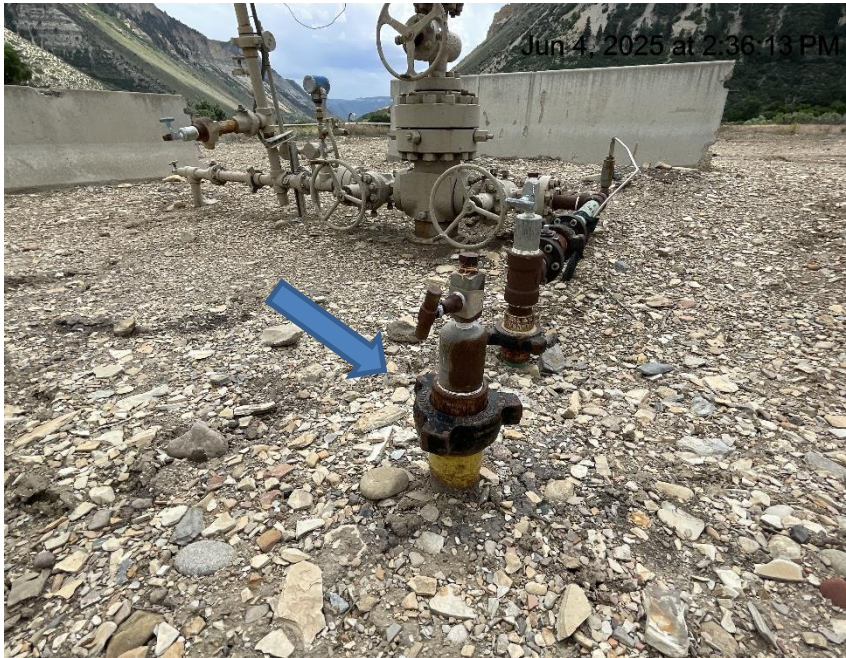
Photo # 6391 Unused flowline does not comply with CECMC rules
