ECMC
Environmental
Field Inspection

Jeffers-Hart Tank Battery
© 20-May-25 04:03:55 PM
ECMC Environmental Inspection

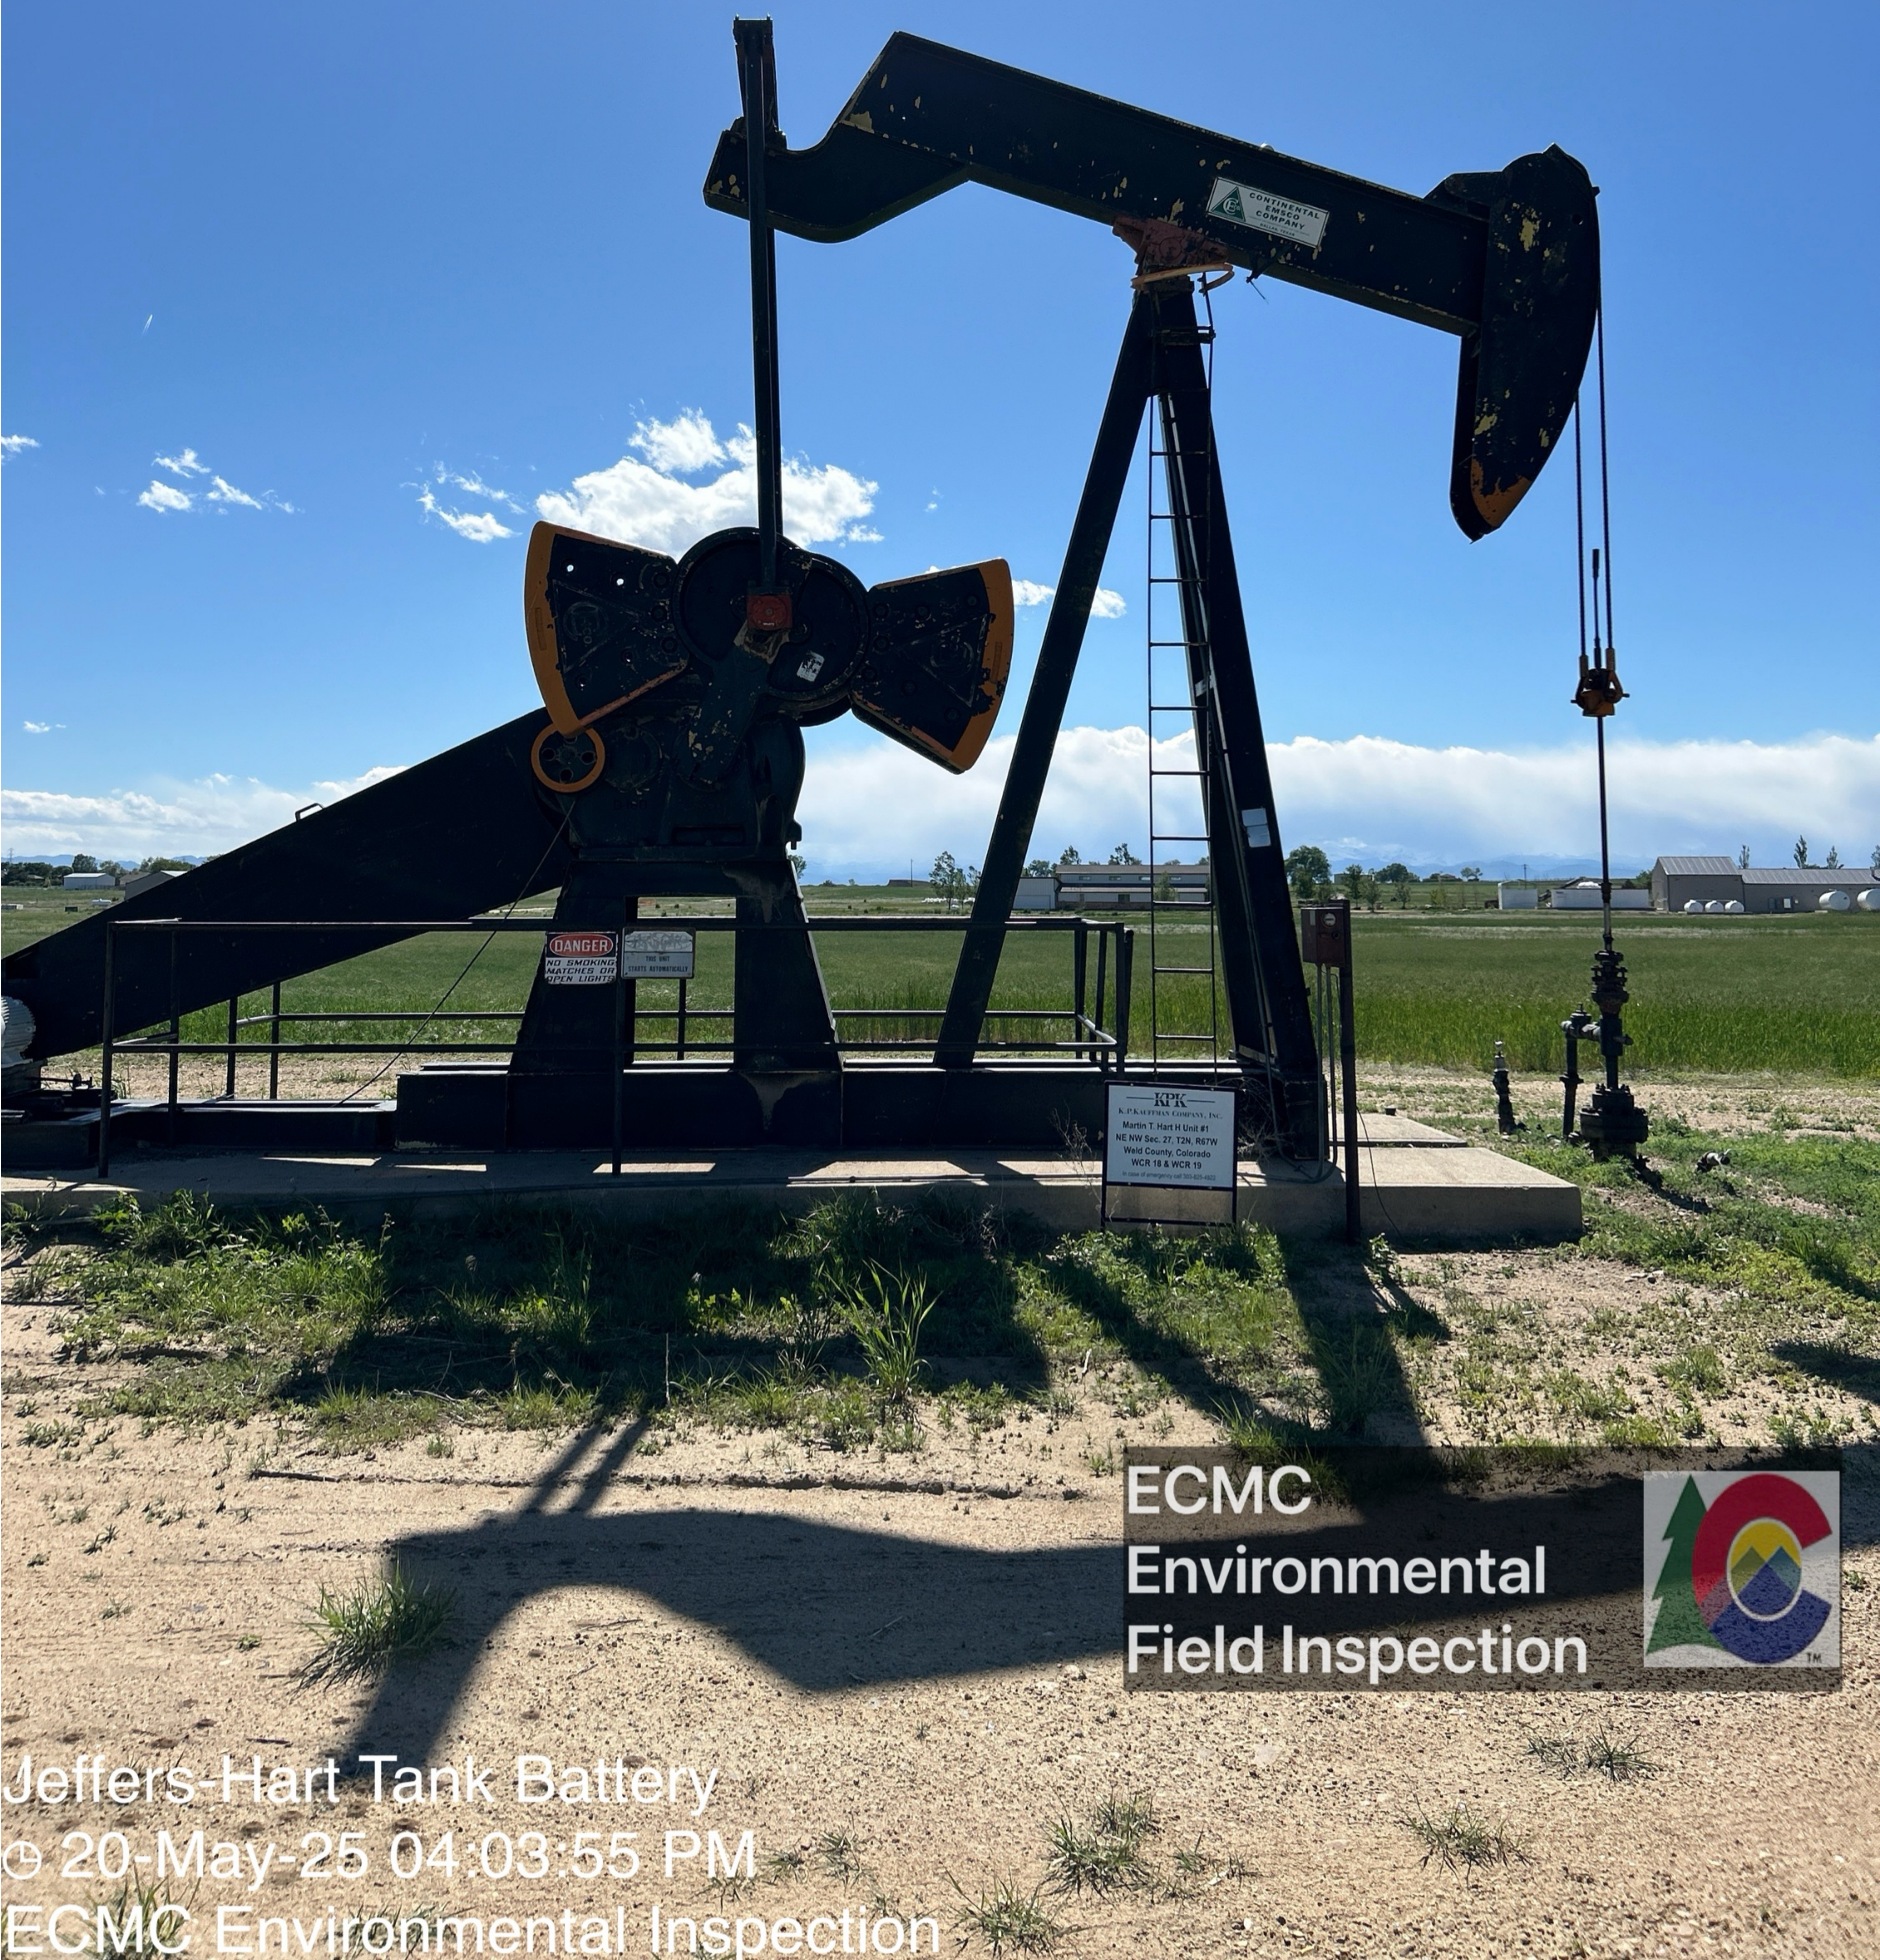
Signage with emergency contact number is visible at the wellhead. Weeds are beginning to grow.

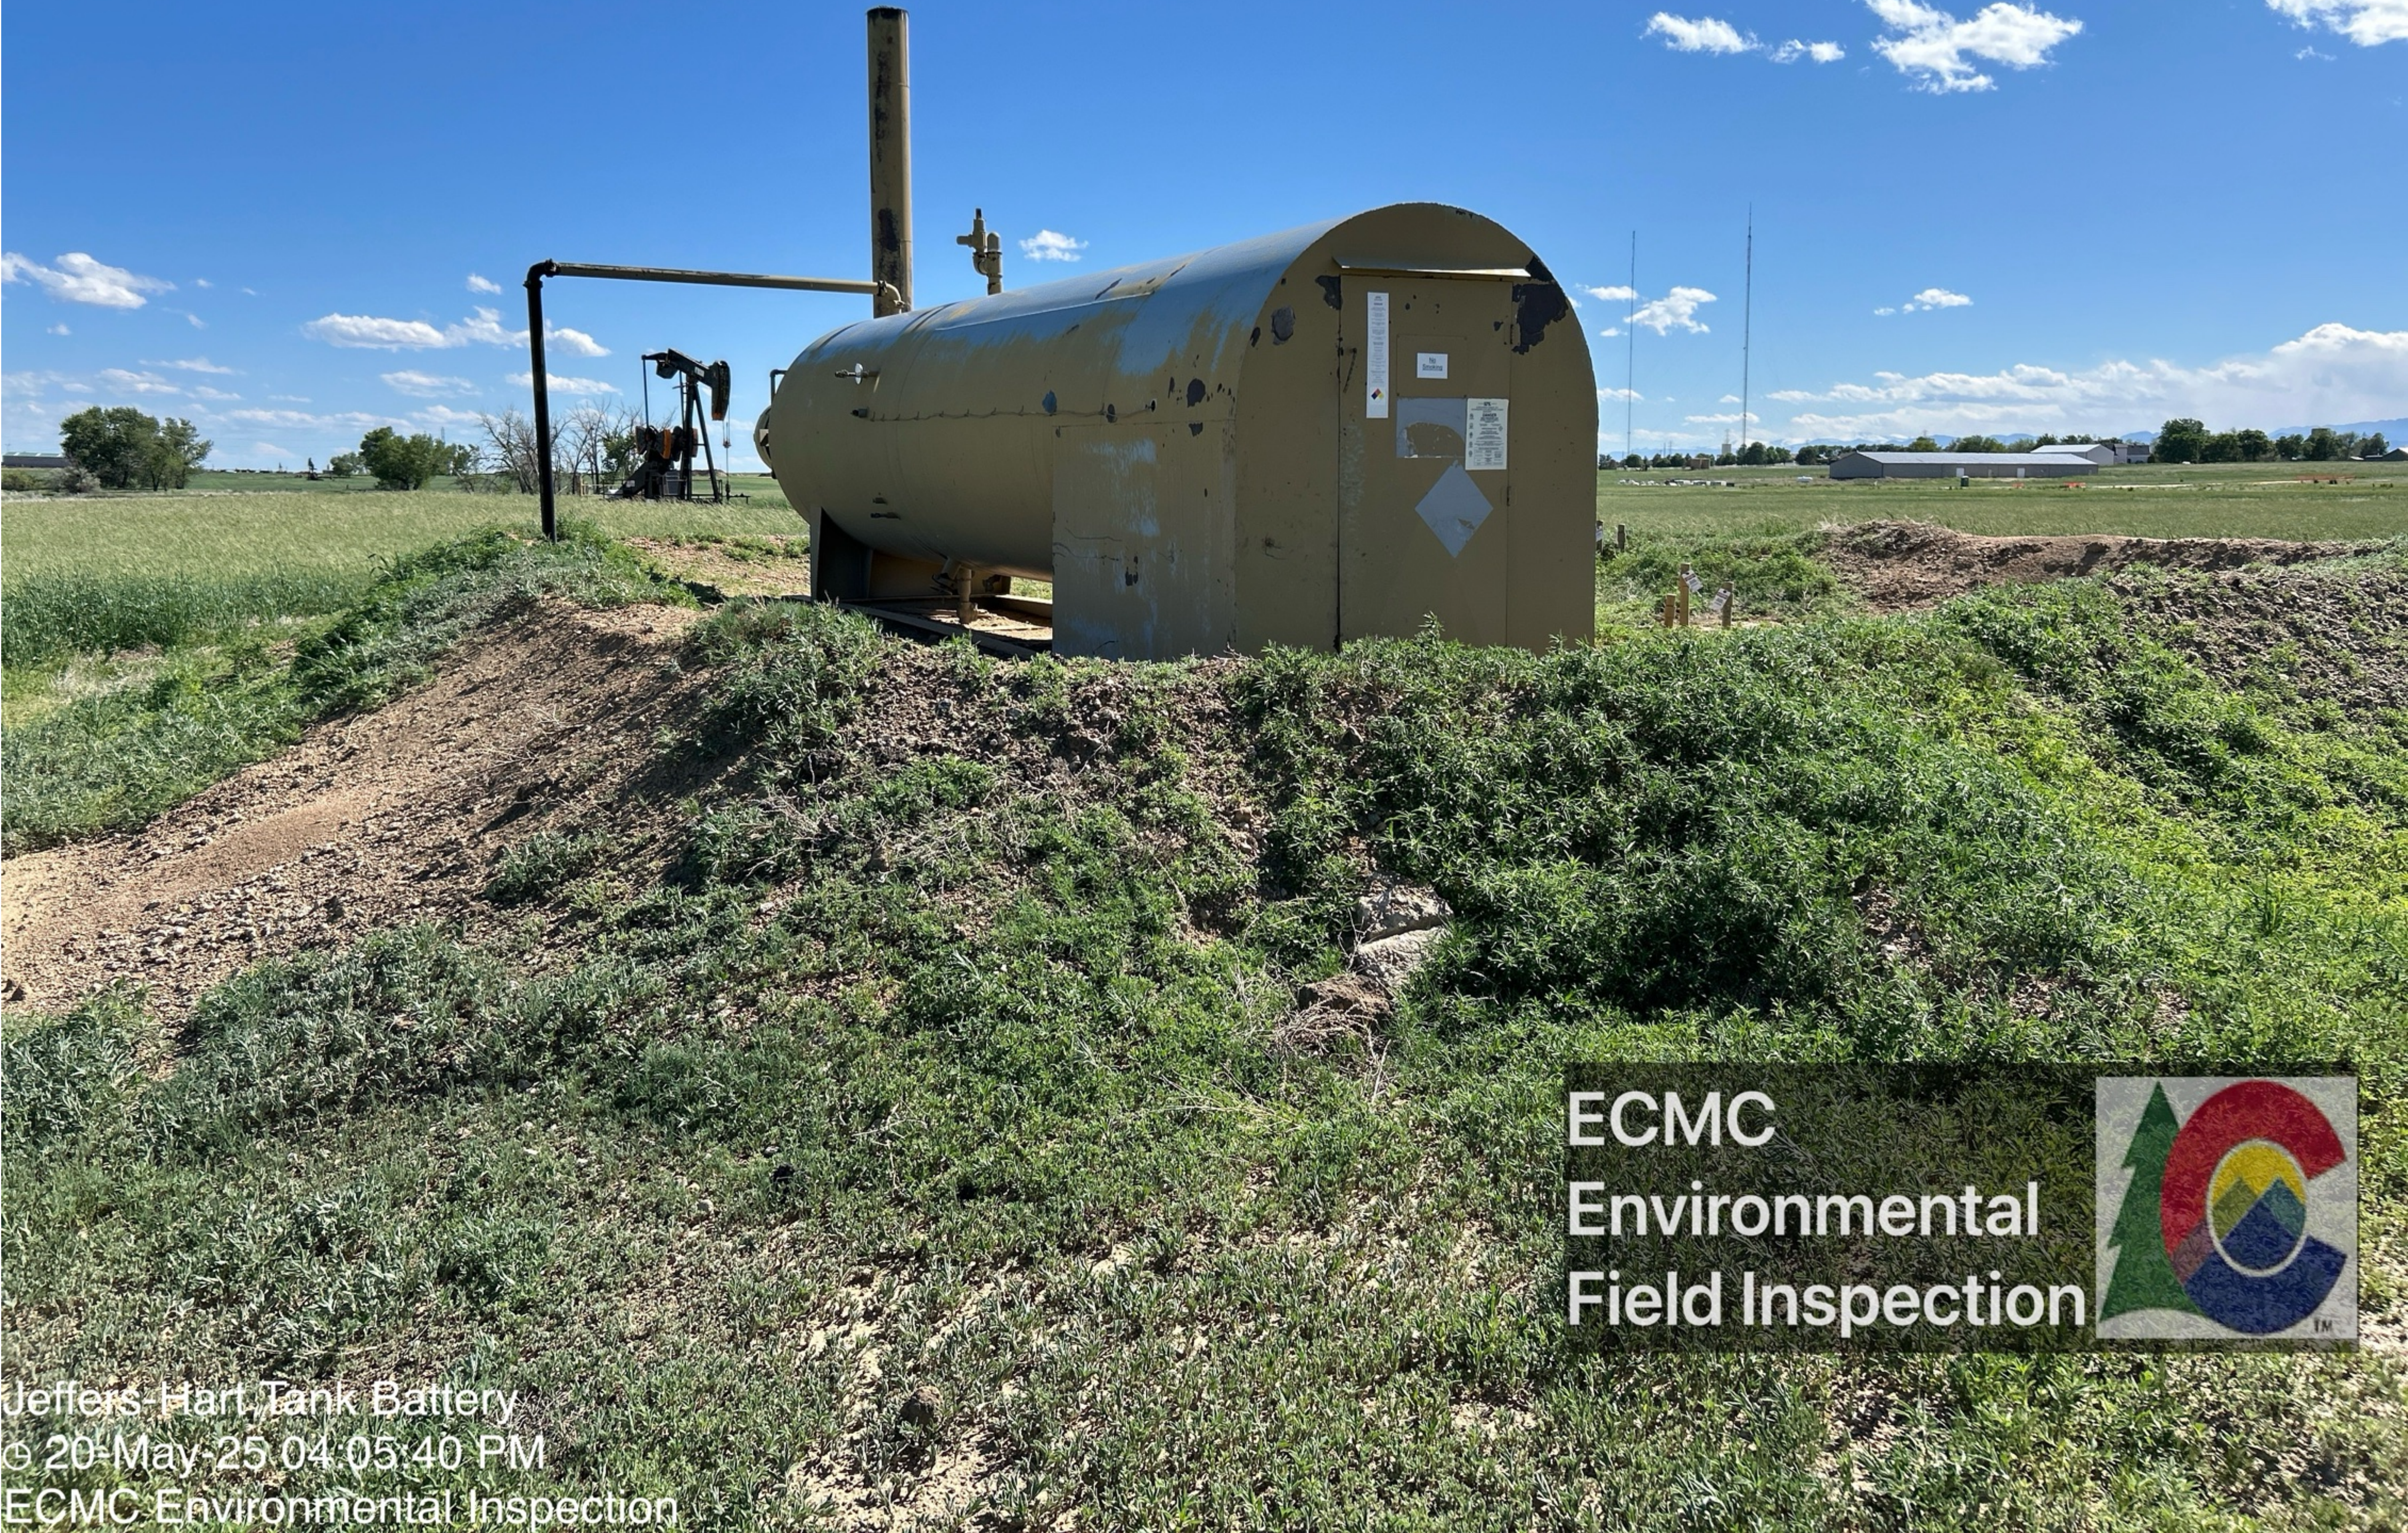
Approximate spill location. Excavation has been backfilled.

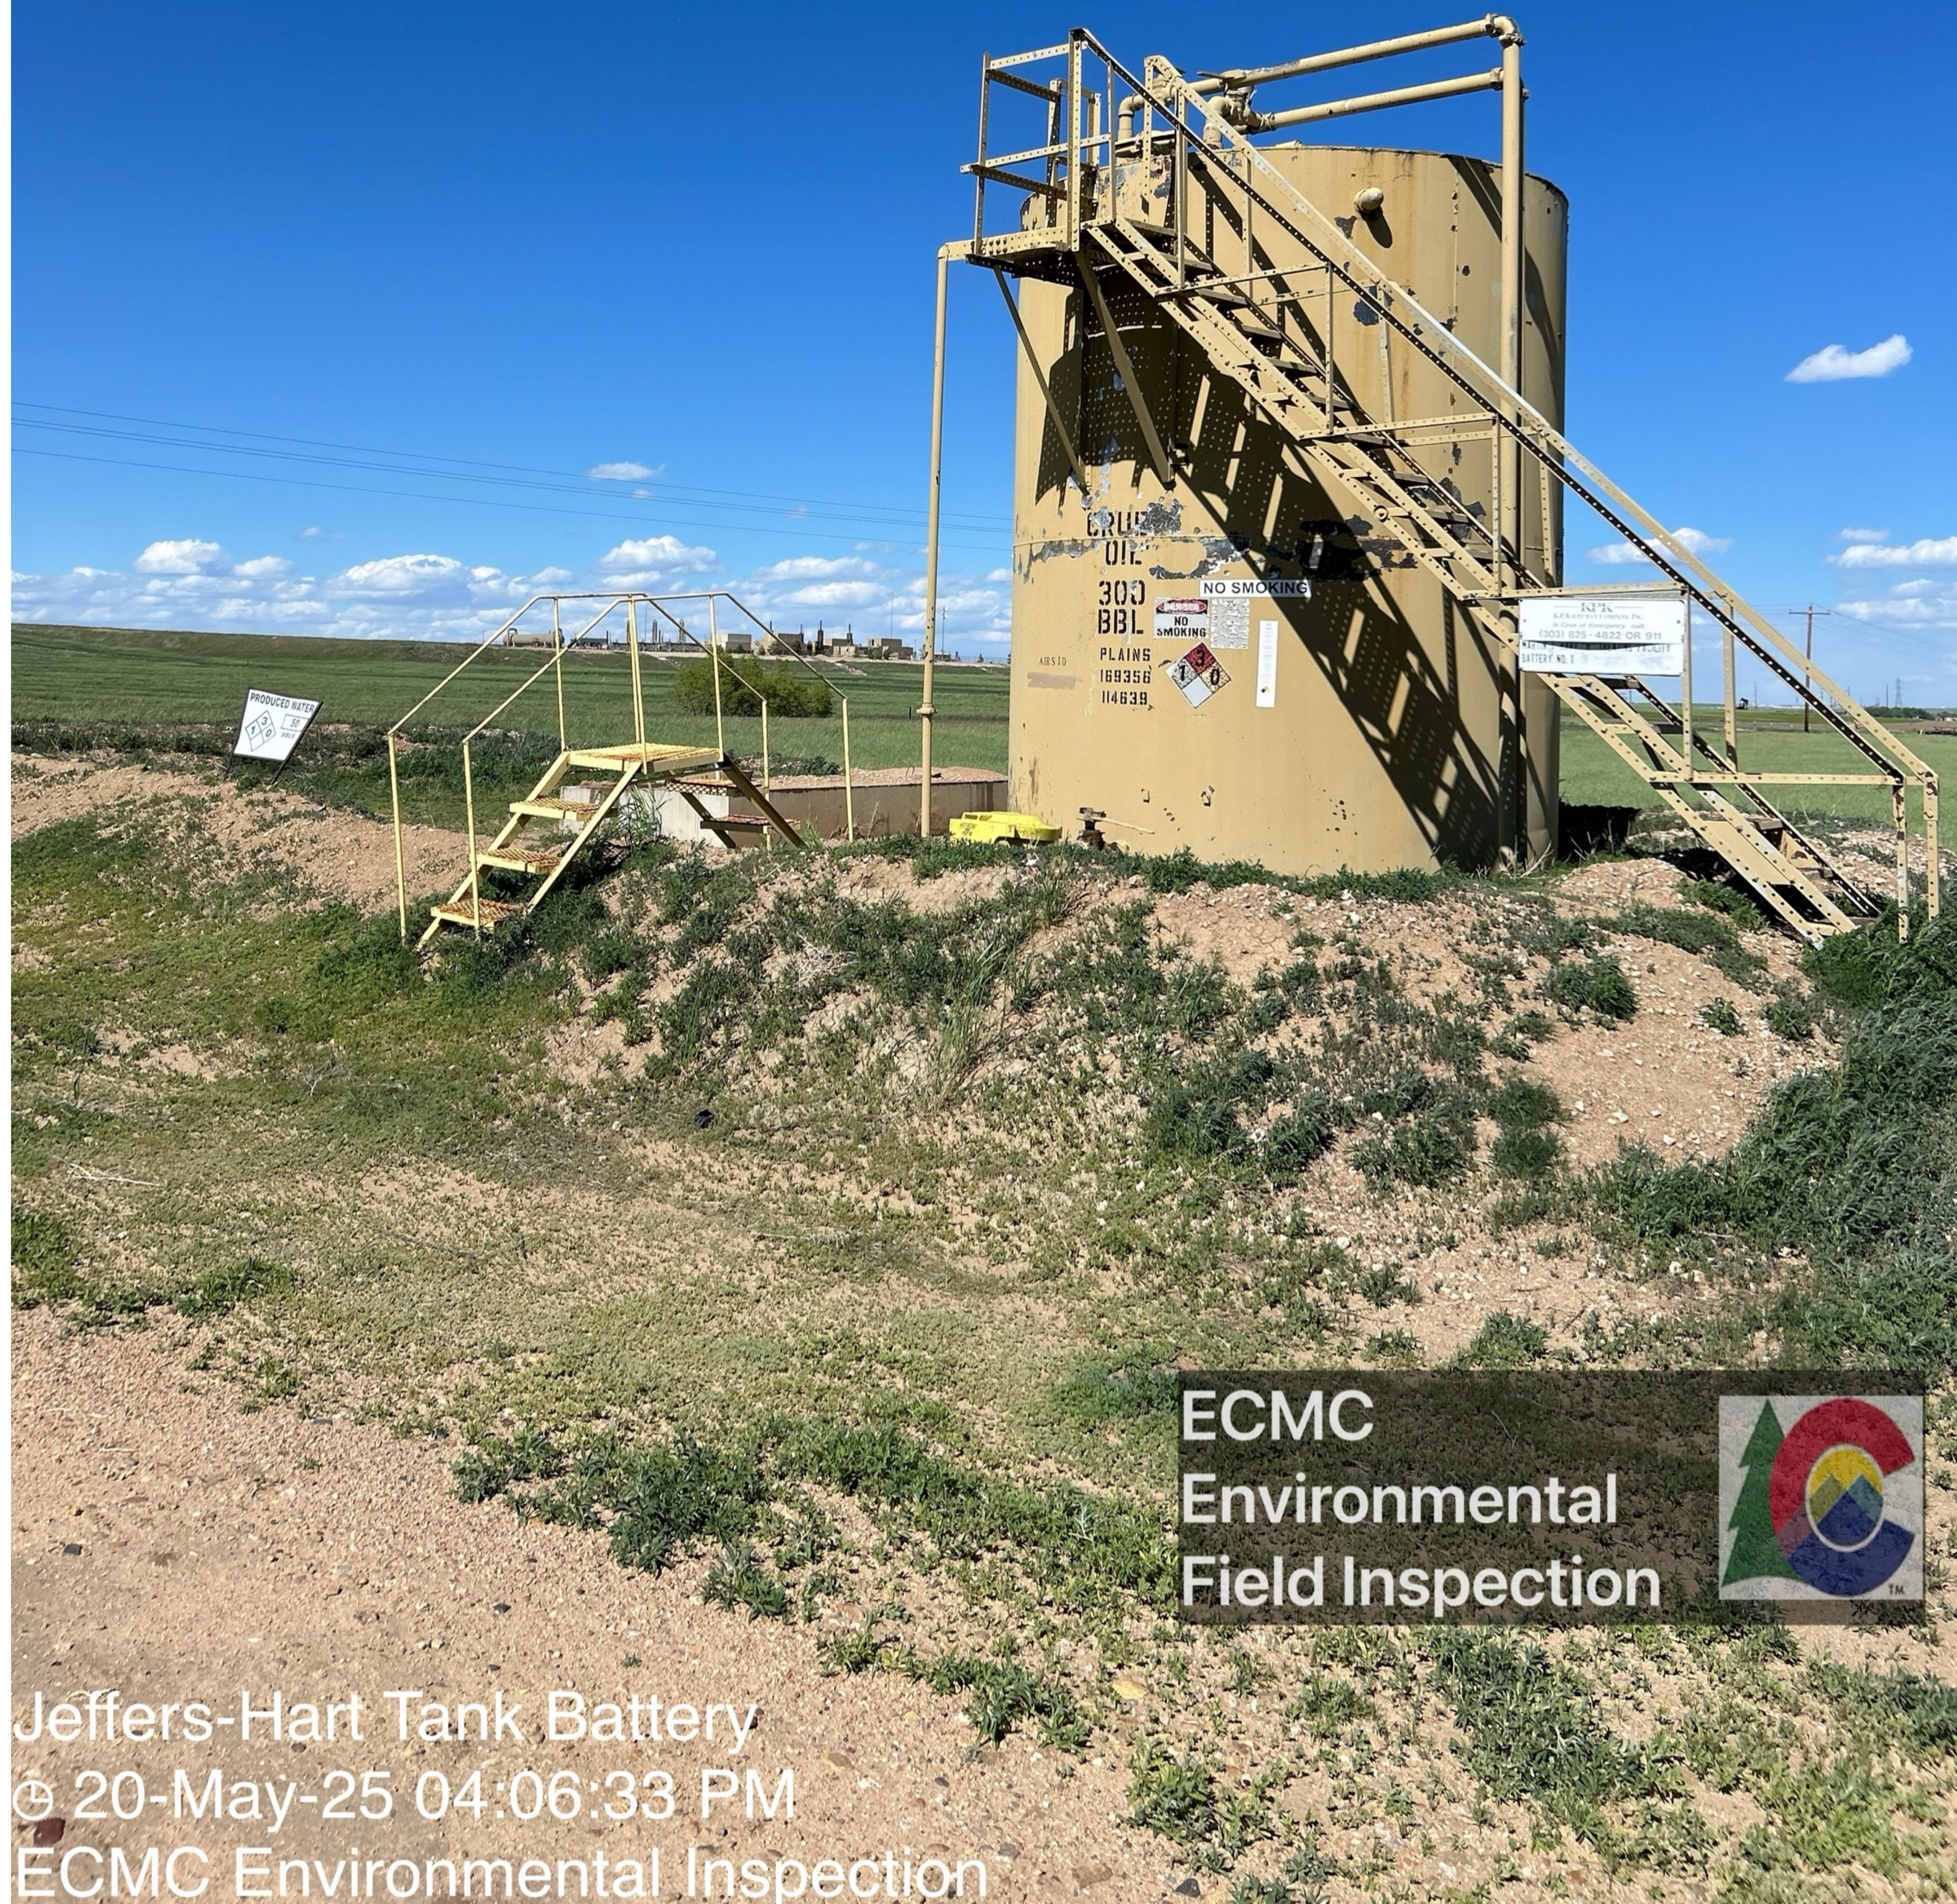
Paint is peeling on the production tank; labels are becoming illegible. Signage with emergency contact number is visible. Weeds are visible on and within the shared production tank and produced water vault berm.
