ECMC
Environmental
Field Inspection

Anderson Trust #1
© 21-May-25 09:23:26 AM
ECMC Environmental Inspection

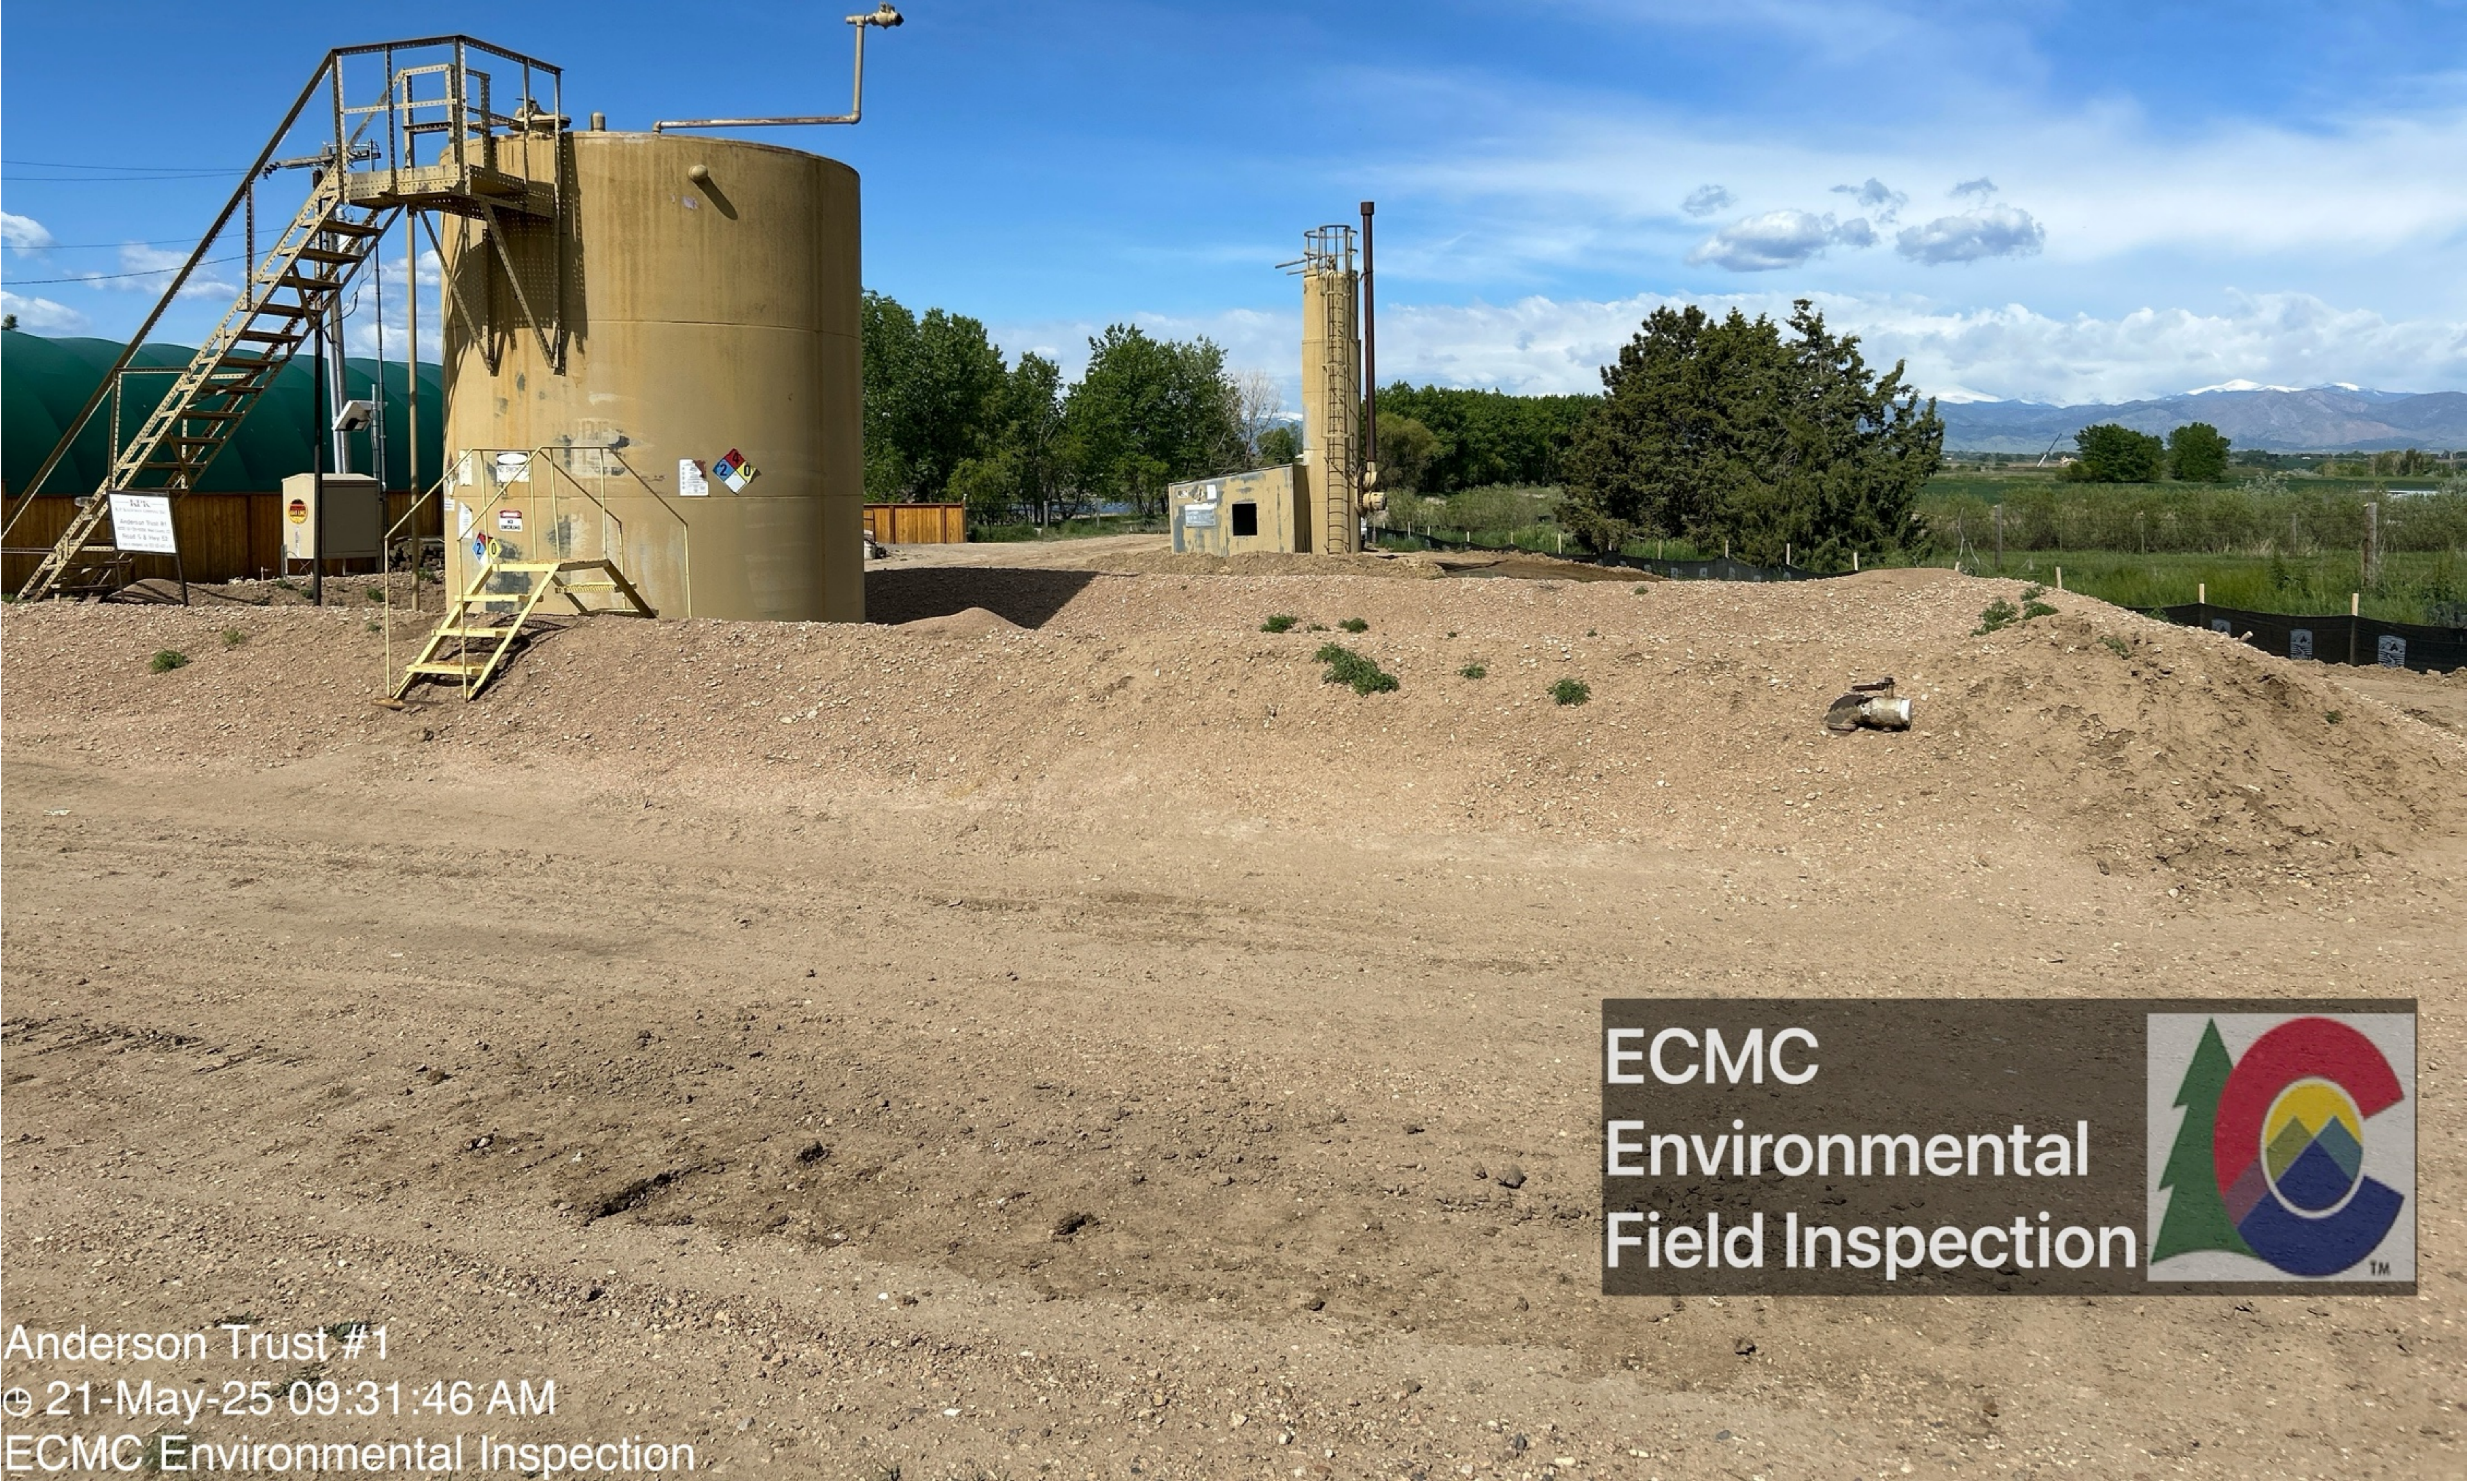
Anderson Trust #1
⌚ 21-May-25 09:31:46 AM
ECMC Environmental Inspection
Weeds were visible on the production tank berm.
