State 14
© 21-May-25 09:57:33 AM
ECMC Environmental Inspection

ECMC
Environmental
Field Inspection

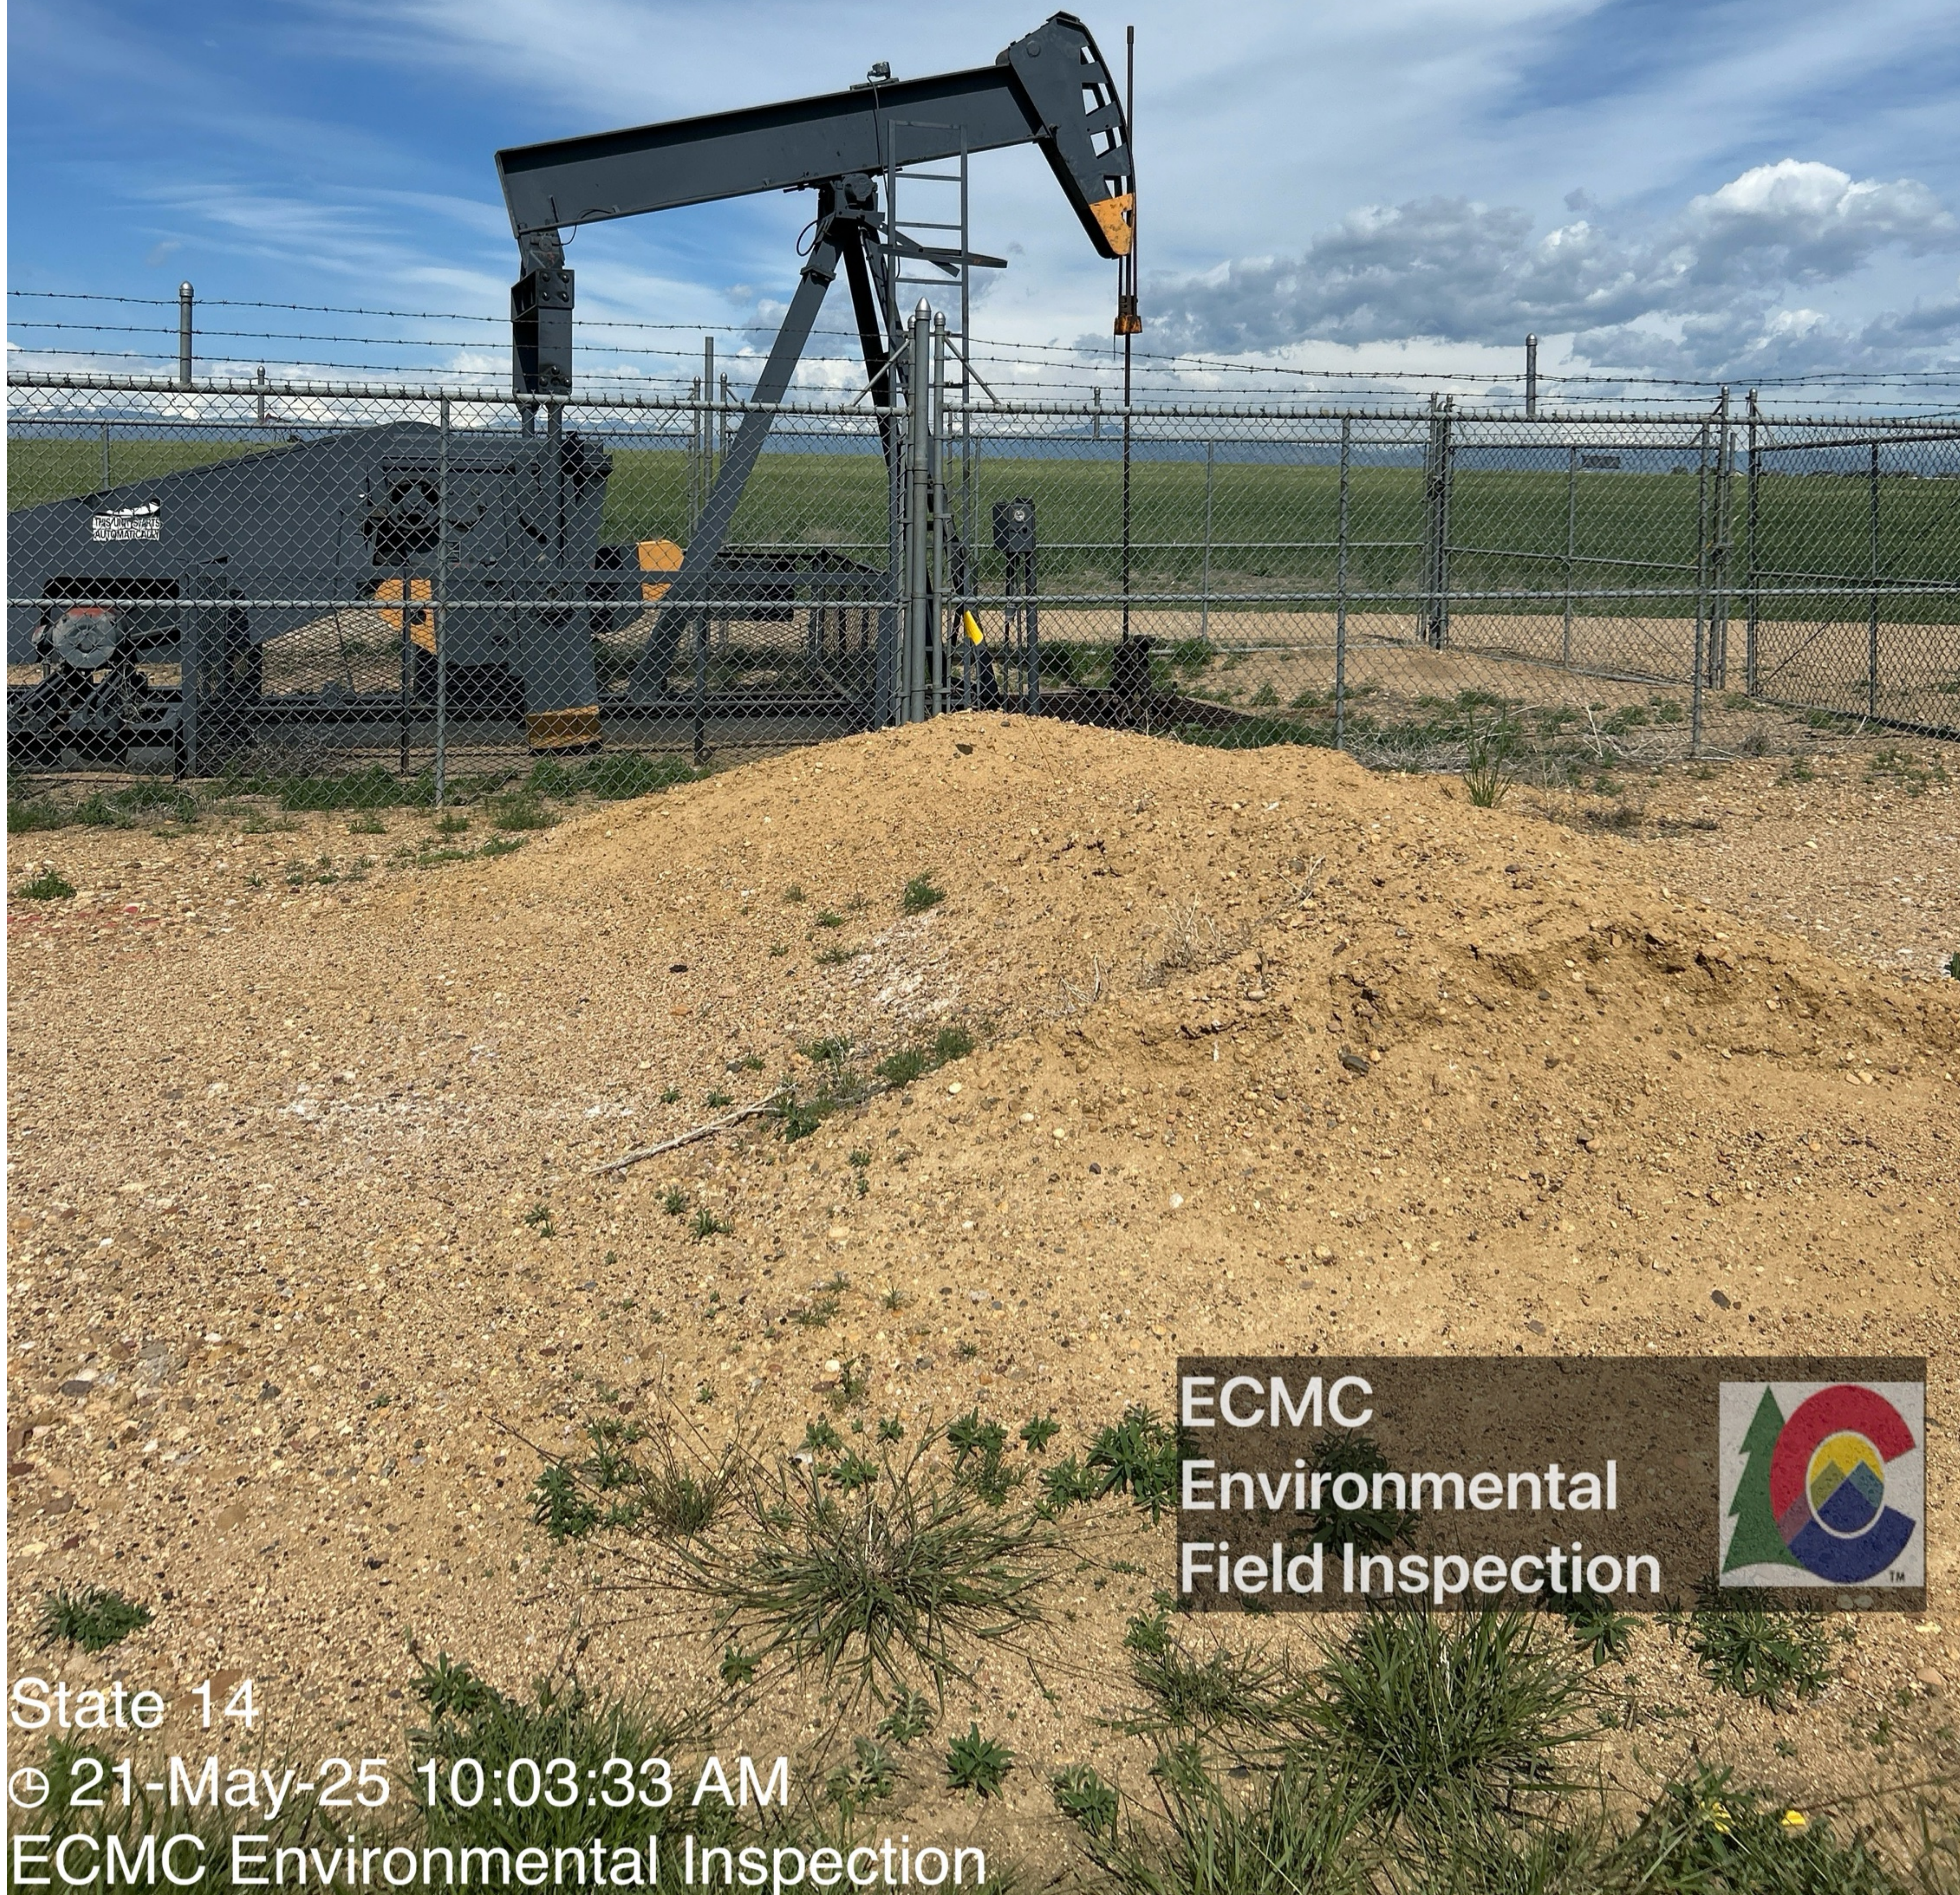
Trash was visible adjacent to the wellhead.

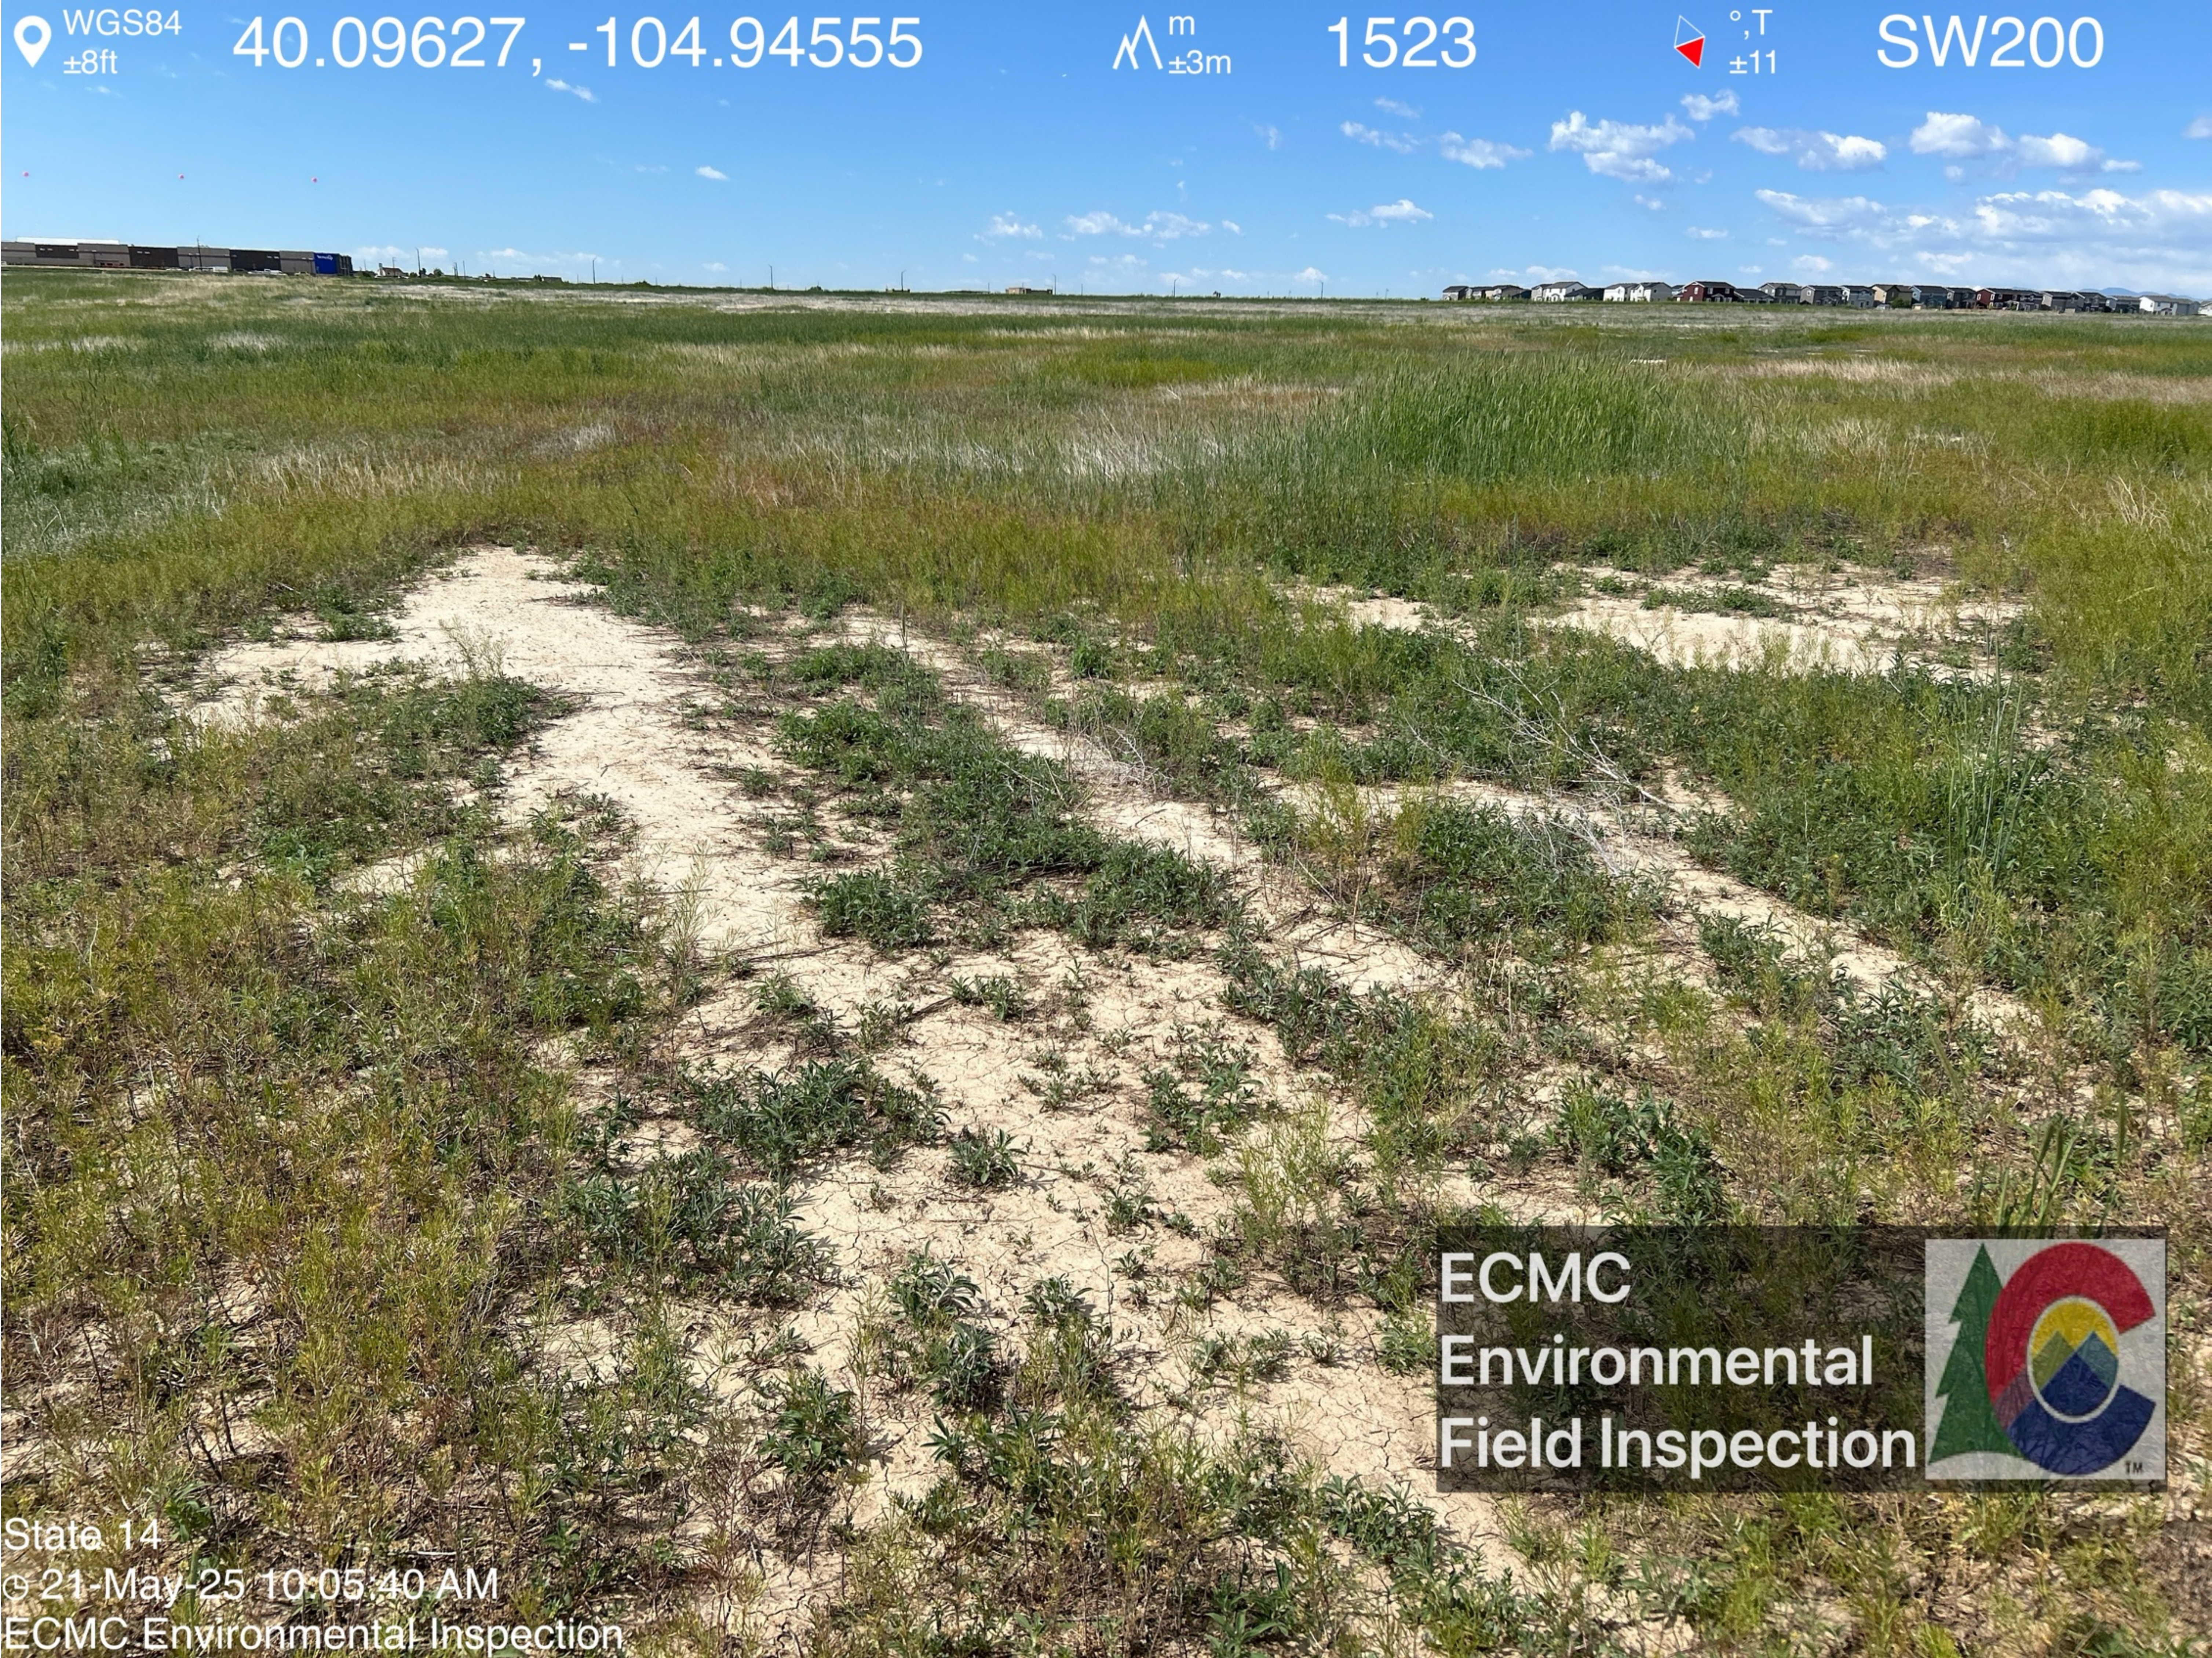
Approximate spill location. Excavation has been backfilled. Vegetation growth appears limited.

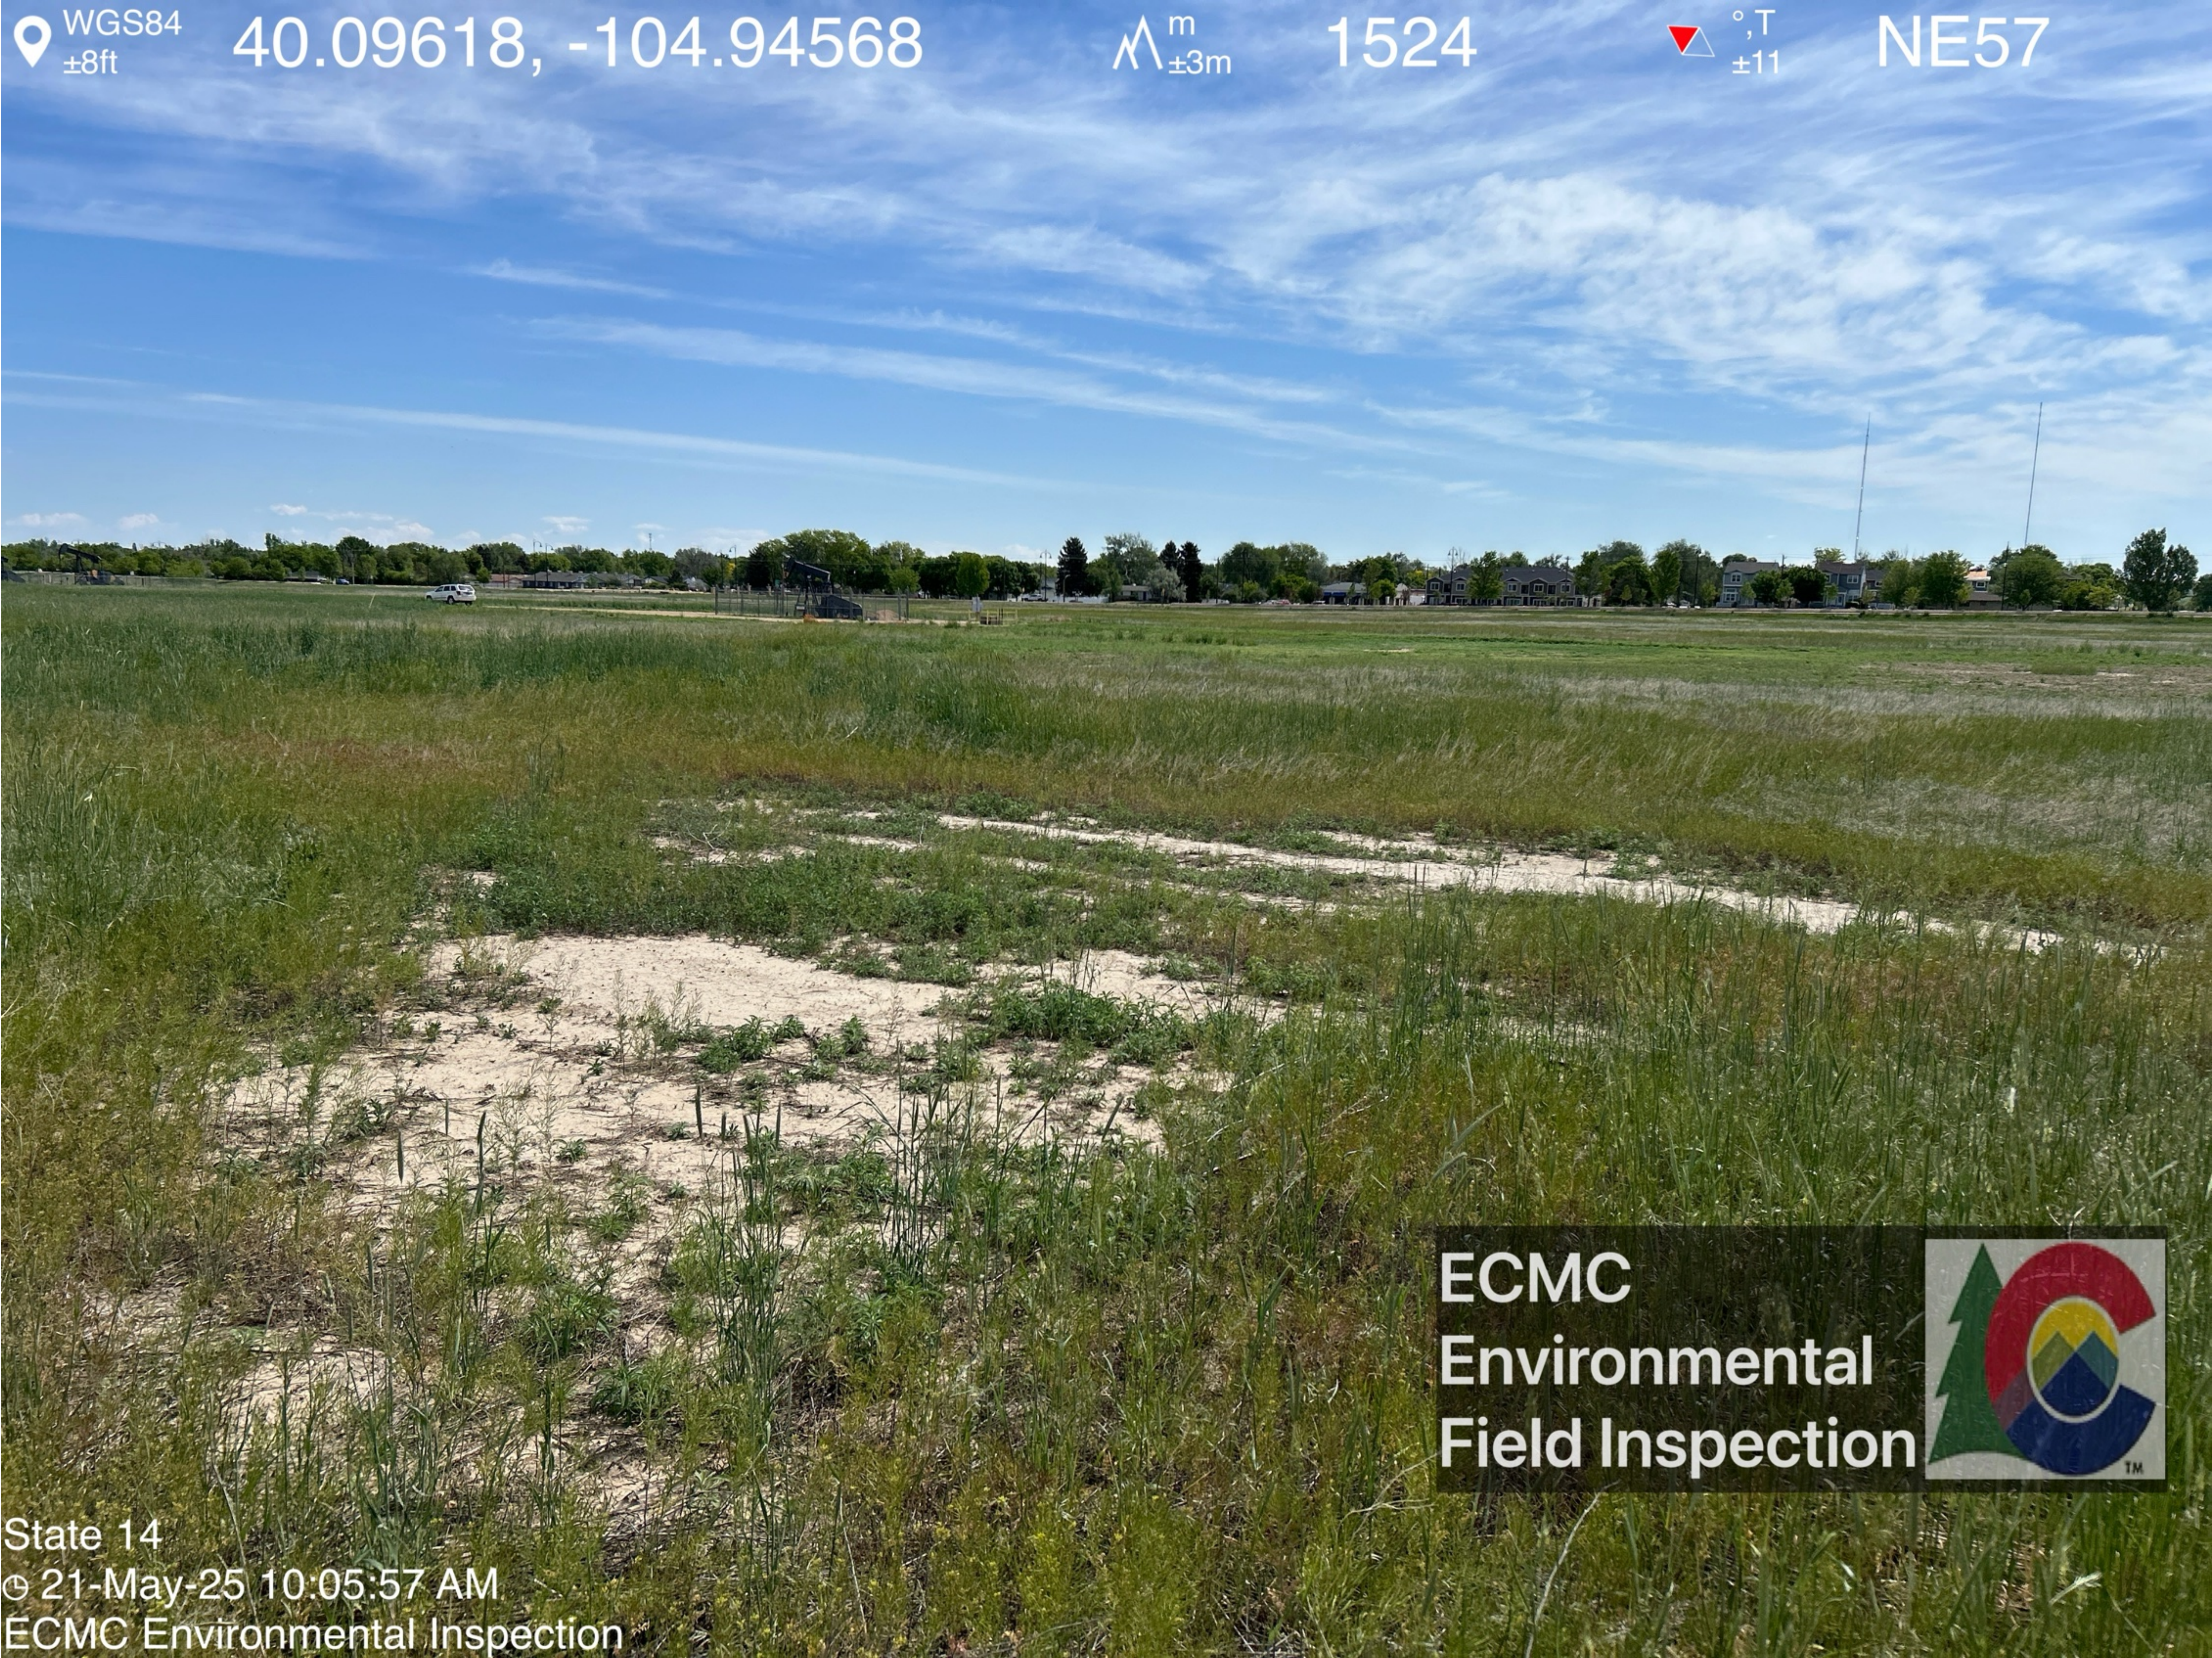
Approximate spill location. Excavation has been backfilled. Vegetation growth appears limited.
