Final Reclamation and Stormwater Inspection

Operator: RAMPART ENERGY COMPANY - 5685

Location ID: 387259

Inspection Document #: 718700462

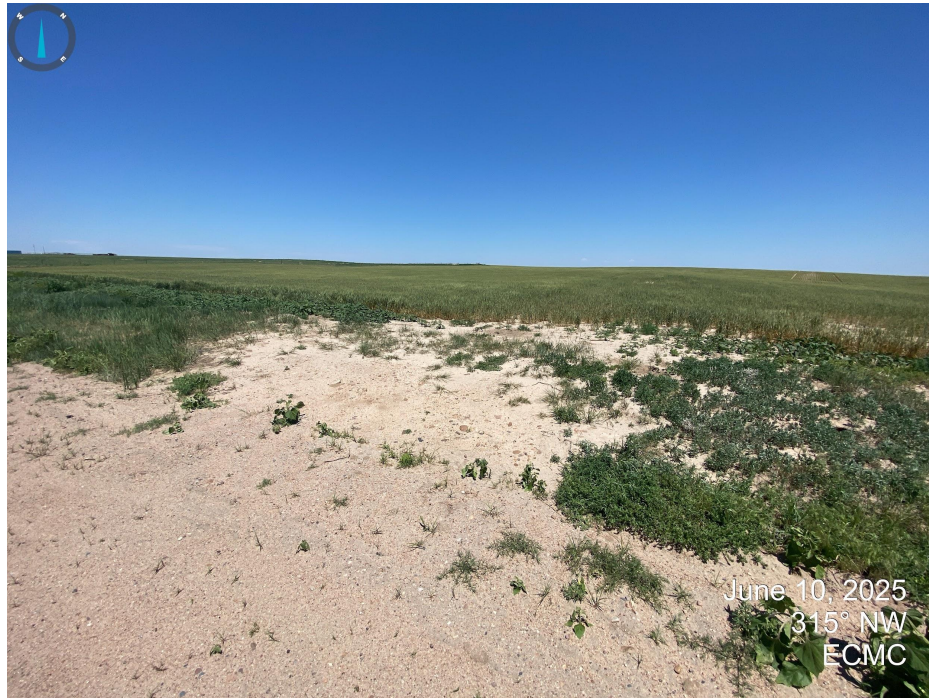
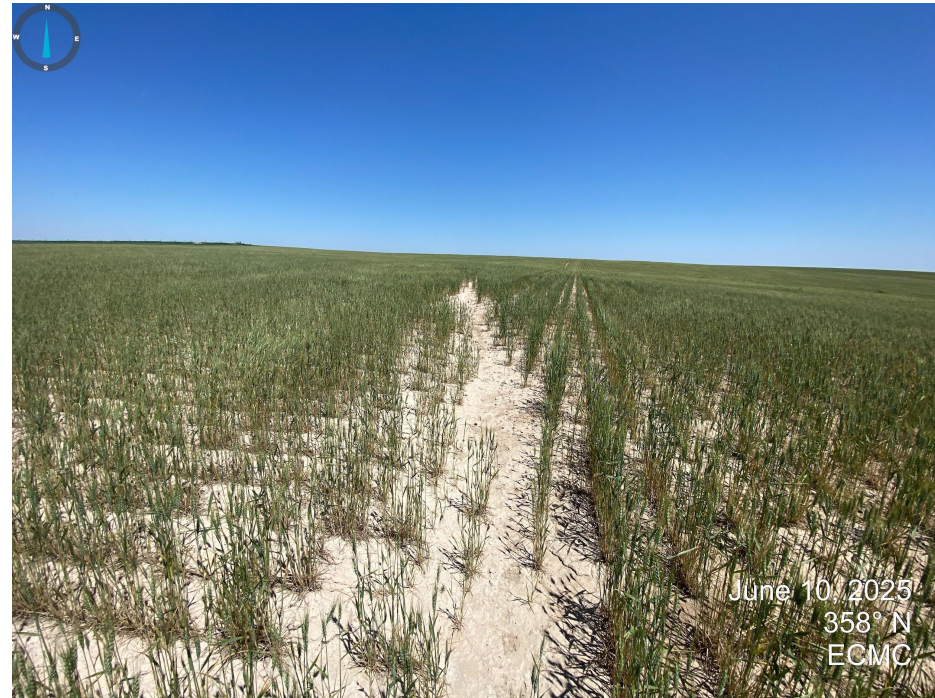
Photos 1 & 2. Taken along the access road, facing north. It does not appear that the access road has been reclaimed with evidence of contouring and grading issues.

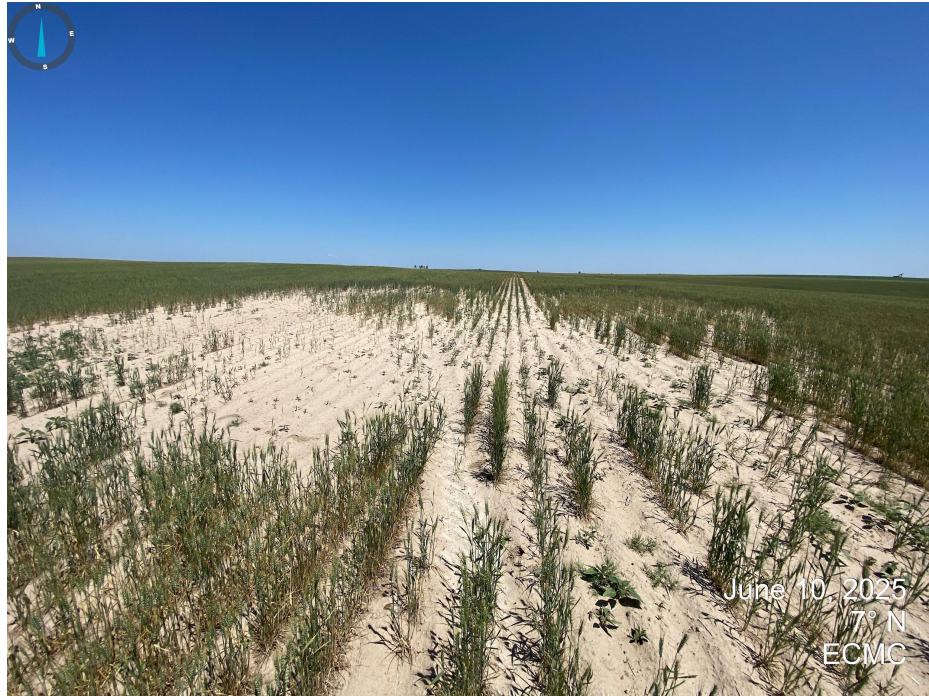
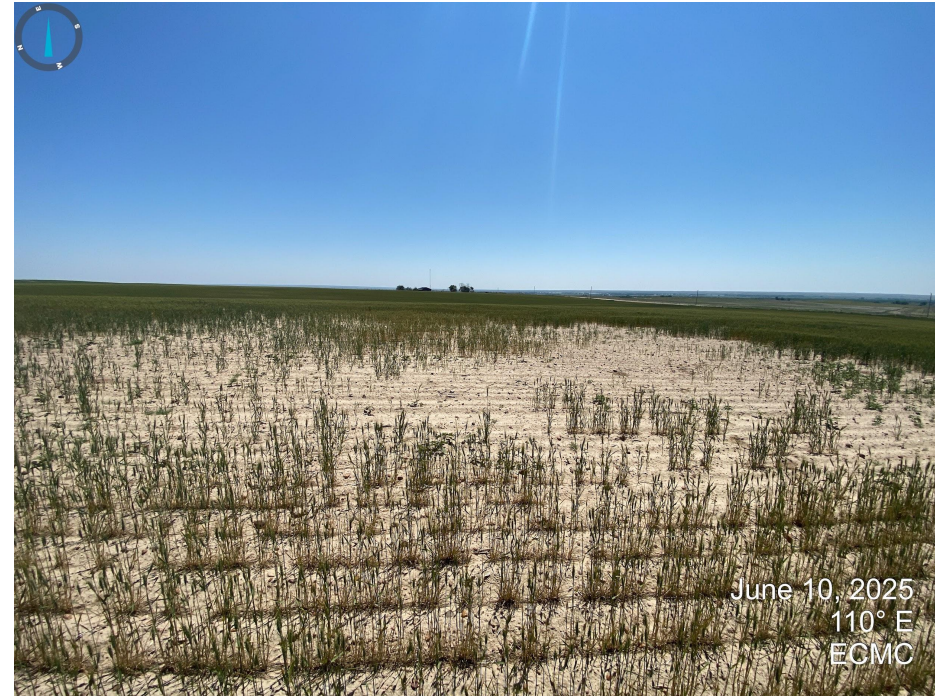
Photos 3 & 4. Taken near the well location, facing north (Photo 3; left) and east (Photo 4; right). The former well location does not appear to be progressing towards reclamation standards and regulations with evidence of non-uniform vegetation cover that is not reflective of the adjacent reference areas.

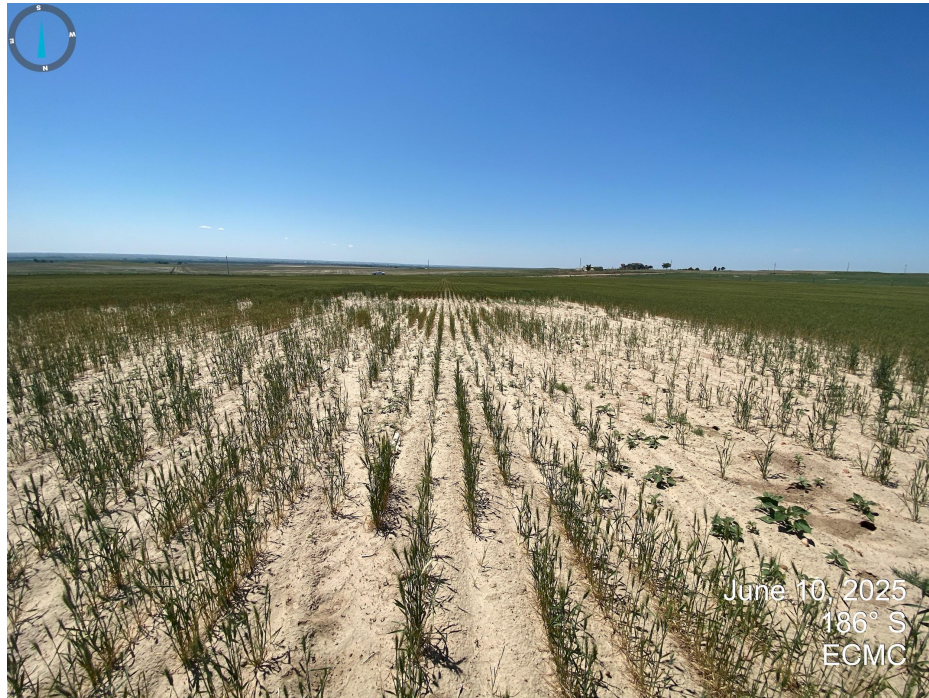
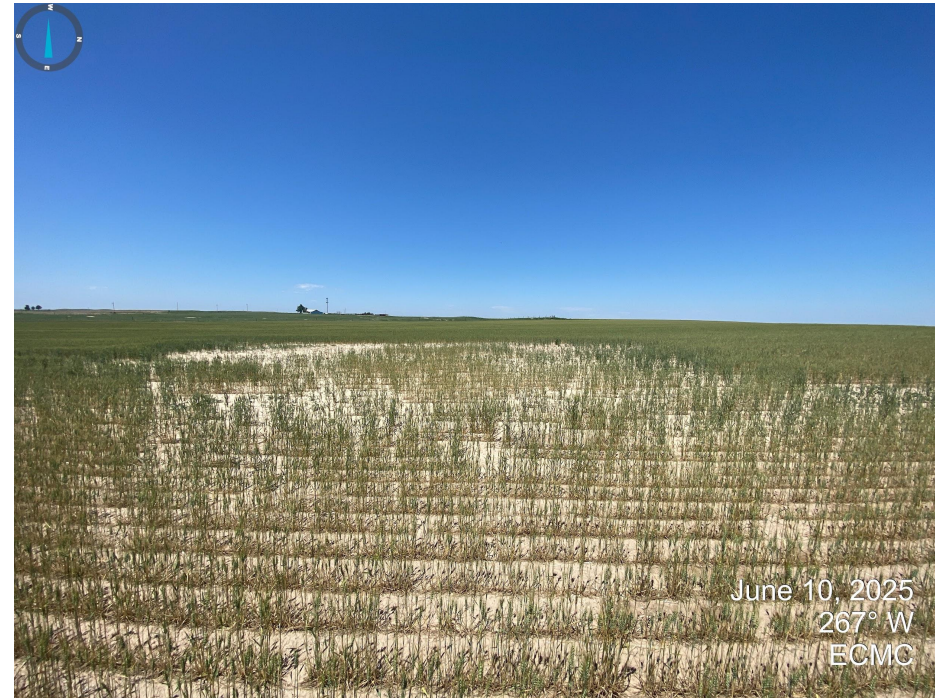
Photos 5 & 6. Taken near the well location, facing south (Photo 5; left) and west (Photo 6; right). See comments in Photos 3 & 4 for additional information.

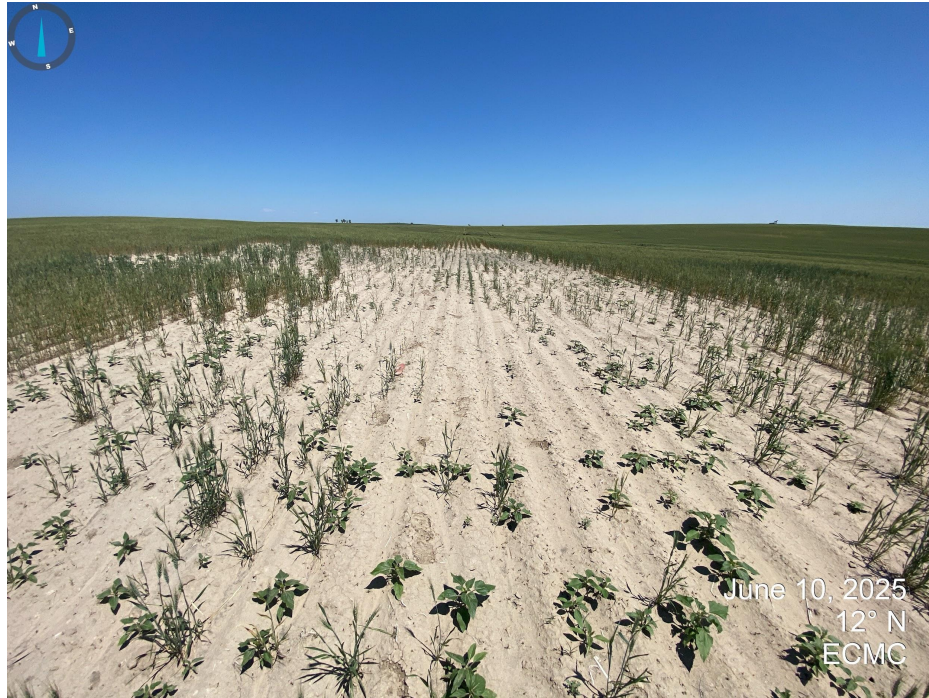
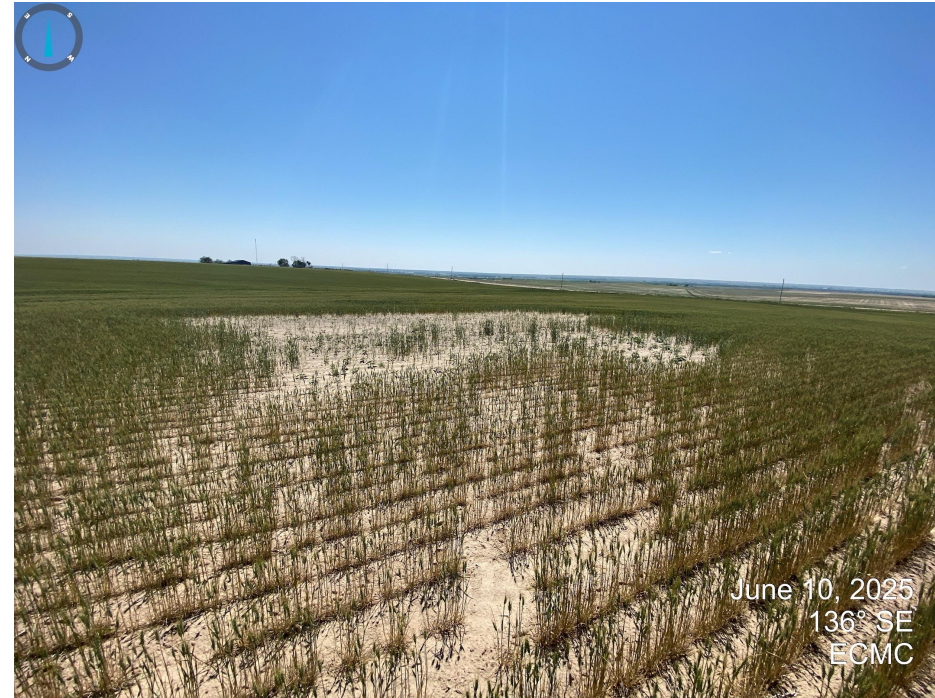
Photos 7 & 8. A disturbance area southeast of the former well location, possibly a former drilling pit, tank battery, or production facility, is also experiencing non-uniform vegetation cover resulting in bare soils.

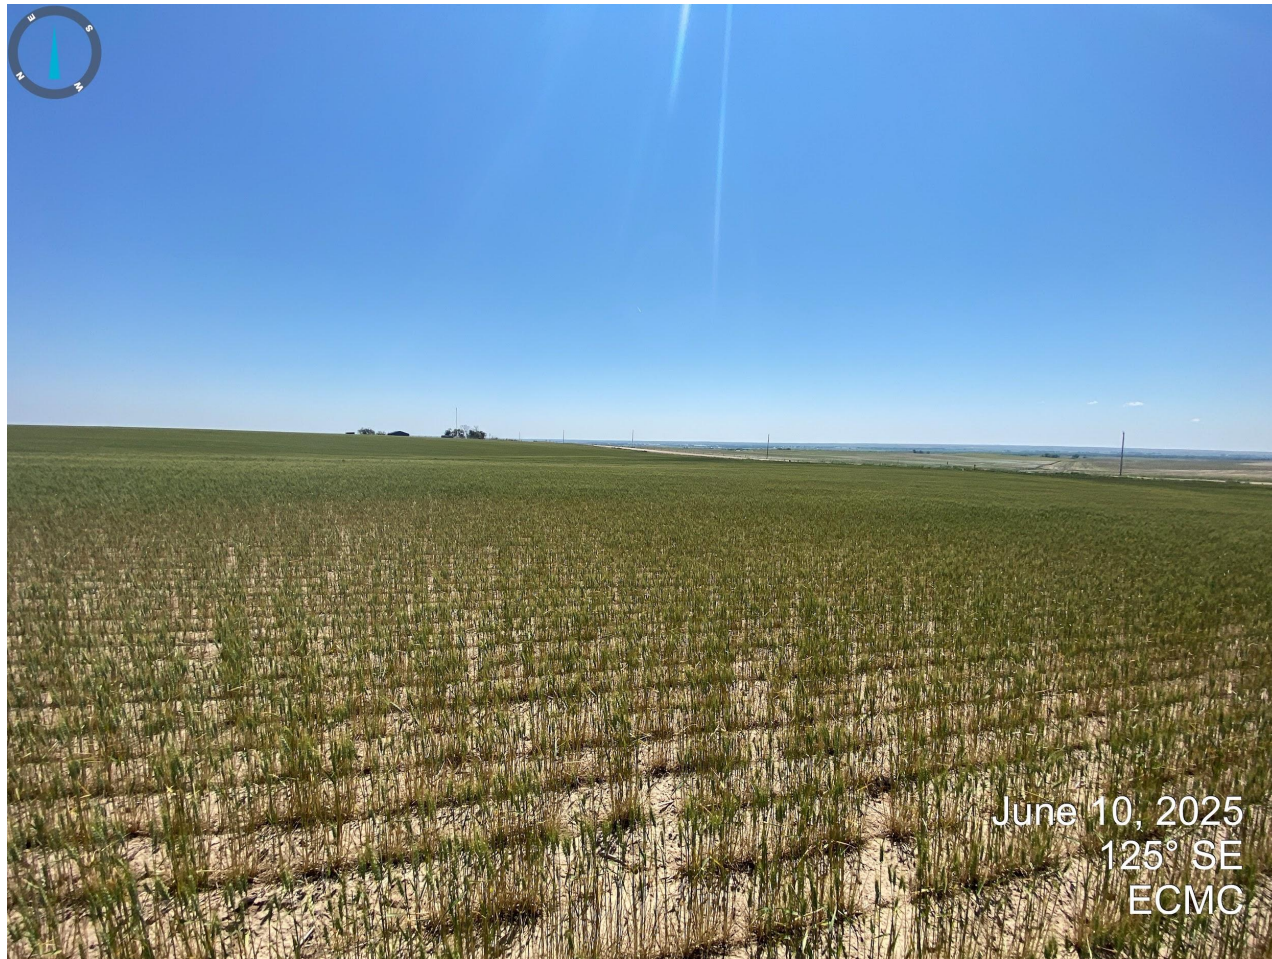
Photo 9. Photo of the adjacent reference area south of the former well location.

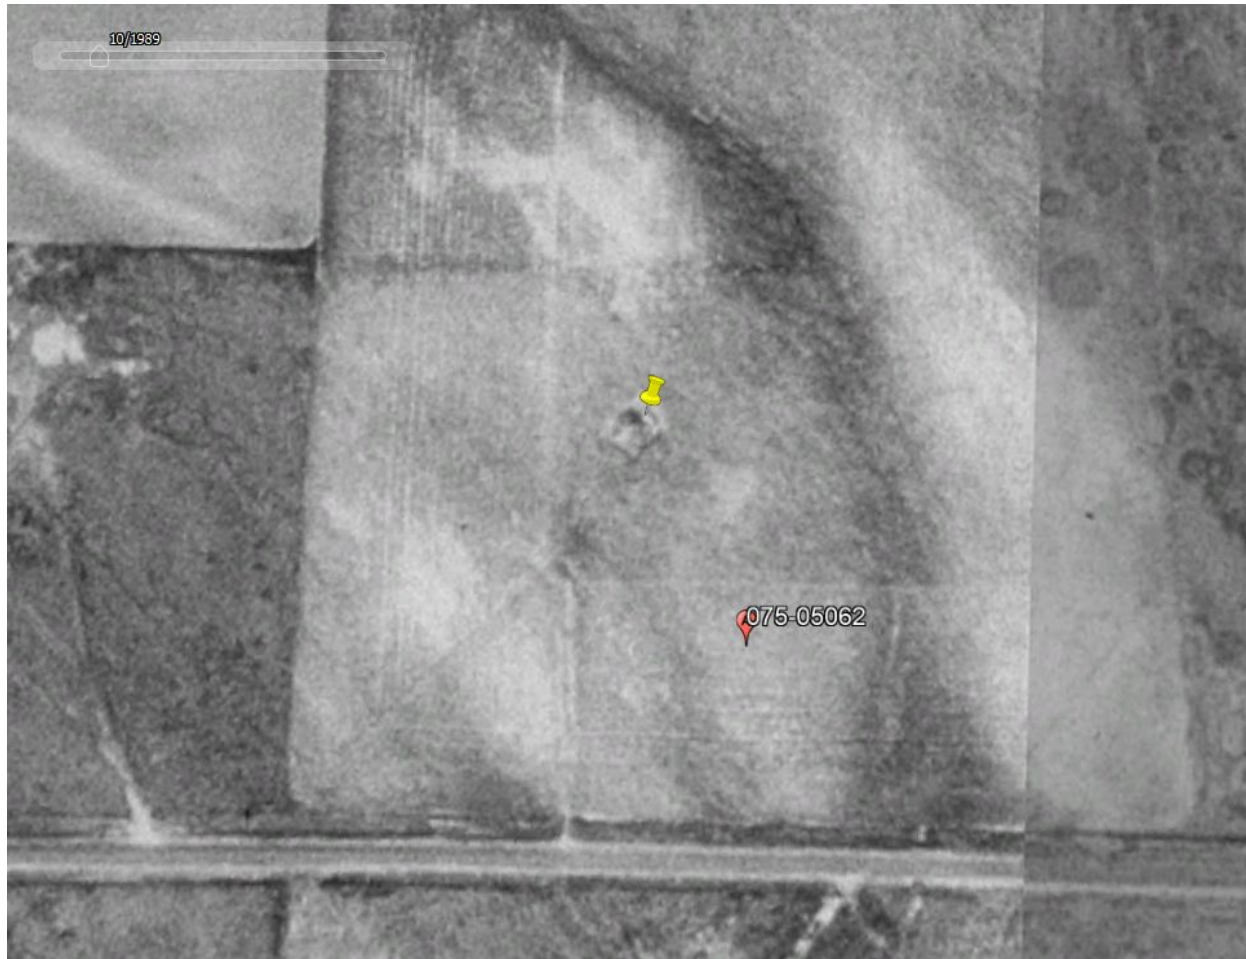
Photo 10. Google Earth historical aerial imagery (circa 10/1989) illustrating that the reported lat/long on the scout card for API 075-05062 (40.465150, -103.434530; red dot) differs from field observations and historical imagery, represented by the yellow pin (approx. 40.4658422, -103.4350519).
