## Inspection Photos

**Operator: LOCIN OIL CORPORATION- 51130**

**Location Name: COLUMBINE SPINGS #8-11-4-104 WDW**

**Inspection Date: 6/11/2025 Inspection Doc#: 693808828**

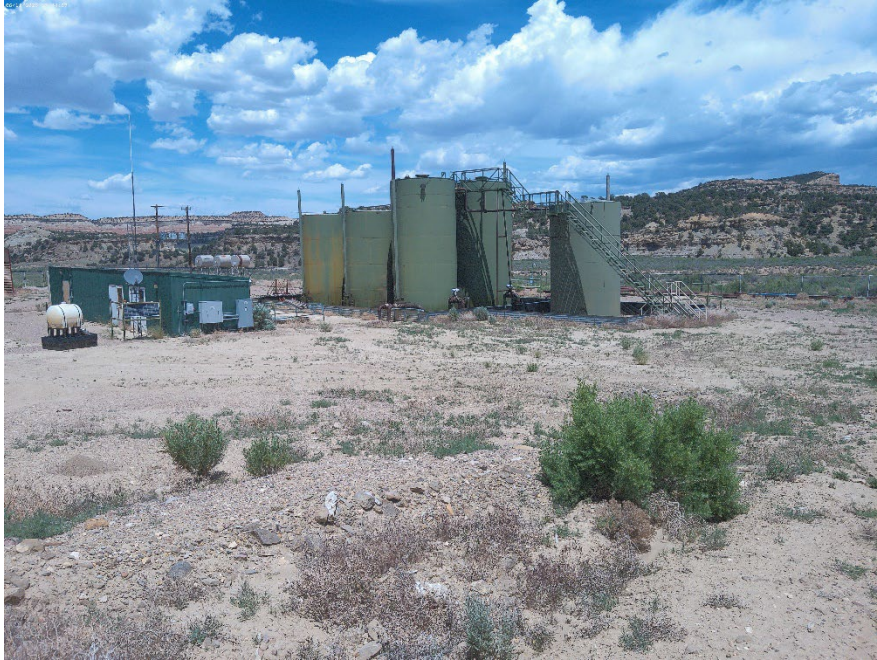
**Location overview looking E**

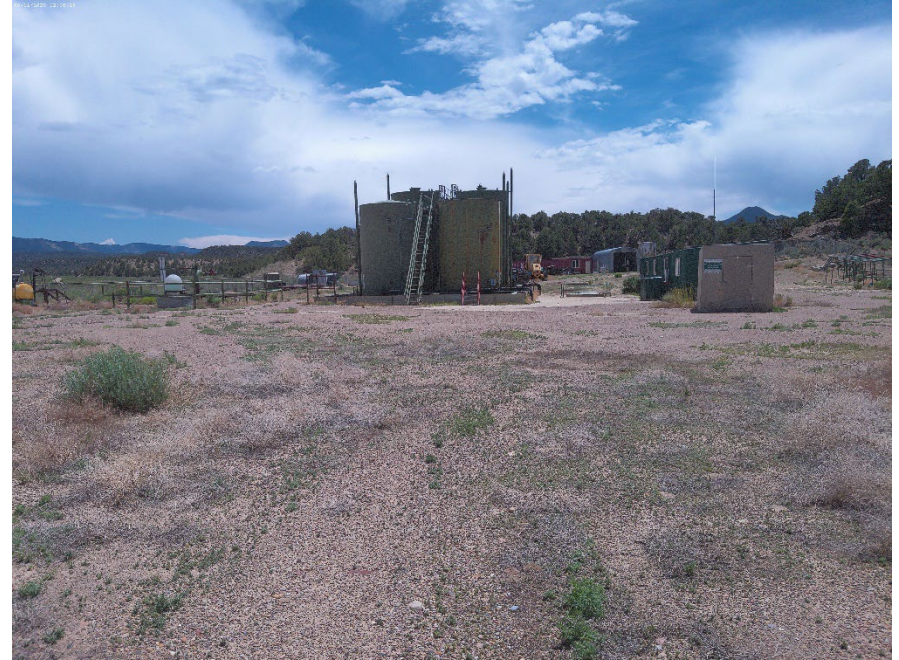
**Location overview looking S**

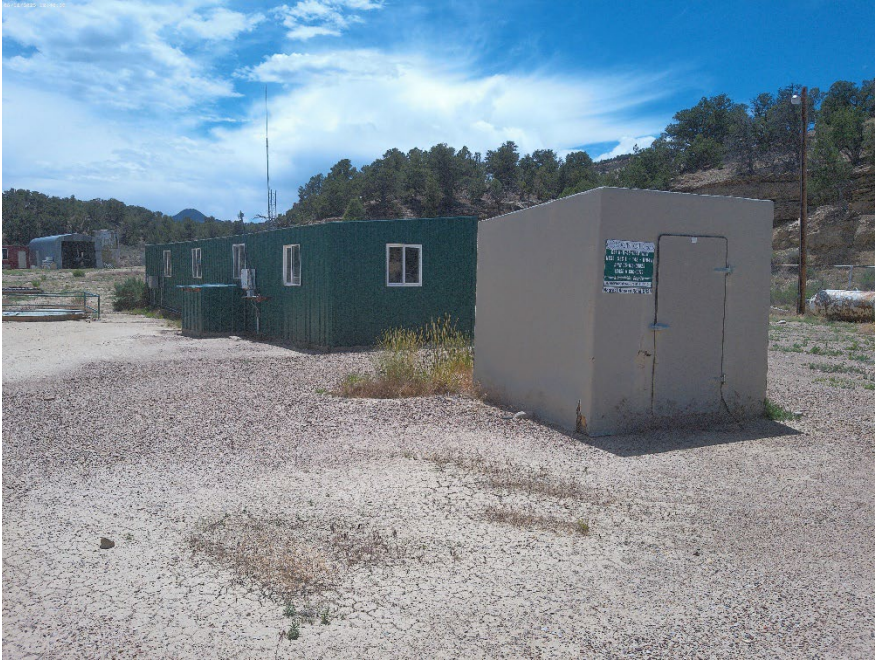
**Injection wellhead housing**

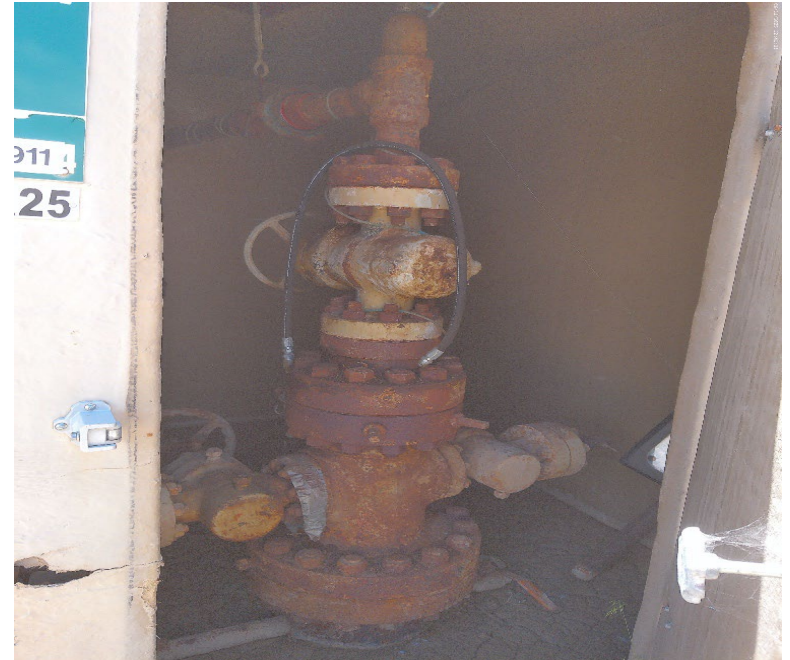
**Wellhead inside housing**

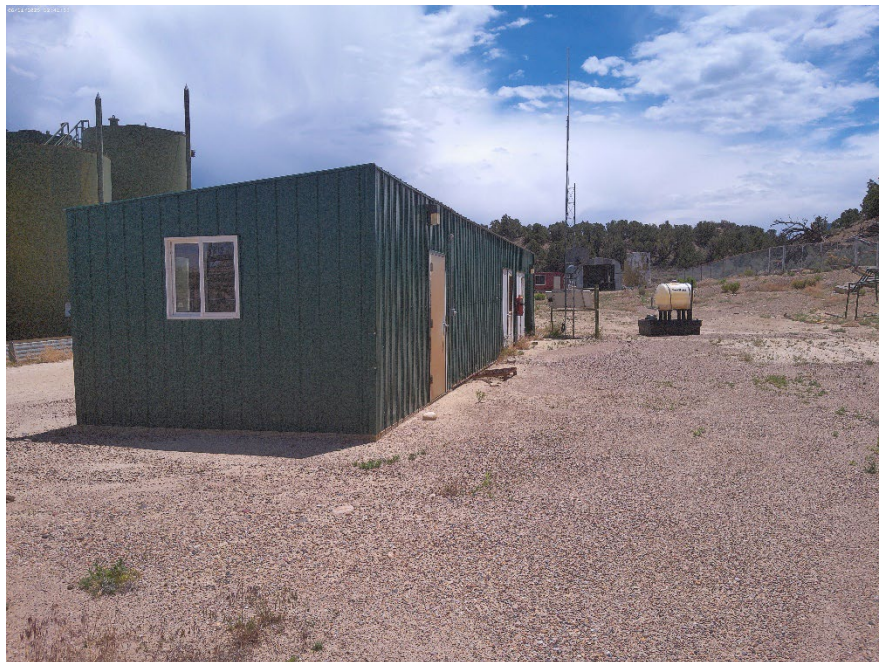
**Pump housing**

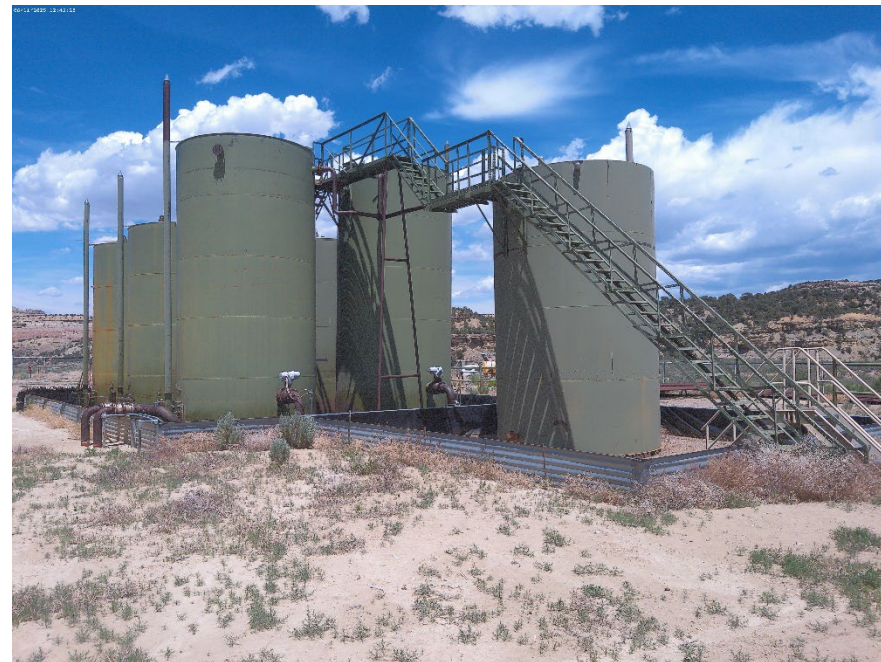
**Tank Battery**

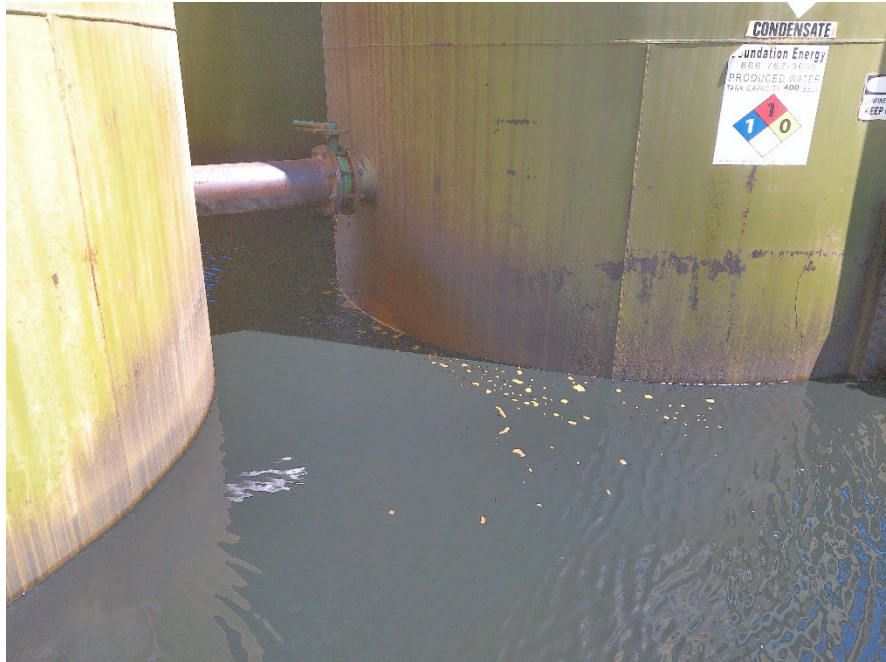
**Leaking valve on Produced Water/ Condensate tank**

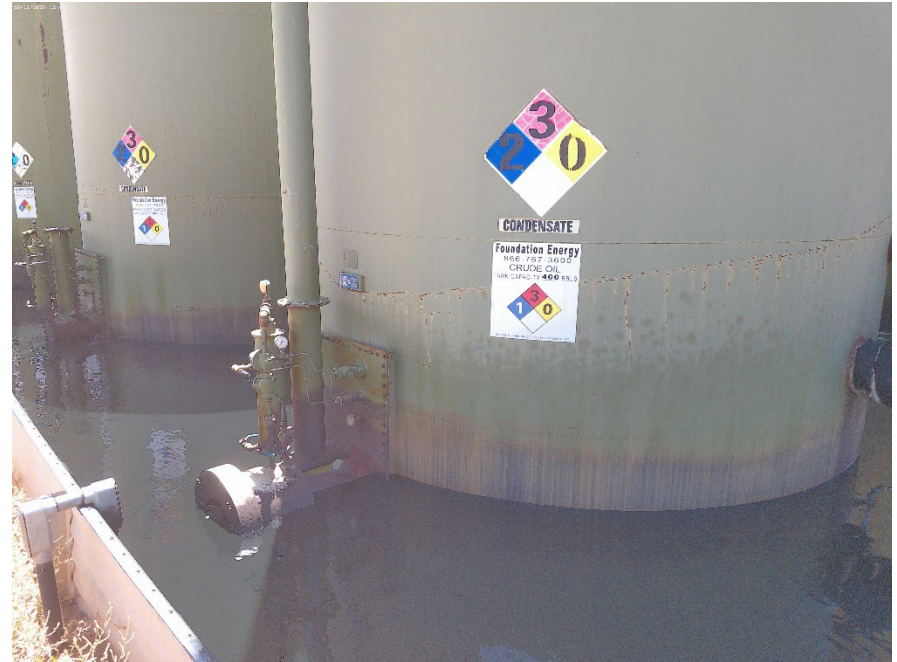
**Produce Water/Condensate fluid level inside berms.**

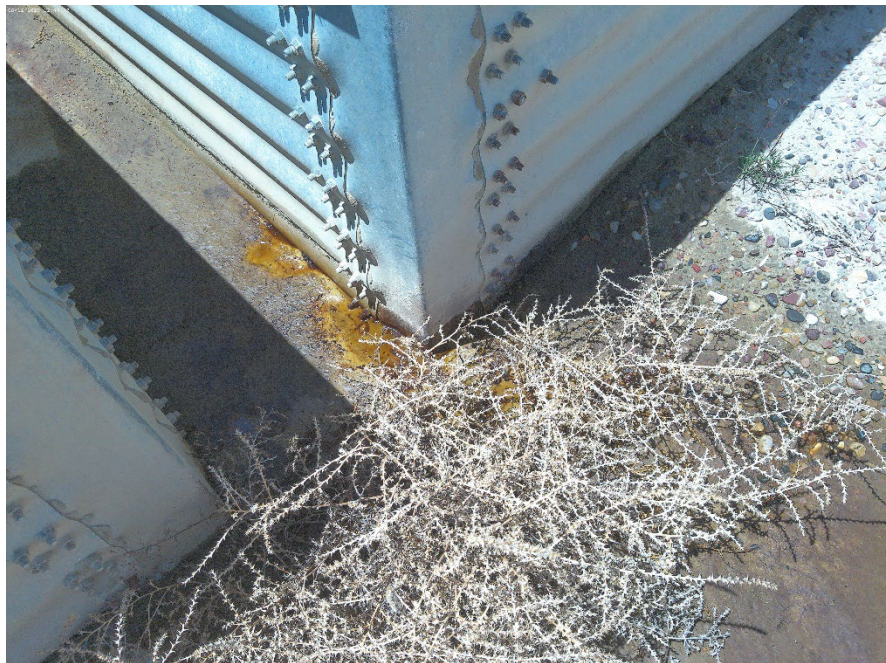
**Leaking berm liner on SE corner of tank berms**

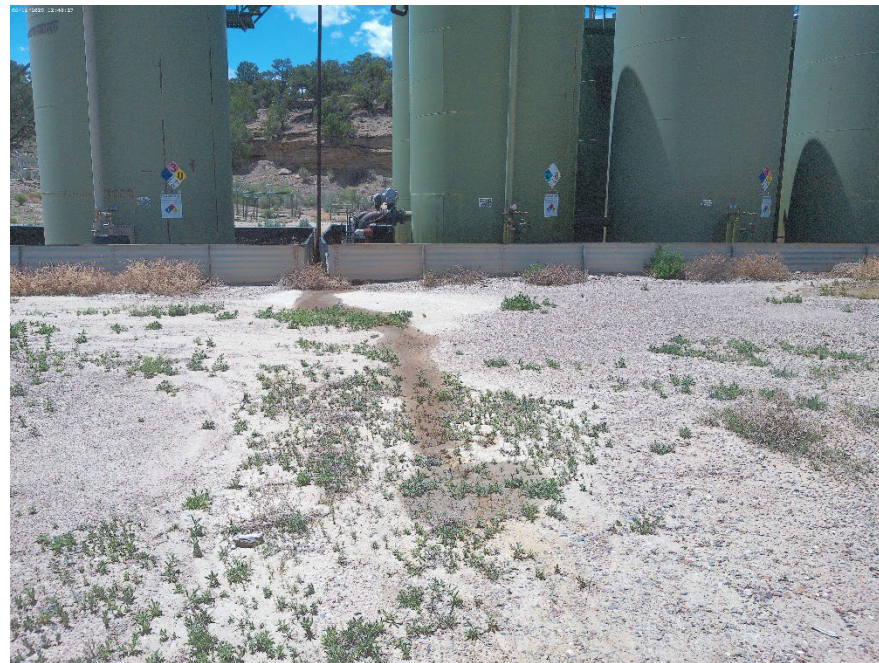
**Spill area from leaking berms.**

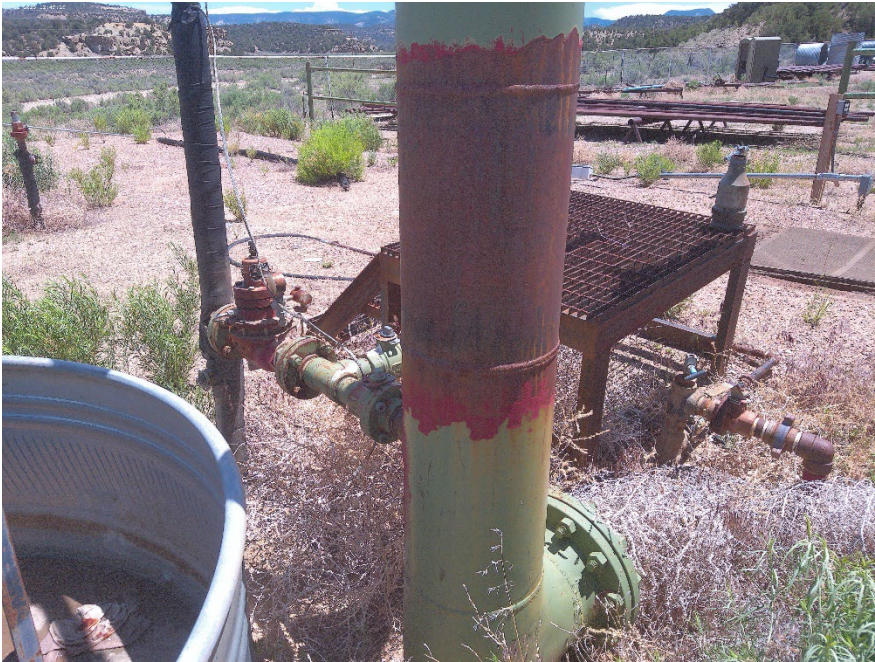
**Flowline riser with audible gas leak**

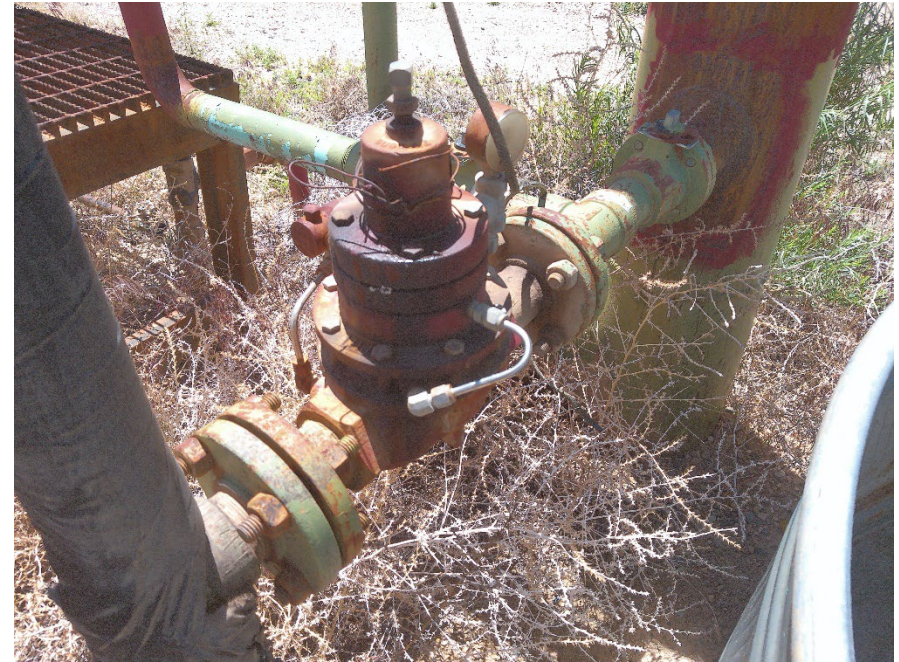
**Valve with audible gas leak.**
