# Interim Reclamation and Stormwater Inspection

June 12, 2025

Operator: COPPER LAND RESOURCES LLC - 10808

Well Name: LINDA #2

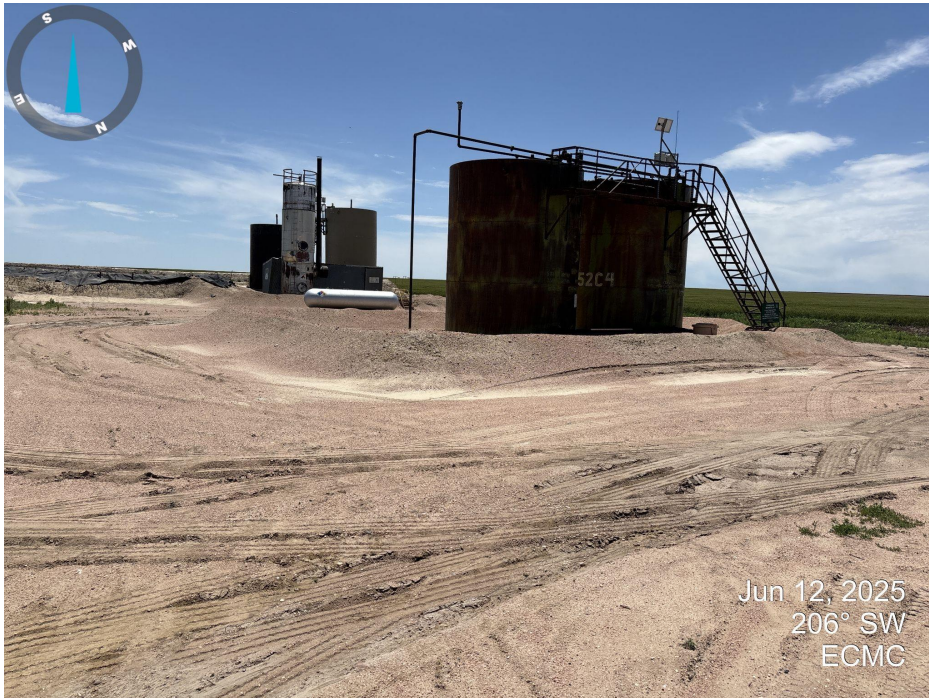
**Photo 1.** Looking south across tank battery.

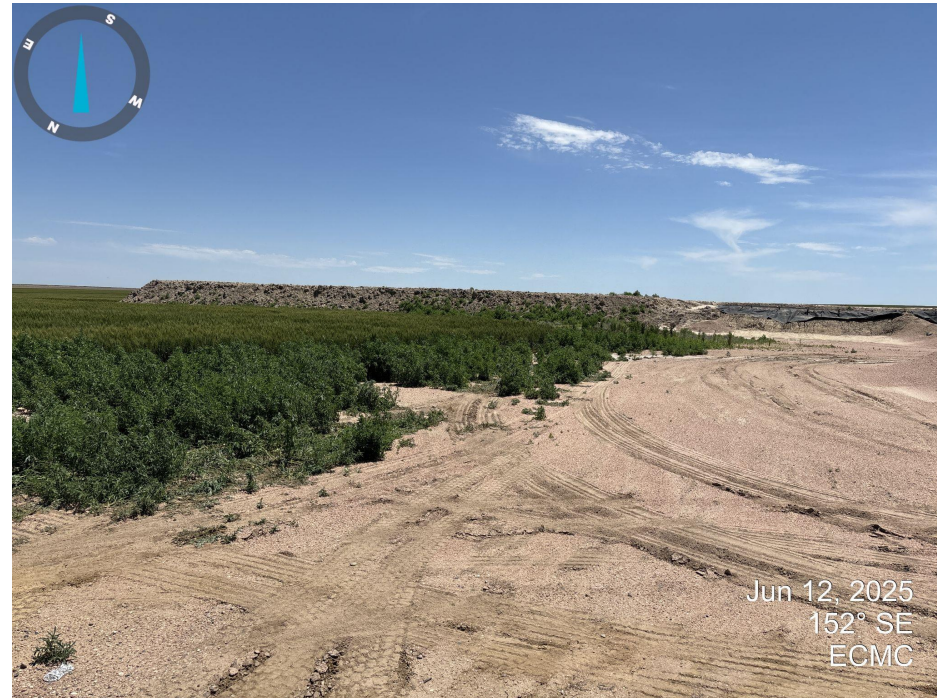
**Photo 2.** Looking south across the east side of tank battery towards produced water pit. Undesirable weed kochia is present at location. Location is surrounded by active cropland.

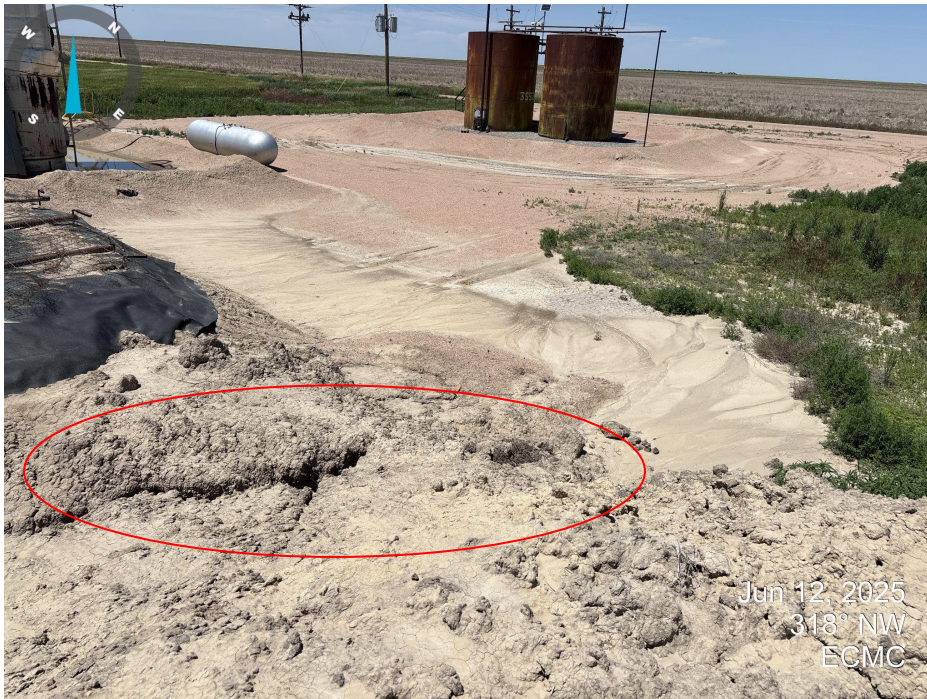
**Photo 3.** Picture taken near skim pit looking northwest. Gully erosion is present between produced water pit and skim pit (red circle).

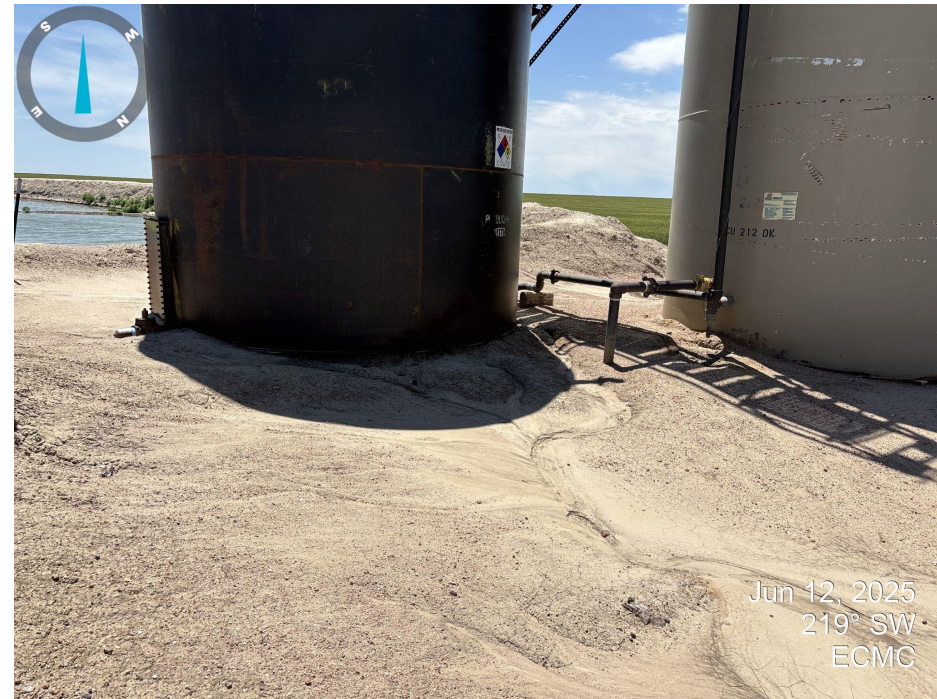
**Photo 4.** Picture taken at tank behind separator. Erosion is beginning to wash out underneath the north edge of the tank.

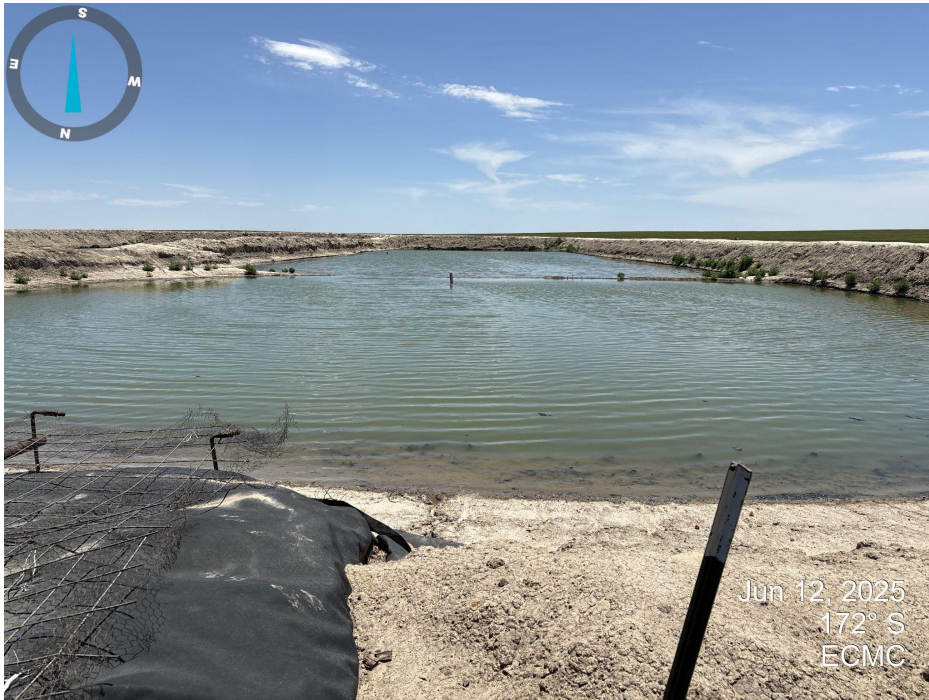
**Photo 5.** Looking south across the eastern produced water pit. The wall on this edge of pit is approximately 18" above water level.

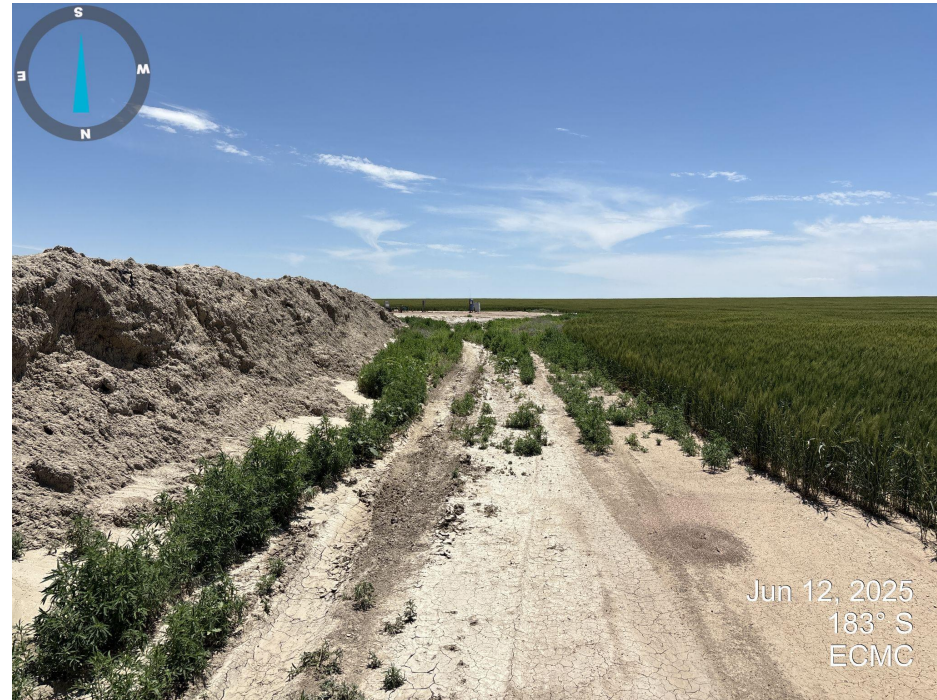
**Photo 6.** Looking south down access road to wellhead. Undesirable weed kochia is present.

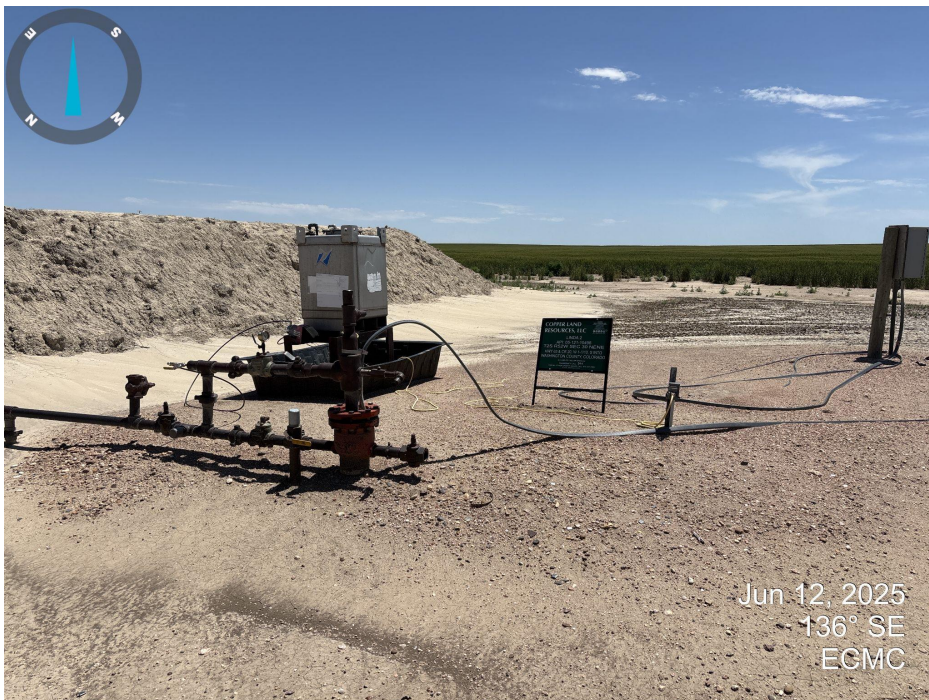
**Photo 7.** Looking southeast at wellhead.

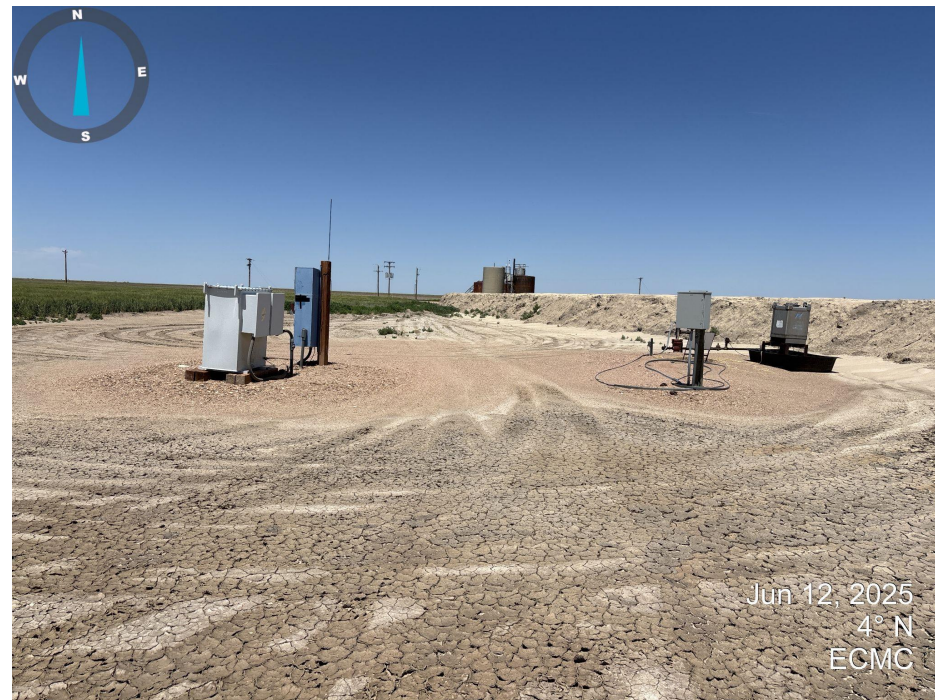
**Photo 8.** Looking north across wellhead area.

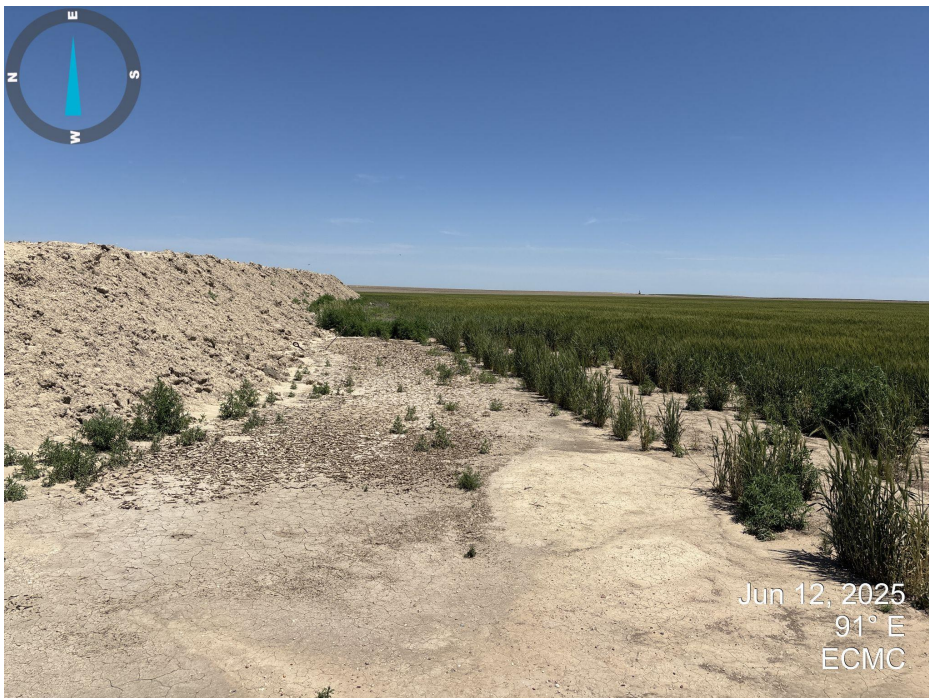
**Photo 9.** Looking east along the south side of the location. Location is surrounded by cropland.

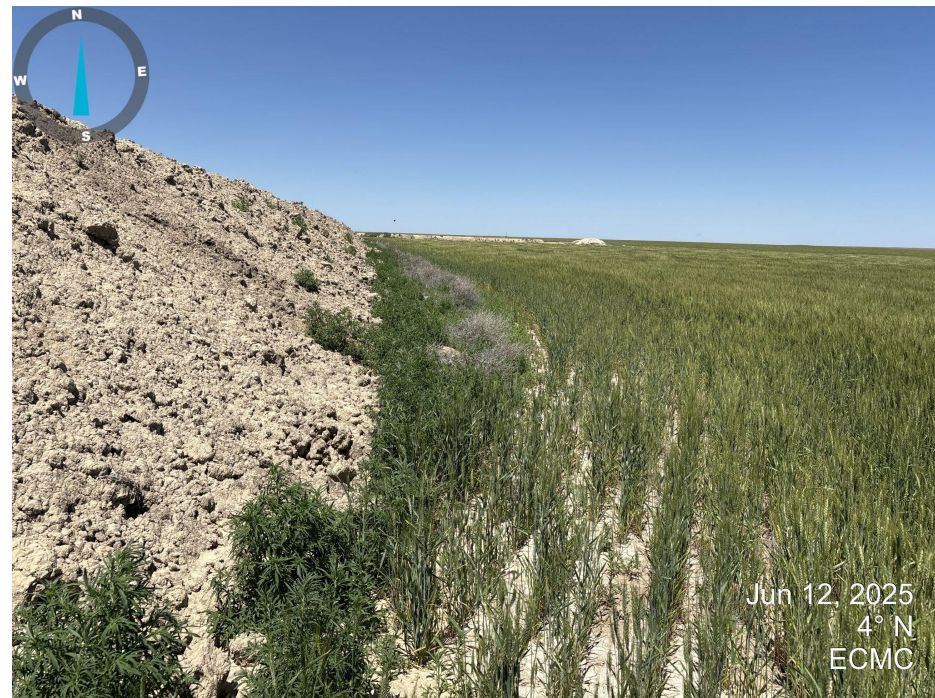
**Photo 10.** Looking north along the east side of location. See photo 9 comments.
