ECMC
Environmental
Field Inspection

Mama Bear Tank Battery (479908)
04-Jun-25 12:04:25

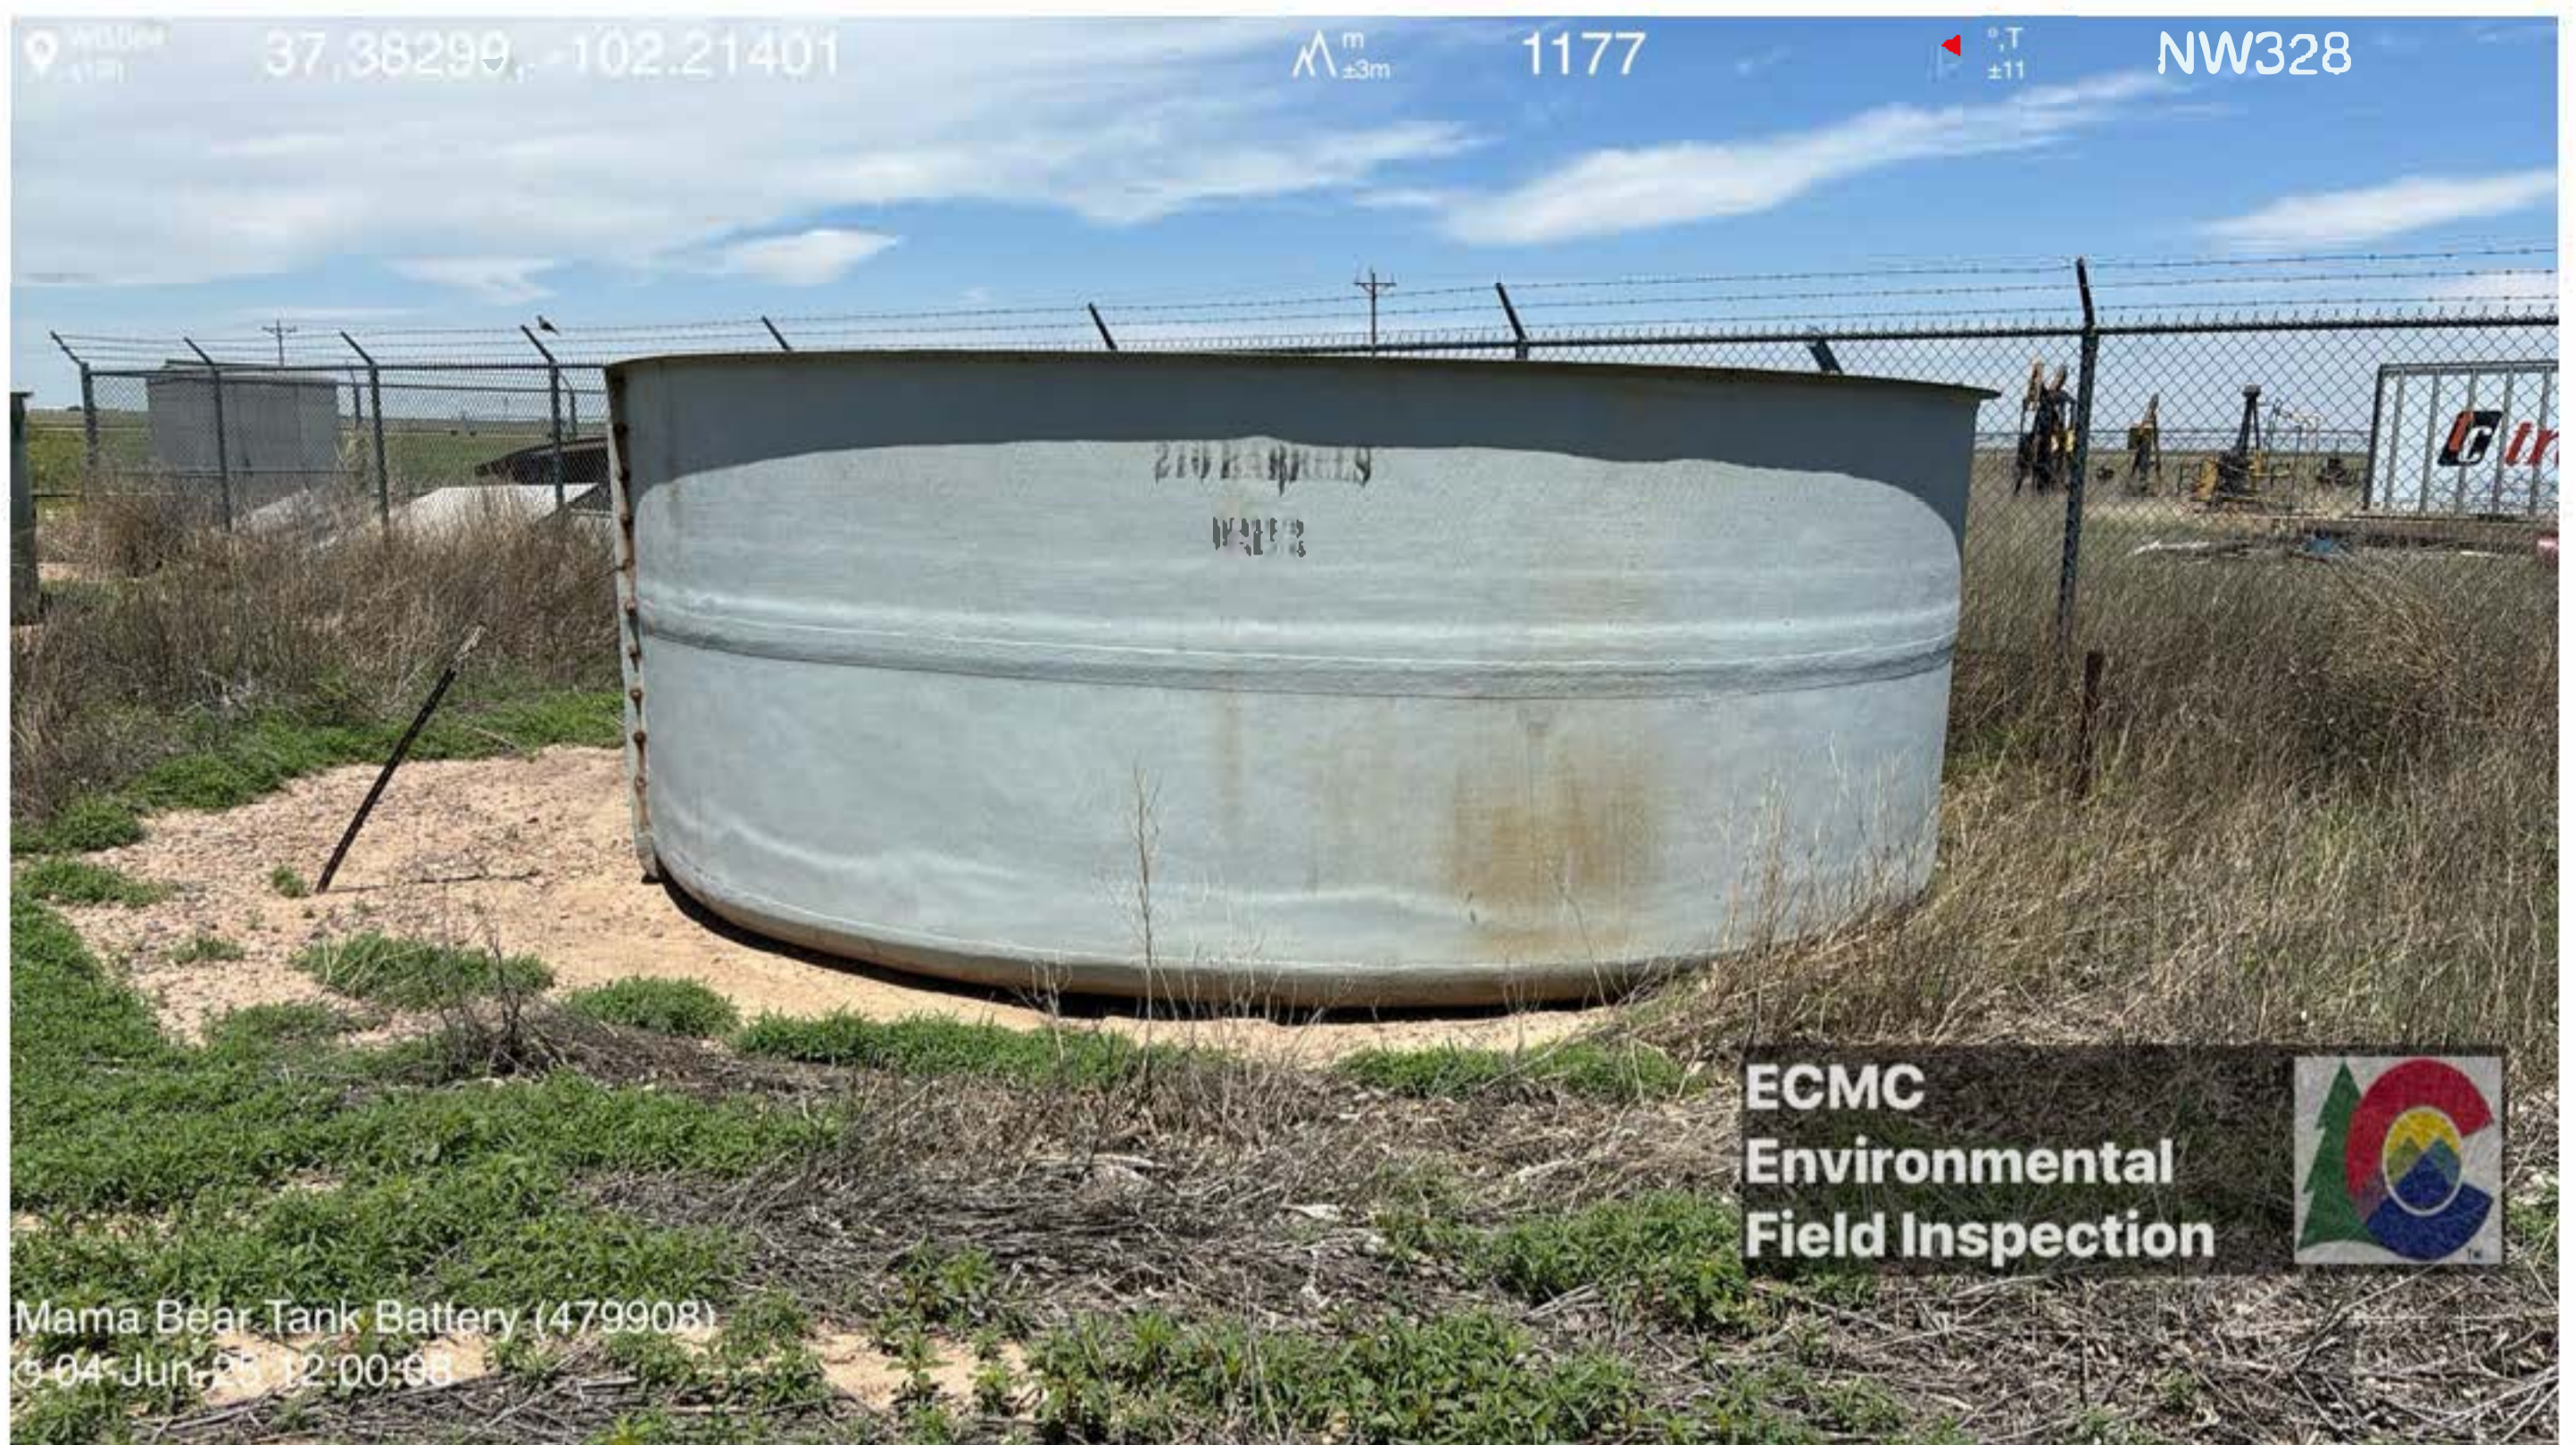
- Inadequate secondary containment for the 210-bbl open top fiberglass produced water storage tank.
- Wildlife protection equipment (netting) is missing on the 210-bbl open top fiberglass produced water storage tank (empty at time of inspection)
- Missing NFPA Placard
- Weeds

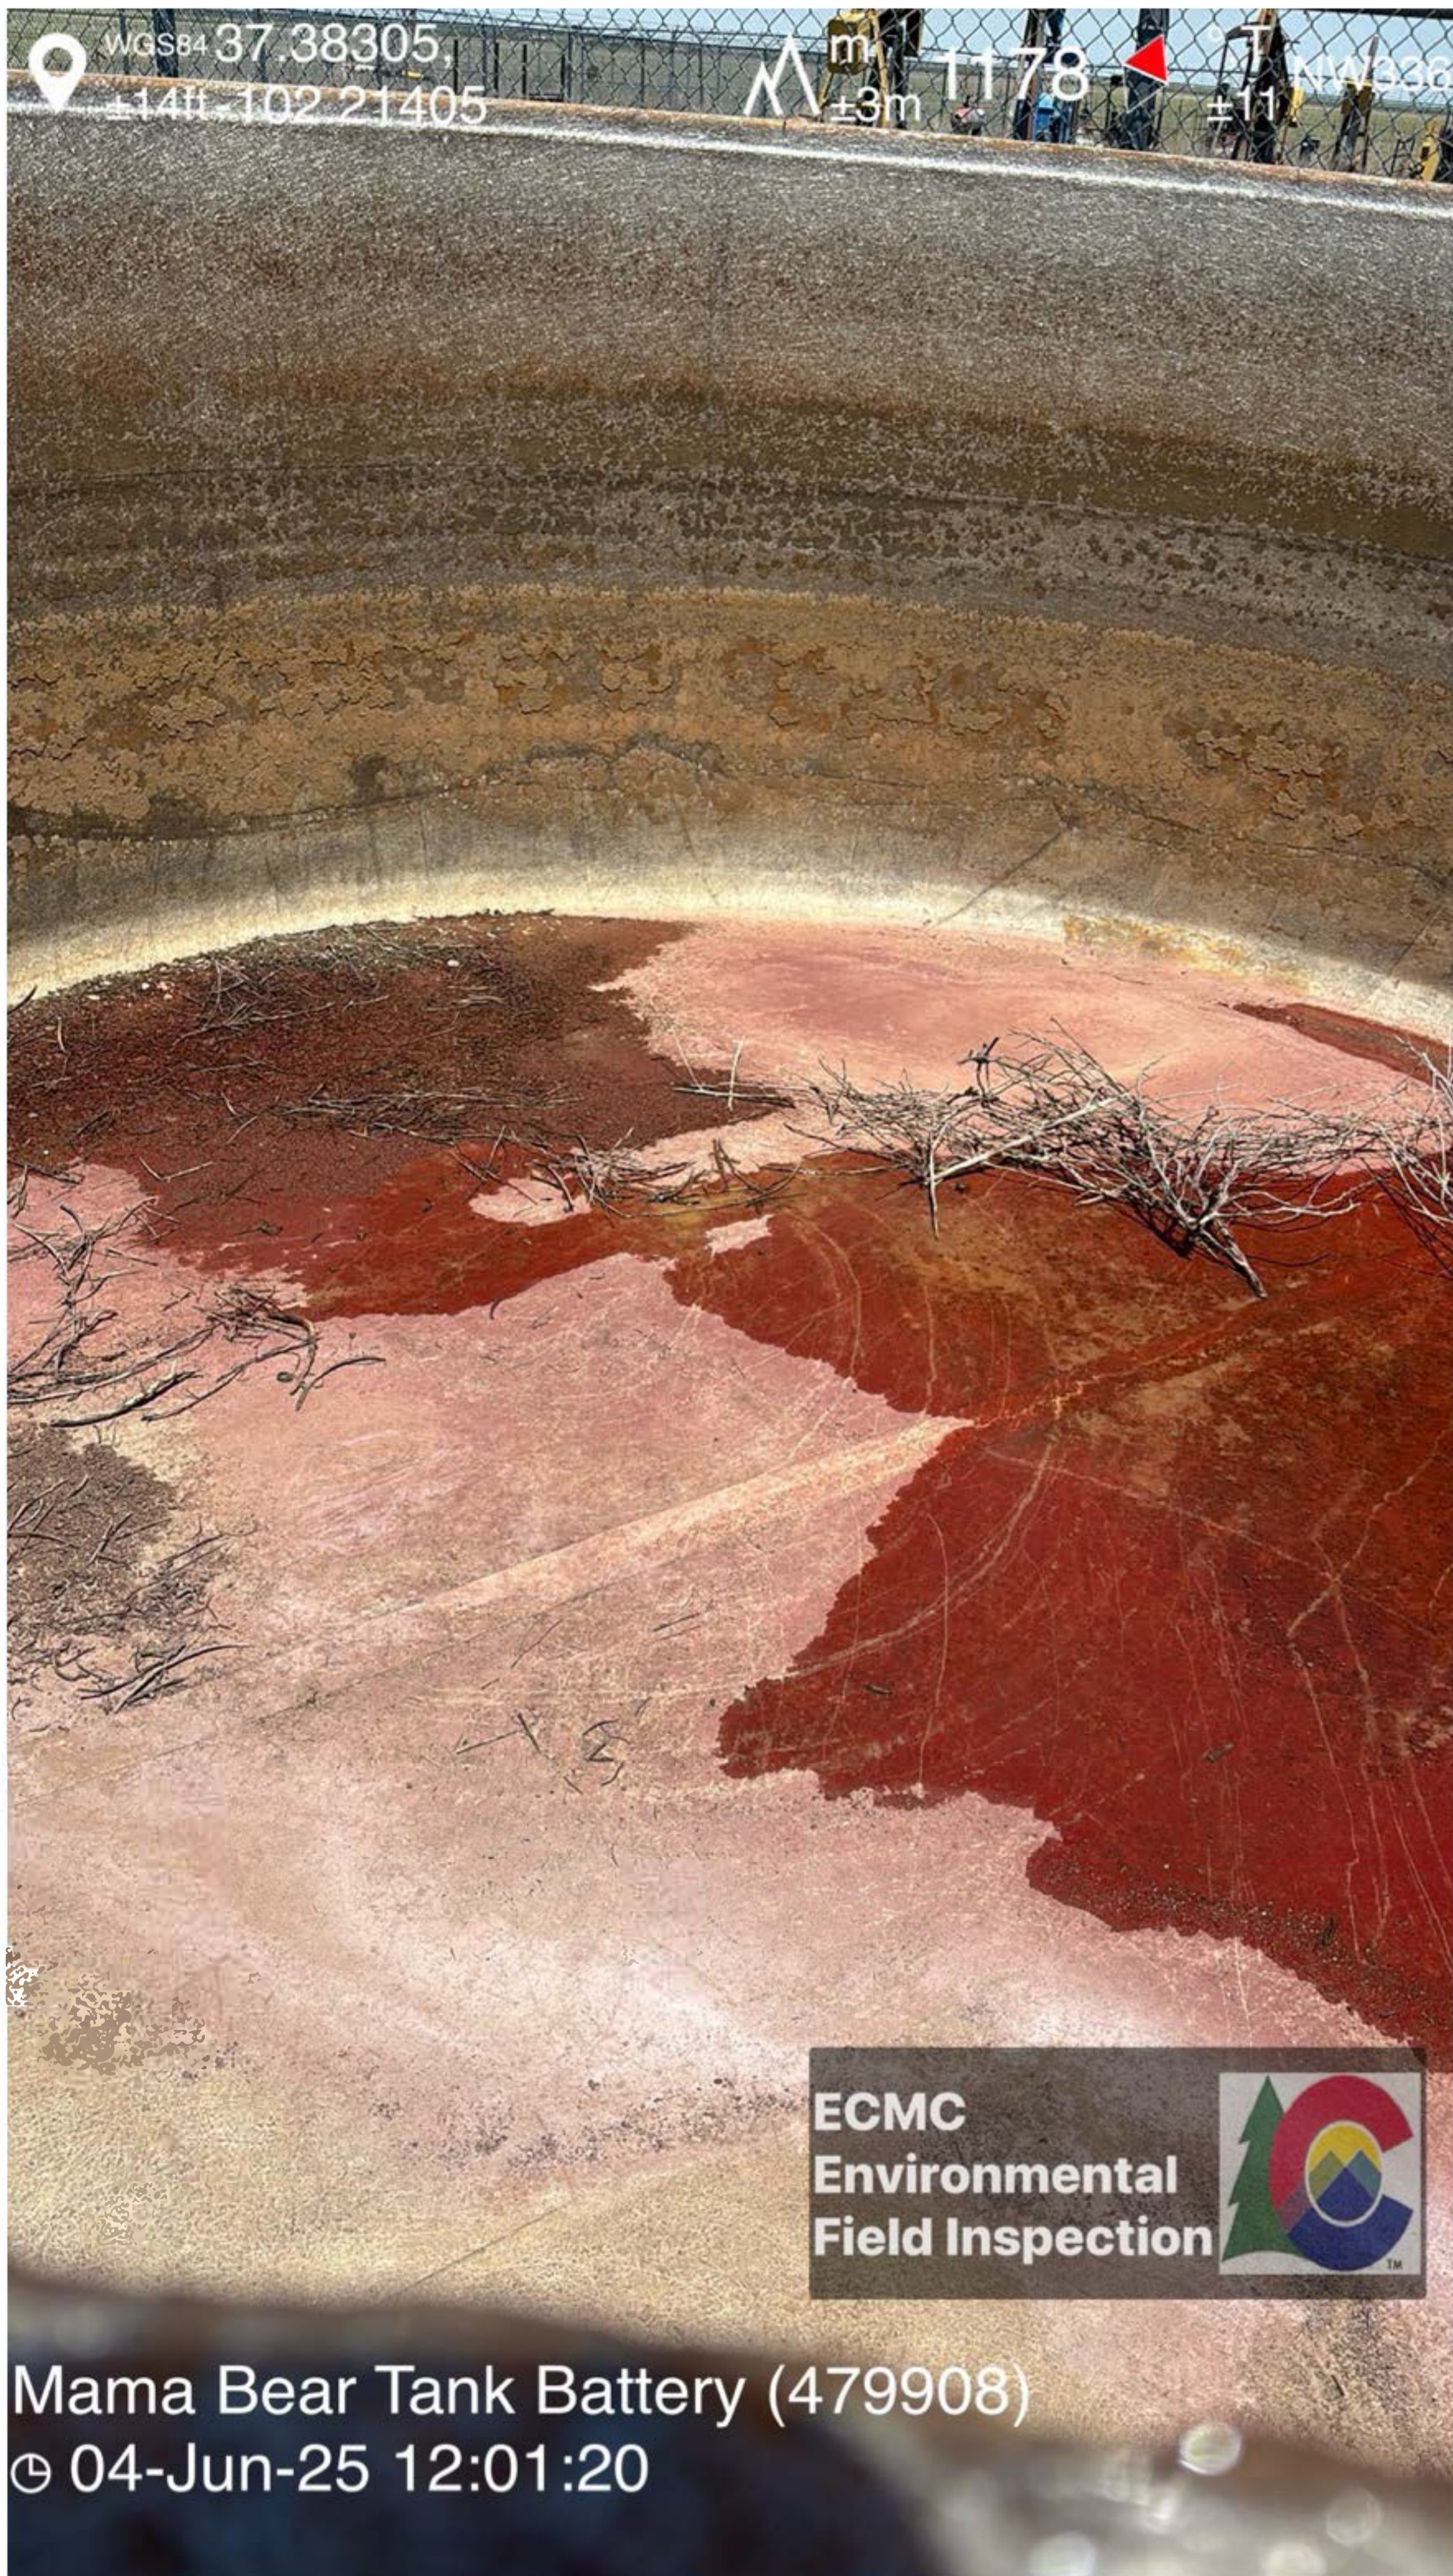
-Wildlife protection equipment (netting) is missing on the 210-bbl open top fiberglass produced water storage tank (empty at time of inspection)

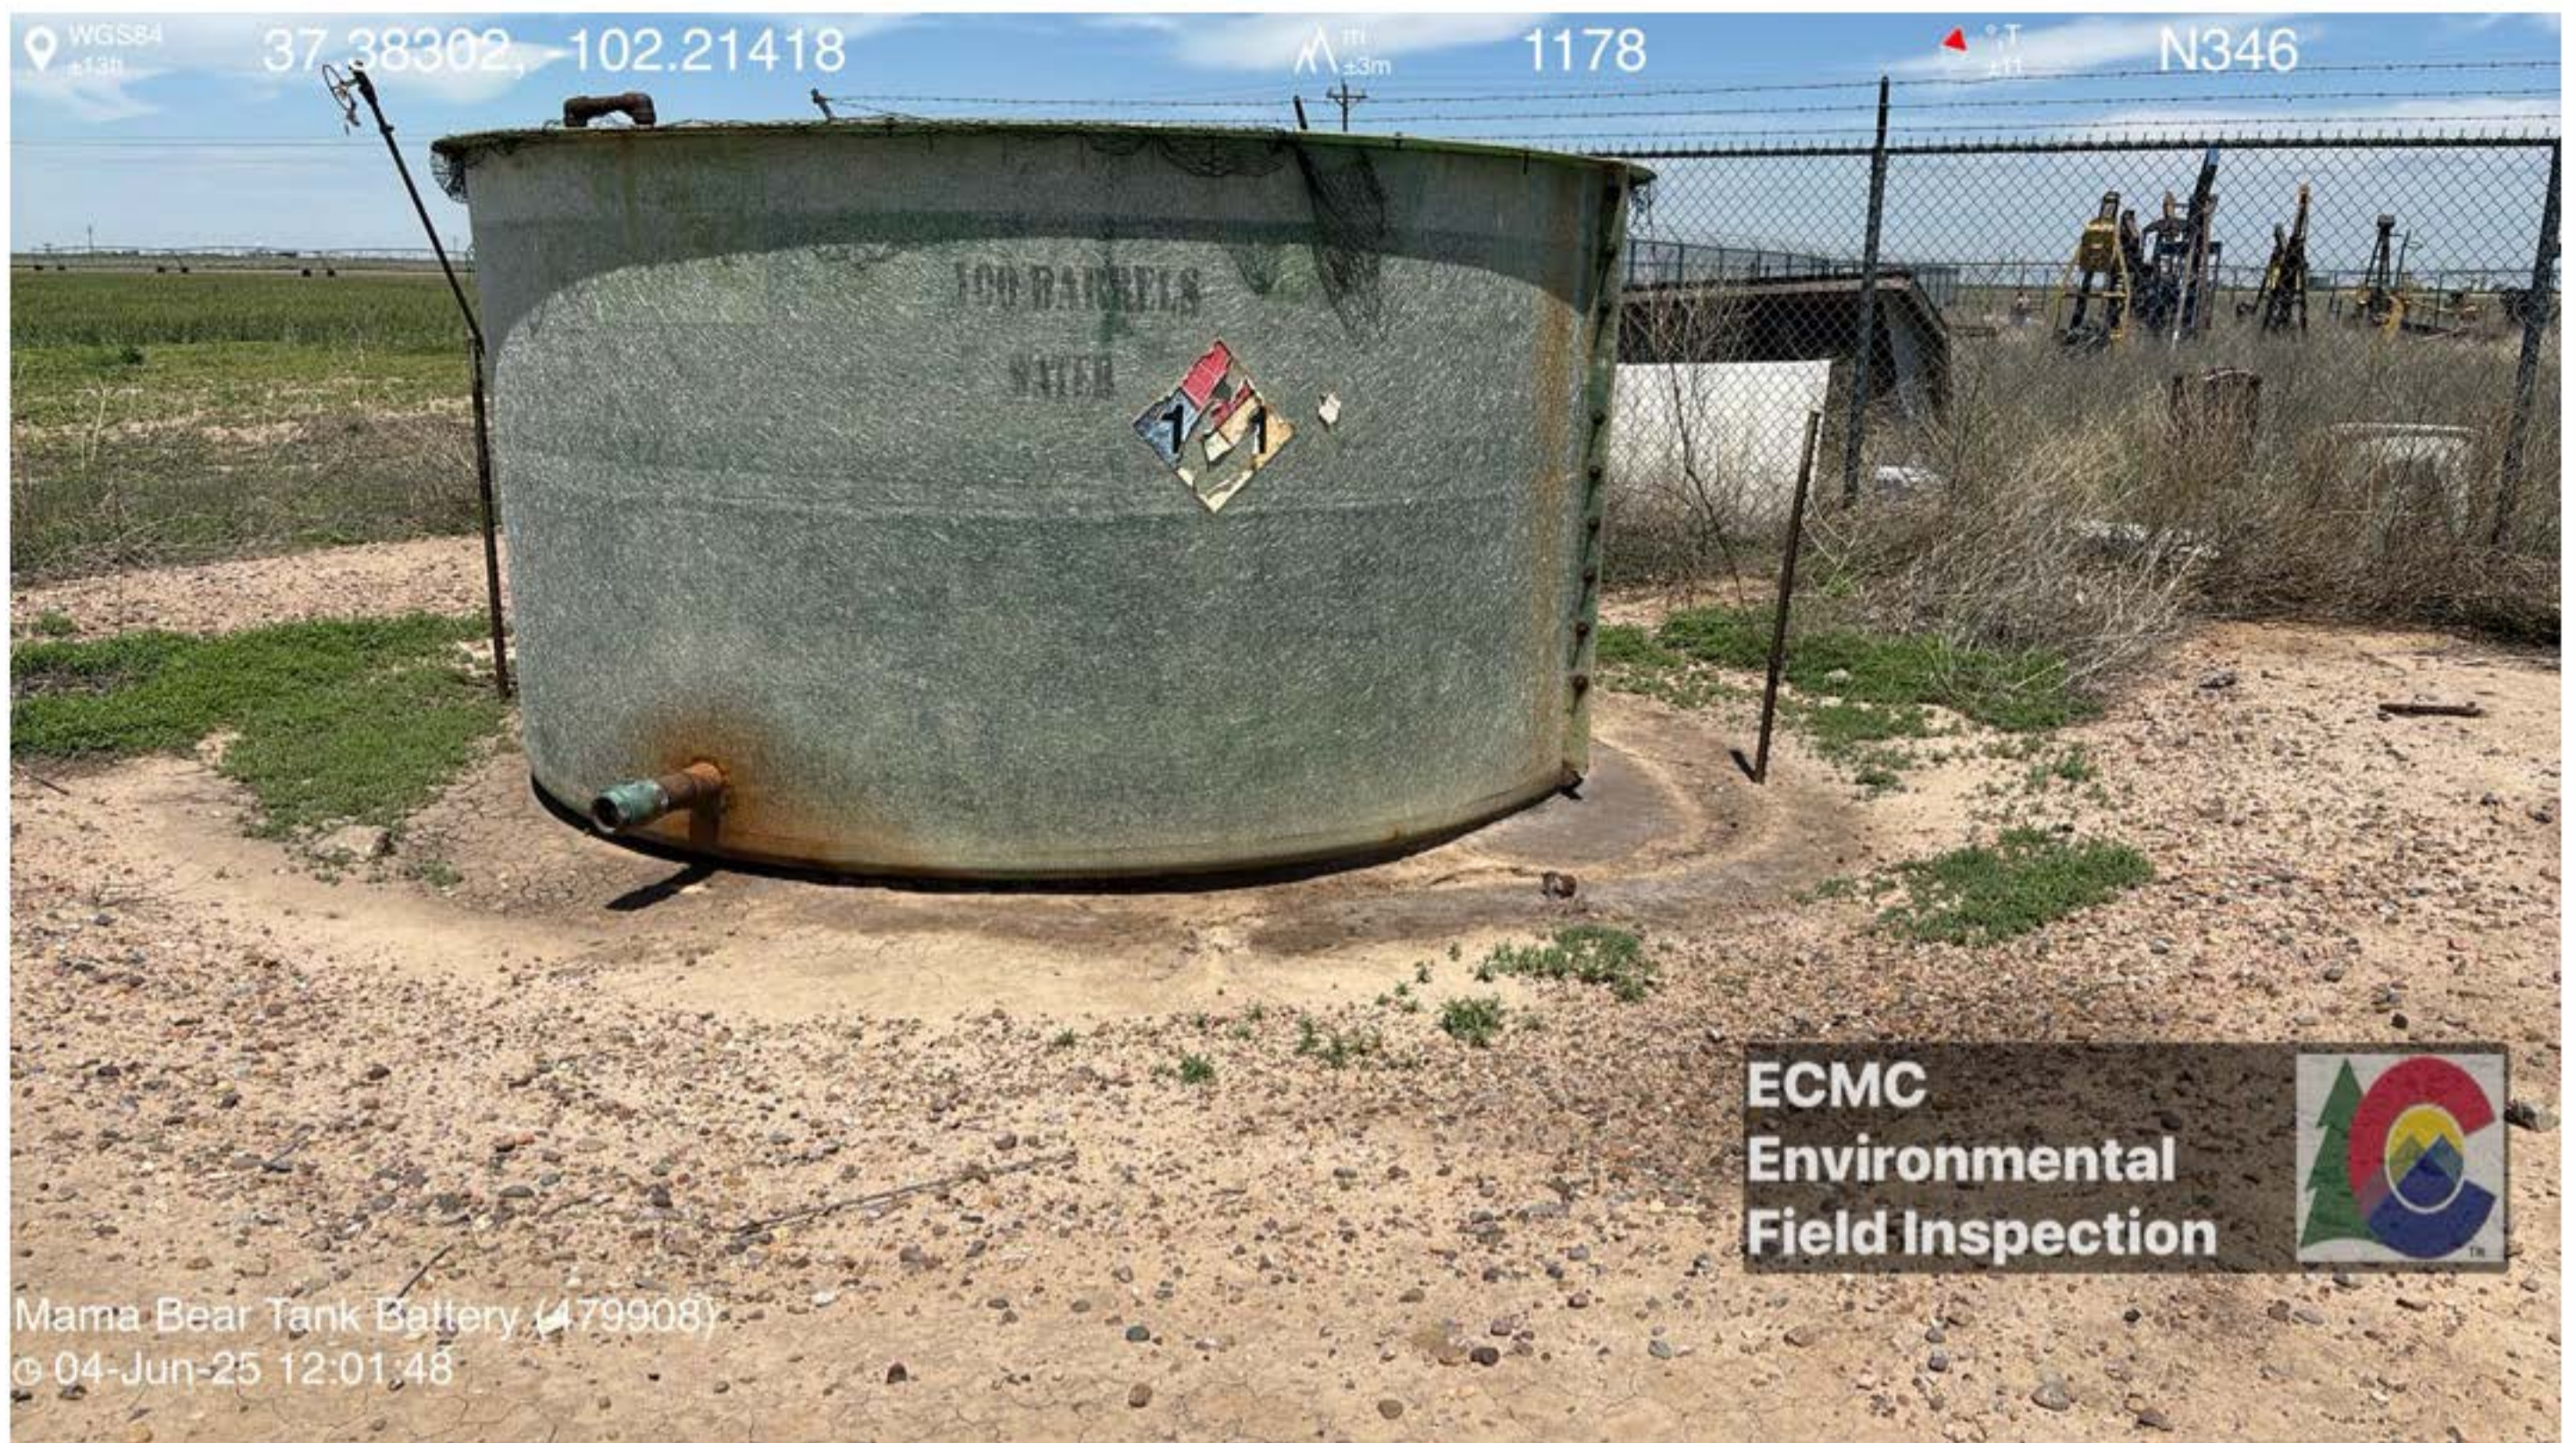
- Inadequate secondary containment for the 100-bbl open top fiberglass produced water storage tank
- Wildlife protection equipment (netting) is torn/falling on the 100-bbl open-top fiberglass produced water storage tank
- Peeling/faded NFPA Placard
- Stained soil observed around the base of the 100-bbl open-top fiberglass produced water storage tank
- Weeds

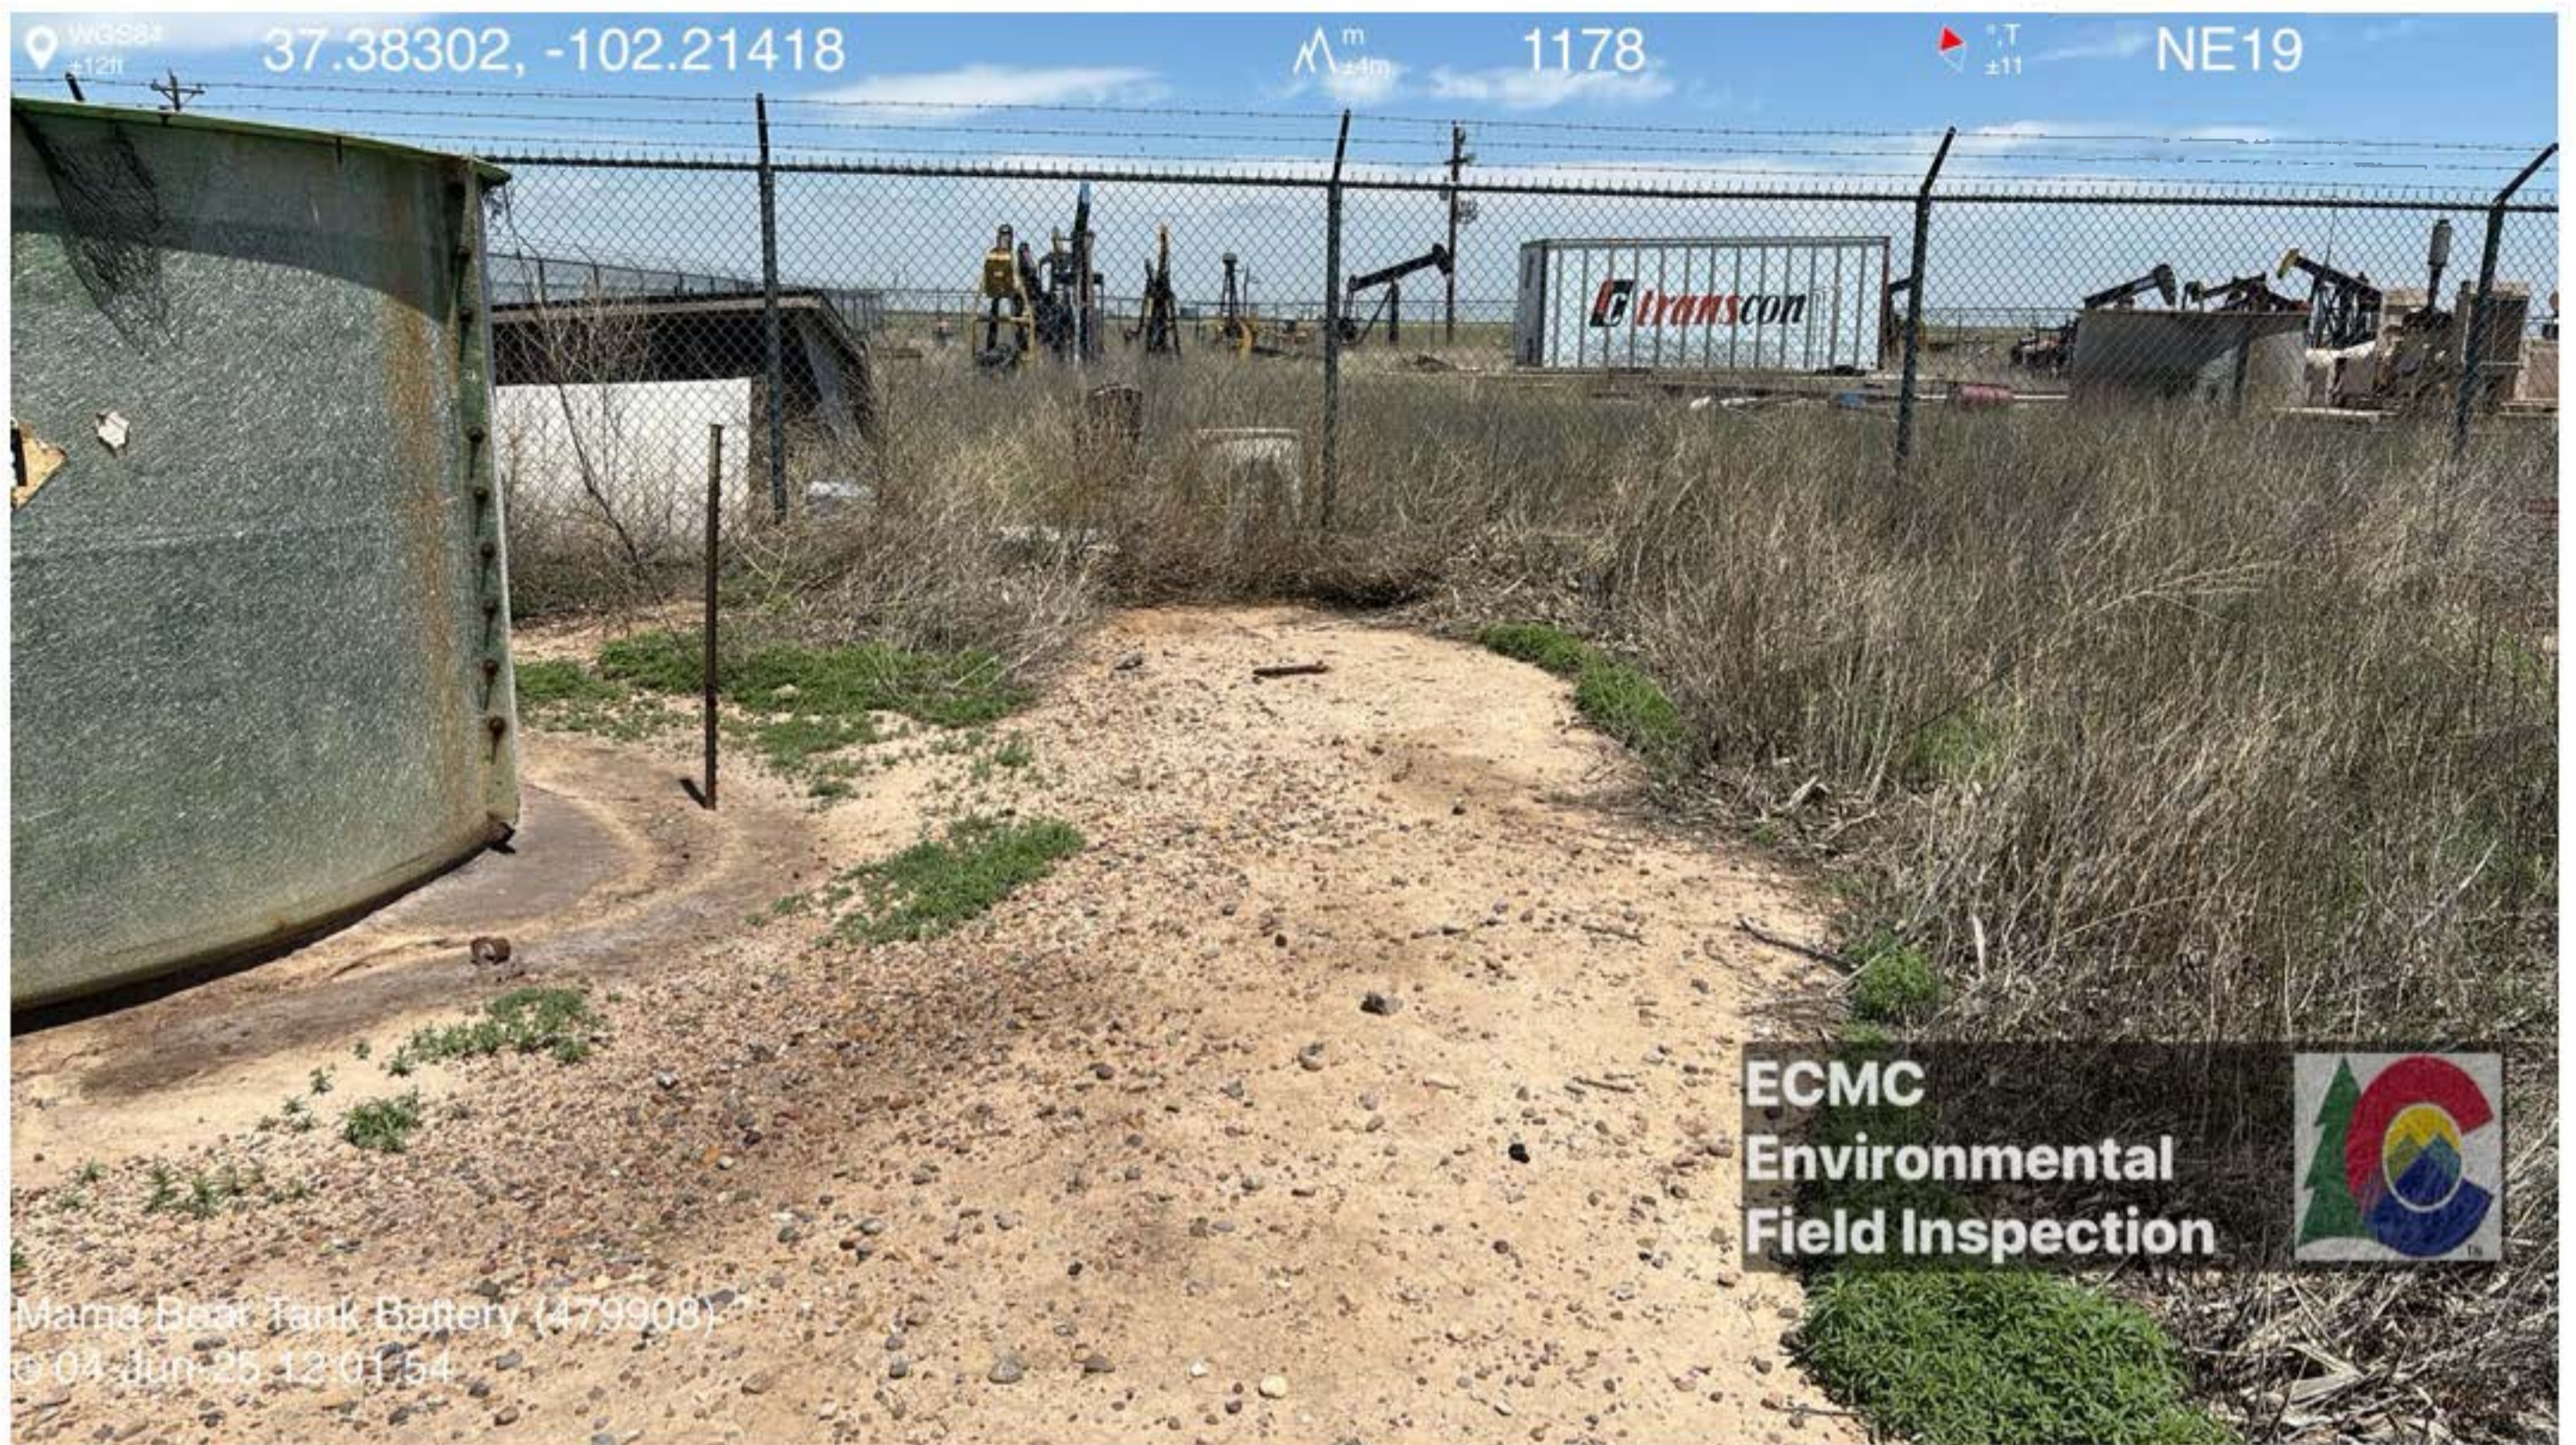
- Adjacent property - Fenced in storage area with oil and gas equipment (N/NE) of tank battery
- Stained soil observed around the base of the 100-bbl open-top fiberglass produced water storage tank
- Inadequate secondary containment for the 100-bbl open top fiberglass produced water storage tank
- Weeds

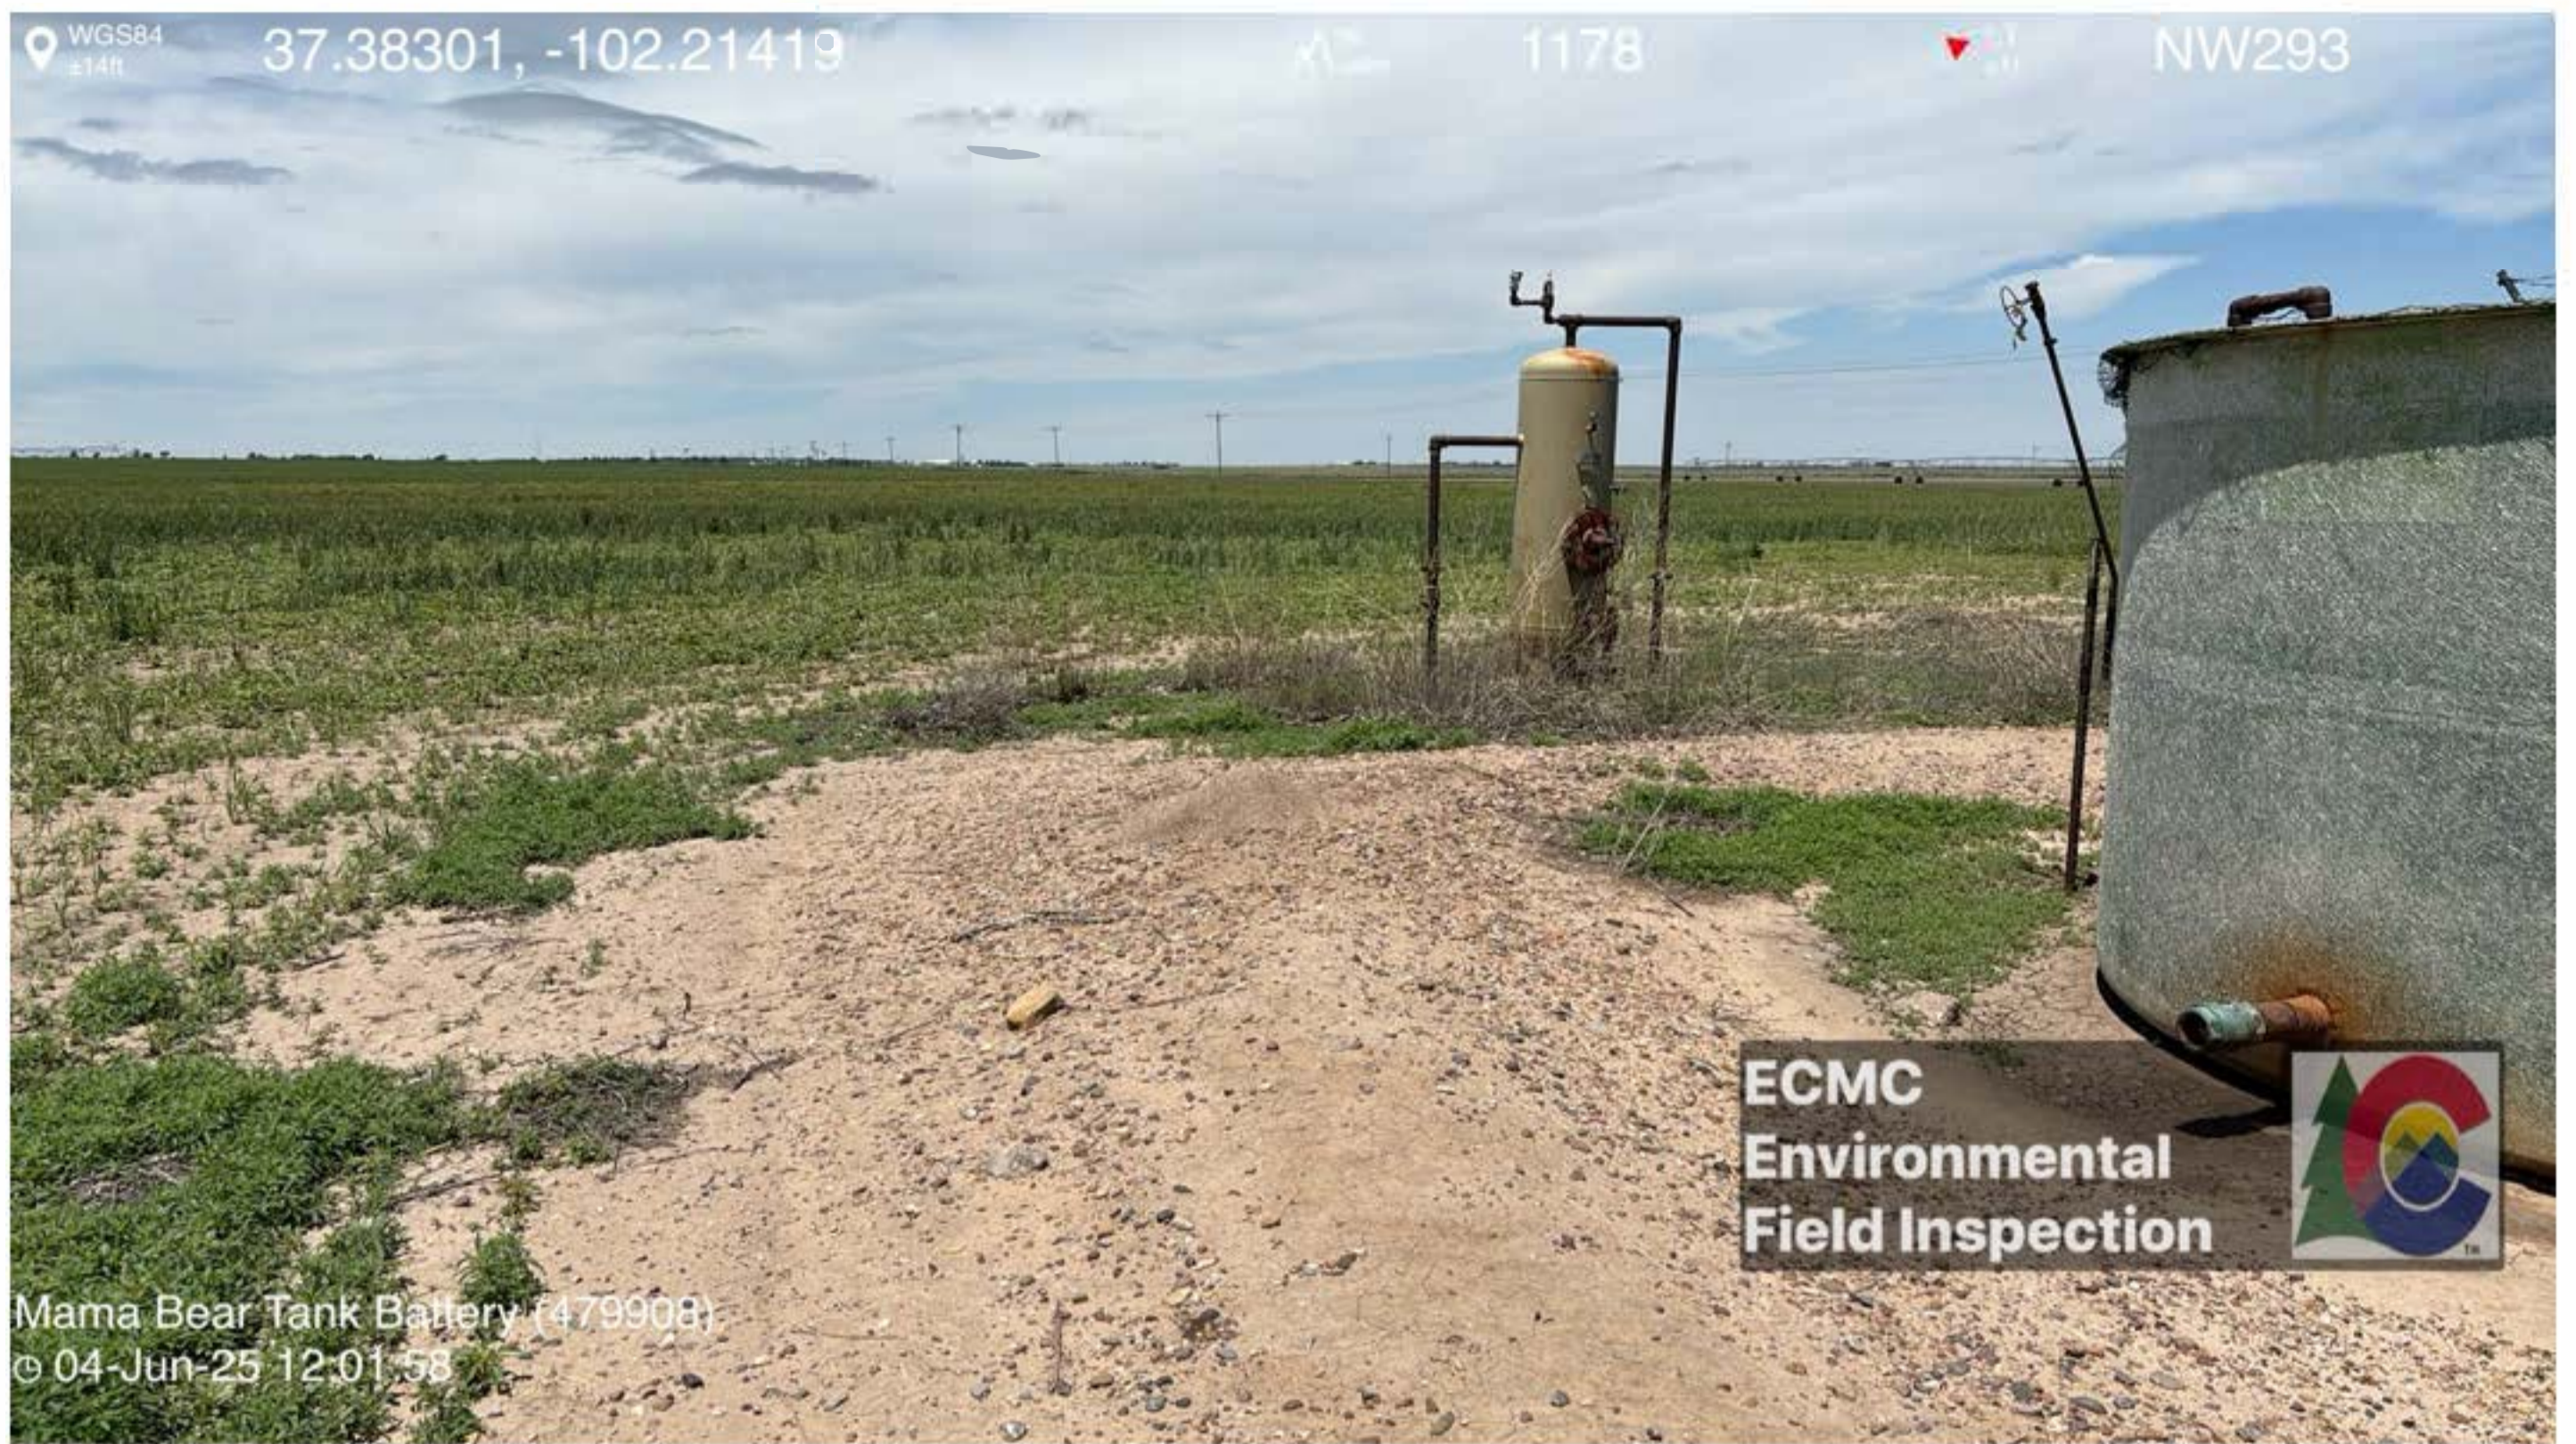
Weeds

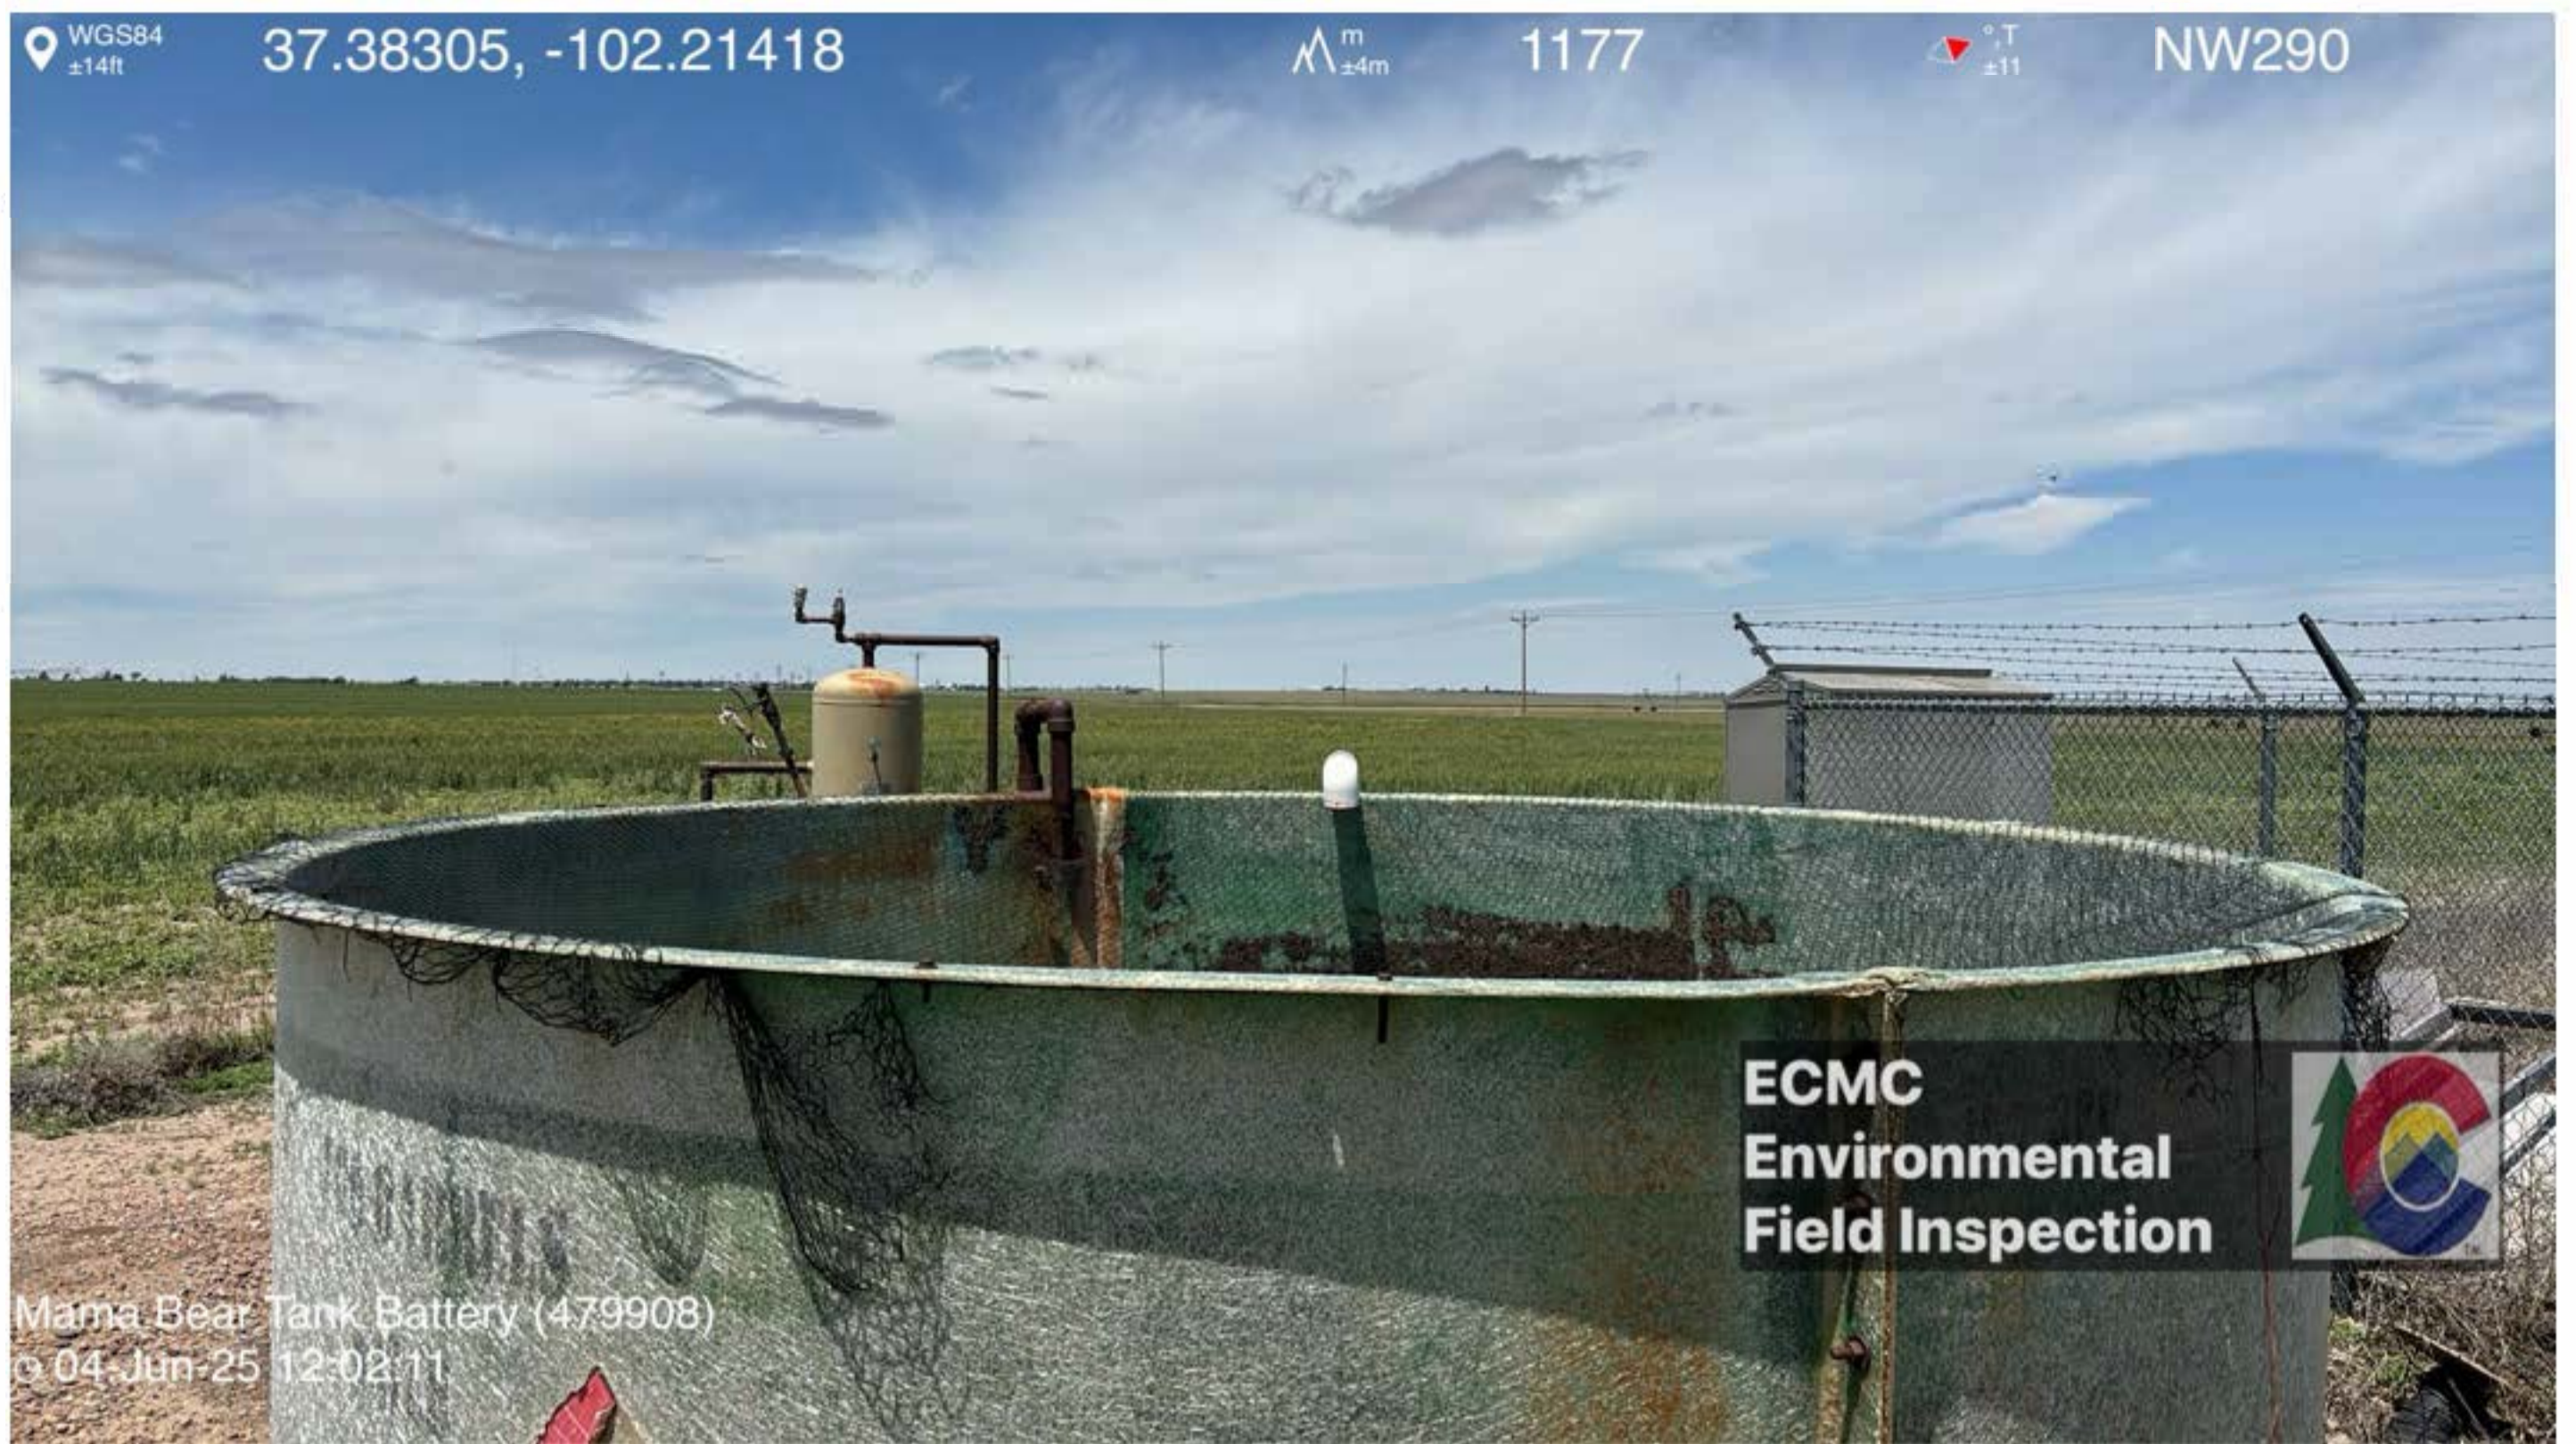
- Wildlife protection equipment (netting) installed on the 100-bbl open top fiberglass produced water storage tank is torn/falling and requires maintenance/repair
- Weeds
