ECMC
Environmental
Field Inspection

Mama Bear Tank Battery (479908)
04-Jun-25 12:04:25

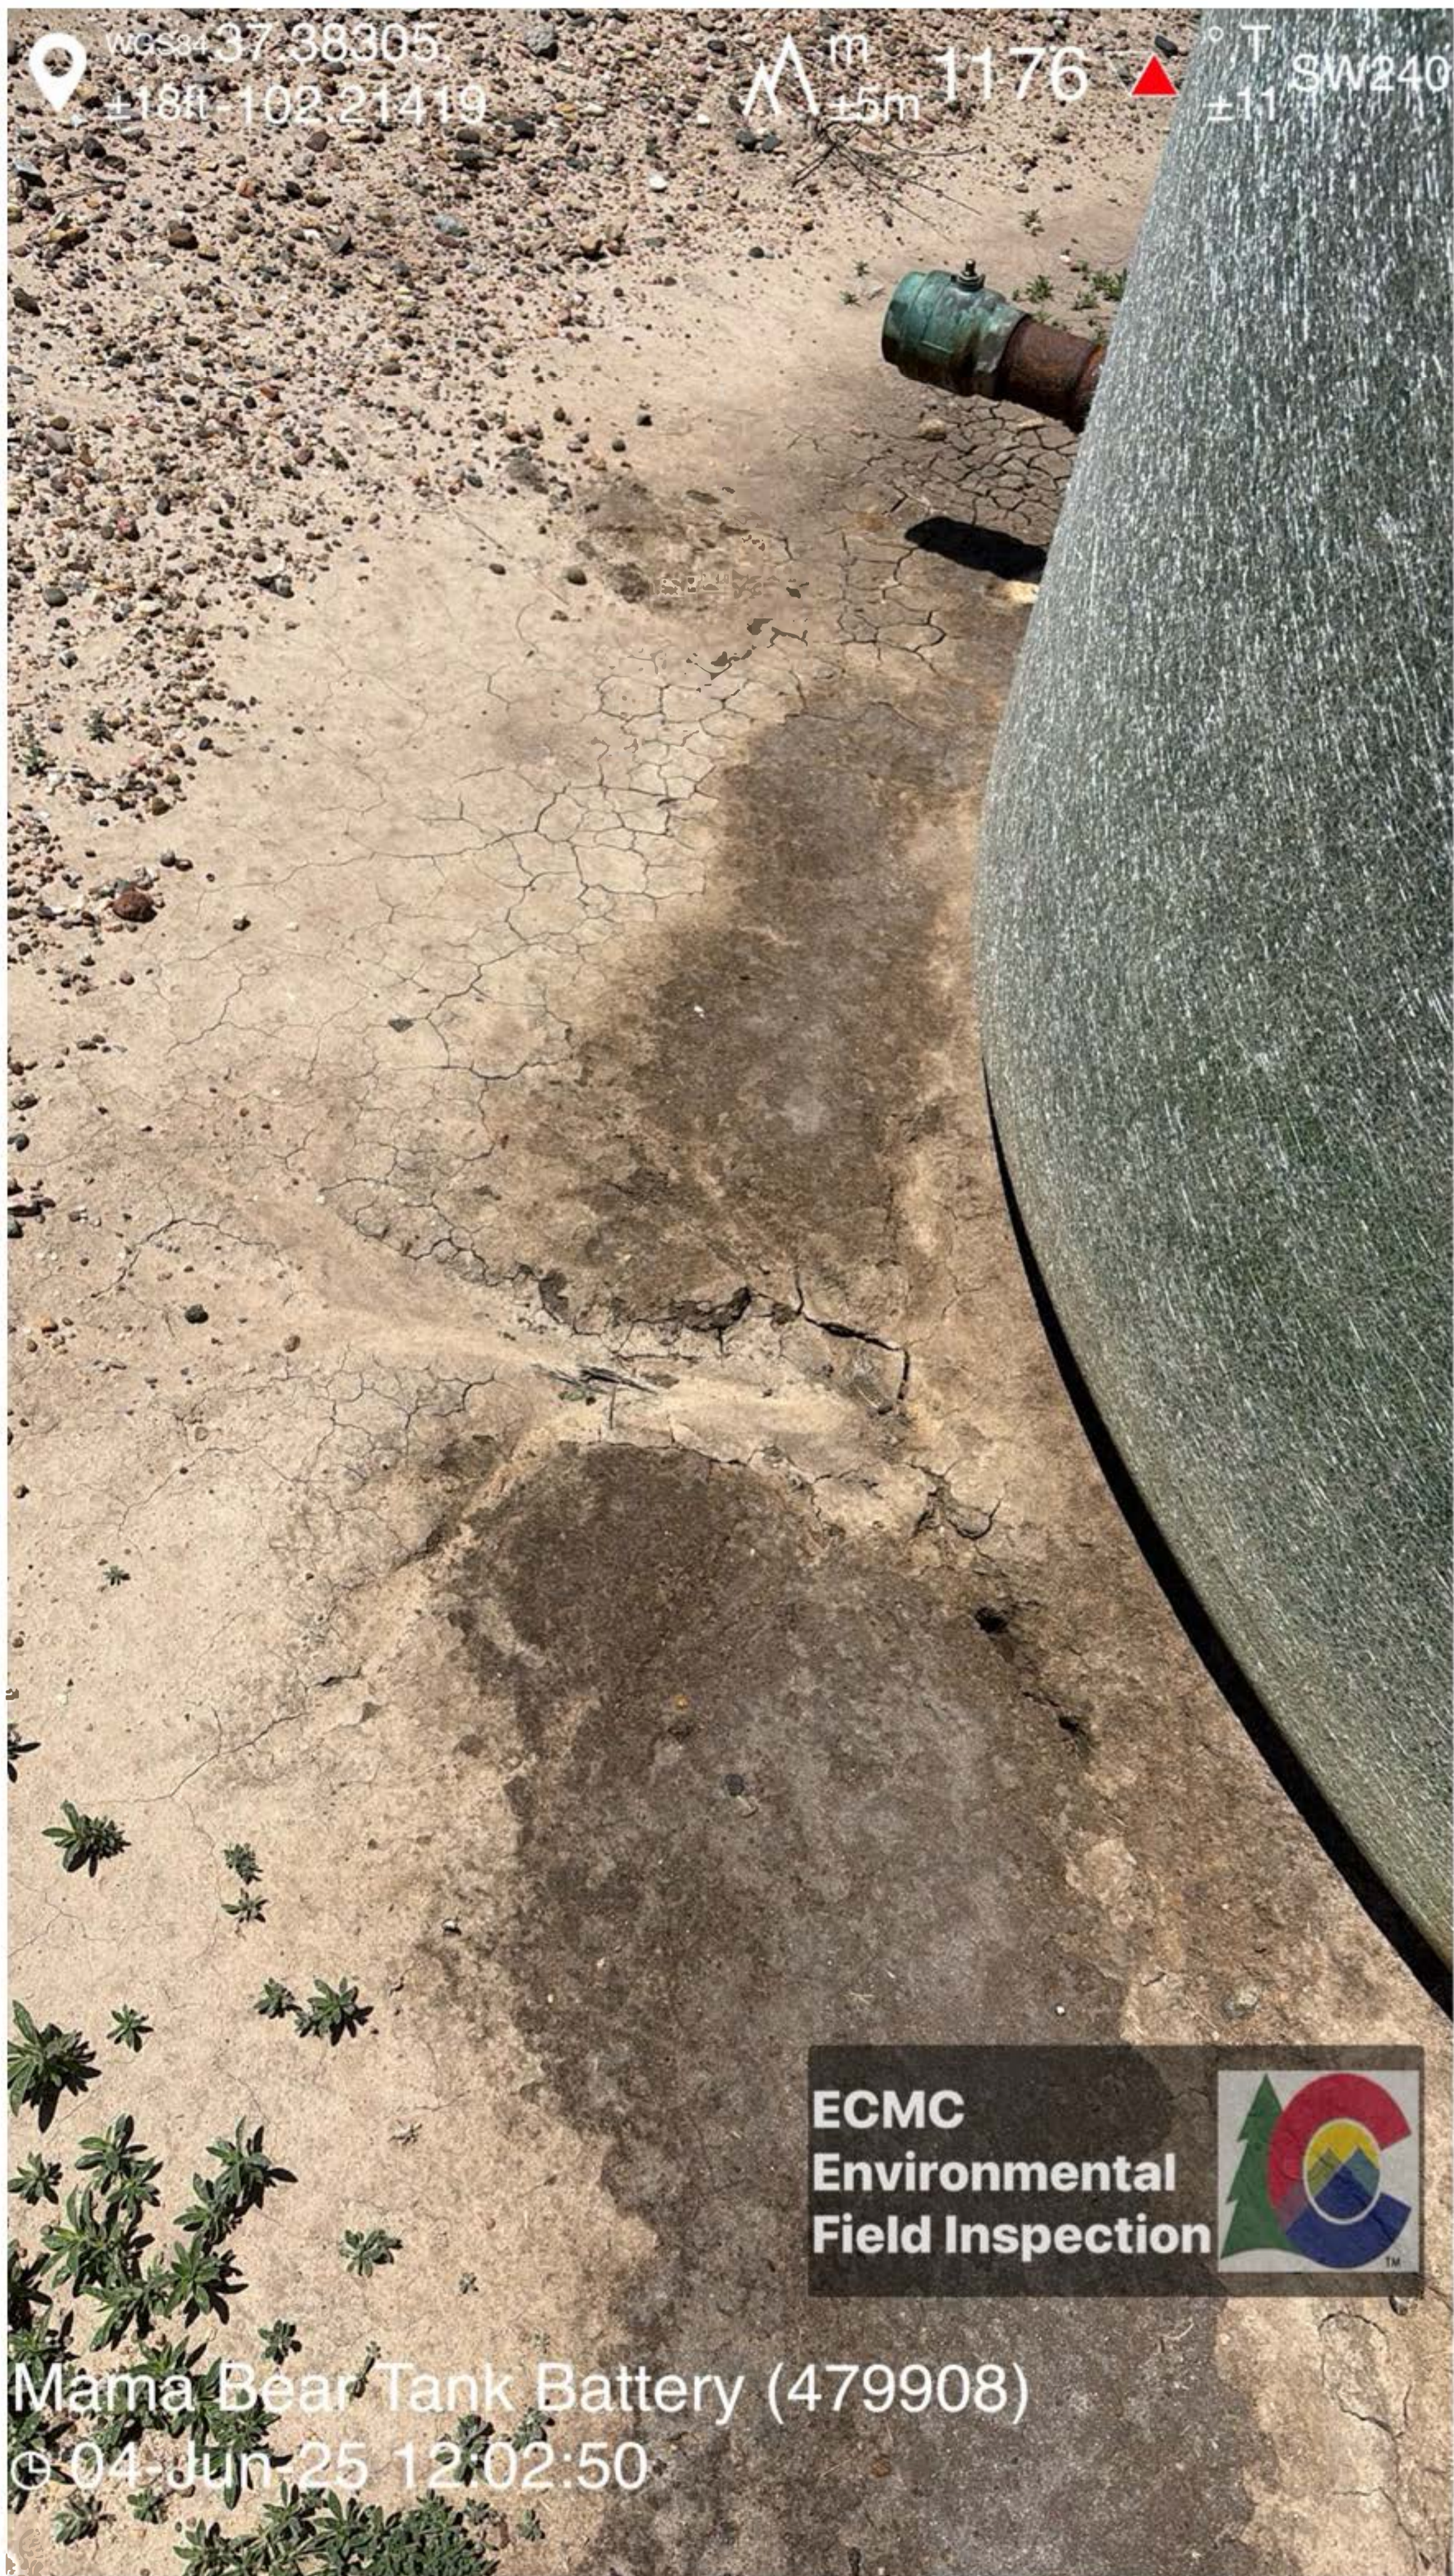
-Stained soil observed around the base of the 100-bbl open-top fiberglass produced water storage tank
-Weeds

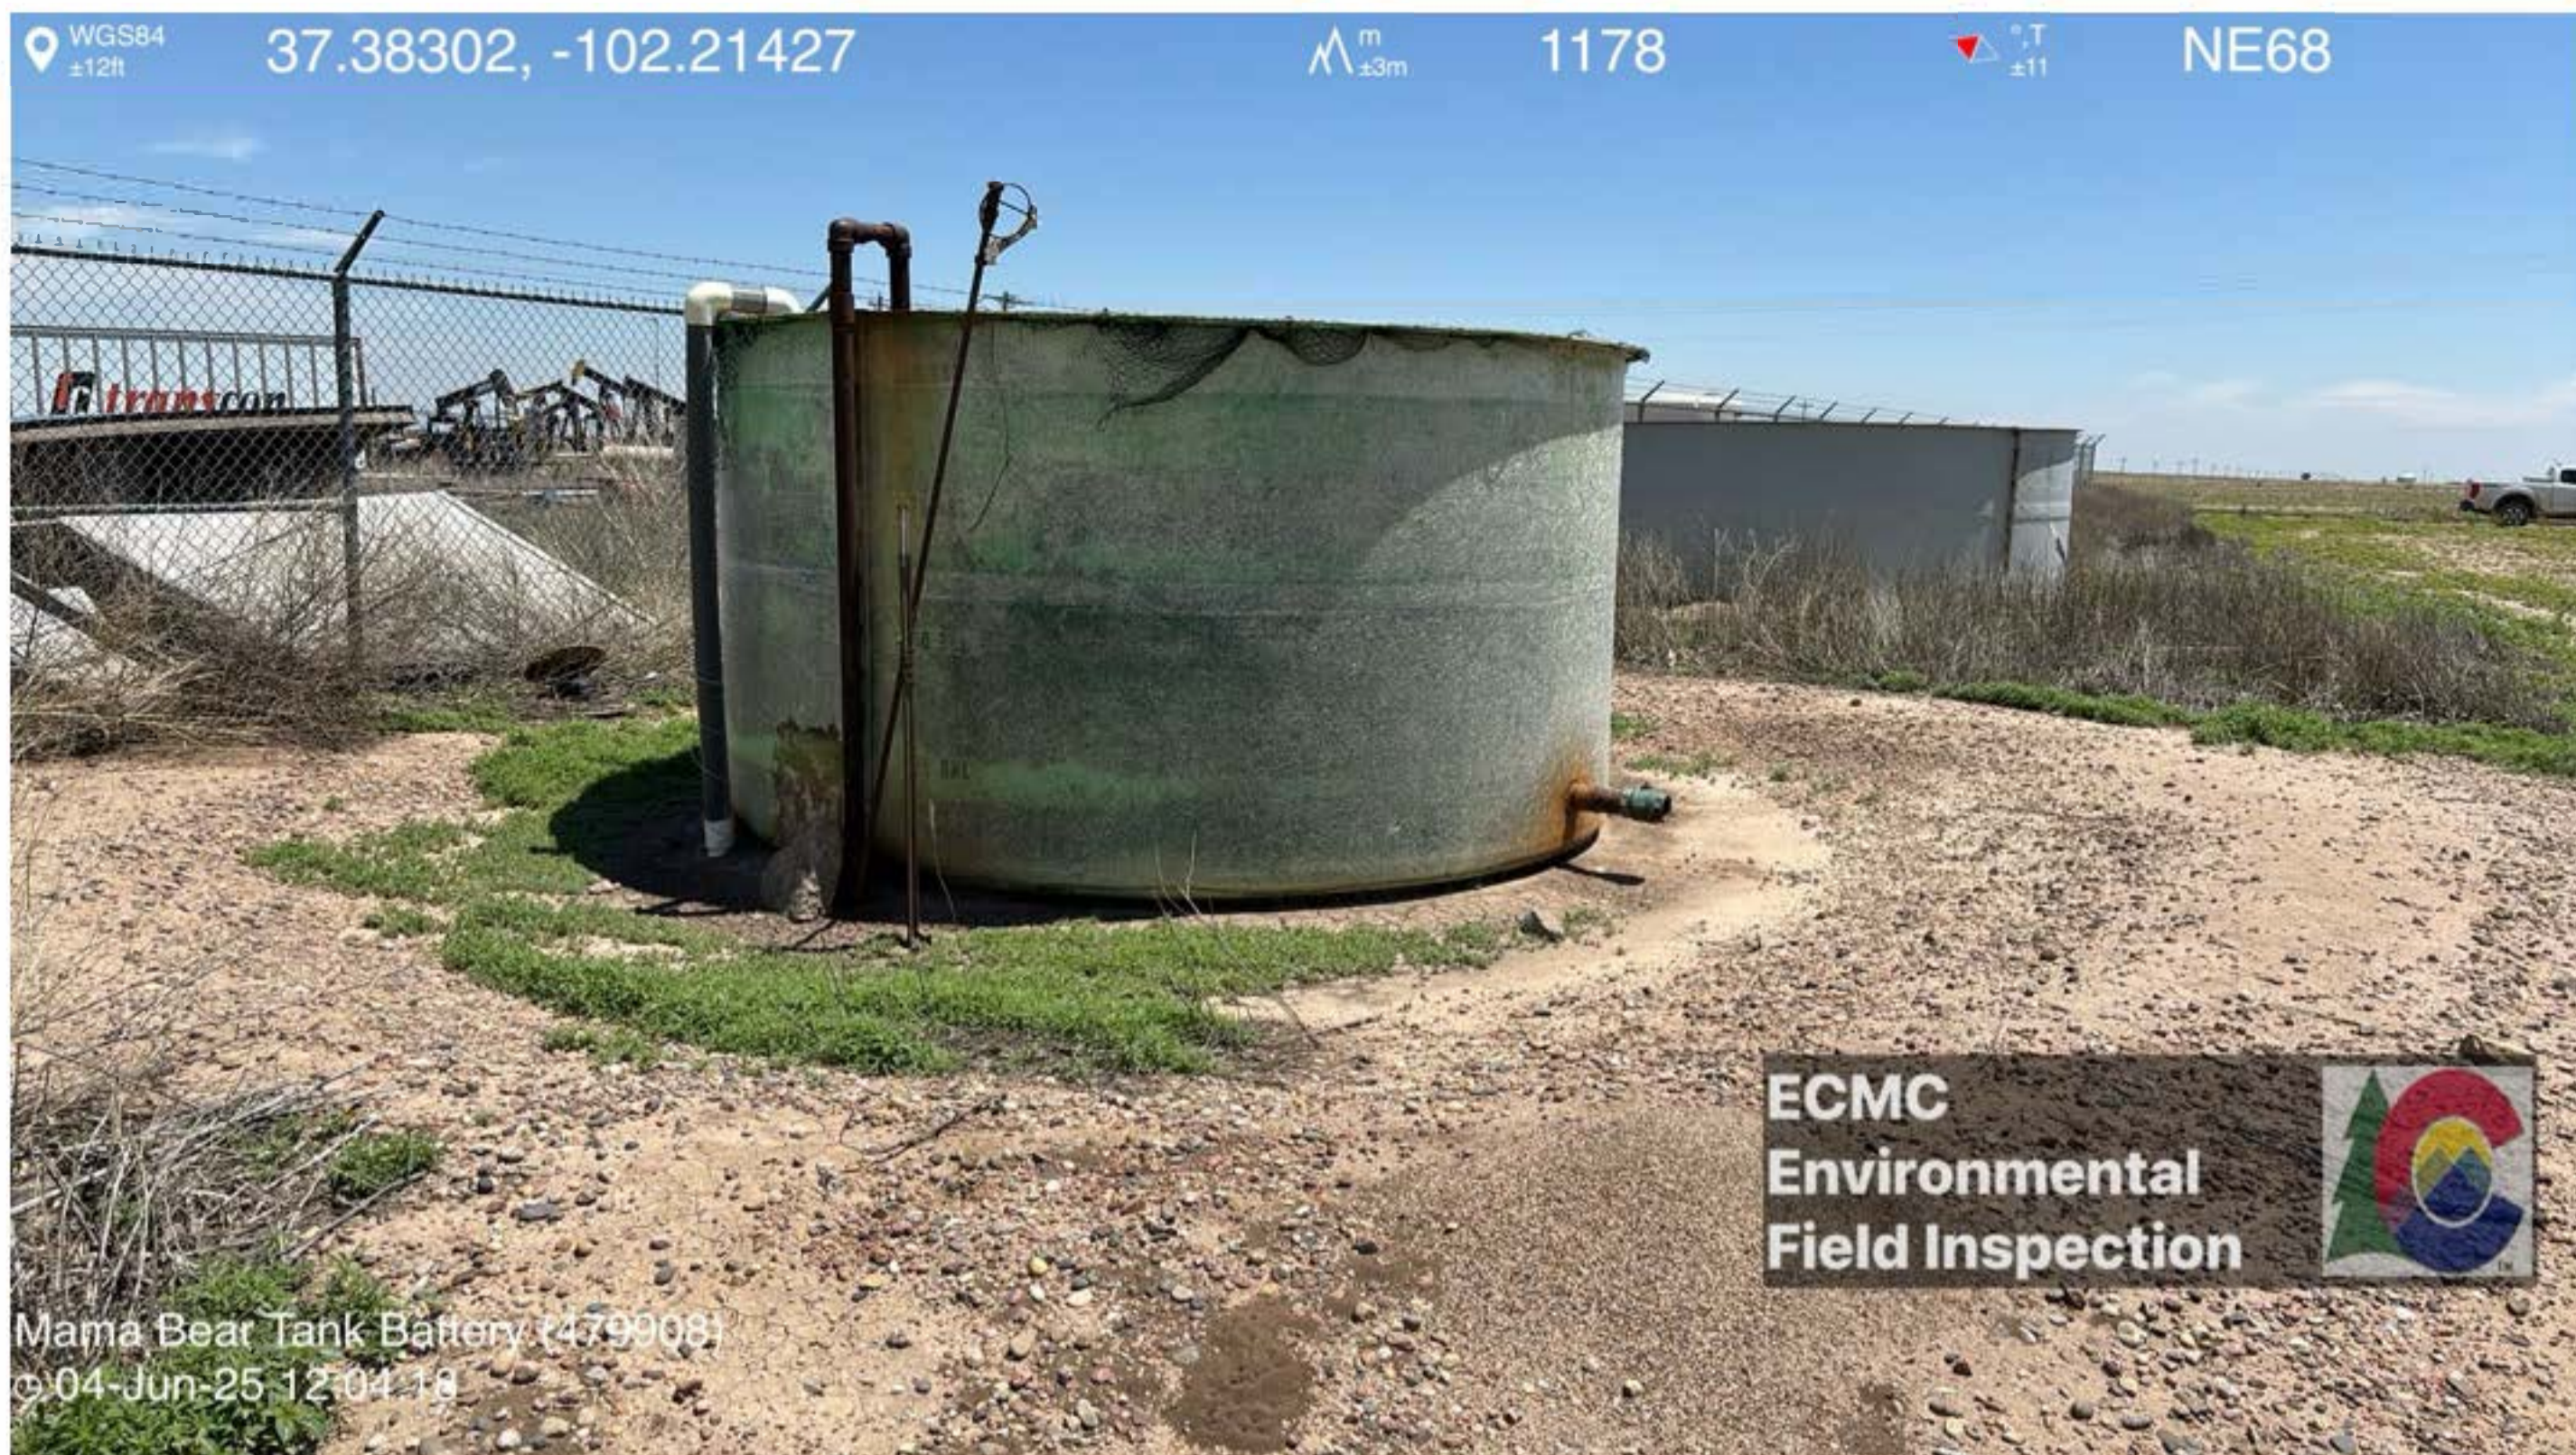
- Inadequate secondary containment for the 100-bbl and 210-bbl open top fiberglass produced water storage tanks
- Wildlife protection equipment (netting) was missing on the 210-bbl open-top fiberglass produced water storage tank (empty at time of inspection)
- Wildlife protection equipment (netting) was torn/falling on the 100-bbl open-top fiberglass produced water storage tank
- Stained soil observed around the base of the 100-bbl open-top fiberglass produced water storage tank
- Weeds

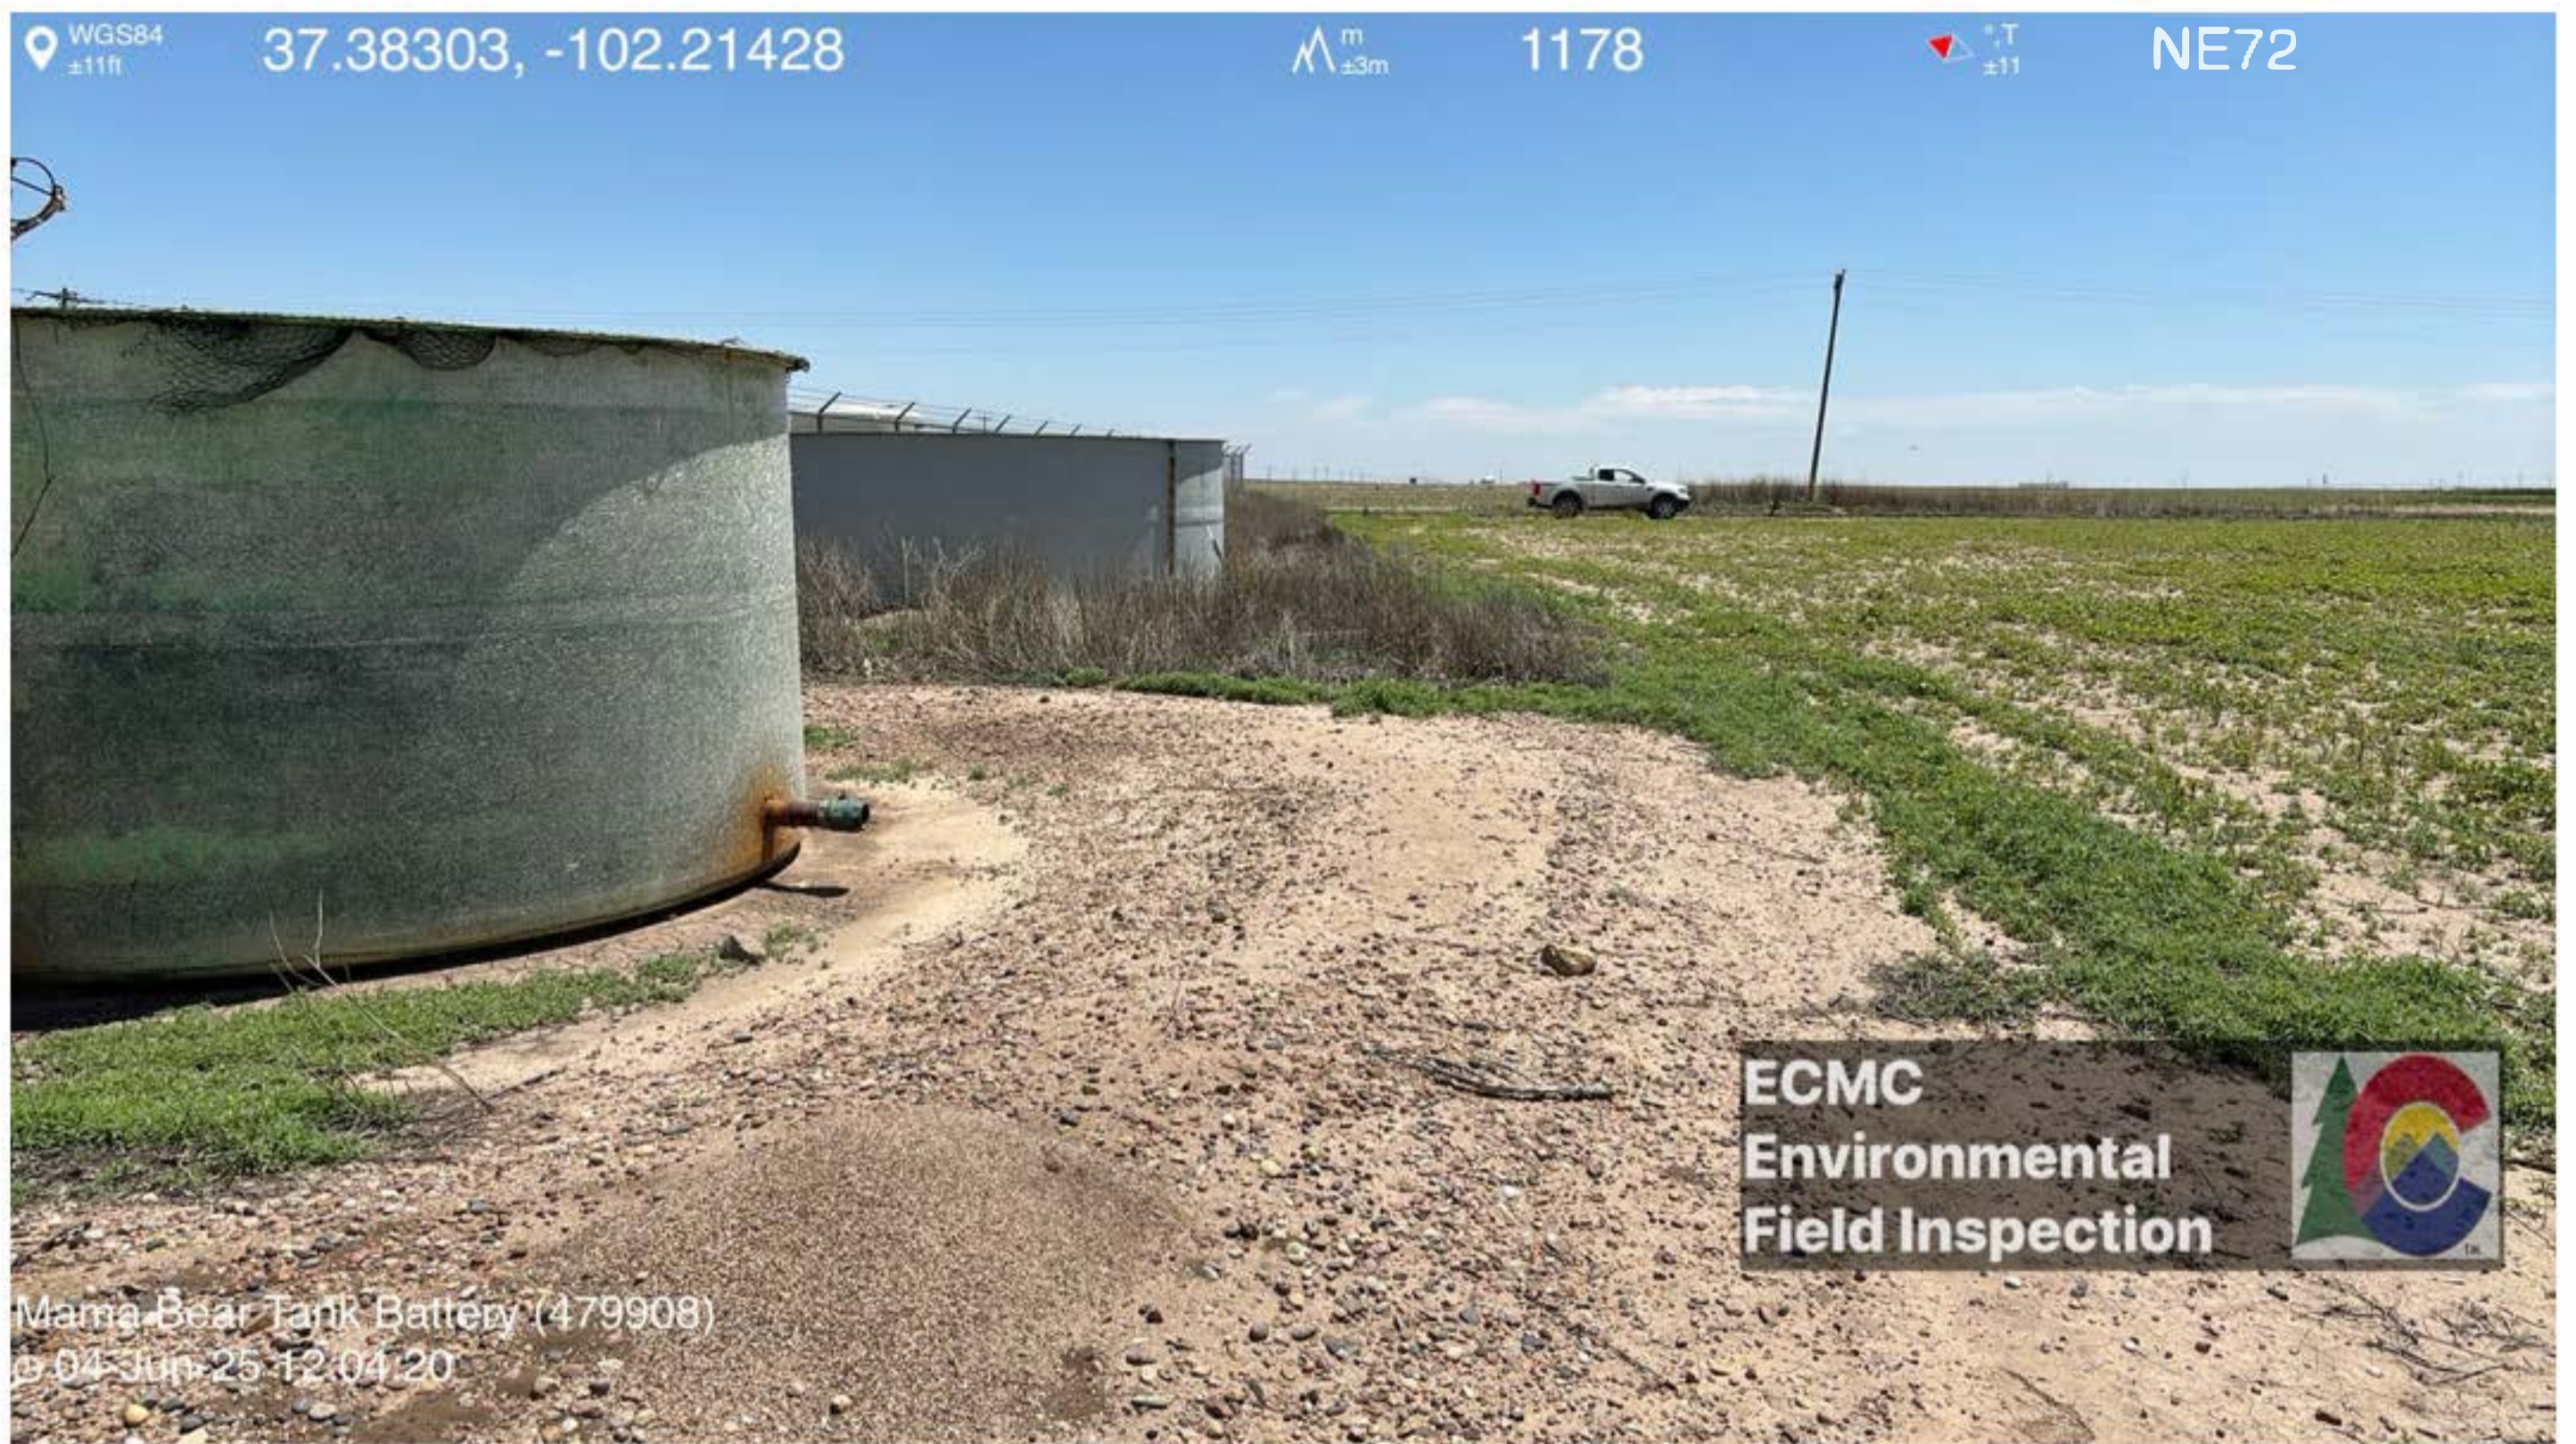
- Inadequate secondary containment for the 100-bbl and 210-bbl open top fiberglass produced water storage tanks
- Weeds

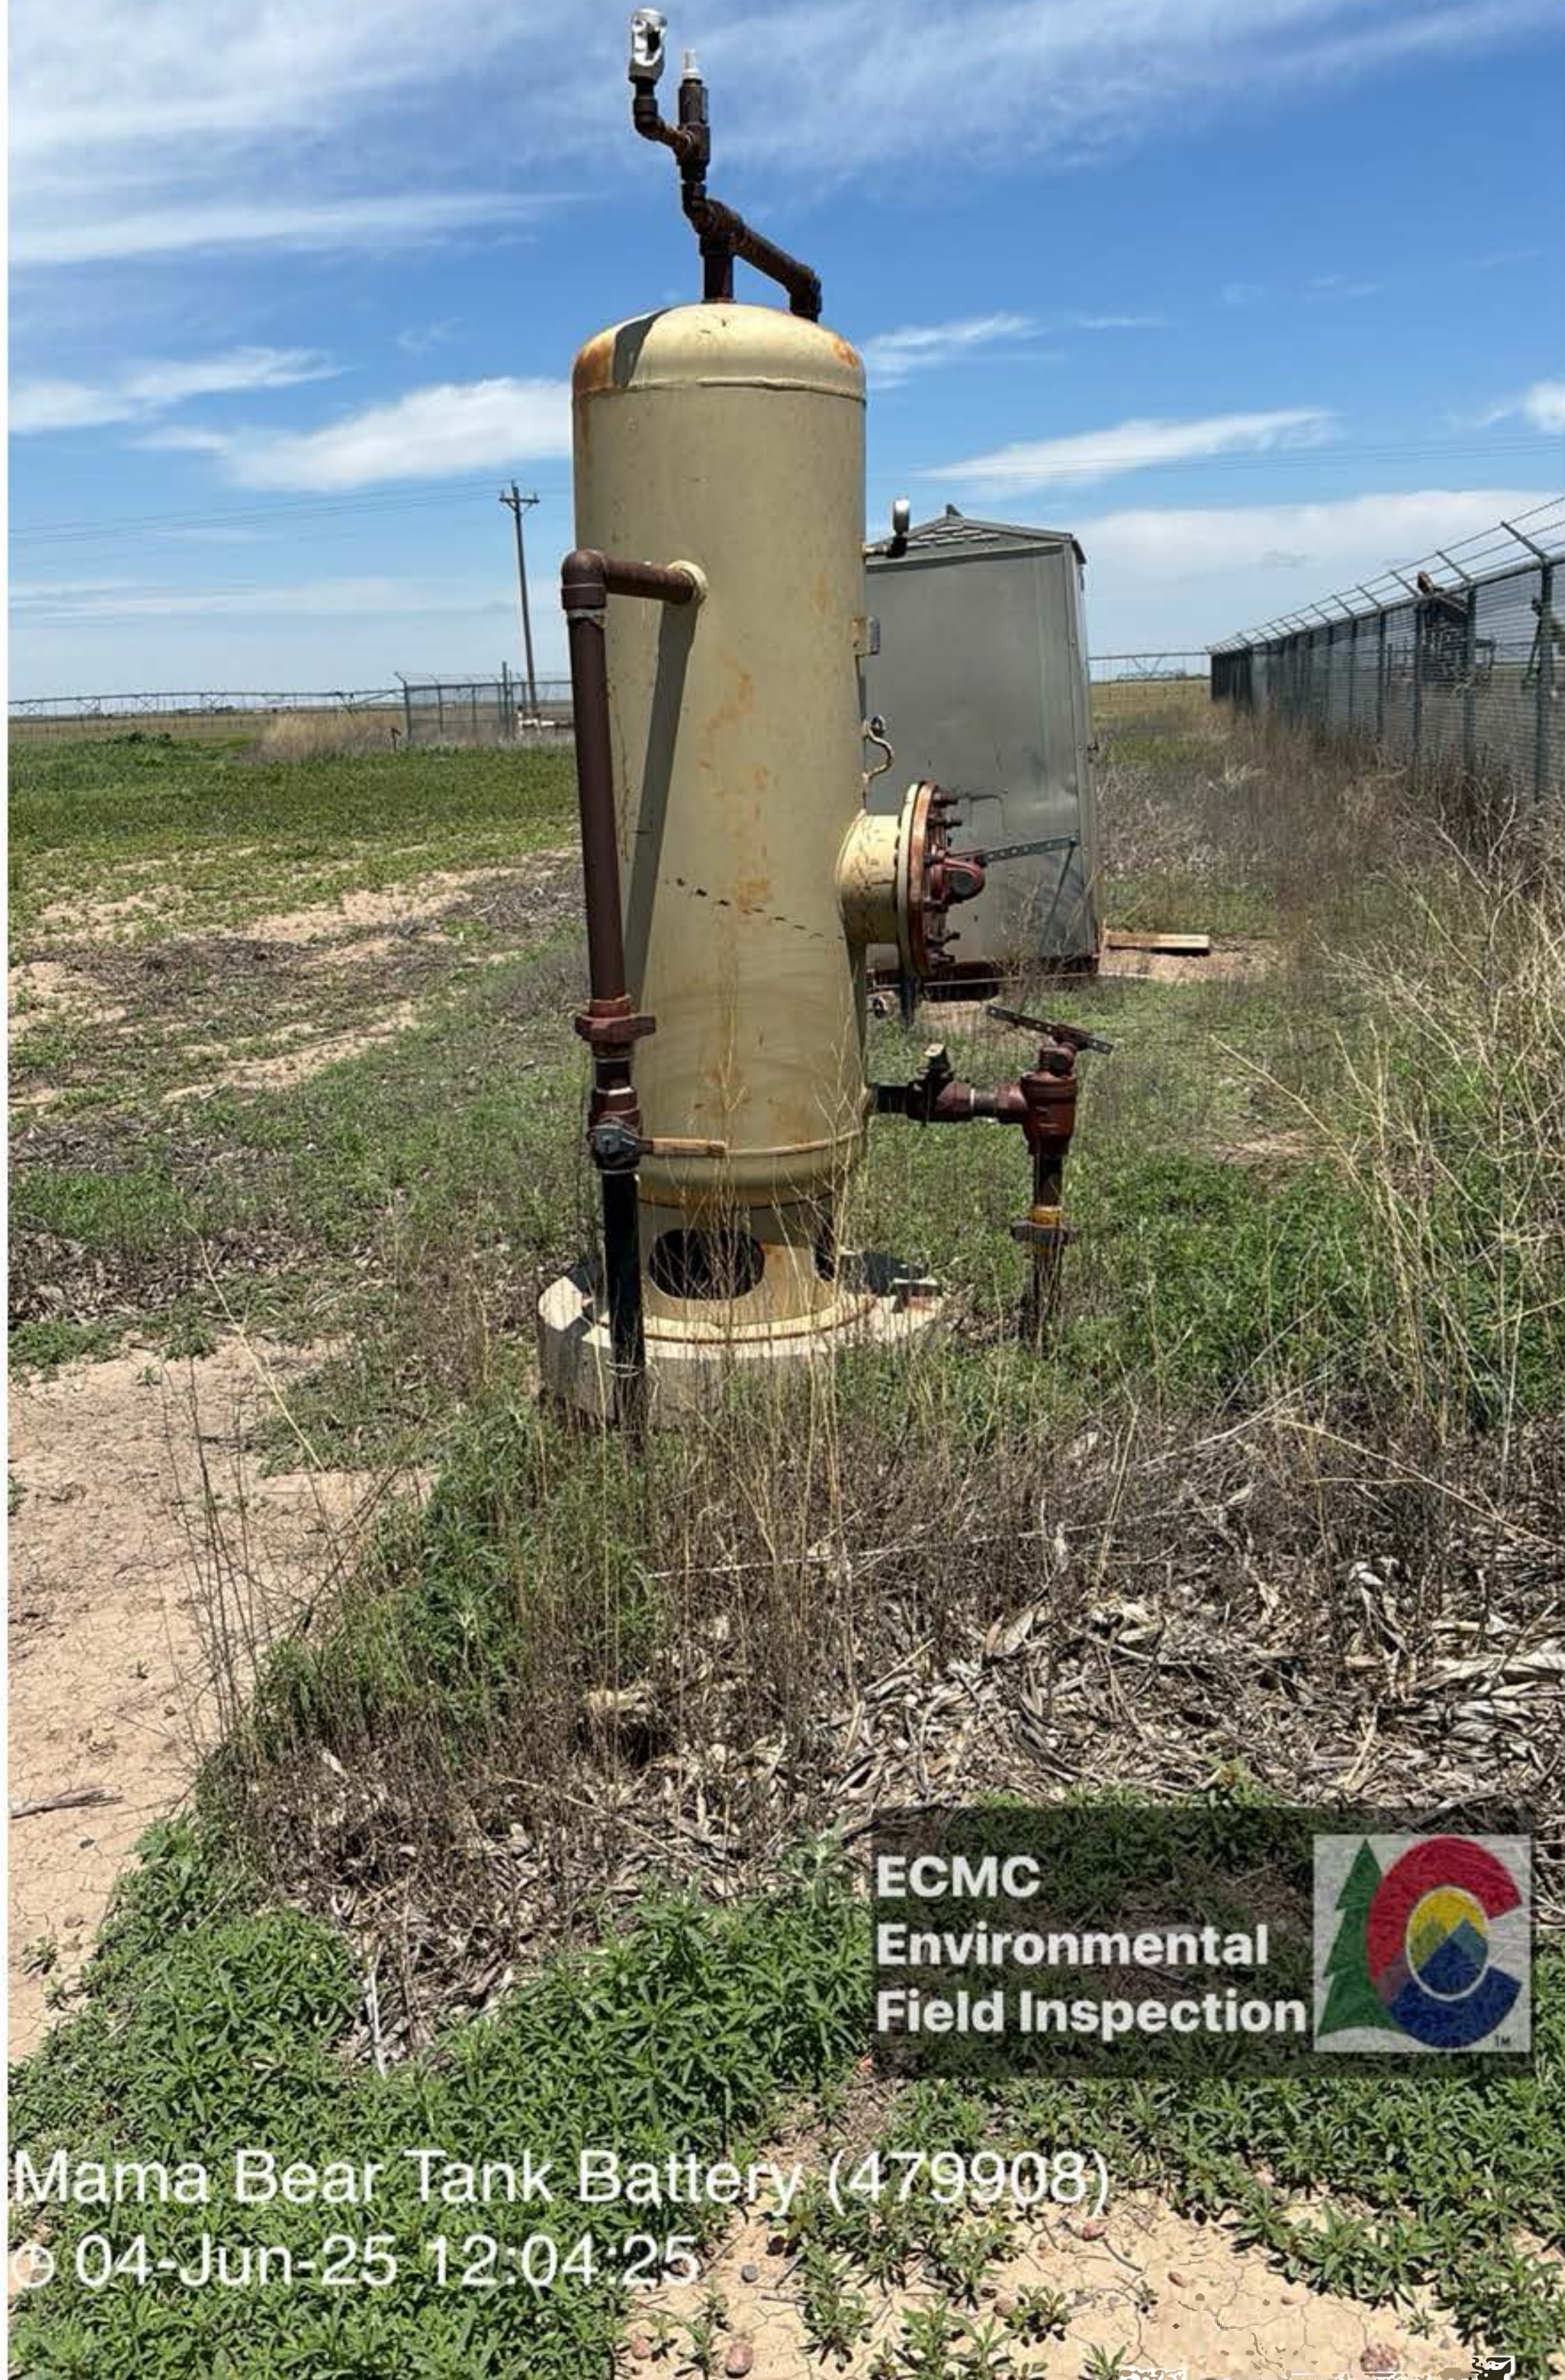
Weeds/Debris.

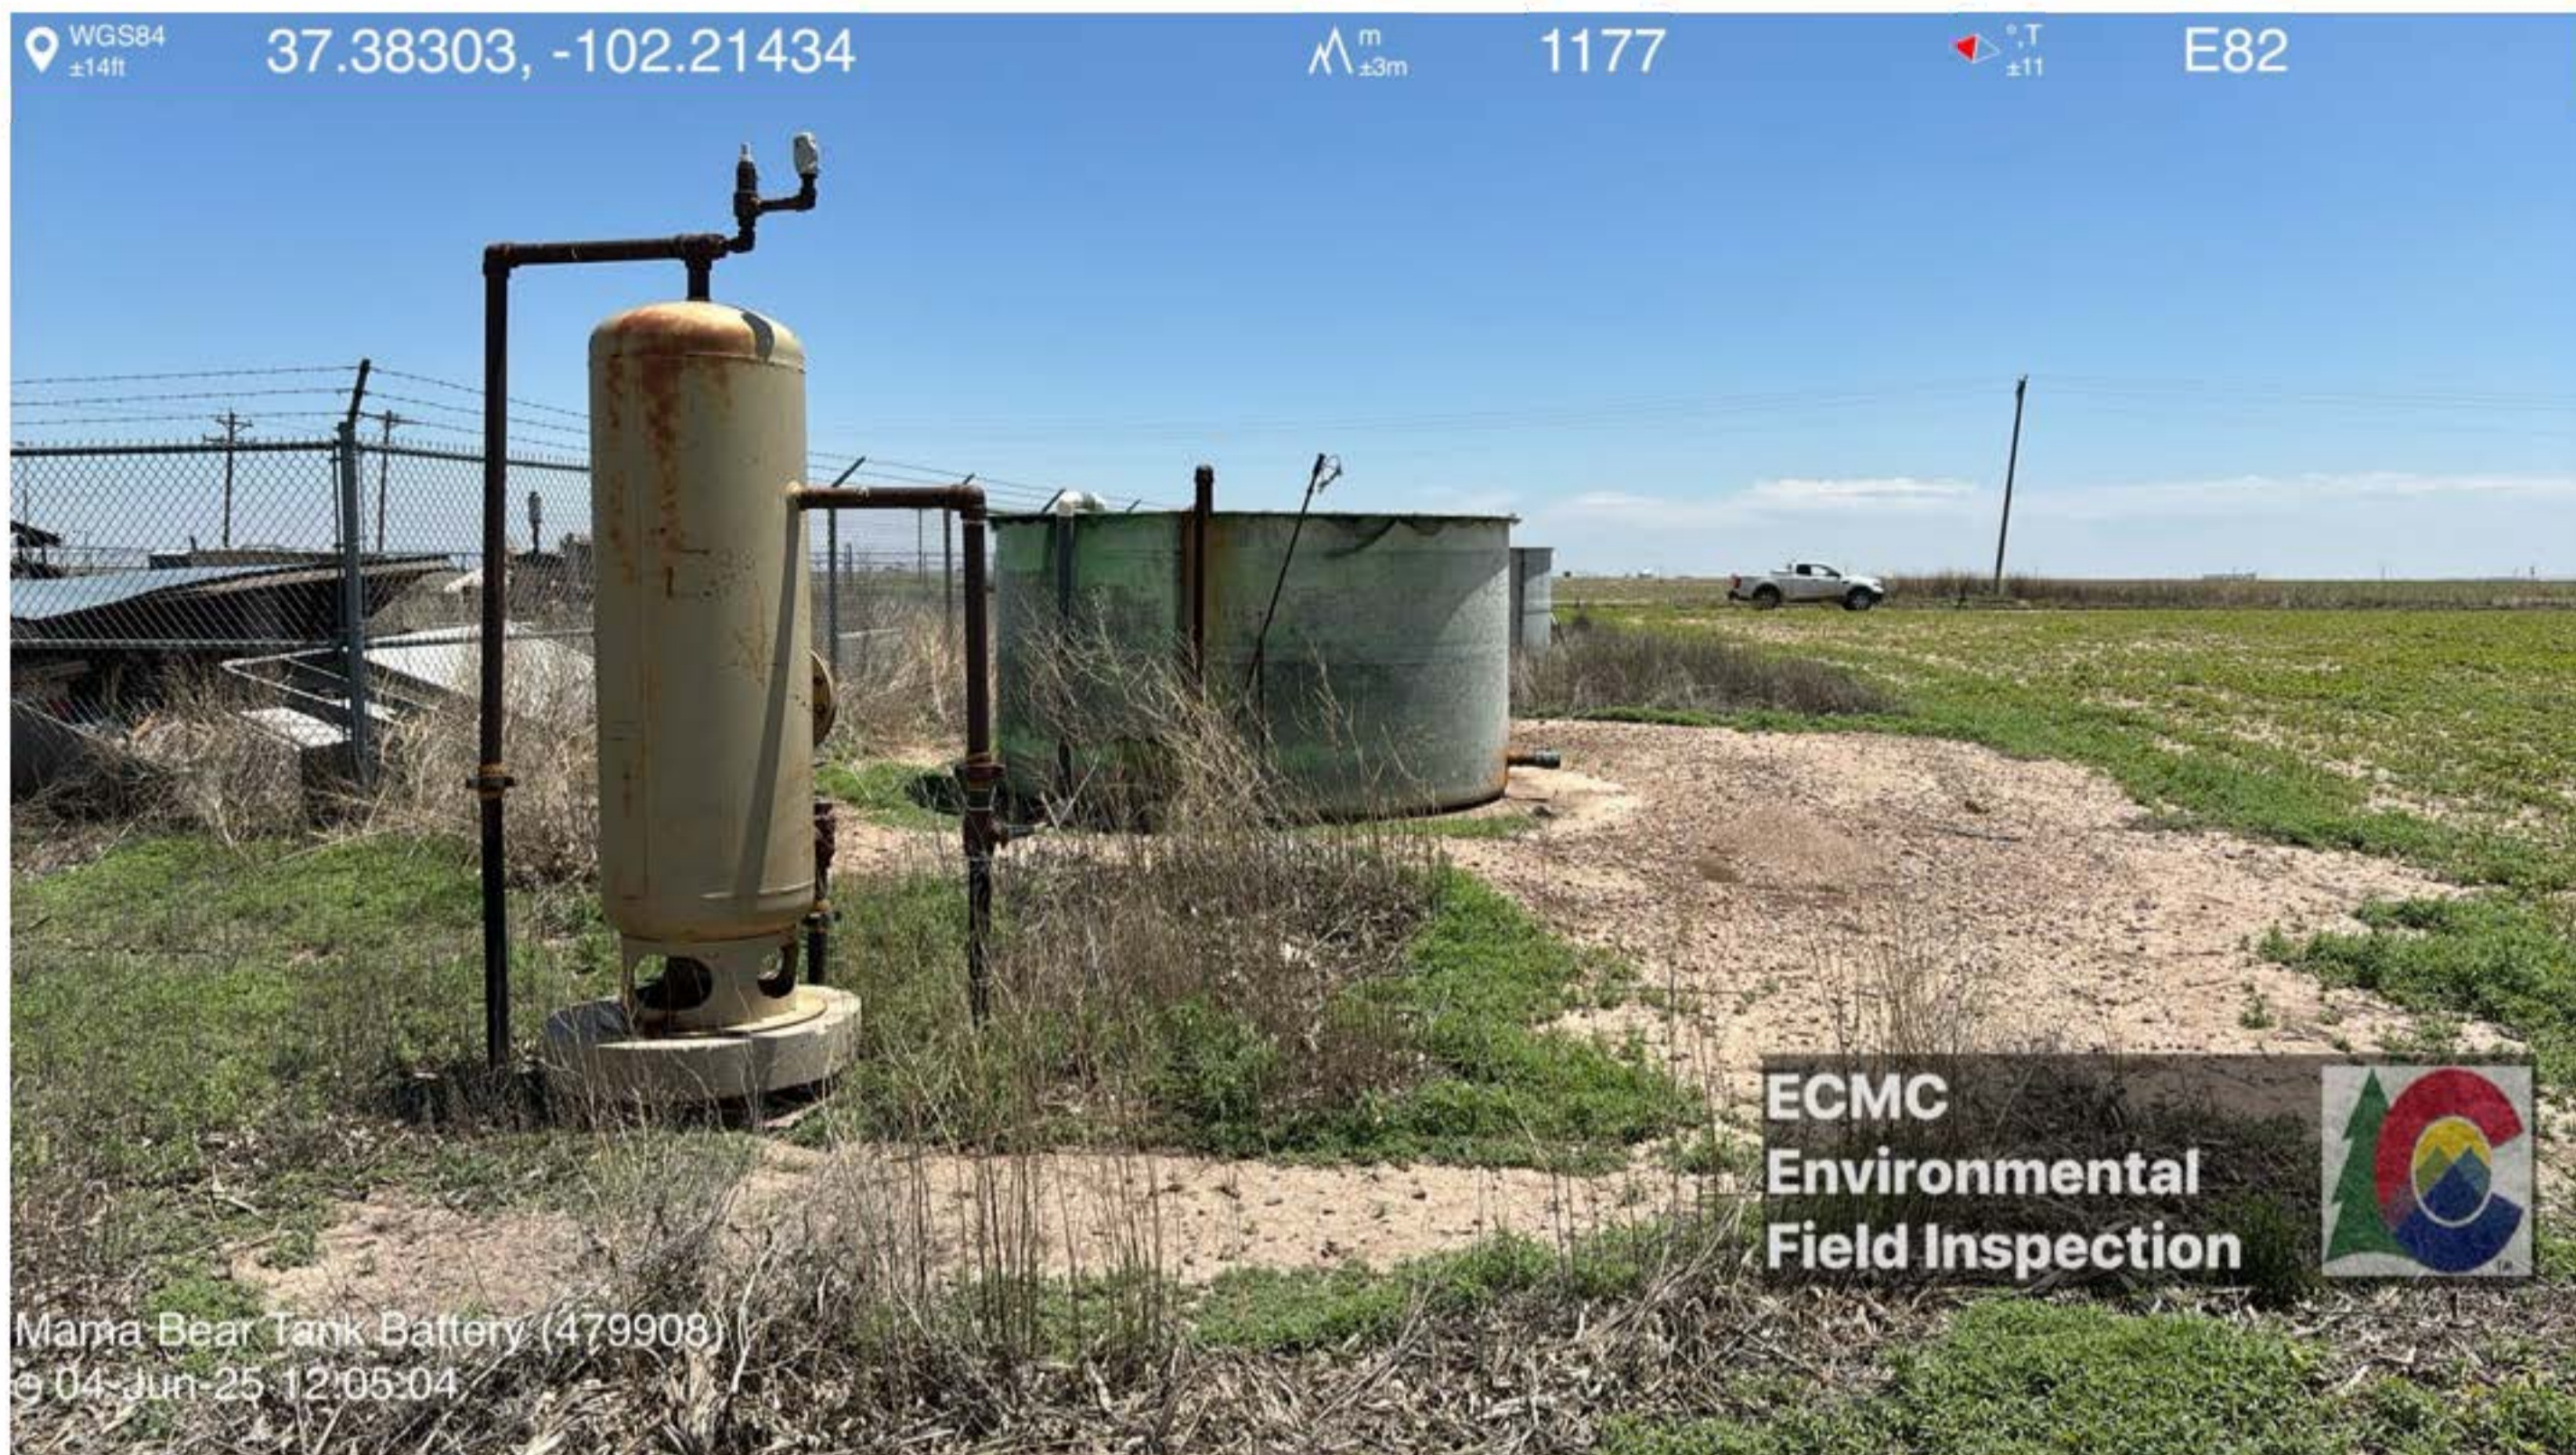
- Inadequate secondary containment for the 100-bbl and 210-bbl open top fiberglass produced water storage tanks
- Weeds

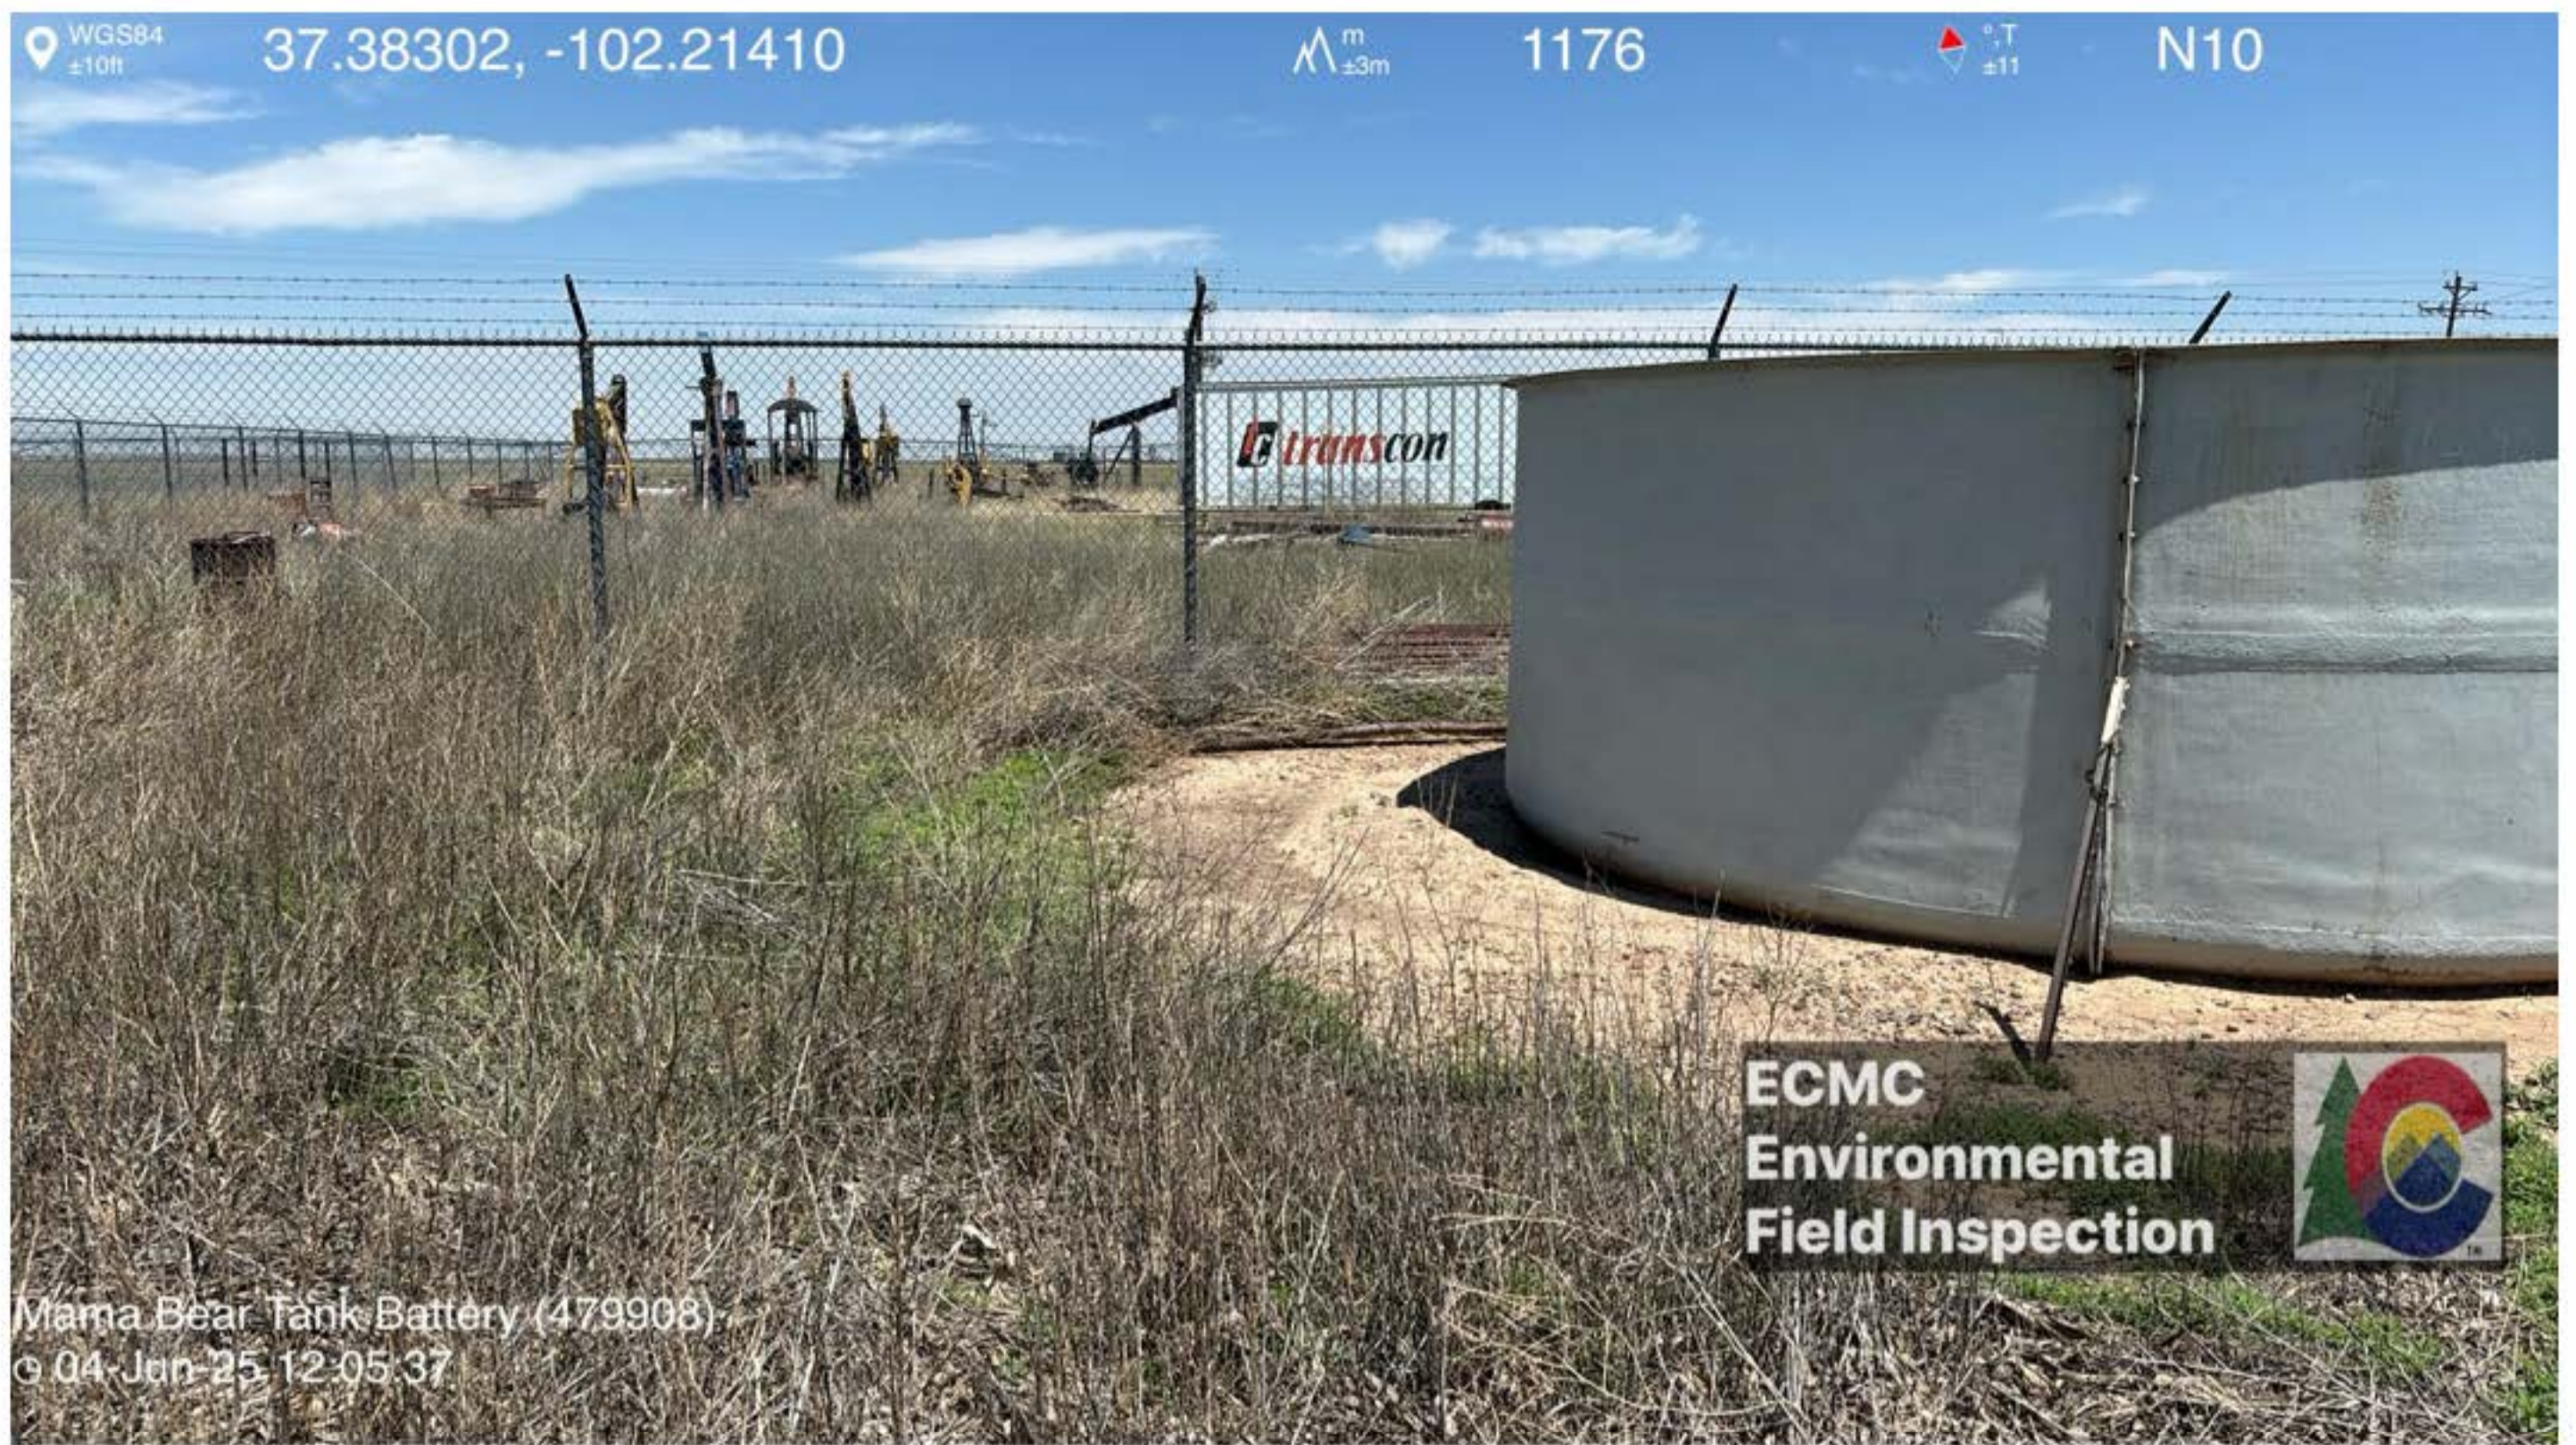
- Inadequate secondary containment for the 100-bbl and 210-bbl open top fiberglass produced water storage tanks
- Wildlife protection equipment (netting) was missing on the 210-bbl open-top fiberglass produced water storage tank (empty at time of inspection)
- Weeds
- Unused equipment (piping) stored along N/NE adjacent property fencing
