ECMC
Environmental
Field Inspection

Mama Bear Tank Battery (479908)
04-Jun-25 12:04:25

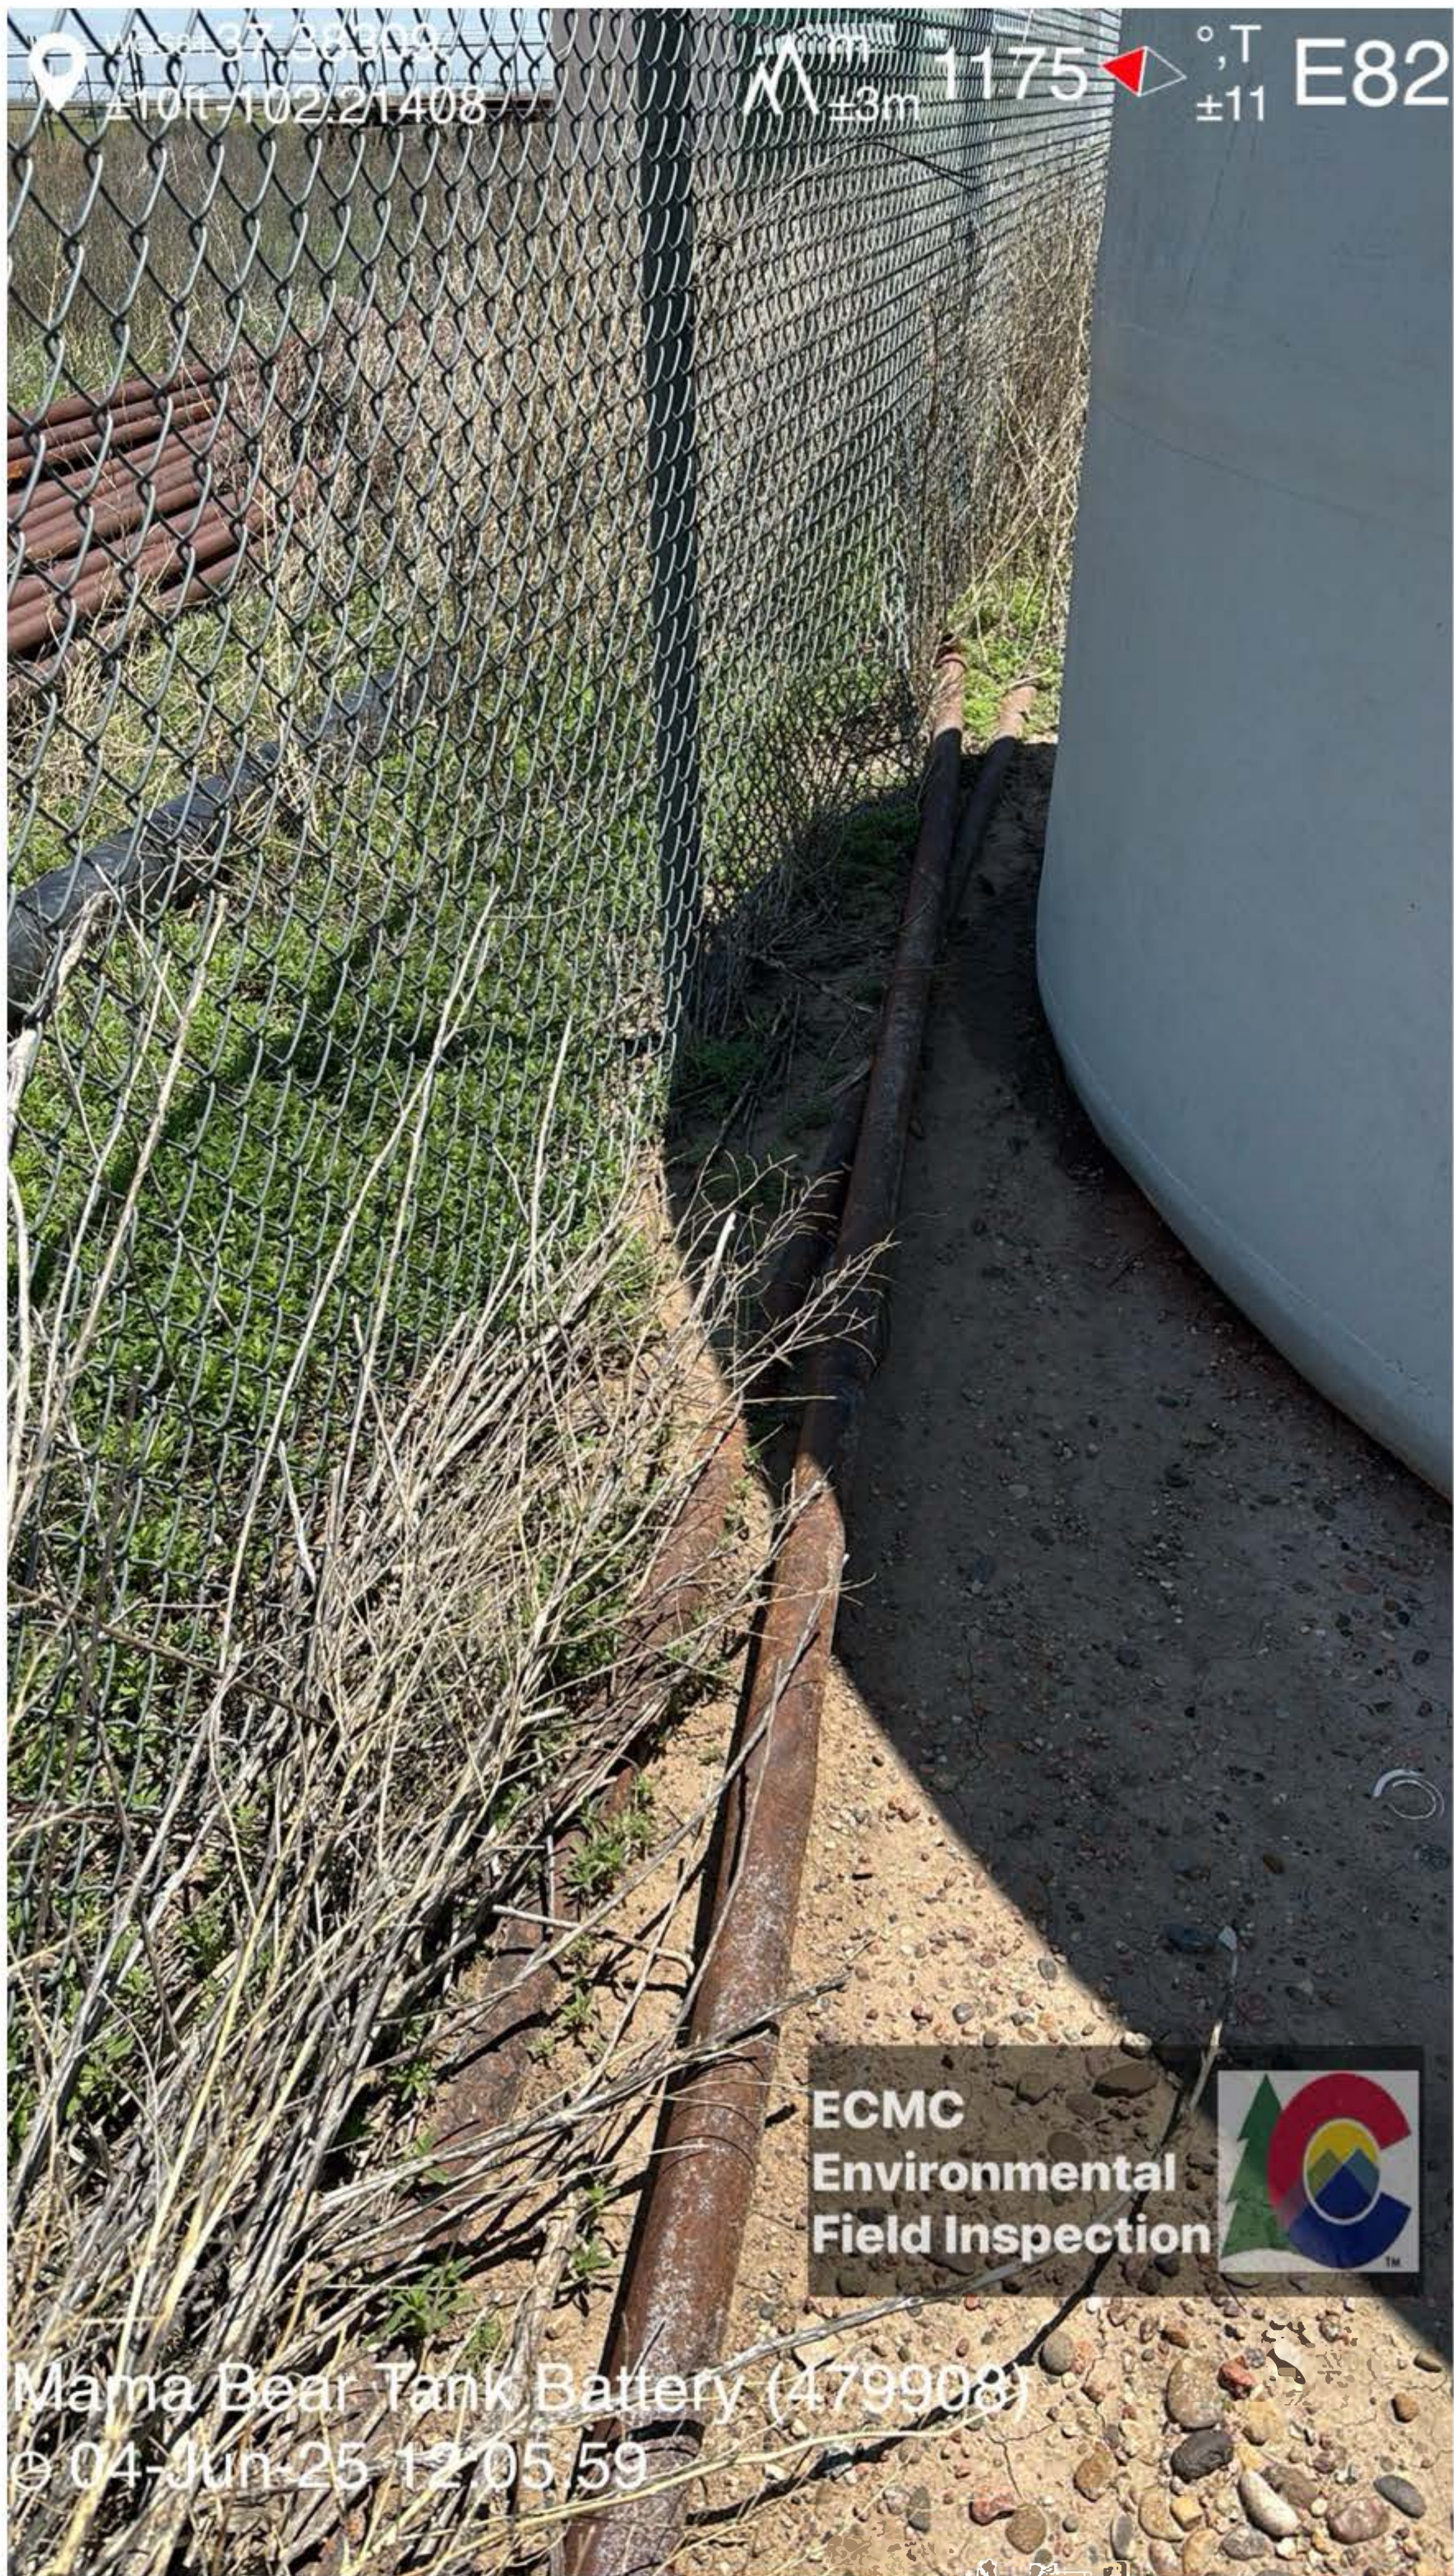
- Weeds
- Unused equipment (piping) stored along N/NE adjacent property fencing
