ECMC
Environmental
Field Inspection

Hancock M-631S43W (321046)
© 04-Jun-25 12:45:02

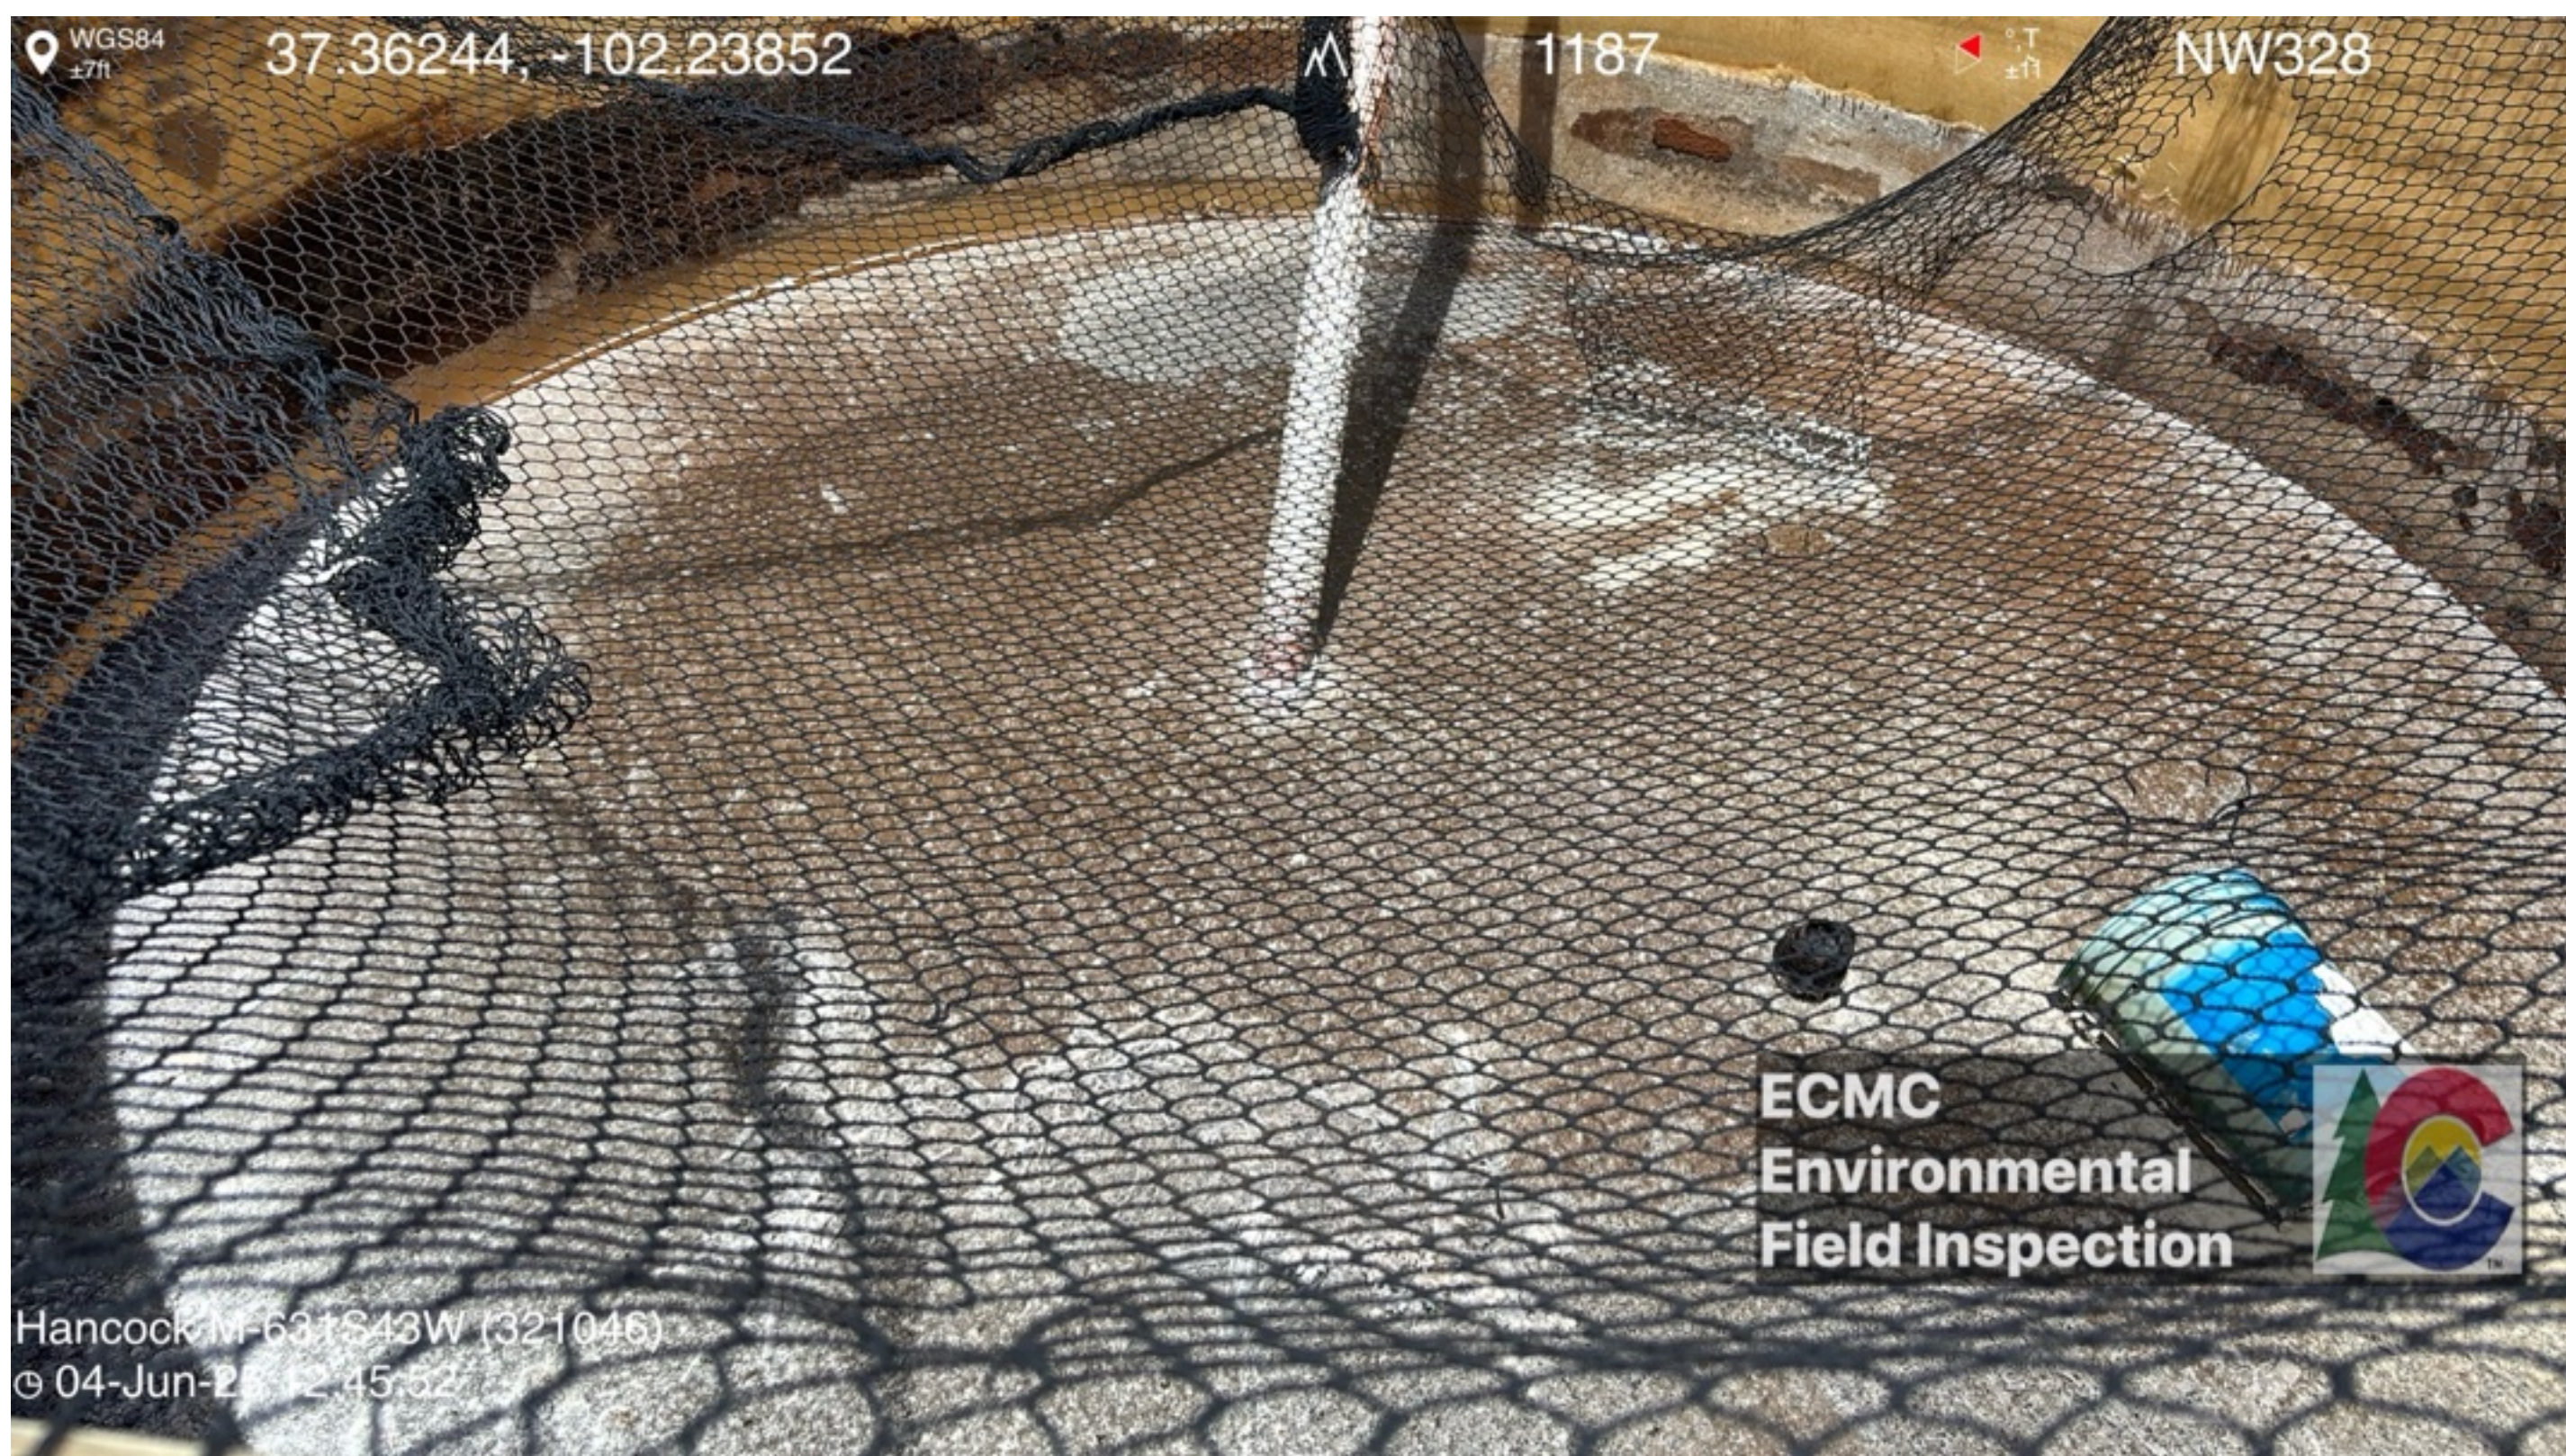
~100-bbl open top fiberglass produced water storage tank has trash/debris in base and wildlife protection equipment (netting) has fallen and requires maintenance/repair.

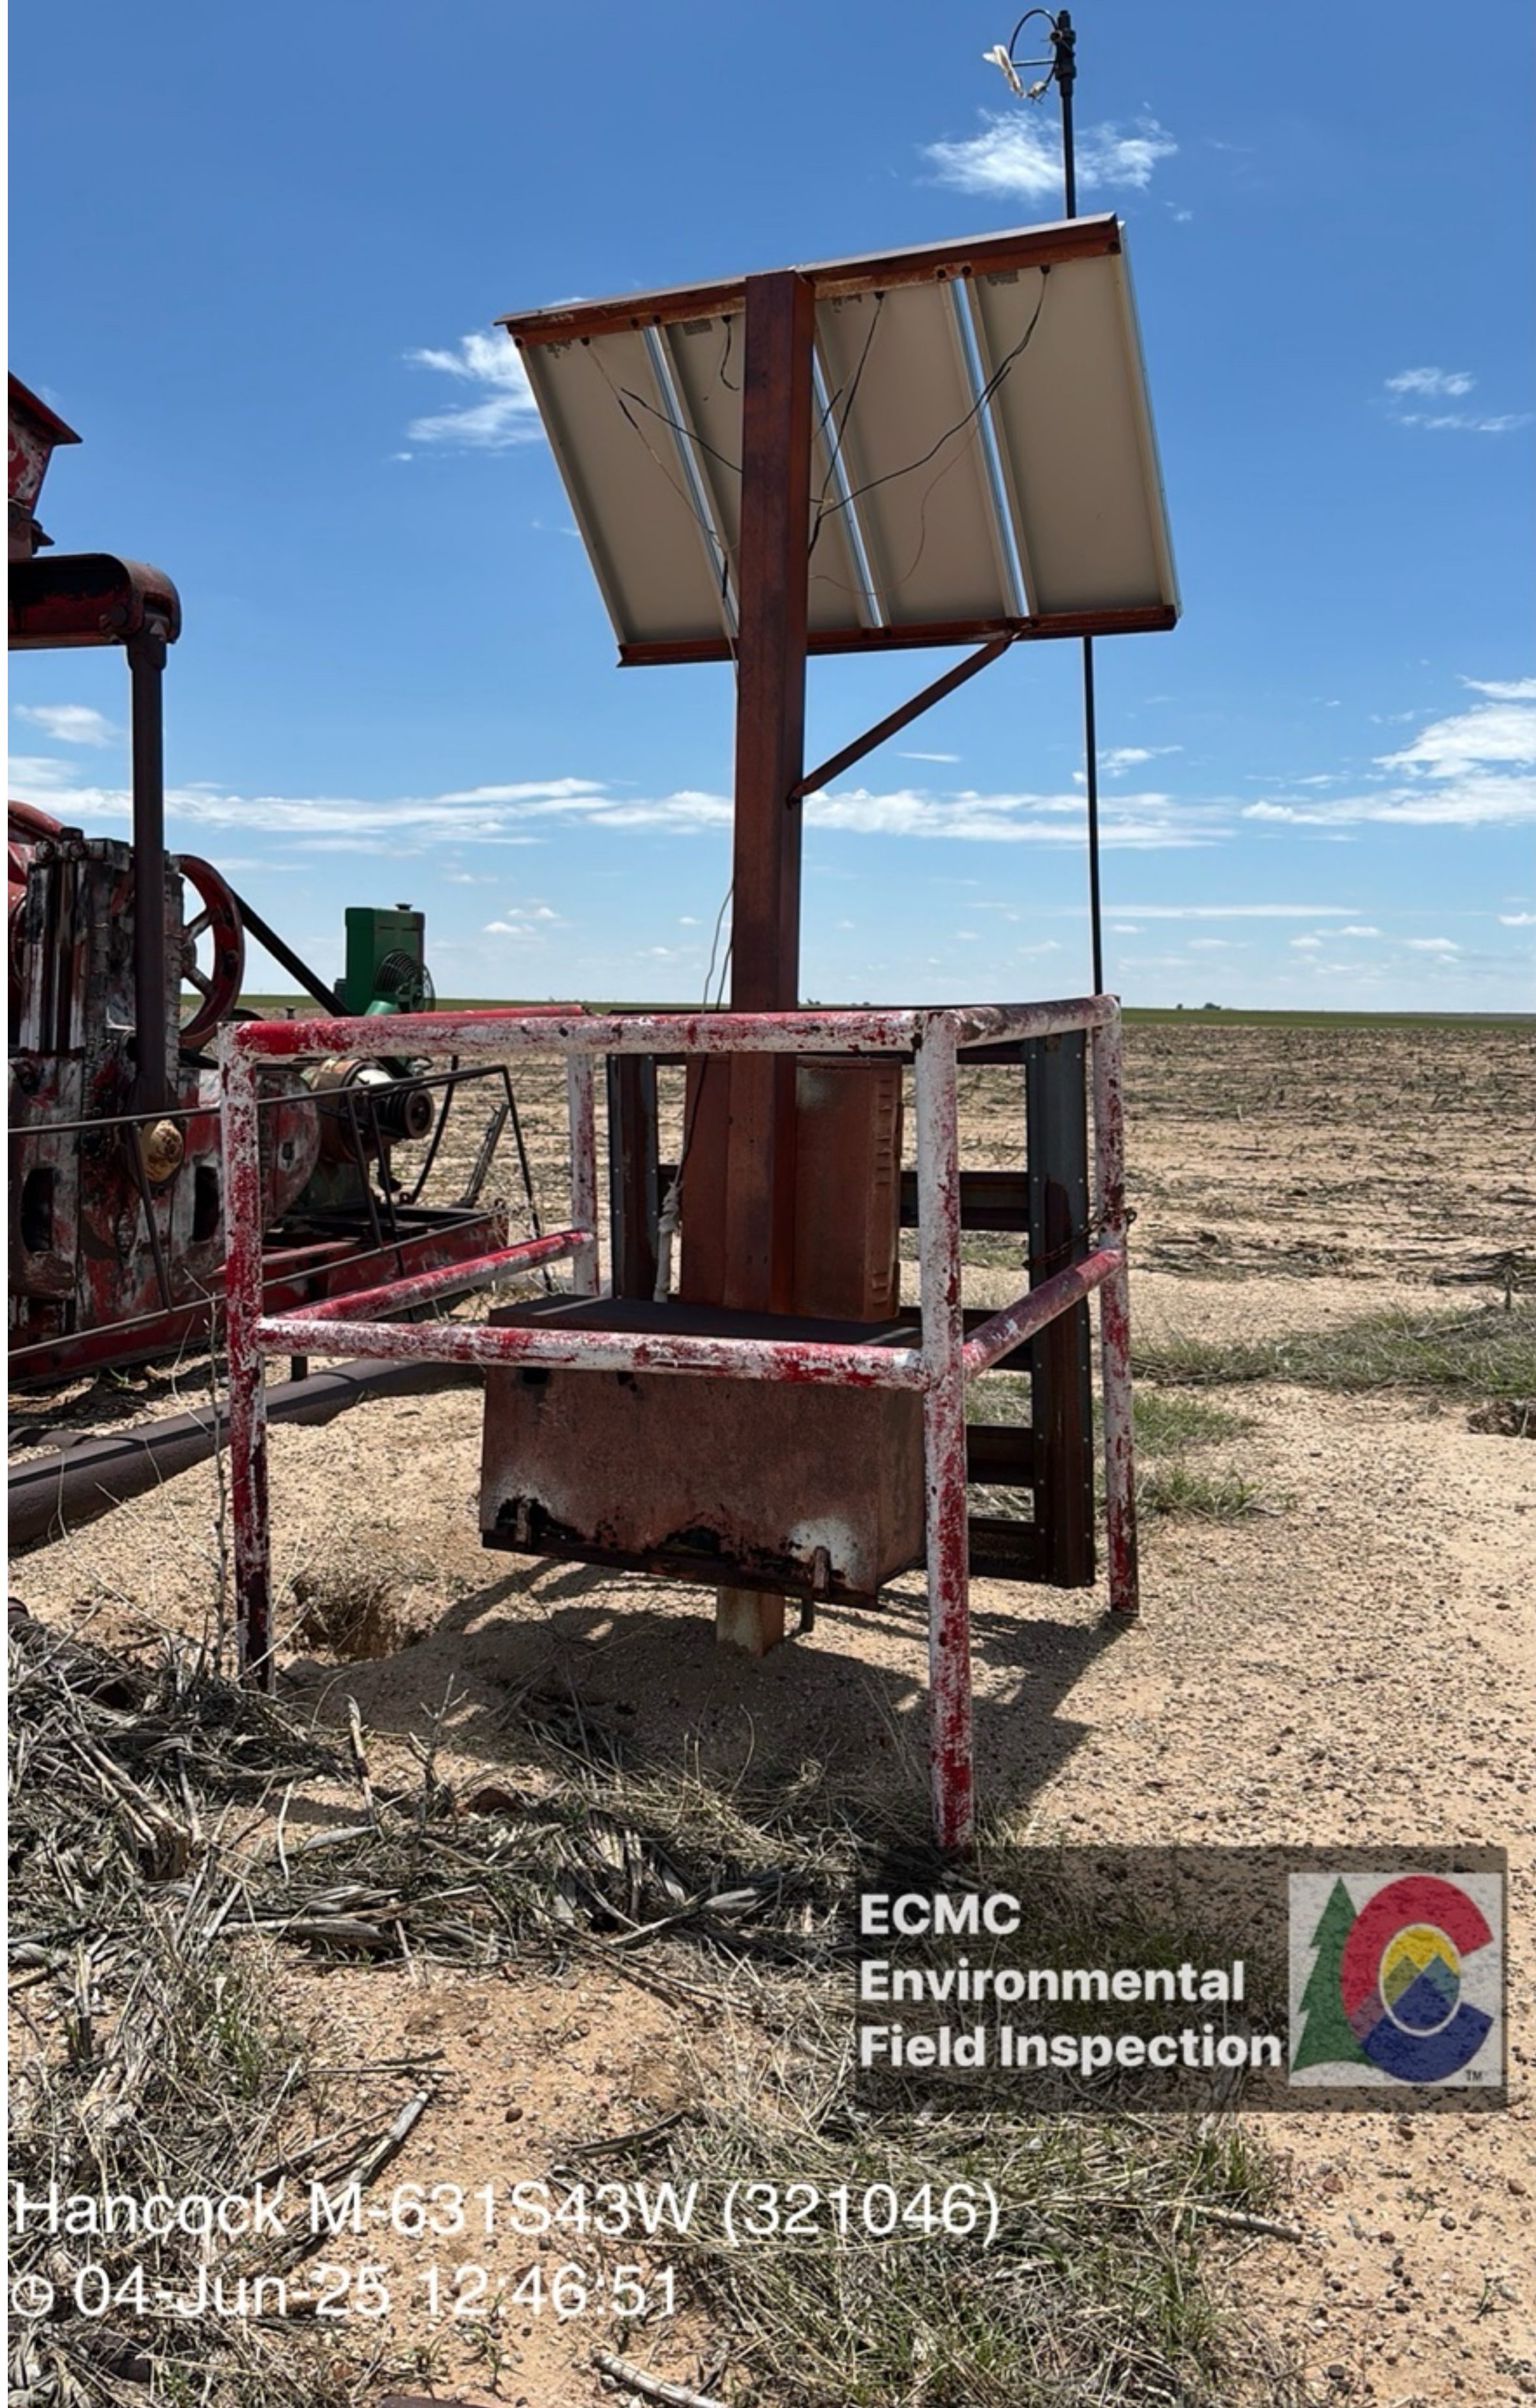
Weeds/debris observed next to welhead and cathodic rectifier.

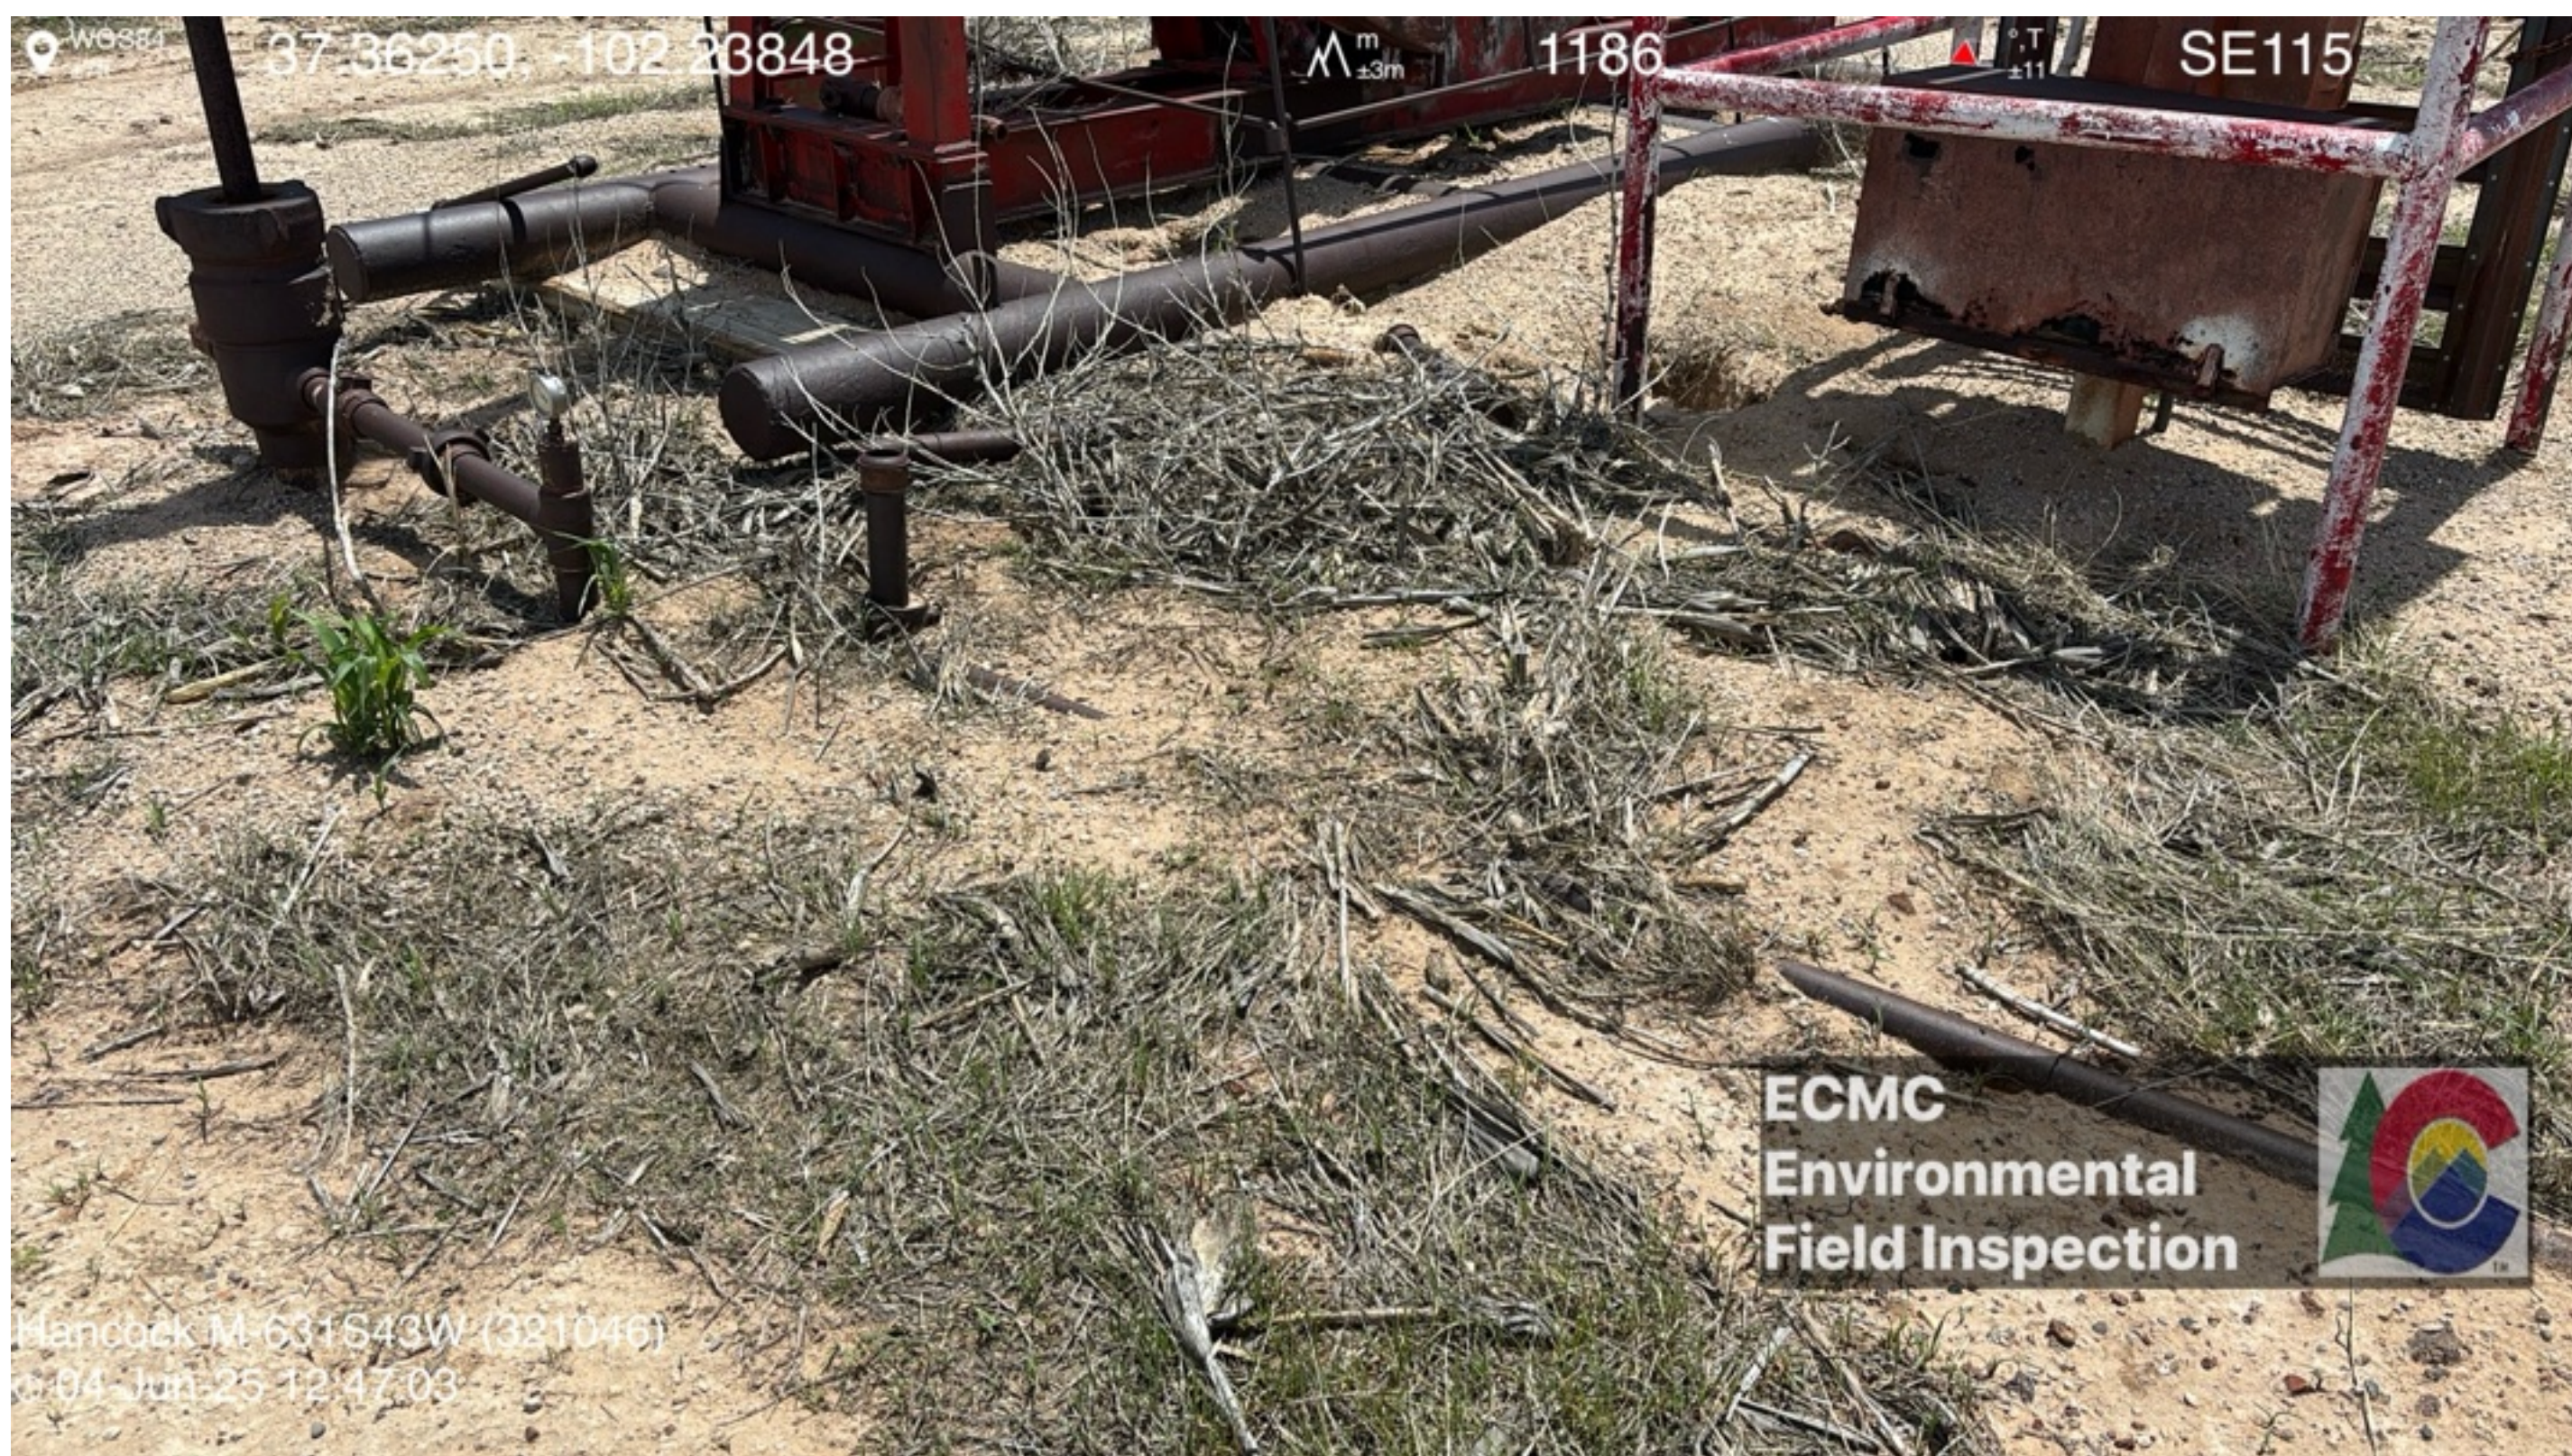
Weeds/debris observed next to wellhead and cathodic rectifier.

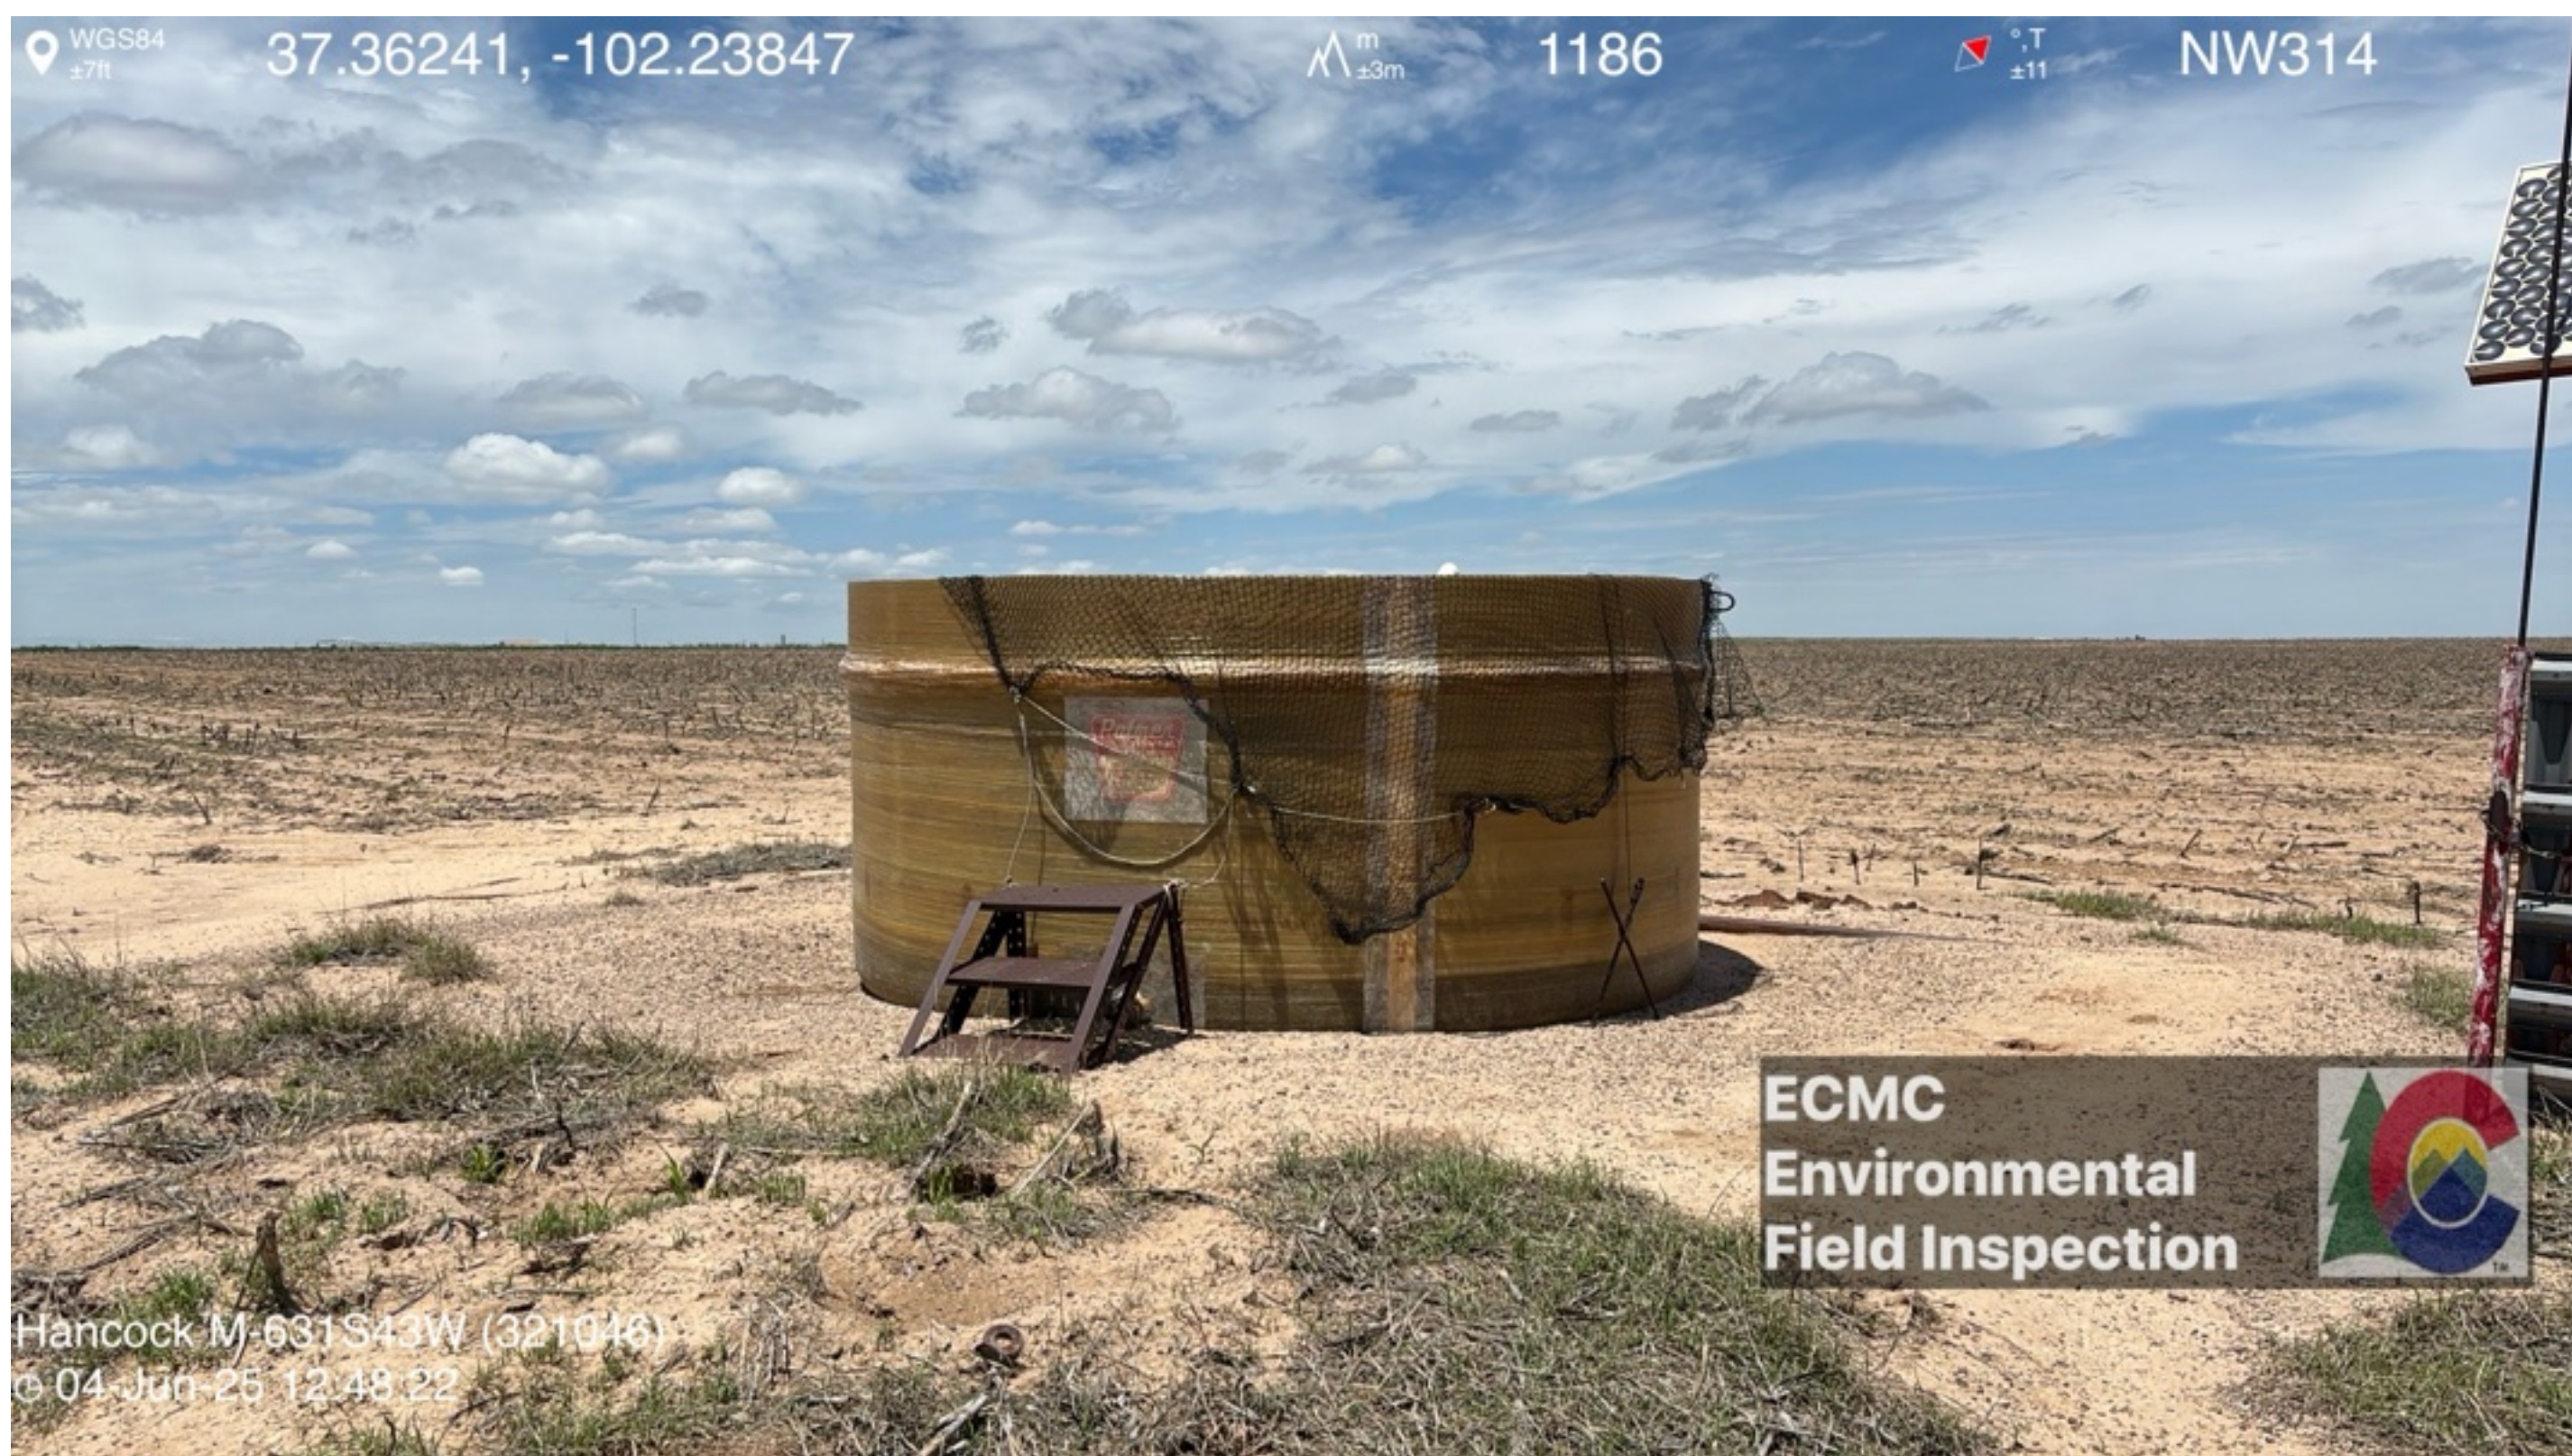
~100-bbl open top fiberglass produced water storage tank missing contents/volume labels and hazard/NFPA placards.
Inadequate secondary containment.
Weeds/debris
Wildlife protection equipment (netting) has fallen and requires maintenance/repair.
