ECMC
Environmental
Field Inspection

Tate Tank (479916)
© 04-Jun-25 12:27:13

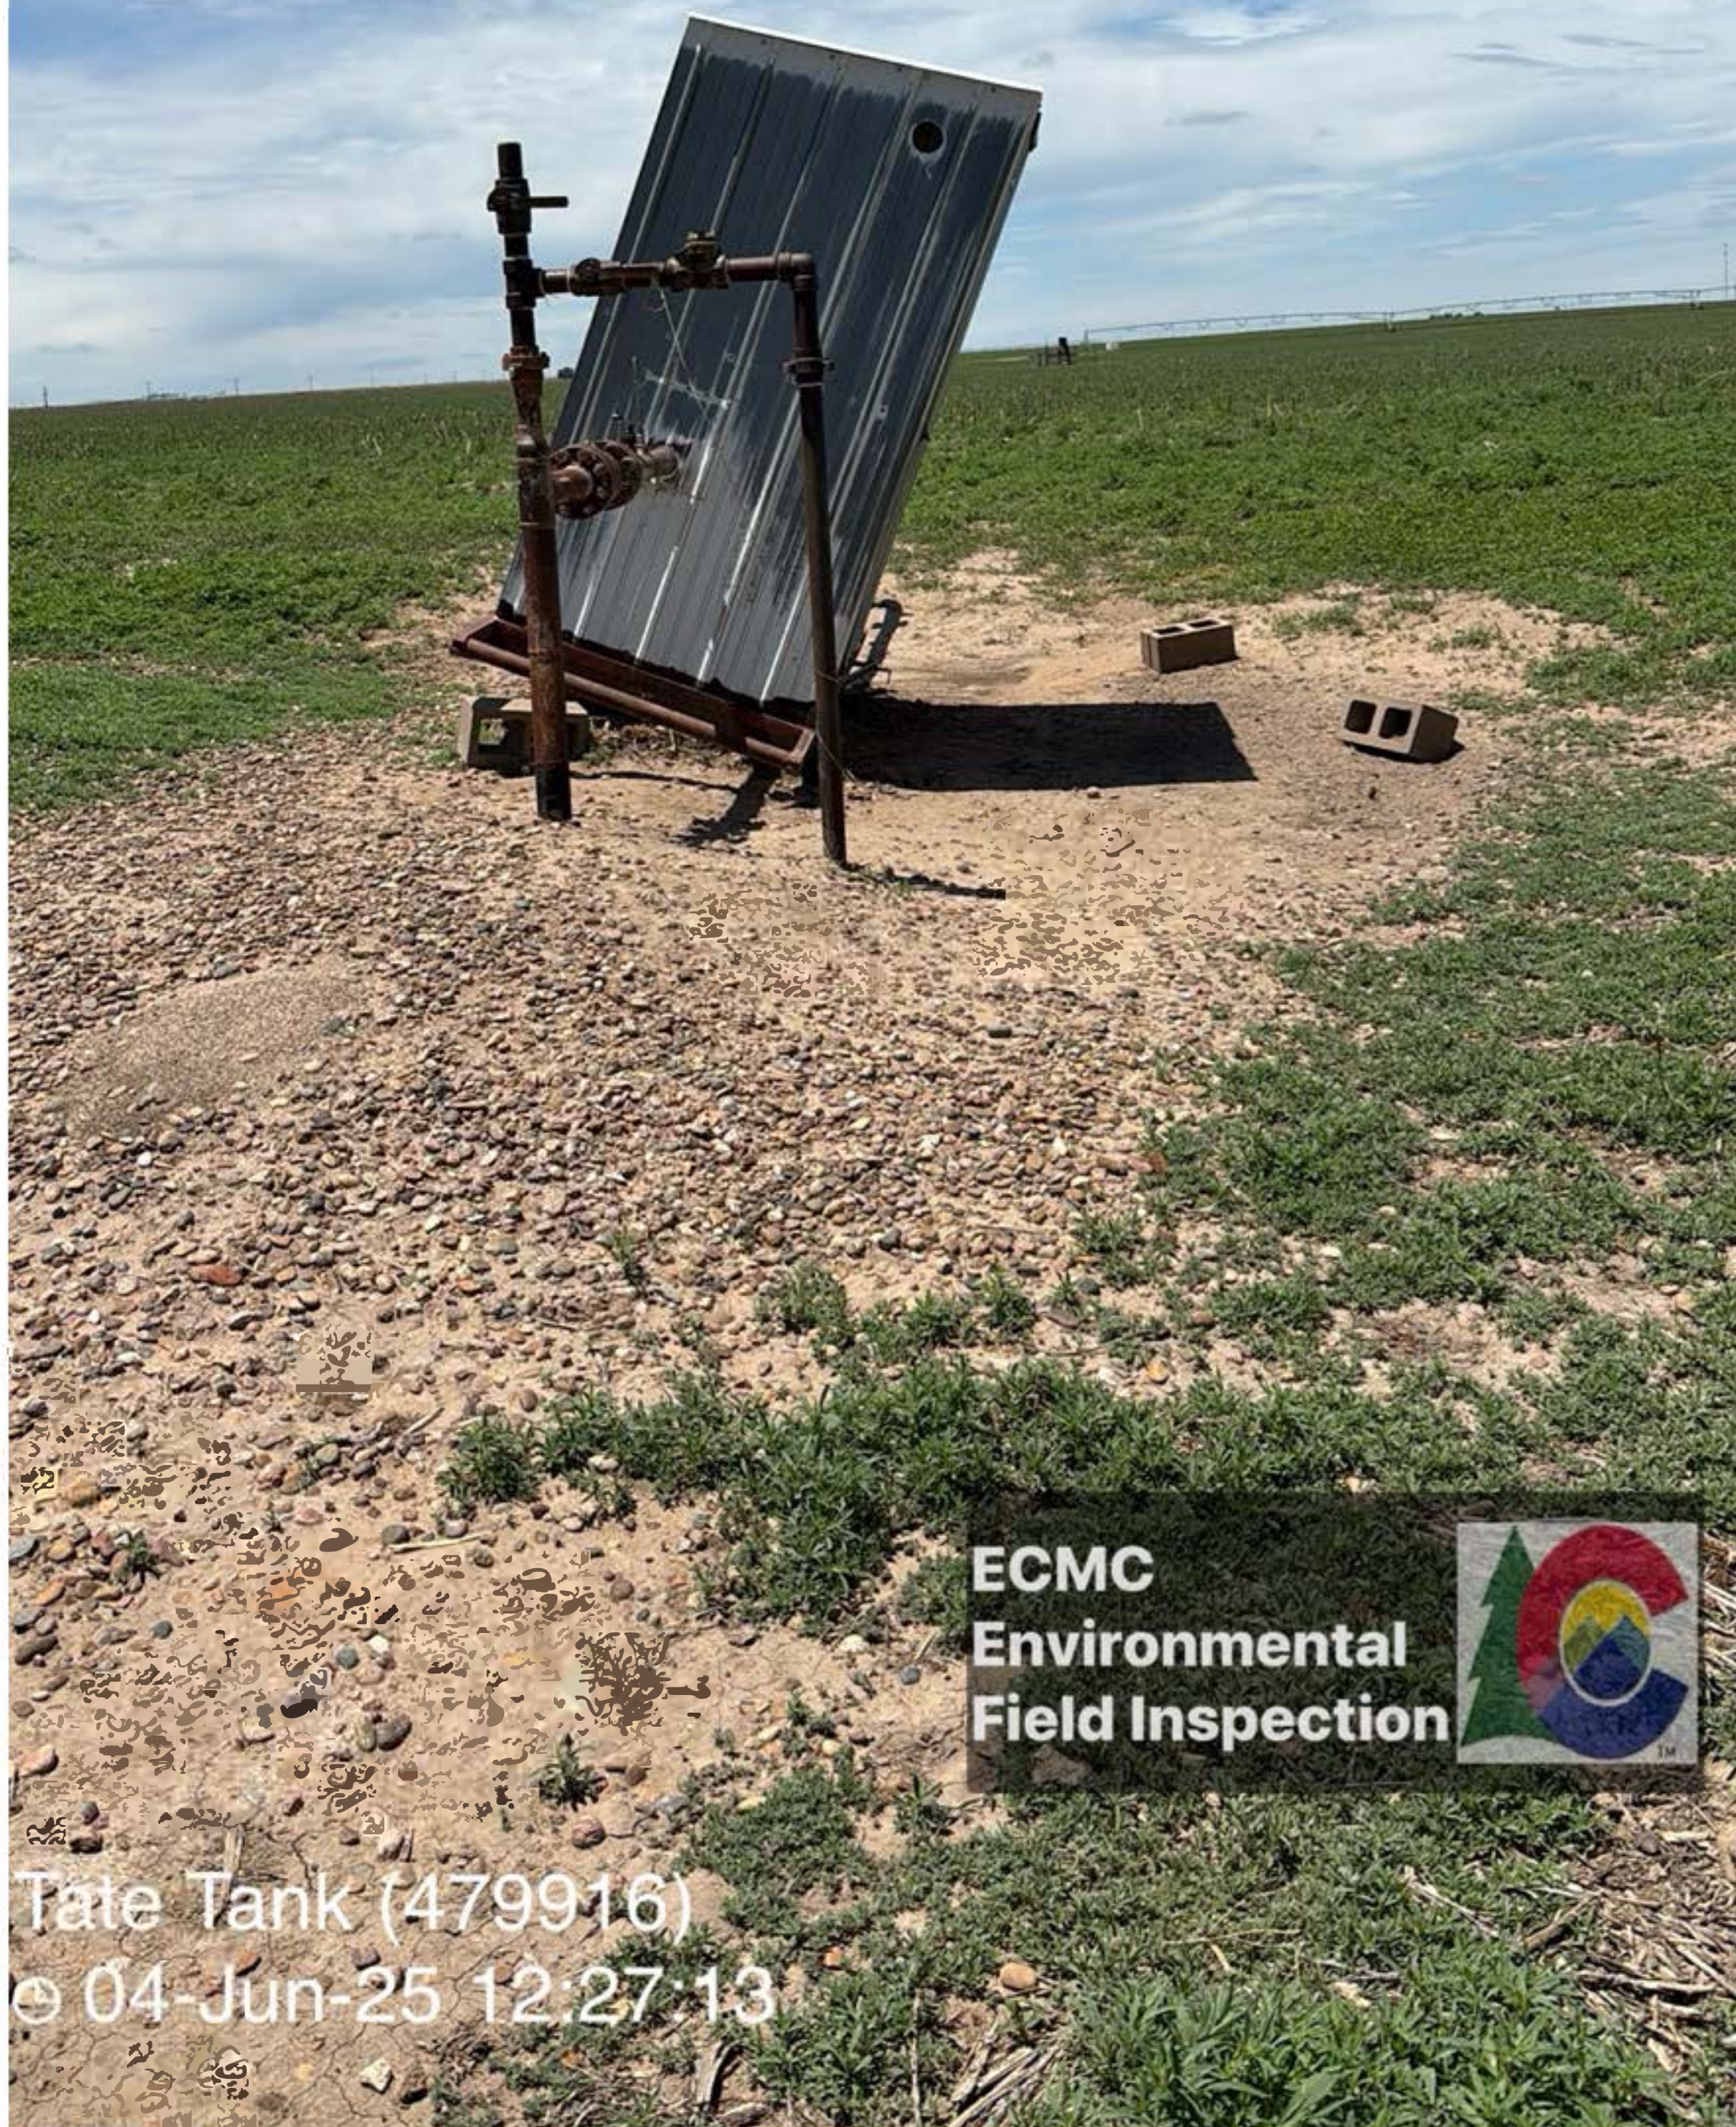
Meter shed leaning/not level. - requires maintenance.

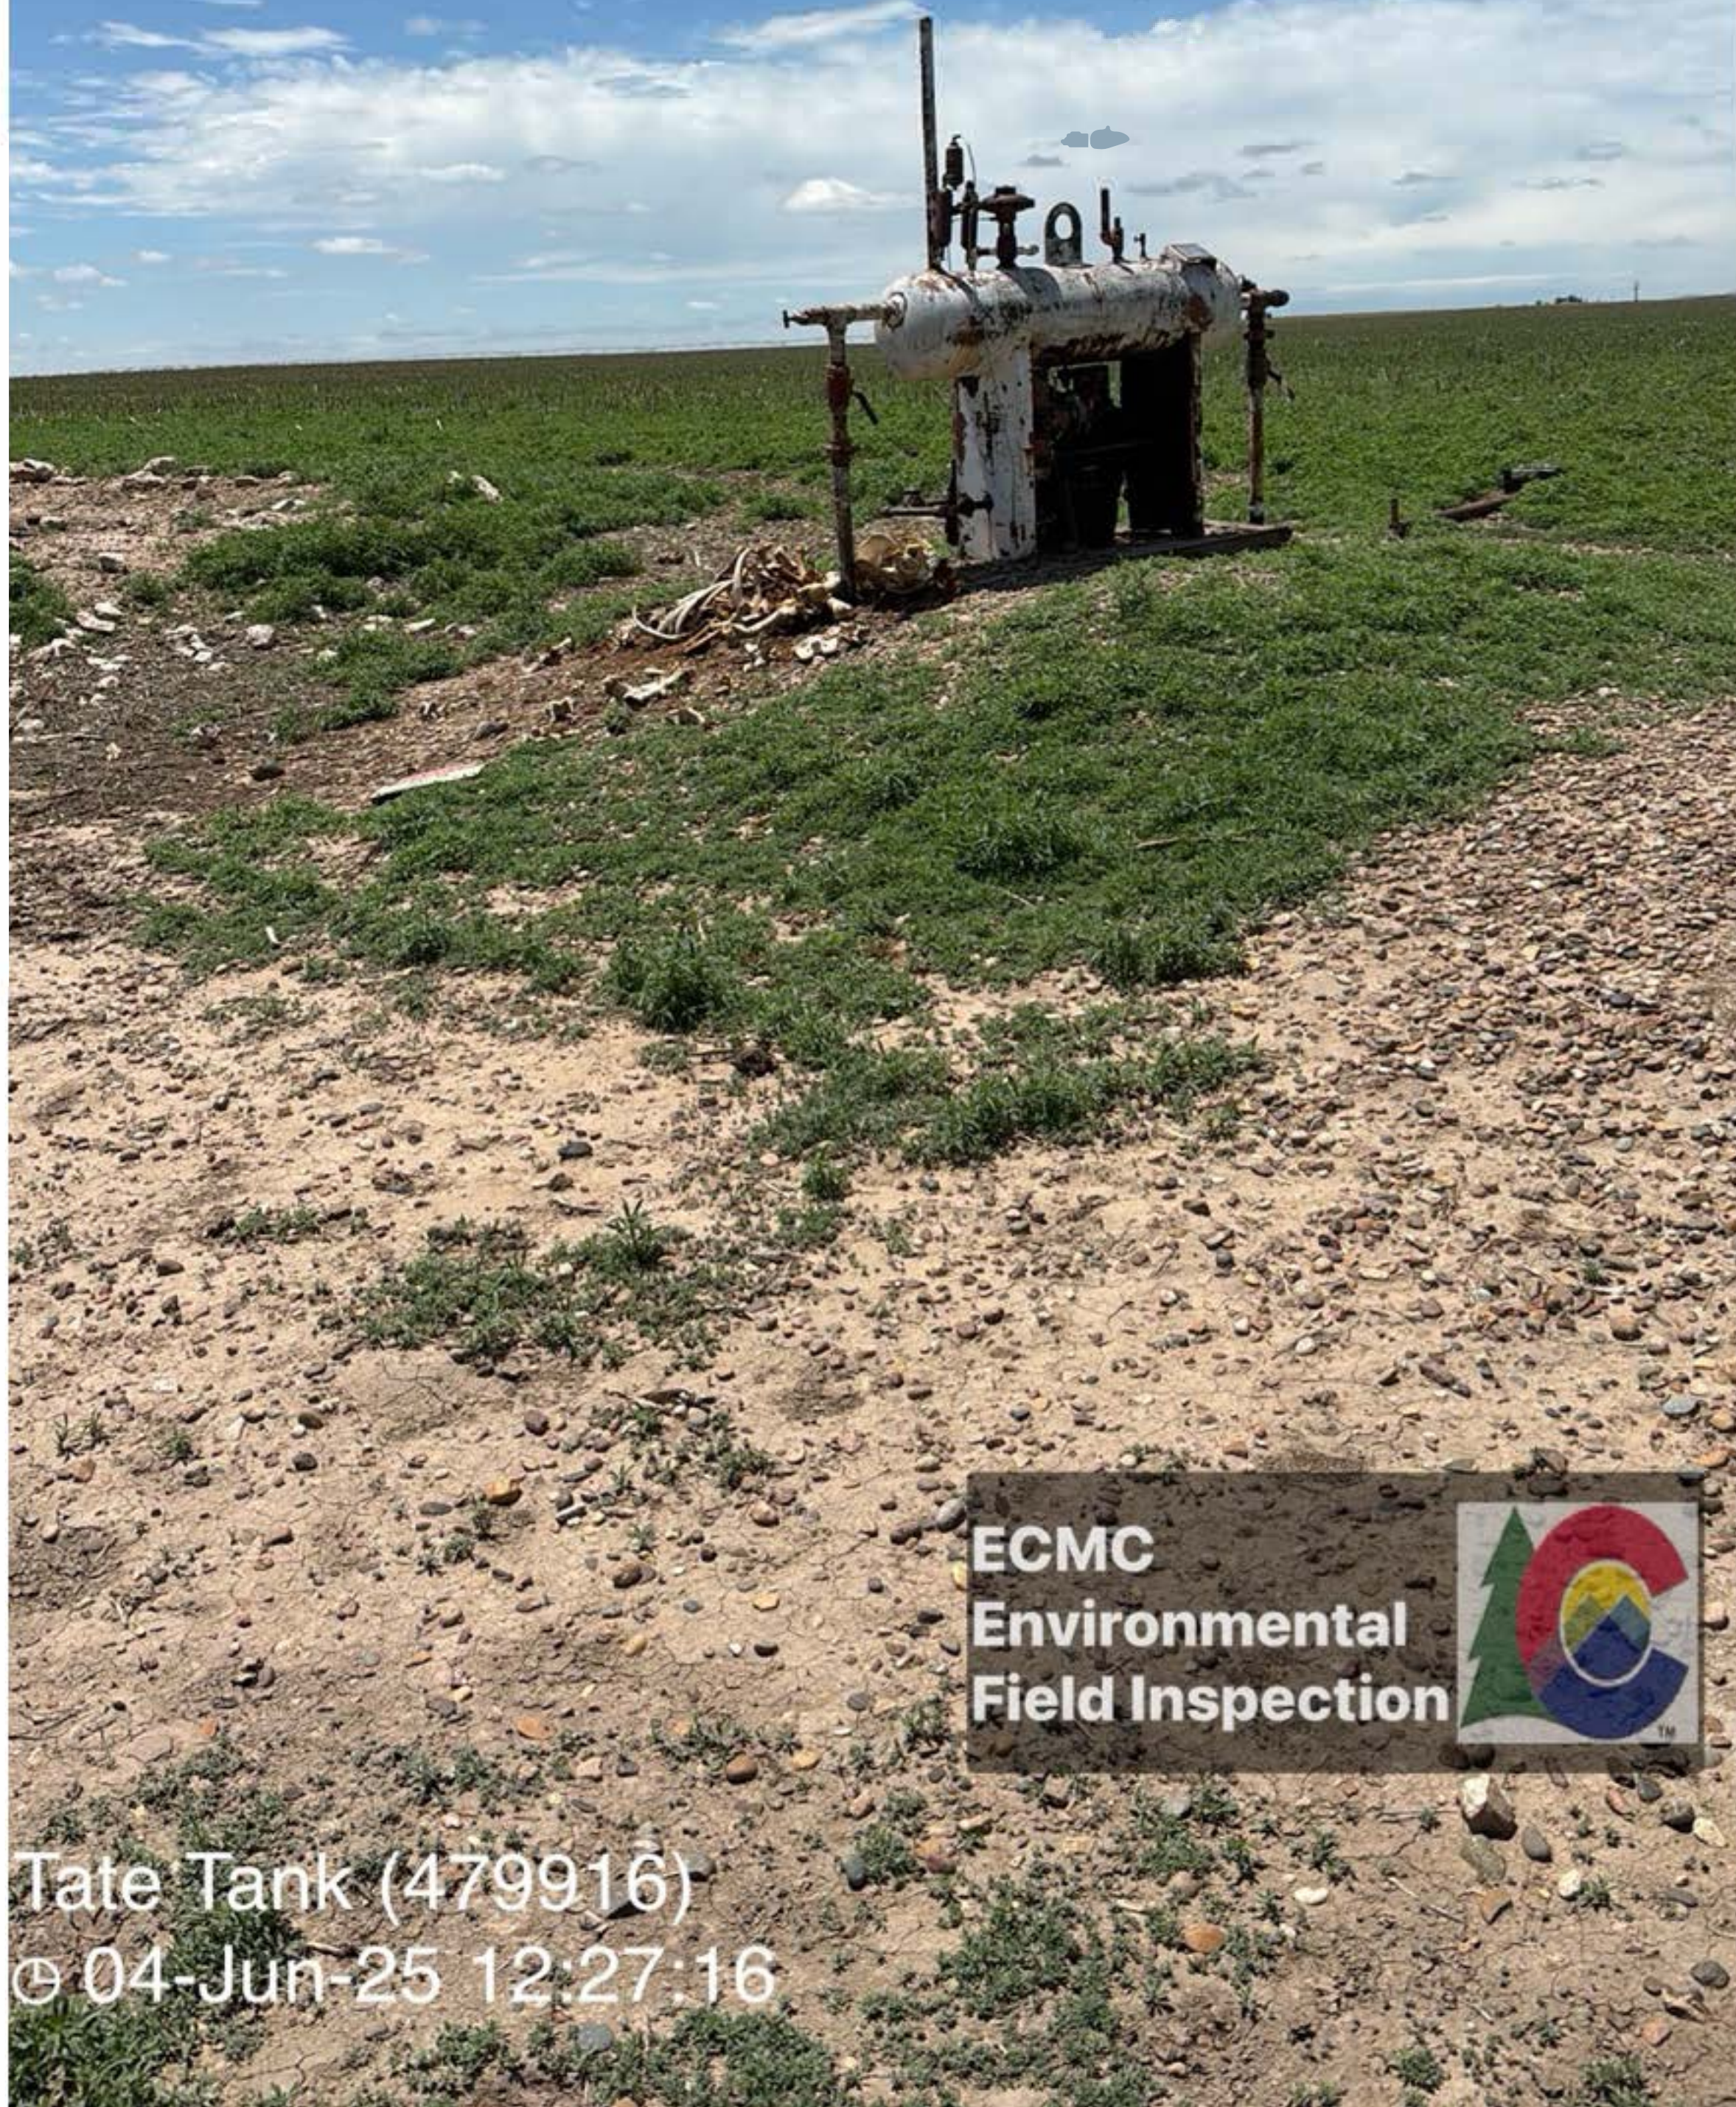
Tate Tank (479916)
© 04-Jun-25 12:27:16

Cattle carcass, weeds, fallen/inadequate signage at separator.

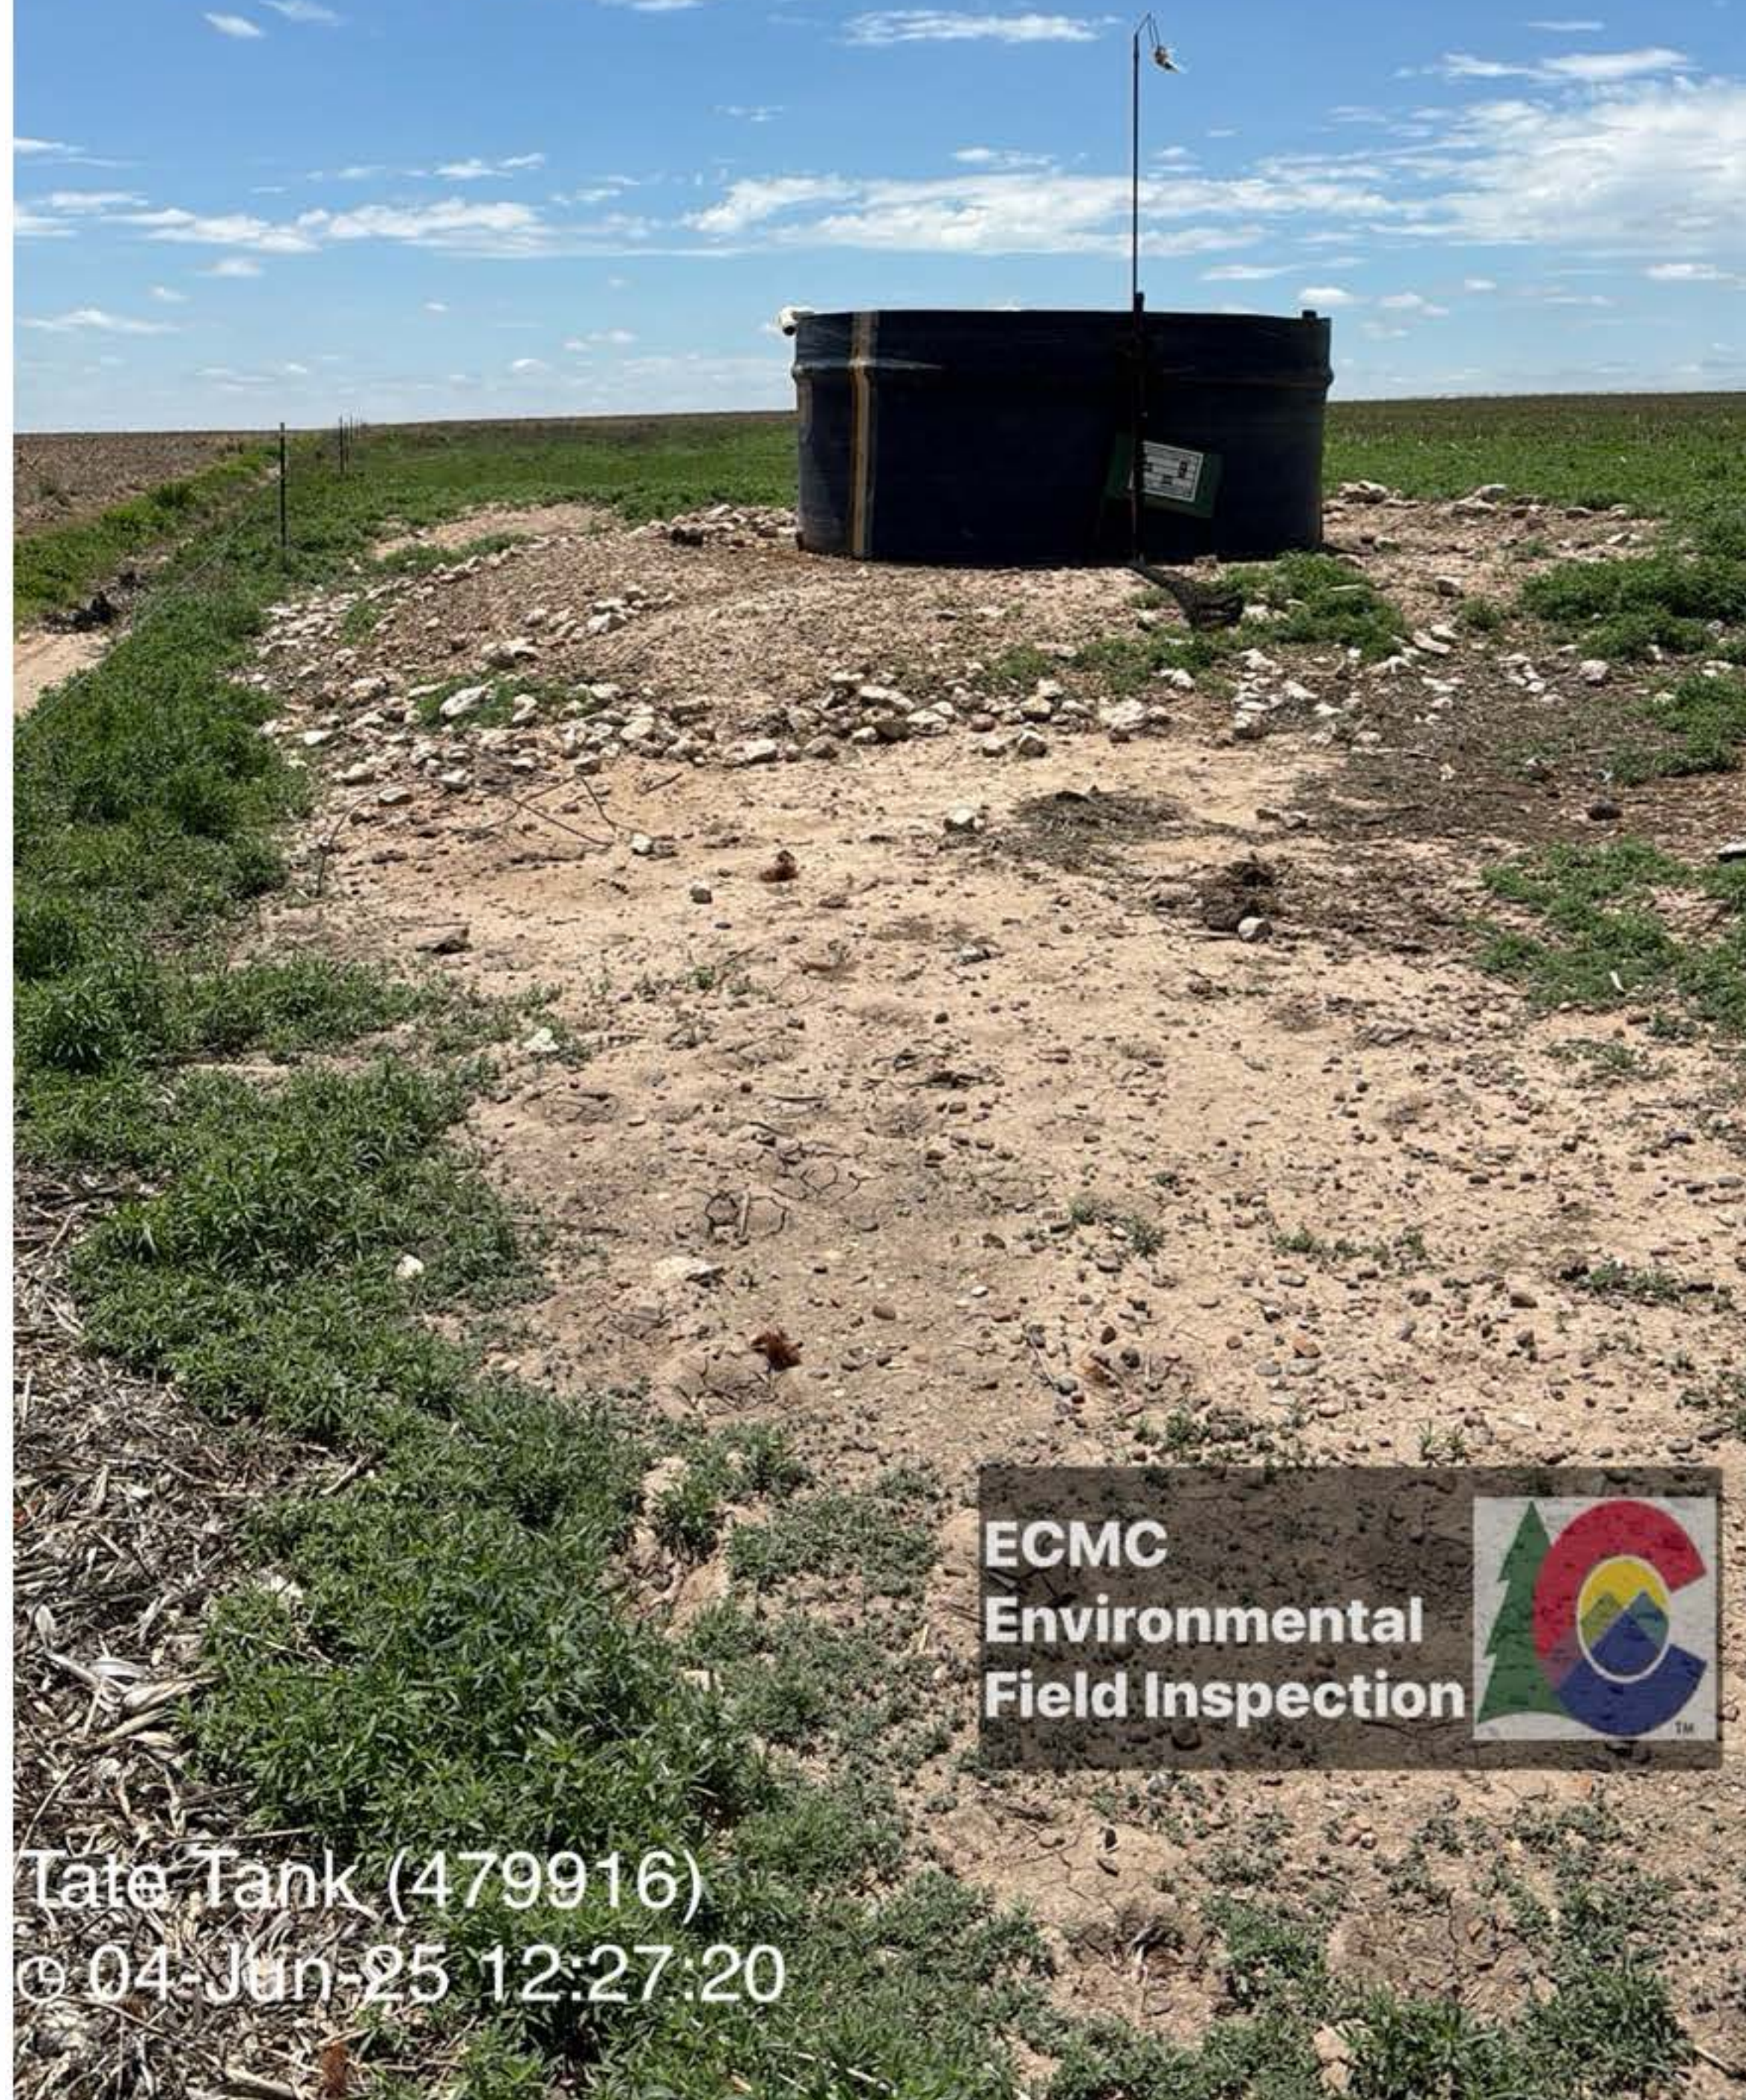
Late Tank (479916)
© 04-Jun-25 12:27:20

Weeds/debris, insufficient secondary containment, stained soil, insufficient wildlife protection equipment, tank battery signage illegible.

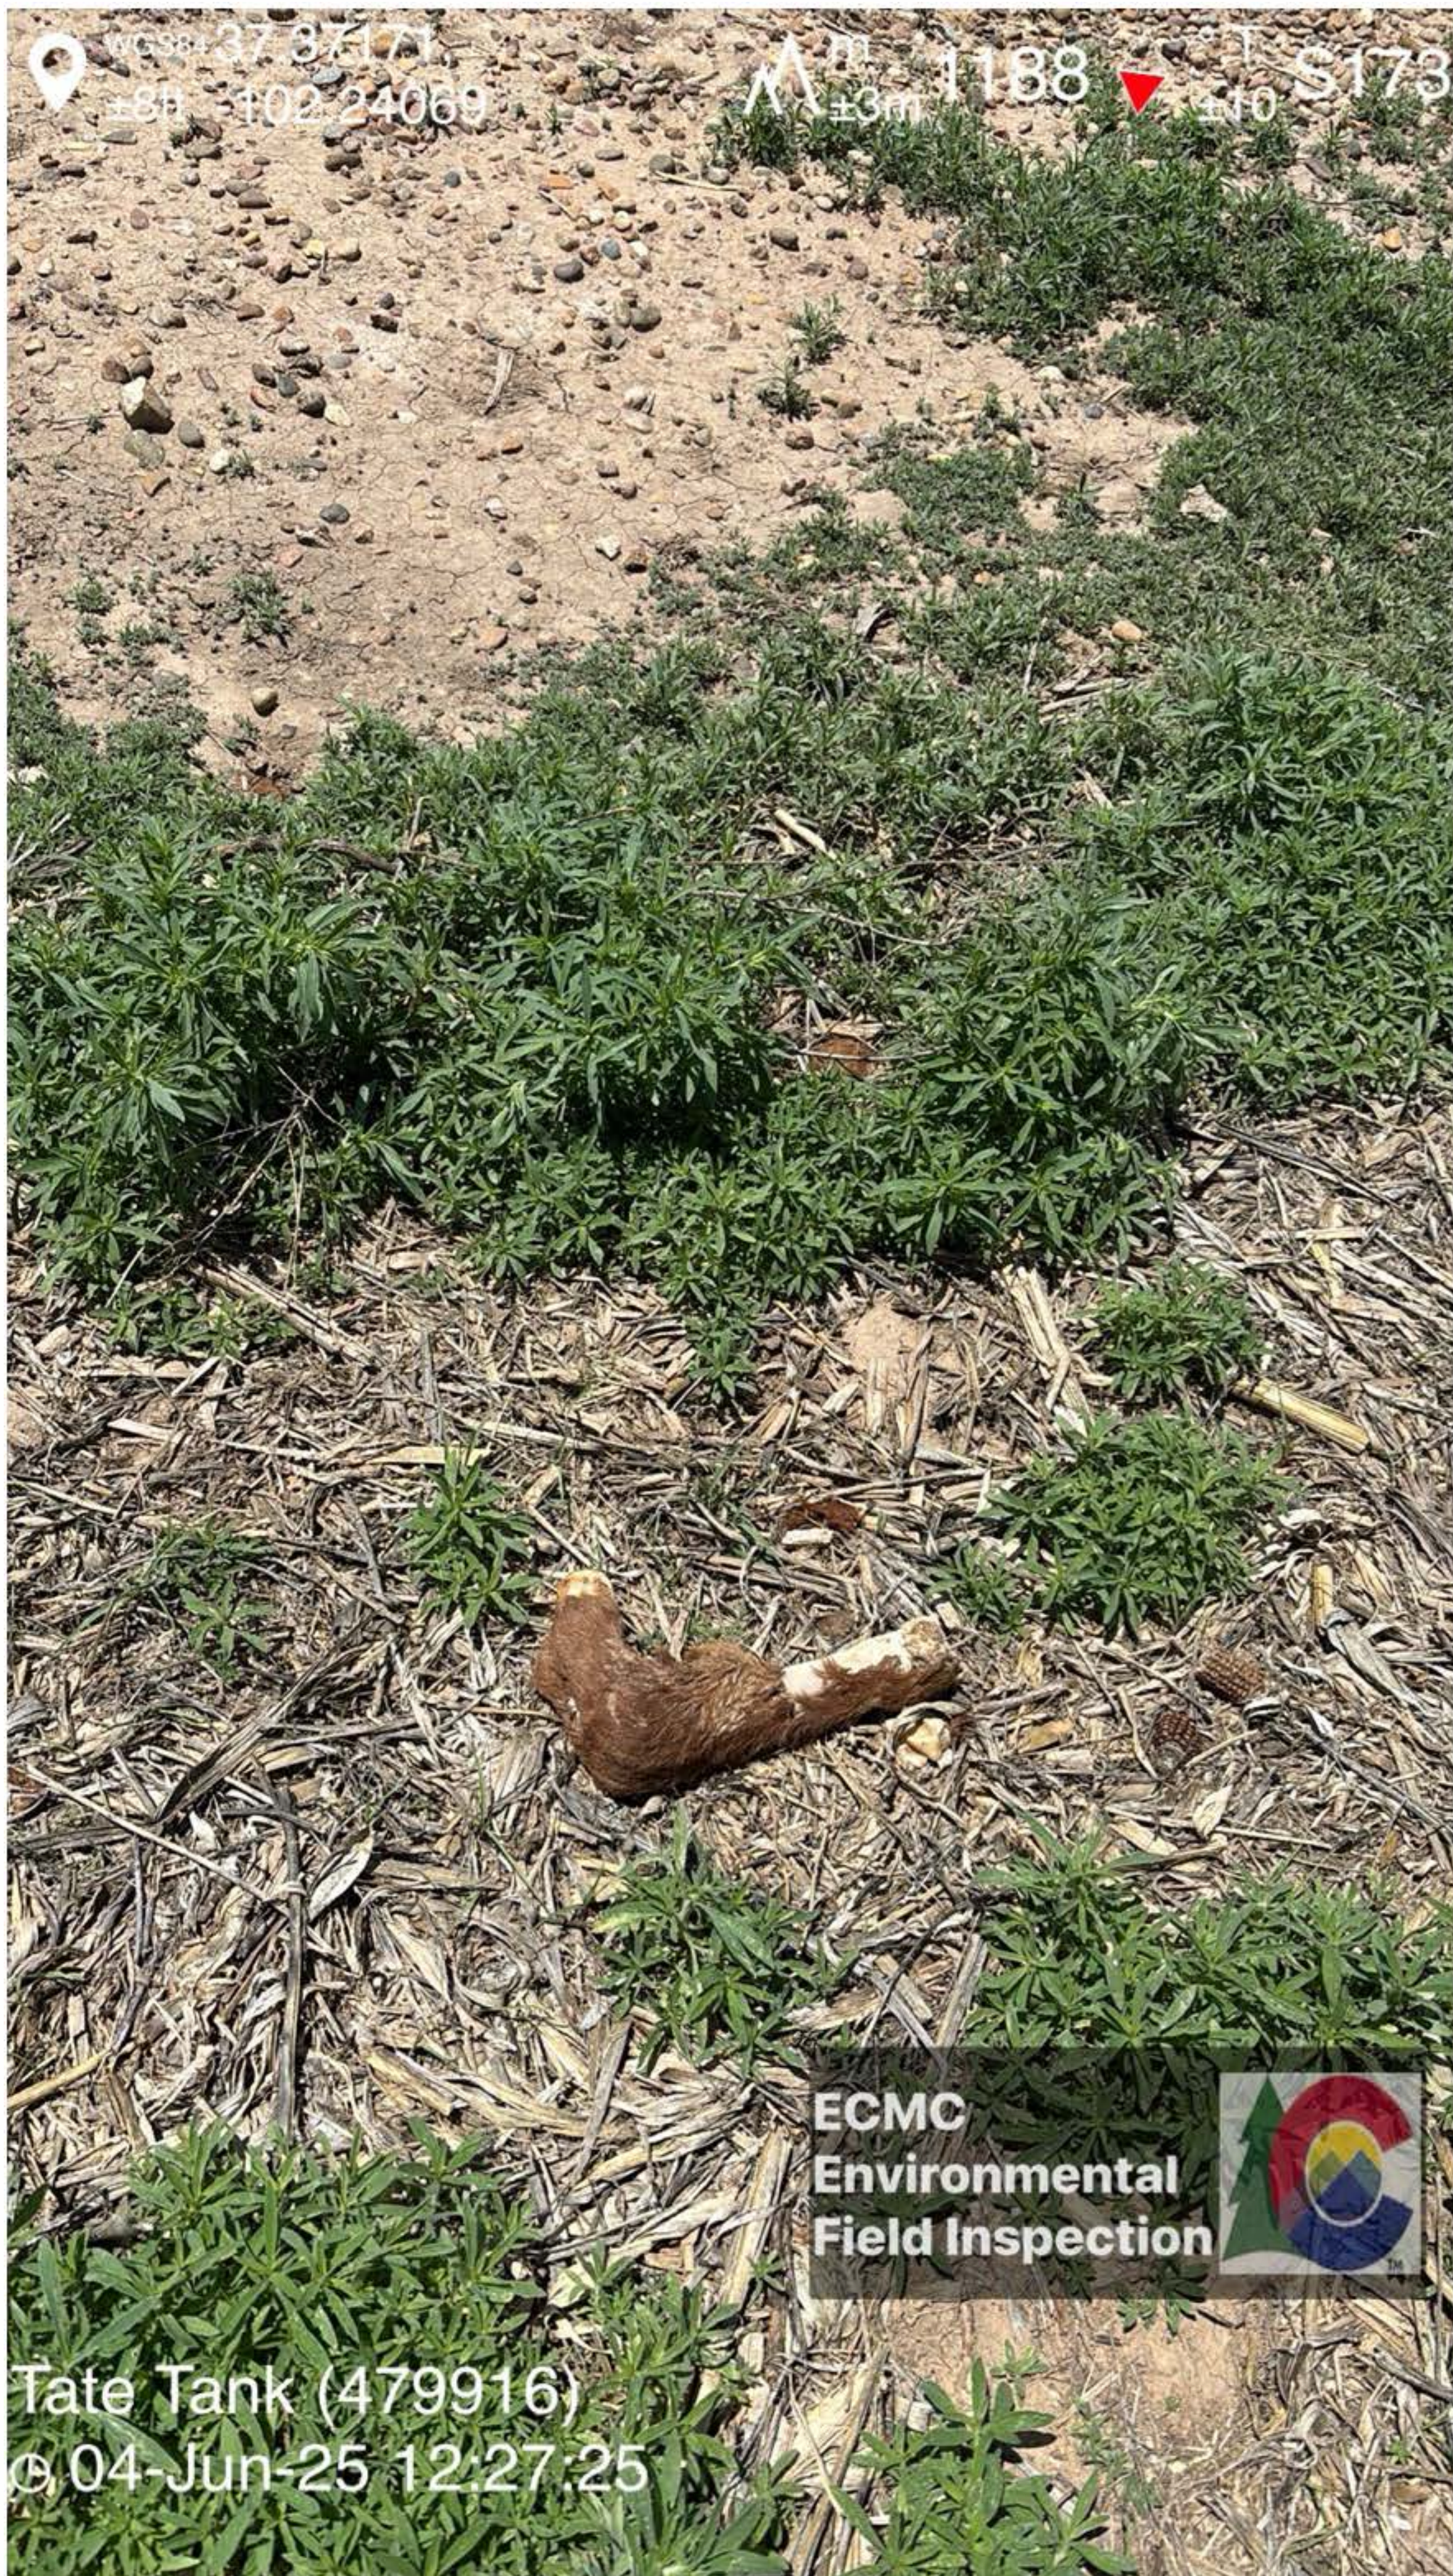
Hoof, weeds.

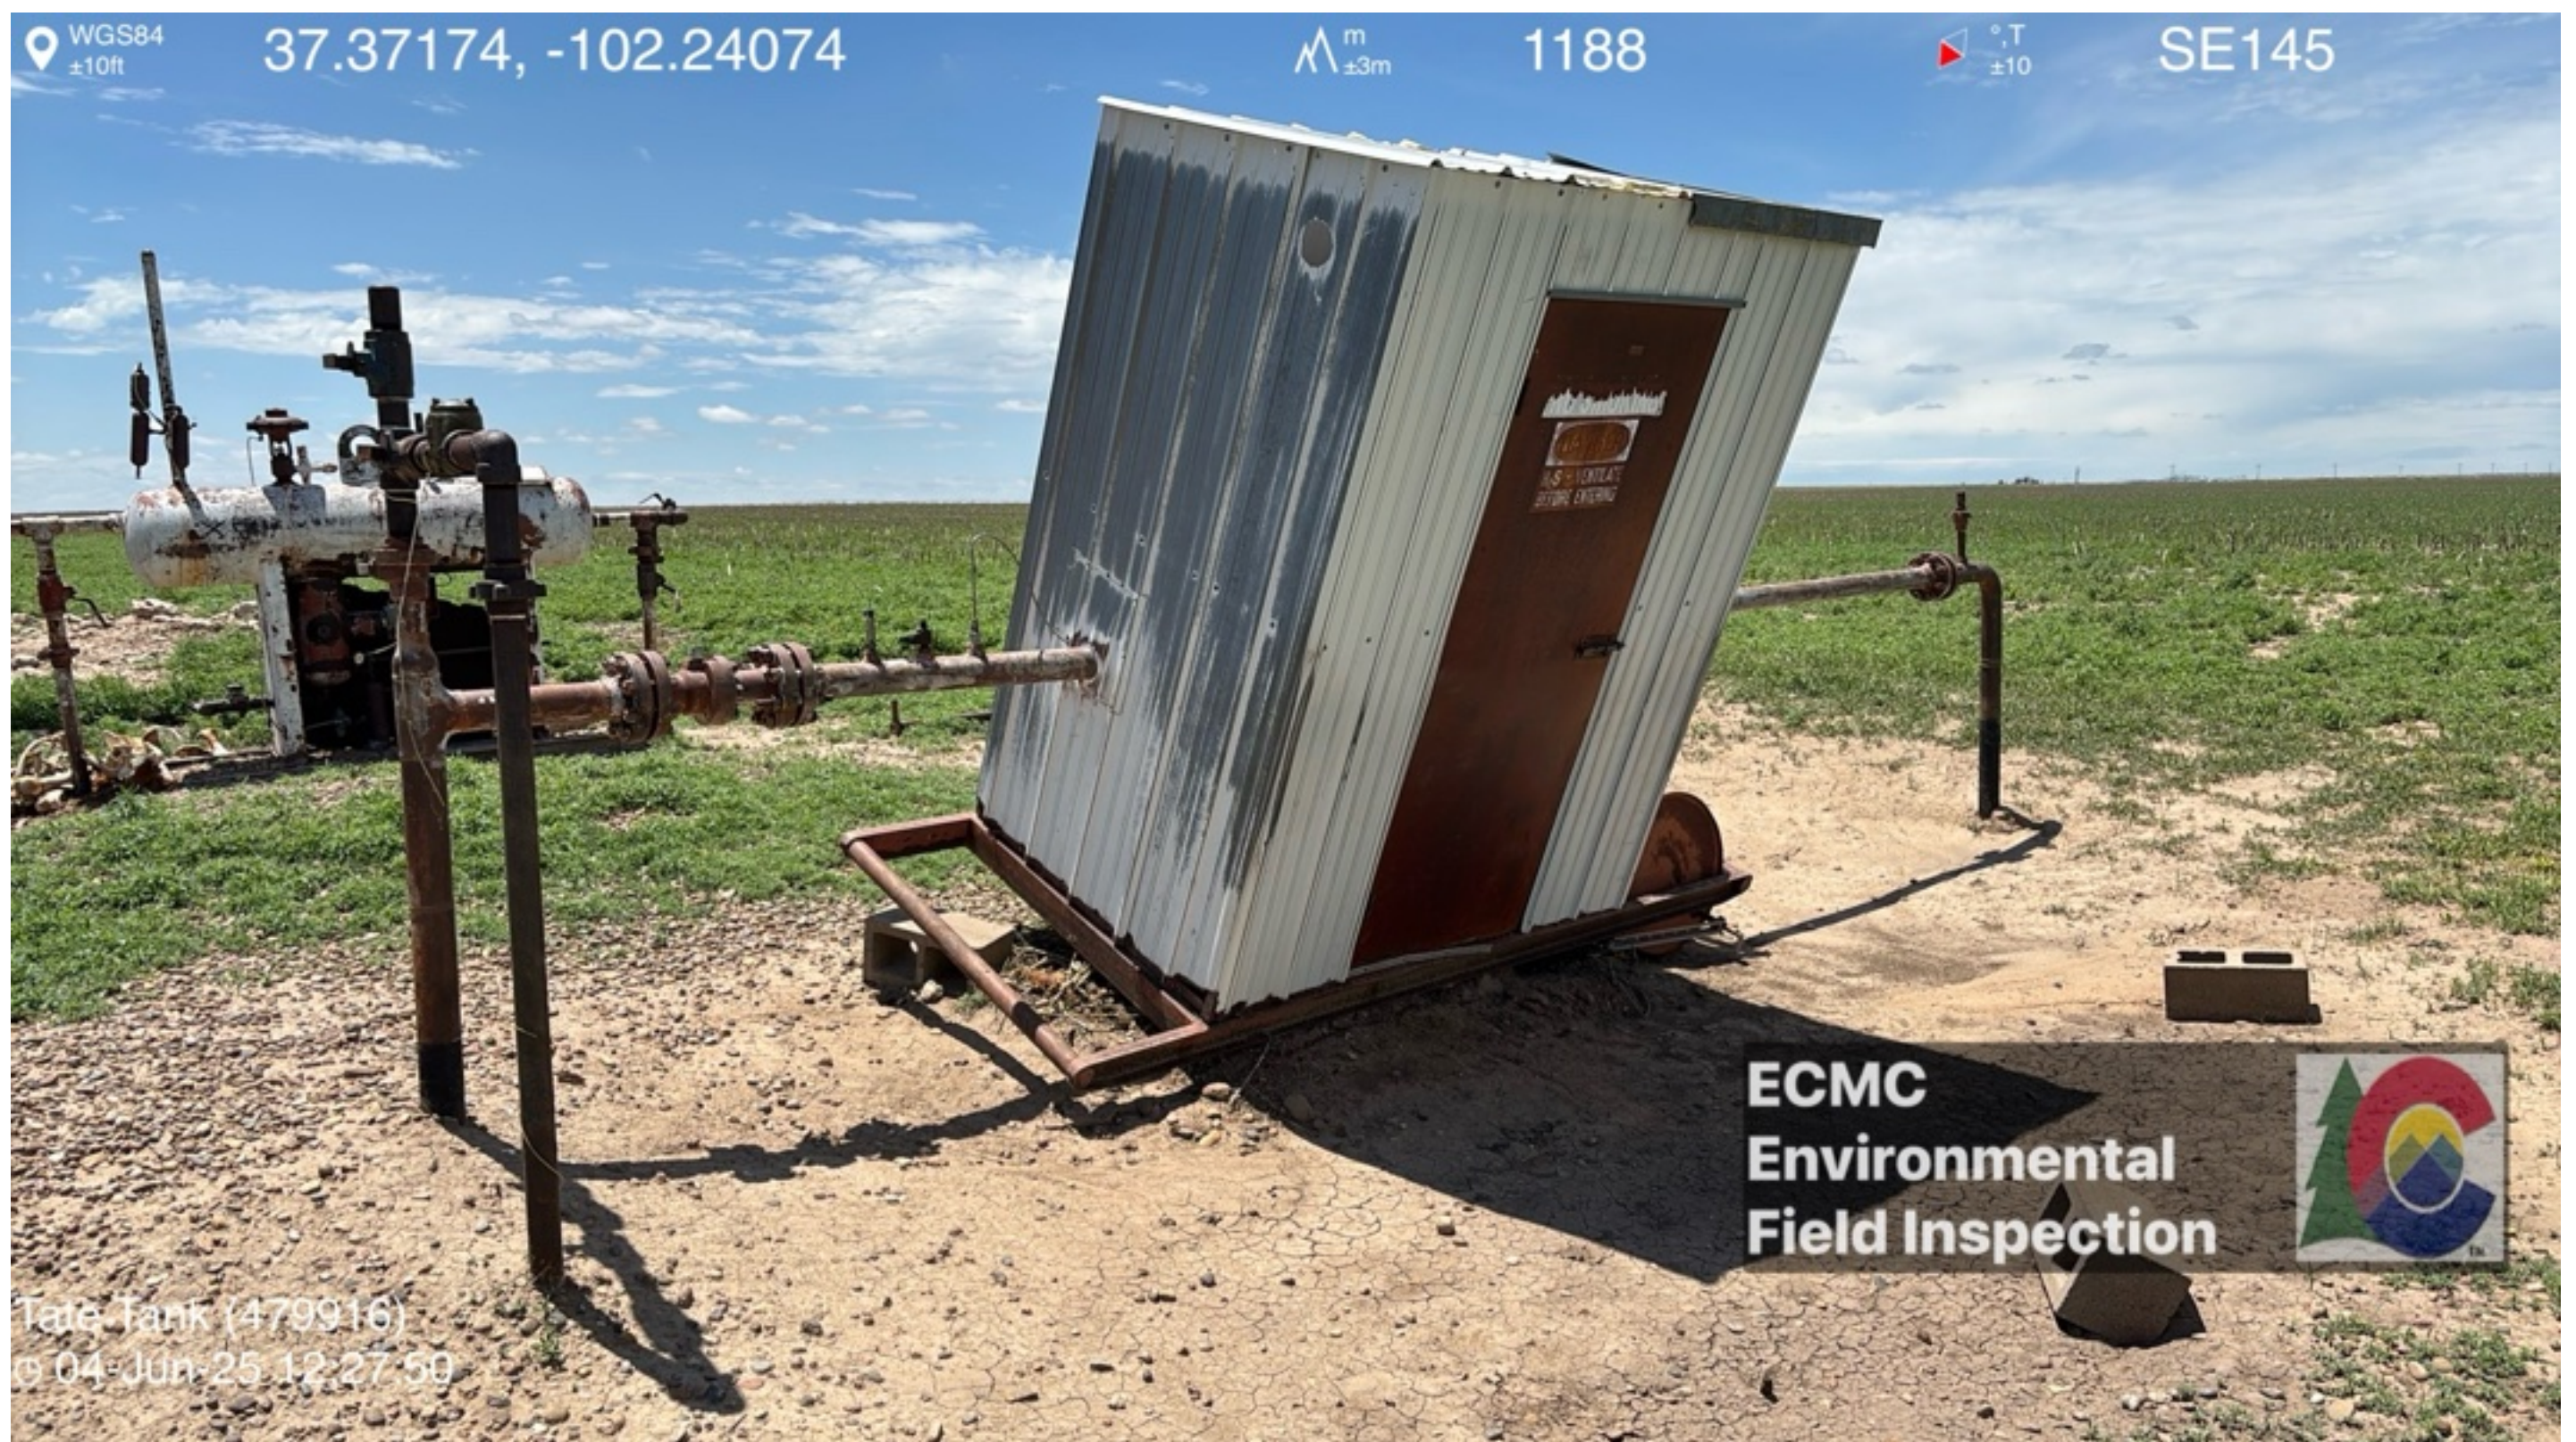
Meter shed not level/leaning, placards/signage faded and illegible.

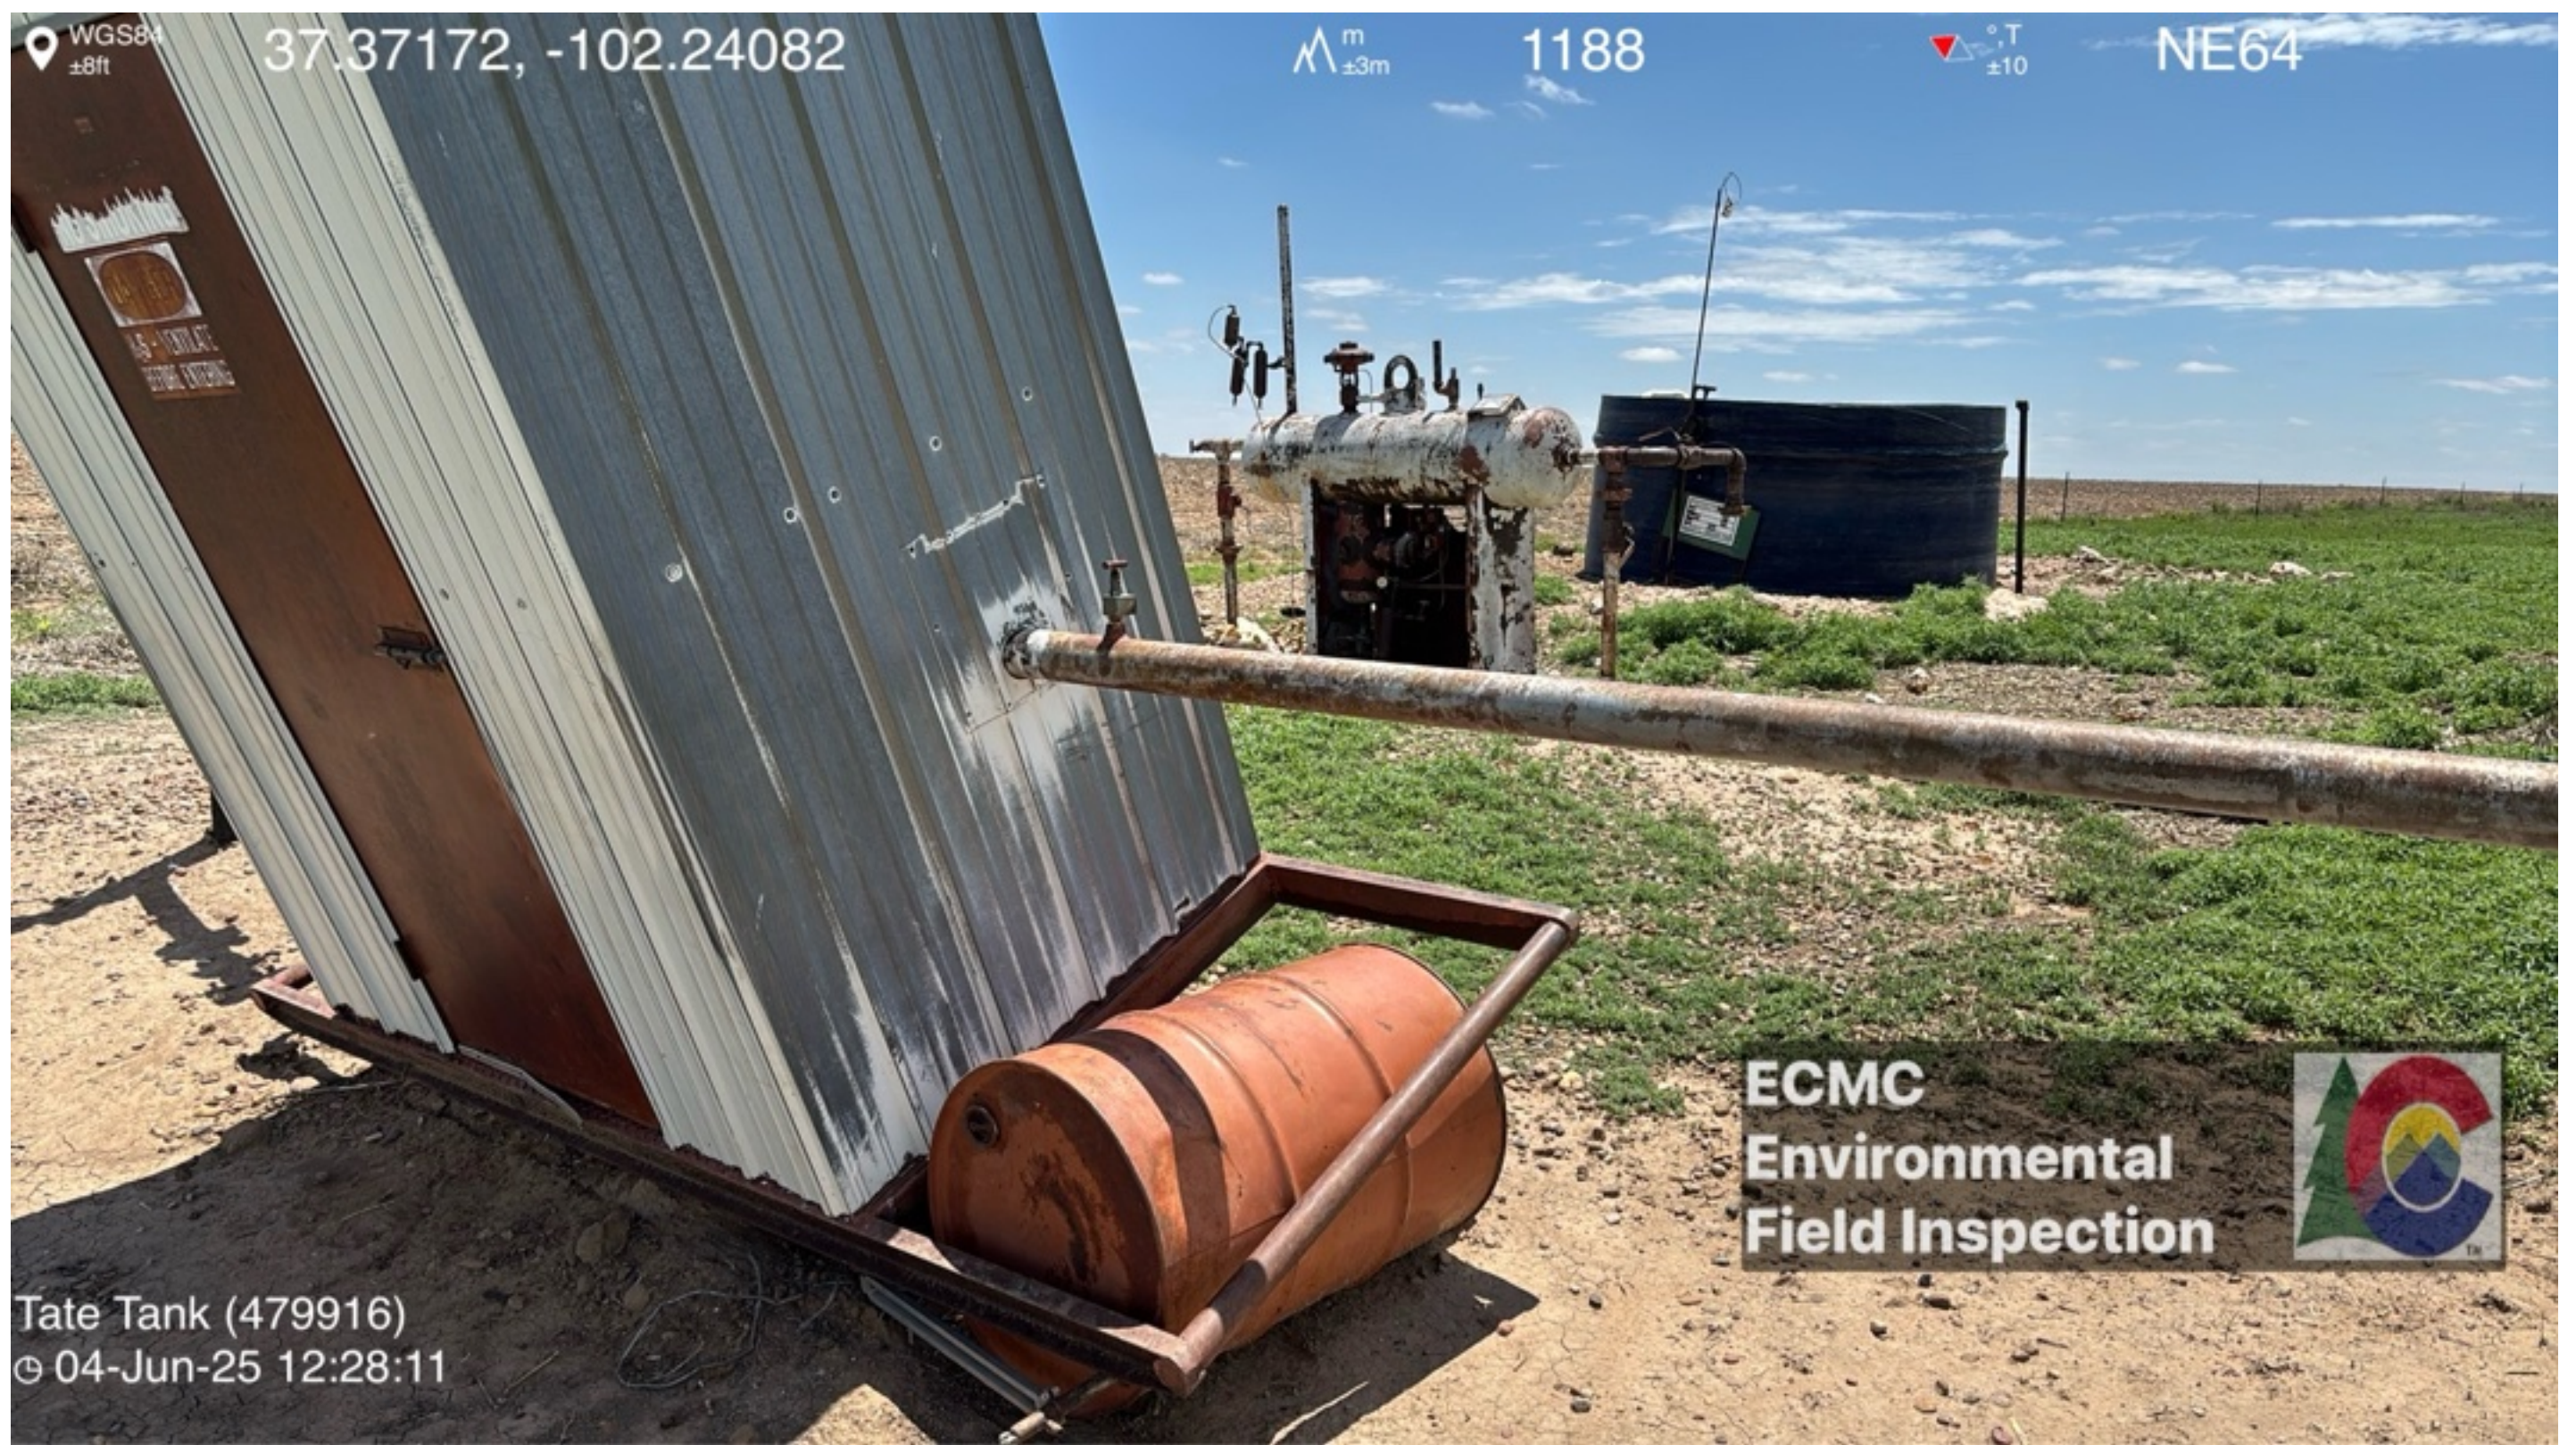
Unlabeled ~55-gallon steel drum without secondary containment/signage, weeds.
