ECMC
Environmental
Field Inspection

Tate Tank (479916)
© 04-Jun-25 12:27:13

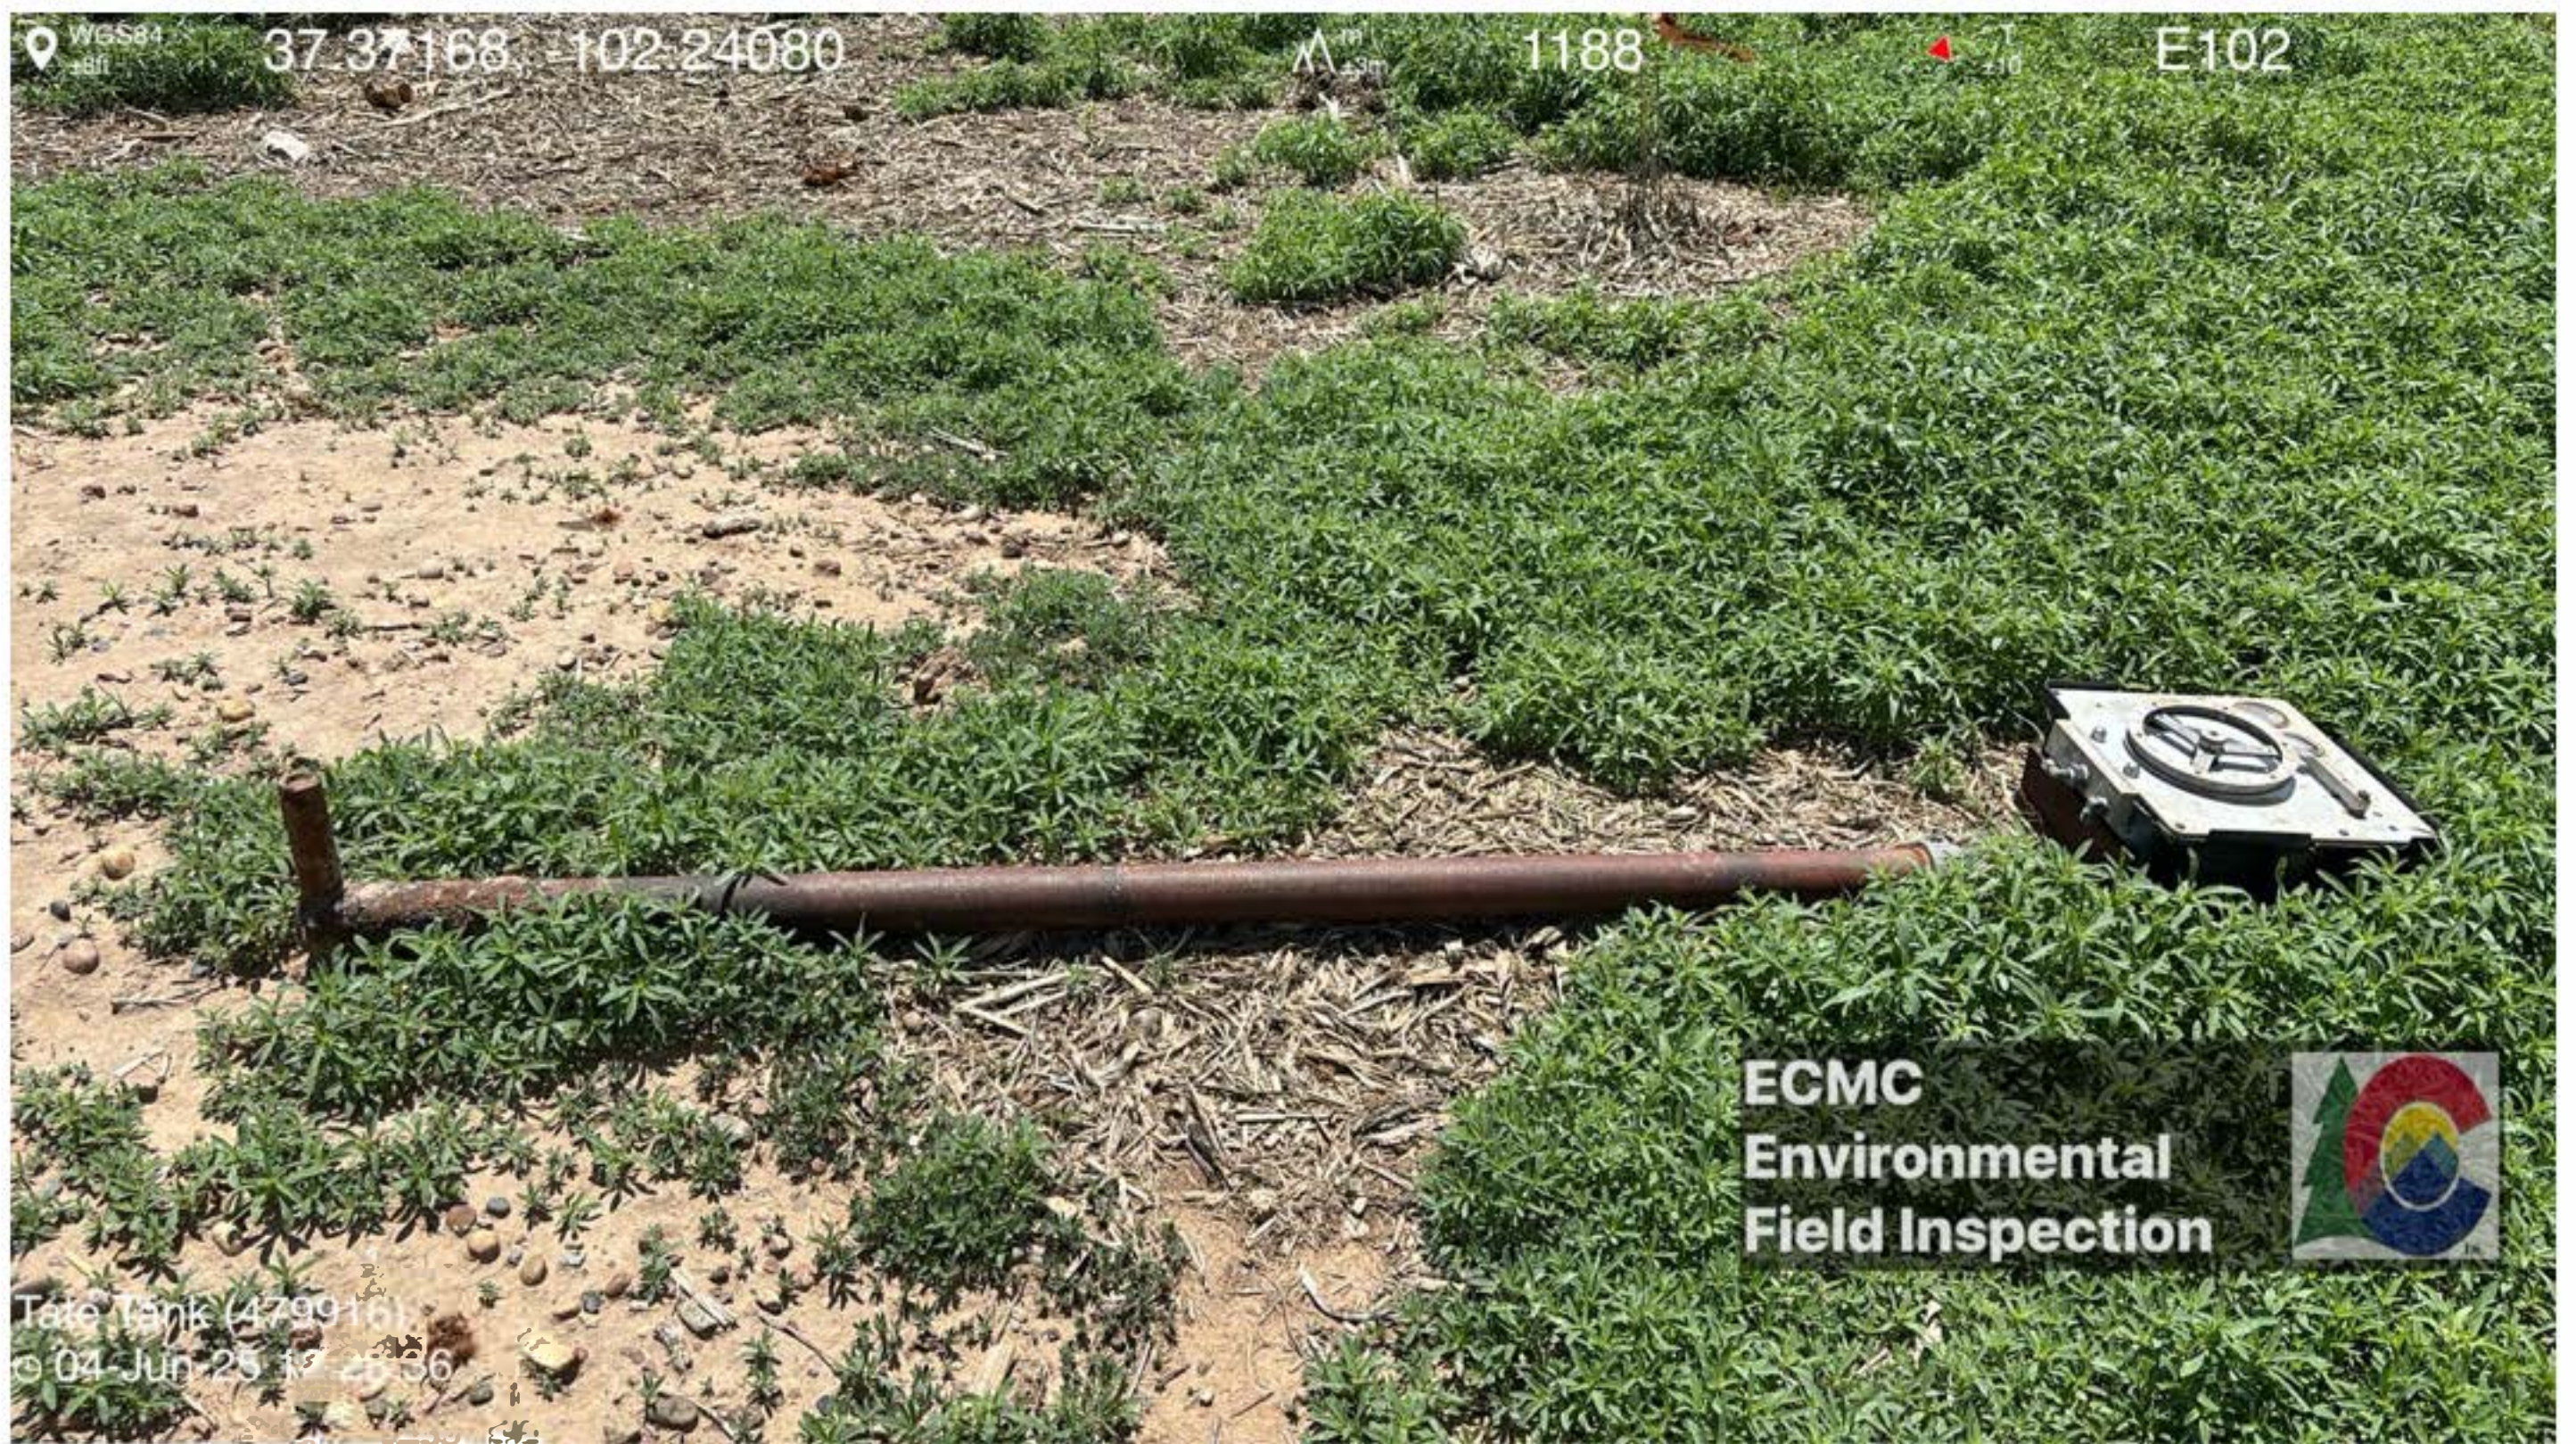
Weeds

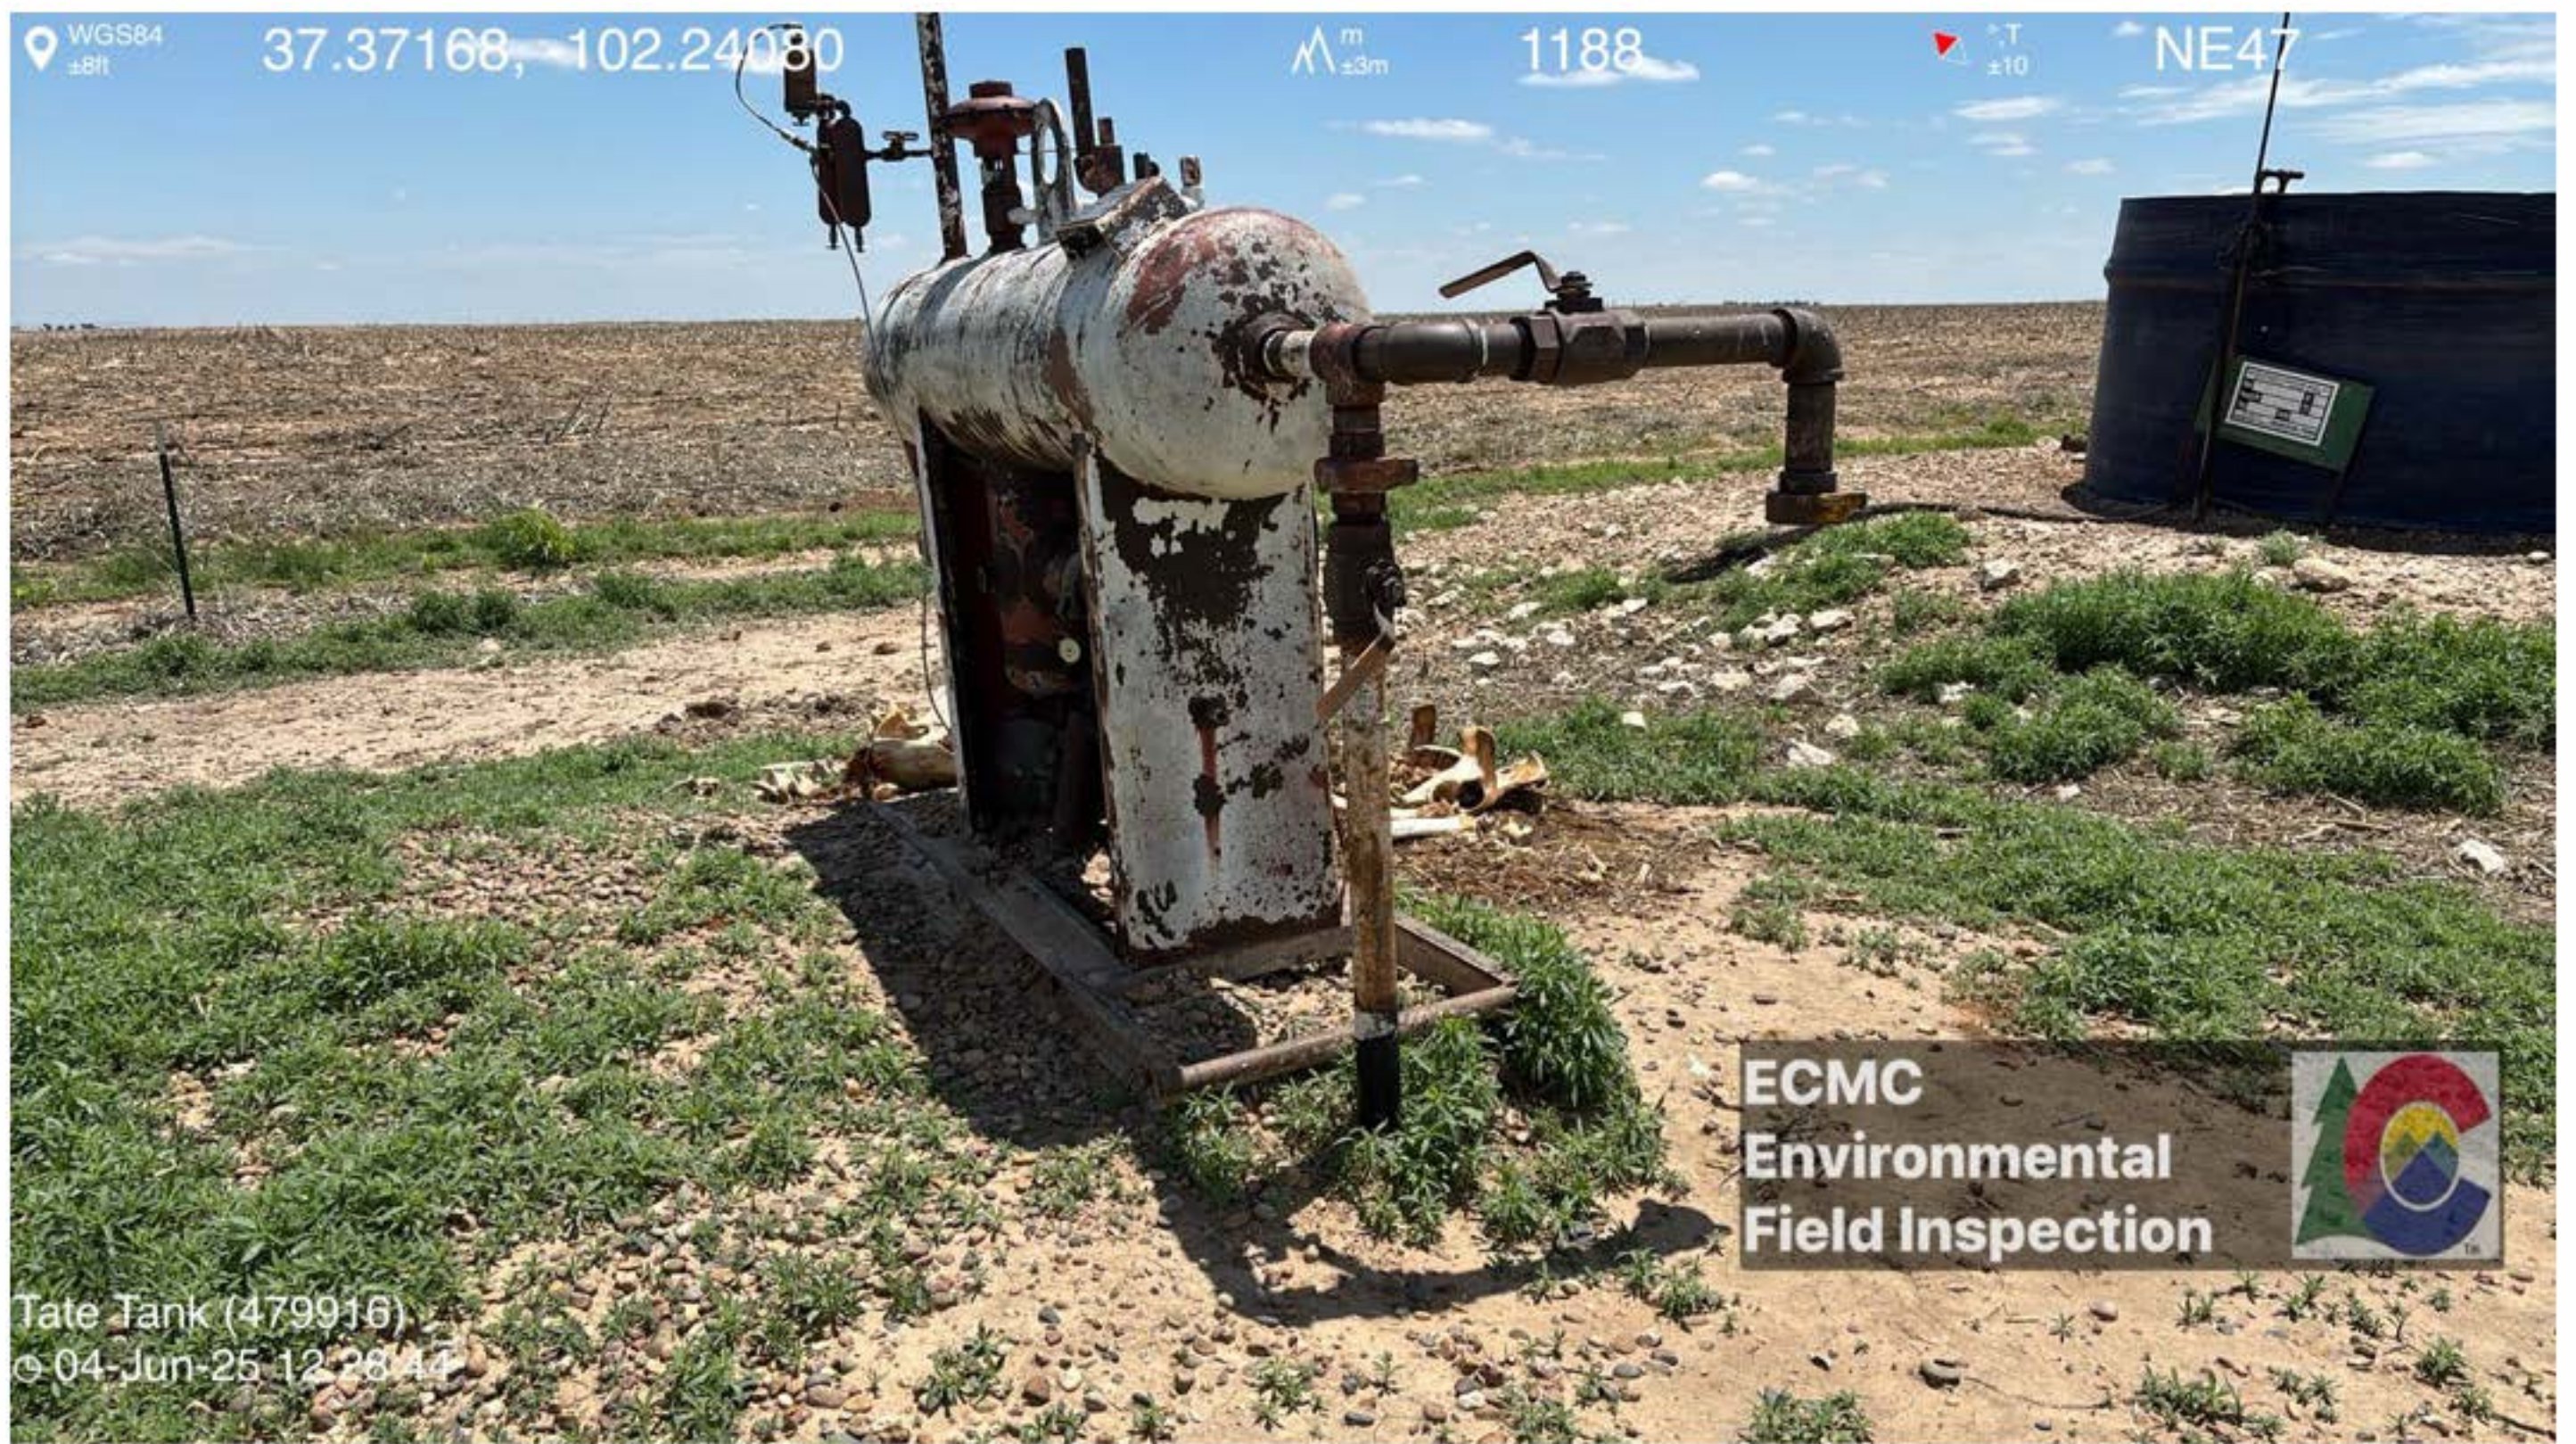
Separator, weeds, cattle carcass, inadequate secondary containment for produced water tank.

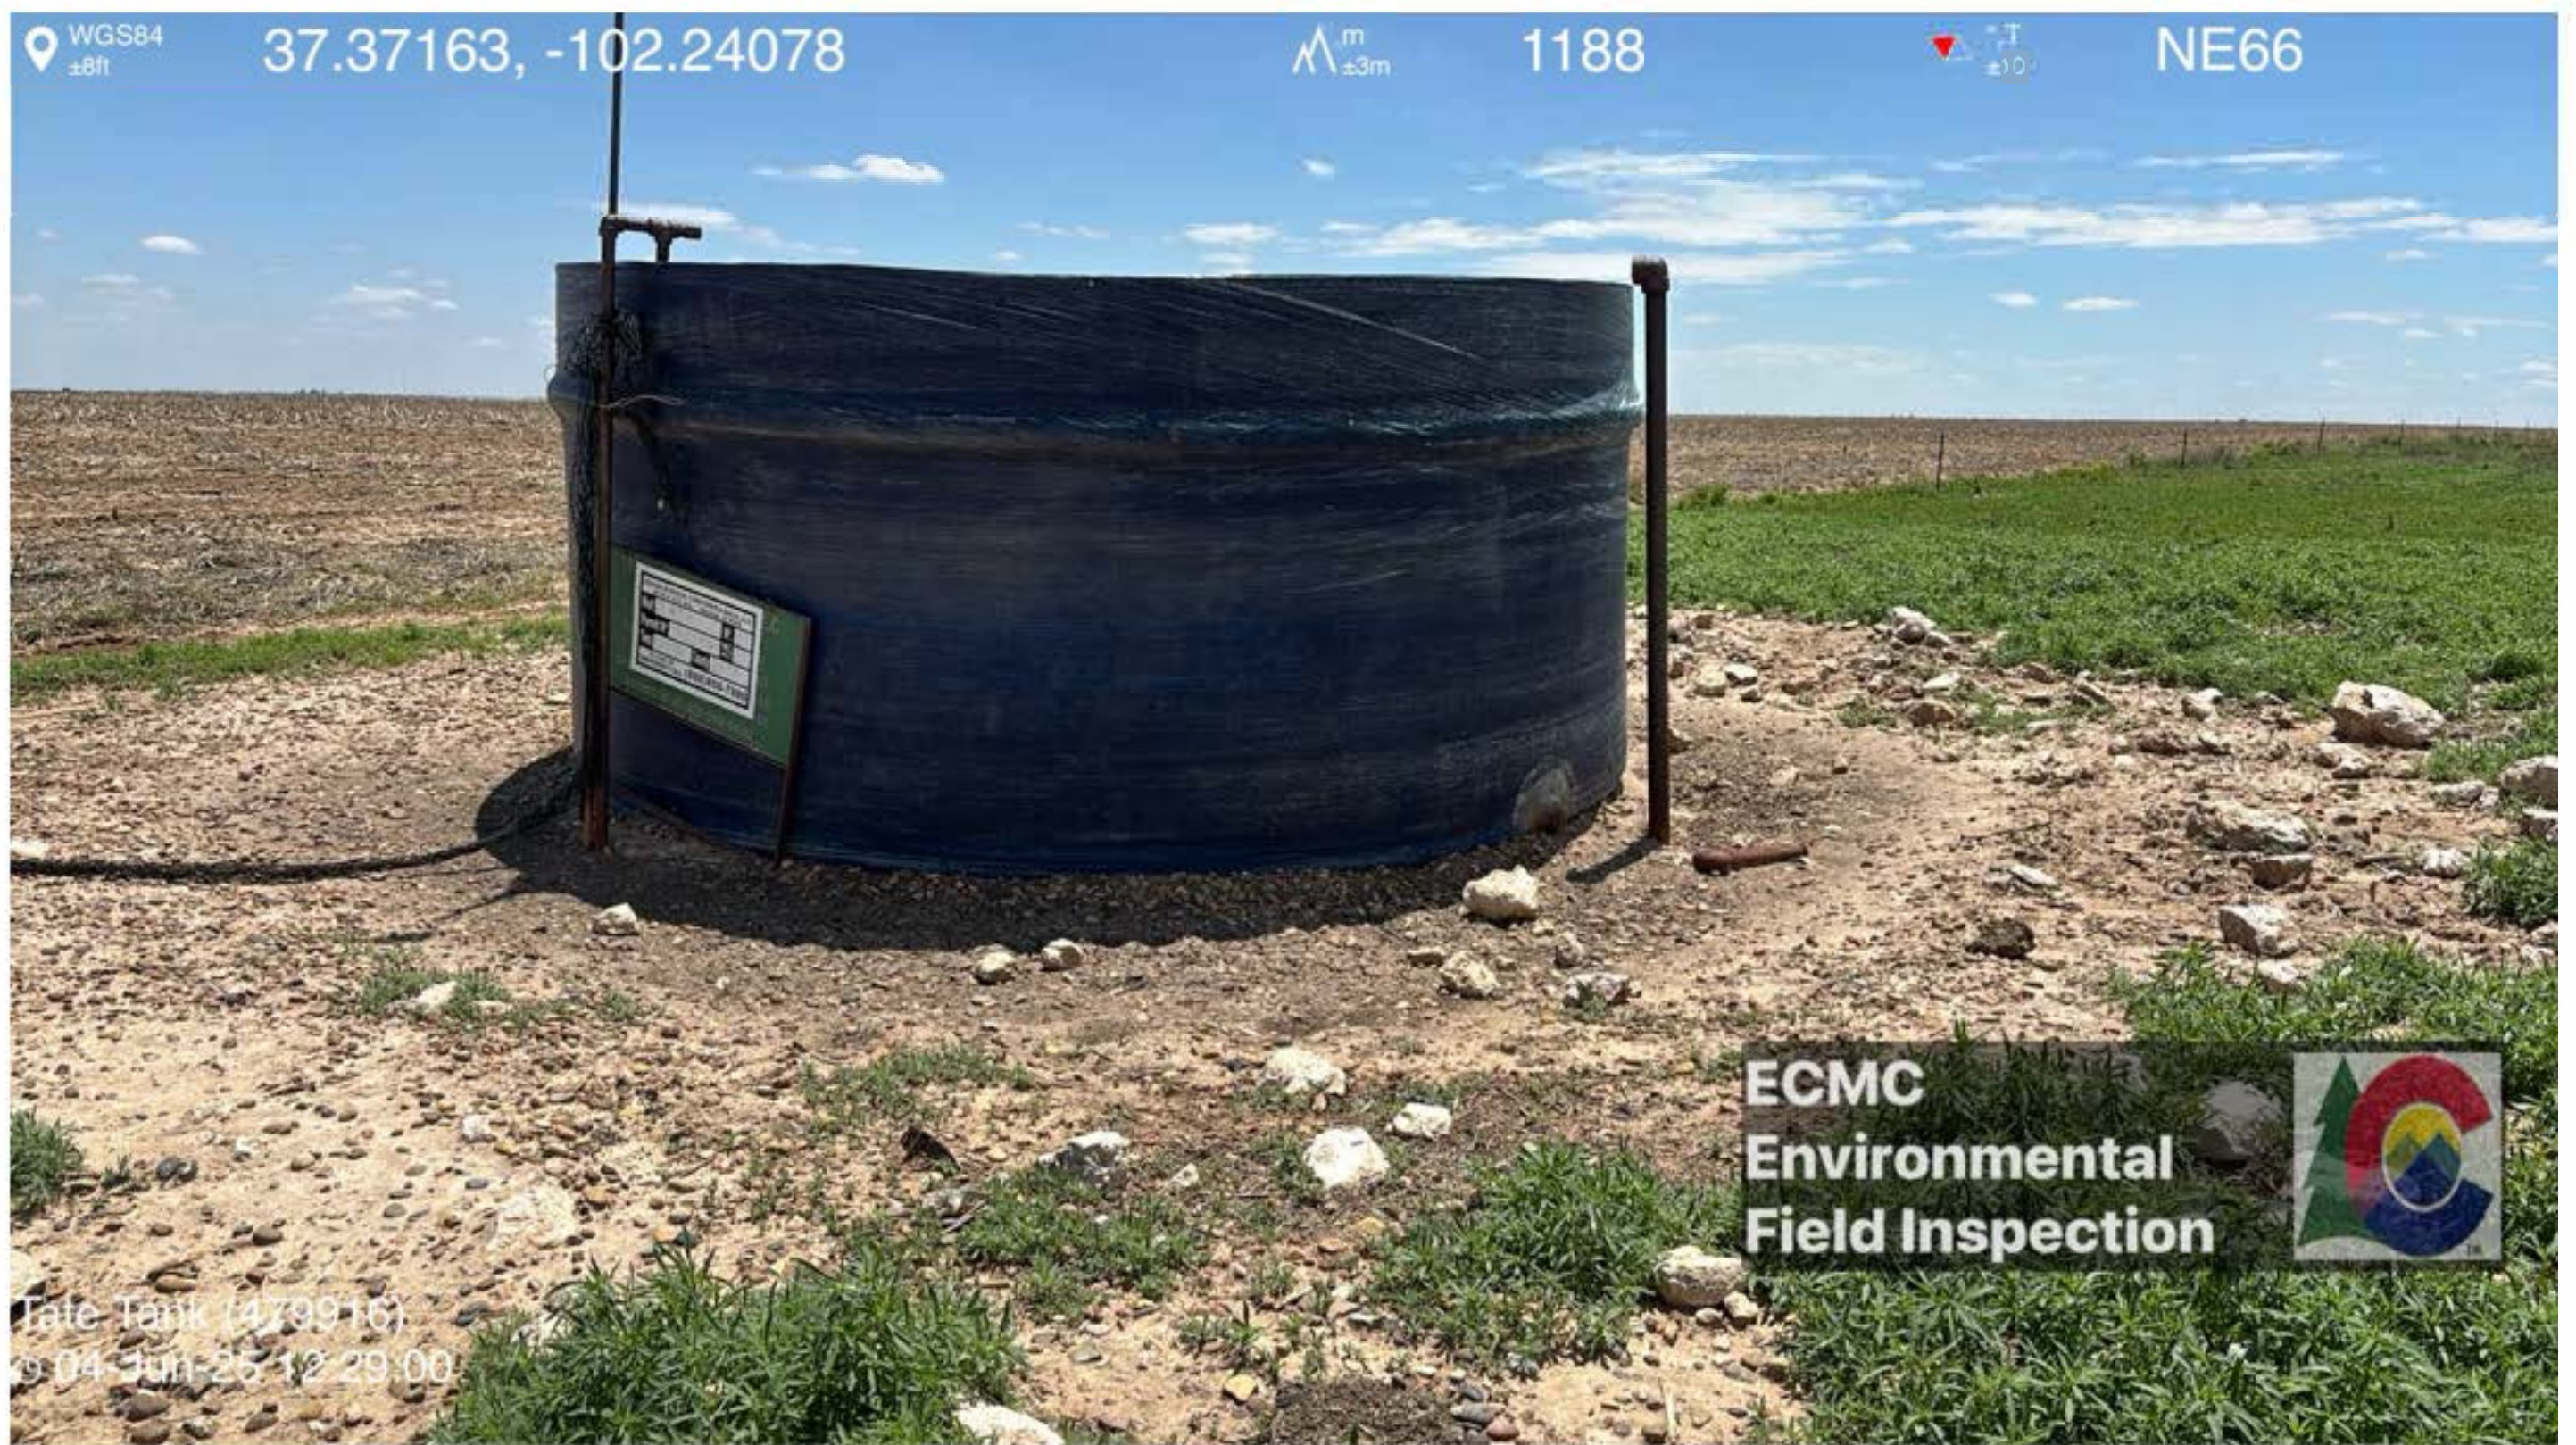
Location signage faded and illegible, wildlife protection equipment (netting) torn and fallen, piping disconnected without LOTO, no secondary containment, no NFPA placard or tank contents/volume labels on ~100 bbl open top fiberglass storage tank, unused equipment (piping) stored on location.

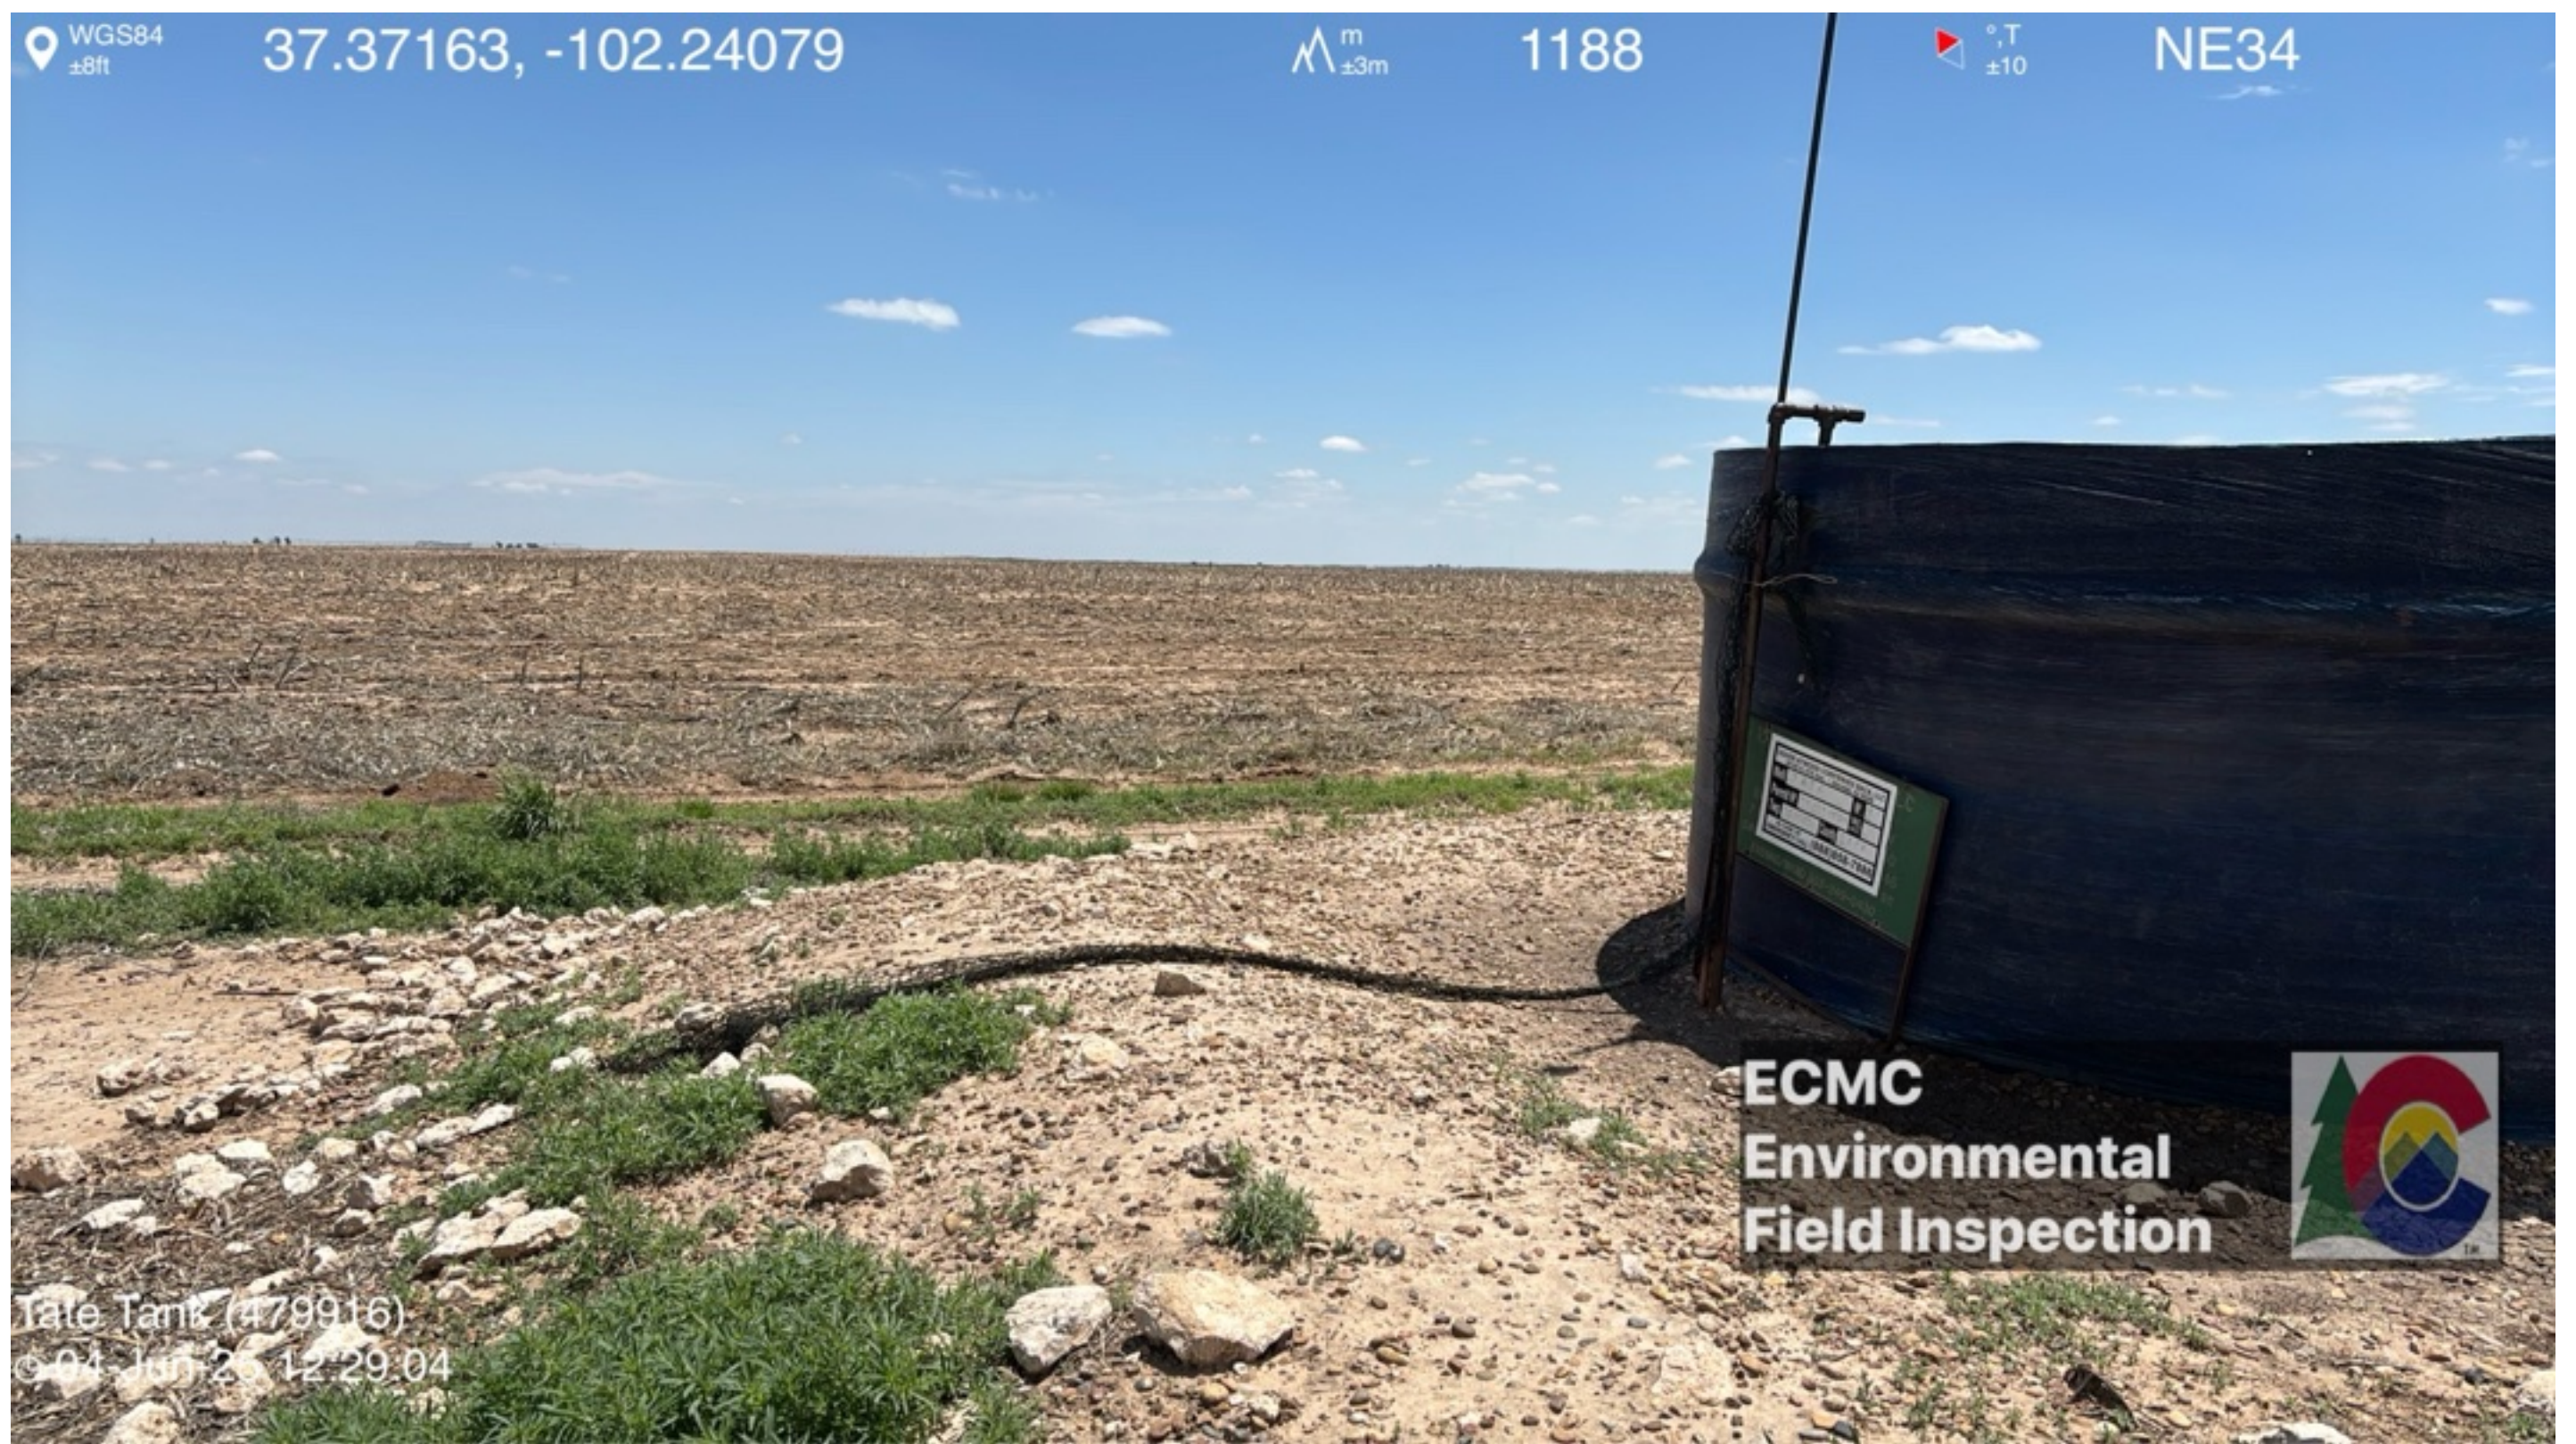
Weeds/debris, inadequate secondary containment, faded illegible signage, torn wildlife protection equipment.

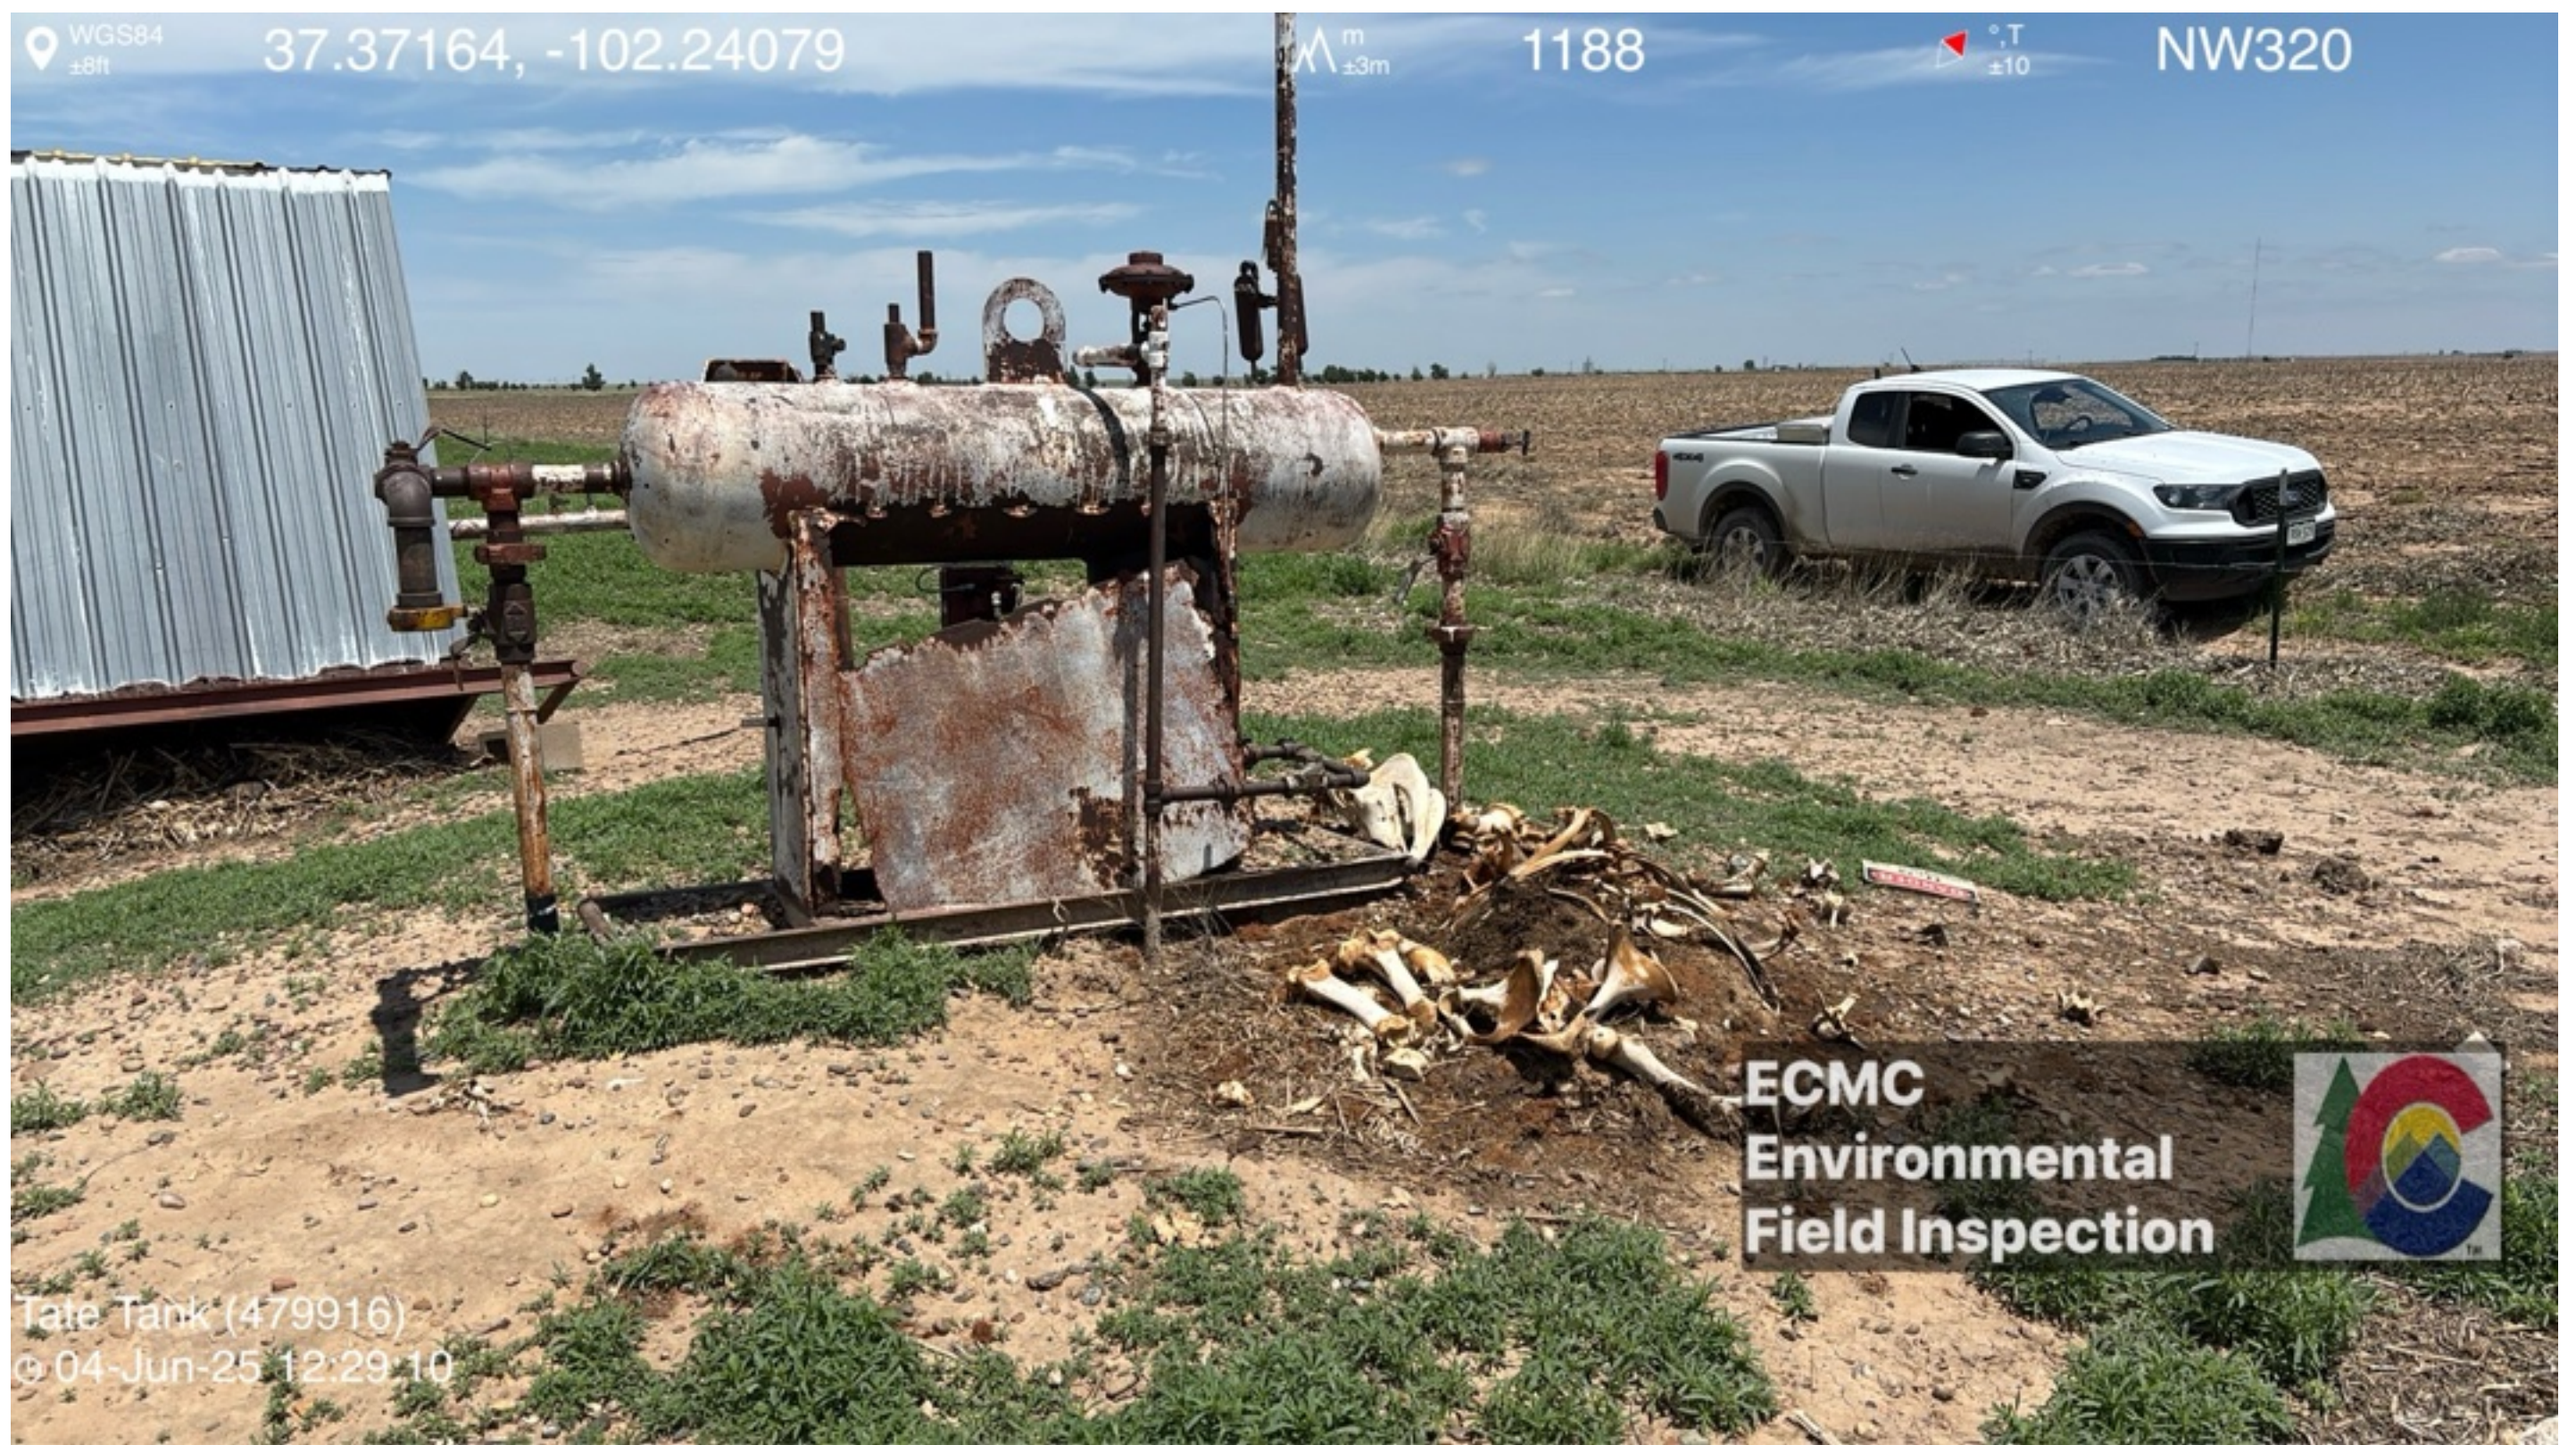
Cattle carcass, weeds, fallen signage.

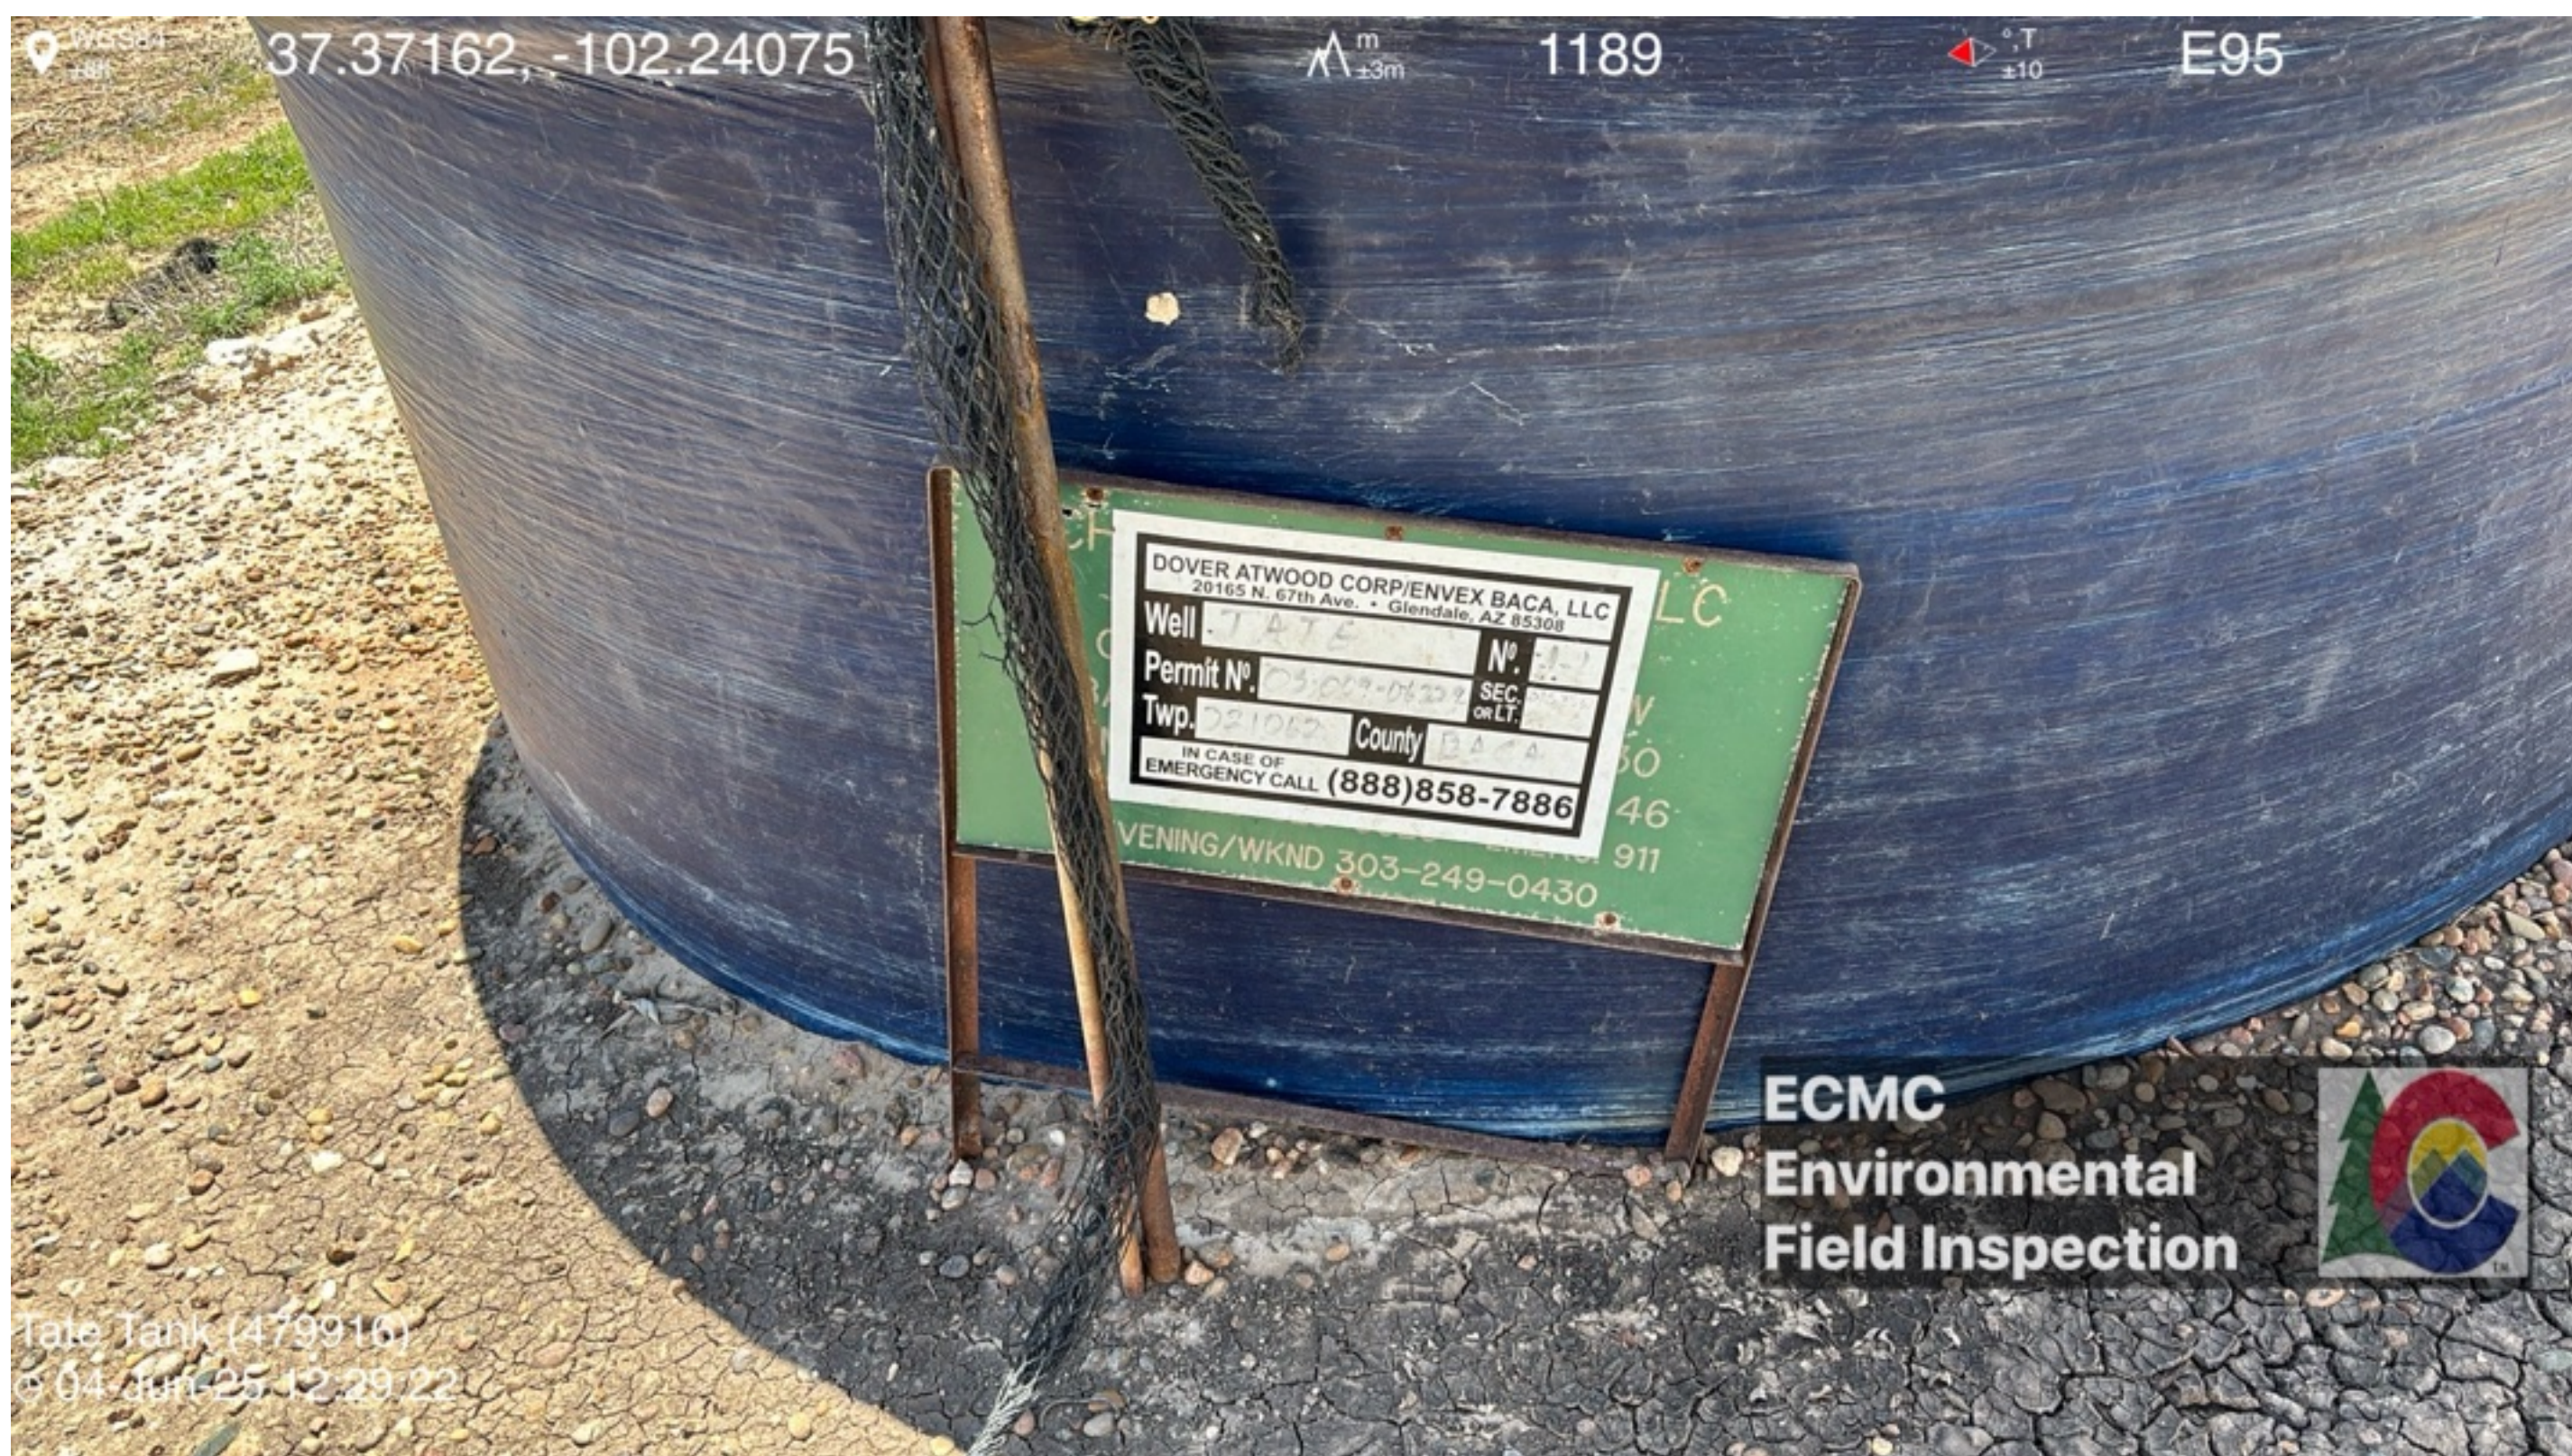
Signage faded and illegible from a distance, stained soil.
