ECMC
Environmental
Field Inspection

Tate Tank (479916)
© 04-Jun-25 12:27:13

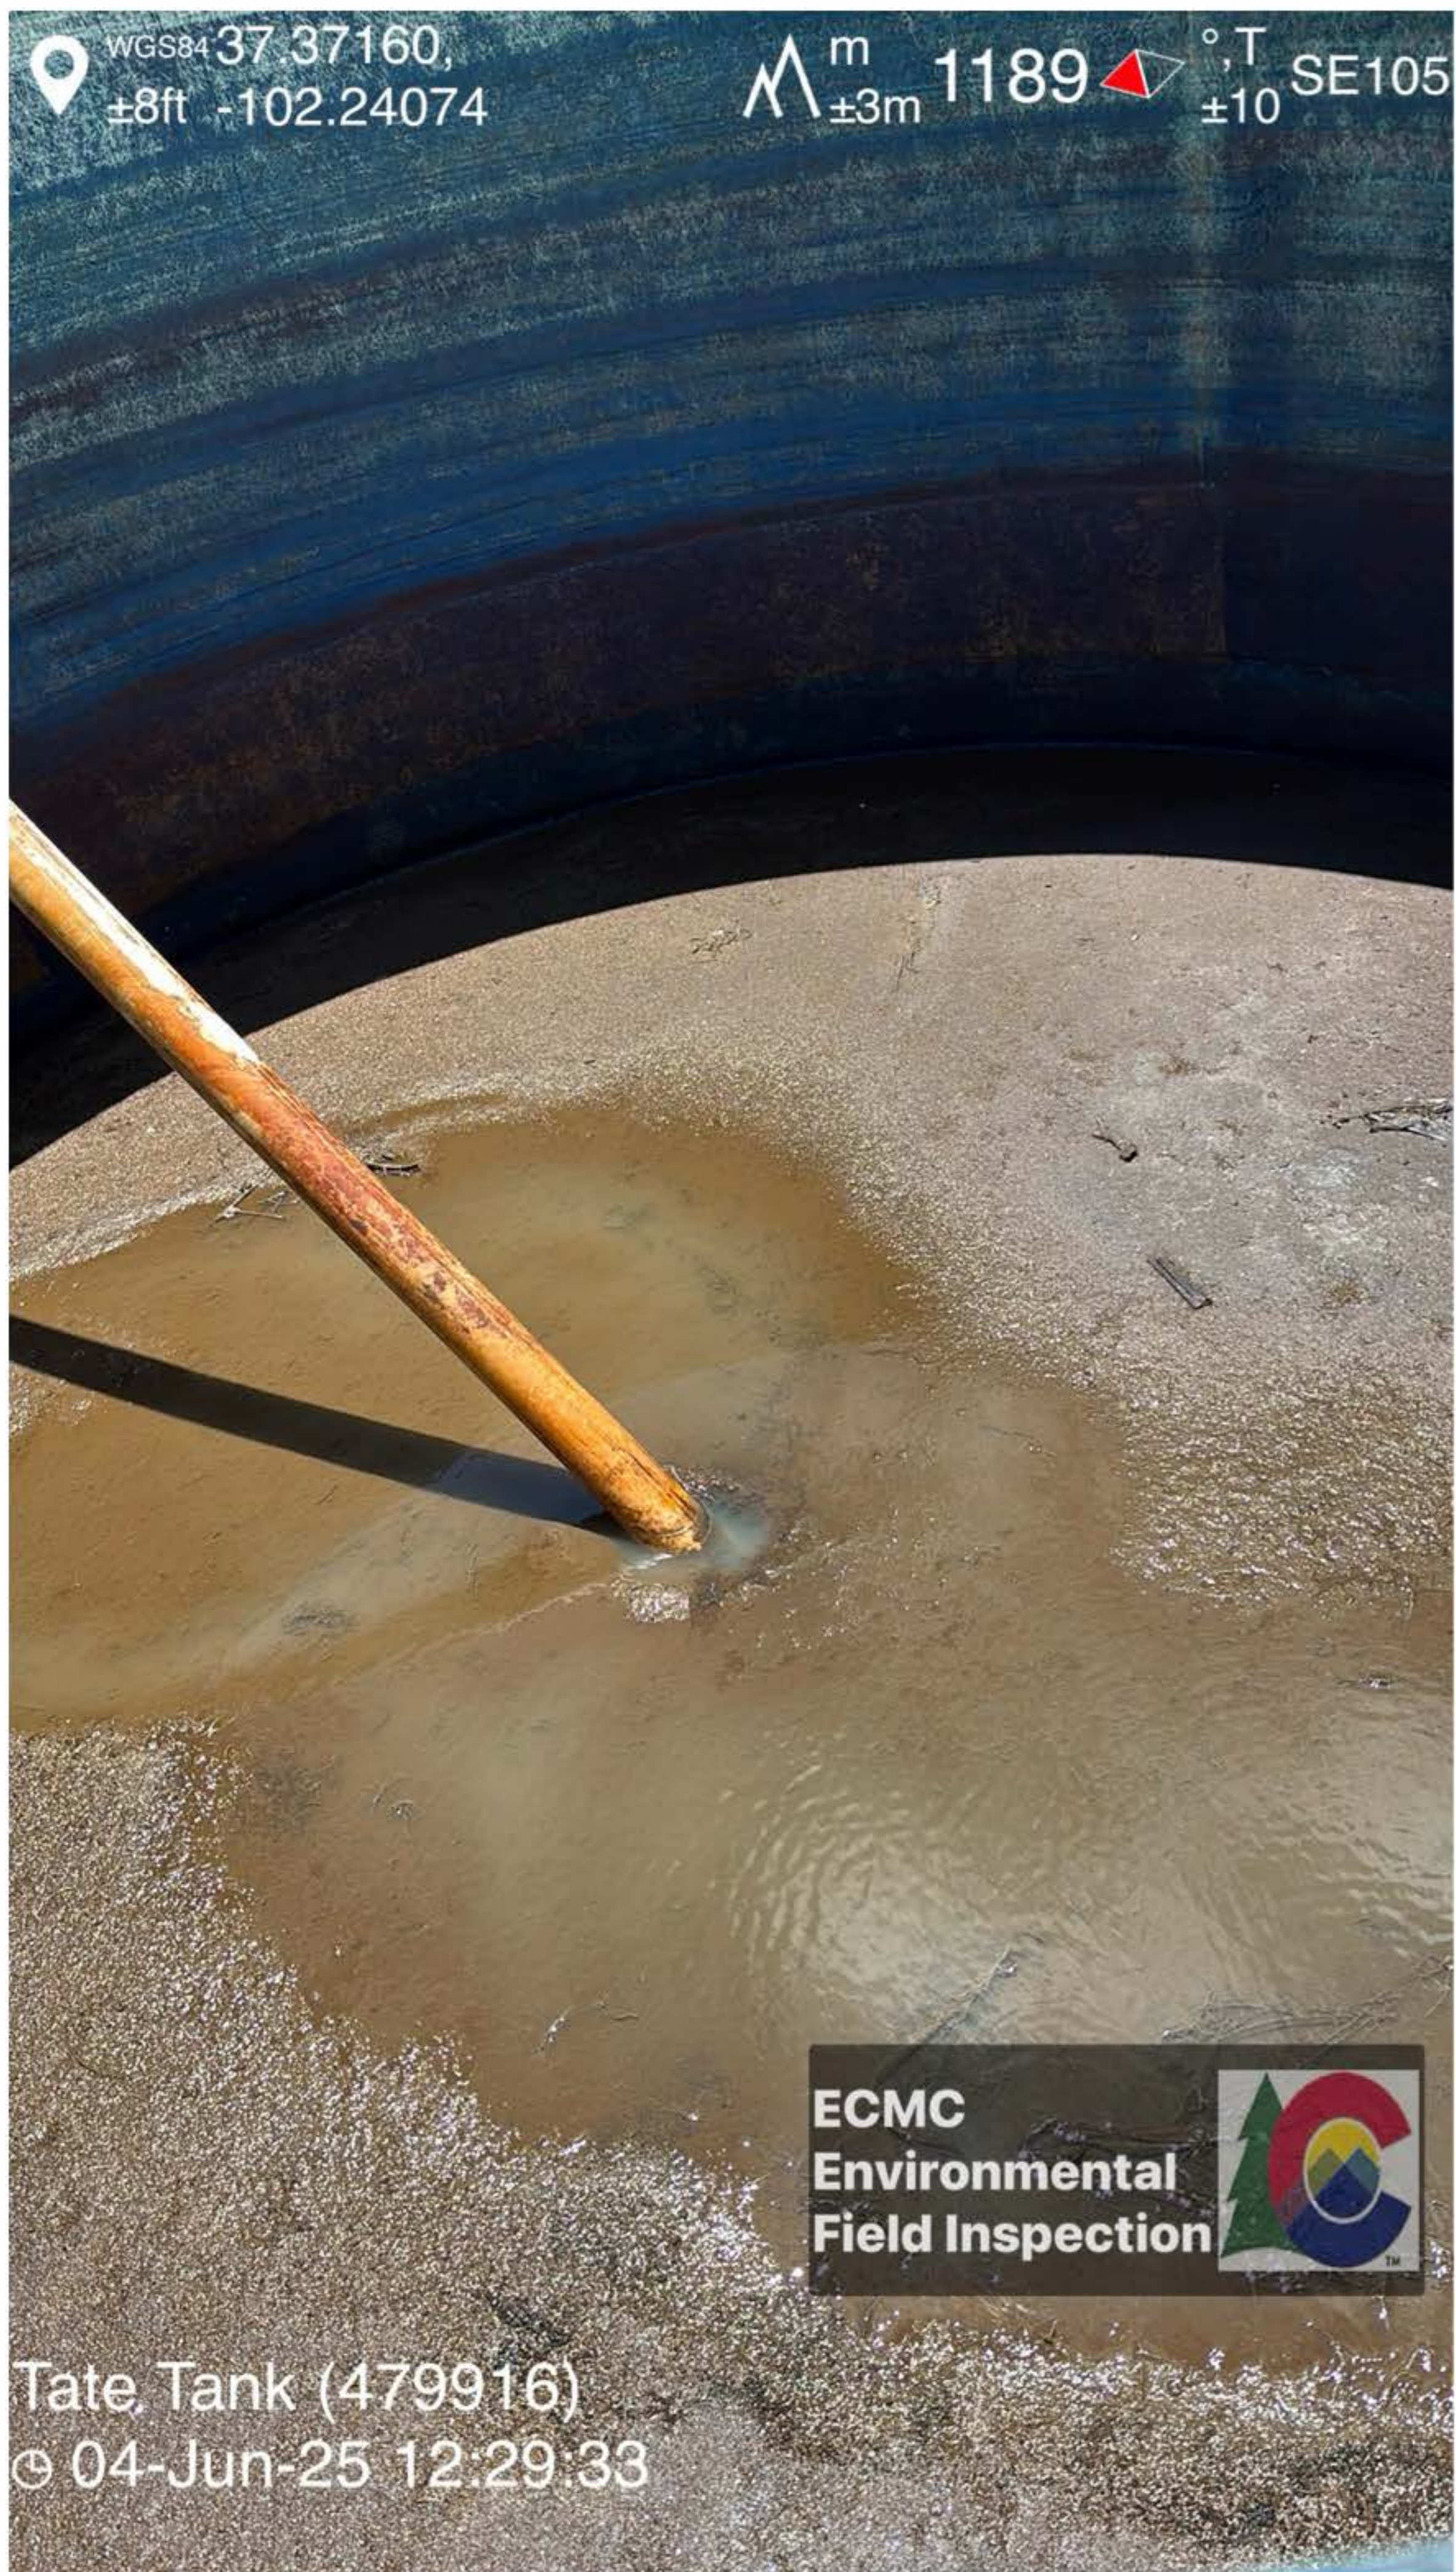
Liquid in base of the ~100-bbl open top fiberglass produced water storage tank.

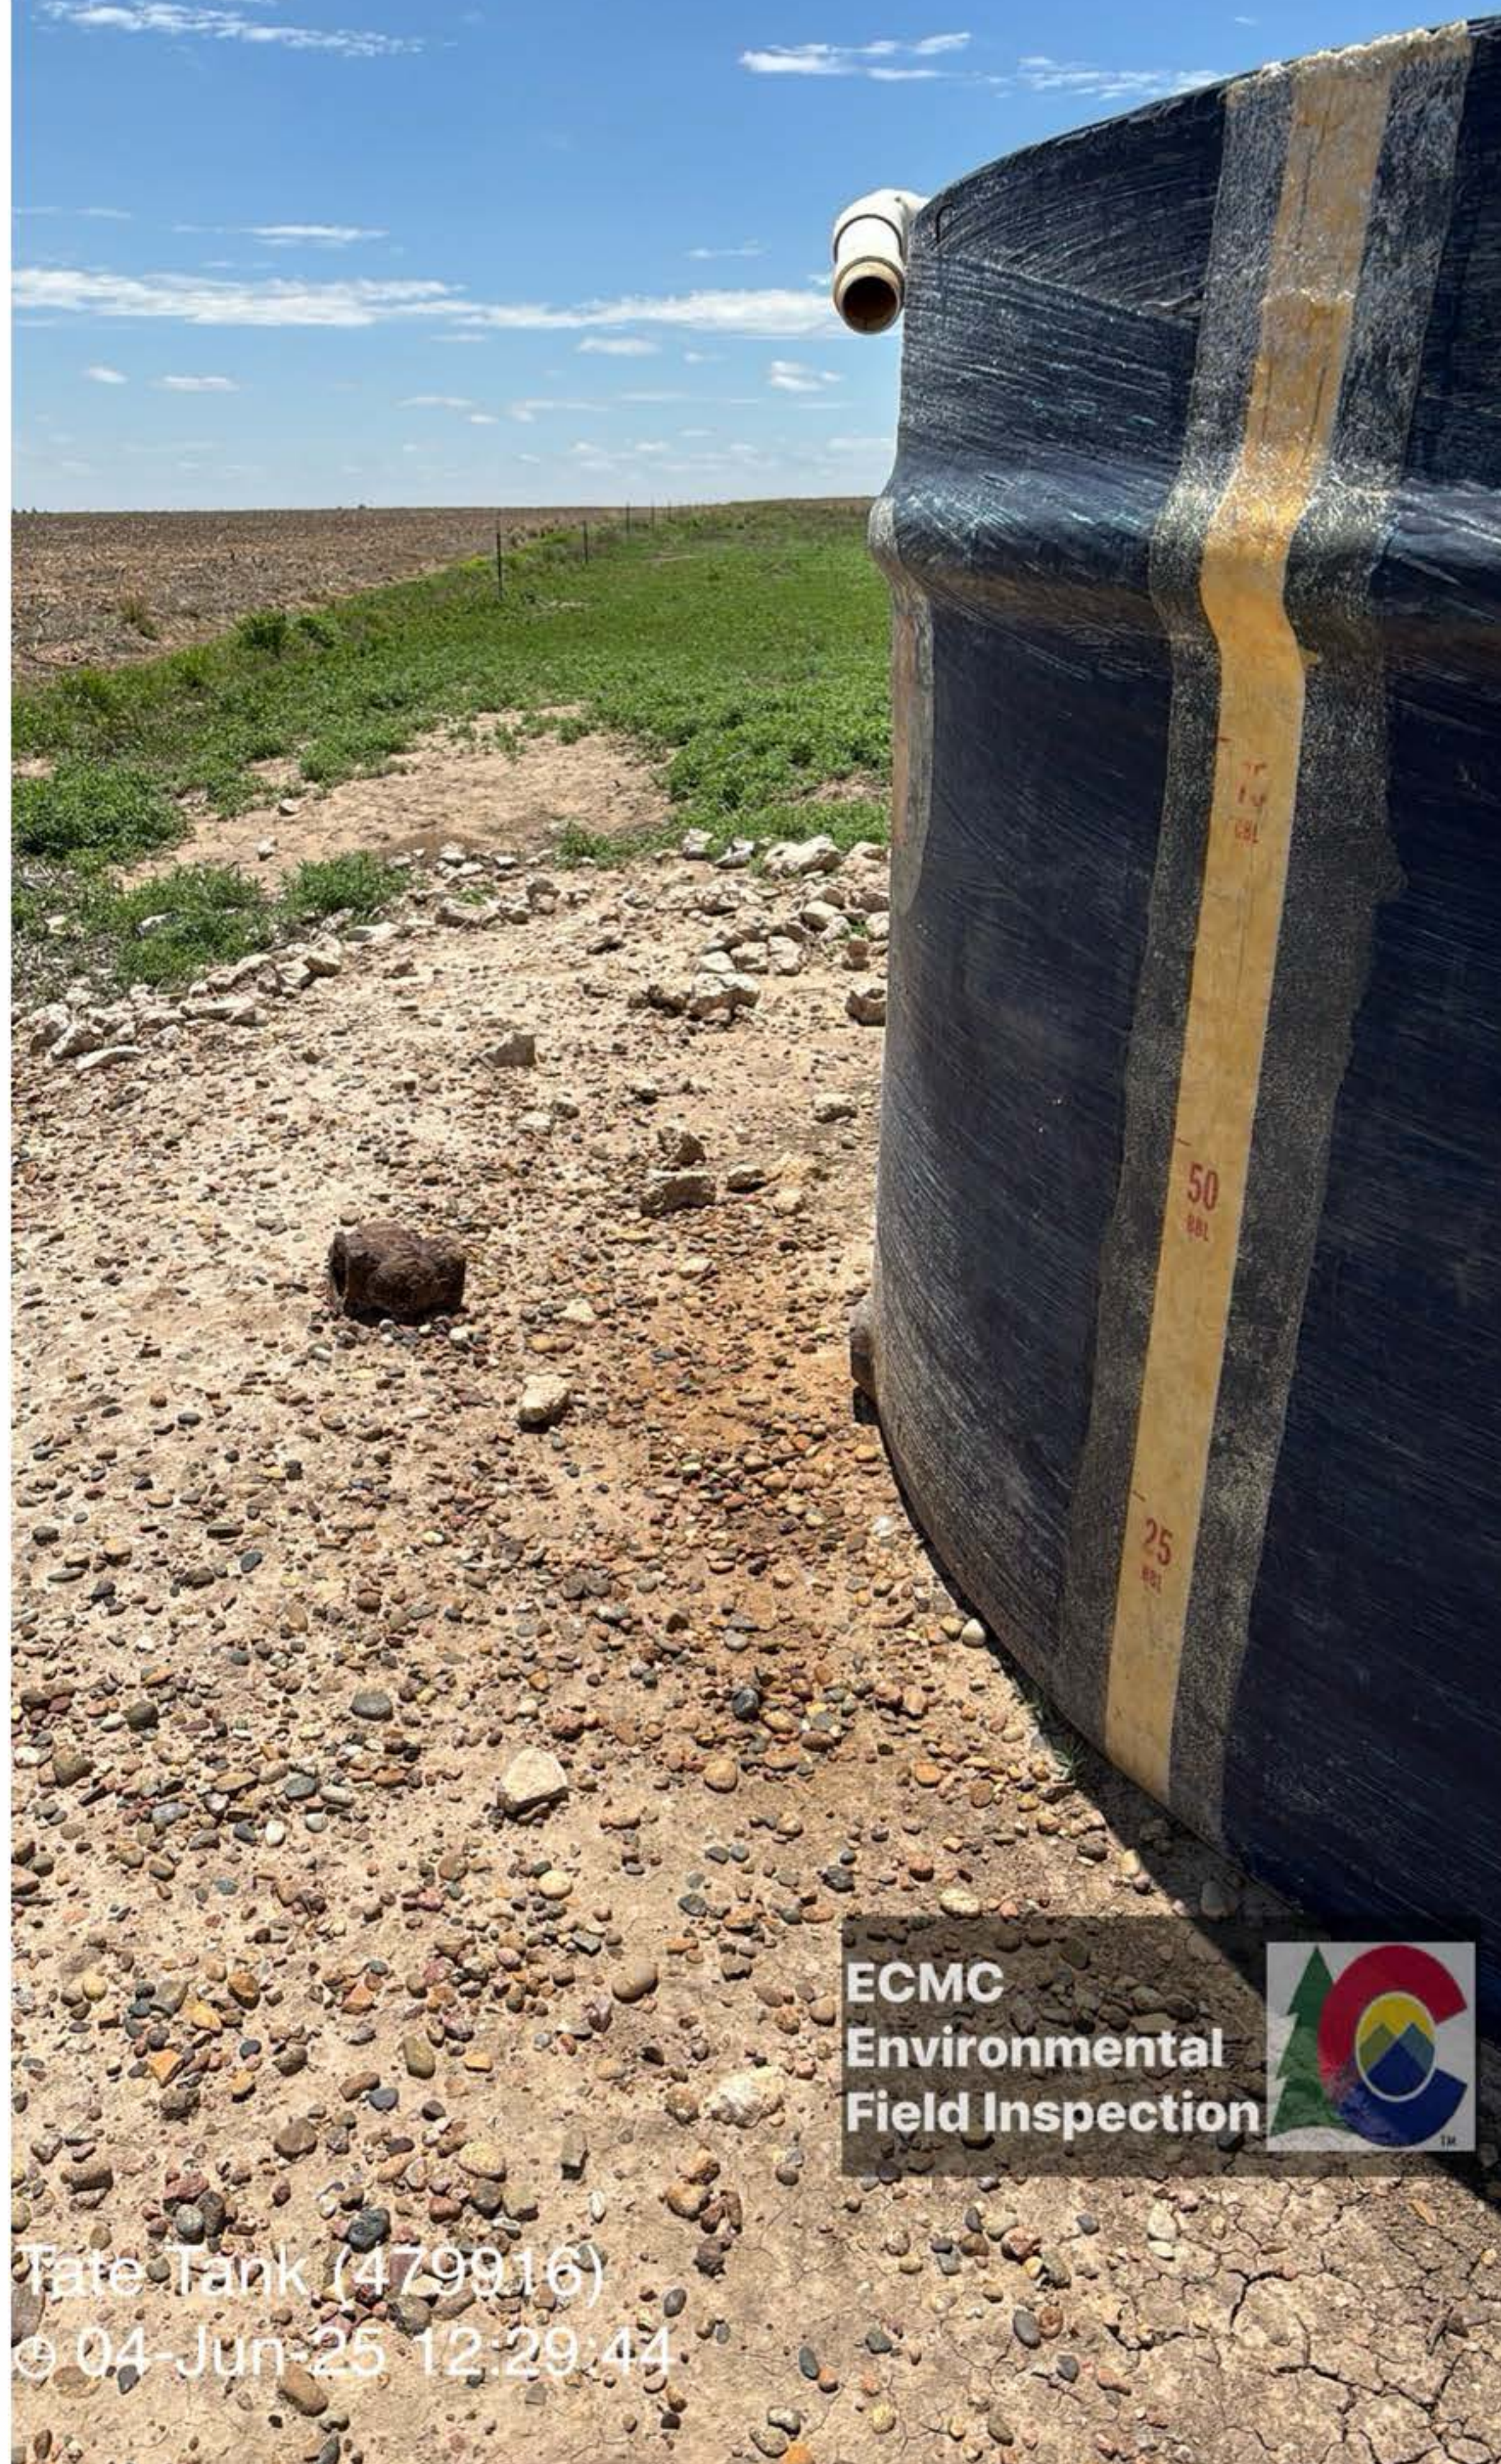
Tate Tank (479916)
© 04-Jun-25 12:29:44

Stained soil adjacent to open outlet/drain port, unused equipment, weeds/debris.

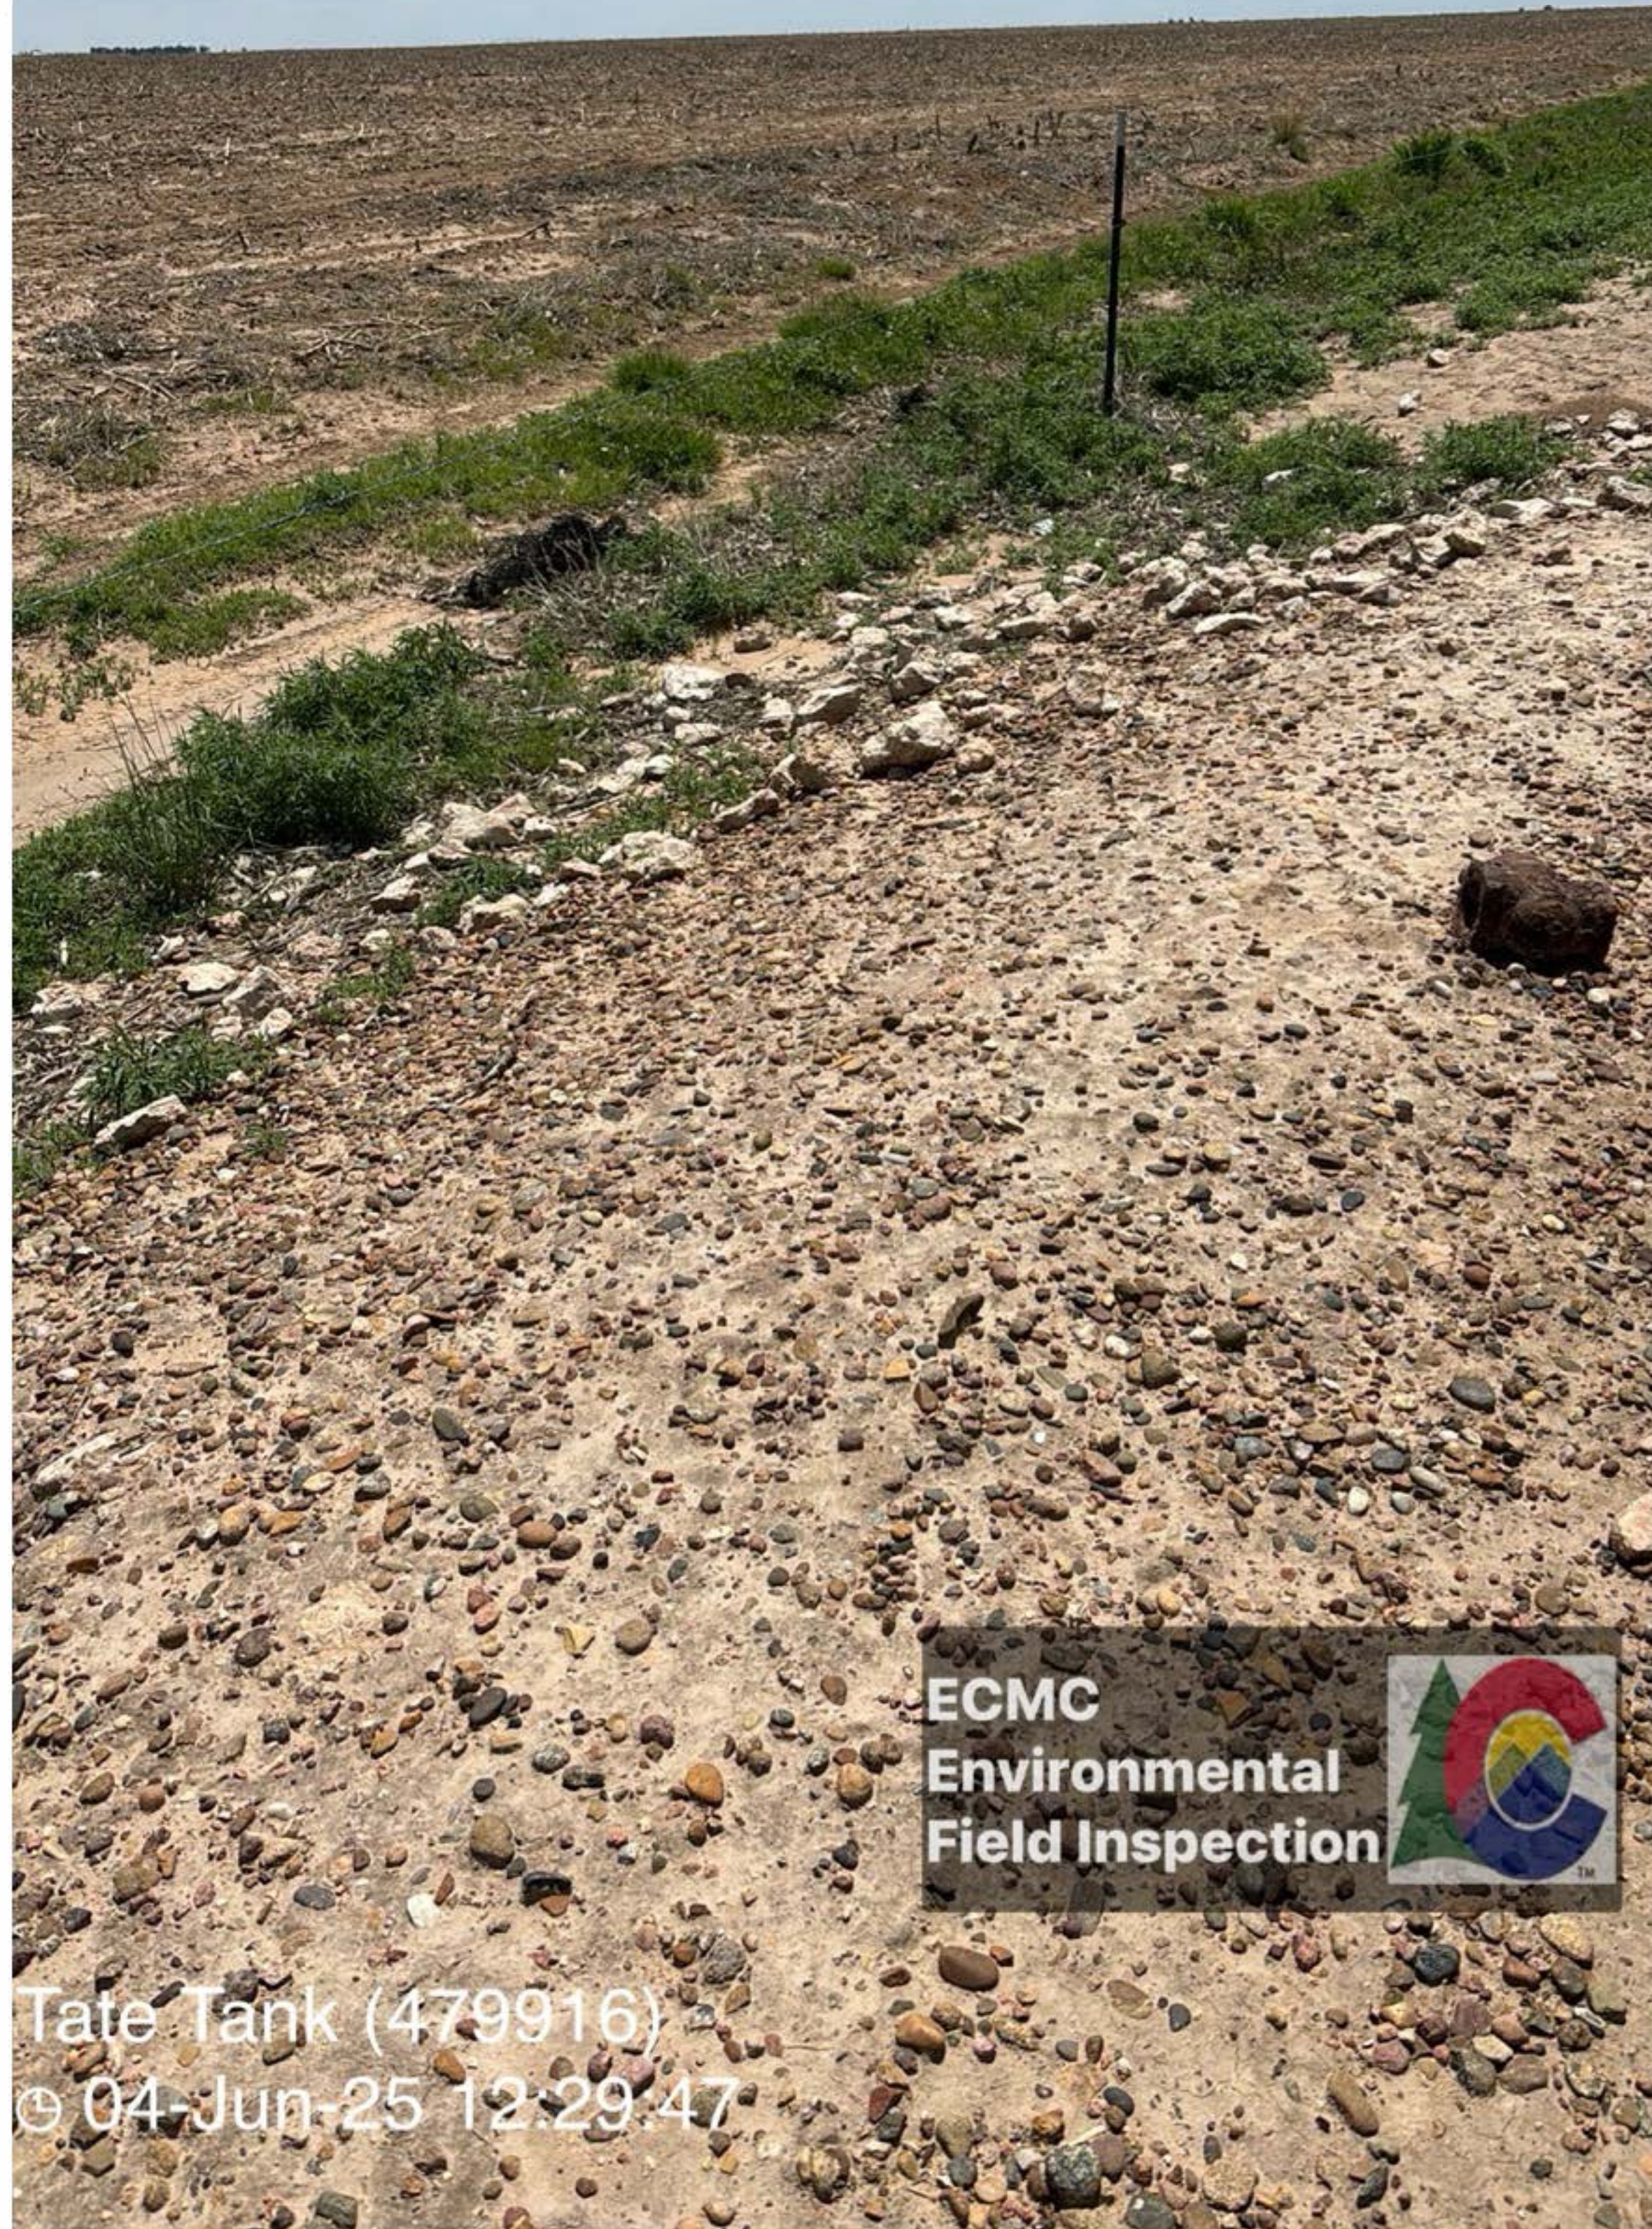
Tate Tank (479916)
© 04-Jun-25 12:29:47

Stained soil adjacent to/down-gradient from open outlet/drain port, unused equipment (fitting), trash/debris - torn wildlife protection equipment (netting) blown off-location.

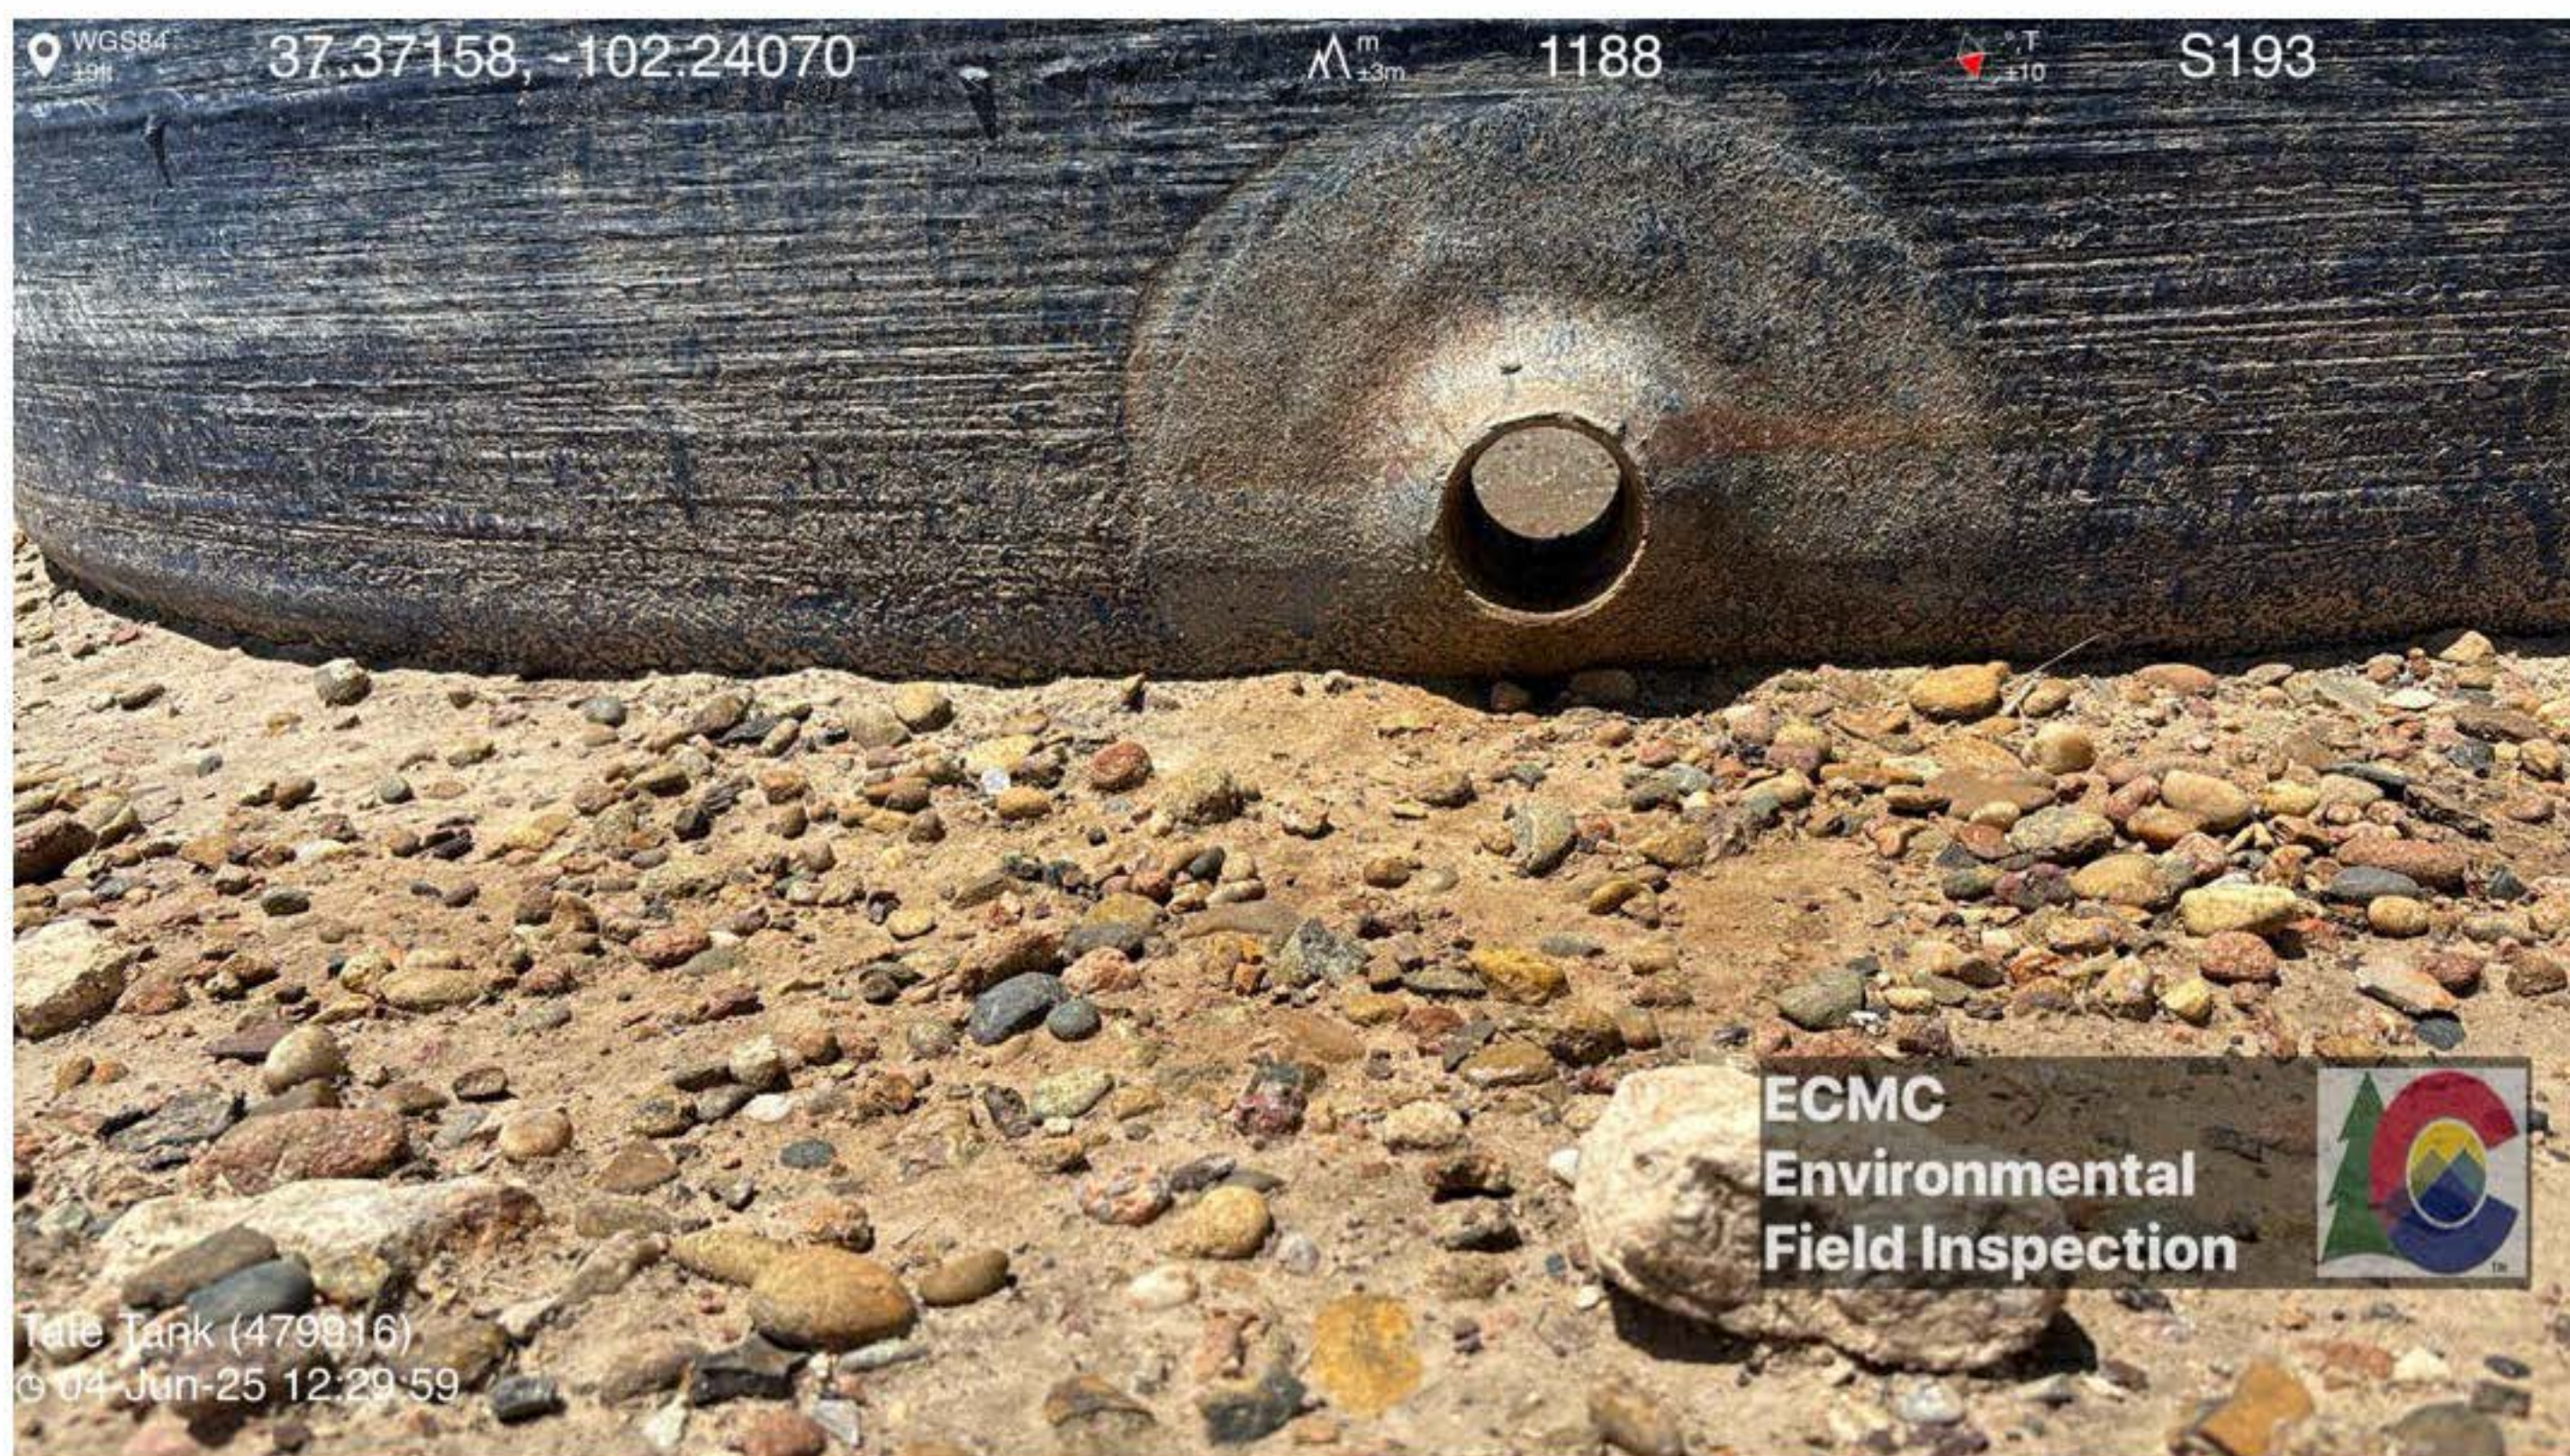
Stained soil adjacent to/down-gradient from open outlet/drain port, east side of ~100-bbl open top fiberglass produced water storage tank

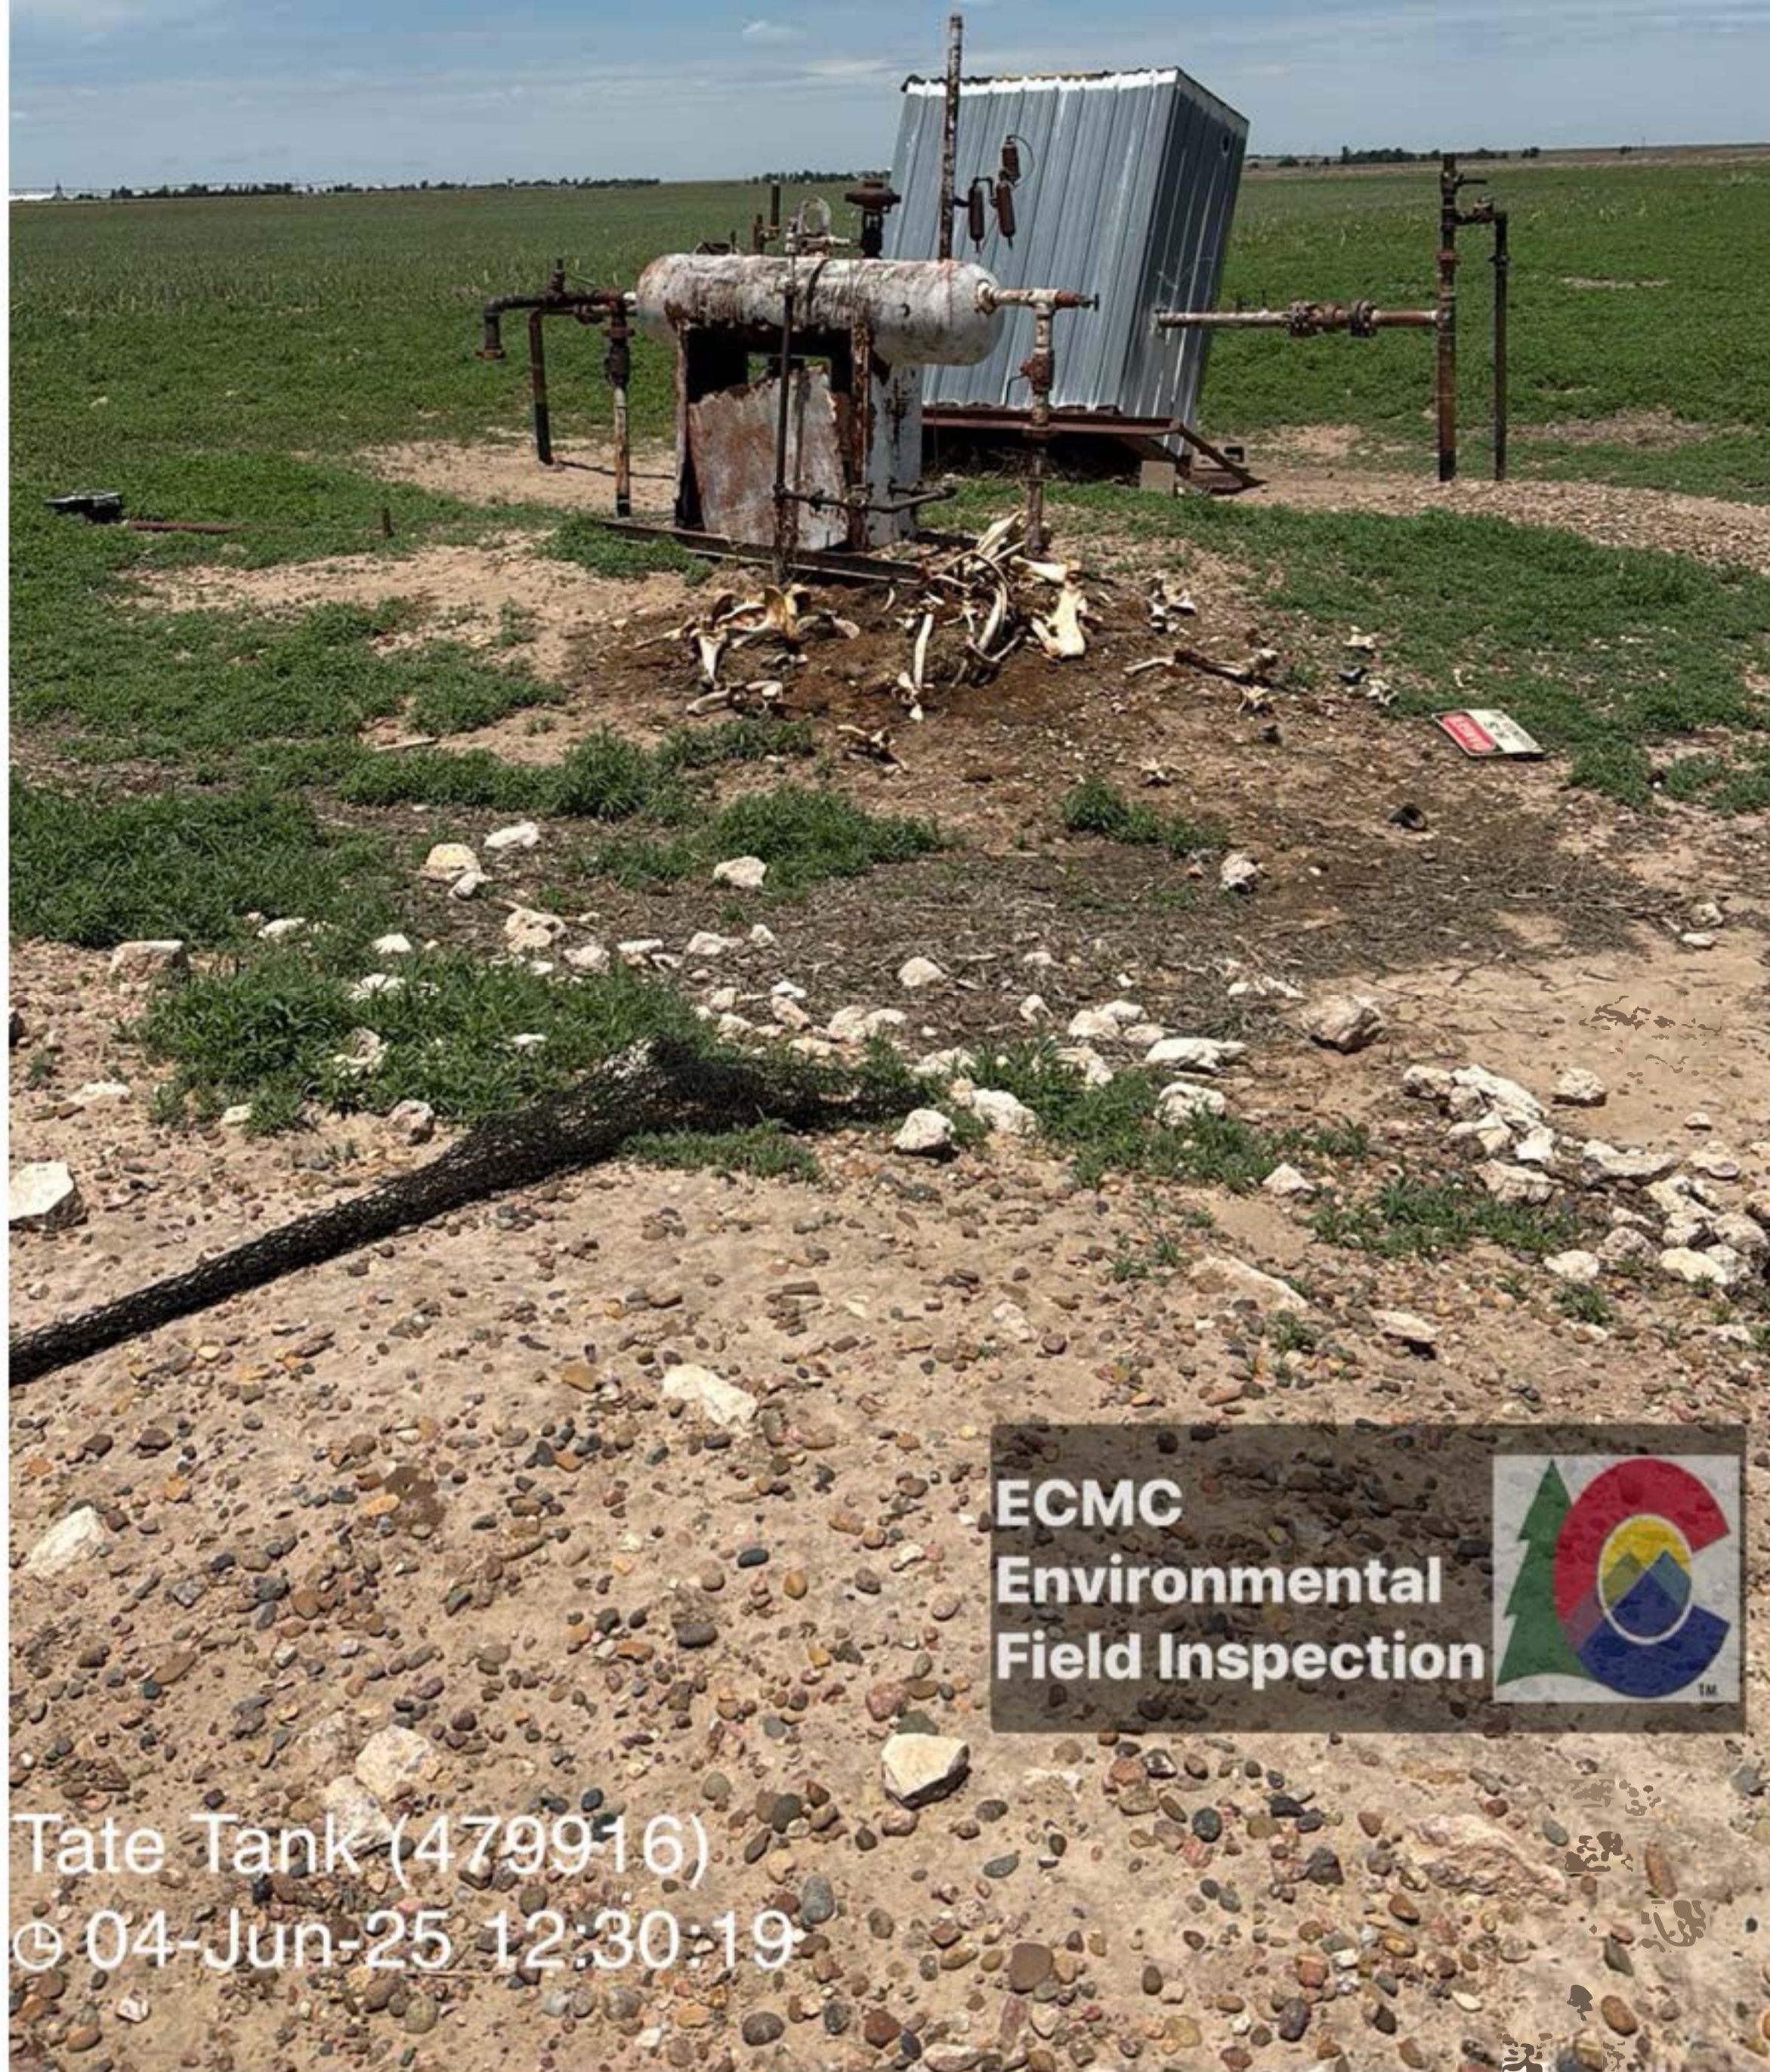
Tate Tank (479916)
© 04-Jun-25 12:30:19

Cattle carcass, trash/debris - torn wildlife protection equipment (netting), weeds, fallen signage.

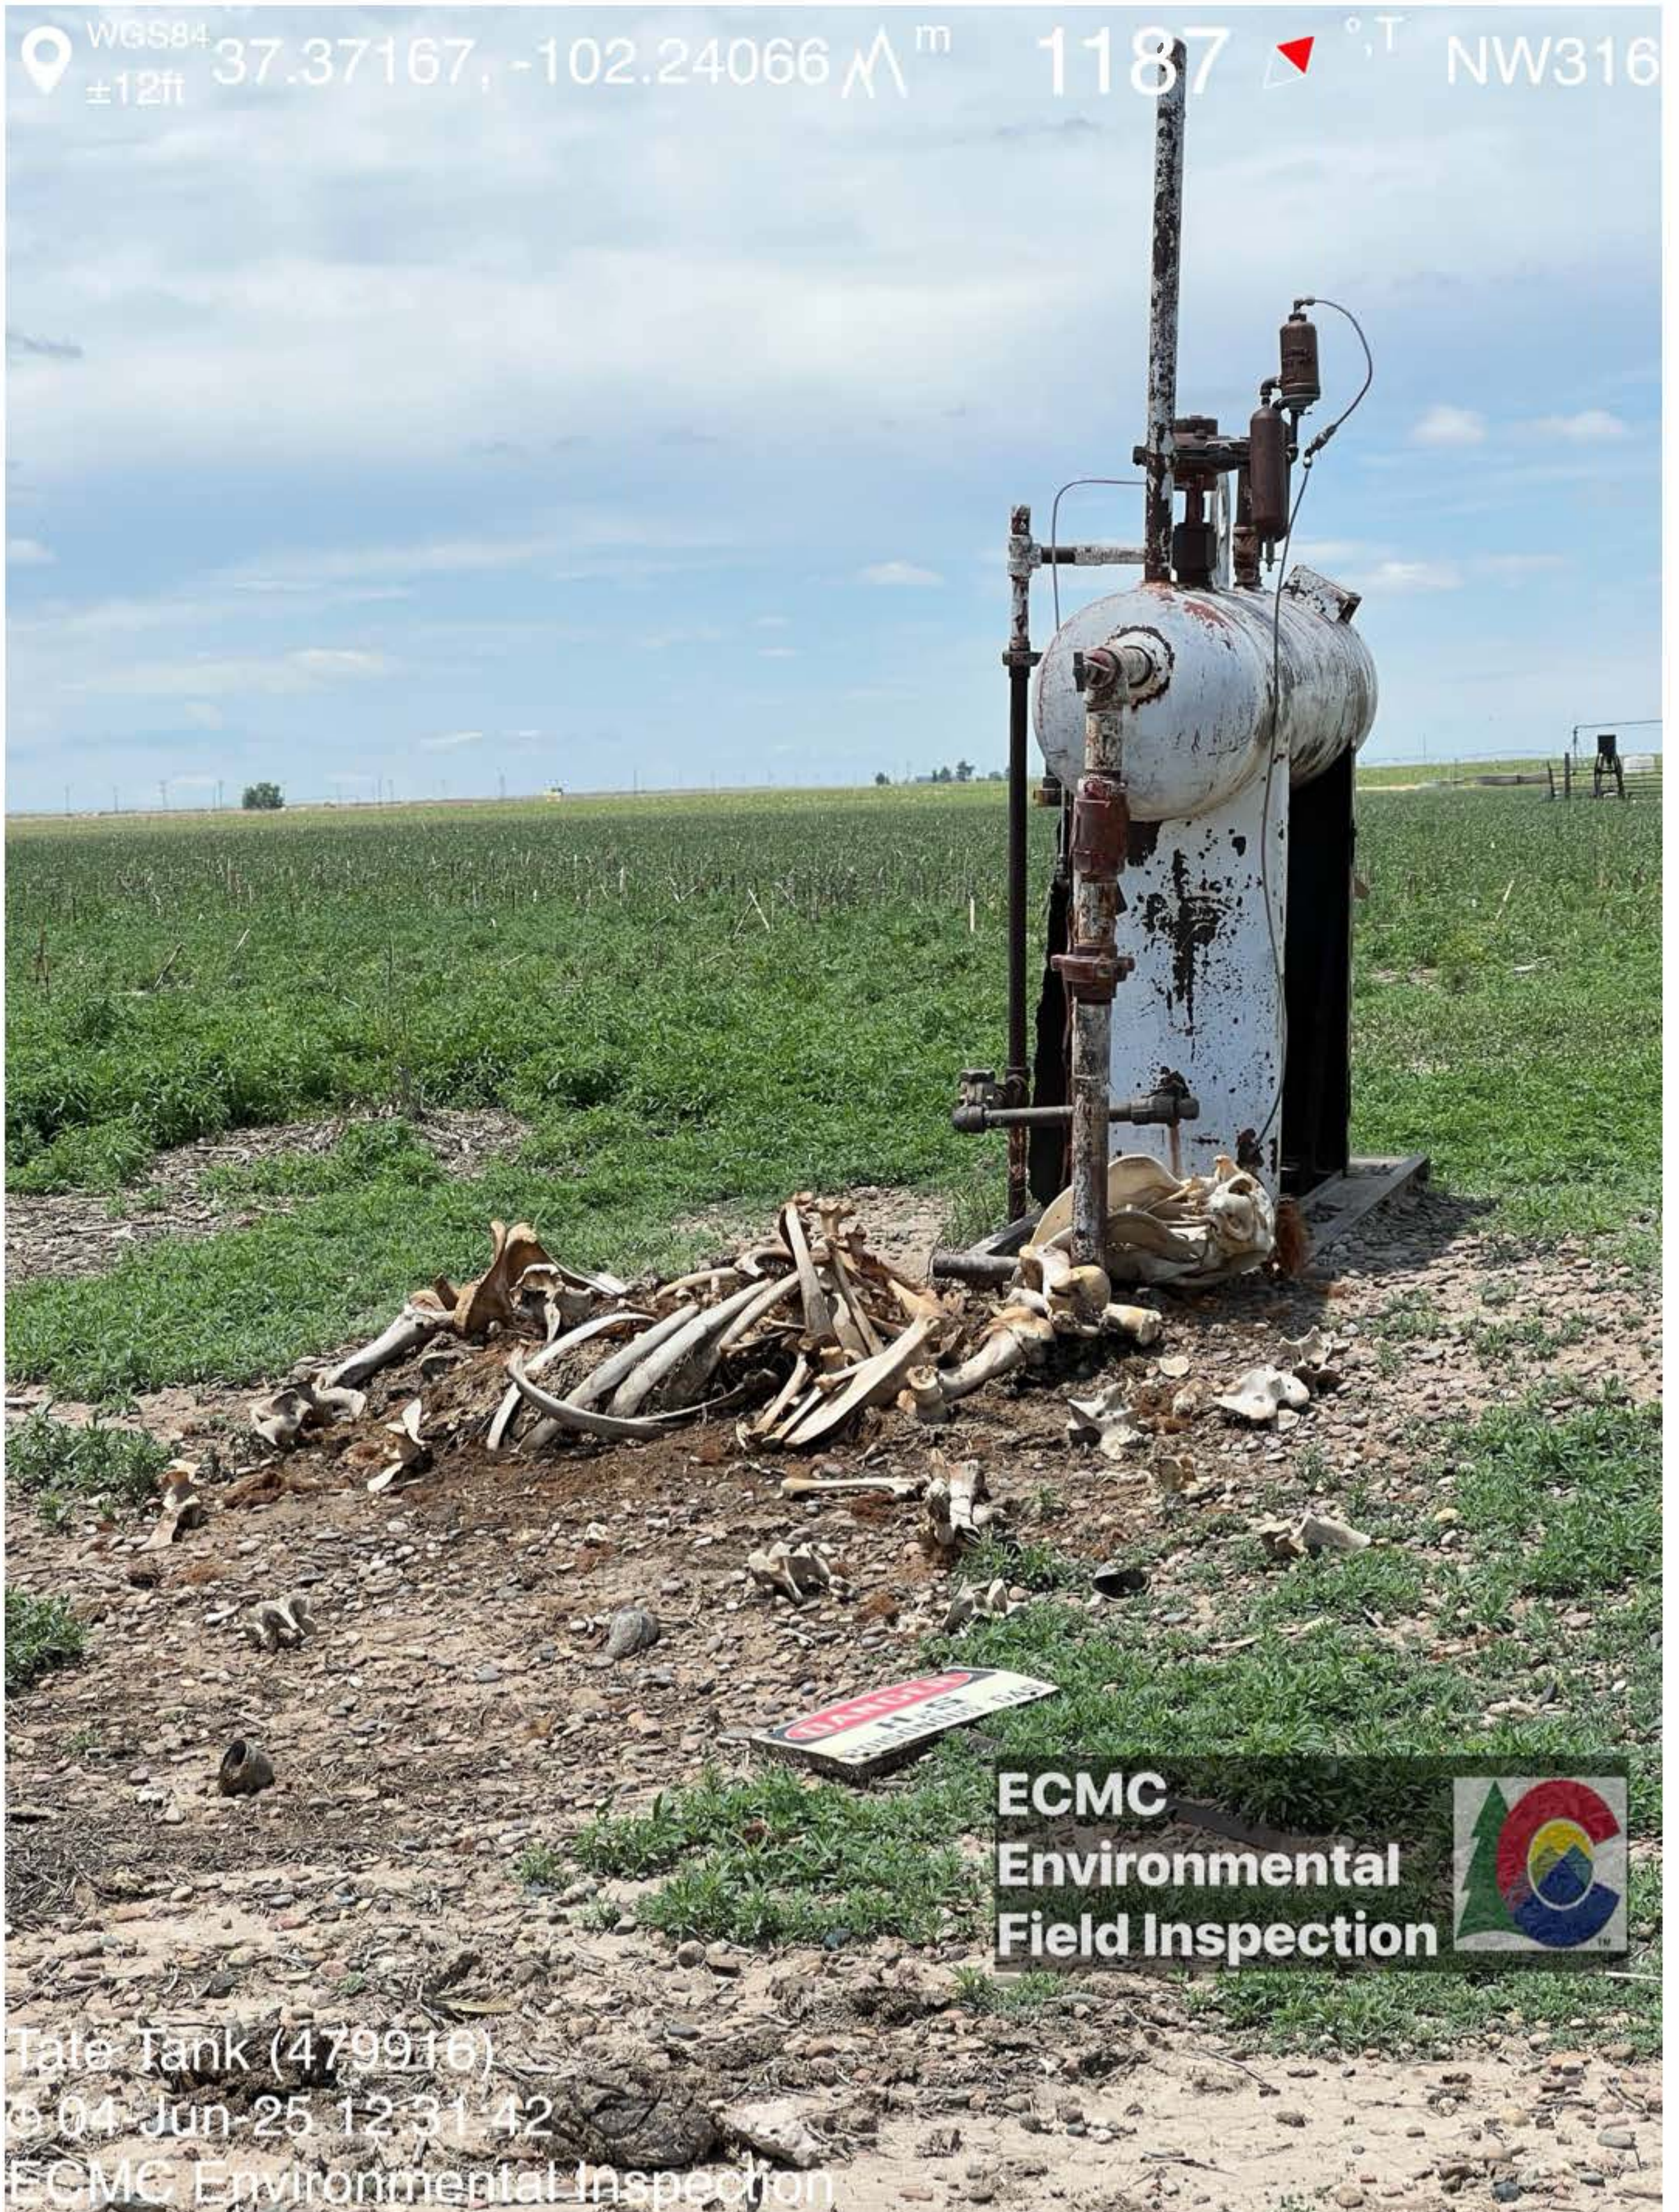
Tate Tank (479916)
04-Jun-25 12:31:42
ECMC Environmental Inspection

Cattle carcass adjacent to separator and piping, trash/ debris - torn wildlife protection equipment (netting), weeds, fallen signage.
