ECMC
Environmental
Field Inspection

Nininger Wellhead
© 30-May-25 11:48:50 AM
ECMC Environmental Inspection

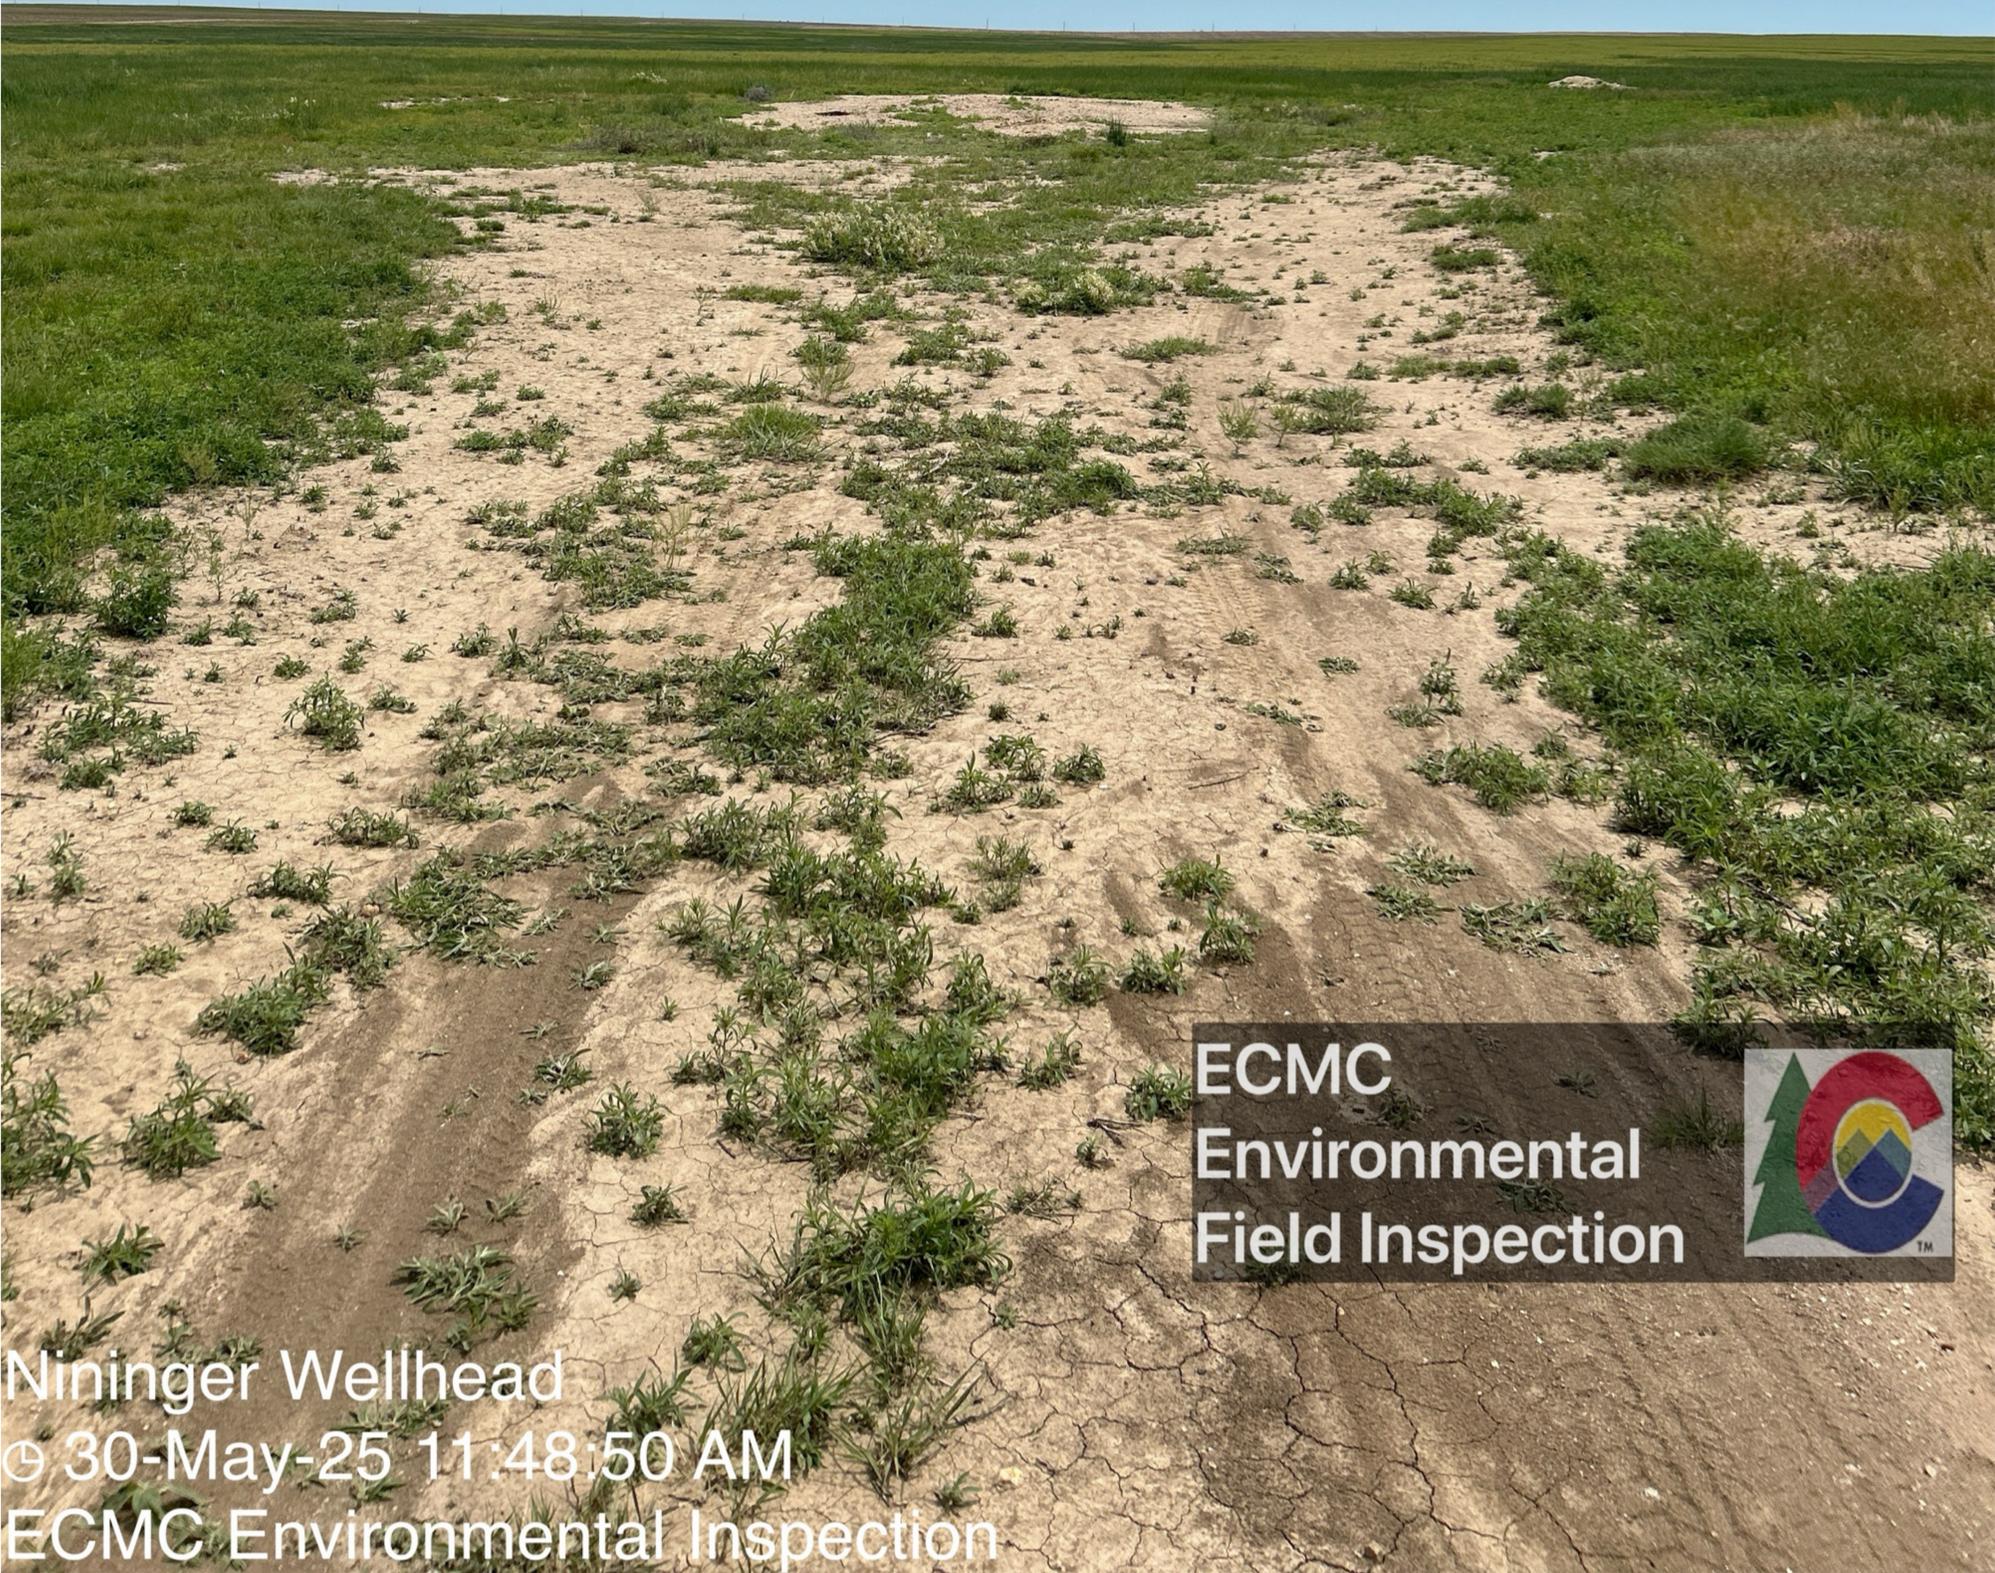
Looking at former wellhead from the access road.

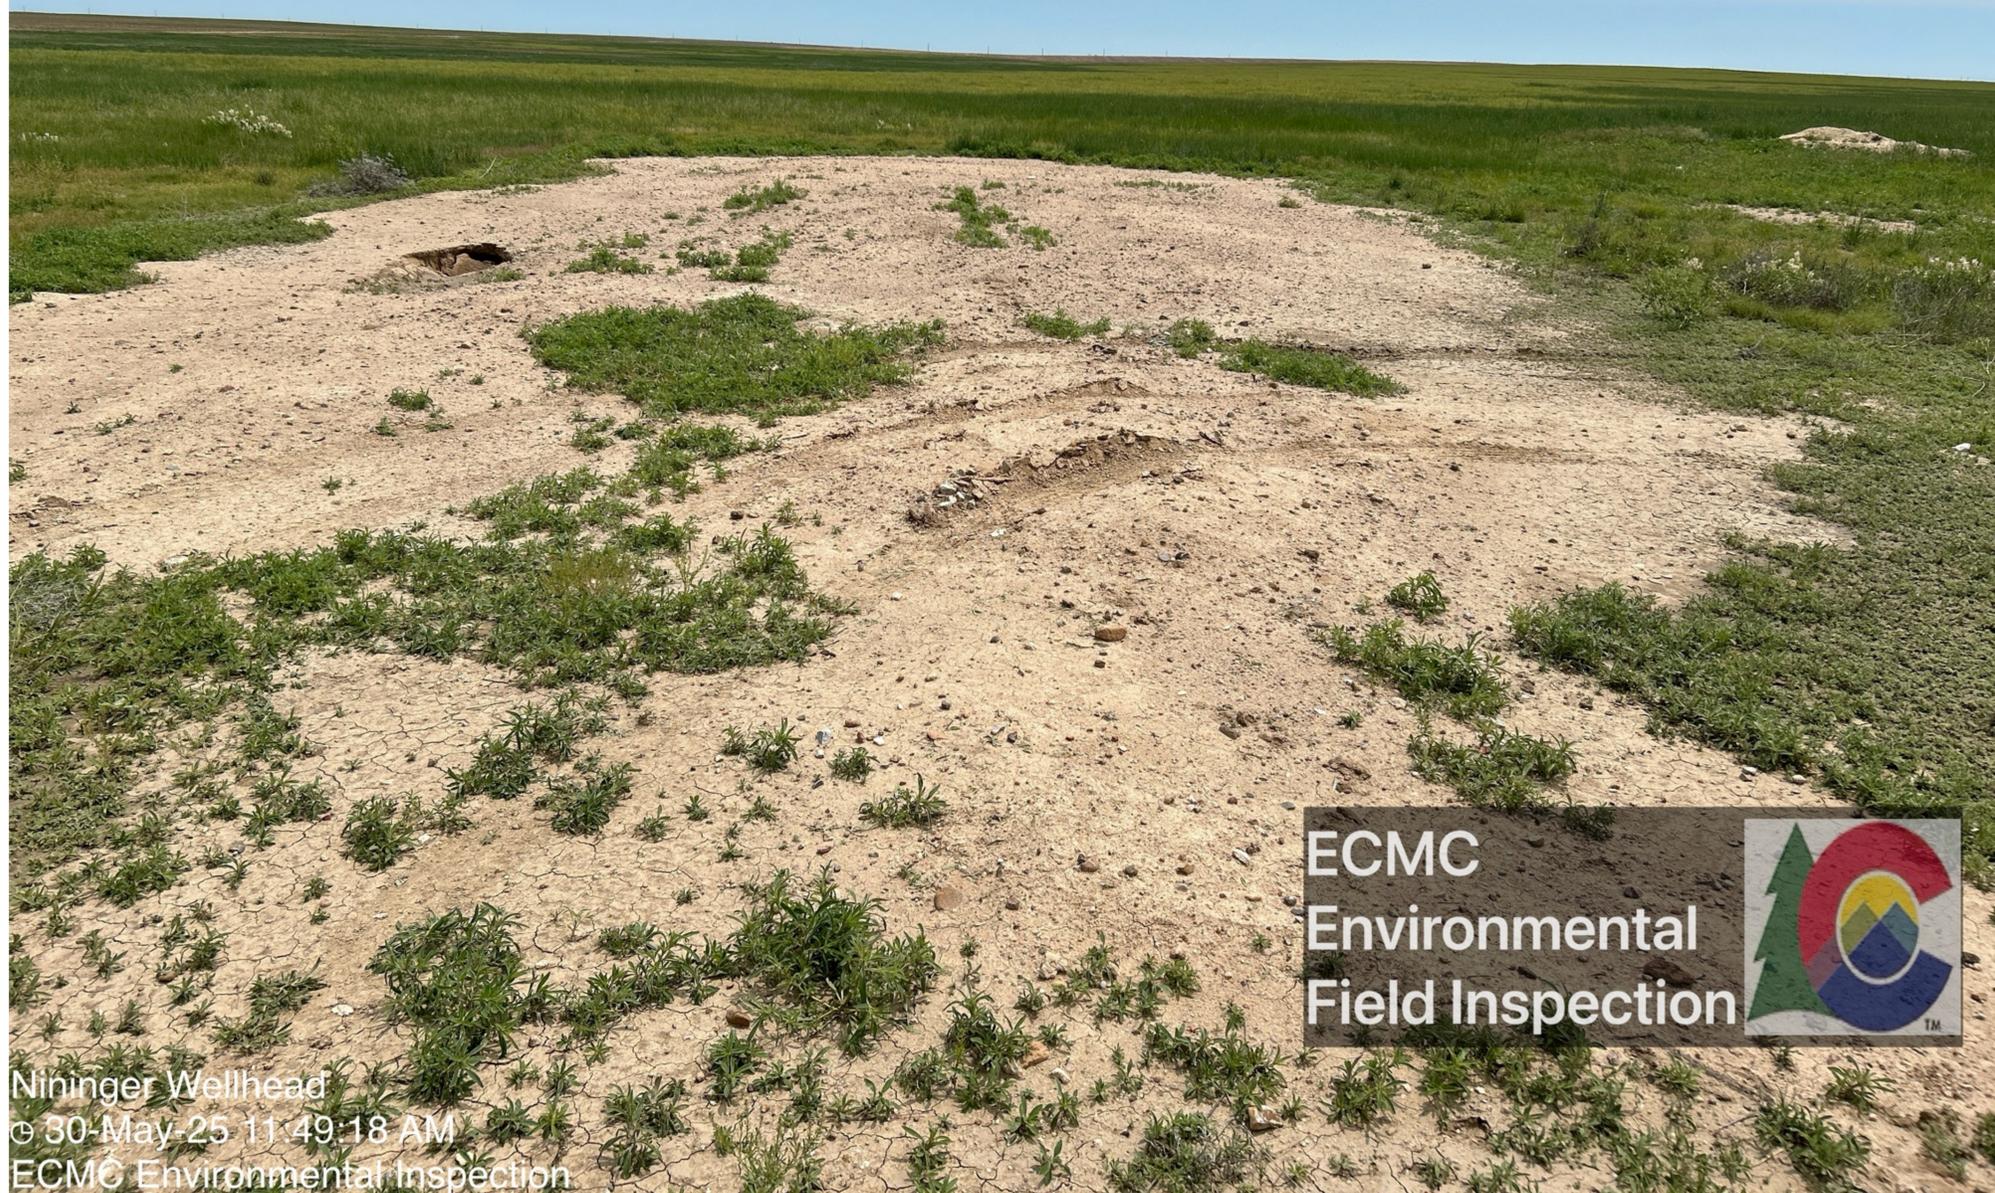
The excavation at the former wellhead has been backfilled.

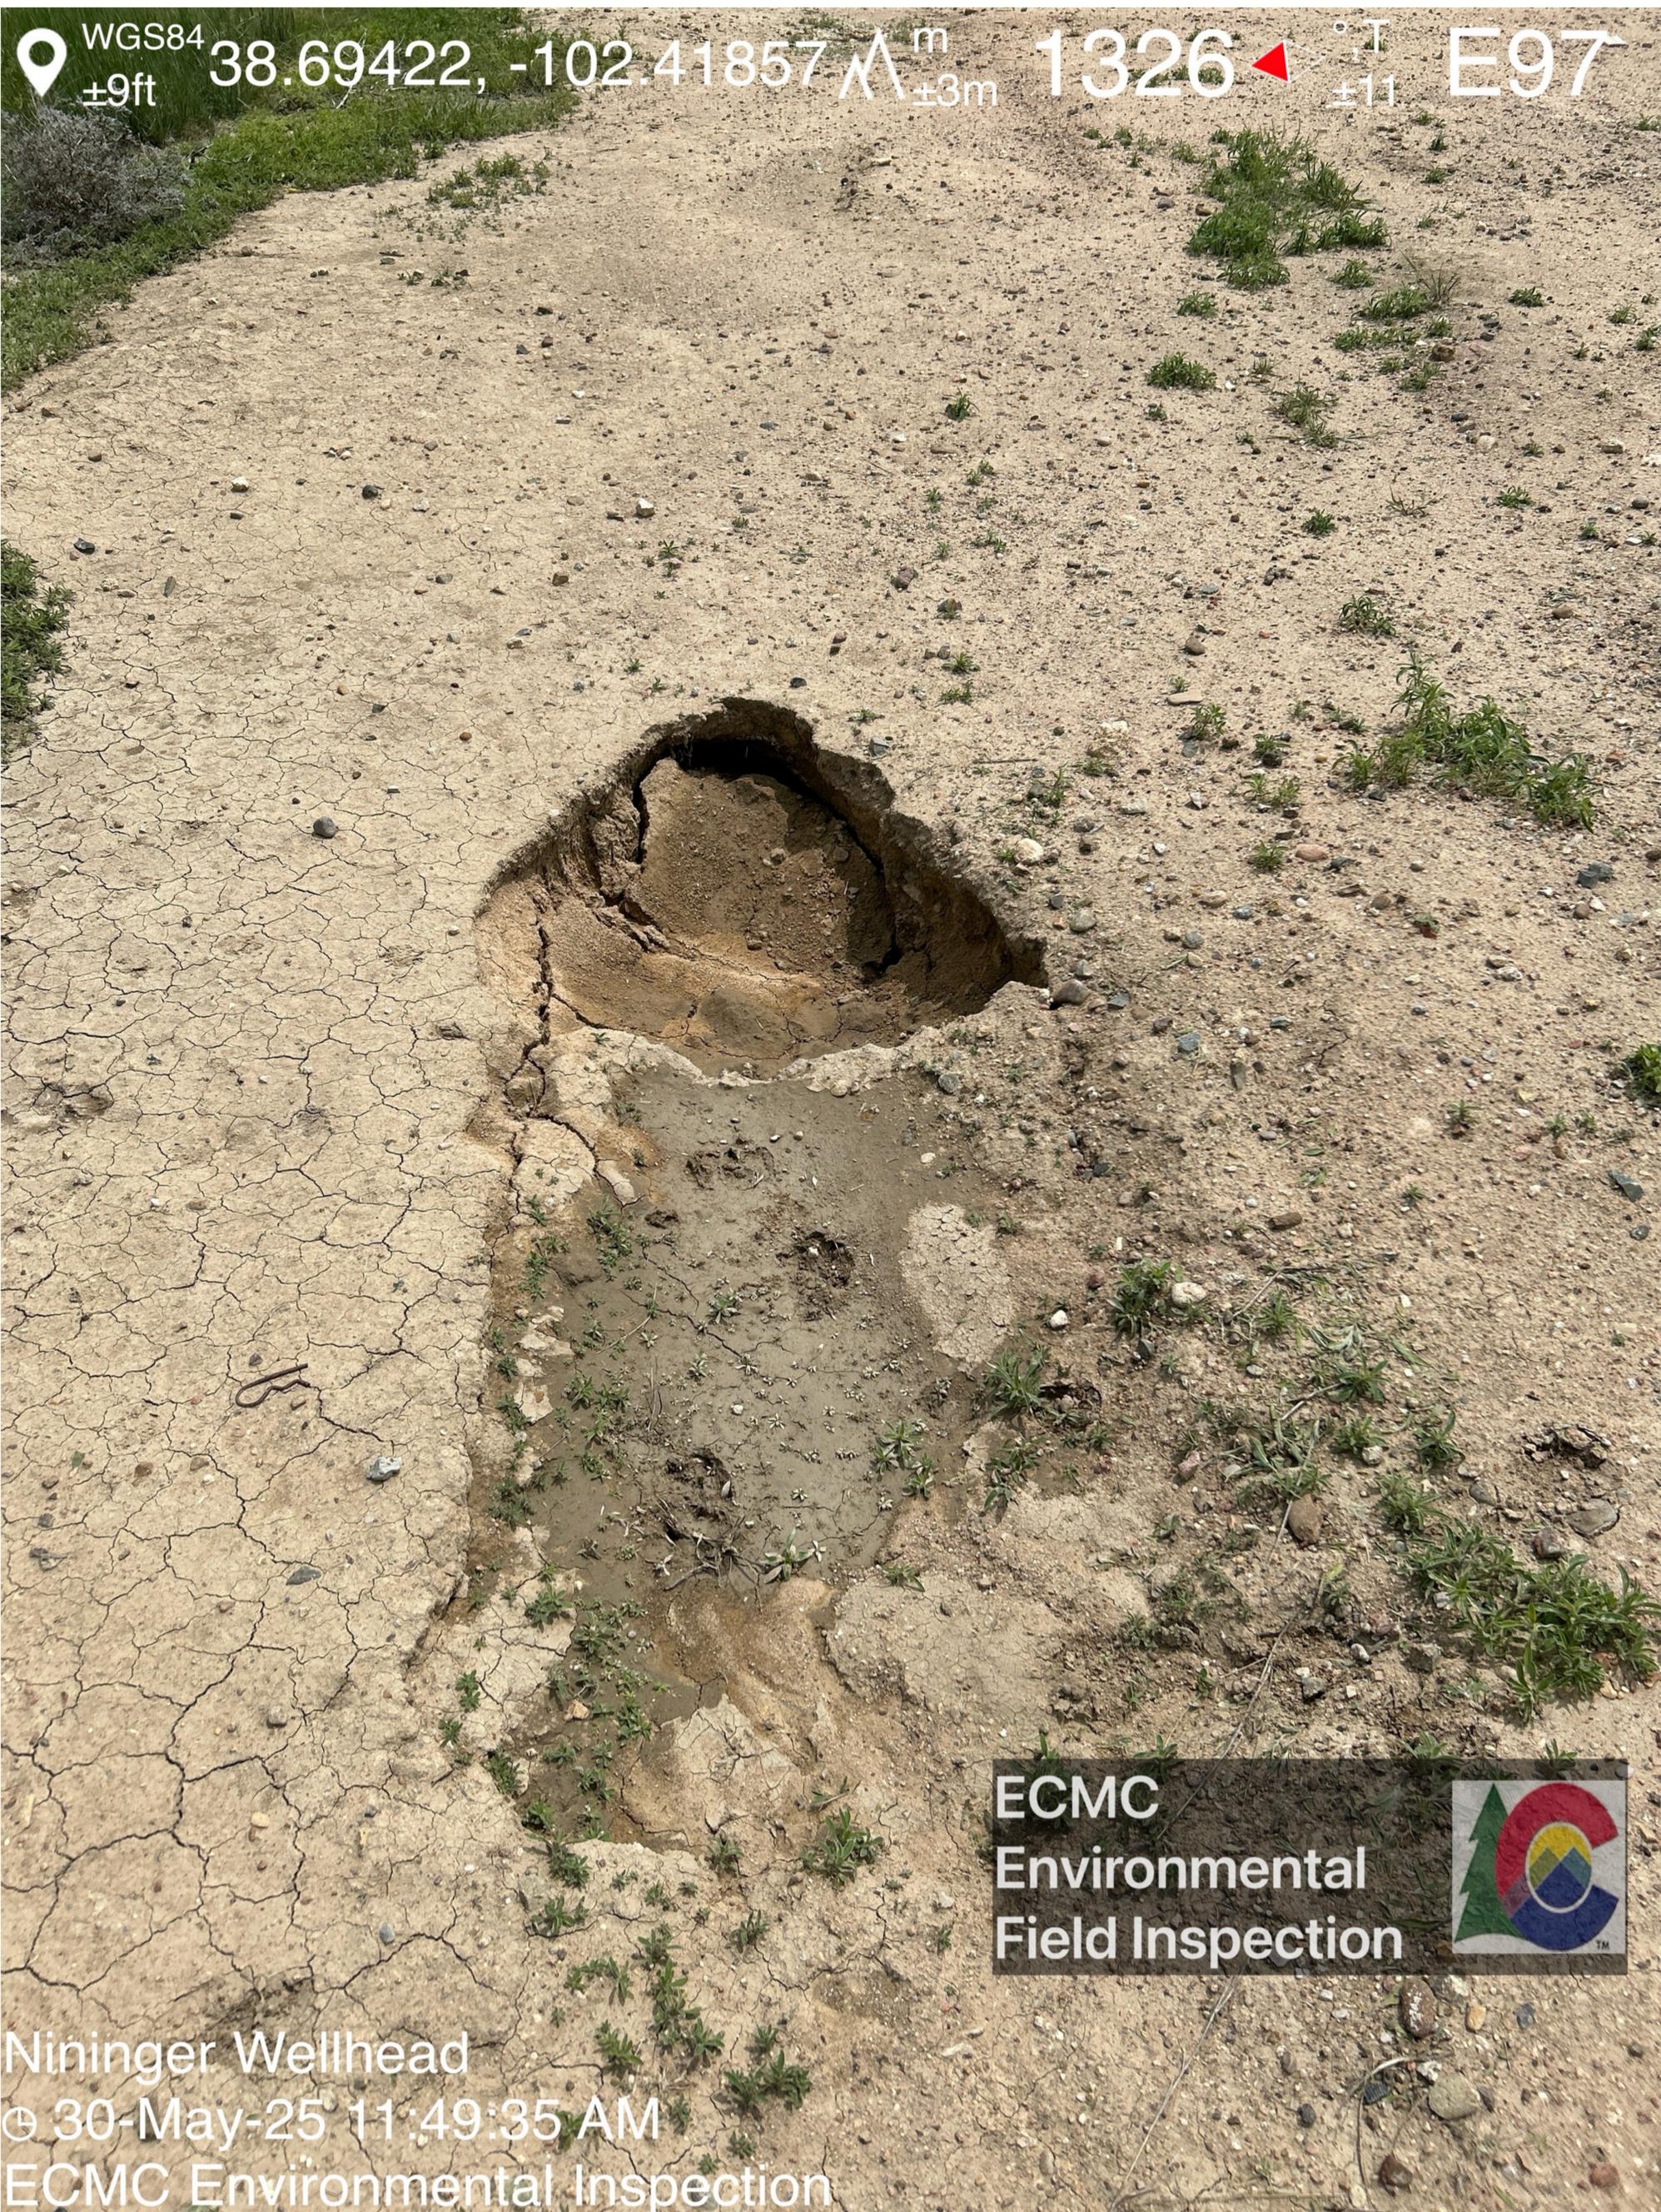
Ground subsidence is visible in the vicinity of the former wellhead.

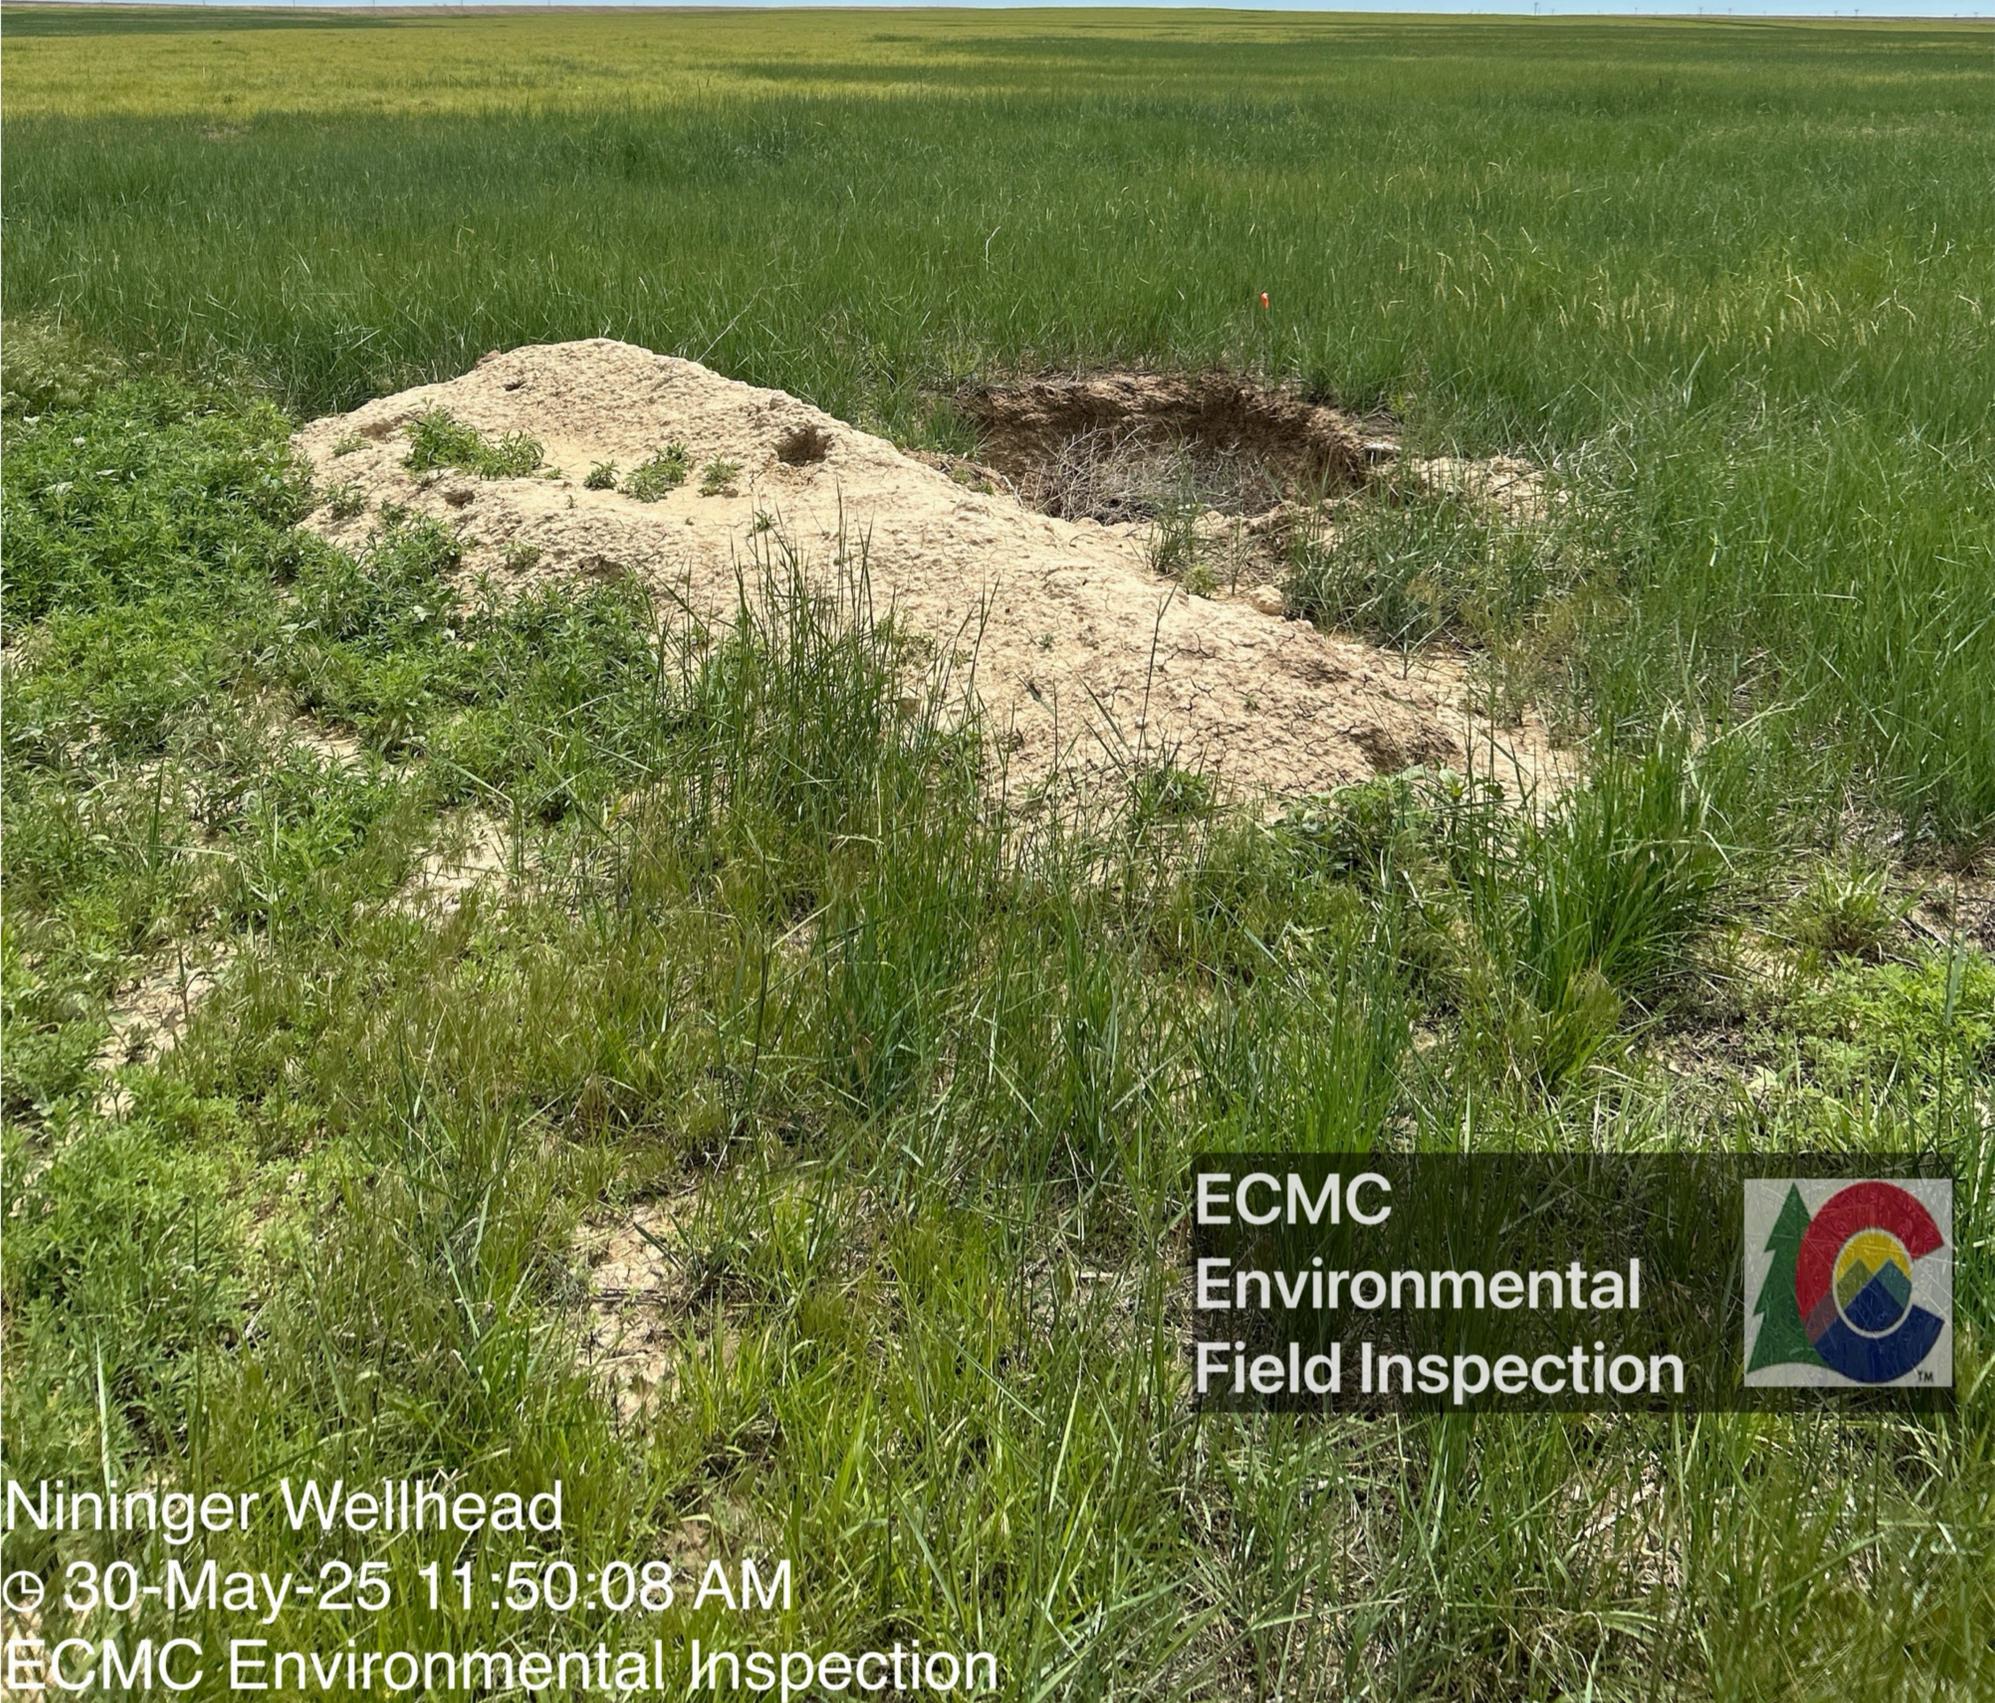
An unmarked soil stockpile is visible next to a small excavation southeast of the former wellhead. No stormwater BMPs or liner is visible. No fencing is visible surrounding the excavation.

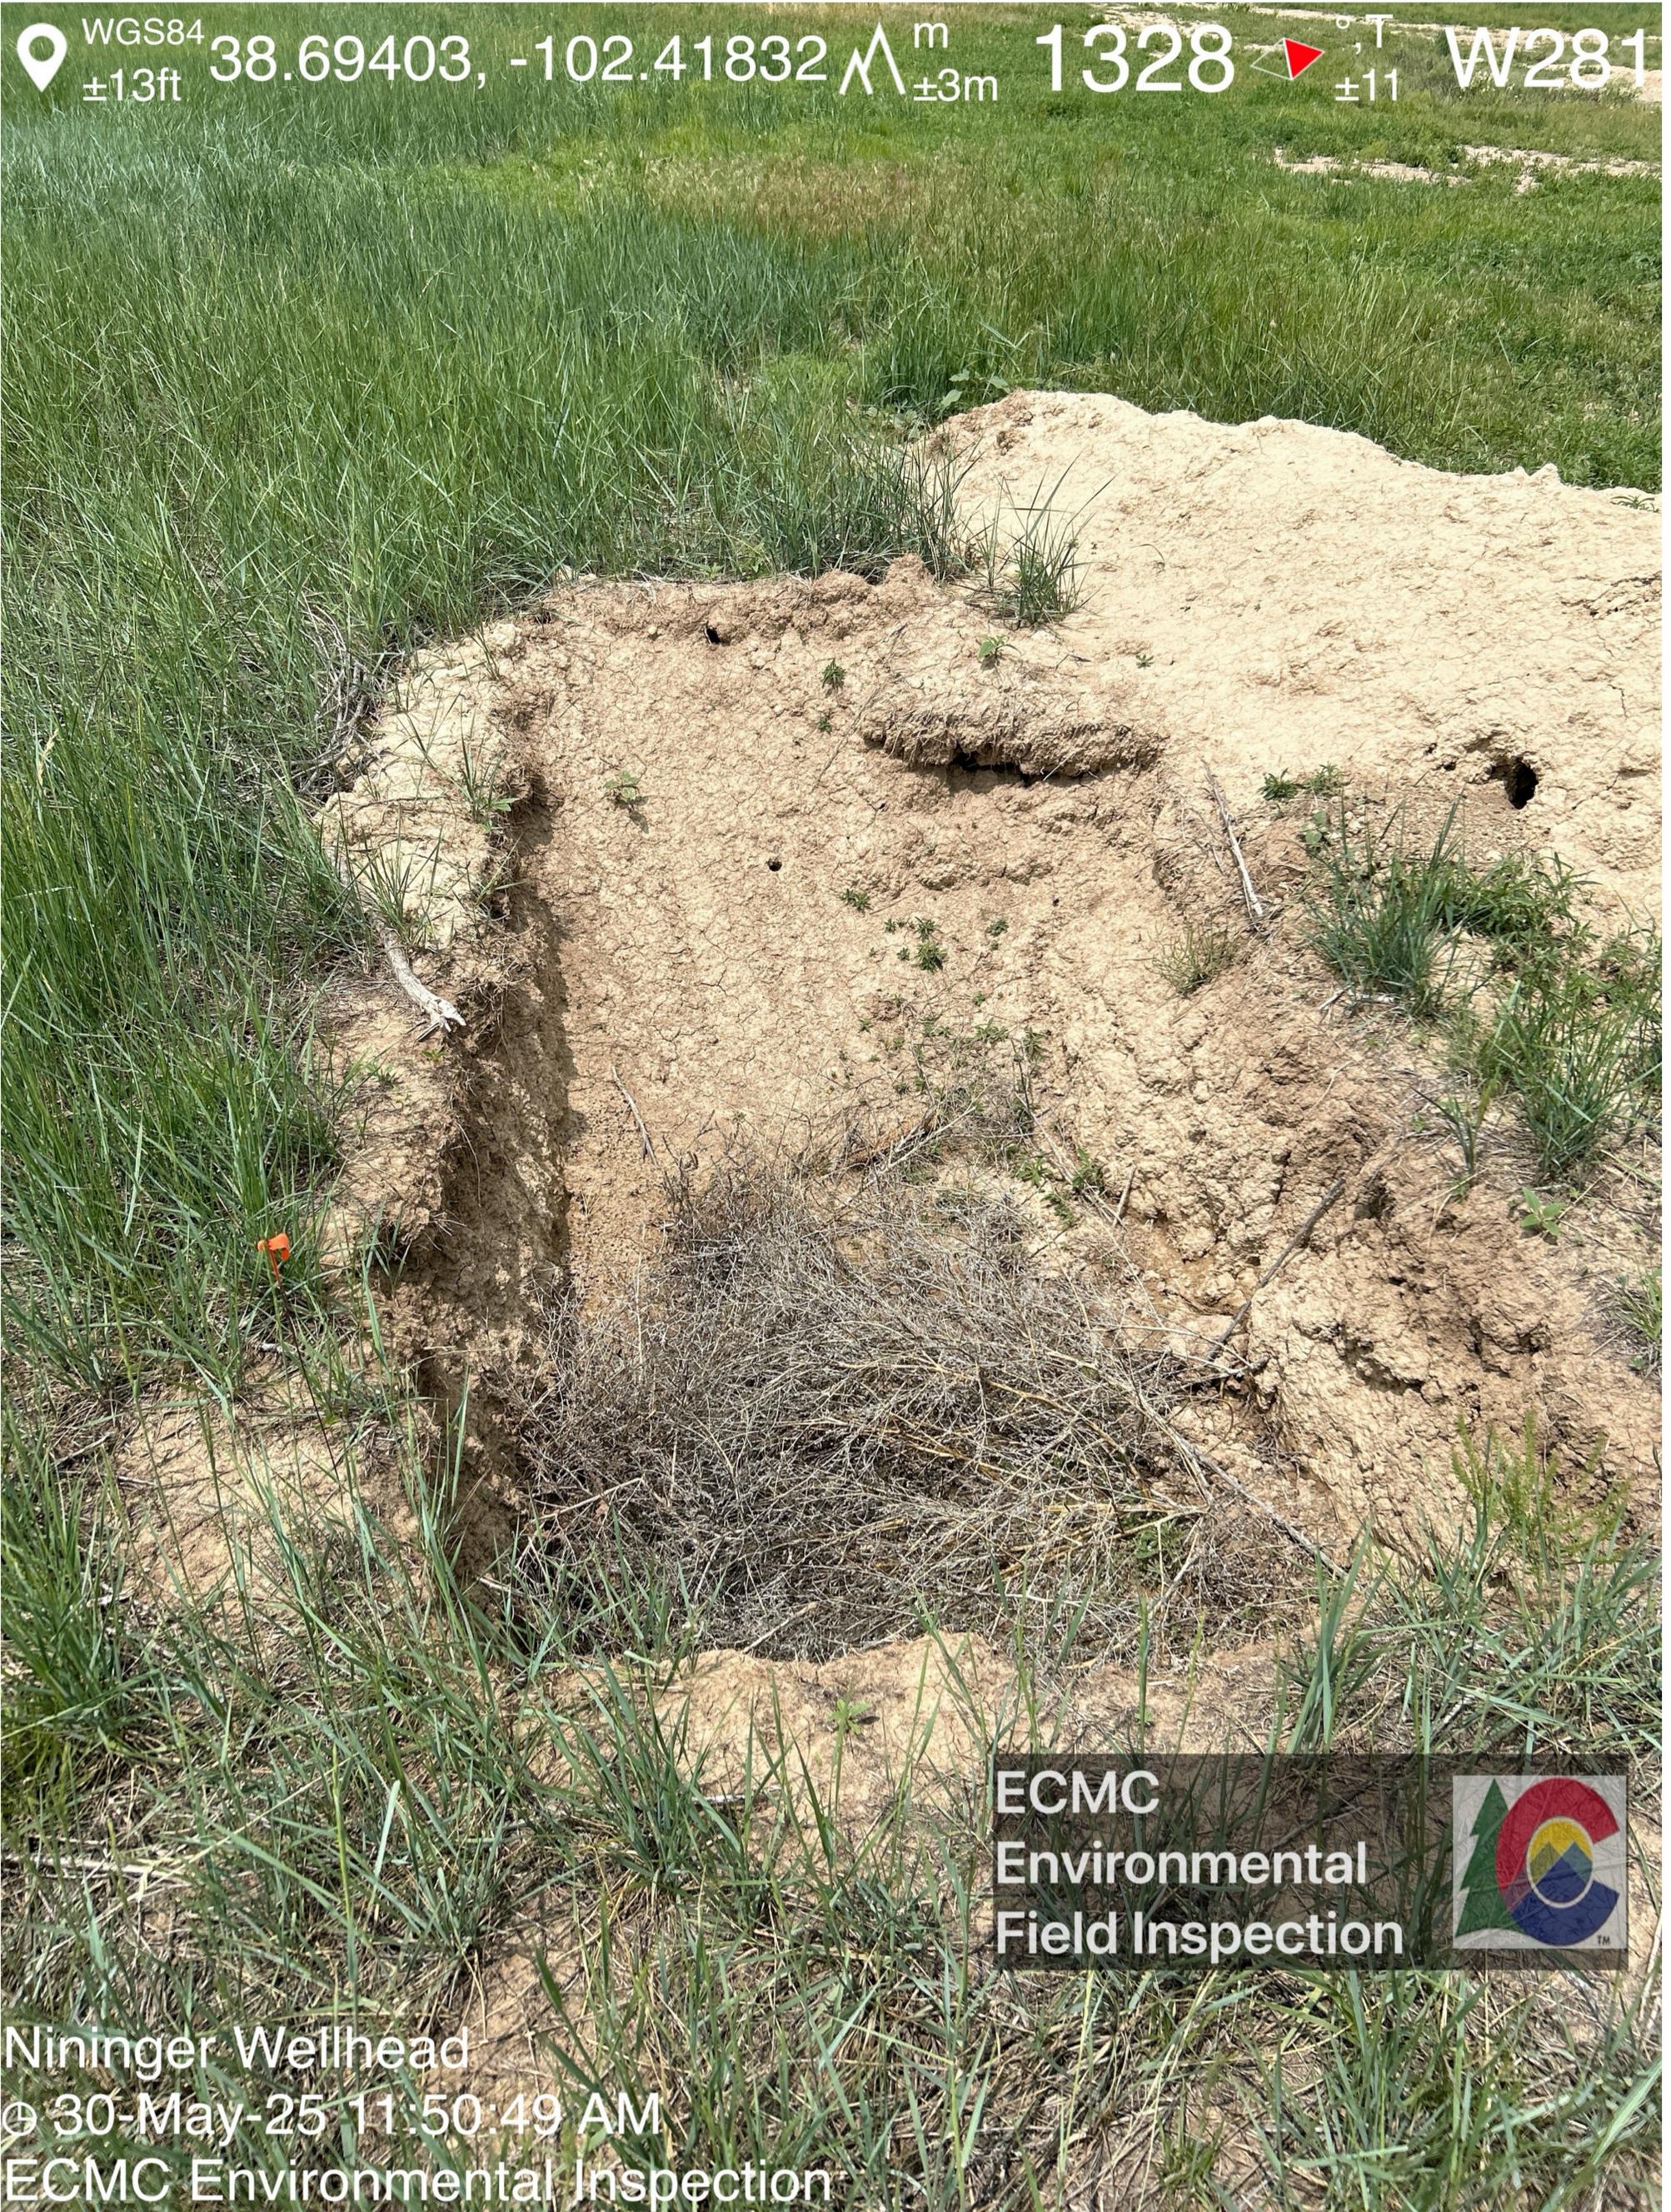
Debris is visible within the excavation. Animal burrows are visible within the stockpile.
