Nininger Tank Battery
© 30-May-25 11:56:16 AM
ECMC Environmental Inspection

ECMC
Environmental
Field Inspection

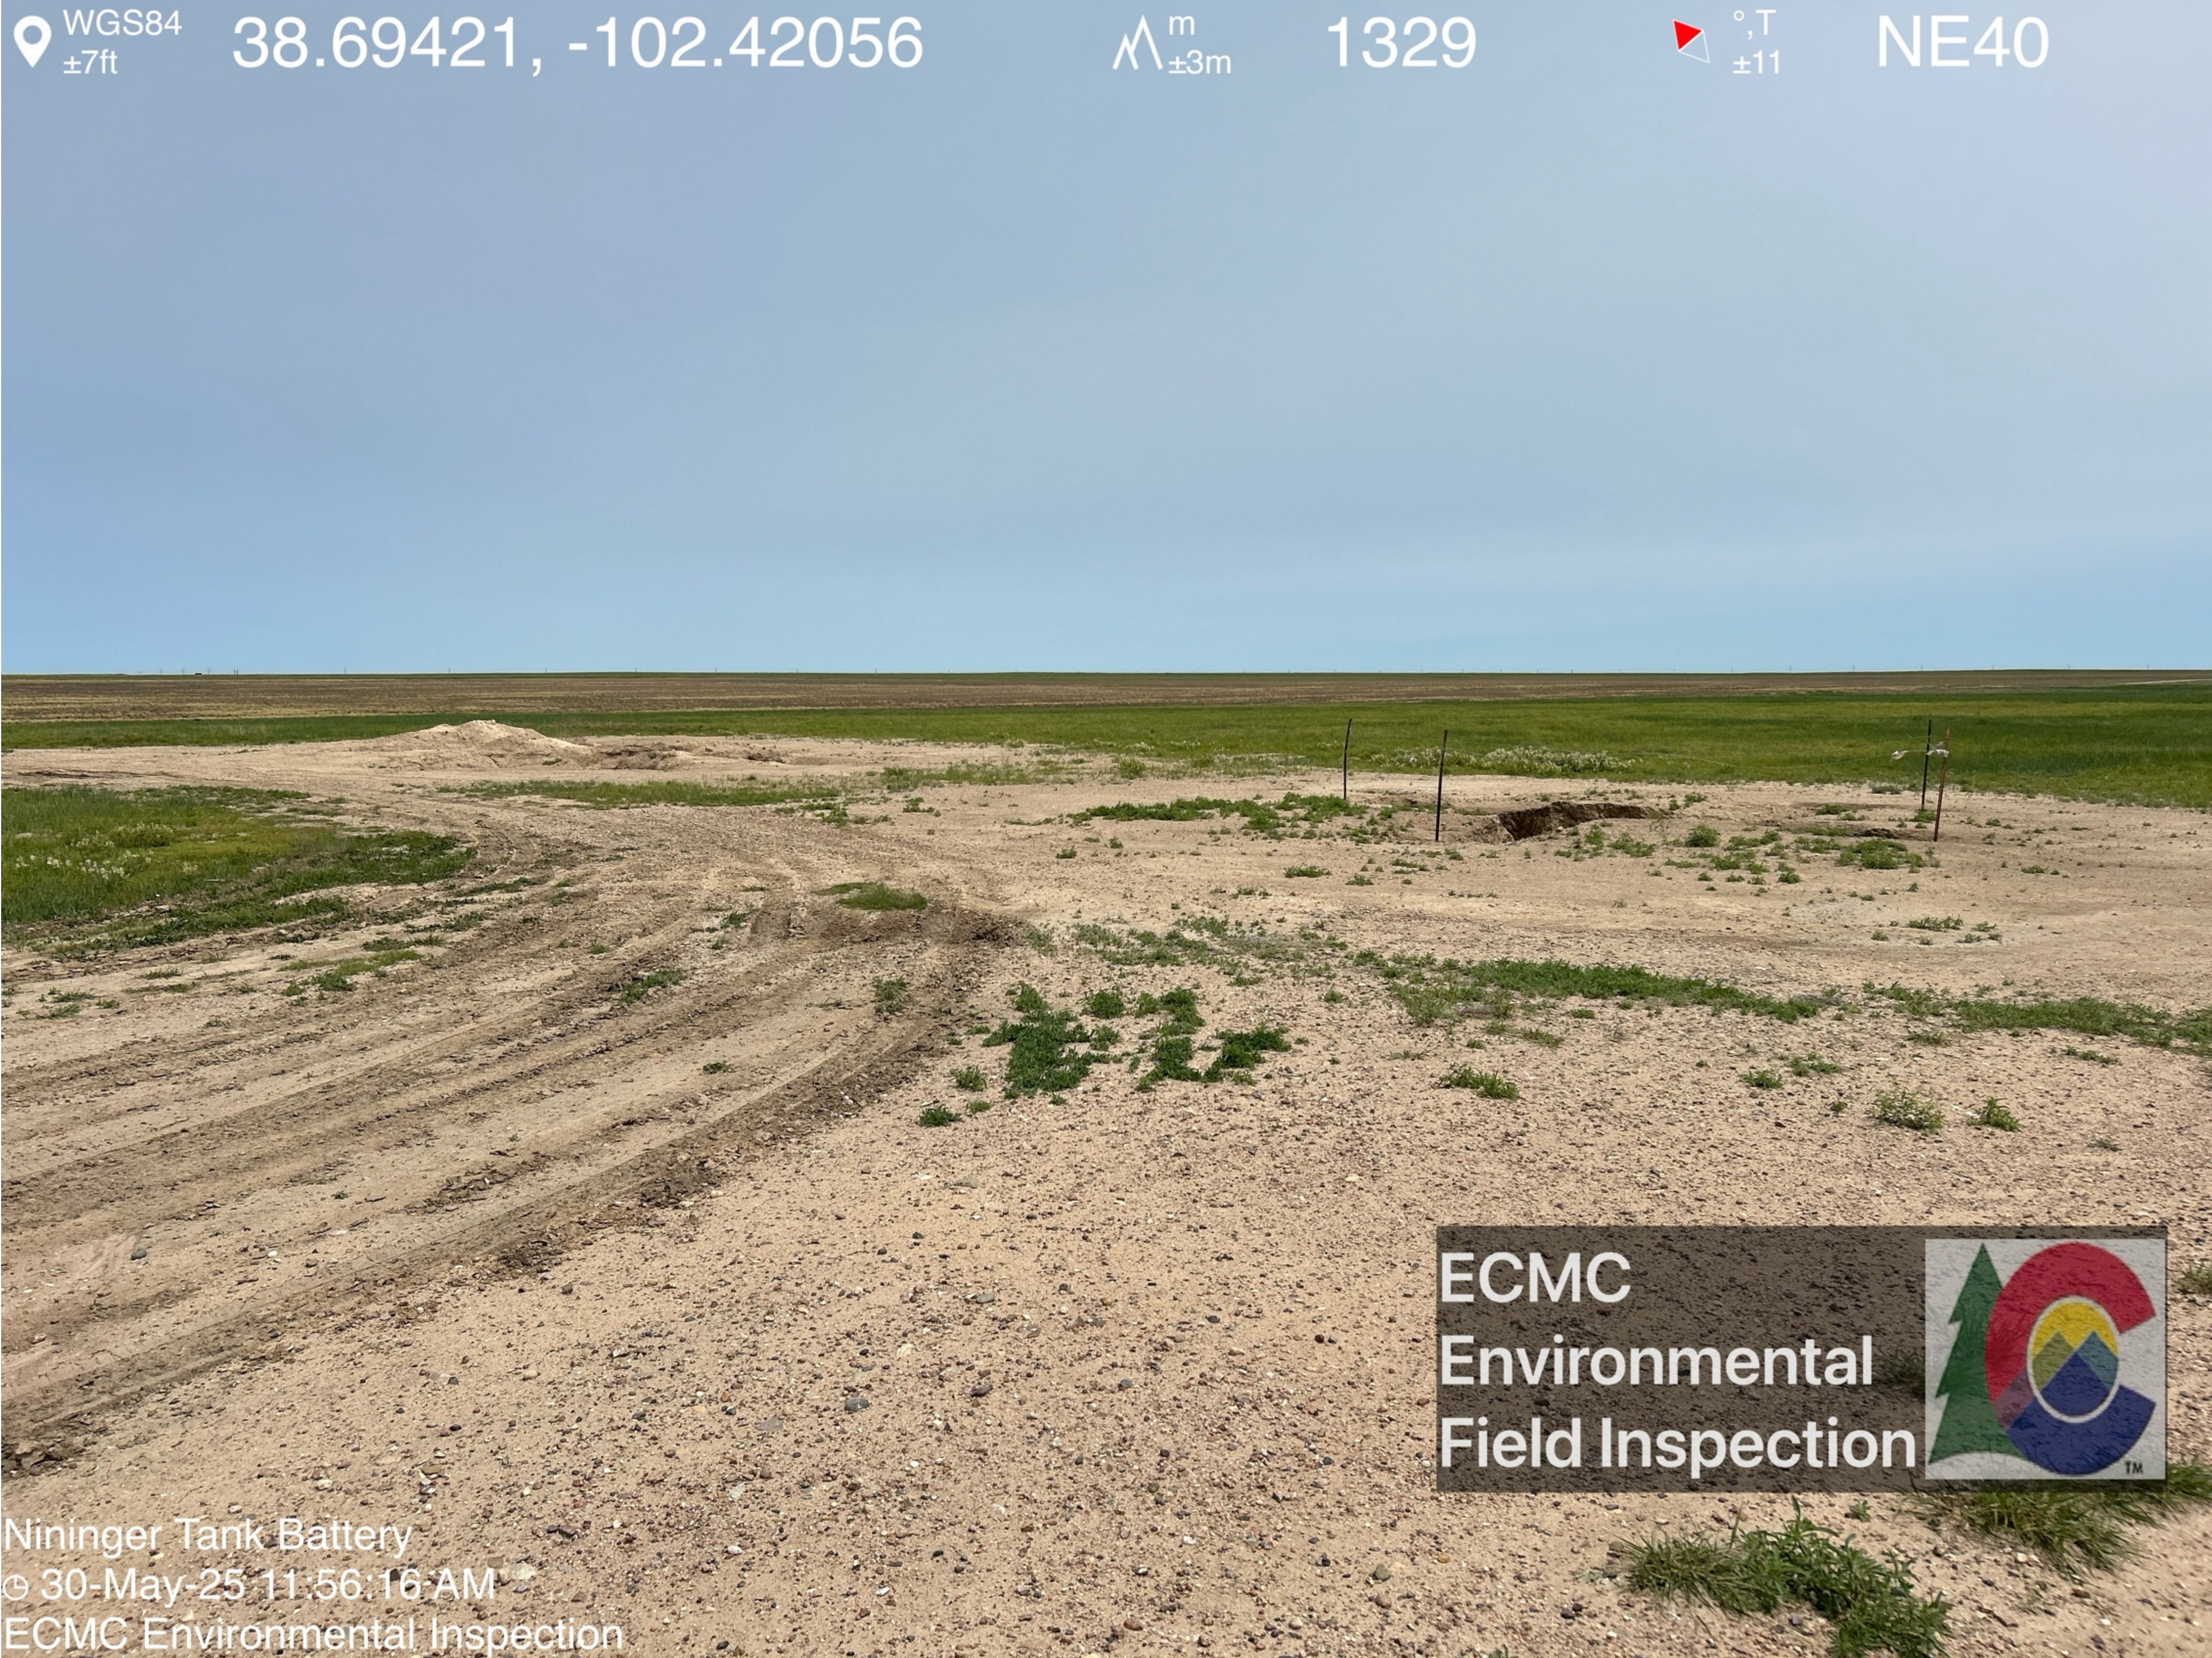
Looking at former tank battery from access road. Excavations remain open in the areas of former infrastructure. The excavations consist of interconnected trenches. Fence posts and a metal wire have been installed around one of the open excavations.

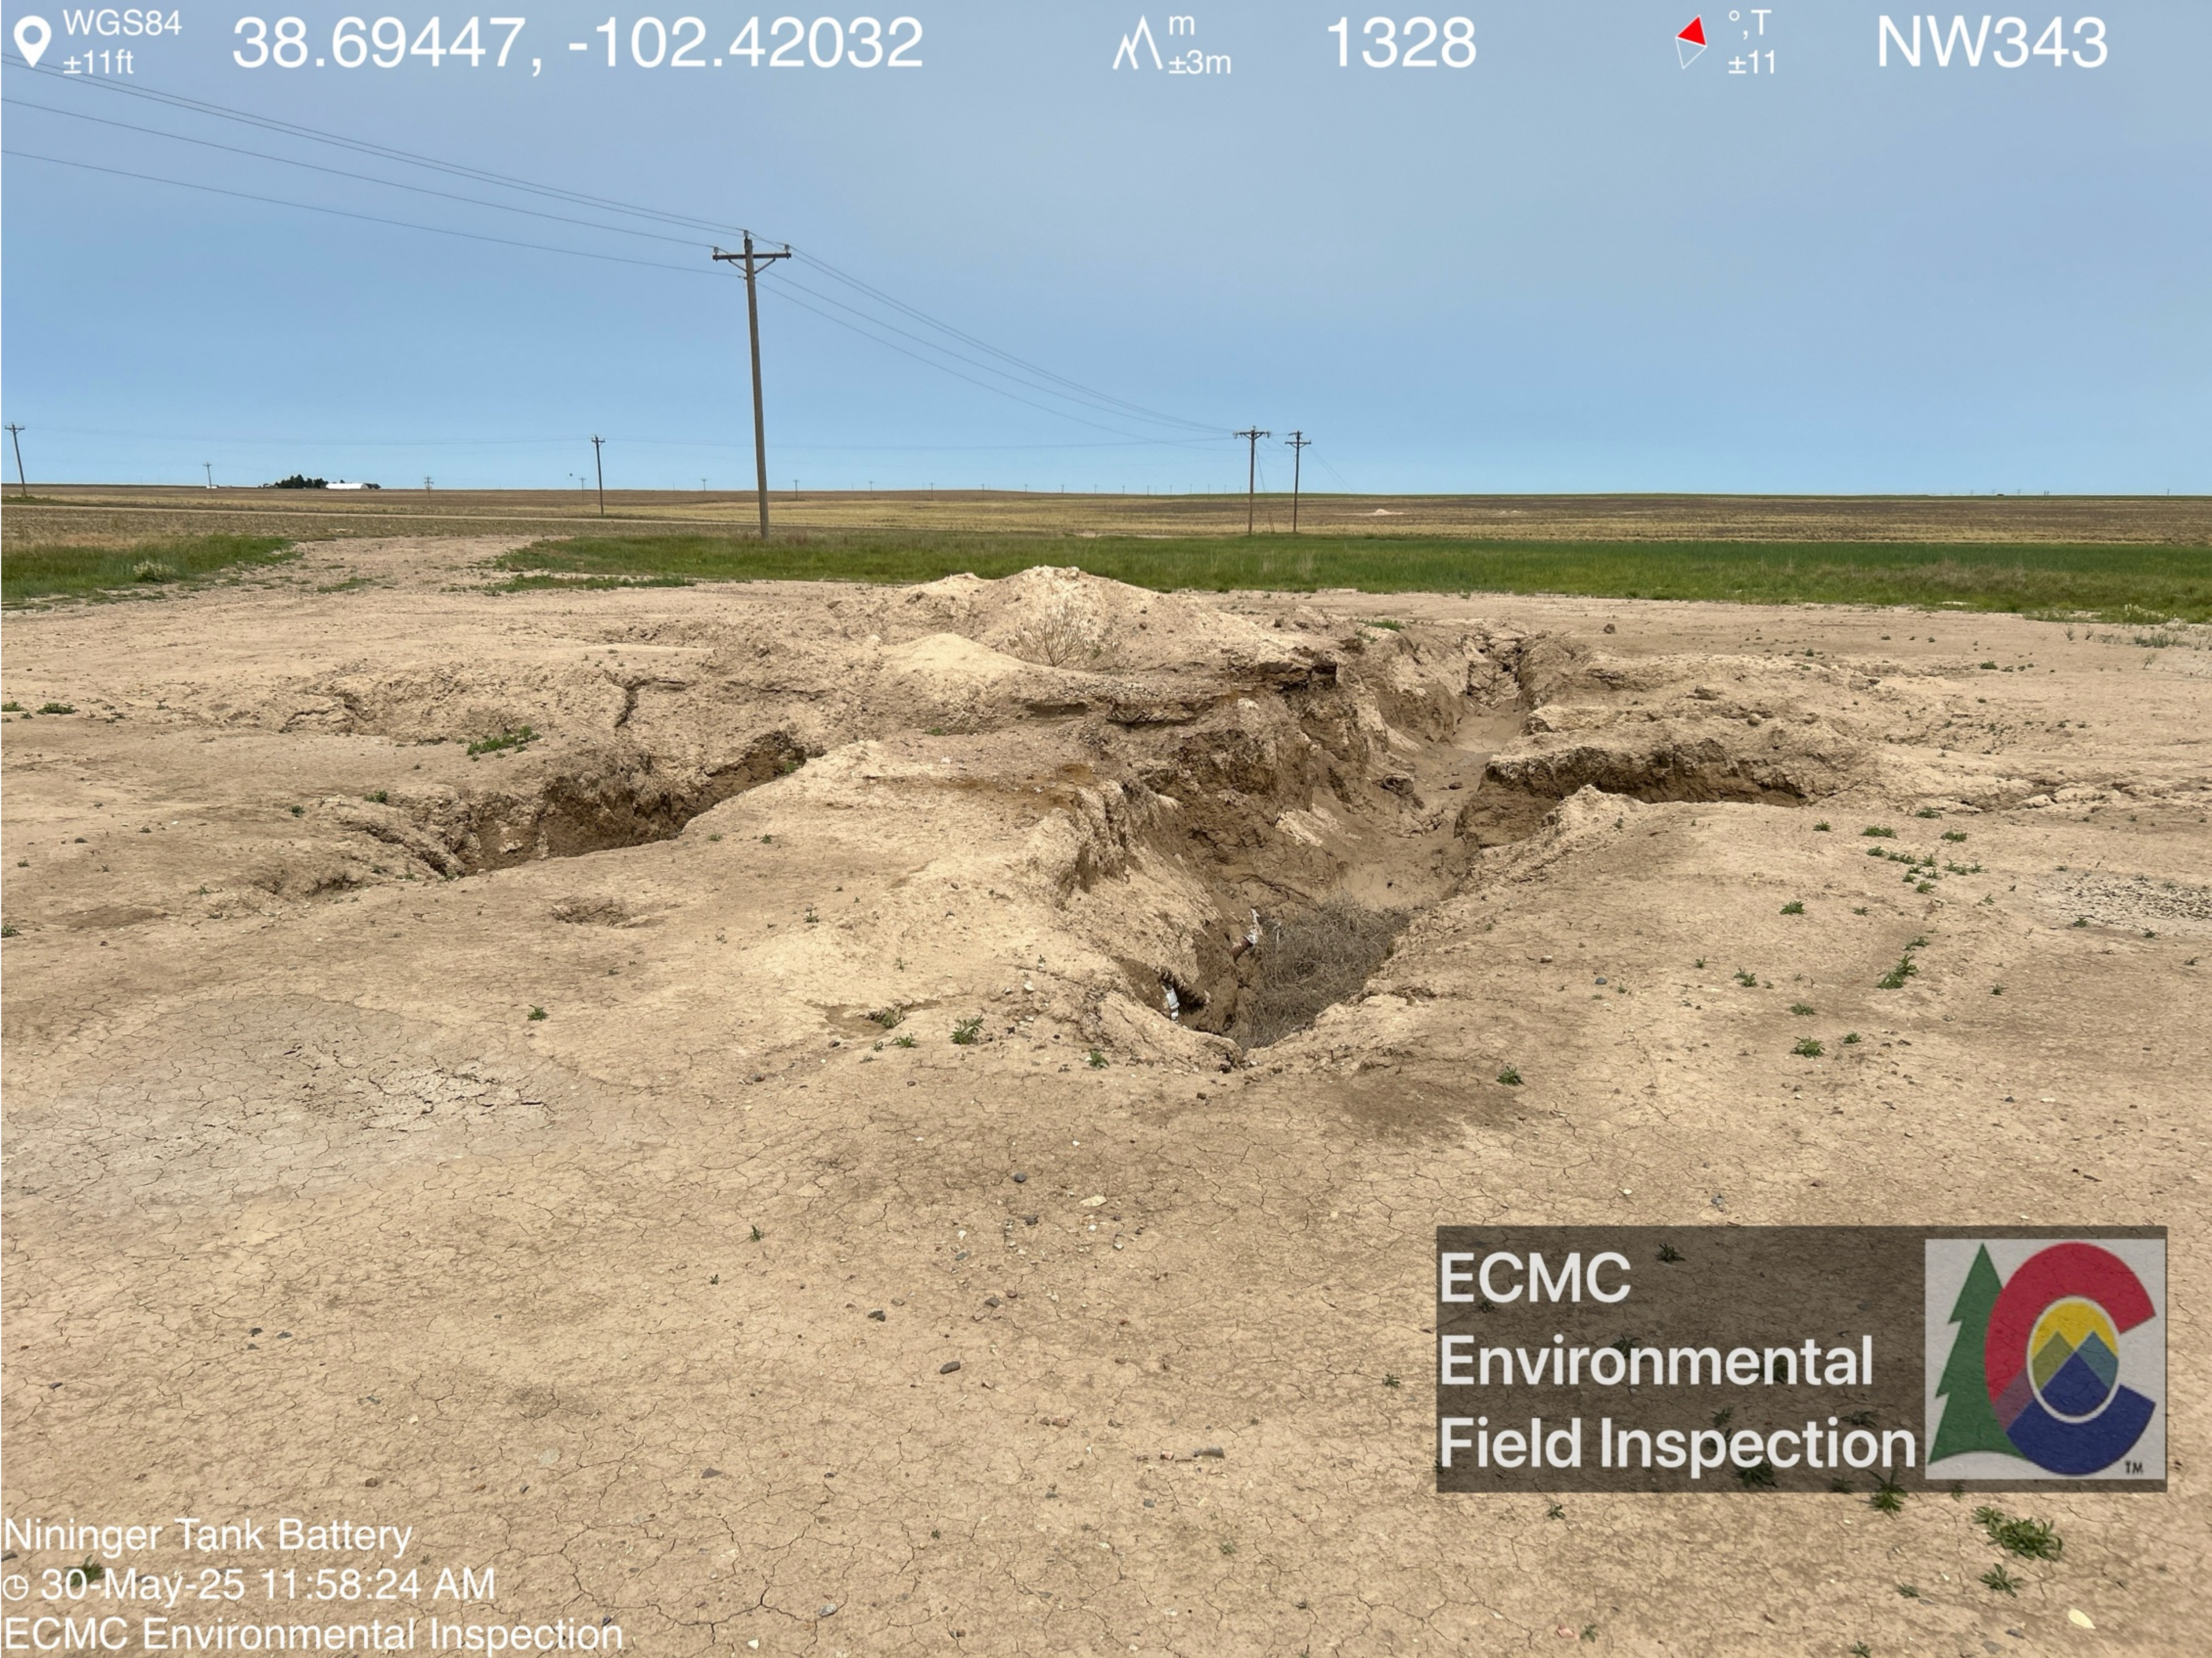
Nininger Tank Battery
Ⓢ 30-May-25 11:58:24 AM
ECMC Environmental Inspection

A second excavation remains open at the former tank battery. No fencing is visible.
