ECMC
Environmental
Field Inspection

Lowe #1-2R Wellhead
© 30-May-25 12:20:37 PM
ECMC Environmental Inspection

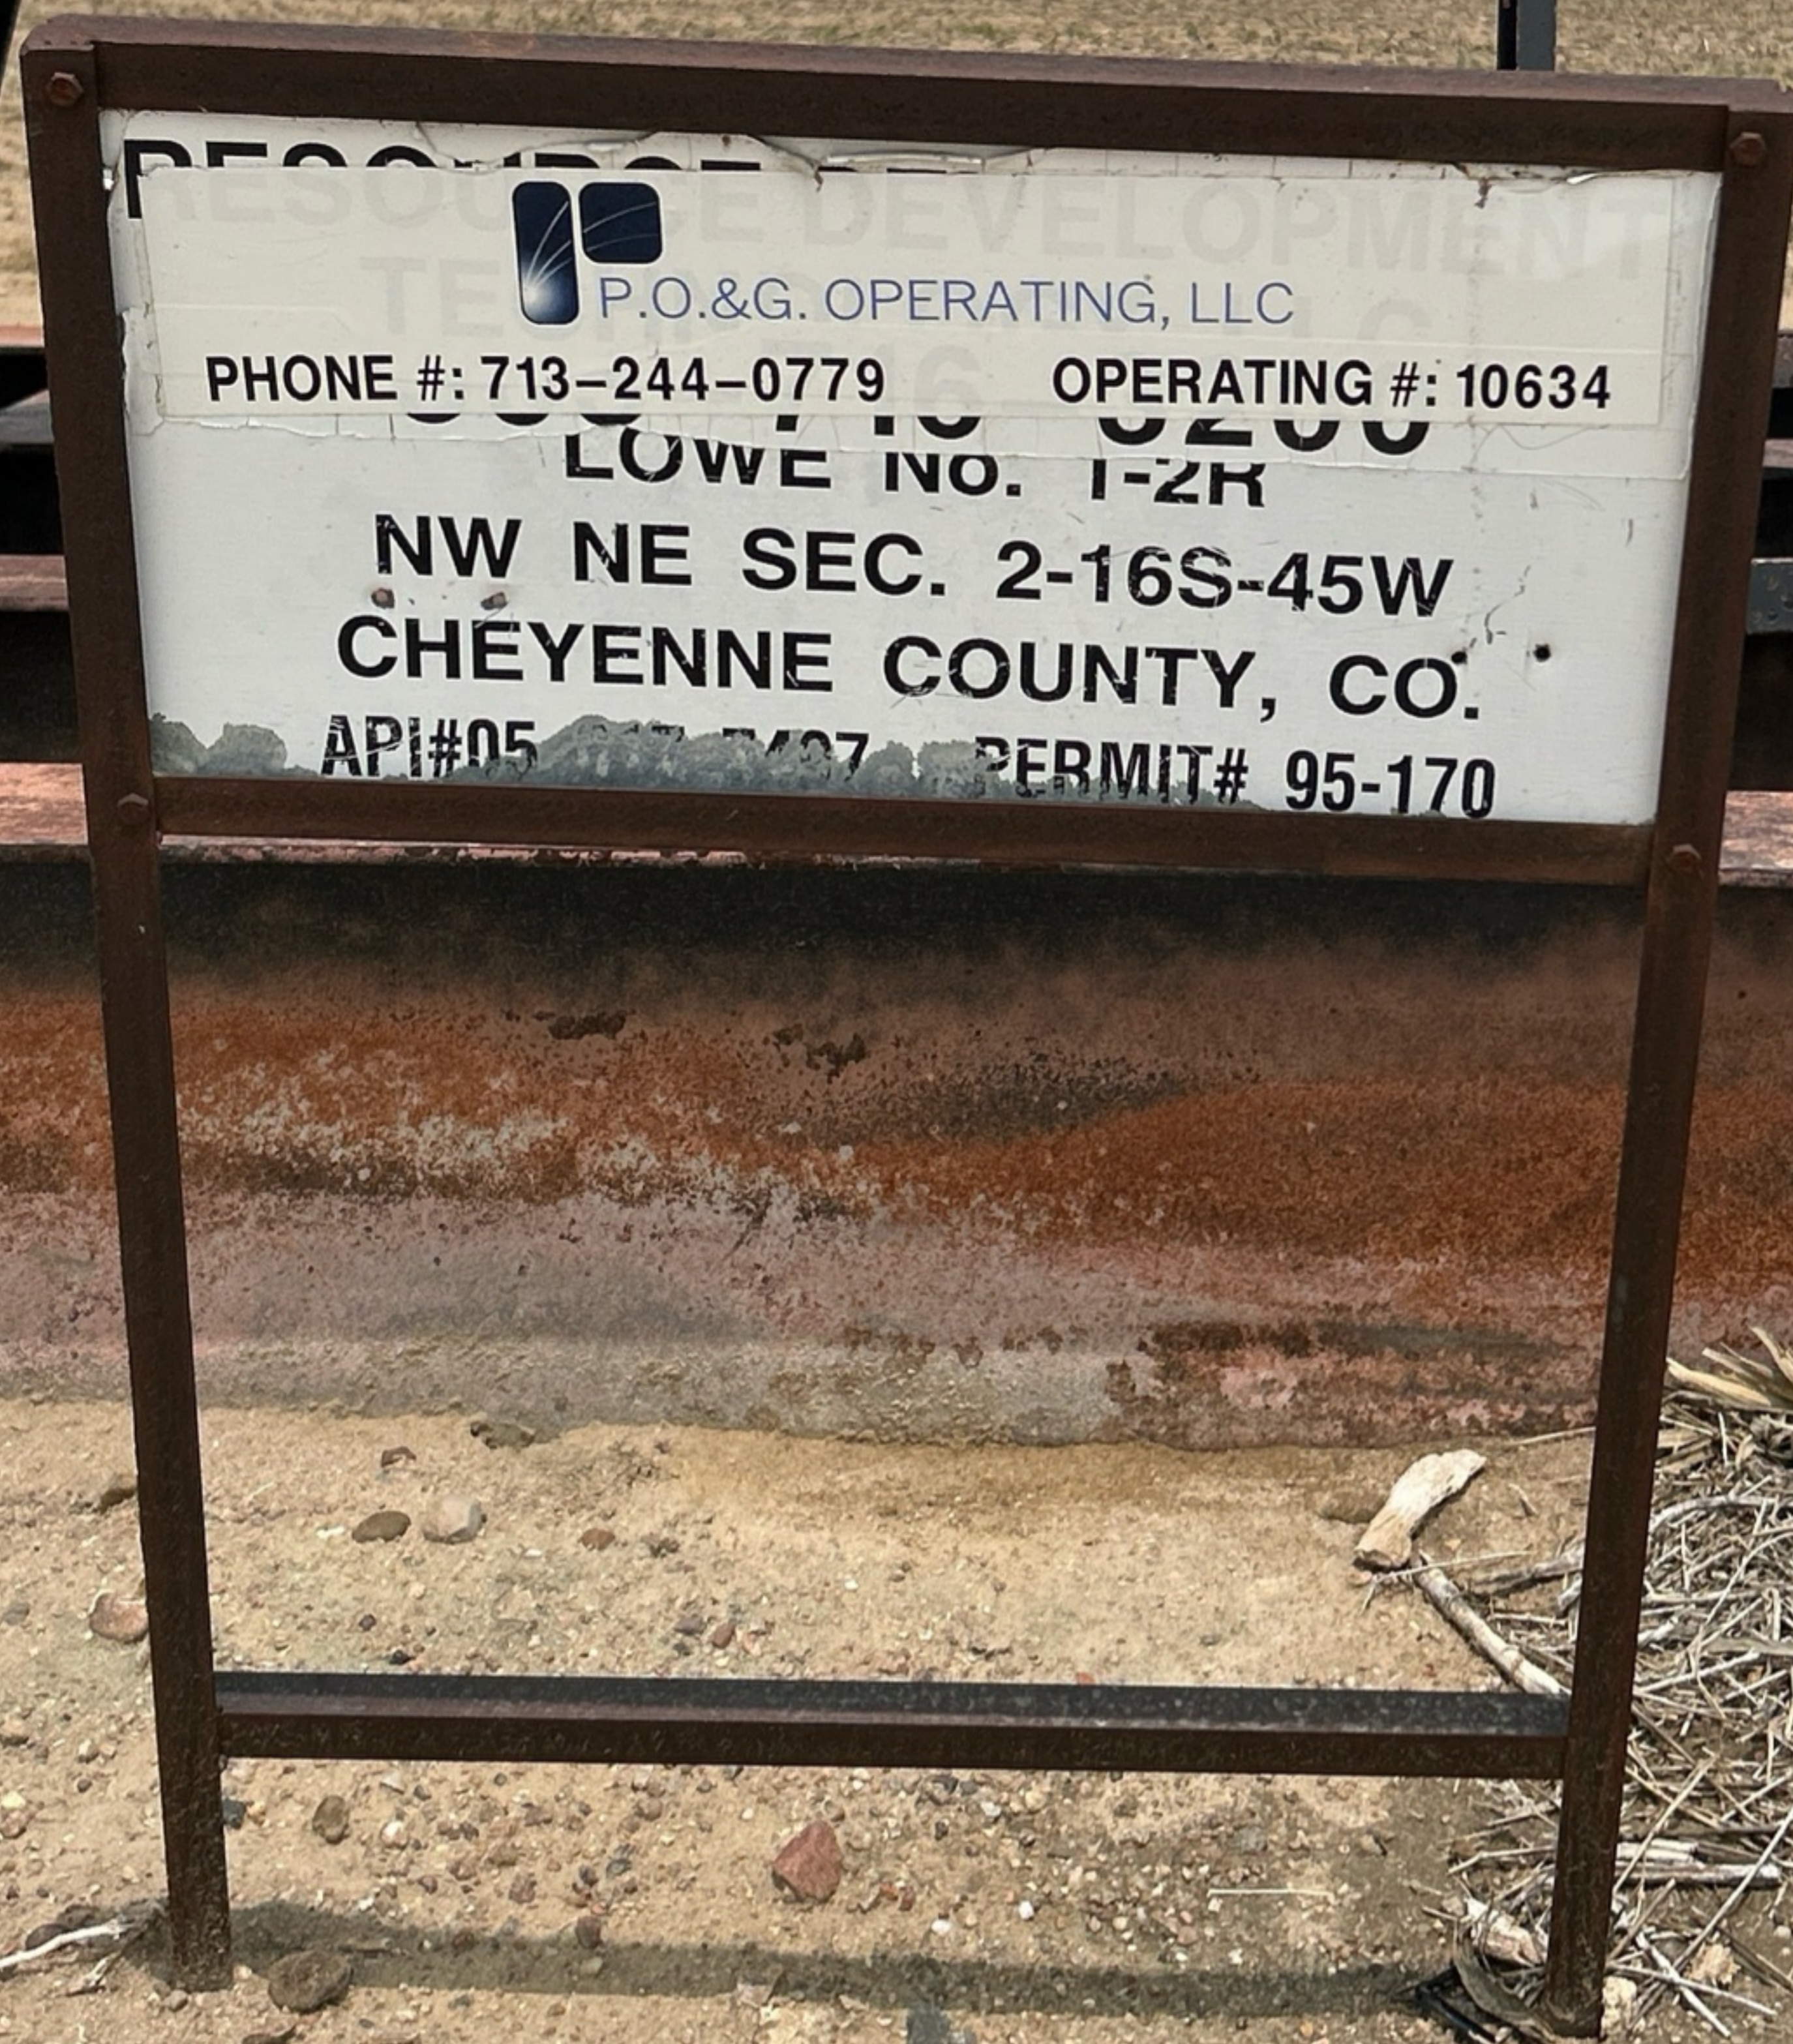
Lowe #1-2R Wellhead
© 30-May-25 12:20:57 PM
ECMC Environmental Inspection

Signage with emergency contact number is visible. Portions of the sign including, the API number, are illegible.

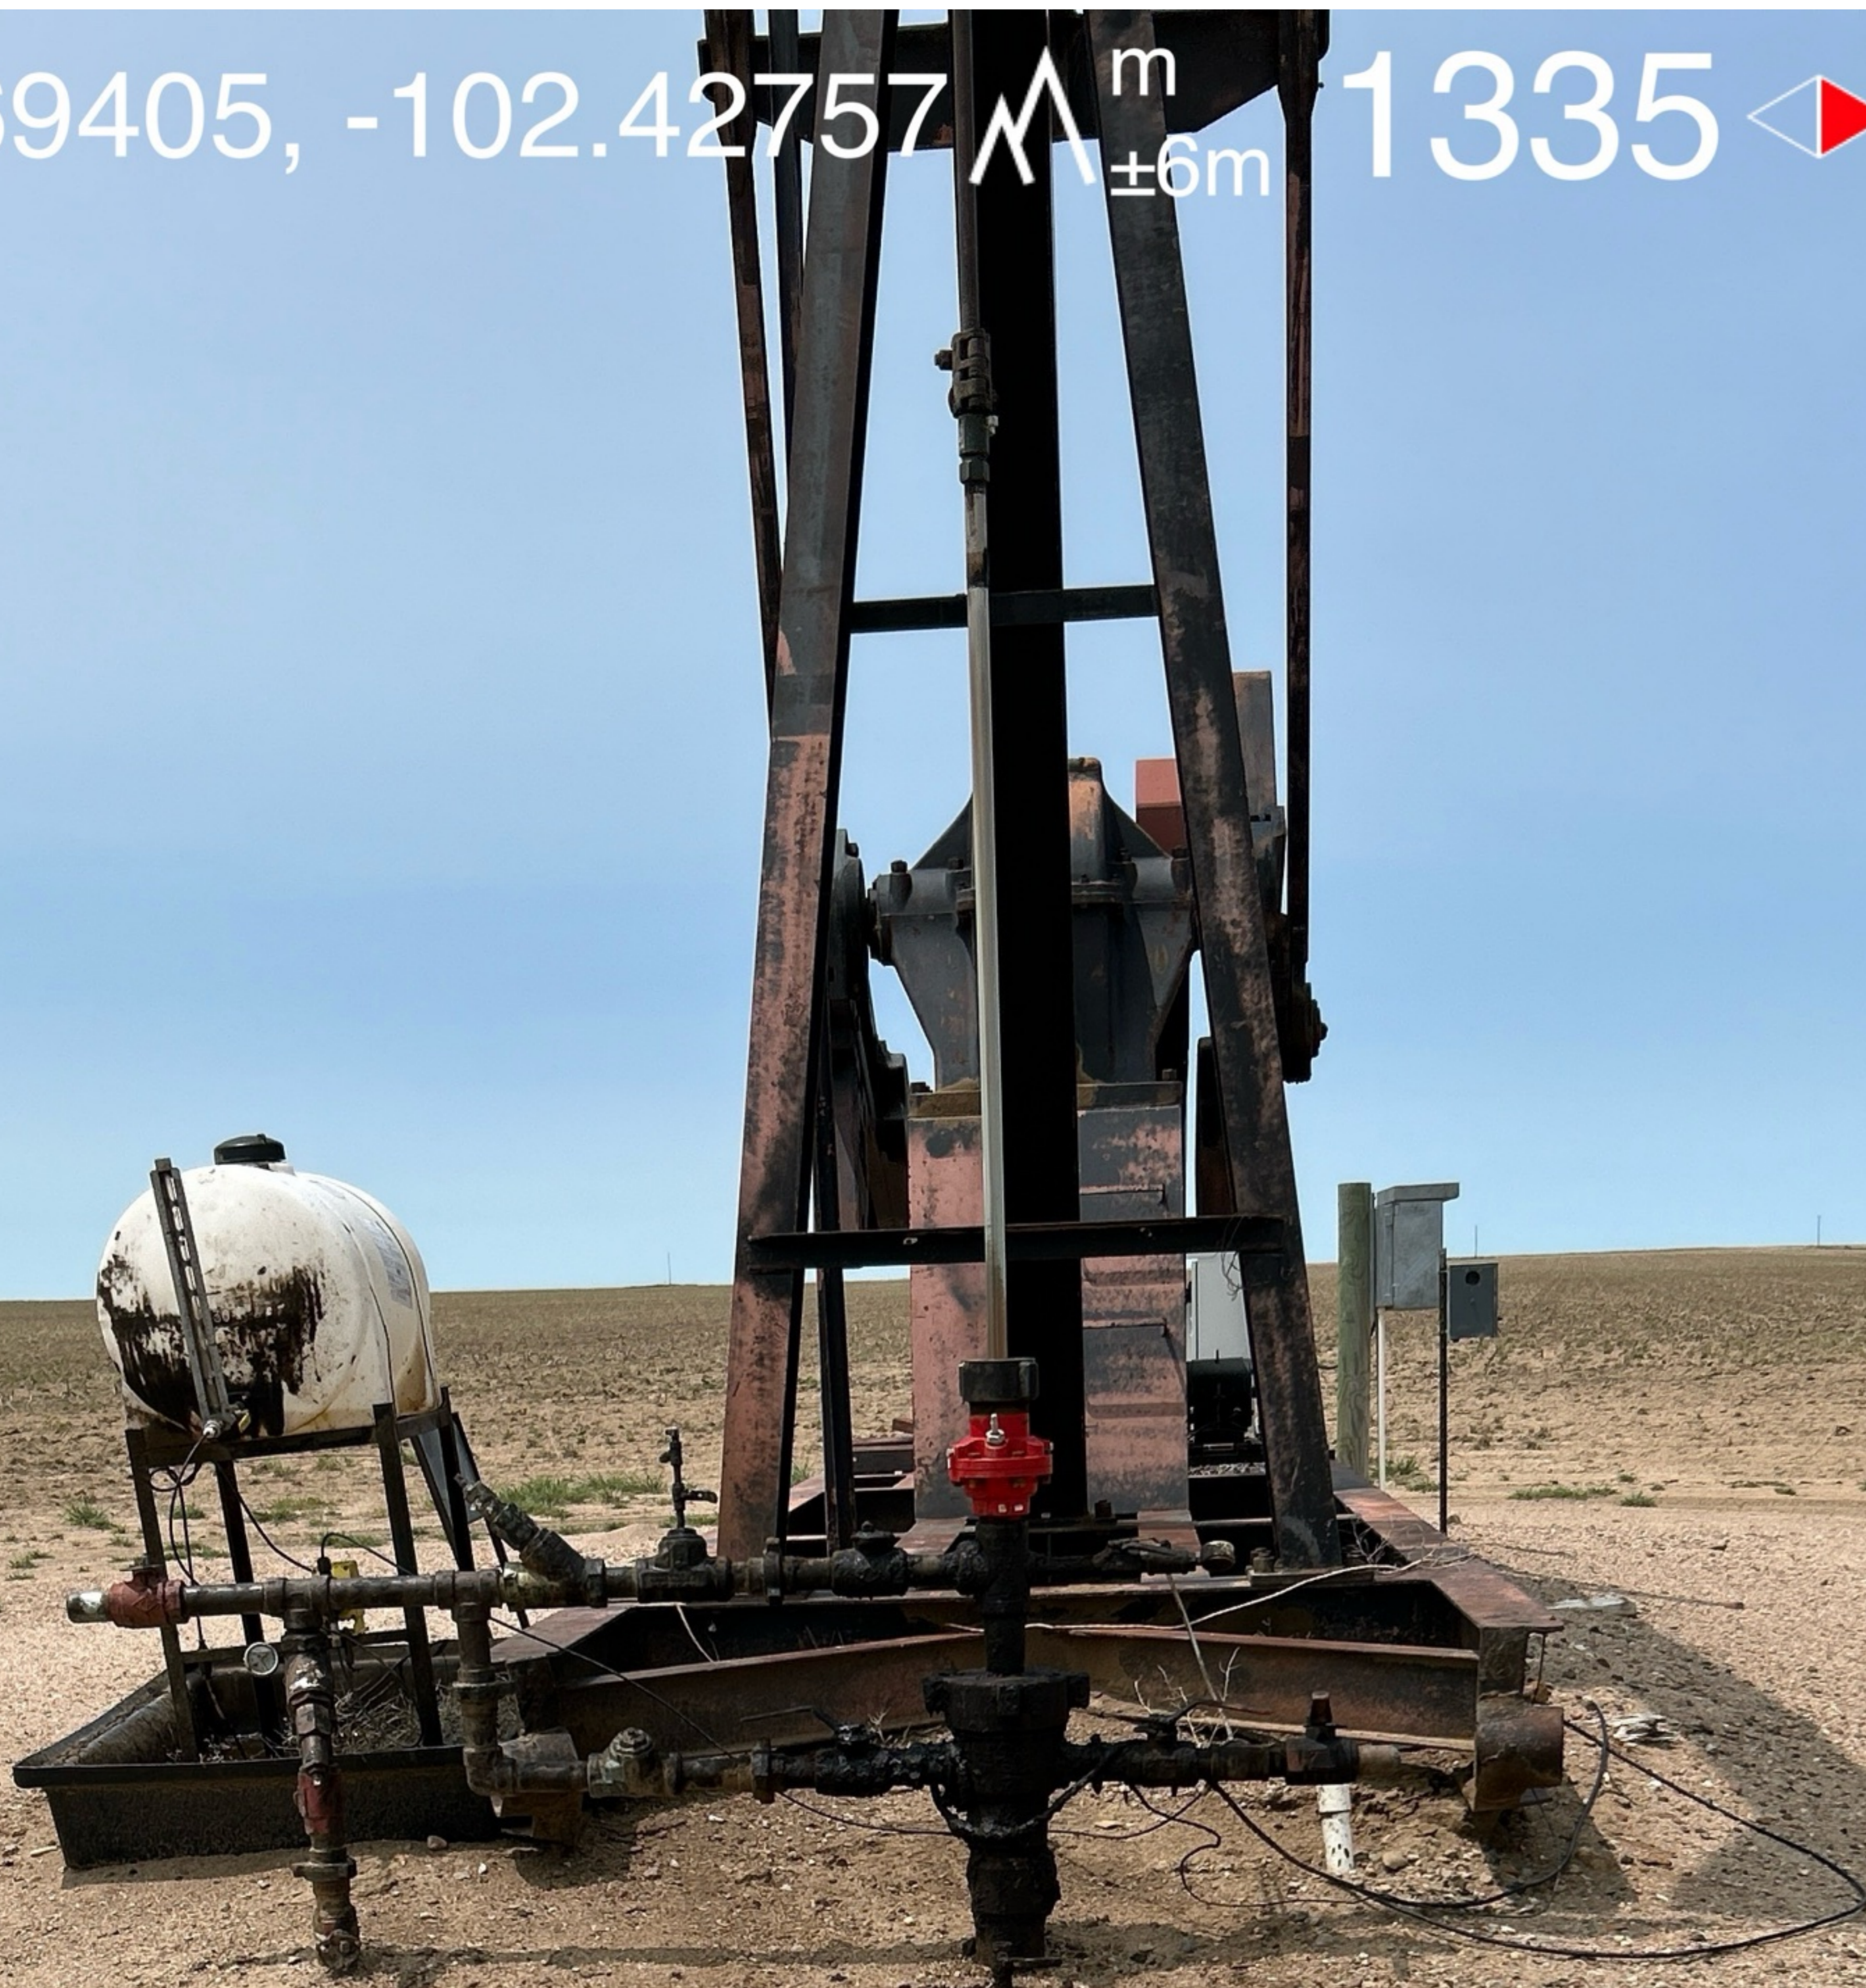
Lowe #1-2R Wellhead
© 30-May-25 12:23:27 PM
ECMC Environmental Inspection

Stained soil is visible adjacent to the wellhead. A petroleum hydrocarbon odor was observed when the stained soil was disturbed.
