ECMC
Environmental
Field Inspection

Lowe 1B SWD Well
© 30-May-25 01:29:36 PM
ECMC Environmental Inspection

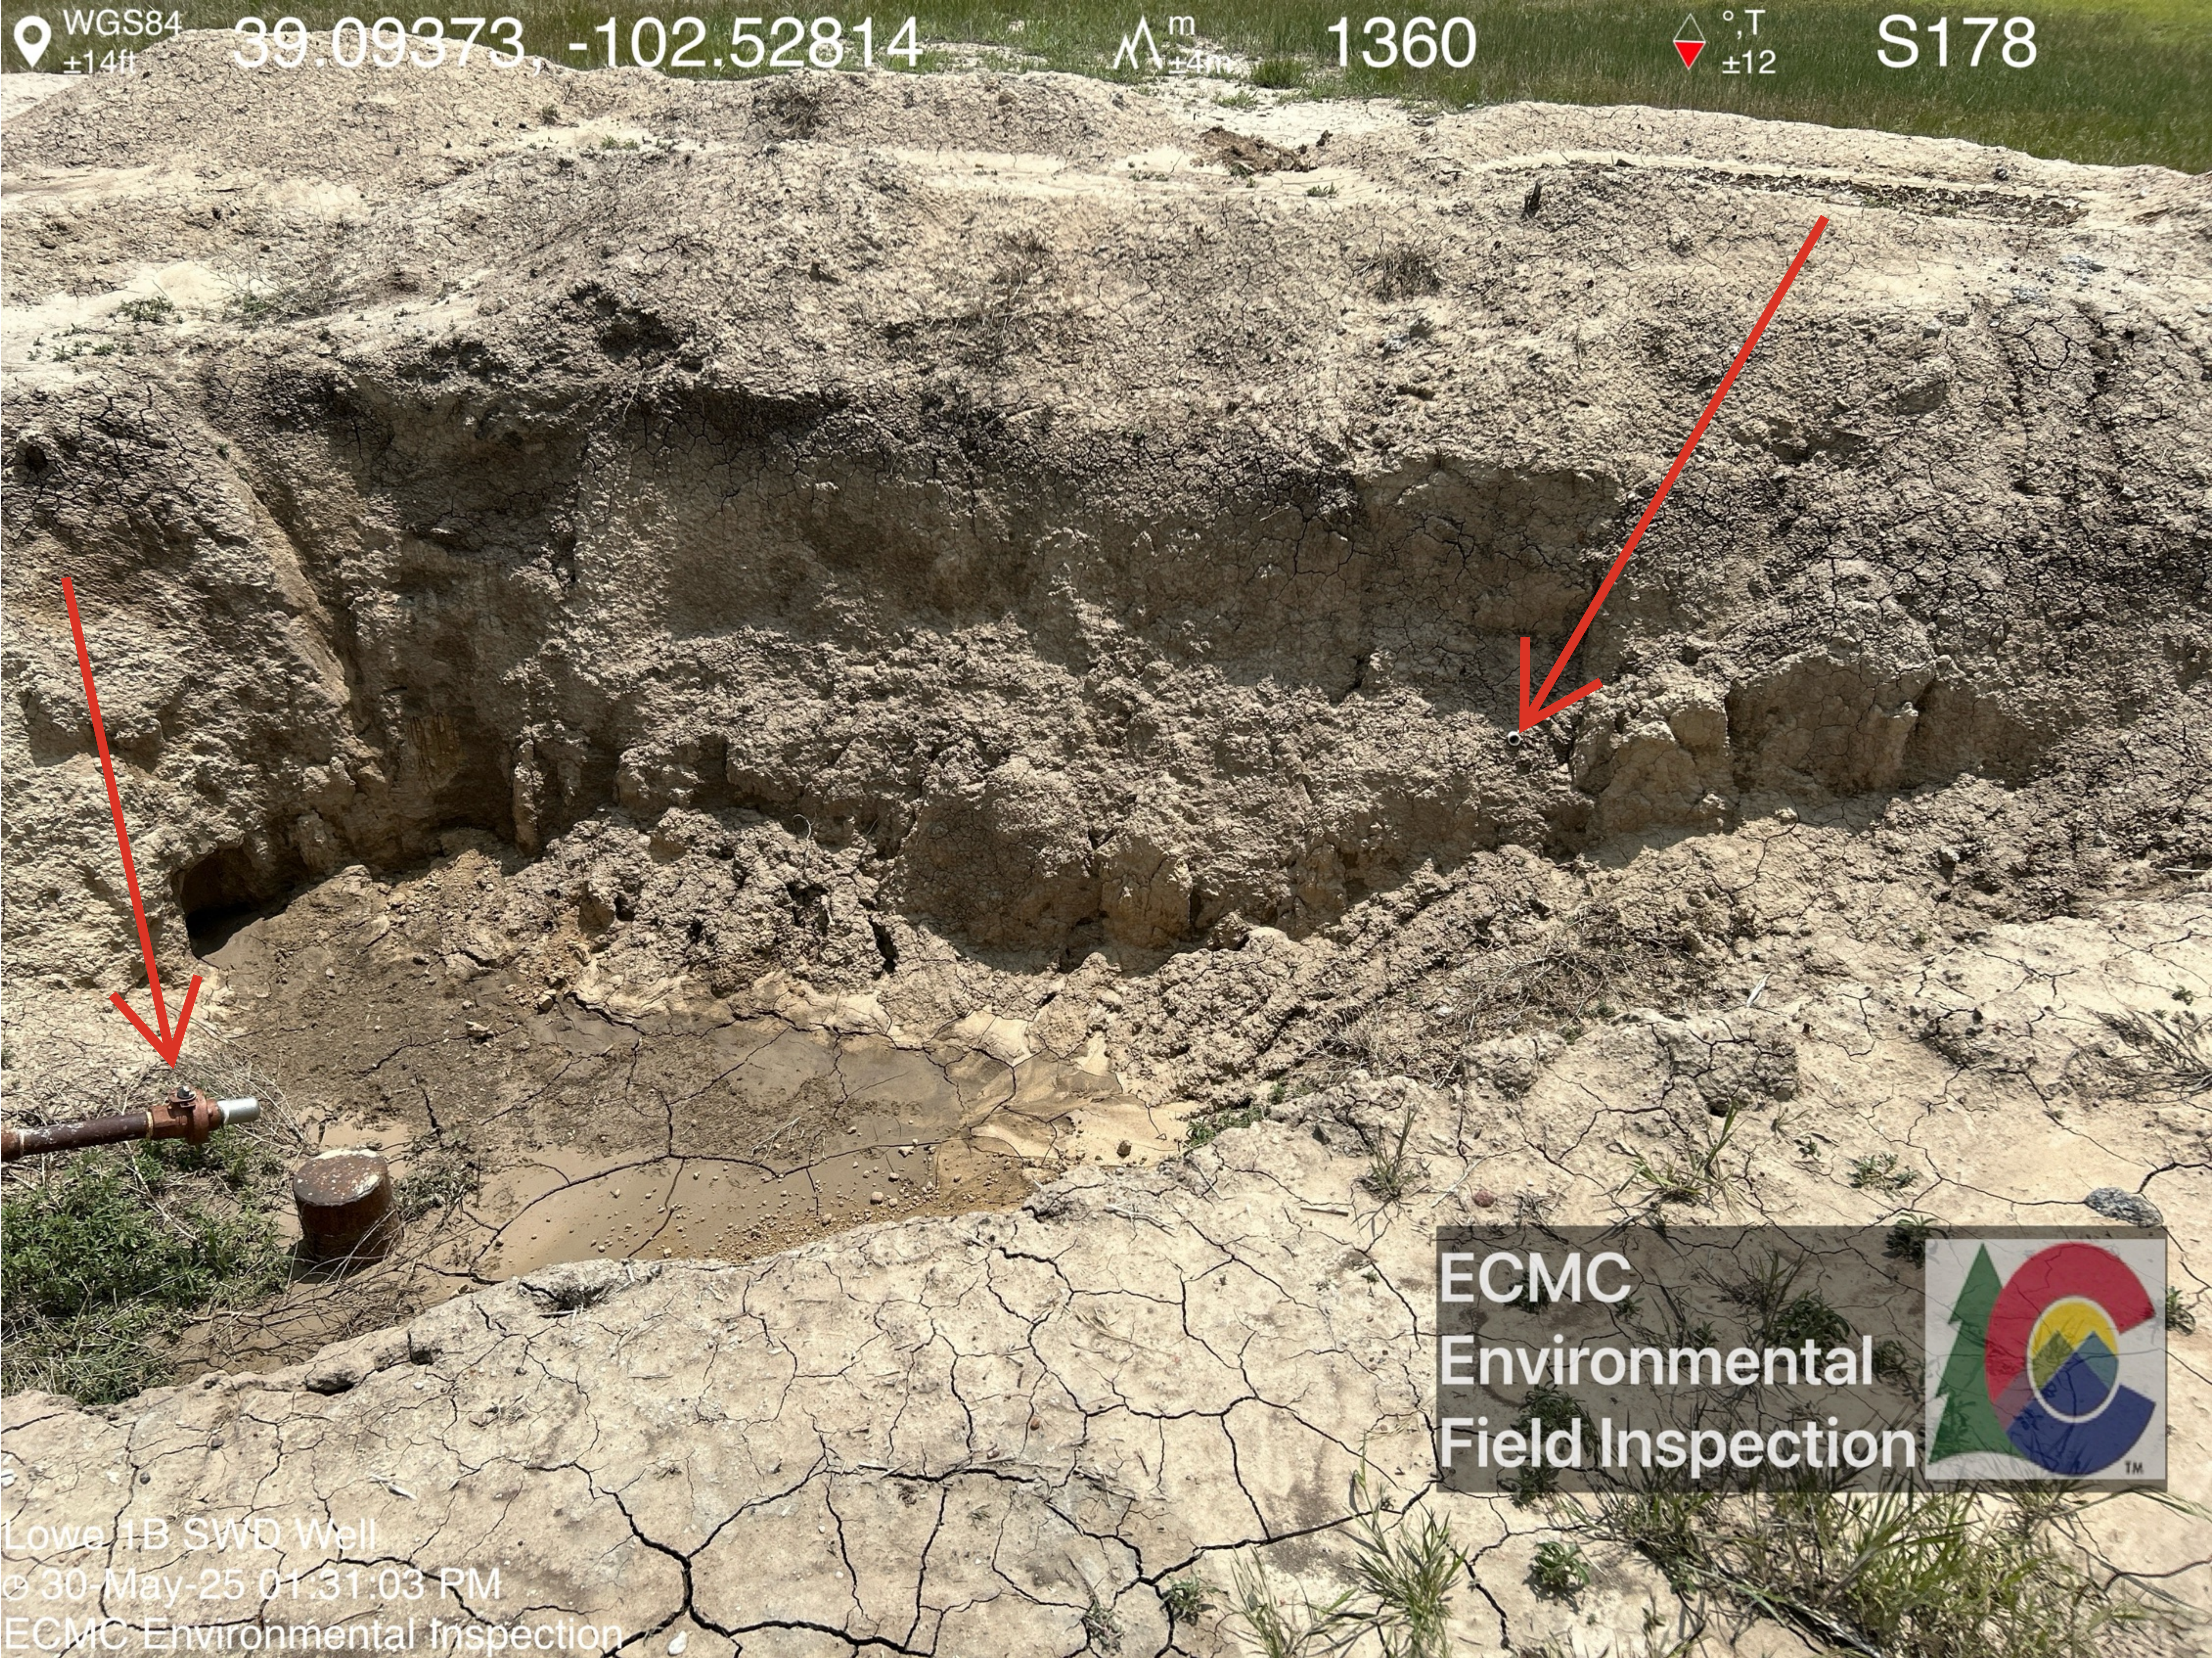
A segment of white plastic pipe is visible within the excavation; the pipe is uncapped. A segment of flowline is visible within the excavation; valves remain attached and a bull plug has been installed. The base of the excavation sidewalls appear to have partially eroded.

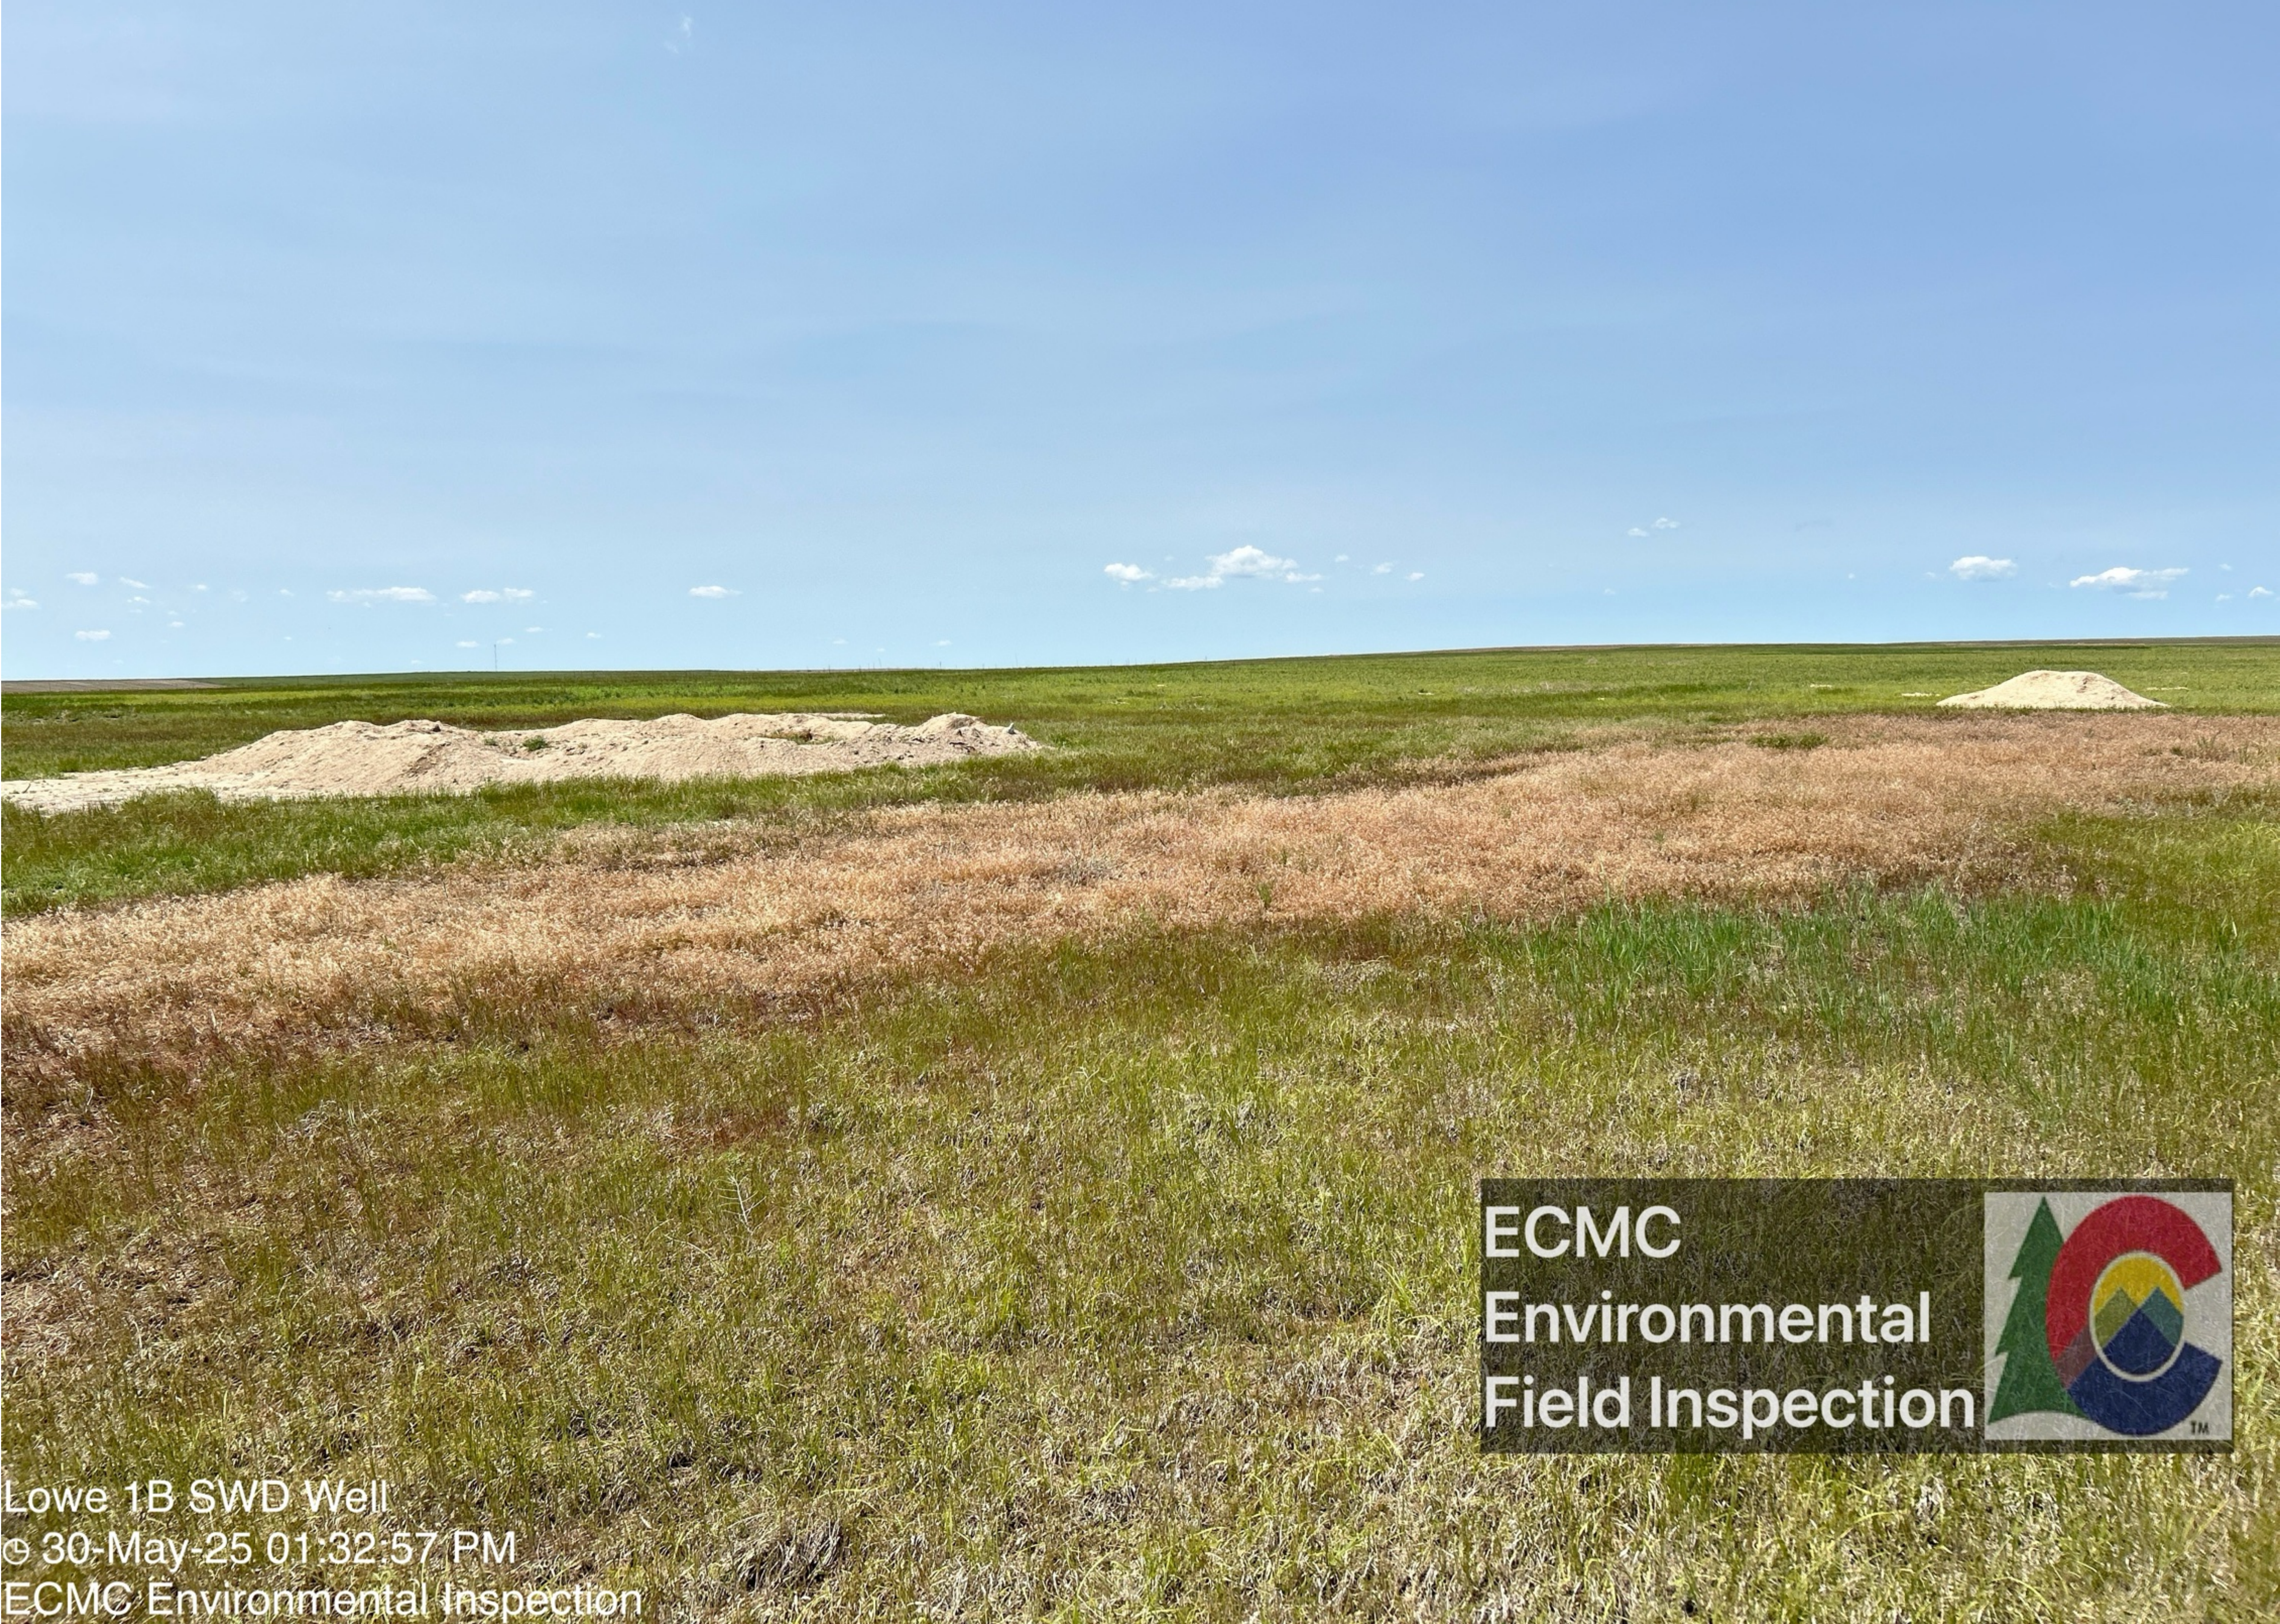
Lowe 1B SWD Well
© 30-May-25 01:32:57 PM
ECMC Environmental Inspection

Vegetation appears depressed in an area east of the former wellhead.

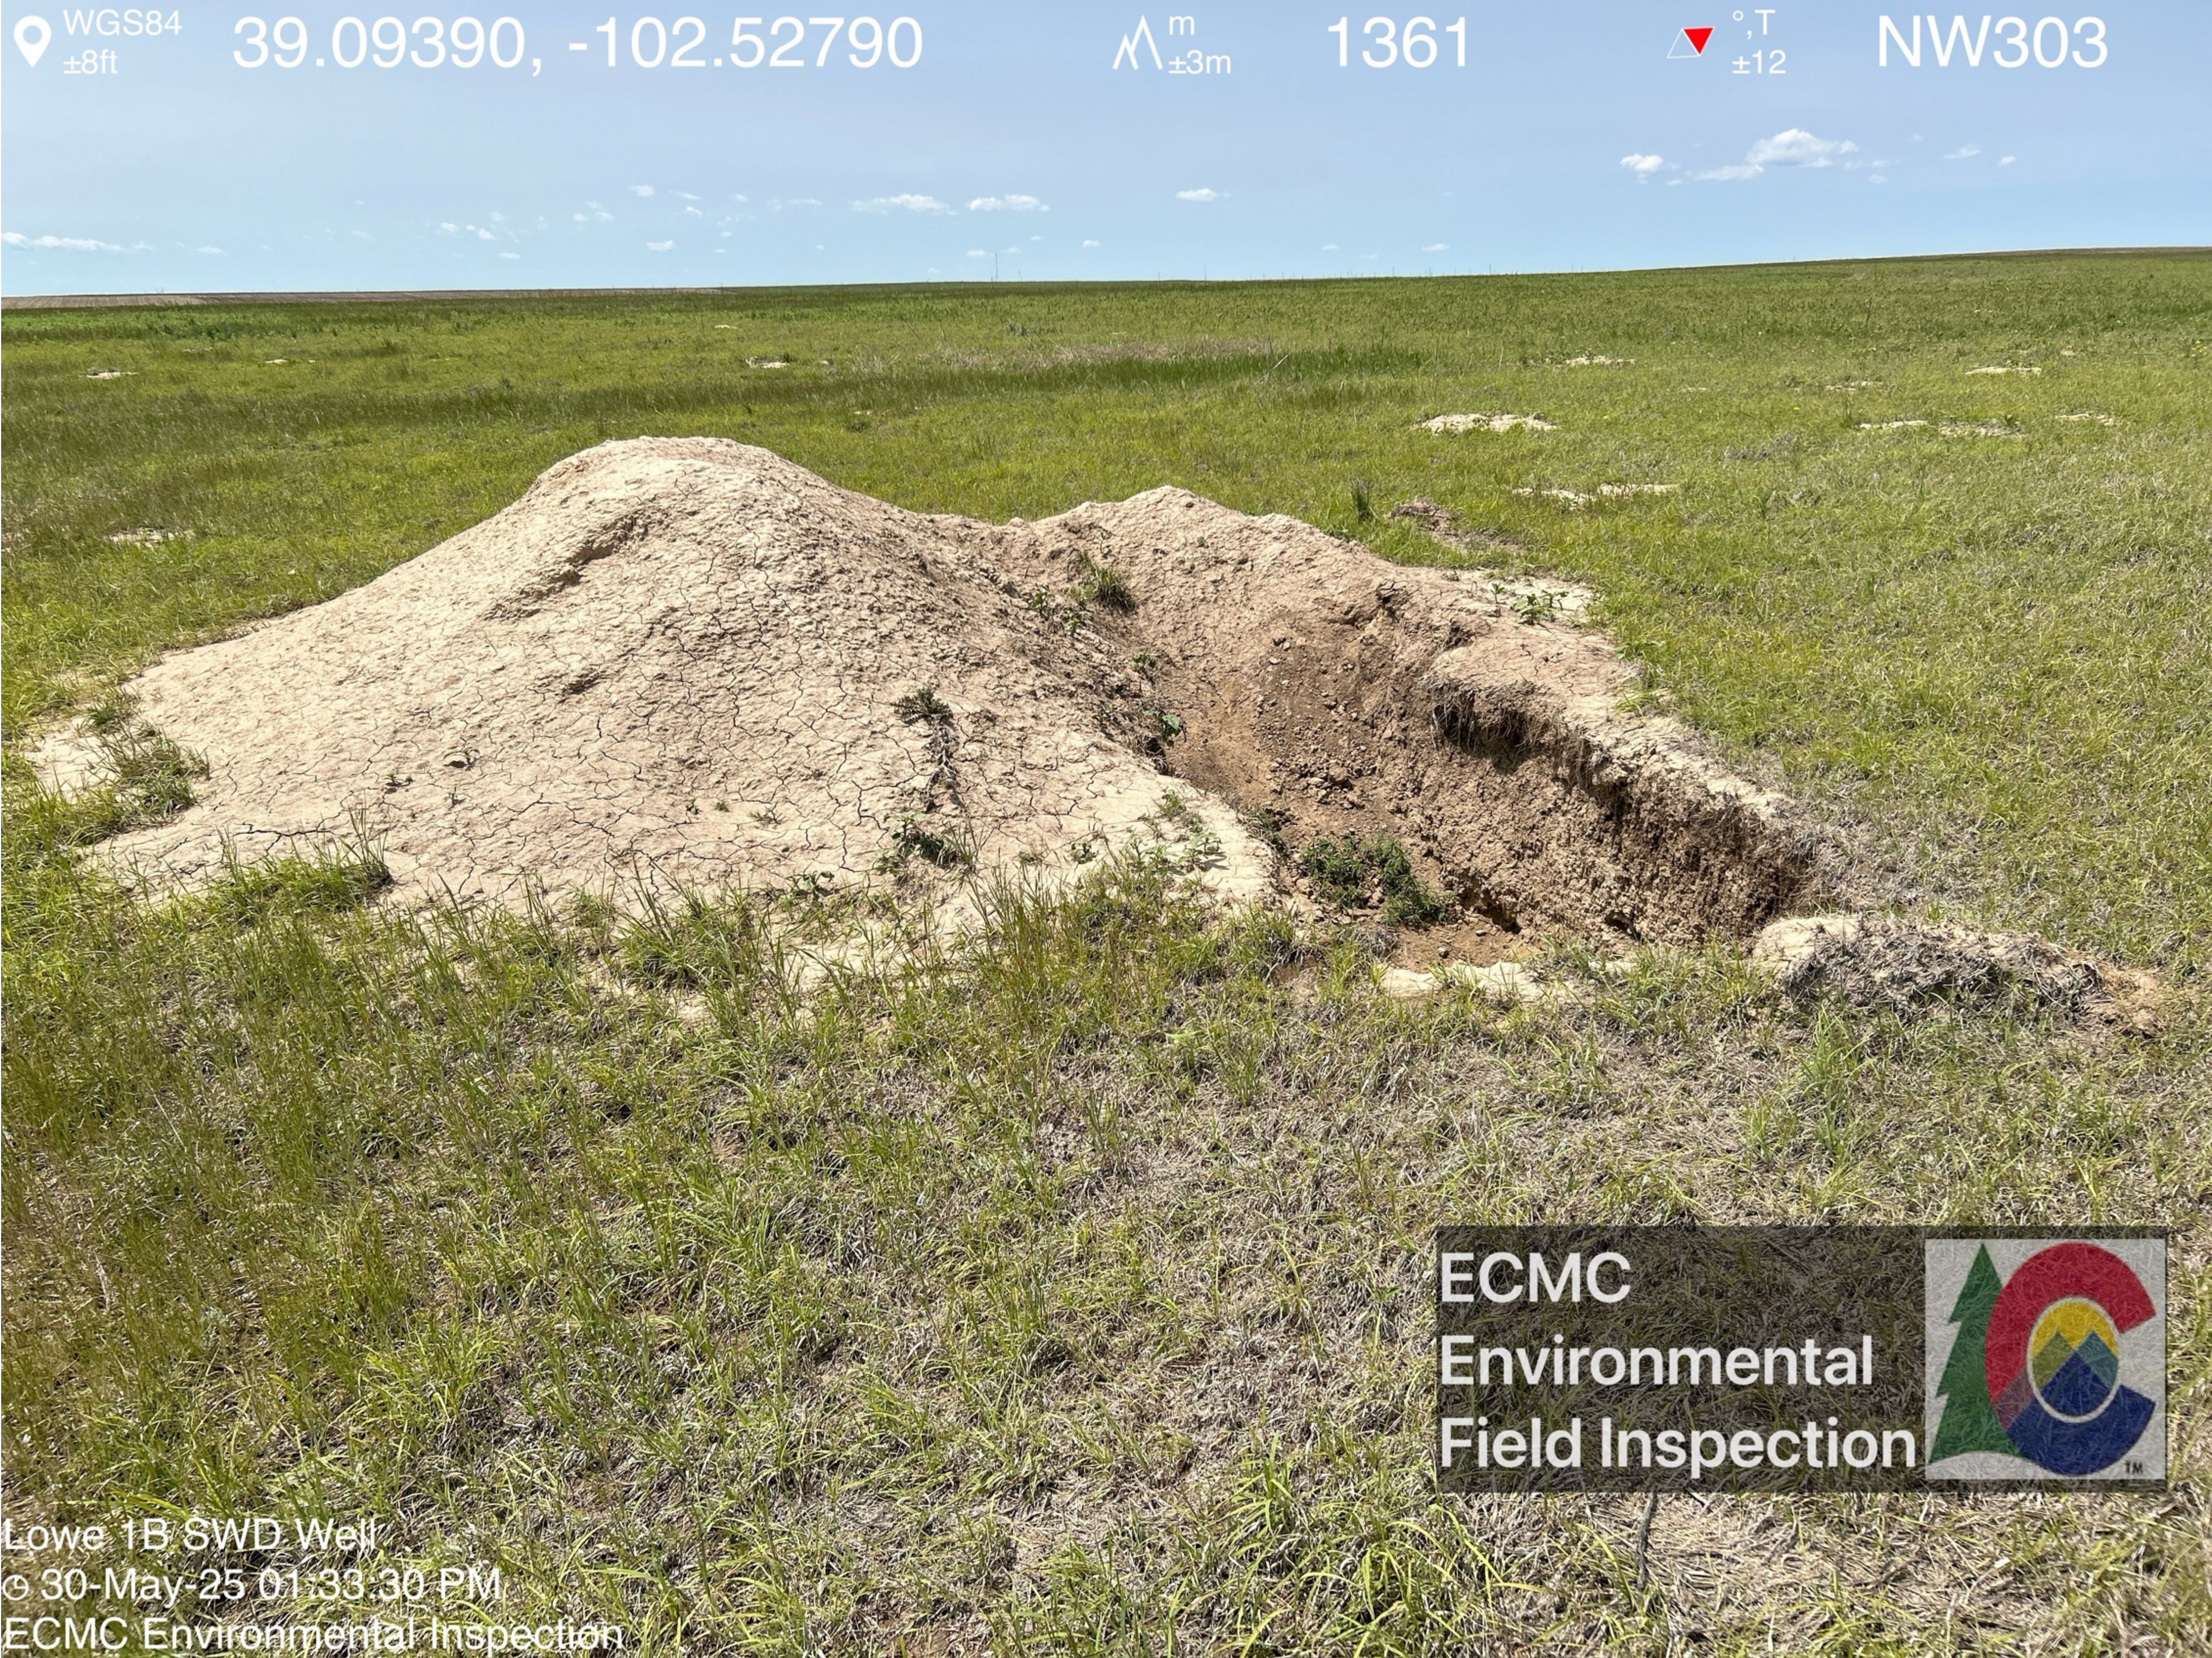
An unmarked soil stockpile and a small excavation are visible southeast of the former wellhead.
